PART III: FEASIBILITY STUDY

C: NEW LANDFILL SITE SURVEY

PART III-C: NEW LANDFILL SITE SURVEY

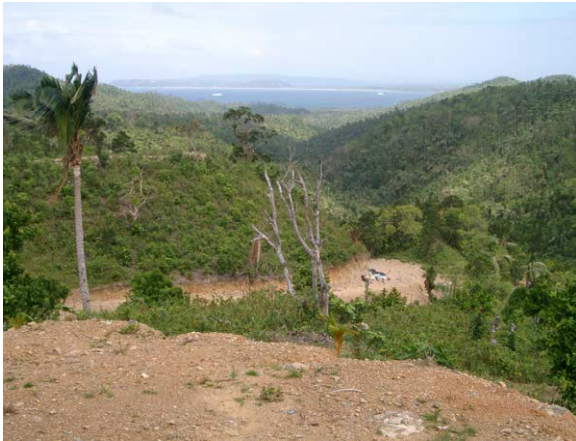
Overall Profile of Proposed Site of New Sanitary Landfill Site

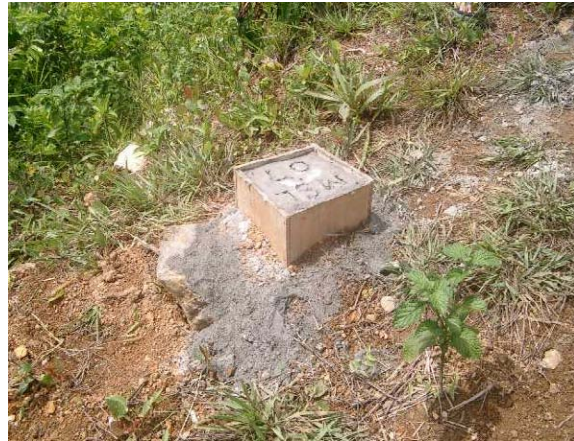
Benchmark for Topographic Survey

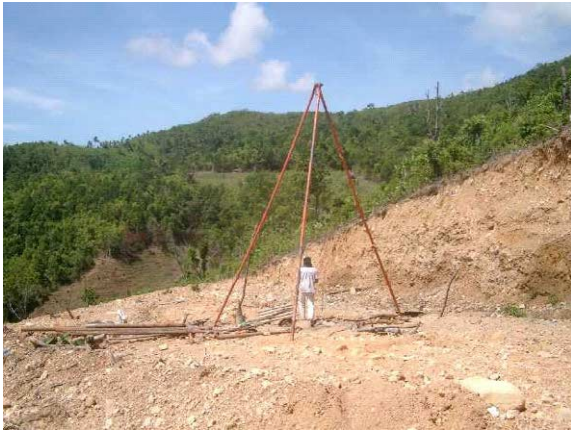
Excavation of Borehole for Geological Investigation

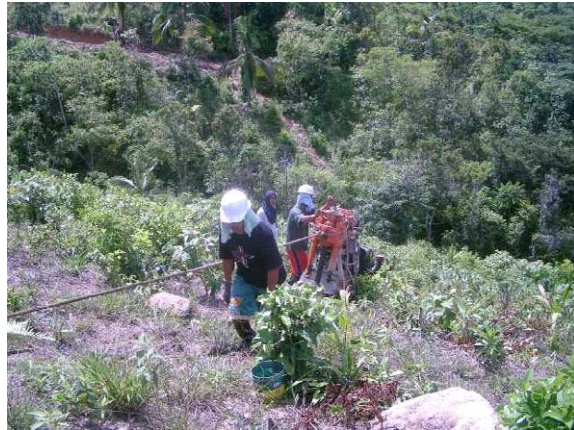
Excavation of Groundwater Monitoring Well

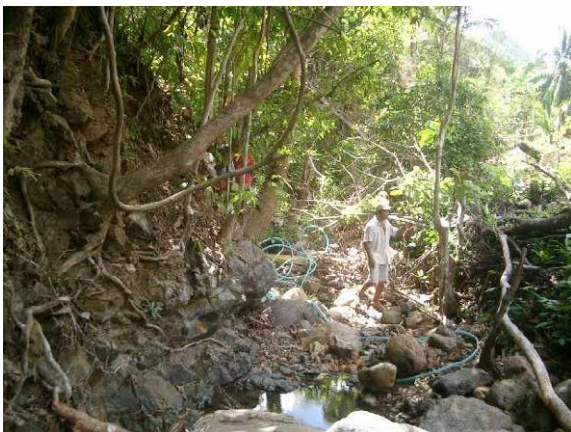
Water Suction for Boring

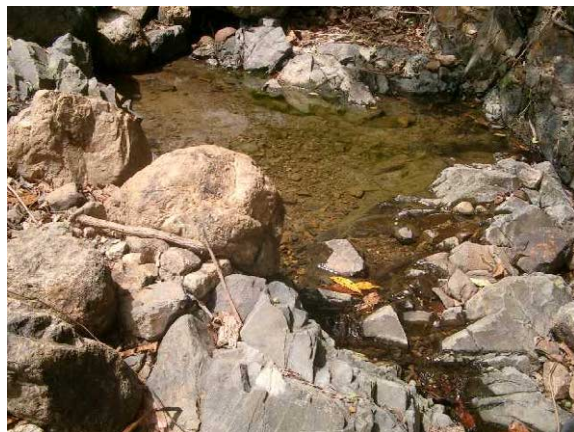
Surface Water Monitoring Point

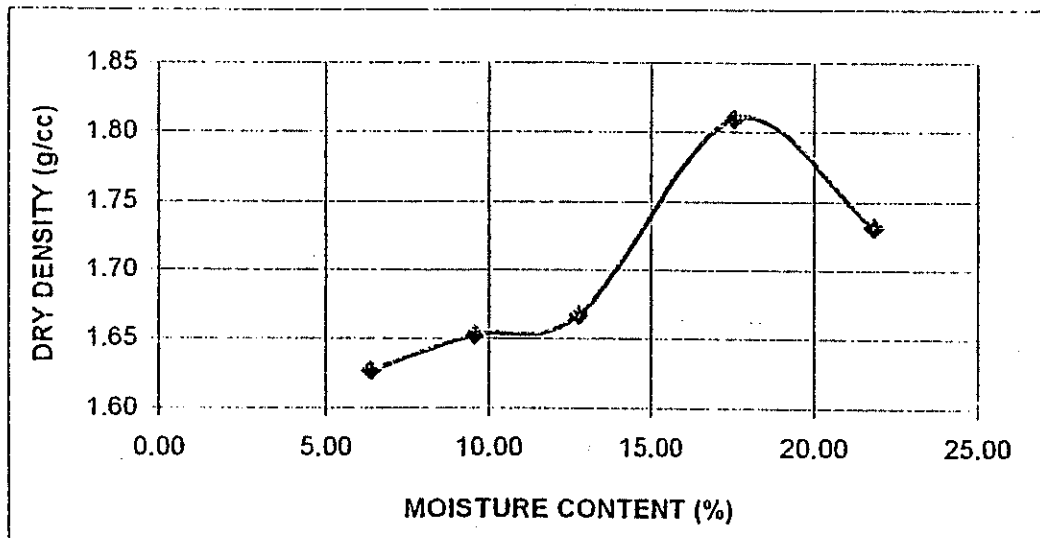
Trial Number	1	2	3	4	5
Water added in ml	200	200	200	200	200
Mold + Wet Soil (g)	3530	3602	3664	3888	3872
Mold (g)	1966	1966	1966	1966	1966
Wet Soil (g)	1564	1636	1698	1922	1906
WET DENSITY (g/cc)	1.73	1.81	1.88	2.13	2.11
Container Number	A15	A17	A11	A20	A2
Container (g)	22	22	22	22	22
Container + Wet Soil (g)	221	262	243	276	262
Container + Dry Soil (g)	209	241	218	238	219
Water (g)	12	21	25	38	43
Dry Soil (g)	187	219	196	216	197
MOISTURE CONTENT (%)	6.42	9.59	12.76	17.59	21.83
DRY DENSITY (g/cc)	1.63	1.65	1.67	1.81	1.73

Volume of Mold (cc)	903.21
Method Used (A, B, C, D)	C
Rammer (2.5 kg, 4.5 kg)	2.5 kg
Layer No. (3, 5)	3 layers
No. of Blows / Layer (25, 56)	25 blows
Maximum Dry Density (MDD), g/cc	1.812
Optimum Moisture Content (OMC), %	18

Mechanical properties of the soil by California Bearing Ratio (CBR) test was conducted on the soil samples (TP-3 & TP-1). Values obtained for the Maximum Dry Density and Optimum Moisture Content is as follows :

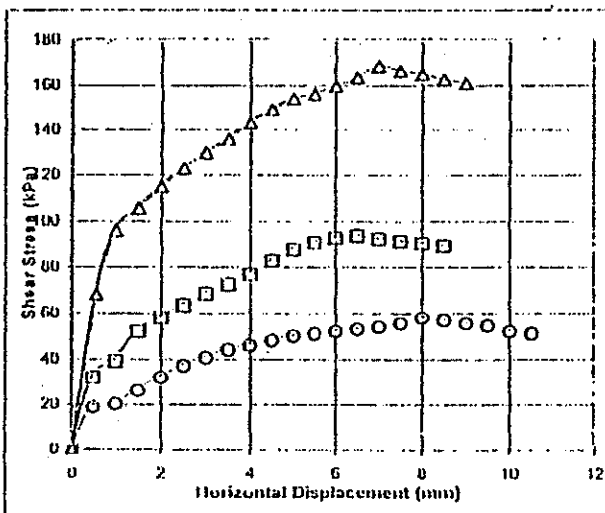
Area of specimen mm² : 4032
 Height of specimen mm : 19
 Moisture content % : 24.4
 Bulk density g/cm³ : 2.09
 Dry density g/cm³ : 1.68
 Rate of strain mm/min : 0.0024
 Specimen tested : wet

Load Step	Applied Normal Stress kN/m ²	Maximum Shear Stress kN/m ²	Displacement at Max. Stress mm
1	100	58.0	7.5
2	200	93.7	6.5
3	400	168.6	7.0

Cohesion Intercept (C) = 21 kPa
 Angle of Shear Resistance (φ') = 20°

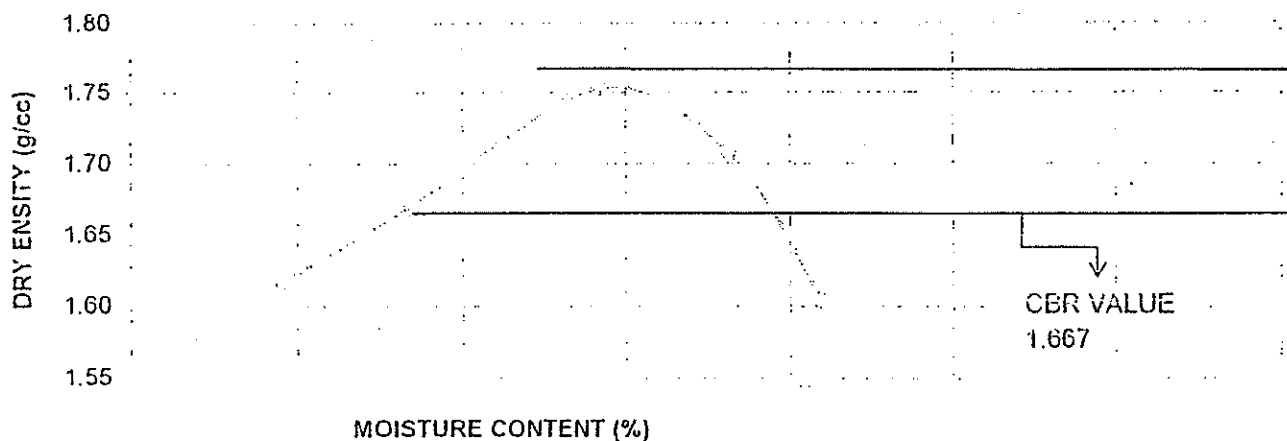
CALIFORNIA BEARING RATIO

Trial Number	1	2	3	4	5
Water added in ml	200	200	200	200	200
Mold + Wet Soil (g)	3566	3676	3855	3865	3791
Mold (g)	1966	1966	1966	1966	1966
Wet Soil (g)	1600	1710	1889	1899	1825
WET DENSITY (g/cc)	1.77	1.89	2.09	2.10	2.02
Container Number	A29	A26	A21	A30	A3
Container (g)	22	22	22	22	22
Container + Wet Soil (g)	228	183	183	224	317
Container + Dry Soil (g)	210	164	157	186	256
Water (g)	18	19	26	38	61
Dry Soil (g)	188	142	135	164	234
MOISTURE CONTENT (%)	9.57	13.38	19.26	23.17	26.07
DRY DENSITY (g/cc)	1.62	1.67	1.75	1.71	1.60

Volume of Mold (cc)	903.21
Method Used (A, B, C, D)	C
Rammer (2.5 kg, 4.5 kg)	2.5 kg
Layer No. (3, 5)	3 layers
No. of Blows / Layer (25, 56)	25 blows
Maximum Dry Density (MDD), g/cc	1.755
Optimum Moisture Content (OMC), %	19.9
