**National Directorate of Water and Sanitation Services
Ministry of Infrastructure
The Democratic Republic of Timor-Leste**

**BASIC DESIGN STUDY REPORT
ON
THE PROJECT FOR URGENT IMPROVEMENT
OF
WATER SUPPLY SYSTEM IN BEMOS-DILI
IN
THE DEMOCRATIC REPUBLIC OF TIMOR-LESTE**

JAPAN INTERNATIONAL COOPERATION AGENCY

SANYU CONSULTANTS INC.

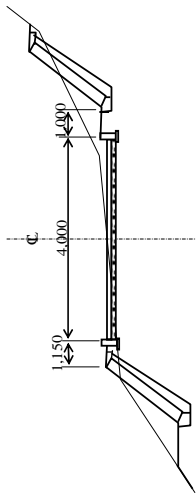
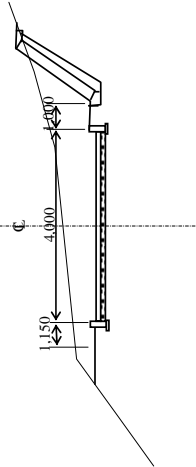
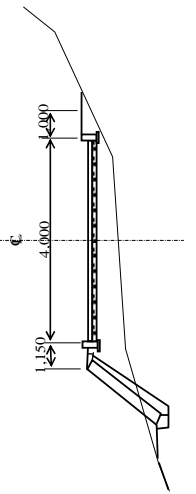
Table 2-2.32 Comparison of the Longitudinal Sloping Method for Access Road

Items	Plan A : Existing Slope (Max. : 43.3%)	Plan B : Excavation (Max. : 19.5%)	Plan C : Embankment (Max. : 19.3%)
Typical Road Cross Section

Pavement Type	Concrete Pavement is selected due to the longitudinal slope more than 12%	Concrete Pavement is selected due to the longitudinal slope more than 12%	Concrete Pavement is selected due to the longitudinal slope more than 12%
Traveling Performance	Worst condition for traveling due to the steepest slope of 43.3%. inferior	Better condition for traveling due to rather gentle slope of 19.5% than that of access road to Bemos WTP (24.7%). good	Better condition for traveling due to rather gentle slope of 19.5% than that of access road to Bemos WTP (24.7%). good
Incidental Facilities	<ul style="list-style-type: none"> • Earth Retaining Works : Length 0.0m Wet Masonry 0.0m² • Road side structure : Length 66.0m Wet Masonry 217.3m² • Total : Length 66.0m Wet Masonry 217.3m² Small scale incidental facility is required. Best (1.00)	<ul style="list-style-type: none"> • Earth Retaining Works : Length 38.5m Wet Masonry 122.8m² • Road side structure : Length 56.5m Wet Masonry 176.7m² • Total : Length 95.0m Wet Masonry 299.5m² Rather large scaled incidental facility is required. Better (1.38)	<ul style="list-style-type: none"> • Earth Retaining Works : Length 38.5m Wet Masonry 90.5m² • Road side structure : Length 76.0m Wet Masonry 235.4m² • Total : Length 114.5m Wet Masonry 325.9m² The largest scaled incidental facility is required. Worse (1.50)
