## 7.3 増設基本案の各構造物地点の地質

### 7.3.1 水路

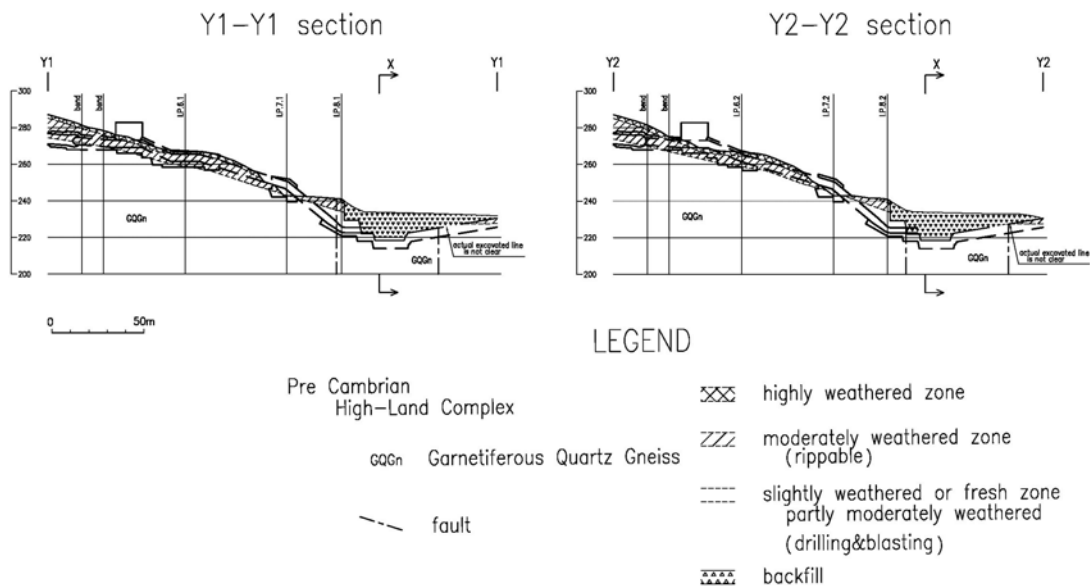
Figure 7.3.1-6 Geologic Profile of New Penstock

予想される地質断面をFigure 7.3.1-6およびDrawing 006に示す。水圧管路地上区間は標高270m付近より標高約230mの発電所へと至る斜面に位置する。基盤岩は片麻岩 (Garnetiferous Quartz Gneiss) が主体で、片理は斜面に流れ目で、風化部では黒雲母や雲母の薄層が分離面となるためにブロック状に不安定化し易く、既設水圧管路では、小断層と複合して100 m<sup>3</sup>の崩壊が発生した。増設の水圧管路工事でも風化部の掘削には、不安定なブロックの発生に注意し、適切な支保を施工する必要がある。なお、図に示す地質境界および風化境界は推定であり、詳細設計時にはアンカー基礎部などでボーリングによる風化深度の確認が必要である。
