# **CHAPTER 7**

# **GEOLOGY**

## Chapter 7 Geology

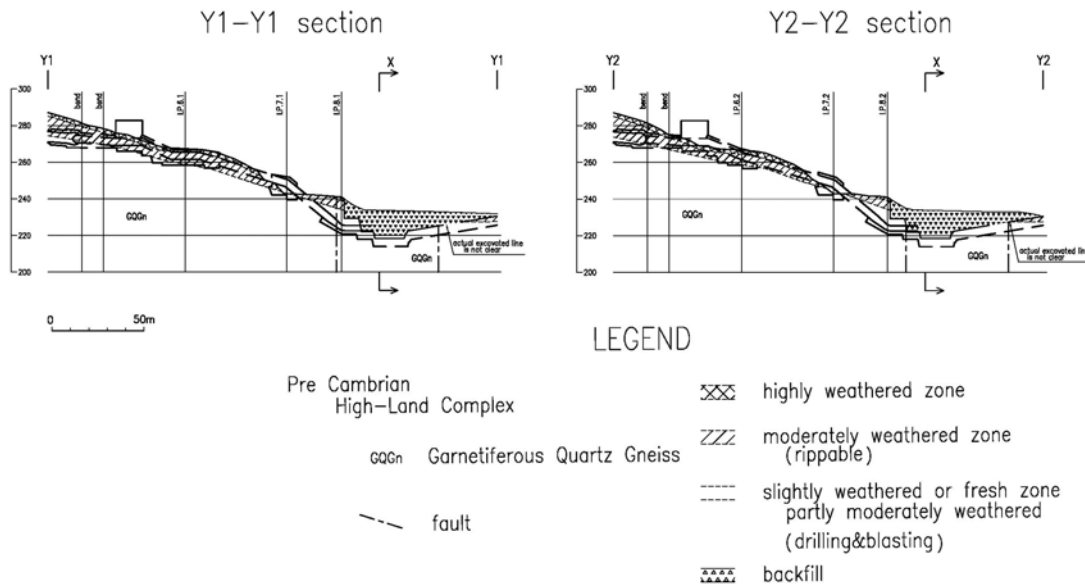
Figure 7.3.1-6 Geologic Profile of New Penstock

The geologic profiles of the new penstock are shown in **Figure 7.3.1-6** and **Drawing 006**. The surface portion of the penstock is situated on the slope between the downstream portal about on 270 m in elevation and the powerhouse about on 230 m in elevation. The basement rock of the slope is mainly composed of Gneiss (Garnetiferous-Quartz-Gneiss), of which foliation is nearly parallel to the slope inclination, and the biotite layers which are included in Gneiss tend to become slippery planes when they are in the weathered zone. Due to such biotite layers and a small fault, a slip of about 100 m<sup>3</sup> of material occurred during the previous construction. It is necessary to pay attention to the appearance of instable blocks during excavating in the weathered zone, and to install the adequate rock bolts when it appears.

The core drillings at the anchors are recommended to be carried out during the detailed design stage in order to certify the boundaries of weathered zones.
