CHAPTER 3

DESCRIPTION OF THE EXISTING ENVIRONMENT

3.1 Project Impact Area

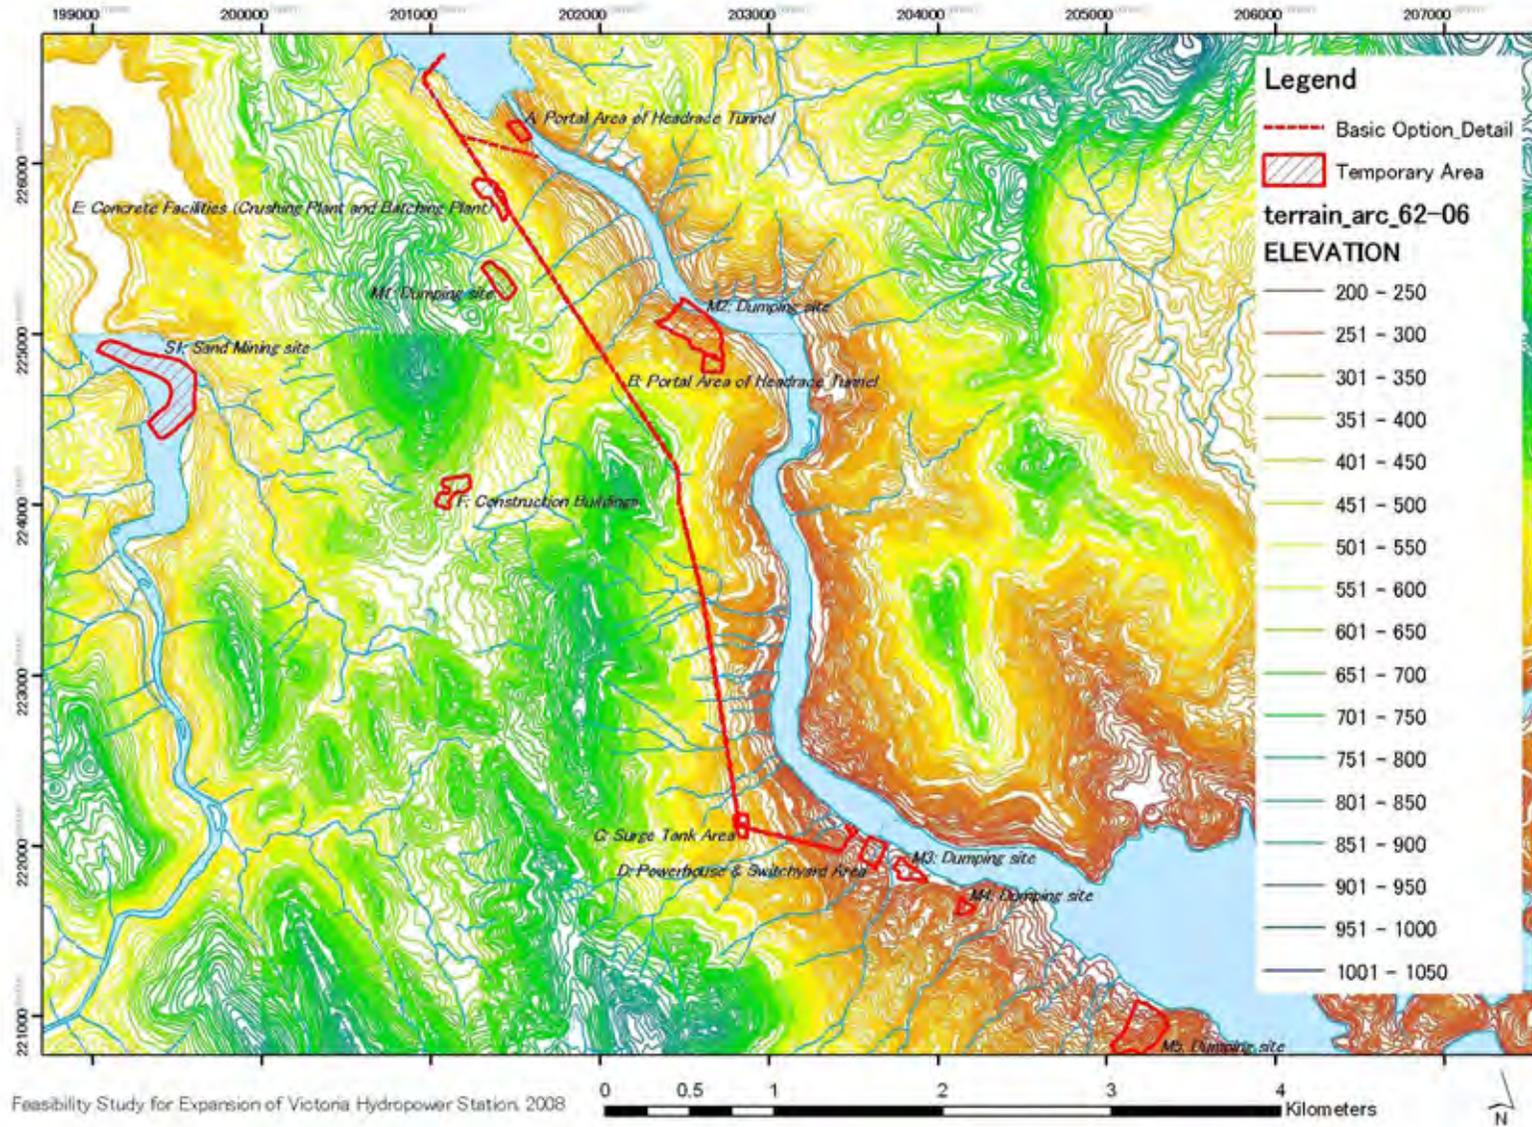
Figure 3-1 Contour map of the PIA

The project area is a rugged terrain with an elevation ranging from about 240m above msl to about 800m (Figure 3-1). This gives the relief of the area to be over 500m. The elevation rises steeply in many sections towards west from the Mahaweli river bed which runs in a northwest-southeast direction. The lowest elevation is marked by the bottom of the Mahaweli River which flowed in a deep valley before the construction of the Victoria Reservoir at the Victoria Falls. Now the flow in the reach from Victoria Dam to the Victoria Powerhouse is limited to local drainage and contributions from small tributaries from the left and right bank areas to the Mahaweli River. The flow derived from the upper catchment is directed through the Victoria tunnel for power generation. The proposed project utilizes the same quantum of water and therefore does not affect the current flow regime of the Mahaweli River up to the Victoria Powerhouse.

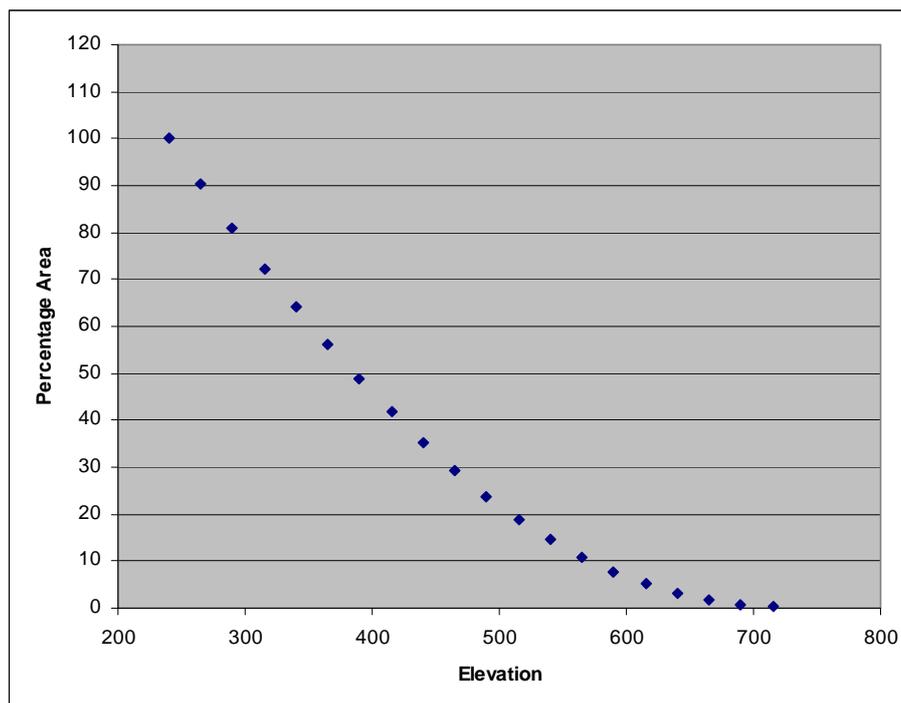
Figure 3-2 Area Altitude Curve of the Project Impact Area (Basic Option)

The percentage land area above various elevation levels is given in Figure 3-2. The curve shows that over 50% of the area has an elevation above 400m. This mountainous terrain is cut by numerous perennial and seasonal streams. The low elevations are found close to the Mahaweli River as a narrow belt.

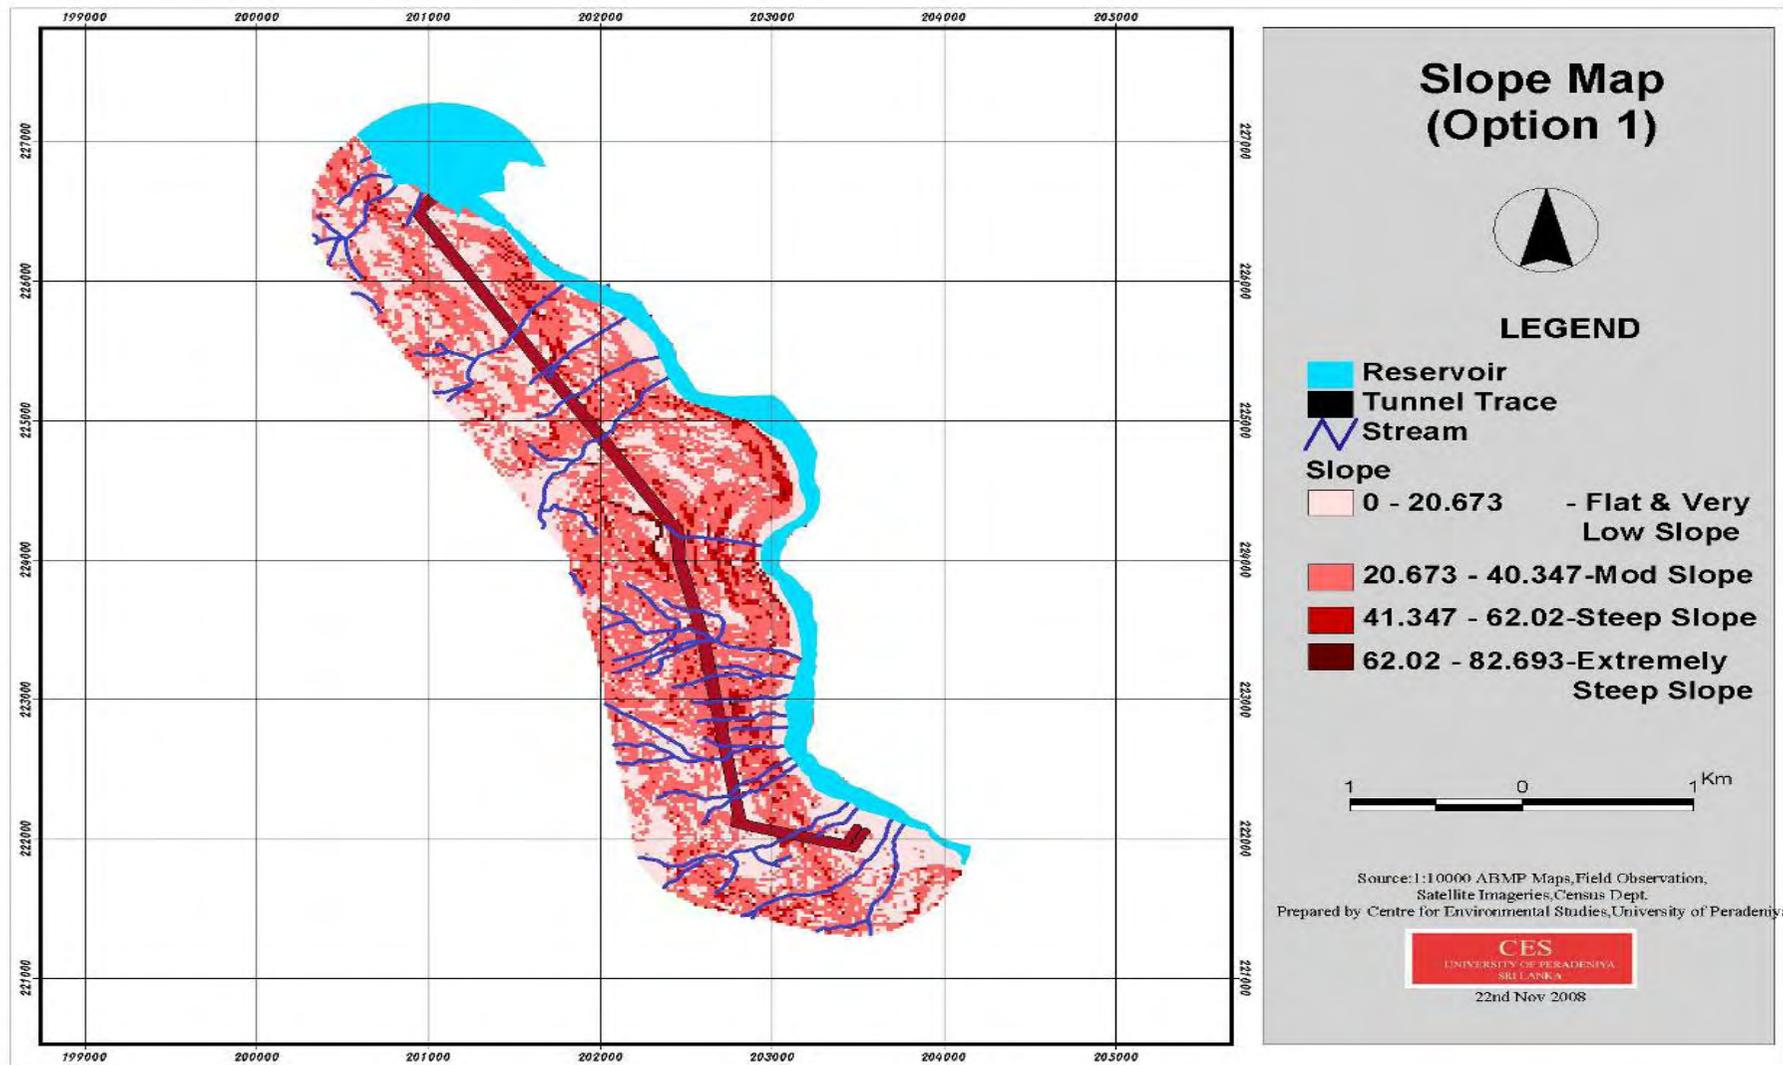
Figure 3-3 The Slope Map of the Project Impact Area

The slopes in the study area range from almost flat to extremely steep slopes. The slope categories are a simplified version of the NRMC classification prepared for agricultural lands. Four slope classes identified are listed in Table 3-1 with the recommended uses. The distribution of slope categories in the PIA is given in Figure 3-3.

The final stretch of the Alternative runs through a very steep terrain with slope gradients exceeding 40°. This area belongs to the Galauda North and Hilpenkandura GN Divisions. The tunnel crosses part of this terrain (Figure 3-3).

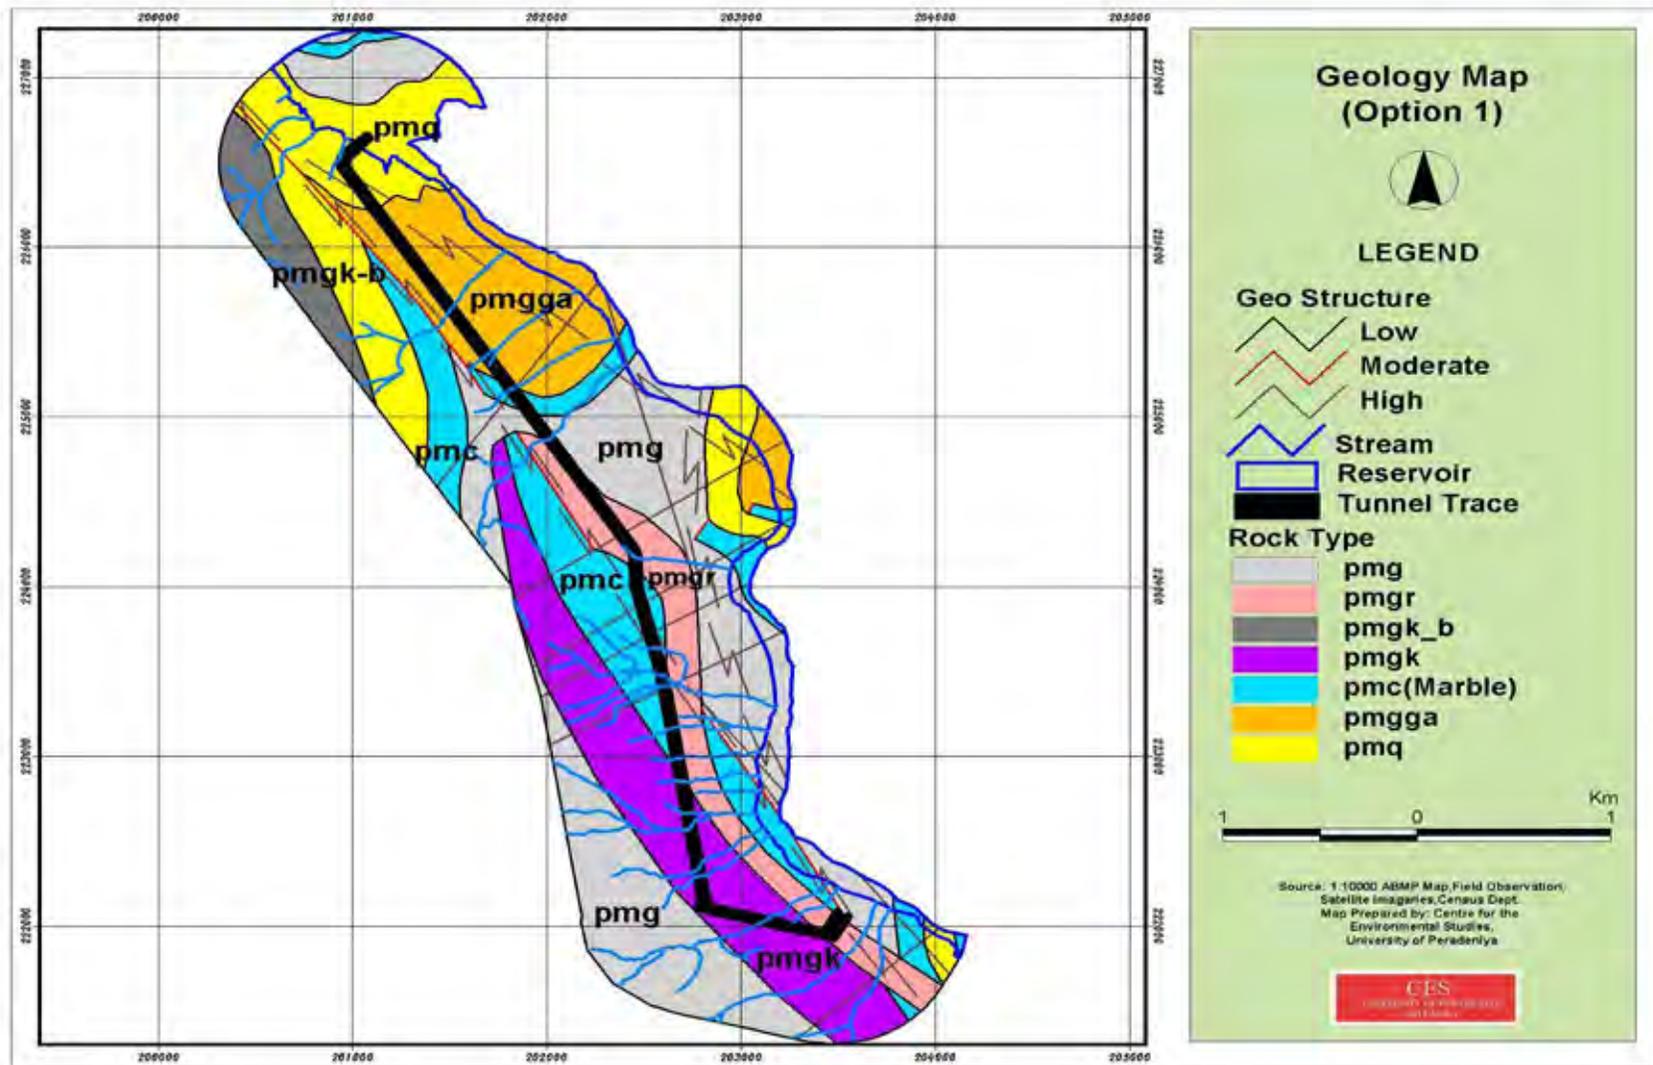
Figure 3-4 Geology of PIA

The Project area is composed of Precambrian metamorphic rocks, such as Gneisses (Garnetiferous Quartz Gneiss, Quartz Biotite Gneiss, Biotite Gneiss), Granulite, Quartzite, and Crystalline Limestone (Marble). Generally, these rocks lie alternately with some folding, as bands nearly parallel to the Mahaweli River (Figure 3-4), and sometimes occur as lens-like shapes or as displaced blocks of rocks. The thickness of each layer of Gneisses, Granulite, and Quartzite varies from several cm to tens of metres.

The strike of the foliation in these metamorphic rocks varies from NW-SE to NNW-SSE from the dam area to the powerhouse area, nearly parallel to the Mahaweli River. The river in this reach lies in a syncline (Huluganga Synform). Hence, the foliation dips downward to the riverbed on both banks. The dip varies 15° near the river bed to 40° at the upper slope. The irregular dip variations occur due to the minor folding and the presence of displaced blocks of rocks. The fresh rock is overlain by the weathered zone which in turn is covered by an overburden of talus deposits. Gneisses are exposed broadly along the riverbed, so only a little river deposit occurs on the riverbed.

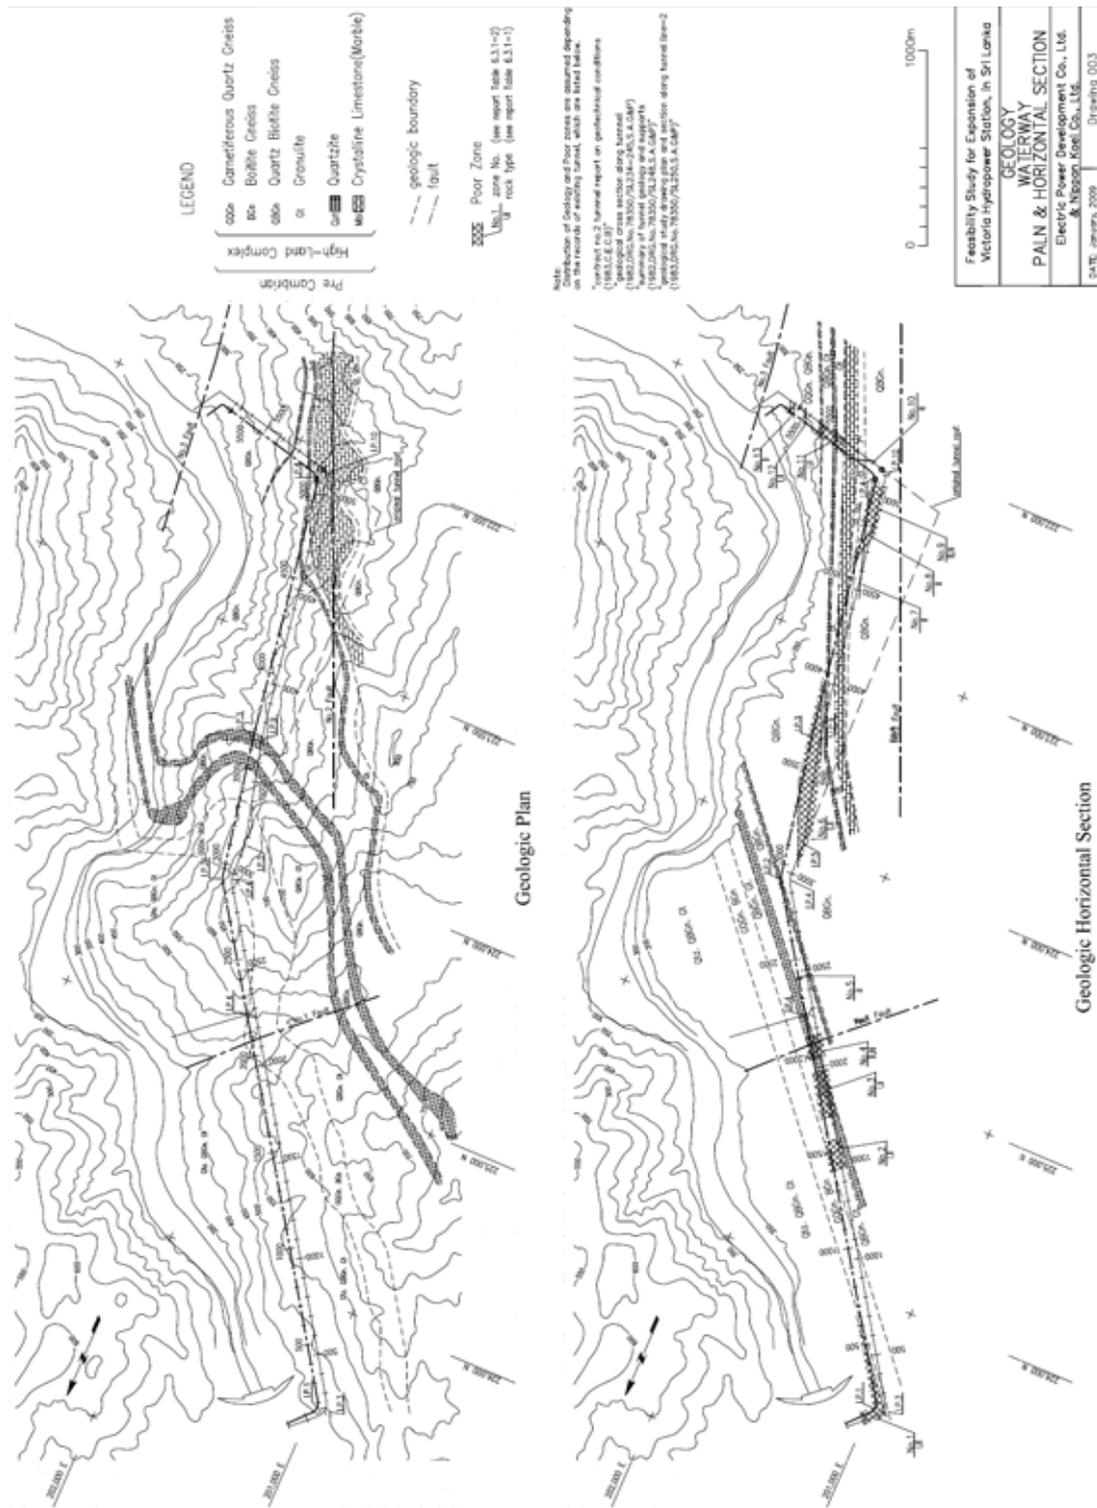
Figure 3-5 Map of Geology of Project Area

The bed rock in the headrace is variable. A vertical section showing the new headrace with the geological formation along the trace is given in Figure 3-5. The records of the existing tunnel construction show that the bed rock in this region has posed stability problems during tunnel excavation. The designers have used a rock classification system to decide on rock competency and hence to select a rock support method.

Information in Figure 3-5 and Table 3-9 show that the bed rock is unstable only at a few locations along the tunnel. However, in general, the rock is in good condition for tunnel dredging.

Five major faults are found in the PIA as shown on Figure 3-5. Four of these five faults can be found in construction reports of the existing Victoria Power project. They are located at the Victoria dam site, the powerhouse basement, near the adit, and near the surge tank. The fault near the surge tank is the biggest and the most troublesome. During the construction of

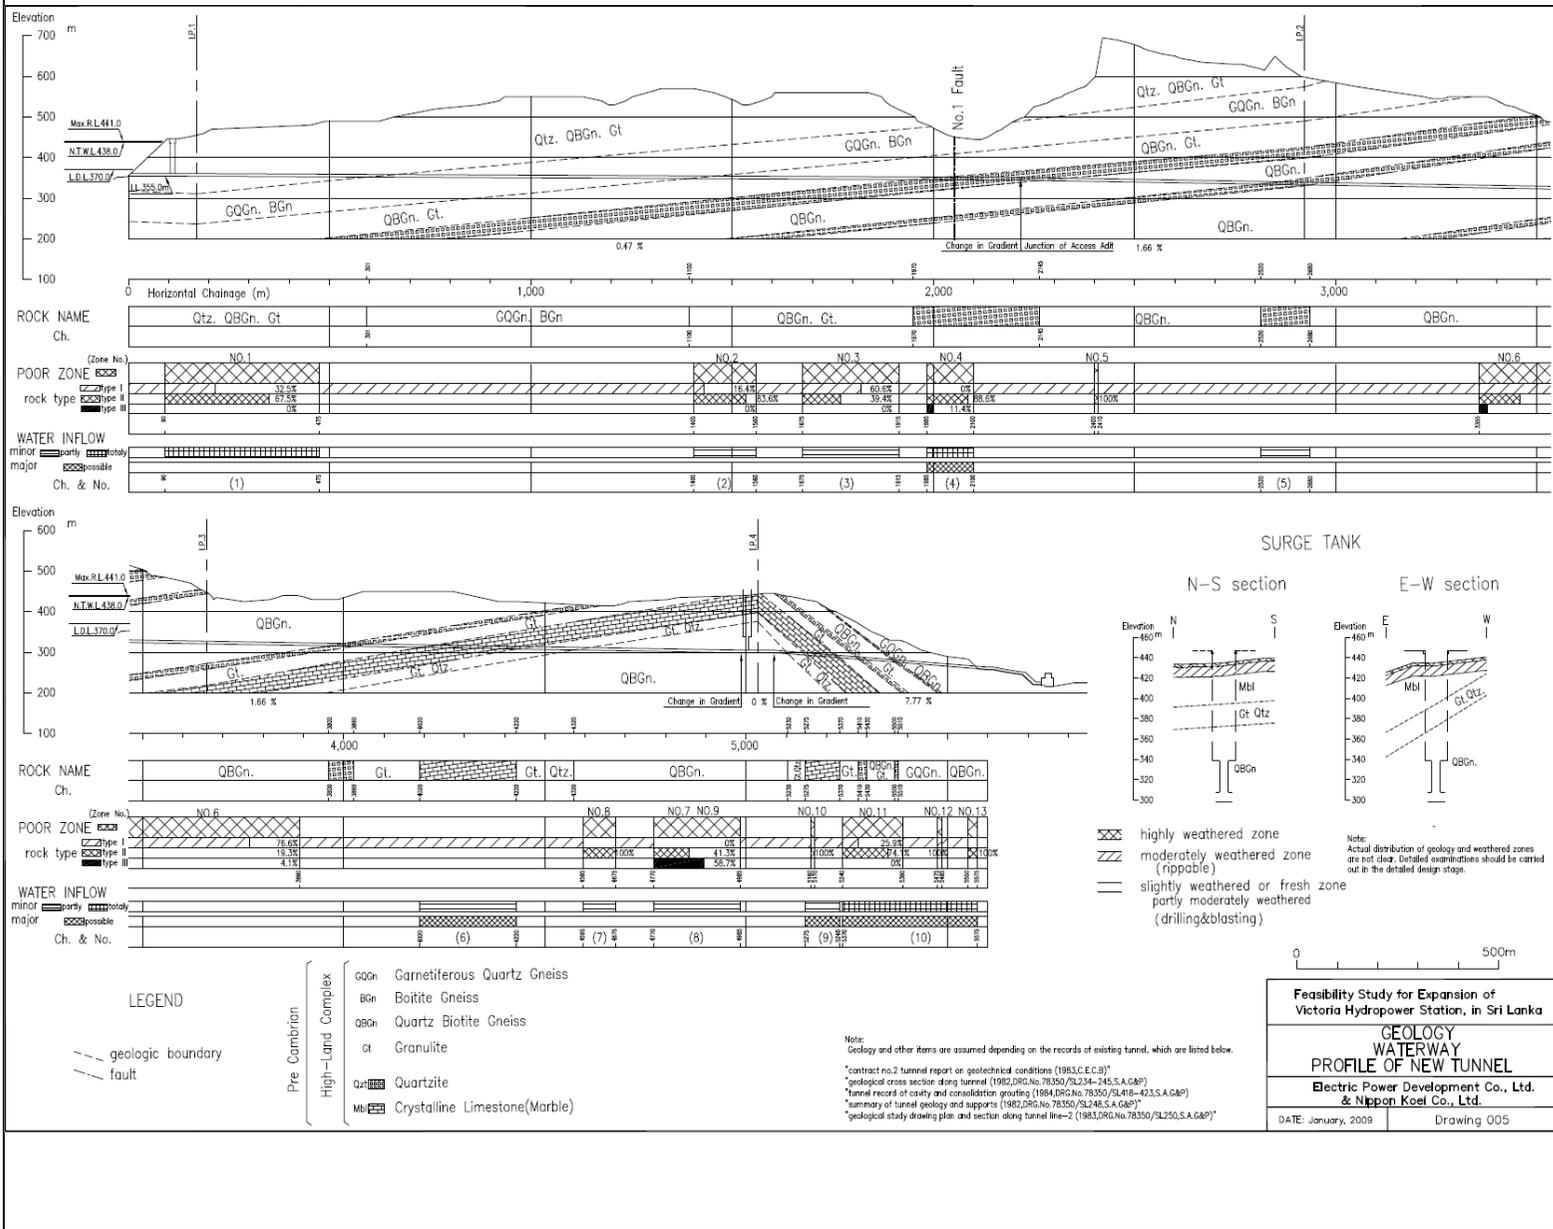
Figure 3-6 Vertical section showing new tunnel and geology Ch 00+00 to 05+750

Table 3-2 and Table 3-2 show critical zones that might be encountered along the new tunnel giving the rock and draw down conditions. Data for this Table was derived from the final report of the feasibility study.

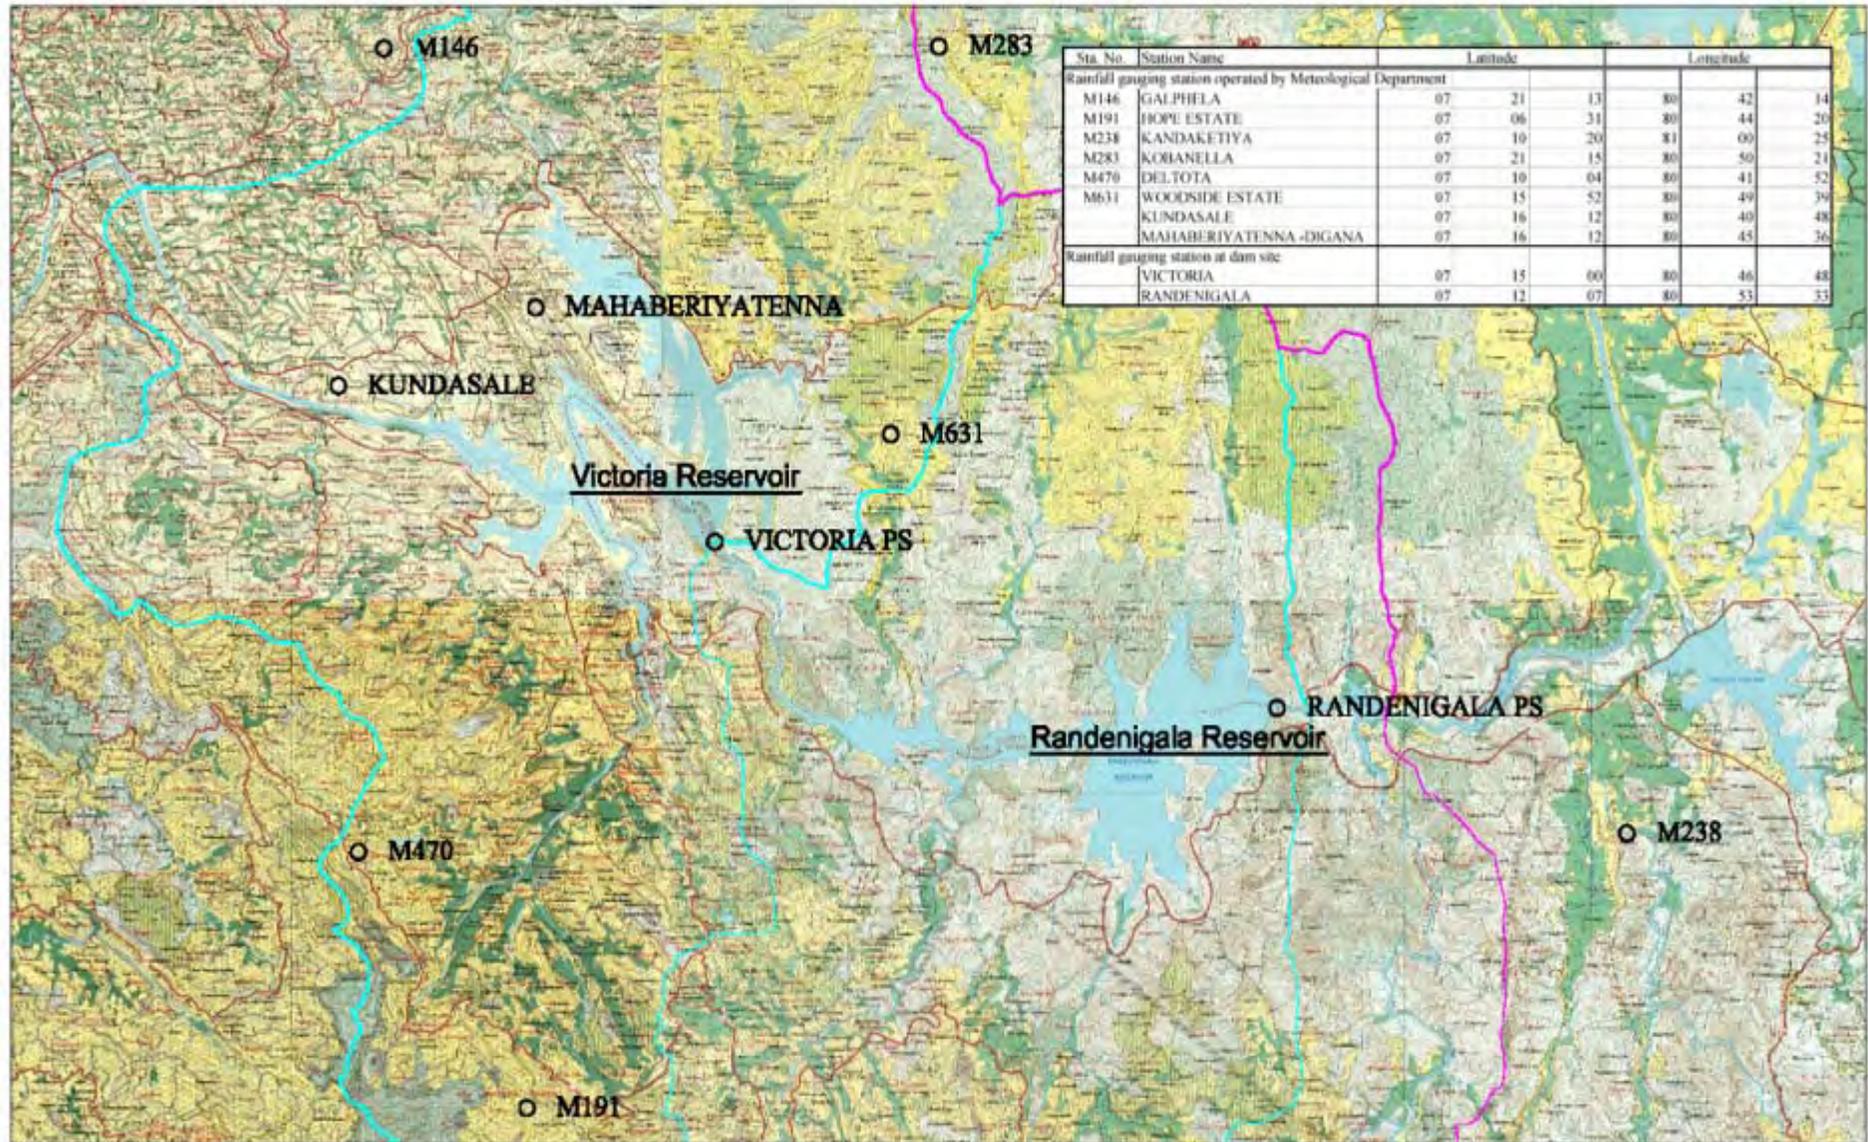
Figure 3-7 The locations of the gauging stations

The wide spatial variation of the rainfall around the study area is clearly seen in the average rainfall distributions observed at the gauging stations closest to the area in Figure 3-8. The locations of the meteorological stations are shown in Figure 3-7. The closest rain gauging station to construction is the Victoria Dam. Here the rain is high from October to January and low in the other months. The rains during the inter-monsoons in April are responsible for the somewhat high rain during that month. Other months, especially June, July and August are drier.

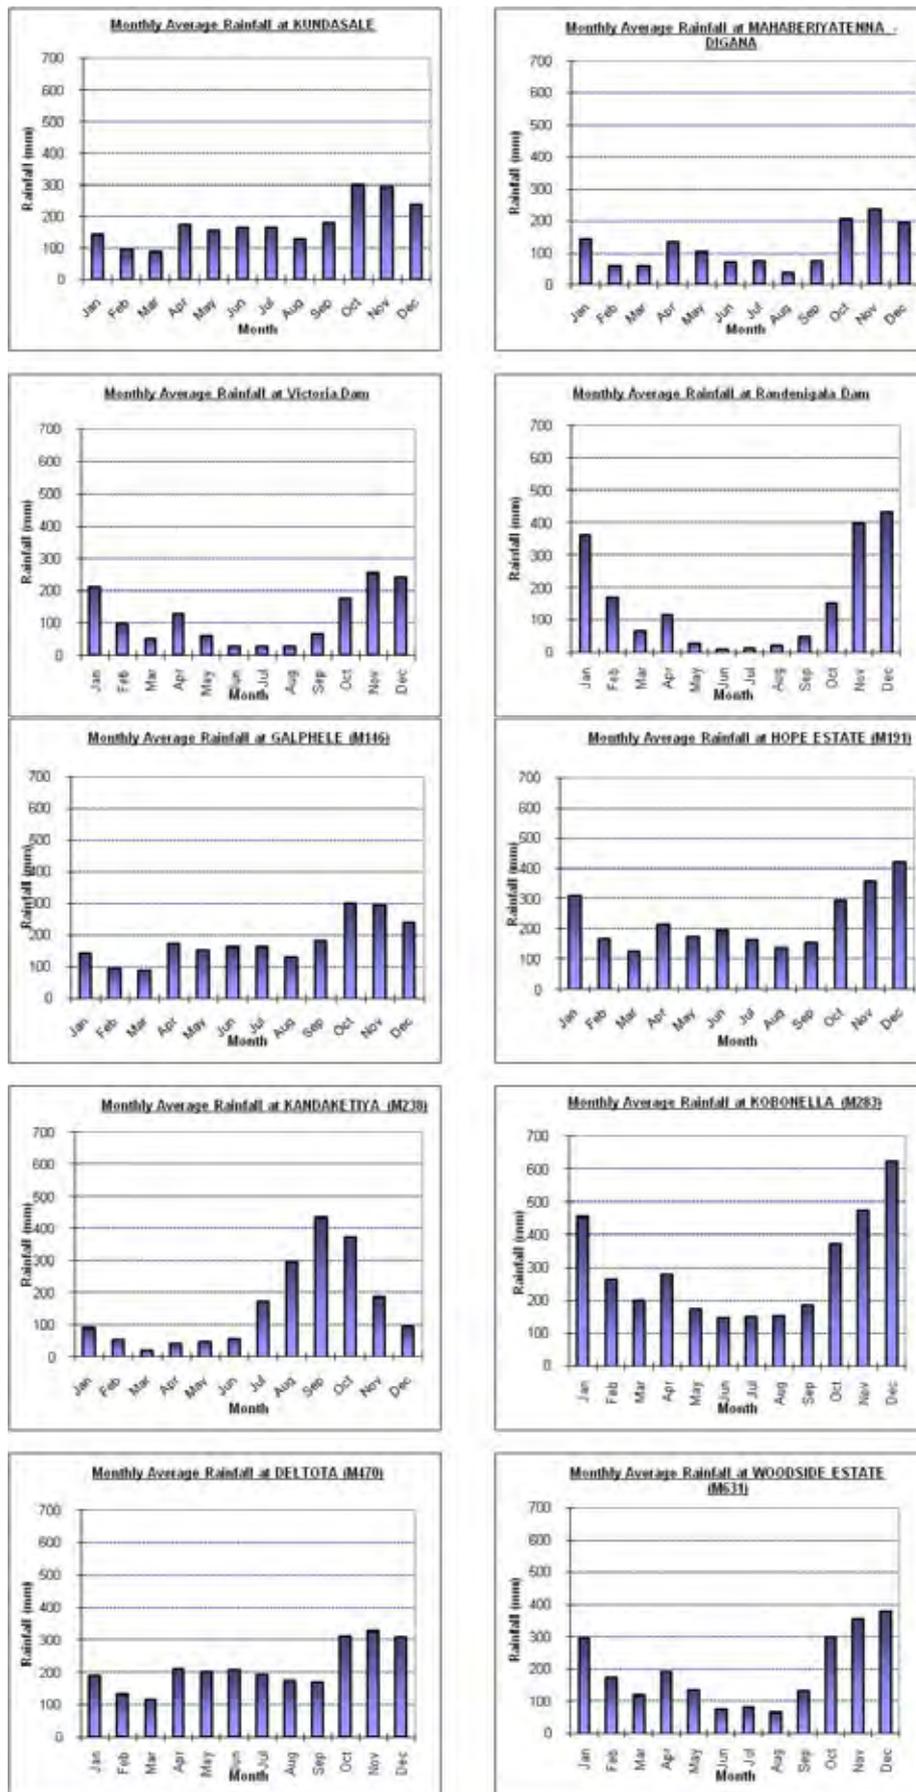
Figure 3-8 Rain fall pattern (2)

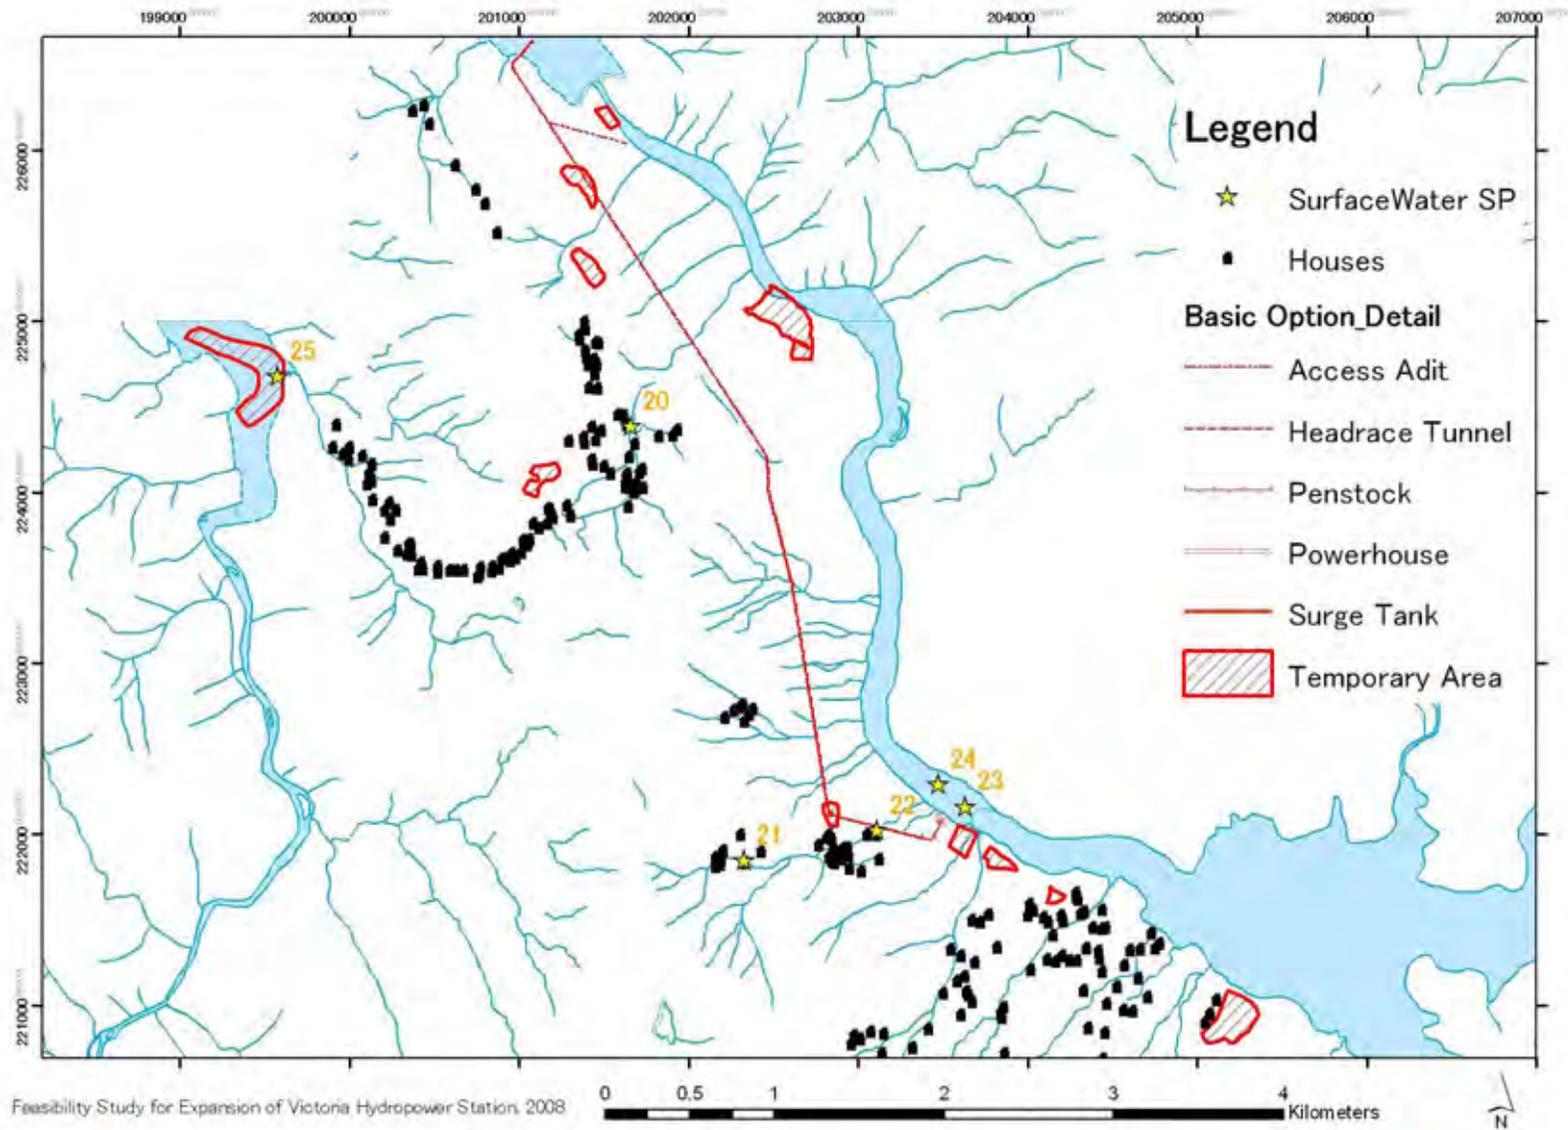
Figure 3-9 Locations of Surface water samplings

Samples were collected from six sites in total with two locations in the Mahaweli River, three locations from the surrounding creeks and one sample from the tributary where sand mining for the project is proposed. Location of these sampling points is shown in Figure 3-9. All these samples were analyzed for a range of general parameters, nutrients, cations, anions and trace metals.

Table 3-4 Surface water quality (Ref. Figure 3-9)

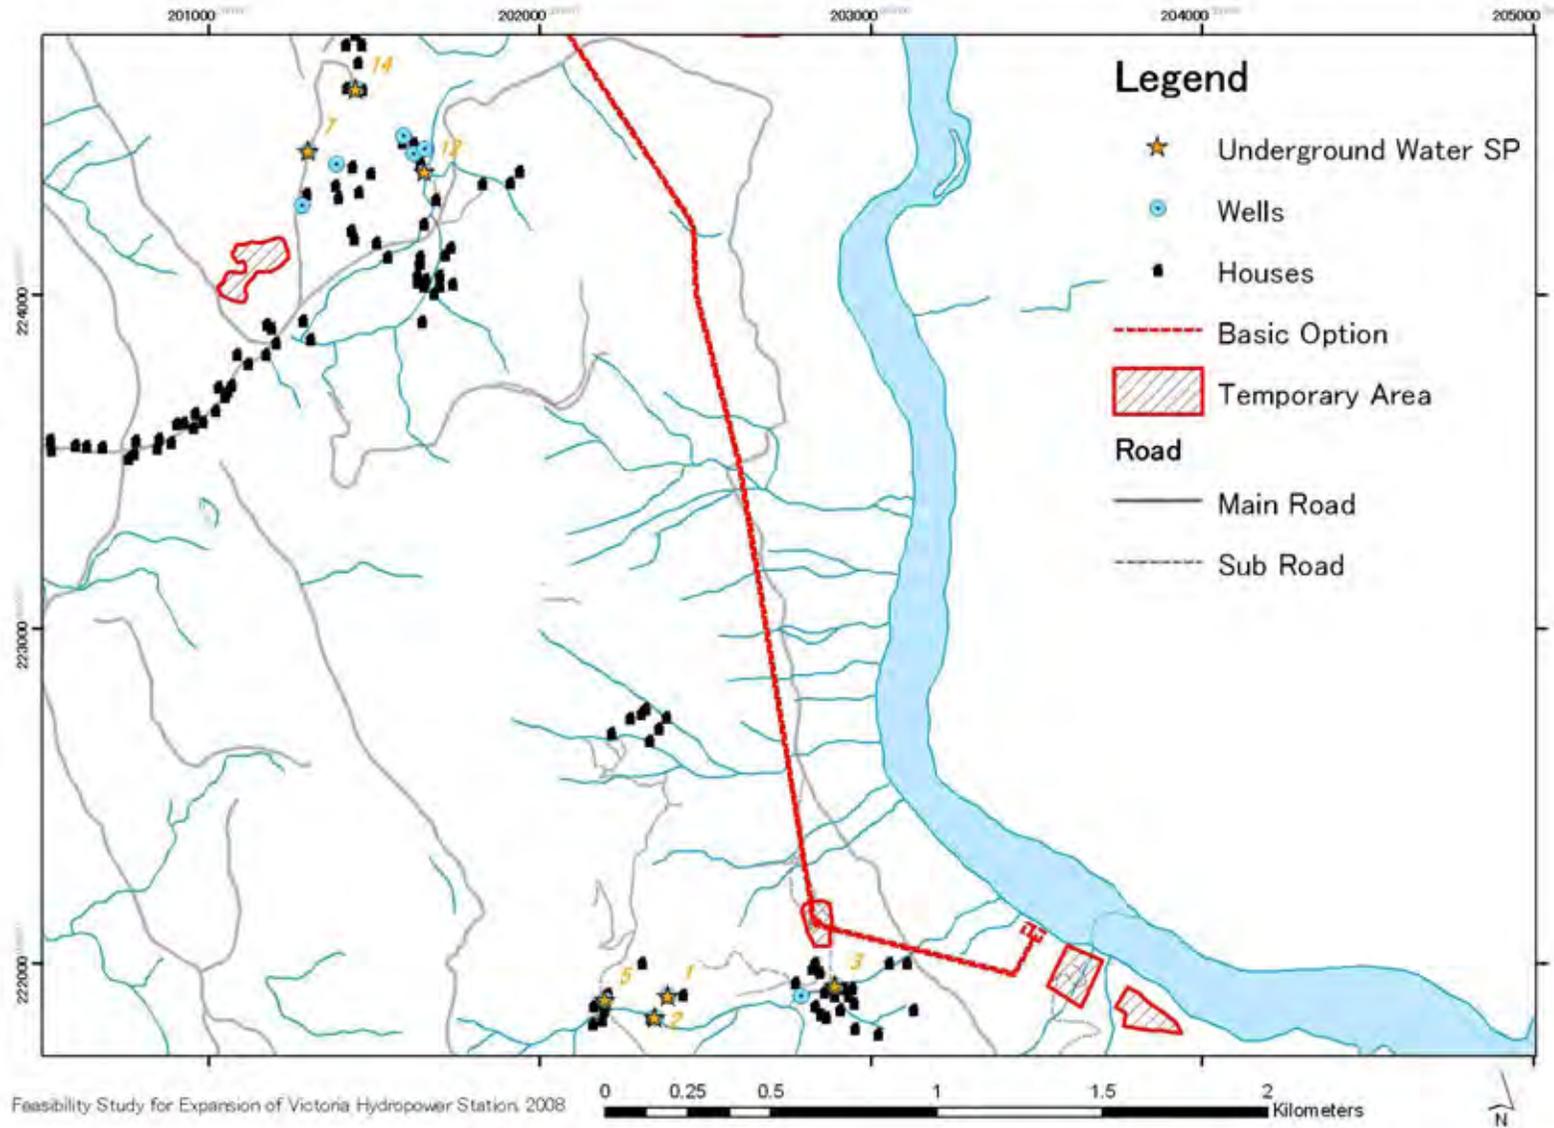
Figure 3-10 Locations of Groundwater sampling

Table 3-5 Water Level (meters below ground surface Ref. Figure 3-10 for locations)

Table 3-6 Current groundwater quality of the area (ref. Figure 3-10 for locations)

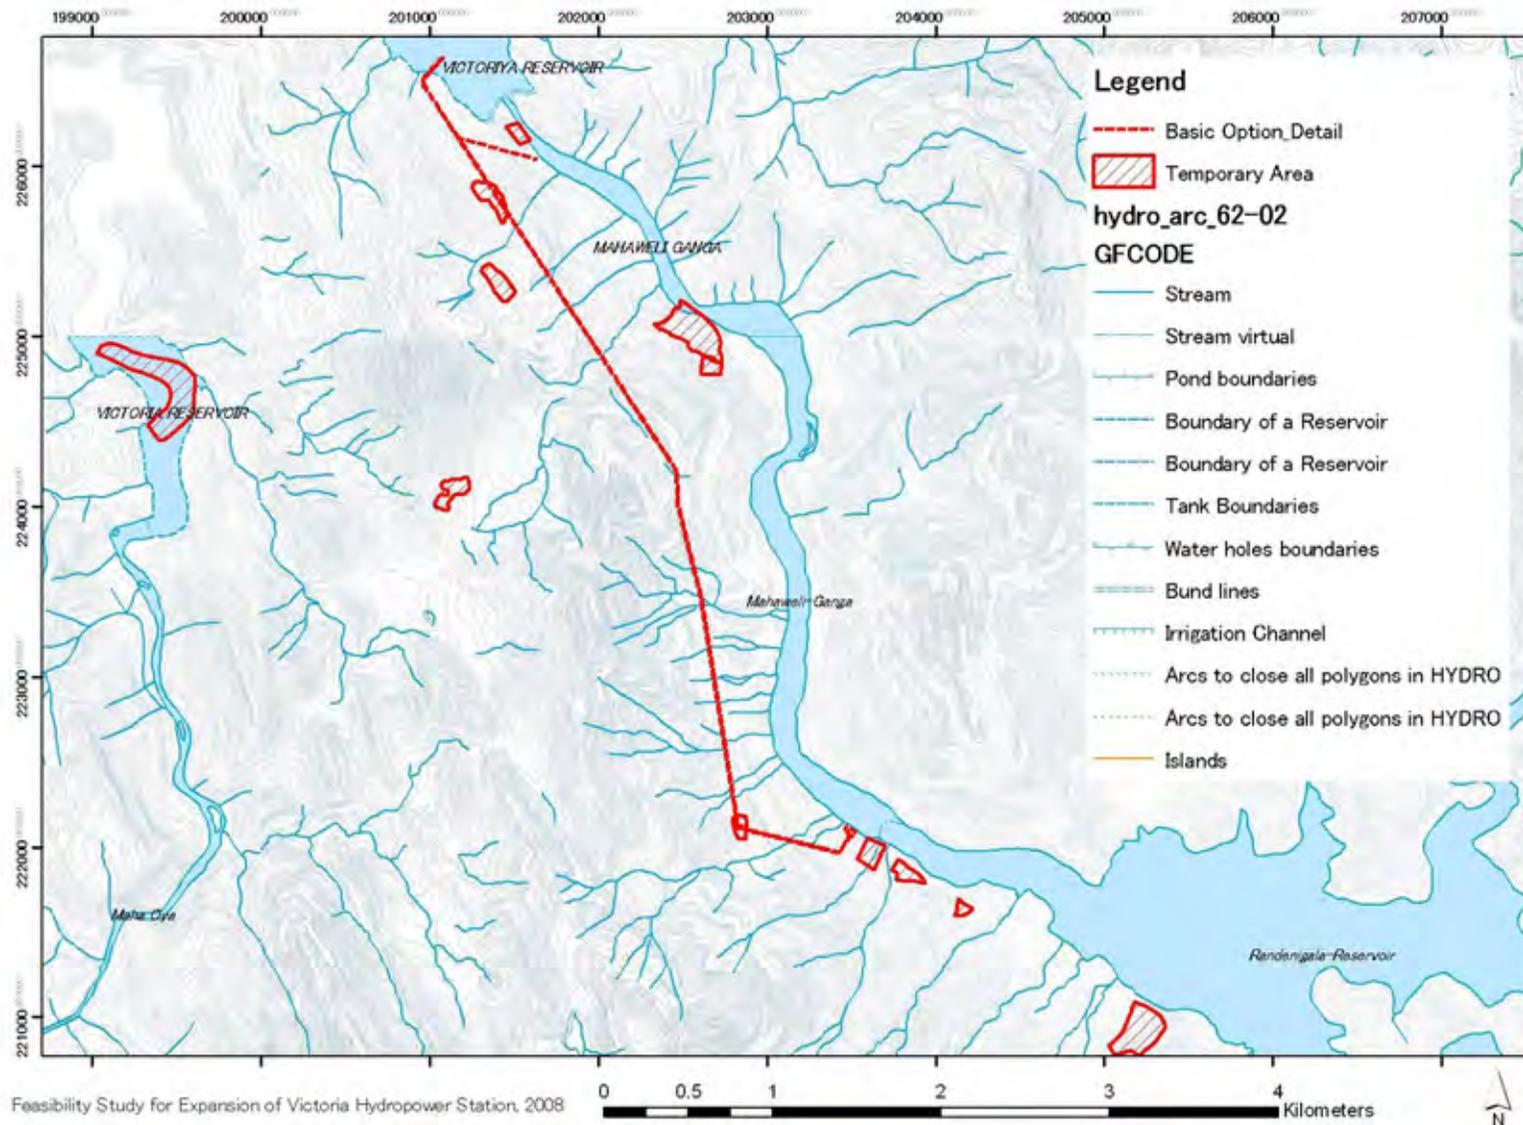
Figure 3-11 Drainage Pattern

The major stream in the project area is the Mahaweli River. The reach from the Victoria Dam to the Victoria Power Station now carries only the local drainage and contribution from the small tributaries draining the valley side slopes on either side of the Mahaweli. Much of the flow from the Victoria Reservoir is diverted through the Victoria headrace tunnel and is discharged back into the Mahaweli River at the outlet of the Power House. The tunnel trace crosses 15 tributaries. In the northern part, the tributaries run in a northeasterly direction and join the Mahaweli River. In the southern half, the tributaries flow in a southeasterly to northeasterly direction. There are numerous dry valleys in the region which become activated during the rainy seasons. The blue line shown on the 1:10,000 maps are the perennial streams. People of the area use the perennial and seasonal streams for irrigation of paddy as well as vegetable cultivations. Even some of the perennial streams are reduced to a trickle during the dry season as observed at the beginning of the field survey before the start of the Intermonsoon and NE monsoon rains. The observed flow pattern in the streams crossing the Mahaweli Rajamawatha in the PIA is illustrated in Figure 3-11.

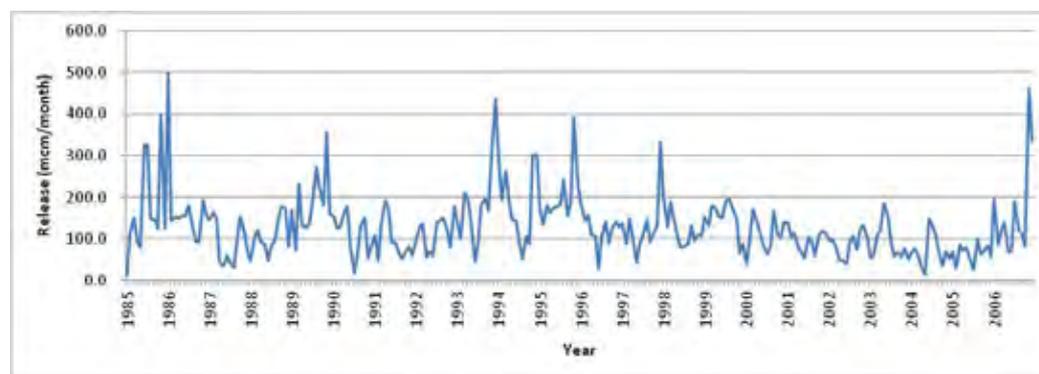
Figure 3-12 The annual variation of the flow

As revealed in Table 3-7, there is a definite seasonal fluctuation in the flow of the Mahaweli River with two clear high flow and low flow periods. (Source: MASL)
 Figure 3-12 indicates that during the last 20 years the flow of Mahaweli has not changed significantly although there are fluctuations. However, the operation of the proposed project is not dependent on the Mahawli flow but on the operational rules of the MASL,

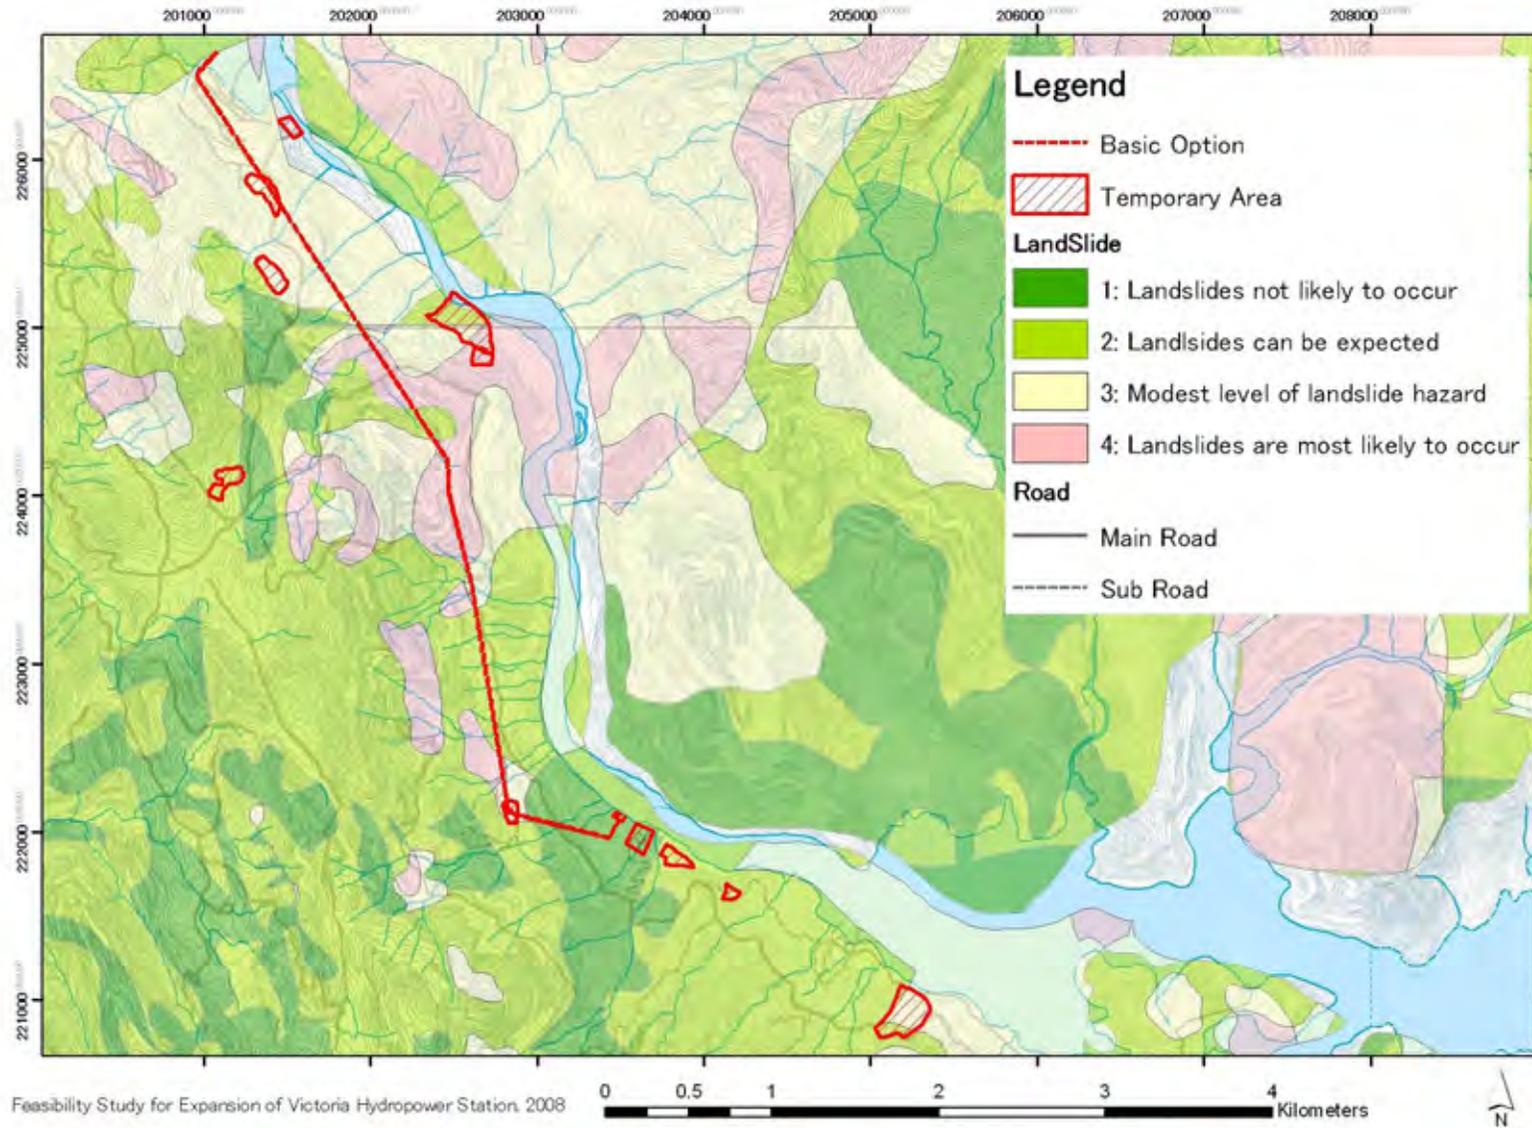
Figure 3-13 Landslide Zonation map

Some parts of the PIA have been identified as having a high landslide hazard potential (Figure 3-14 . Lanslide Zonation Map), but no serious landslides have been reported from the area in the past. Though there were widespread landslides in 2007, they did not affect this

The National Building Research Organization (NBRO) has prepared landslide zonation maps of the area at 1:50,000 scale (Figure 3-13). According to these maps, the landslide potential is divided into four classes with progressively increasing hazard levels as follows:
