CHAPTER 3

DESCRIPTION OF THE EXISTING ENVIRONMENT

3.1 Project Impact Area

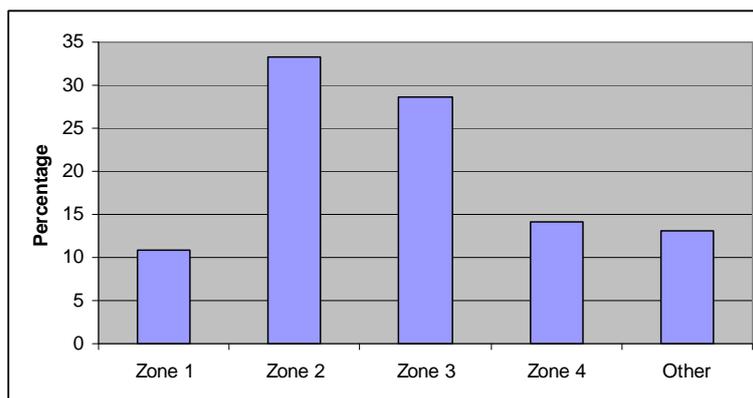
Figure 3-14 Percentage of land Subject to Various Hazard Levels

Most of the PIA fall within low to moderate hazard levels (Figure 3-14). The landslide free area is confined to a small area (11% of PIA area) and located in the Welikada GN Division. This area has moderate slopes. The area designated as Other is waterbodies which are non-landslide prone areas. Four areas have been identified as having a high risk of landslides. The largest of them is located in Bogahalanda GN Division. The other is located above the surge tank at Hakurutale.

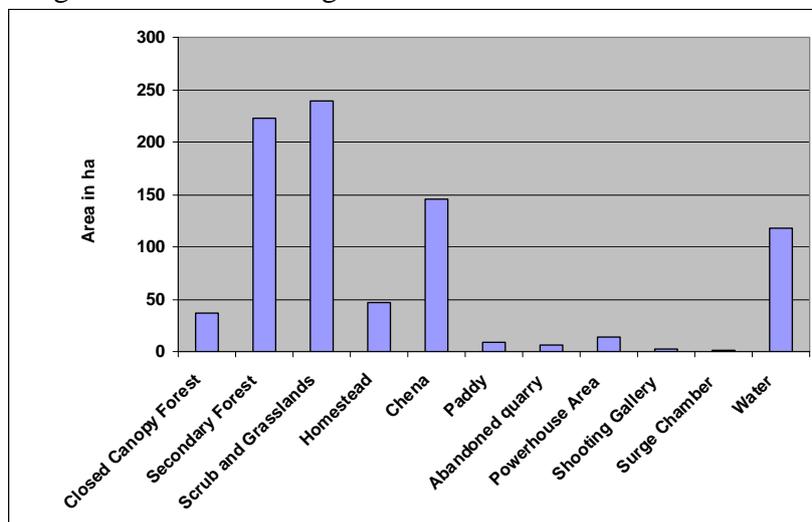
Figure 3-15 Land Use in the Impact Area of the Basic Option

semi-natural vegetation belonging to the land cover types of secondary forests and grasslands and mapped as closed canopy forest, secondary forest, and scrub and grassland, and Grasslands (499 ha or 59%). The total extent of agricultural lands and settlements is 201ha or 24%. The remaining area is covered by waterbodies, the properties of the Victoria Powerhouse and the SL Army’s Shooting Gallery. The total area under different land use categories is shown in Figure 3-15.

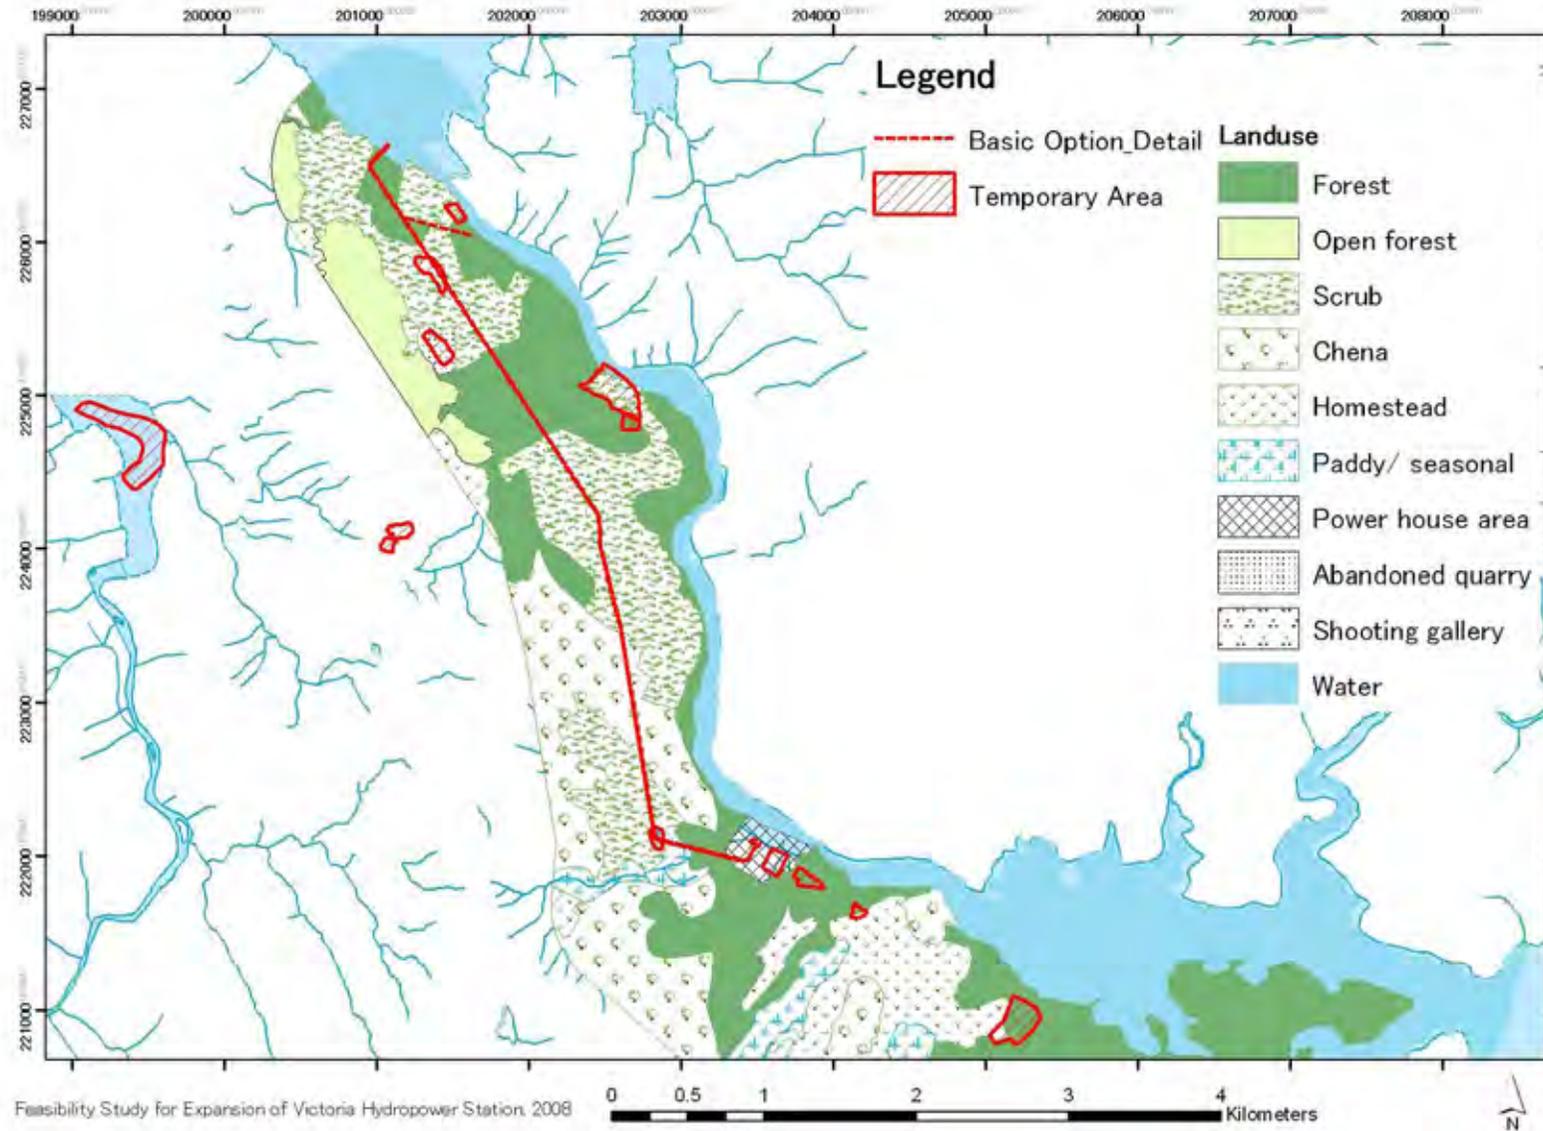
Figure 3-16 Land Use Map

The distribution of land under the different land use types in the impact area for Basic Option is illustrated in Figure 3-16. Most of the PIA of the Basic Option are covered with natural or

Distribution of land use types by GN Divisions (Table 3-9 Figure 3-16) shows that most of the homesteads are confined to Ambewela, Hilpenkadura and Welikada. The remaining Divisions either have no homesteads at all or the extent is insignificant. However, the Divisions that have negligible extents of homesteads are the main chena cultivation areas. The characteristics of the main agricultural and residential land use types are as follows:

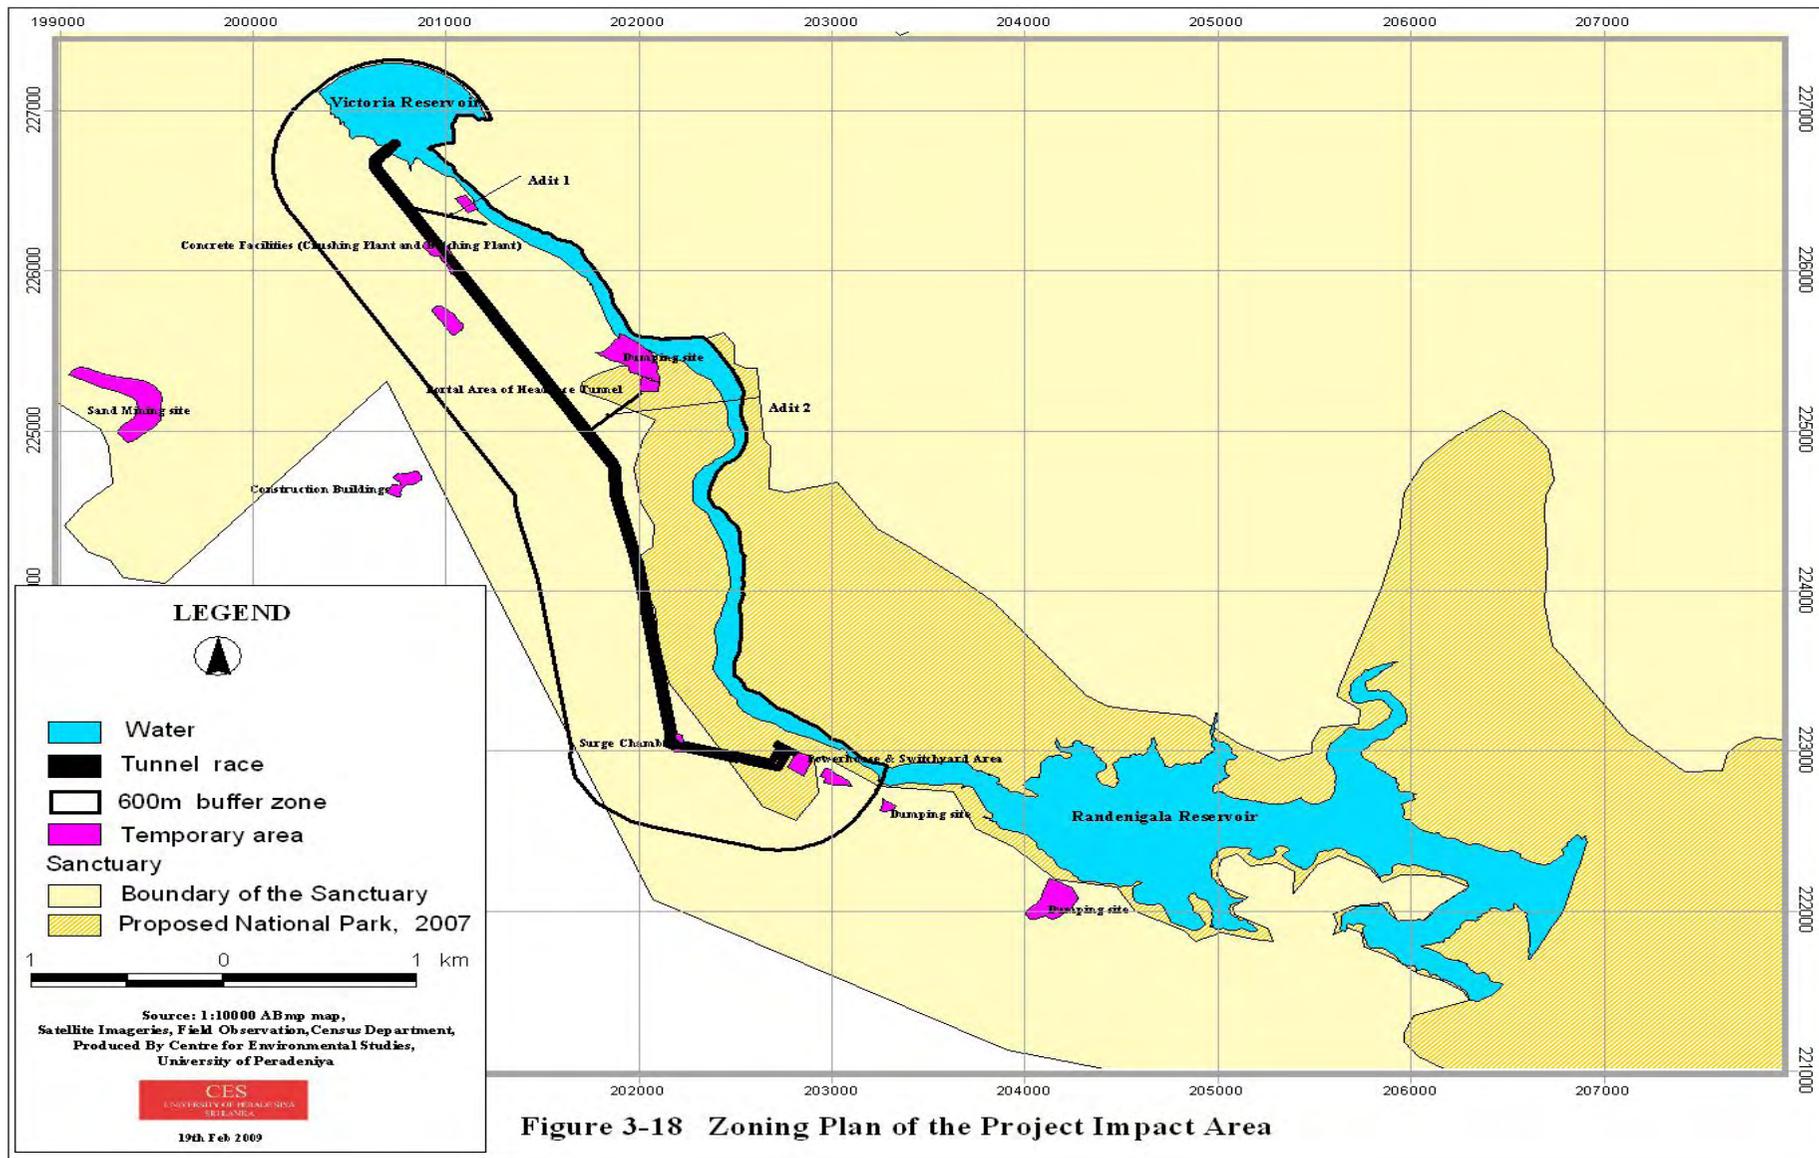
Figure 3-18 Zoning Plan of the Project Impact Area

Figure 3-17 Zoning Plan of the PIA

Since the entire PIA lies within the VRR Sanctuary, it comes under the management plan of the Sanctuary (DWLC, 1999). This management plan has divided the Sanctuary into two zones, Core Area Zone and the Buffer Zone (Figure 3-17). The Core Area Zone is the immediate upper catchment area of the Randenigala and Rantambe Reservoirs and has the best Intermediate Zone forest vegetation. It has been recommended that this zone have minimum human intervention and “allow critical ecological processes to continue unhindered and unaltered” (DWLC, 1999:62). In order to achieve this objective, it has been proposed that the Core Area Zone be declared a National Park. This will involve resettlement of existing villagers within this zone.
