**Presentation material of AIFDR
(Padang Earthquake Post-Disaster Survey)**

Padang Earthquake Post-Disaster Survey

23rd Oct – 11th Nov 2009

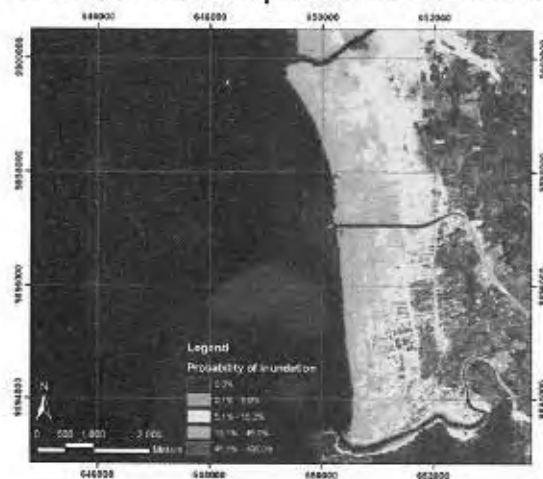
The threat from the next earthquake includes a major tsunami

A large earthquake similar to the 1797 event off Padang will cause a large tsunami that will inundate the coastal strip of Padang

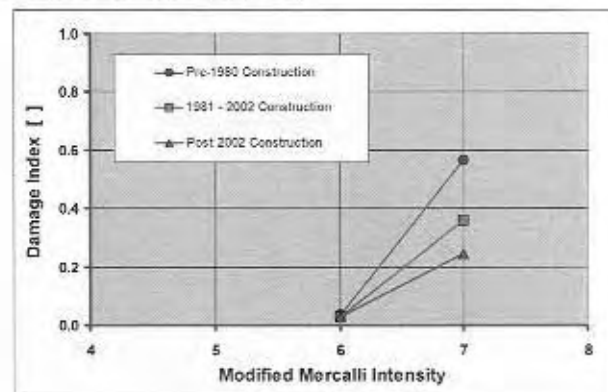
**PRELIMINARY RESULTS: Non-Residential Reinforced Concrete
Frame Low-Rise (1-3 stories)**
