| THE PREPARATORY STUDY FOR SECTOR LOAN ON DISASTER RISK MANAGEMENT | Figure 2.1 Location Map of Dam Site in Ilog-Hilabangan River | |

THE PREPARATORY STUDY FOR SECTOR LOAN ON DISASTER RISK MANAGEMENT

Ilog-Hilabangan River Improvement Plan (Alternative I-1: Full Improvement)

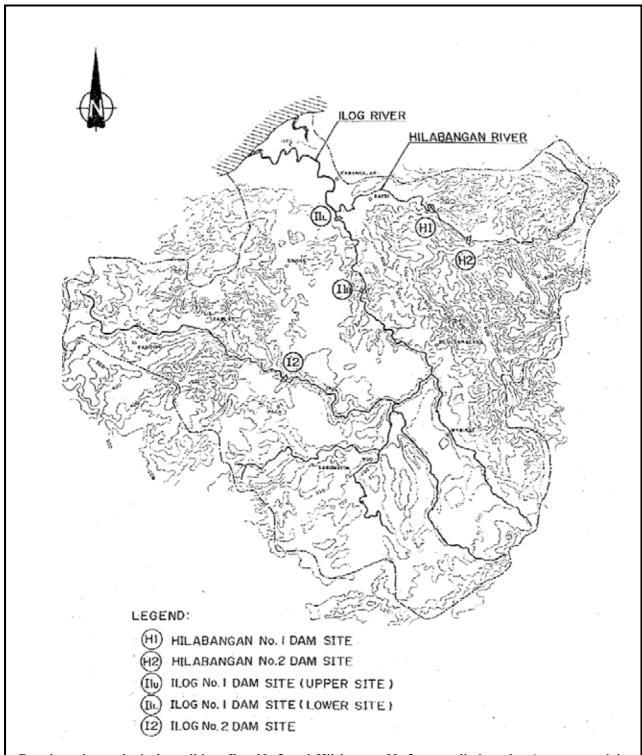
Based on the geological condition, Ilog No.2 and Hilabangan No.2 were eliminated. Among remaining possible dam site, Ilog No.1 Lower Site was selected as the most suitable dam site.

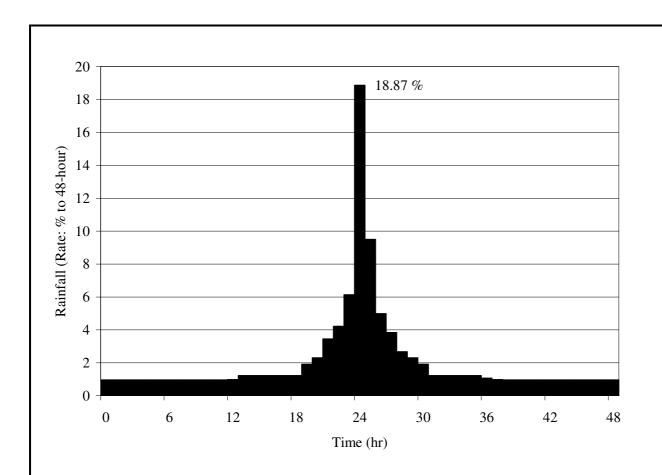
Figure 5.1

Hourly Rate to 48-hour Rainfall

Model Hyetograph

of Ilog-Hilabangan River Basin

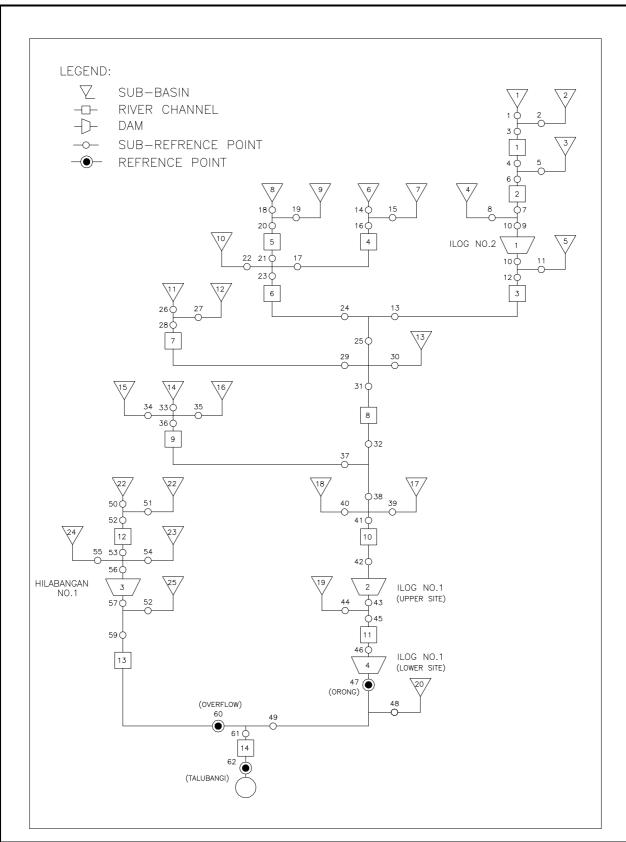
Figure 5.3

River System Model for Flood Runoff Analysis

of Ilog-Hilabangan River Basin

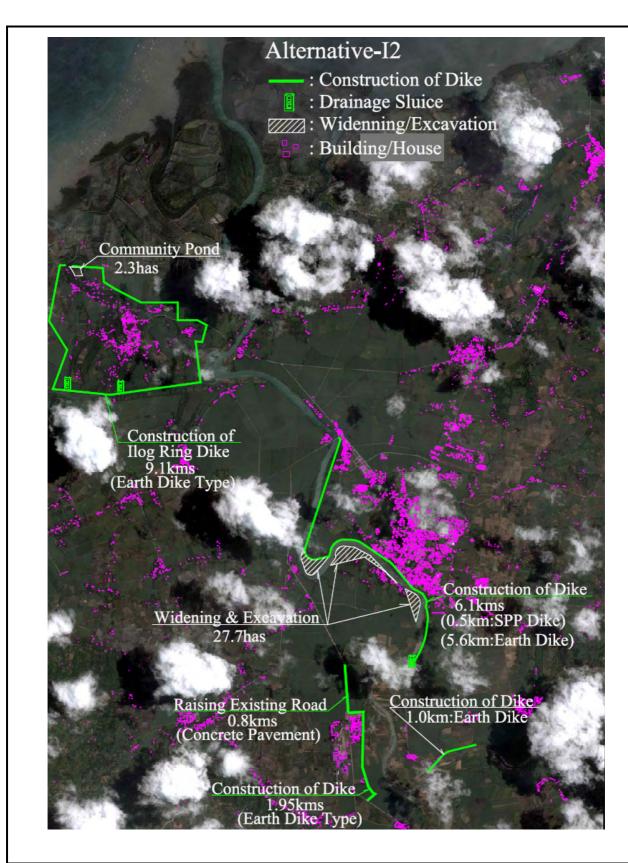
Figure 7.2

Ilog-Hilabangan River Improvement Plan (Alternative I-2: Construction of Dike)

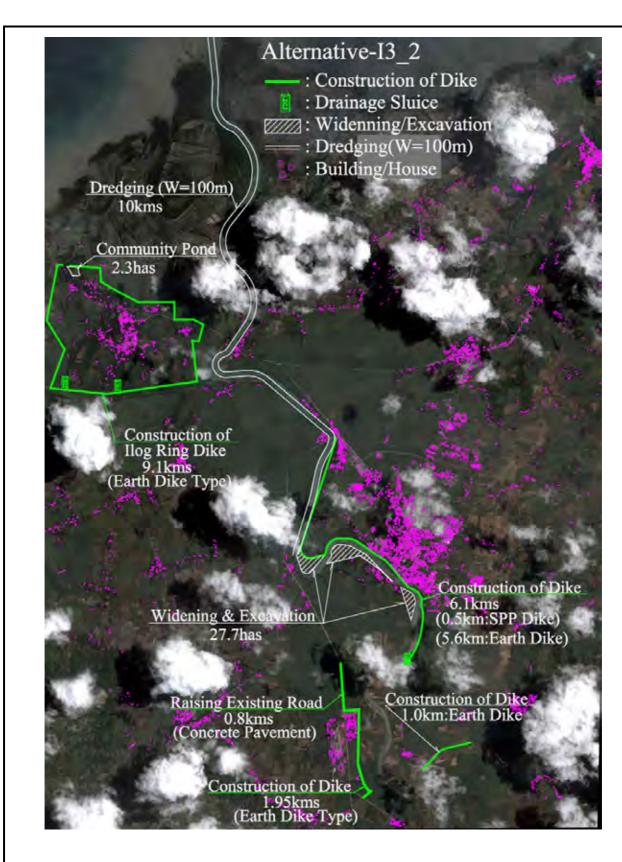
Figure 7.3

Ilog-Hilabangan River Improvement Plan (Alternative I-3: Dike and Dredging)

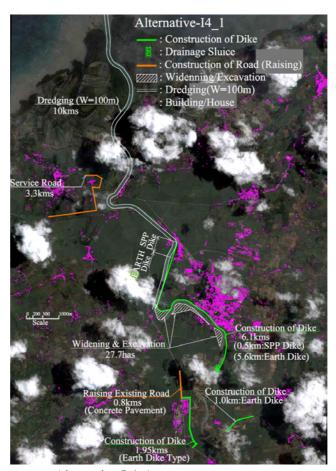
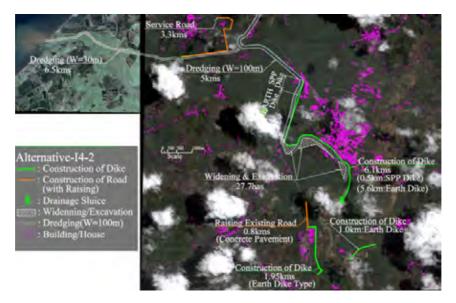
Figure 7.4

Alternative I-4_1

Alternative I-4_2

Ilog-Hilabangan River Improvement Plan
(Alternative I-4: Dike and Dredging:
Partial Protection)

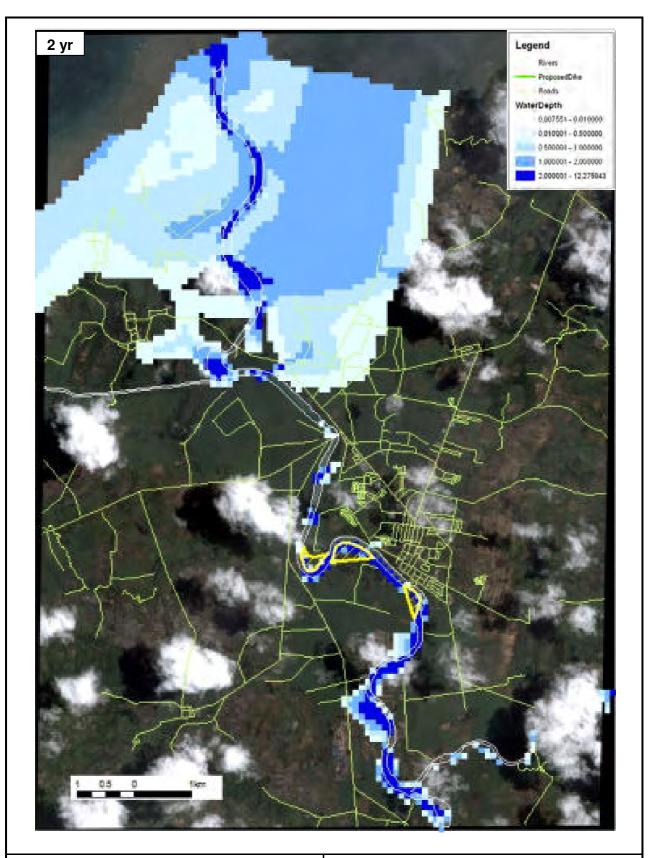
Figure 7.5 (1/6)

Result of Flood Inundation Analysis

(Without Project)

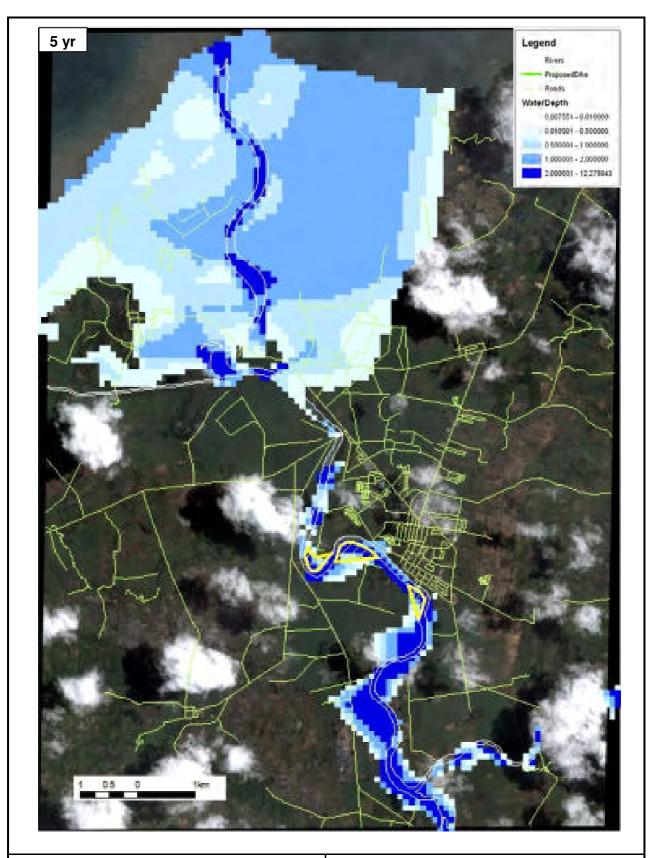
Figure 7.5 (5 yr)

Result of Flood Inundation Analysis

(Without Project)

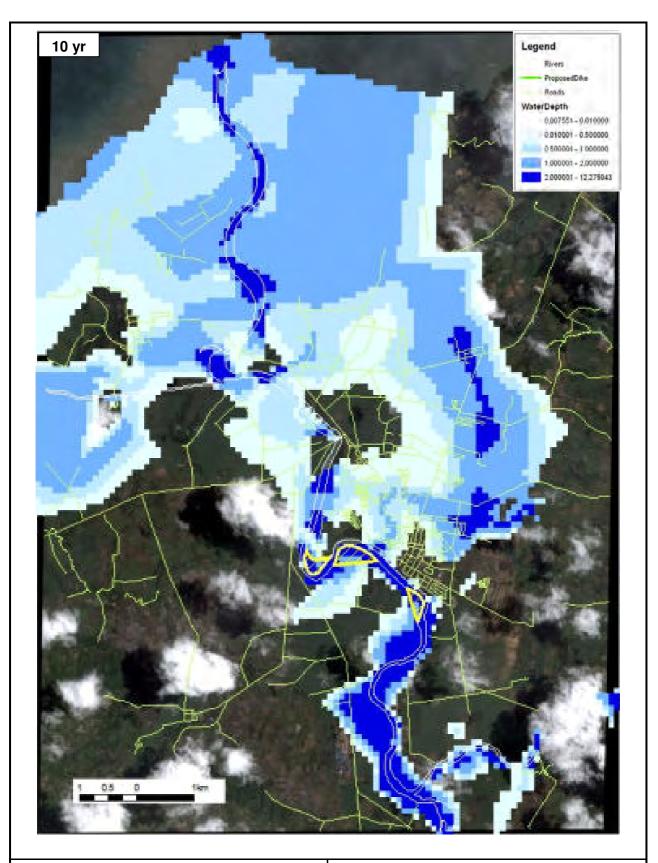
Figure 7.5 (10 yr)

Result of Flood Inundation Analysis

(Without Project)

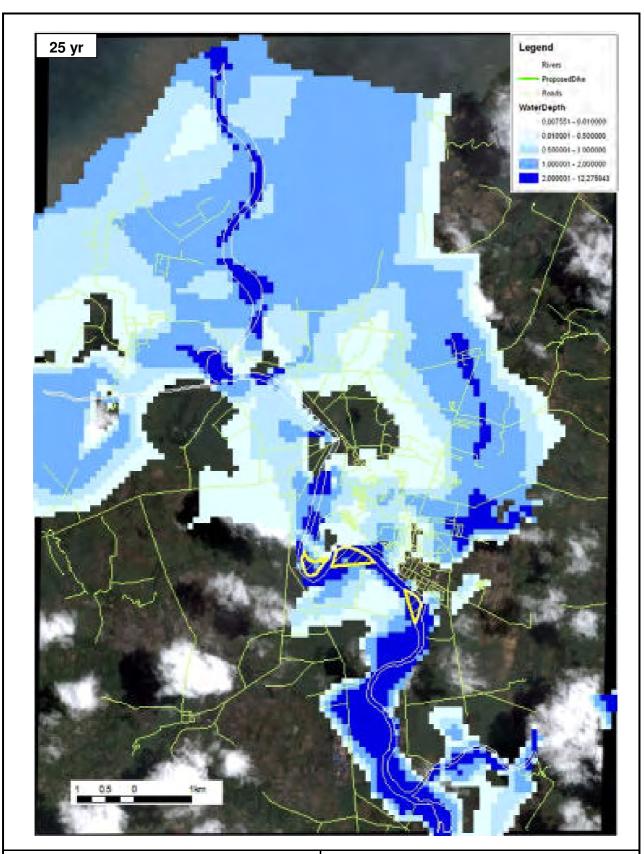
Figure 7.5 (25 yr)

Result of Flood Inundation Analysis

(Without Project)

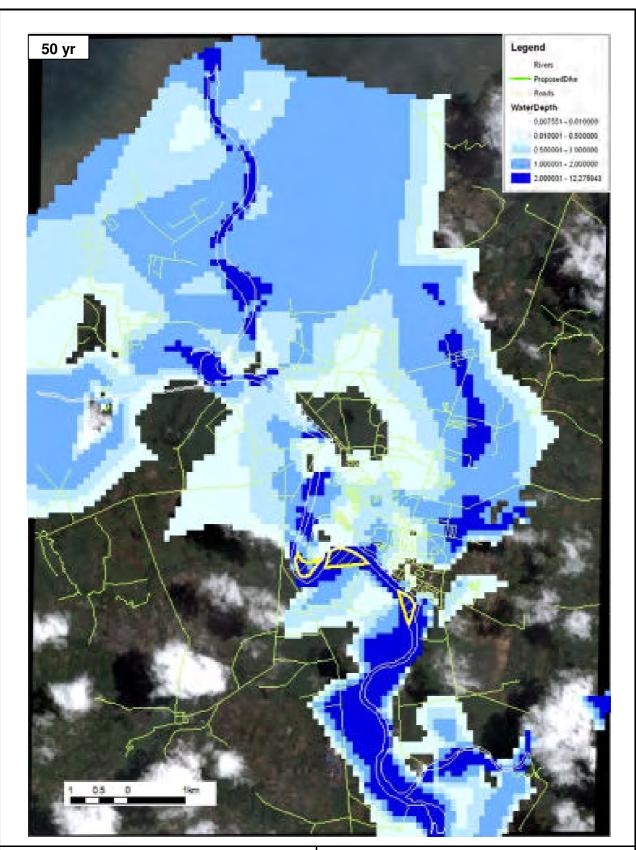
Figure 7.5 (50 yr)

Result of Flood Inundation Analysis

(Without Project)

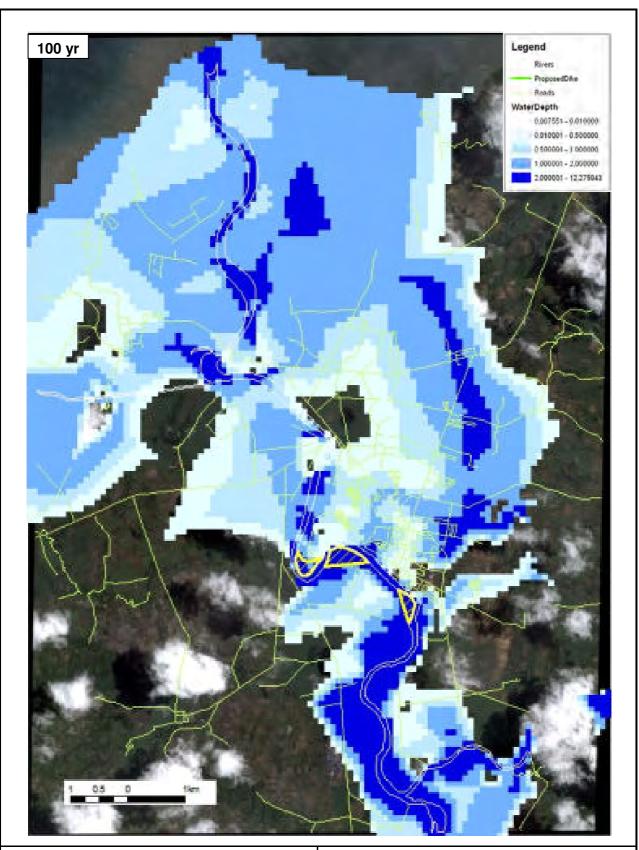
Figure 7.5 (100 yr)

Result of Flood Inundation Analysis

(Without Project)
