2.2.9 Cables

3. Inspection records

3.1 Recording guide for the inspection results

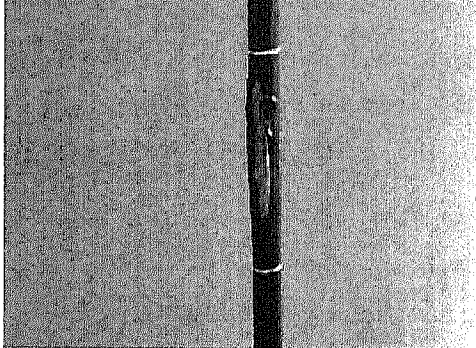
Damage level e	Damage level e

<p data-bbox="276 857 422 880">Damage of cable</p>

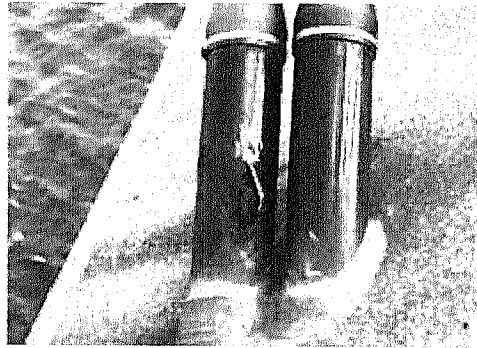
<p data-bbox="818 857 997 880">Damage of anchorage</p>

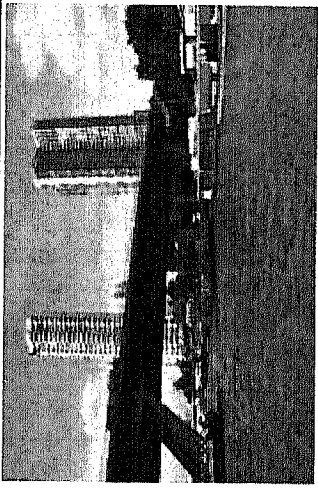
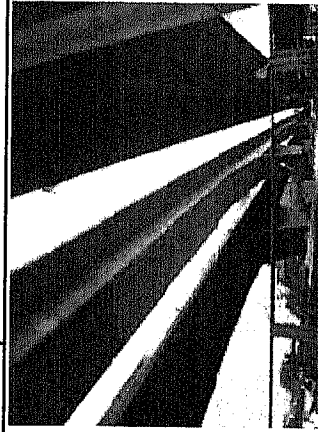
Site Photo	Photo No.	1		Inspection date	6/10/2010		Photo No.	2		Inspection date	30/9/2010	
	Span No.	3		Note			Span No.	3		Note		
	Description	Side						Description	Bottom

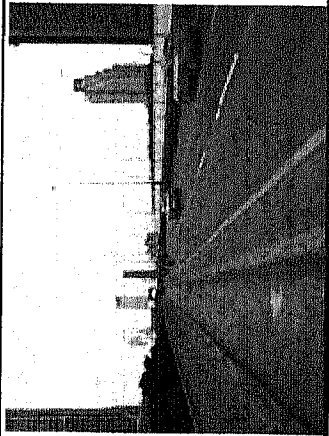
Photo No.	3		Inspection date	30/9/2010		Photo No.			Inspection date			
Span No.	3		Note			Span No.			Note			
Description	Road surface						Description

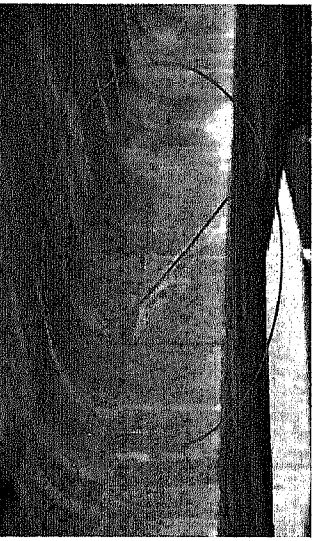
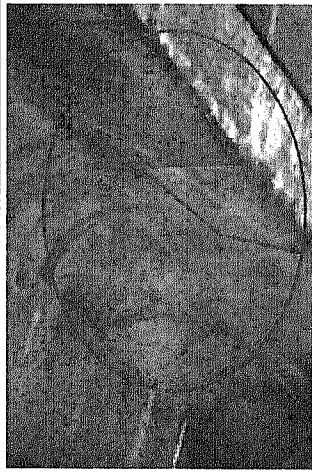
Damage photo	Photo No.	5	Span No.	3	Inspection date	30/9/2010	Photo No.	6	Span No.	3	Inspection date	30/9/2010
	Member name		Member No.	01	Note		Member name		Member No.	01	Note	
	Damage	Cracking	Classification	c			Damage	Cracking	Classification	c

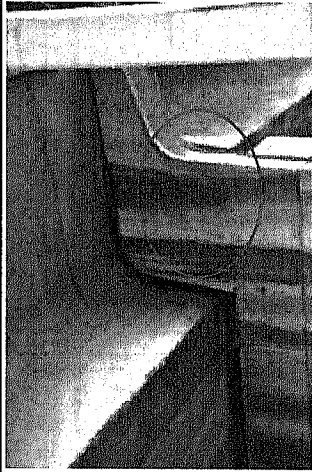
Photo No.	7	Span No.	3	Shooting date	30/9/2010	Photo No.	8	Span No.	3	Inspection date	30/9/2010
	Member name		Member No.	01	Note		Member name		Member No.	02	Note	
	Damage	Free lime	Classification	c			Damage	Cracking	Classification	c

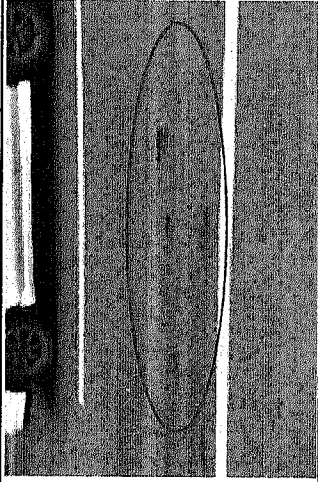
Damage photo	Photo No.	1	Span No.	3	Inspection date	30/9/2010	Photo No.	2	Span No.	3	Inspection date	30/9/2010
	Member name		Member No.		Note		Member name		Member No.	02	Note	
	Damage	Hole	Classification	a			Damage	Cracking	Classification	c
