ジブチ国南部地方給水計画準備調査

協力準備調査報告書

正誤表付属資料

巻末資料

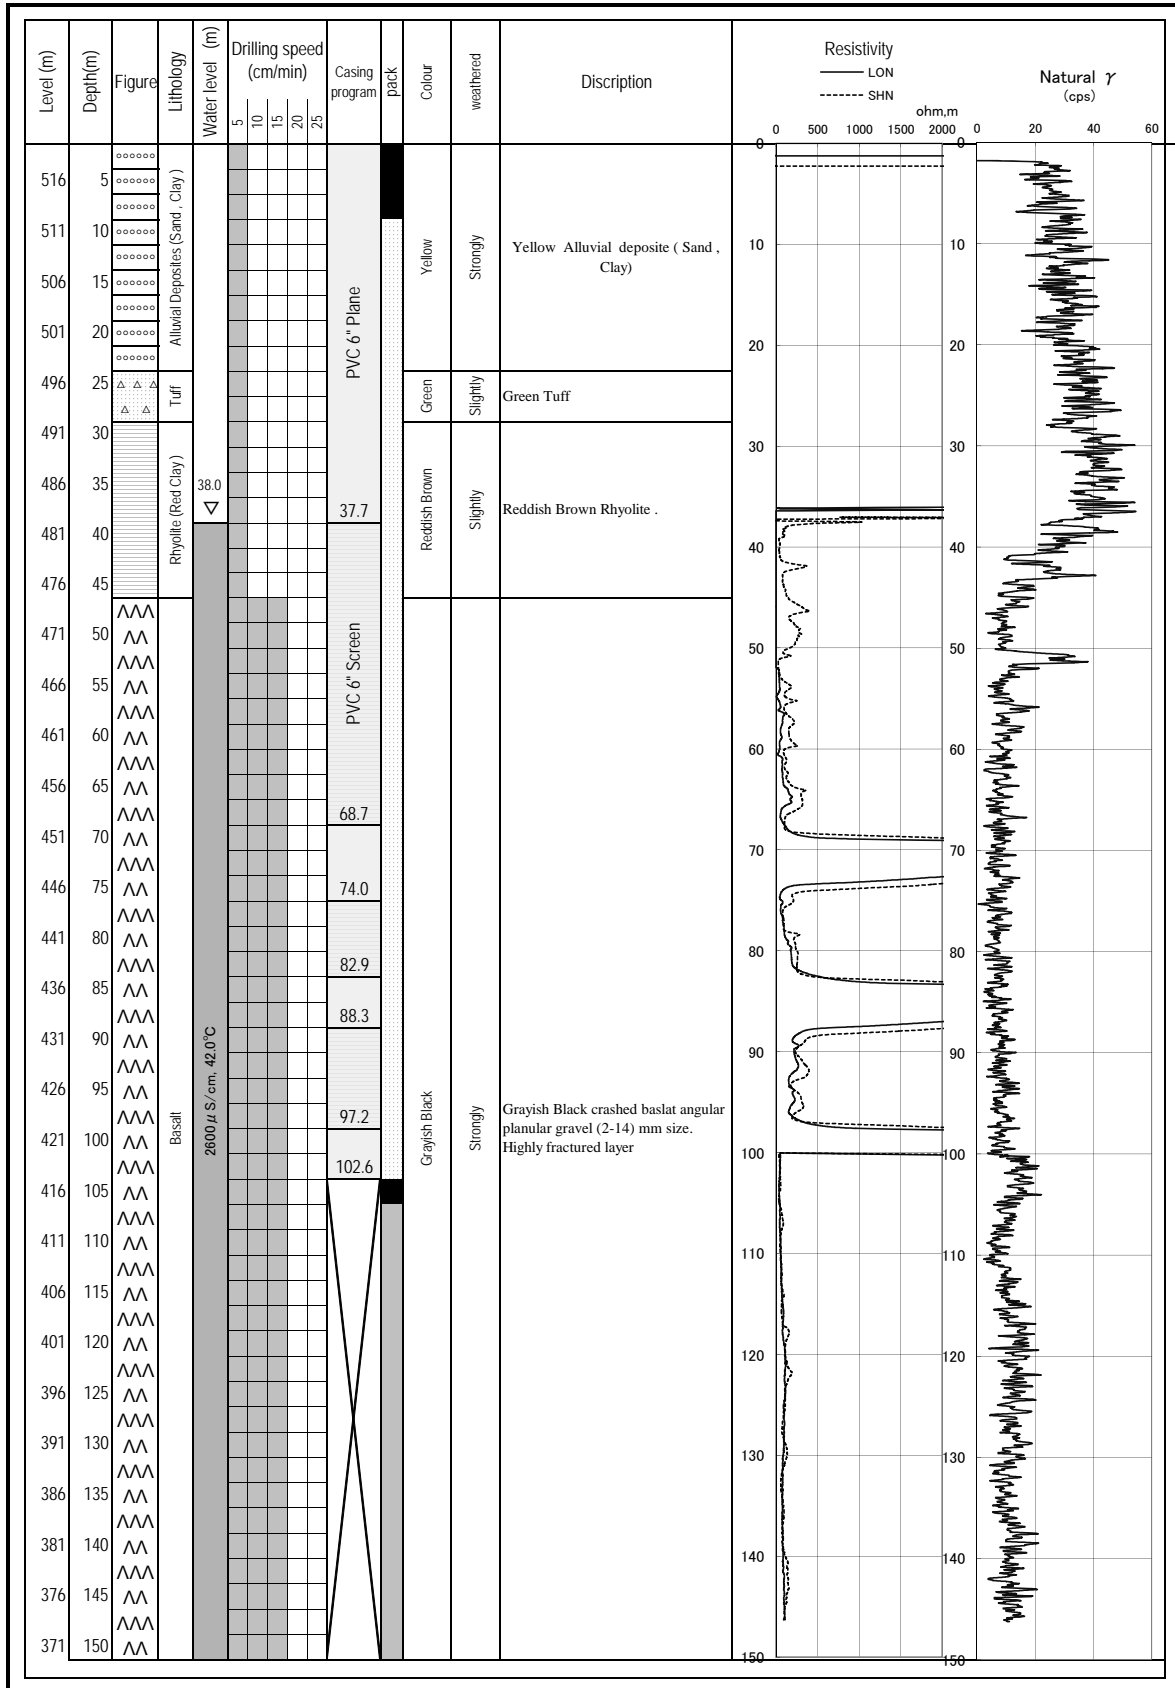
Drilling BH JW-7
 Coordinates: 11.2066N, 42.43183E

Date: 2010/10/27~29
 Village name: MINDIL
 Altitude: 521m
