**MINISTRY OF WATER
THE UNITED REPUBLIC OF TANZANIA**

**THE STUDY
ON
RURAL WATER SUPPLY
IN
TABORA REGION
IN
THE UNITED REPUBLIC OF TANZANIA**

**FINAL REPORT
SUPPORTING REPORT**

JAPAN INTERNATIONAL COOPERATION AGENCY

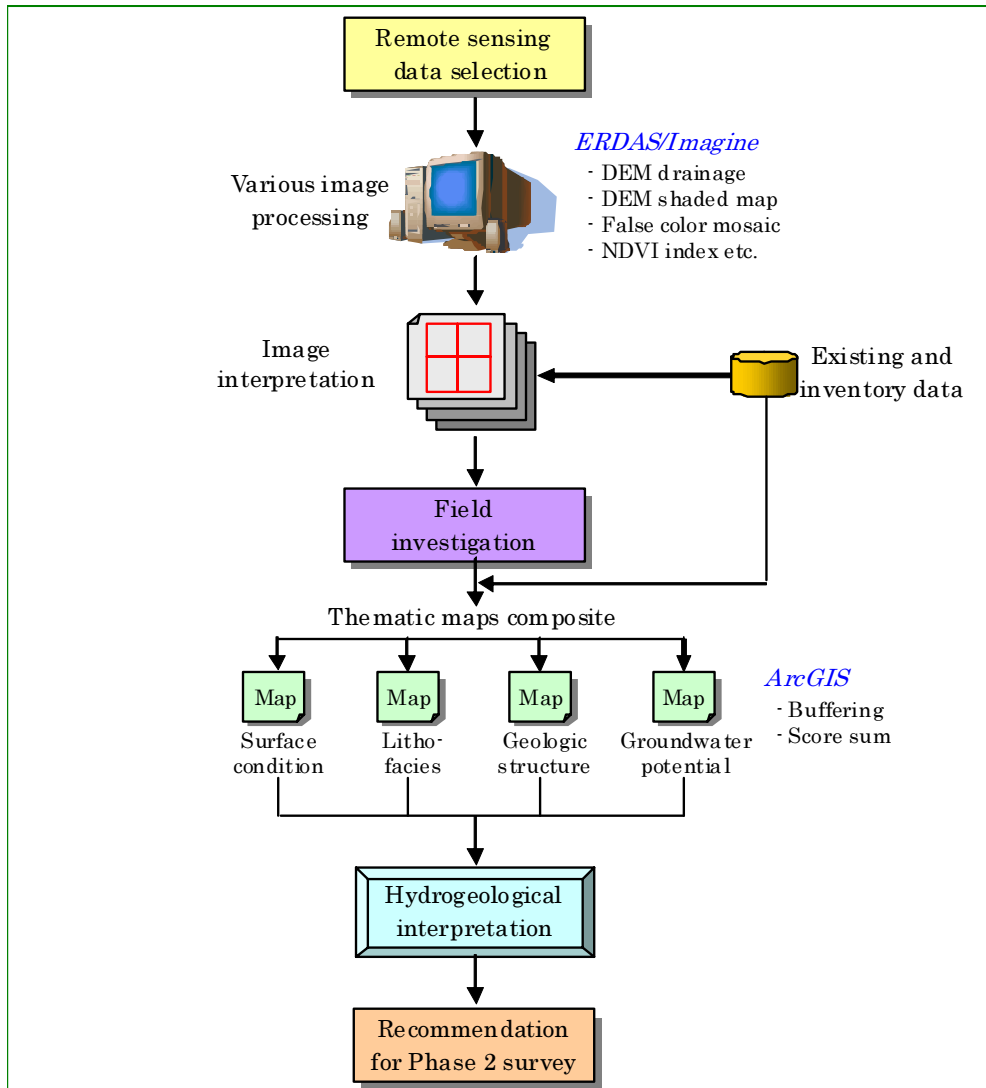
Figure 1.2.1 Flowchart of Satellite Image Analysis for Whole Tabora Region

The methodology of the survey is composed of remote sensing data selection, image processing, image interpretation, field investigation based on the interpretation, compositing thematic maps, their hydrogeological interpretation and a recommendation for Phase 2 survey. In the thematic maps, there are four maps combined with the existing various data, namely a surface condition, a lithofacies, a geologic structure and a groundwater potential maps. The flow chart of the survey is shown in Figure 1.2.1.

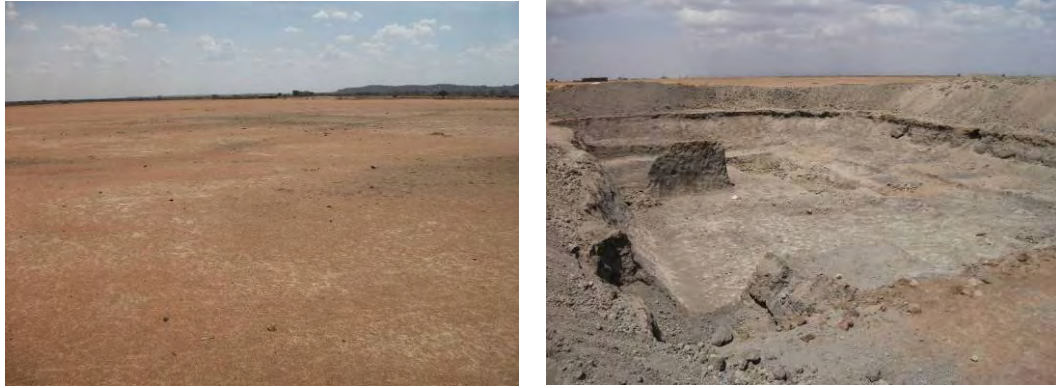
Figure 1.2.4 Landscape of Wembere Depression and Water Basin at Location No. 16

- Granite is widely distributed in all of district and greenstone is limited in the northern part as same as Nzega district.
- Groundwater level in Wembere depression was considered to be a couple of meters bellow the surface in dry season (see Figure 1.2.4).

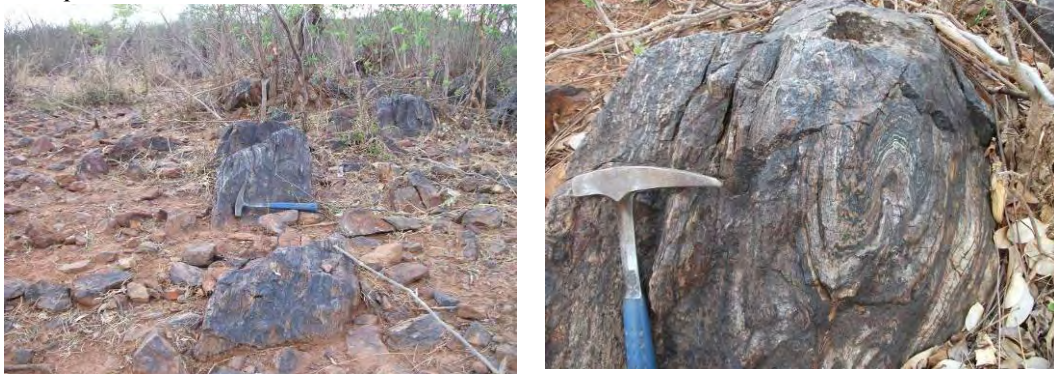
Figure 1.2.5 Outcrops of Greenstone and Rock Texture at Location No. 12

- Granite is widely distributed in all of district and greenstone (see Figure 1.2.5) is limited in its northern portion.

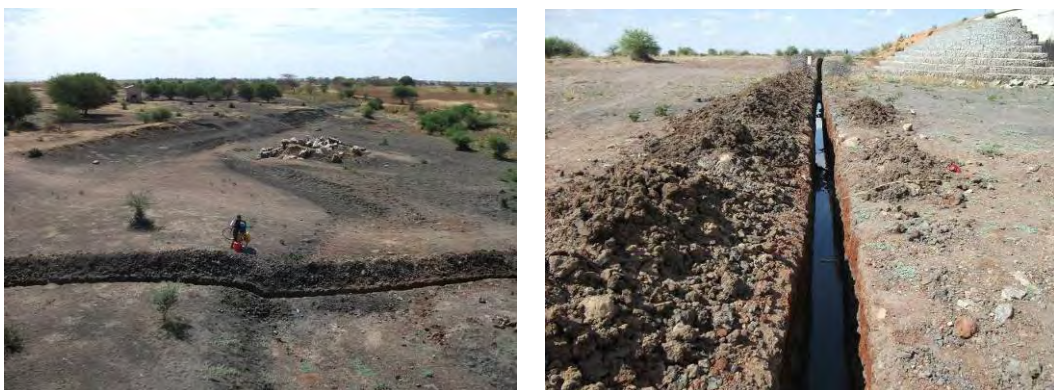
Figure 1.2.6 Upper Stream of Manonga River and Trench at River Floor at Location No. 11

- Ferricrete crust is more likely to be distributed between granite and greenstone distributed areas than others. Unfortunately, the boundary between these two rock facies is not recognized in the field.
- Groundwater level in Manonga River floor was approximately one meter below the surface even in dry season (see Figure 1.2.6).

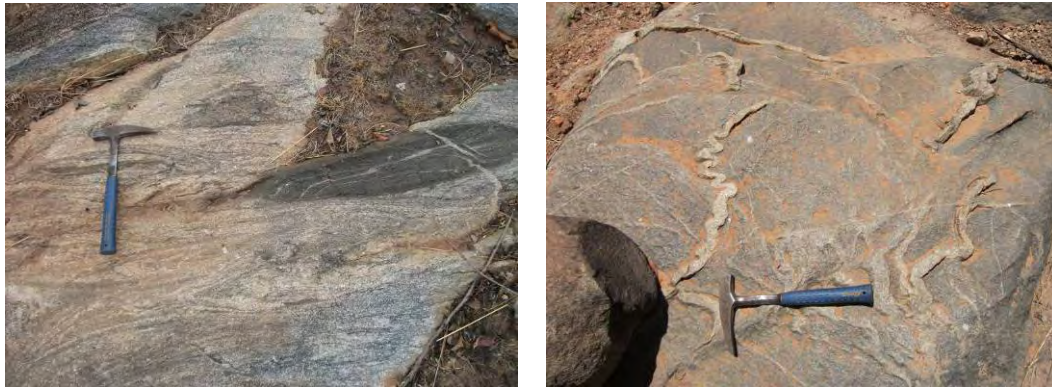
Figure 1.2.7 Gneiss at Sikonge Town and Migmatite at Rungwa Village at Locations No. 27 and 16

- Gneiss originated from granitoids is distributed in around Sikonge town elongating in NW-SE direction. Gneiss likely originated from sedimentary rocks is distributed widely in its south. In the Rungwa village, migmatite is distributed as well. They show different rock resistances against erosion on the image (see Figure 1.2.7).

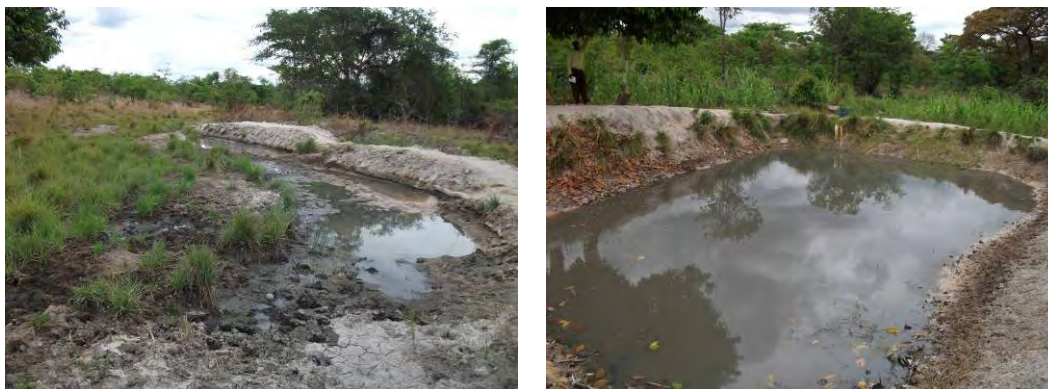
Figure 1.2.9 Spring and its Water Basin close to Sikonge Town at Location No. 26

- Water spring occurs in gneiss distribution area in northern part of Sikonge town. The area corresponds to an intersection of major faults between N-S and NW-SE trending (see Figure 1.2.9).

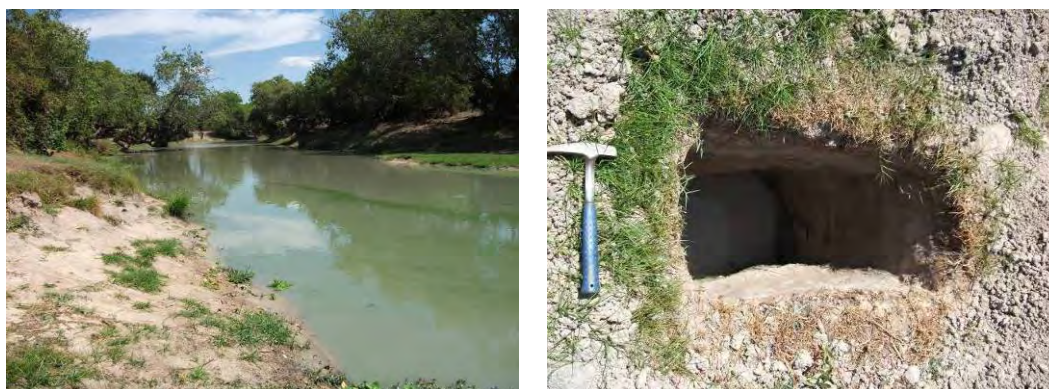
Figure 1.2.10 Condition of Ugalla Katumbiki River and Pit at River Floor at Location No. 37

- Consecutive surface water bodies are observed in Ugalla Katumbiki River in the most south-western end of the district even in dry season. Groundwater level is one to two meters below the surface (see Figure 1.2.10).

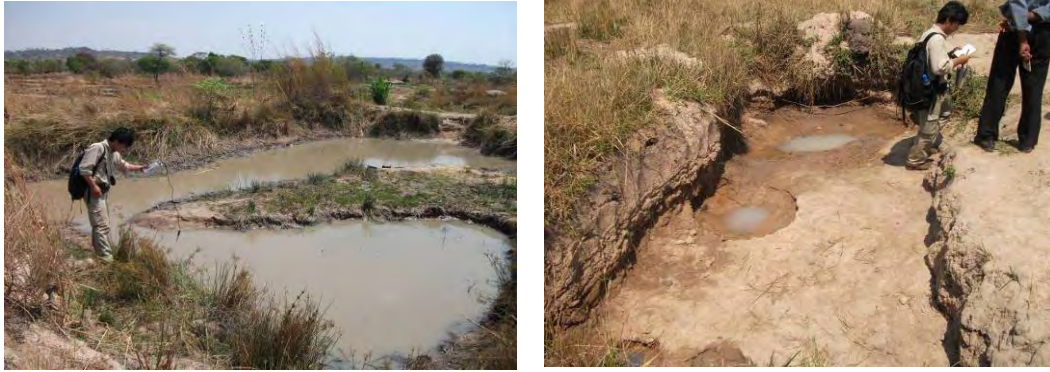
Figure 1.2.11 Water Sources for Irrigation and Life Use at Location No. 06

- Granite is mainly distributed in this district.
- The groundwater level seems to be 1 meter below the surface judging from the field observation (see Figure 1.2.11).
- Surface water indicating about 20 °C in temperature was observed in the rice field west to Tabora Municipality, and it is considered to be water spring from lateral flow of saprolite.
- Circular structures in a couple of kilometers in diameter are clarified in the eastern part of the district. These structures are considered to be filled with surface water in wet season because of their geomorphology like depression structure and clayey materials distributed on the surface.

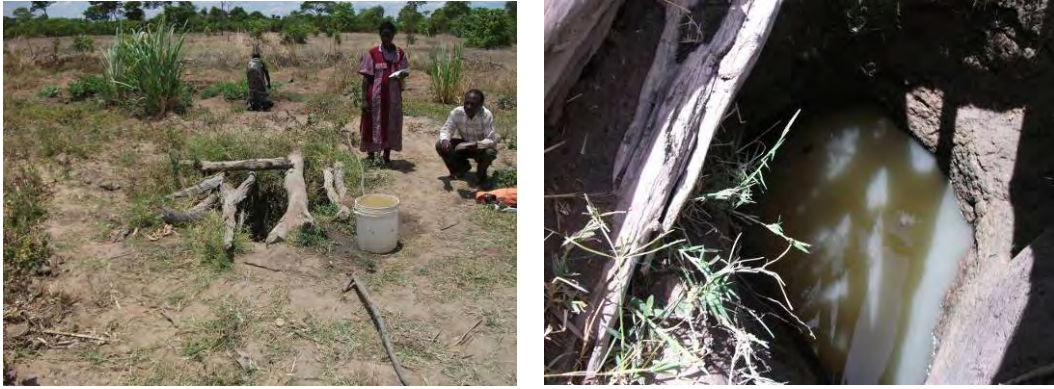
Figure 1.2.13 Human-made Water Well for Irrigation and its Groundwater Level at Location No. 41

- Lowland is widely spread in the western part of the district. Groundwater level is approximately three meters bellow the surface at human made water well for irrigation in Makubi village. The water is silty white in color (see Figure 1.2.13).

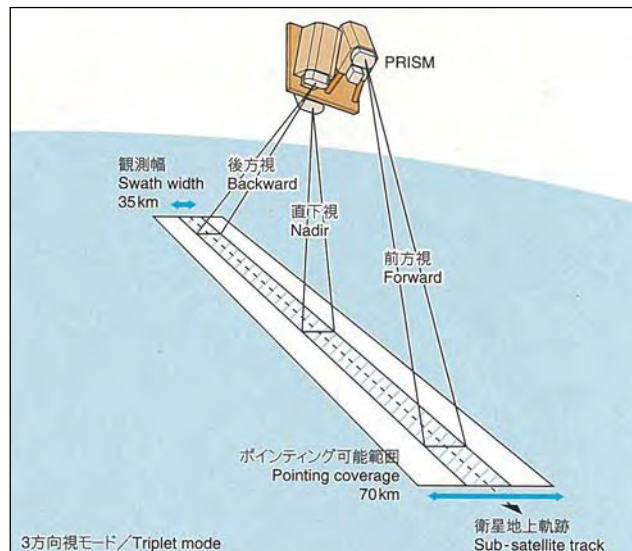
Figure 1.3.2 PRISM's Optical System

The image data used of the study are ALOS/PRISM data. The PRISM is an optical sensor for observing visible terrain areas with a 2.5 m spatial resolution. It has three independent optical systems to acquire terrain data including altitude data so that images for nadir, forward and backward views can be acquired at same time (see Figure 1.3.2). This enables us to get three-dimensional terrain data with a high accuracy and frequency. The list of image data used and their specification is shown in Table 1.3.1.
