#### (4) Mpumbuli village

General geology and image interpretation results in Mpumbuli village are shown in Table 1.3.6 and Figure 1.3.7 respectively.

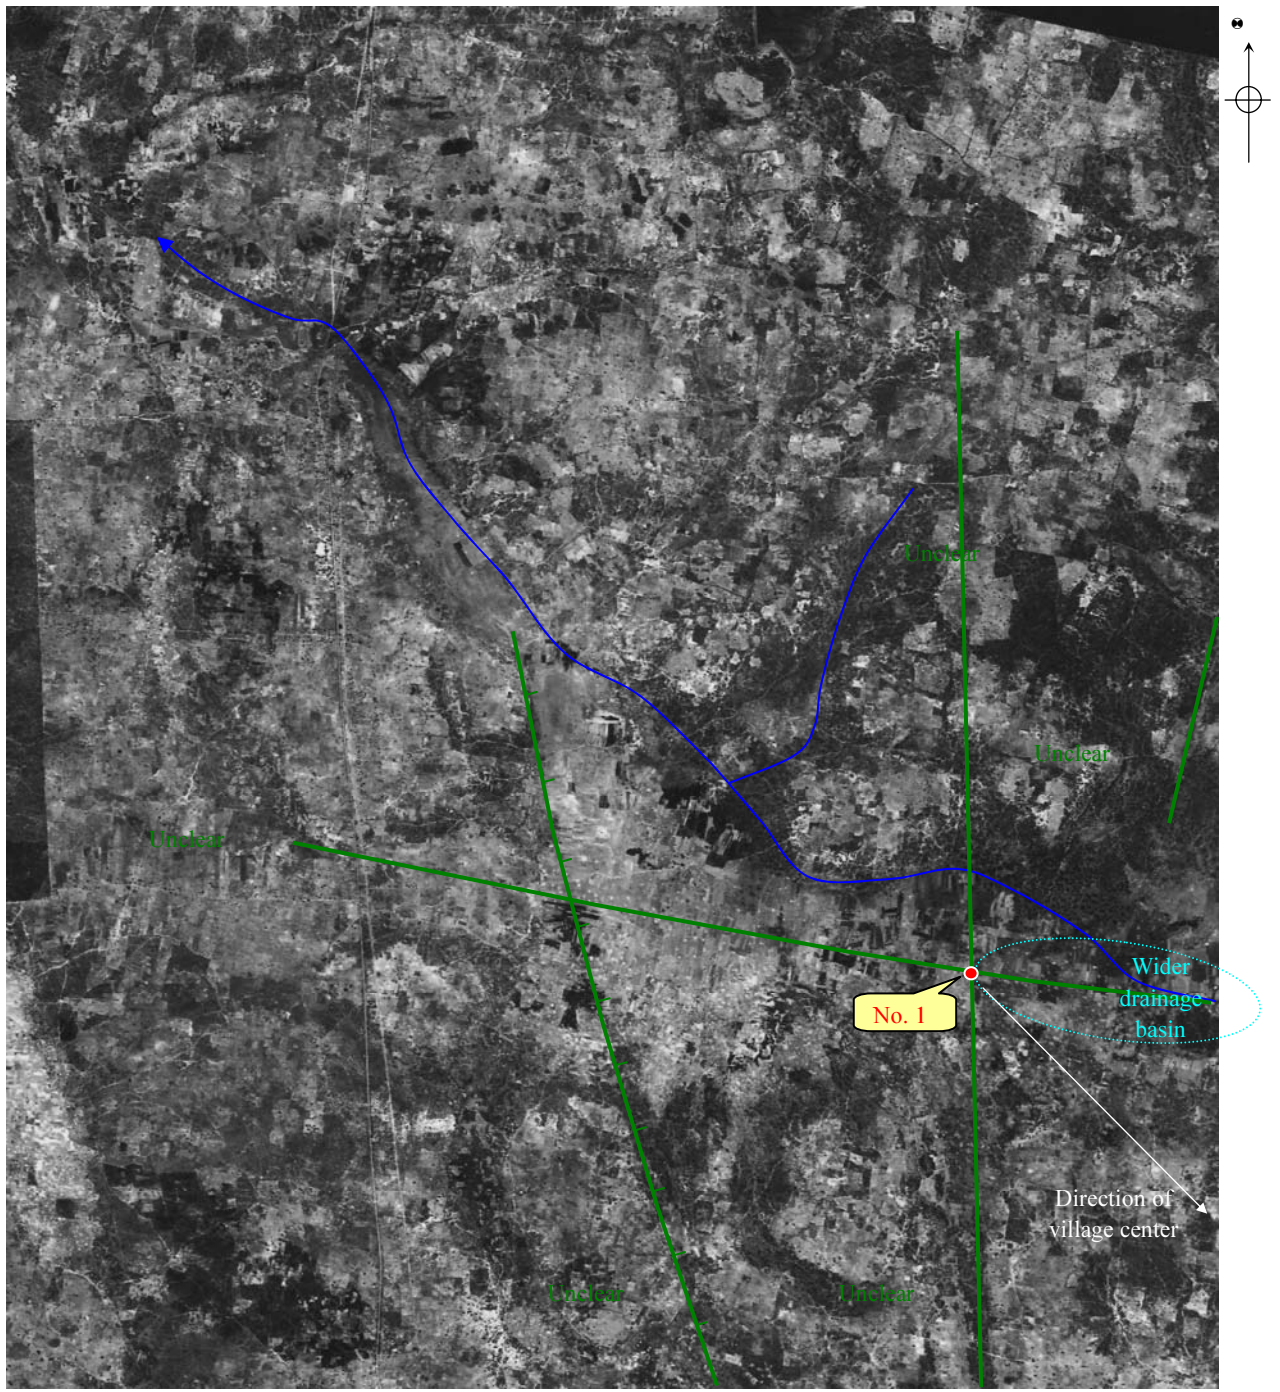
Image interpretation	<p>The result of image interpretation is shown in the next page, and the following features were observed,</p> <ul style="list-style-type: none"> <li>- Topography: Showing extremely flat ground.</li> <li>- Surface: Showing high level of land-use as a cultivated land. White dots like irrigation ponds are observed on the image.</li> <li>- Geology: Granite (Gb) is commonly distributed in the area.</li> <li>- Fracture: Unclear lineaments are developed in N-S and NNE-SSW directions. The former is almost parallel to the major fault. The intersection of these unclear lineaments sits 6 km northwest to the village. Dips of these lineaments are not observed on the image owing to flat ground expression.</li> <li>- Drainage: Wider basin sits in the north where WNW-ESE trending unclear lineament is located.</li> <li>- Others: Not accessible by a vehicle.</li> </ul>

Point selection based on image interpretation	<ul style="list-style-type: none"> <li>- Position: Point No. 1 shown in the next figure is selected as a possible position.</li> <li>- Direction: NE-SW direction could be recommended for further study.</li> <li>- Hydrogeology: Wider drainage basin upstream as a recharge, unclear lineament as a groundwater path and intersection of unclear lineaments as a groundwater storage would function. Dips of the unclear lineaments should be observed in the field.</li> </ul>
Remarks	None

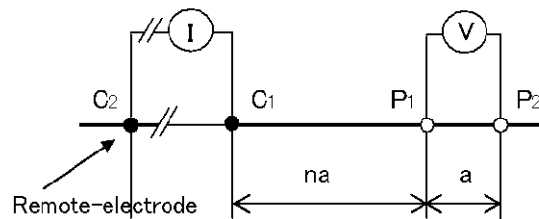
**Figure 2.3.2 Pole-Dipole Configuration**

The Pole-Dipole array is the most suitable method for this area among these (Target: fissure water at GL-50-100m). Because this array is positioned in the middle of the “Pole-Pole array” and the “Dipole-Dipole array”, namely the “Pole-Dipole array” has reasonably good signal strength and sensitivity. Figure 2.3.2 shows the Pole-Dipole configuration.

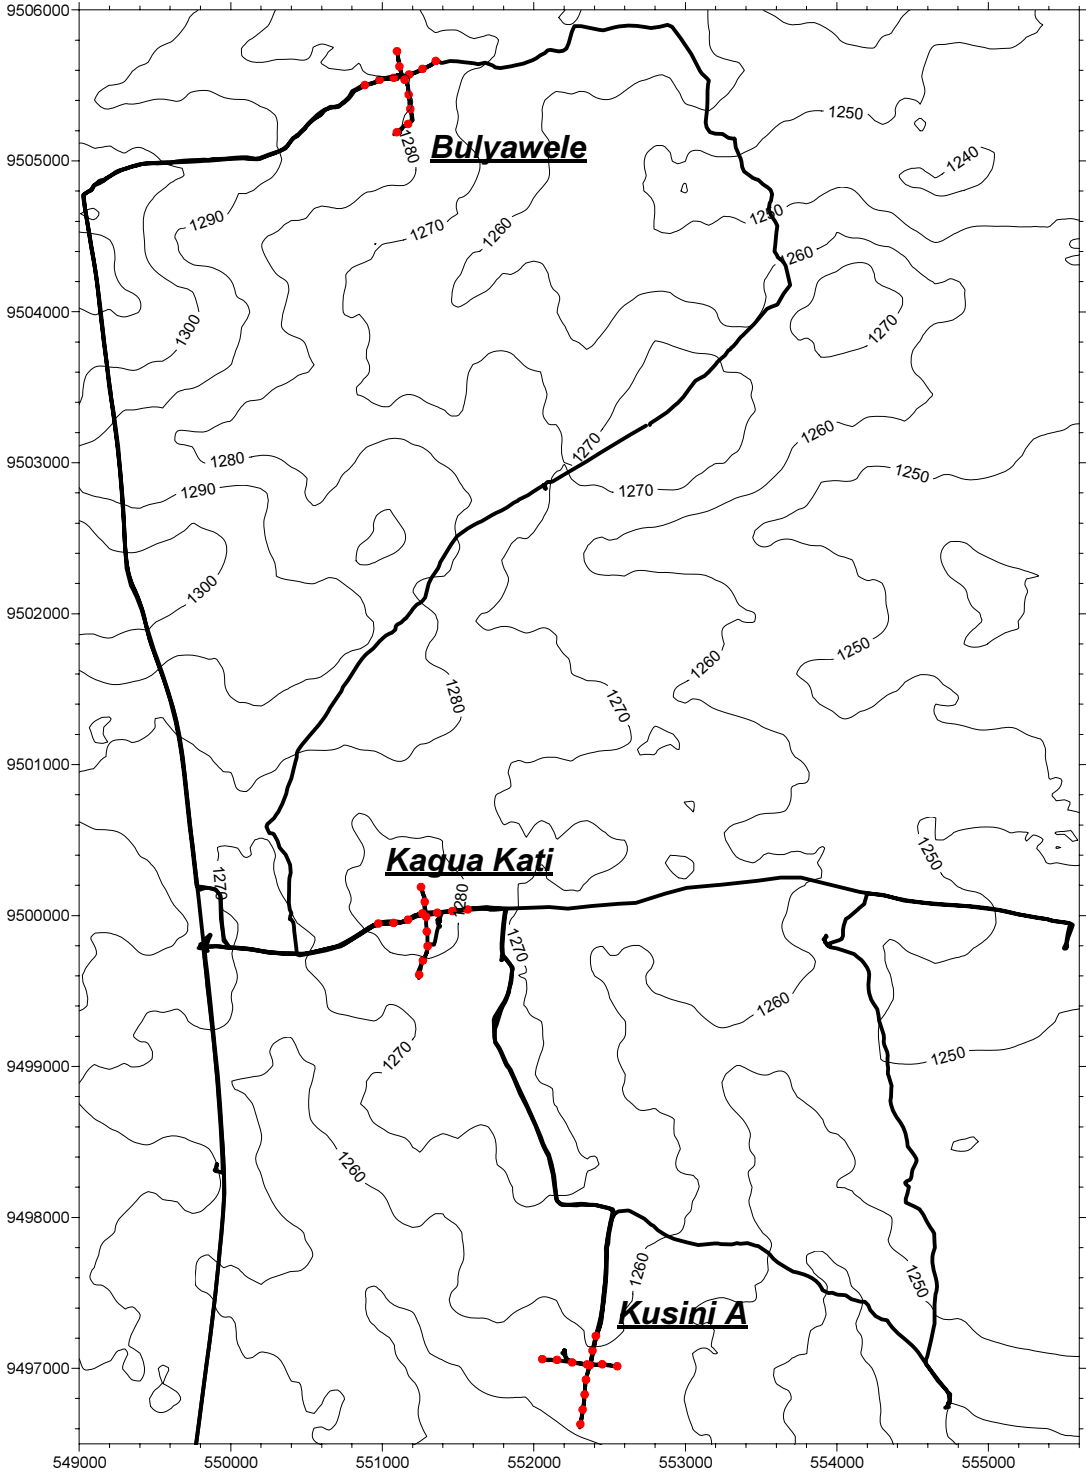
Figure.2.4.1 Geophysical survey location at Busomeke village in Igunga district

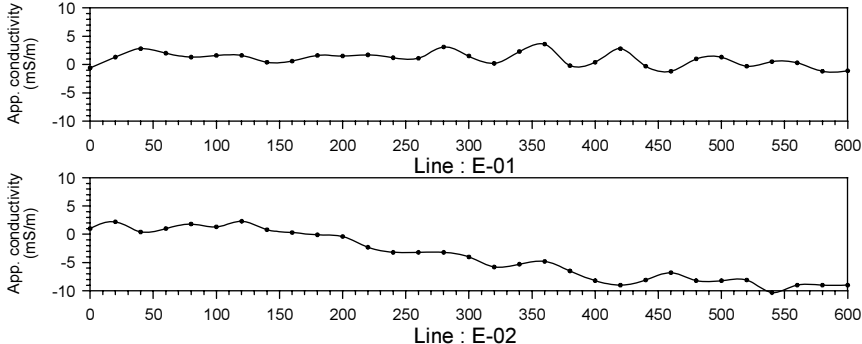
Figure.2.4.3 Geophysical survey results at Kagua Kati sub-village in Busomeke village

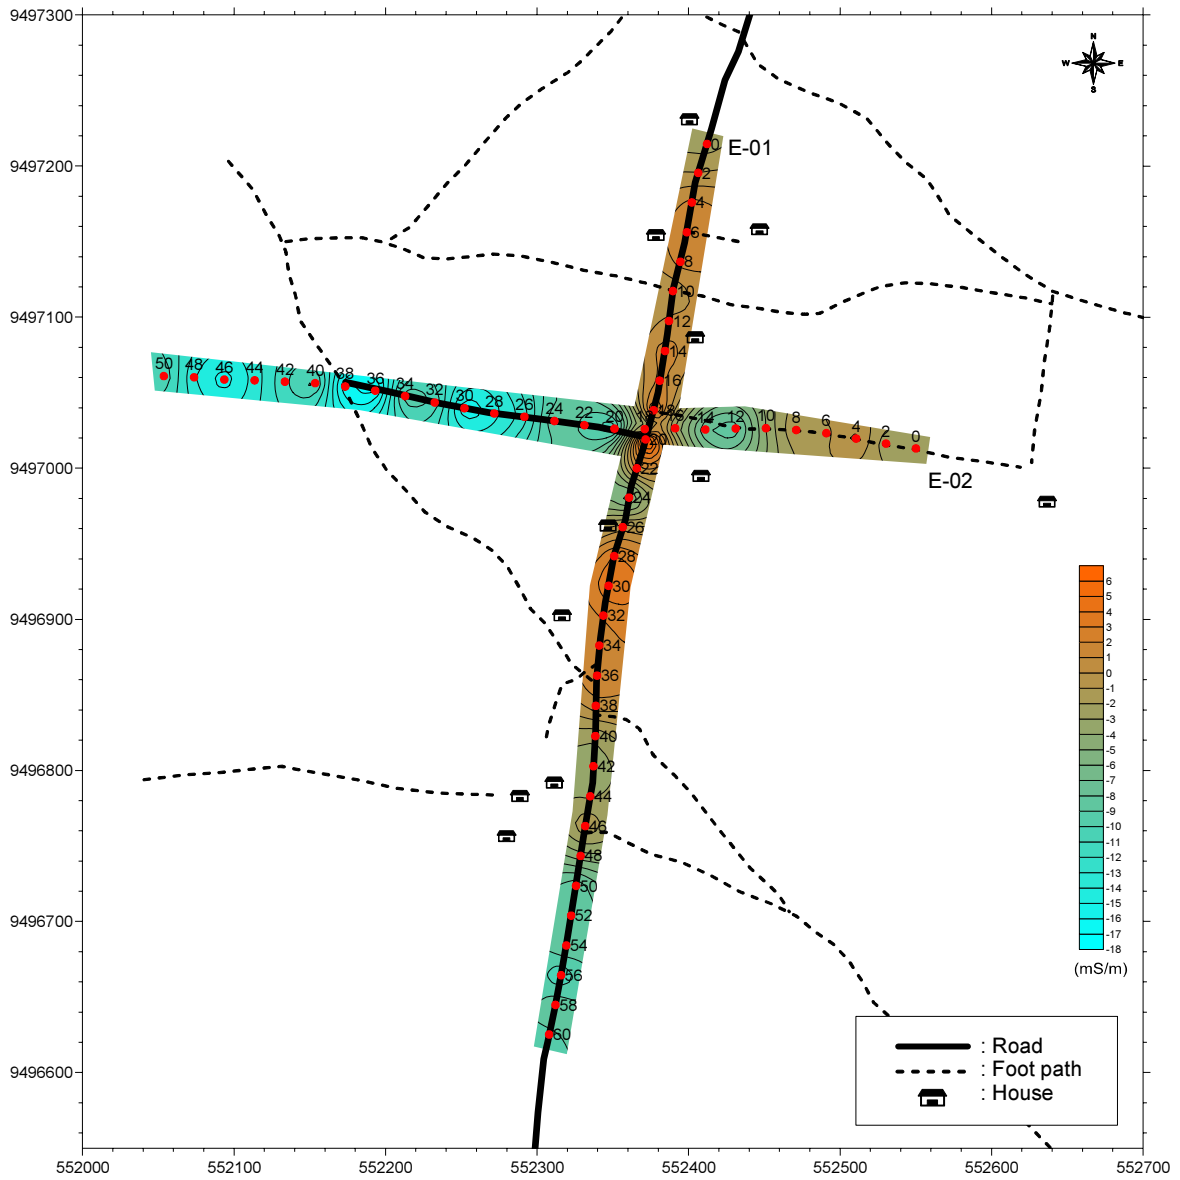
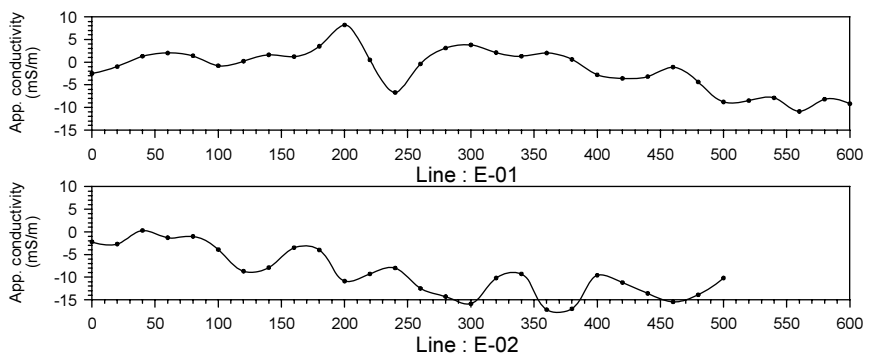
Figure.2.4.4 Geophysical survey results at Kusini-A sub-village in Busomeke village

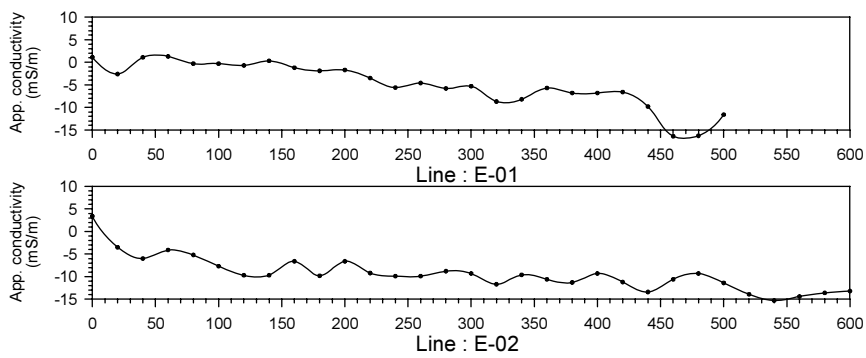
Figure.2.4.5 Geophysical survey results at Bulyawele sub-village in Busomeke village

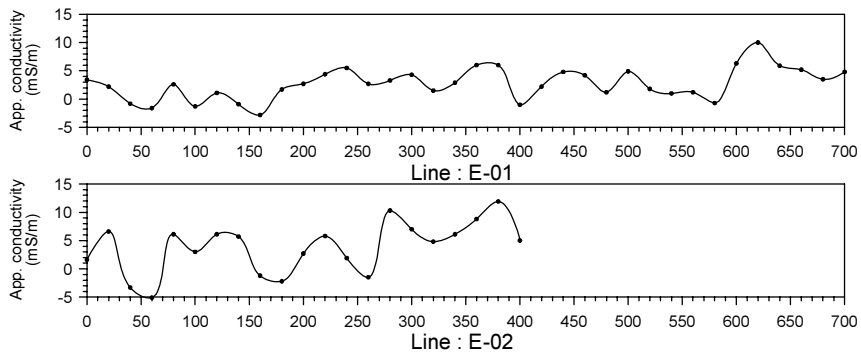
**Figure.2.4.6 Geophysical survey results at Kusini Mashariki sub-village in Kalemela village**

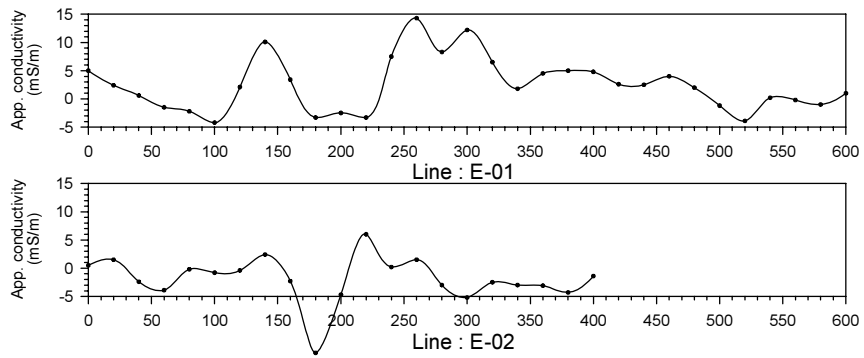
Figure.2.4.8 Geophysical survey results at Mashariki sub-village in Kalemela village

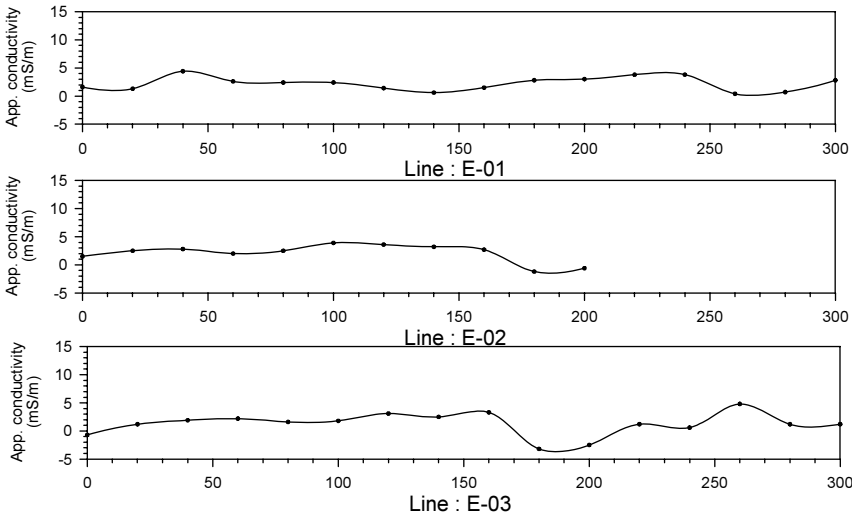
Figure.2.4.12 Geophysical survey results at Bukoli sub-village in Kitangili village
