2.5 RESULTS OF GEOPHYSICAL EXPLORATION OF LEVEL-2

2.5.1 NZEGA DISTRICT

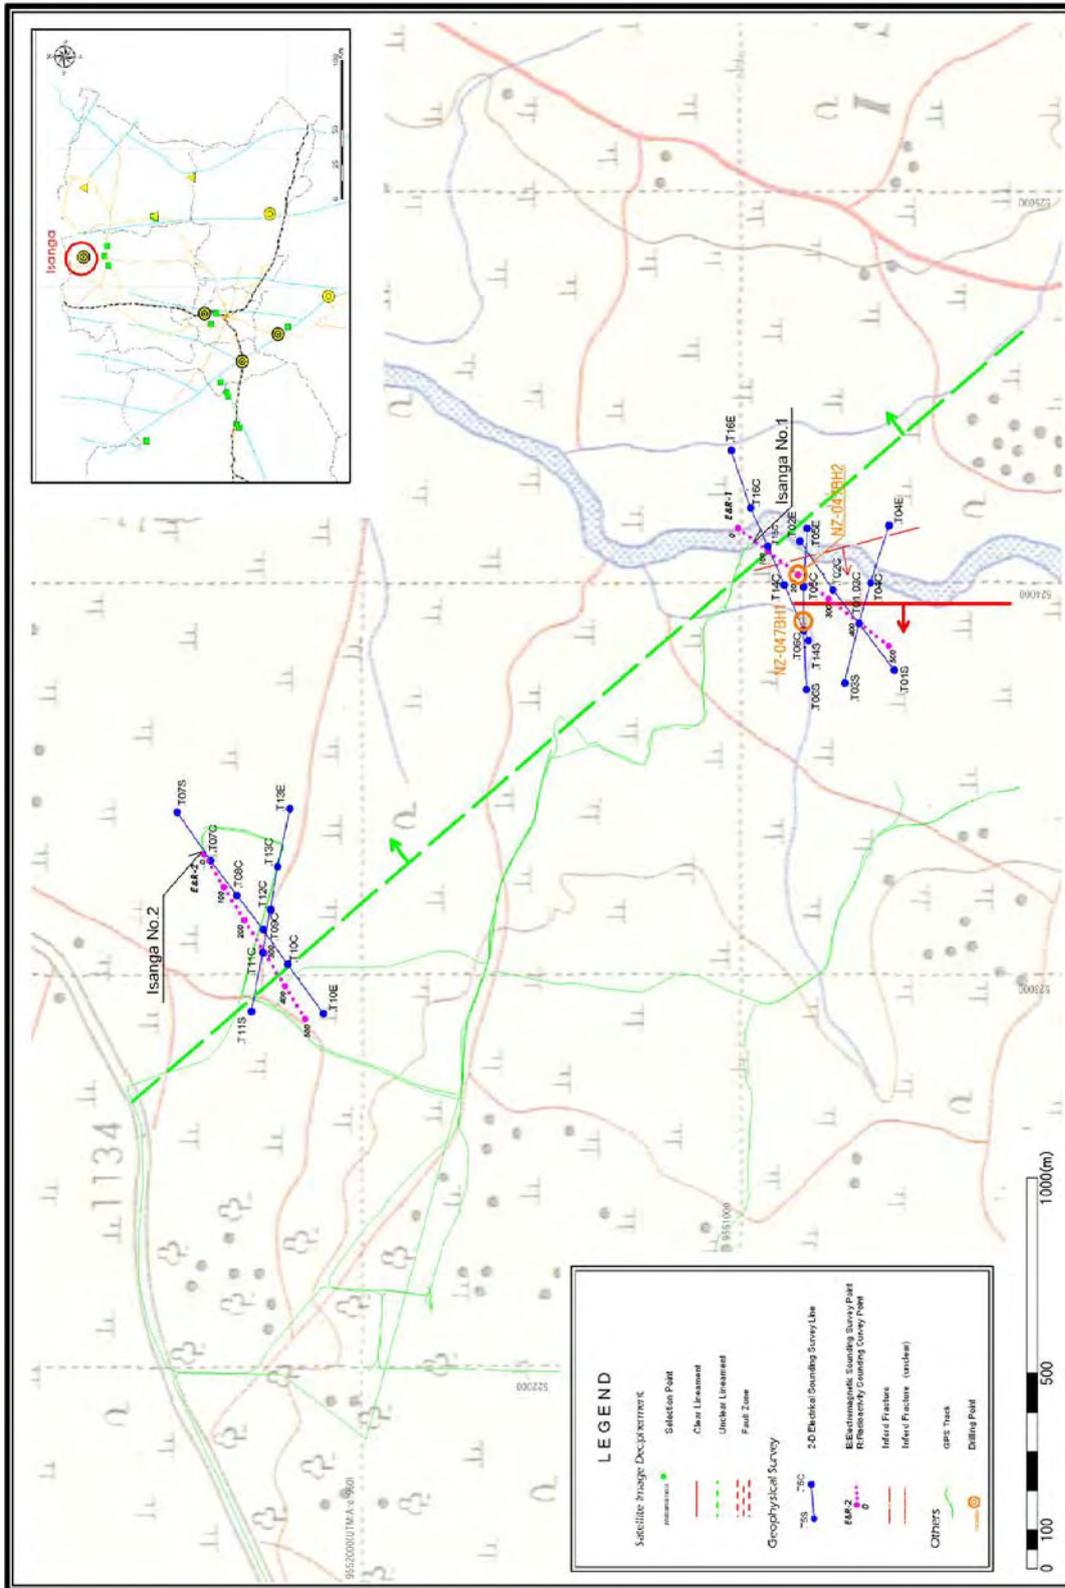
Figure 2.5.1 Layout of Geophysical Exploration (Level-2:Isanga village)

The survey location map shown in Figure 2.5.1, and the interpreted sections of the geophysical exploration are shown Figure 2.5.2 - 4.

The exploration was carried out around the unclear lineament in the E-W direction and around the clear lineament in the N-S direction.

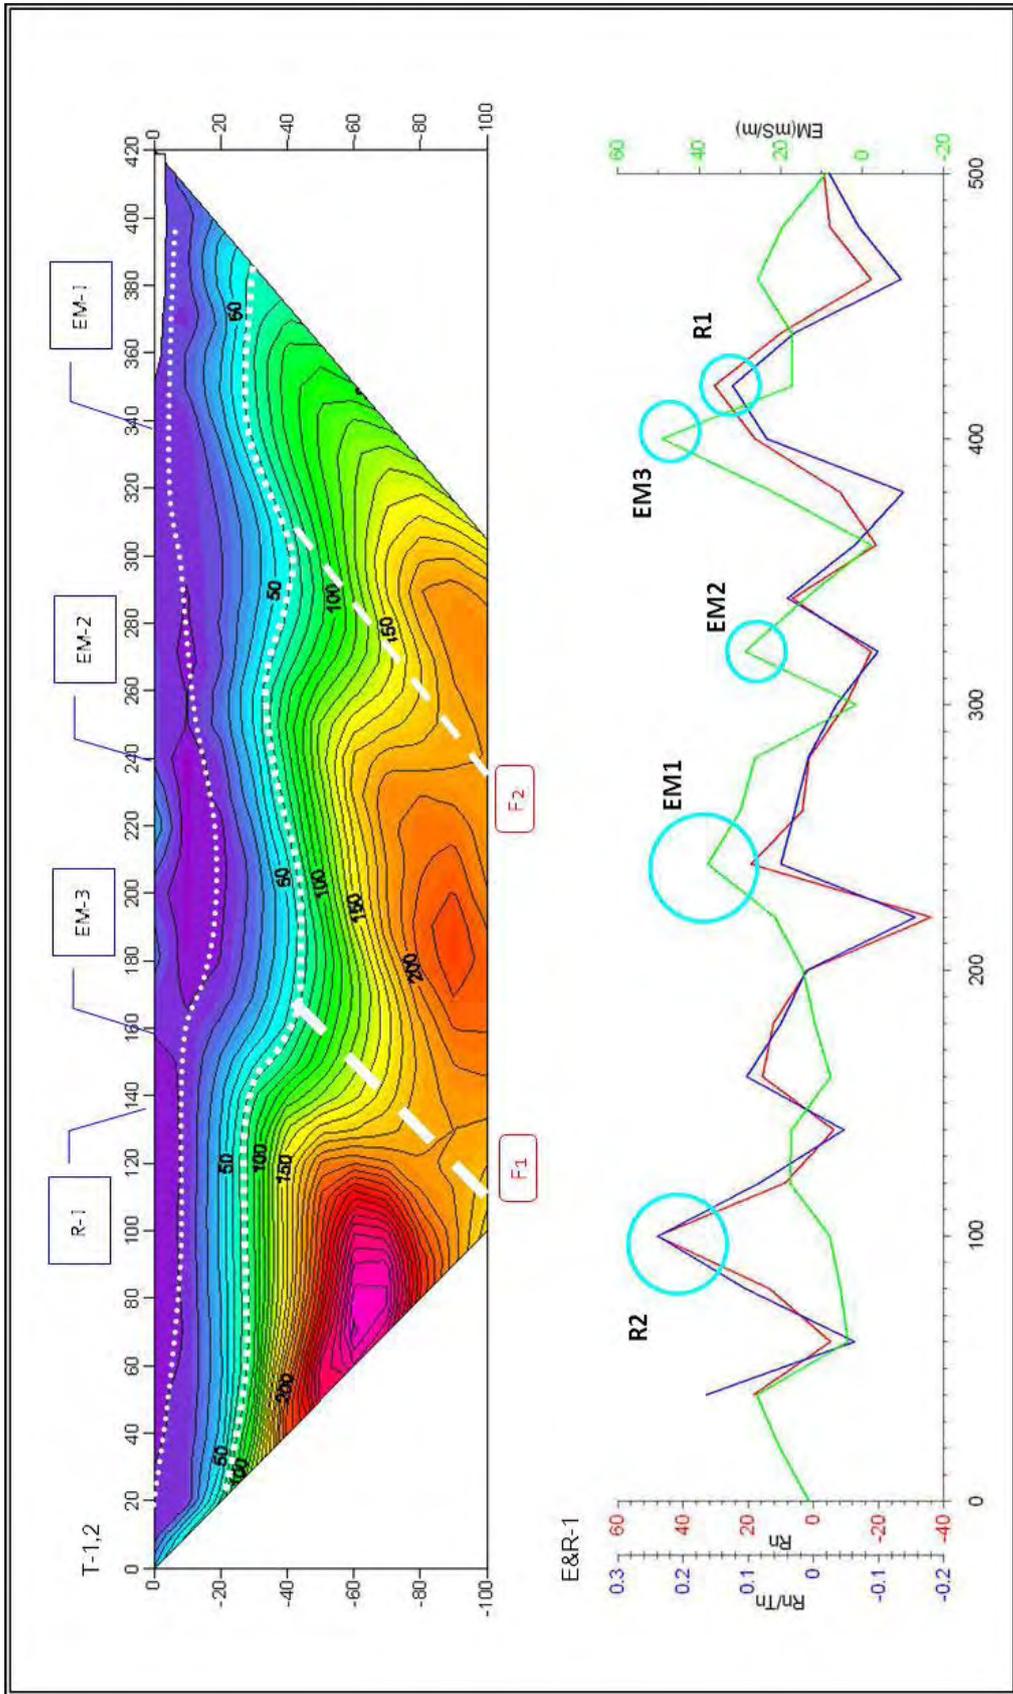
Figure 2.5.2 Results of Geophysical Exploration (Level-2) :Isanaga Village Isanaga No.1 1/2)

2 low resistivity zones that fall into the west direction were detected by 2D electrical sounding. The low resistivity zones are congruent in the clear lineament. Moreover, it is possible to confirm it in other resistivity sections. Therefore, the low resistivity zone is considered as the two fracture zones in the N-S direction.

The resistivity value decreases where the section between two presumptions fractures estimated in the crush zone.

The above-mentioned structure can be expected to have a potential of groundwater storage therefore, 2 drill sites were chosen. (NZ-046BH1, 2)

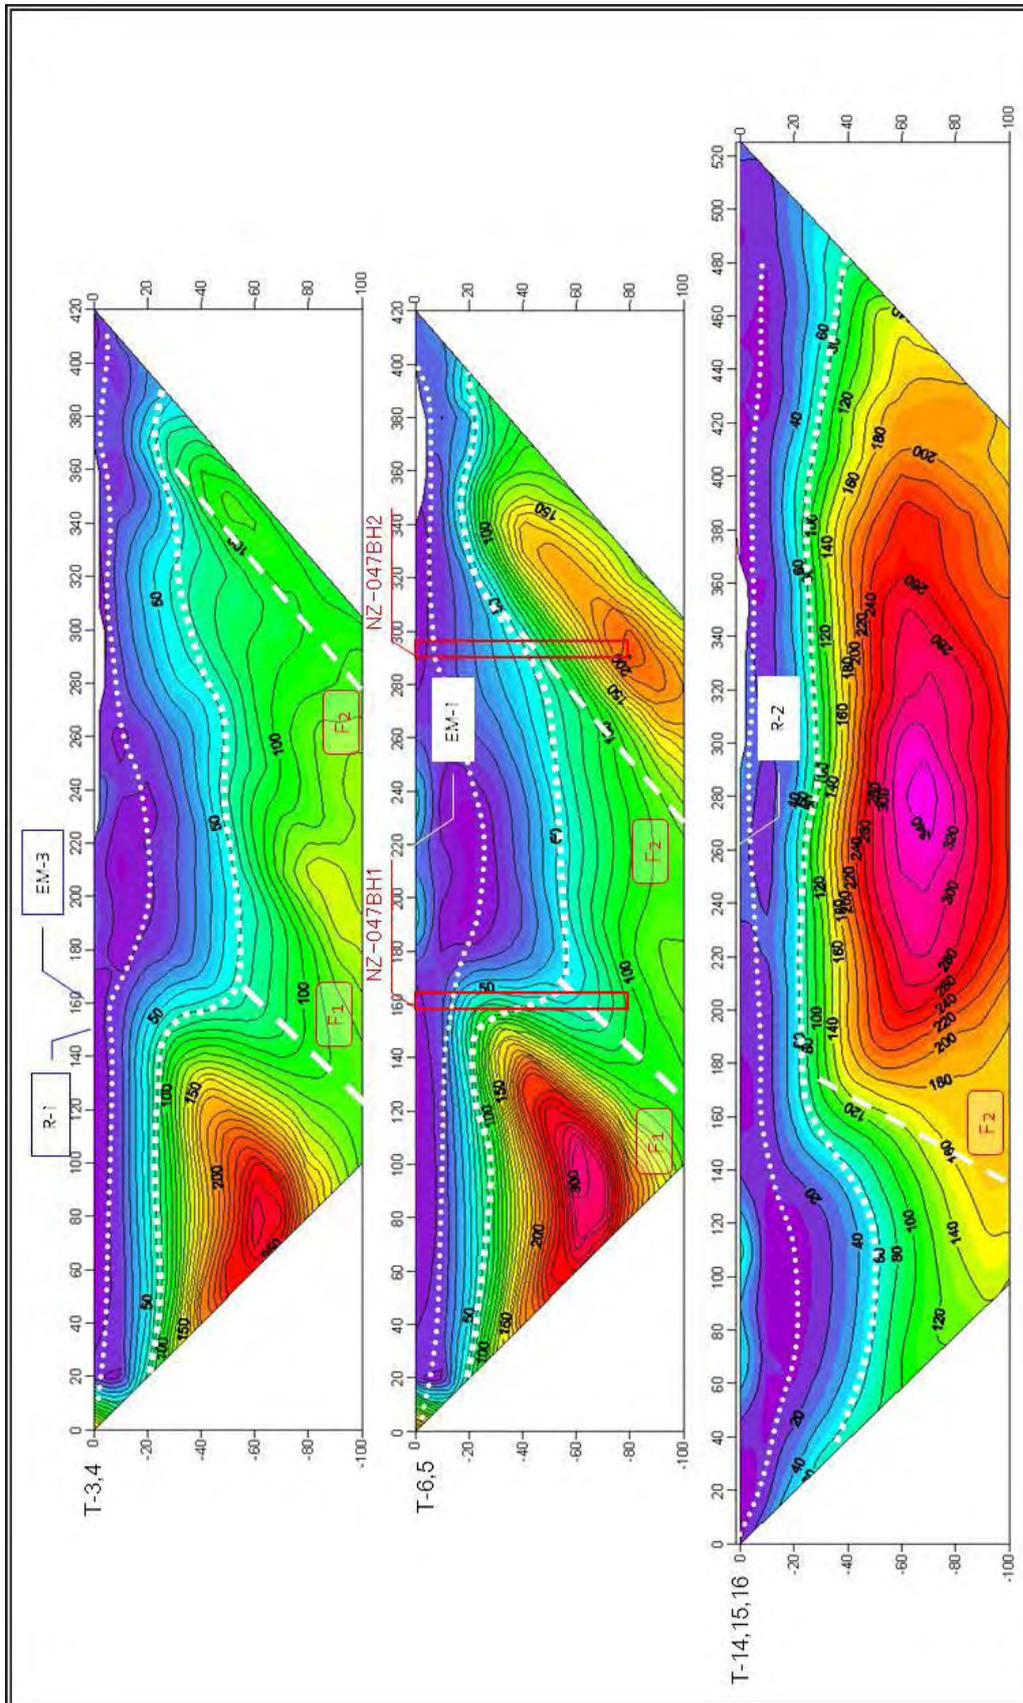
Figure 2.5.3 Results of Geophysical Exploration (Level-2 :Isanaga Village Isanaga No.1 2/2)

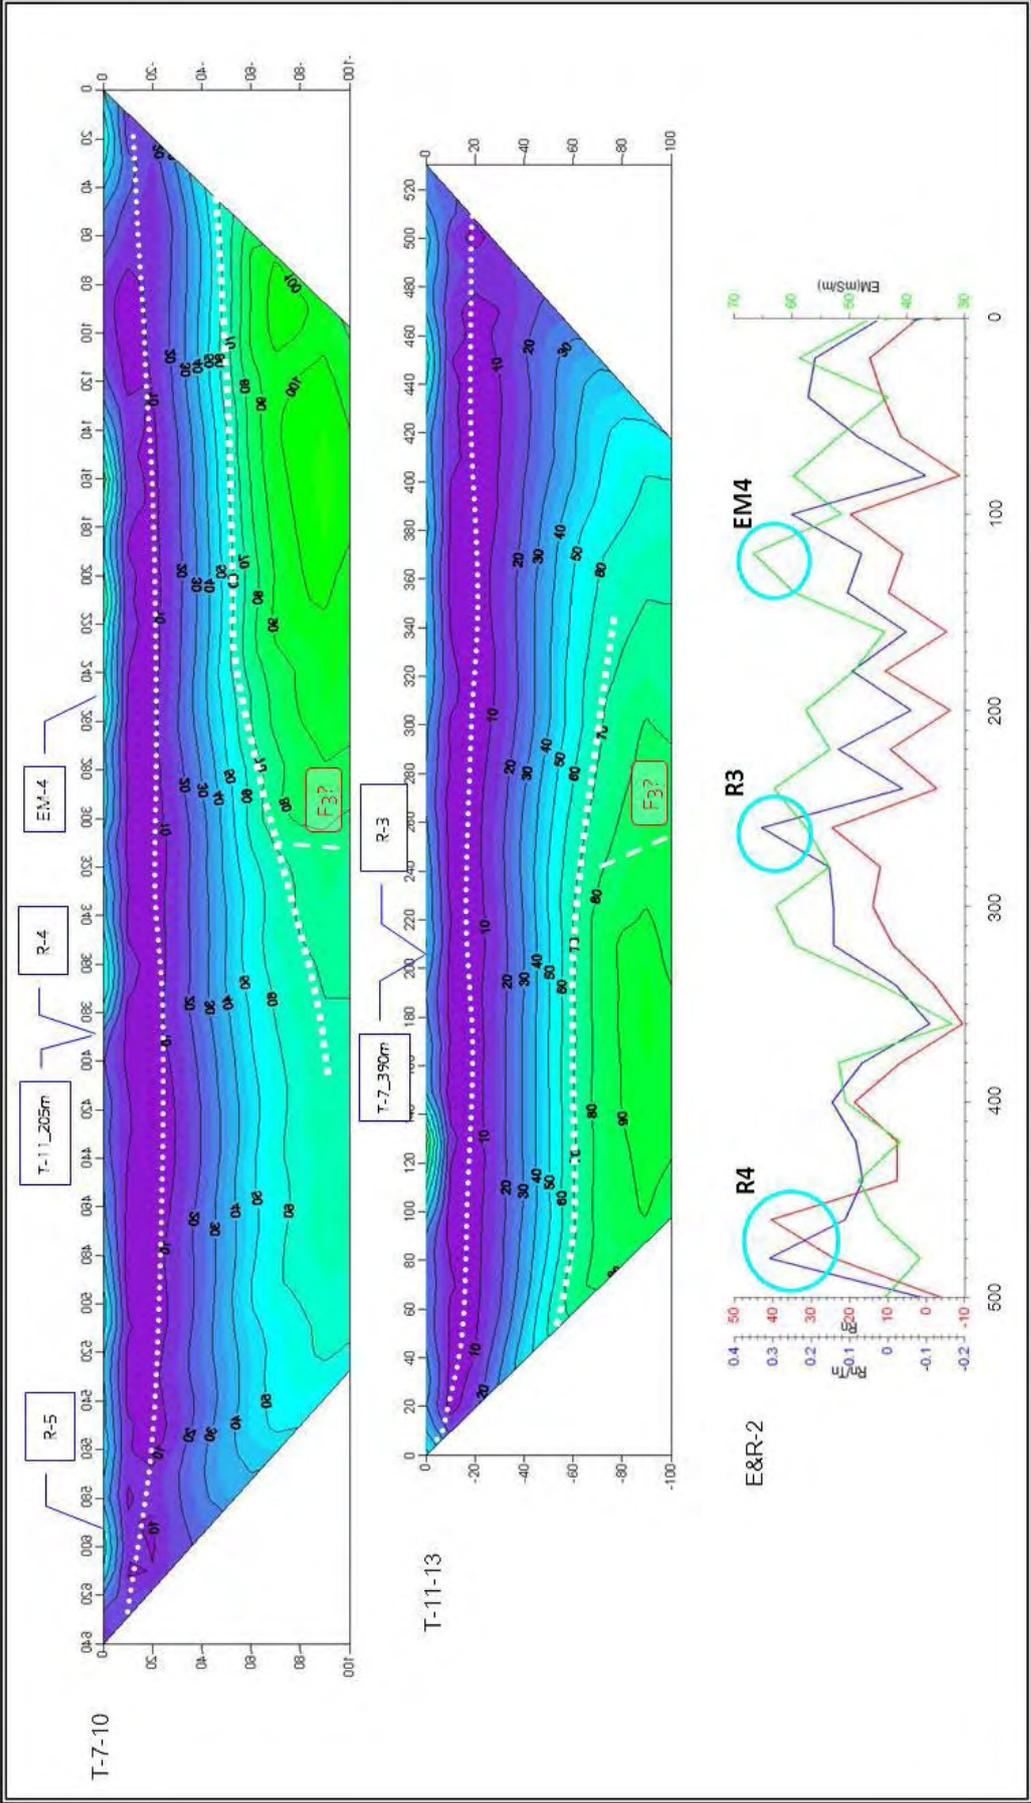
Figure 2.5.4 Results of Geophysical Exploration (Level-2 :Isanaga Village Isanaga No.2)

The results of geophysical exploration suggesting a fault or fracture was not recognized.

The resistivity shows low value overall. Therefore, it is considered that the thickness of the weathered zone or sediment is rather thick.

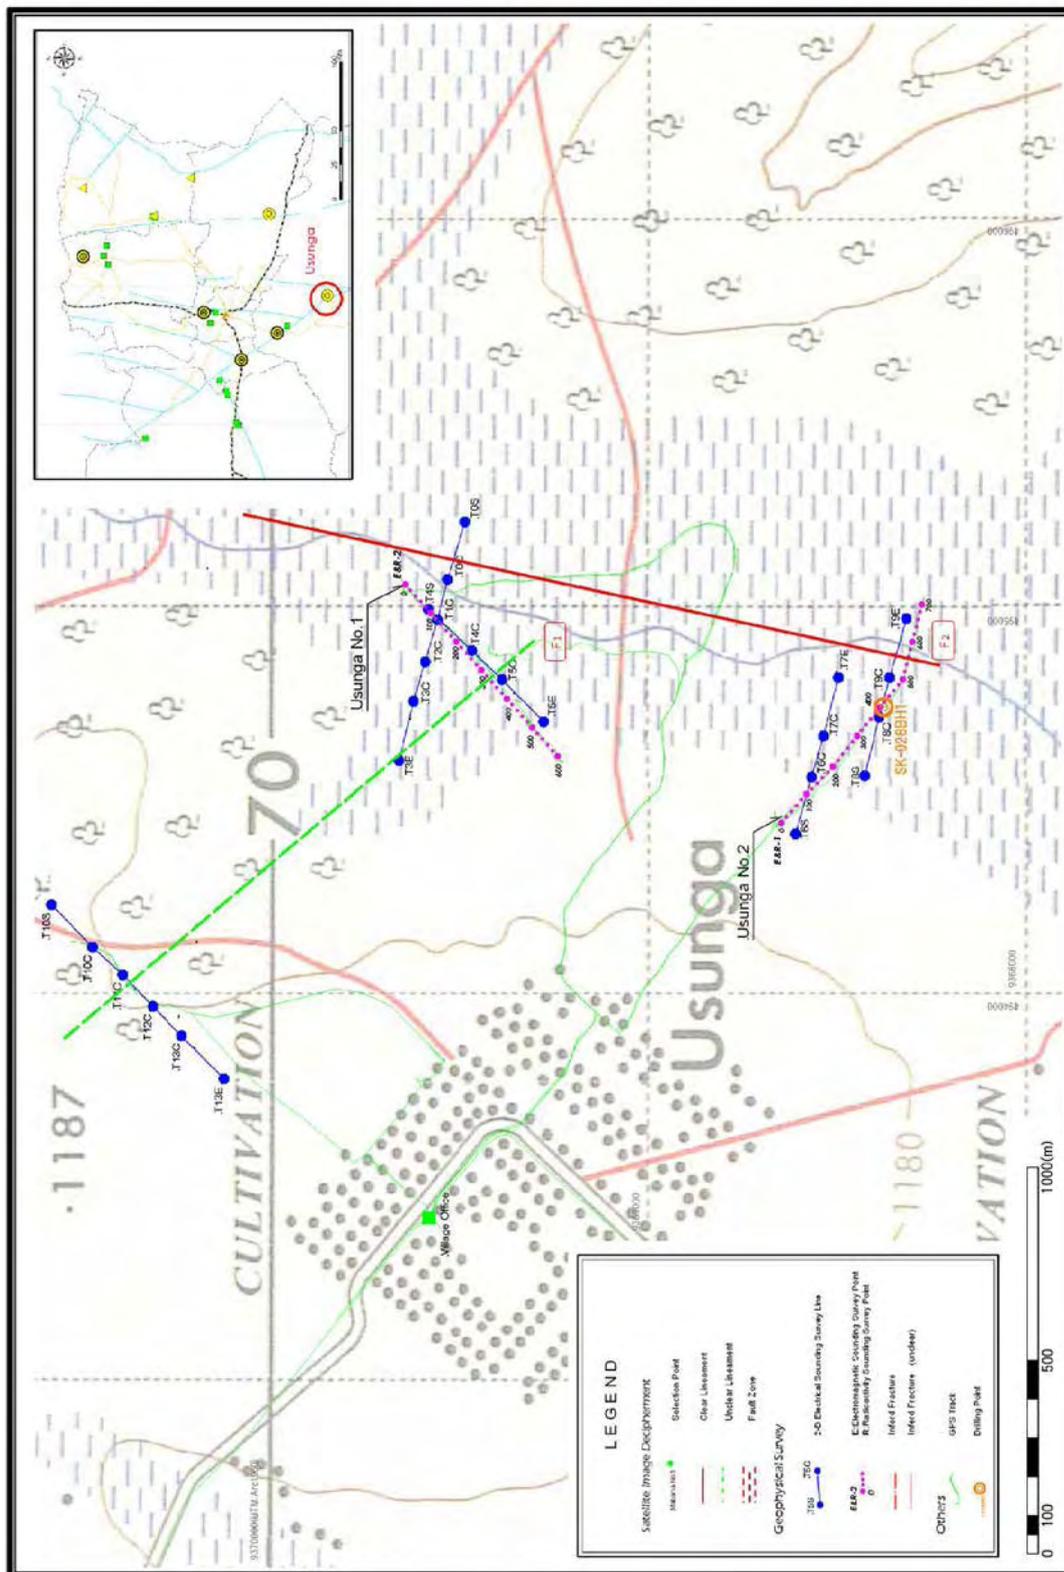
Figure 2.5.5 Layout of Geophysical Exploration (Level-2:Usungu Village1/2)

The survey location maps are shown in Figure 2.5.5 - 2.5.6, and the interpreted sections of the geophysical exploration are shown in Figure 2.5.7 – 2.5.10

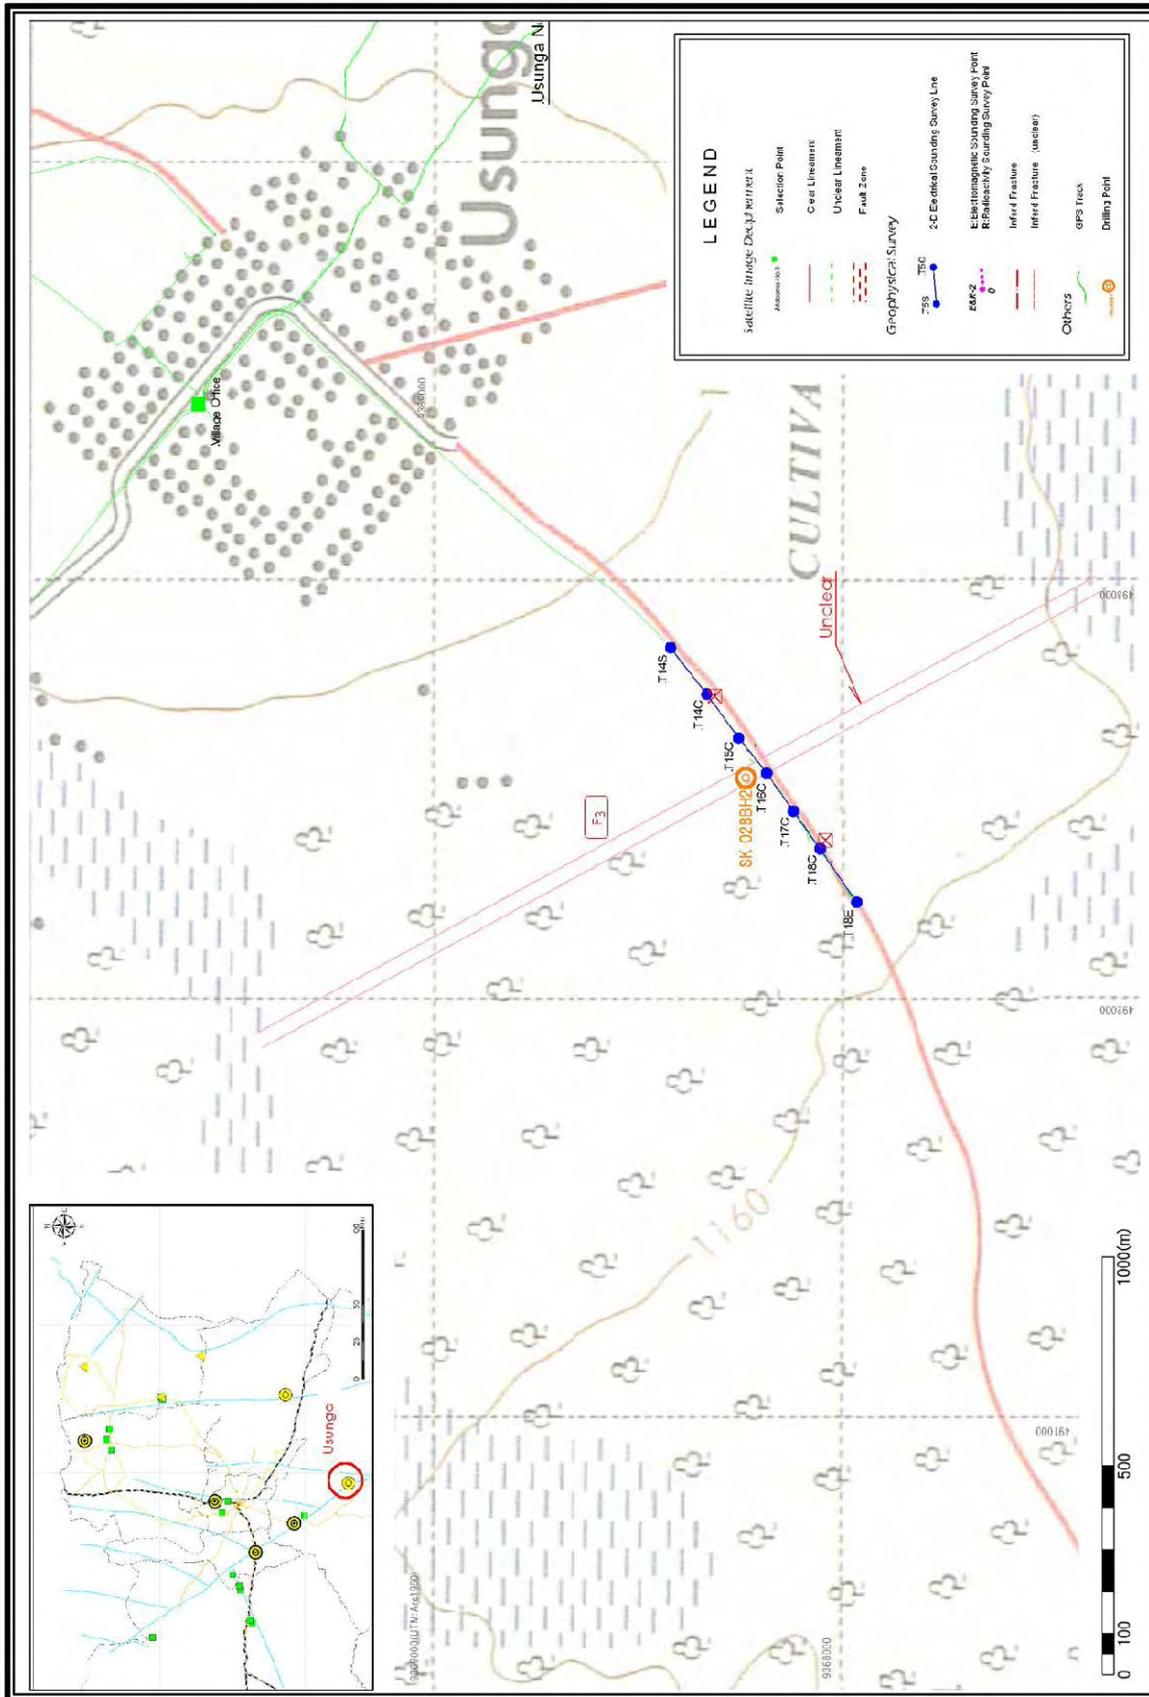
Figure 2.5.6 Layout of Geophysical Exploration (Level-2:Usunga Village 2/2)

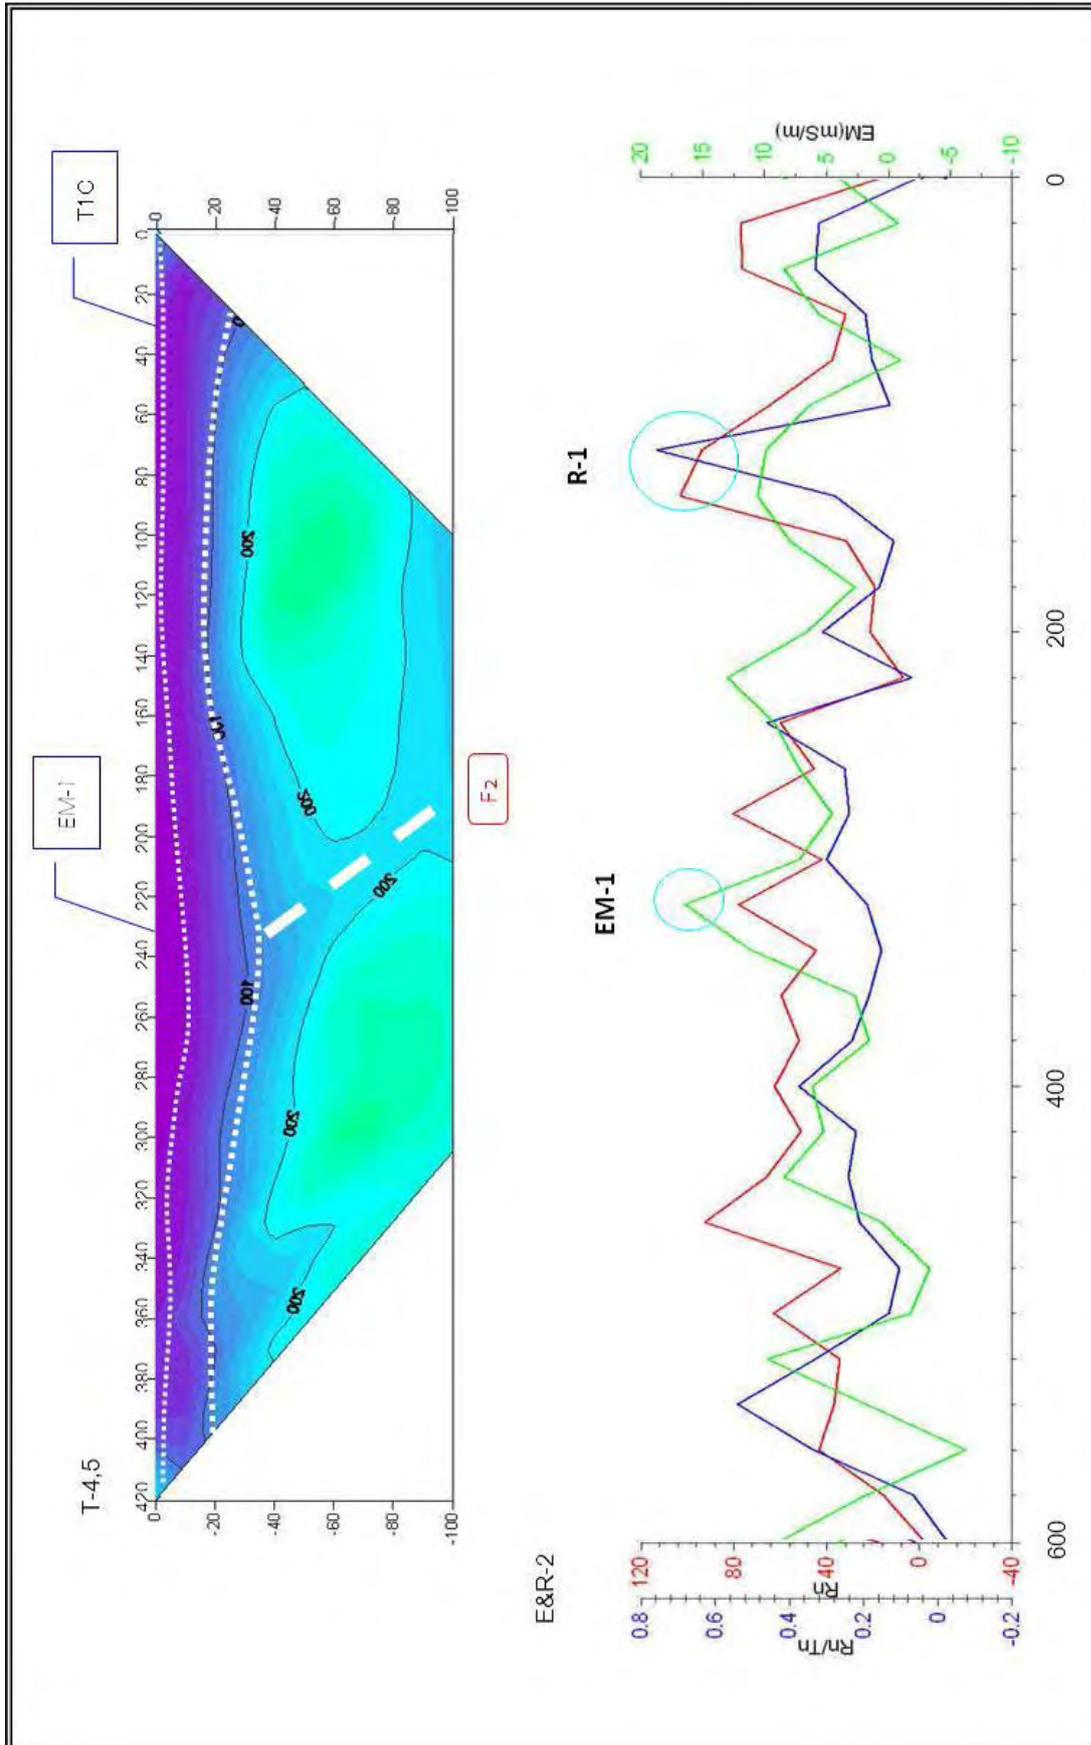
Figure 2.5.7 Results of Geophysical Exploration (Level-2-Usunga village Usunga No.1 1/2)

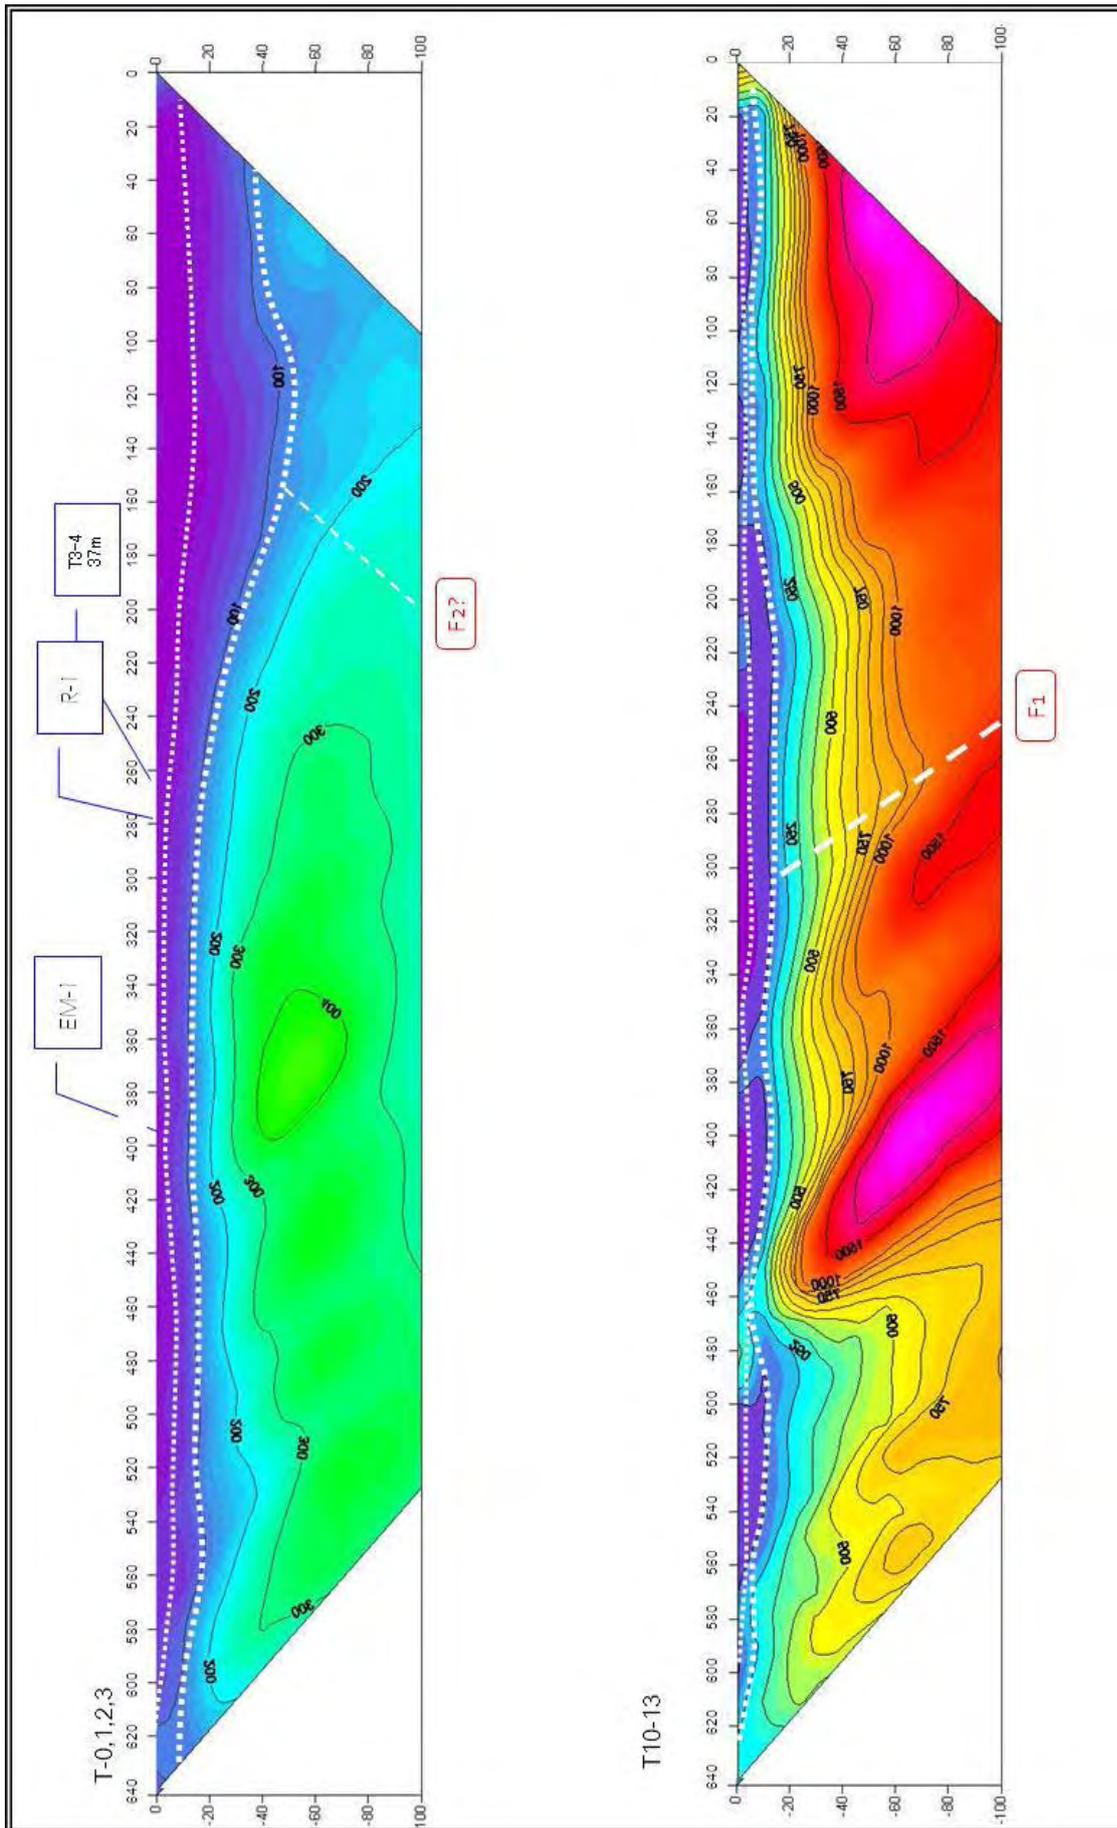
Figure 2.5.8 Results of Geophysical Exploration (Level-2:Usunga village Usunga No.1 2/2)

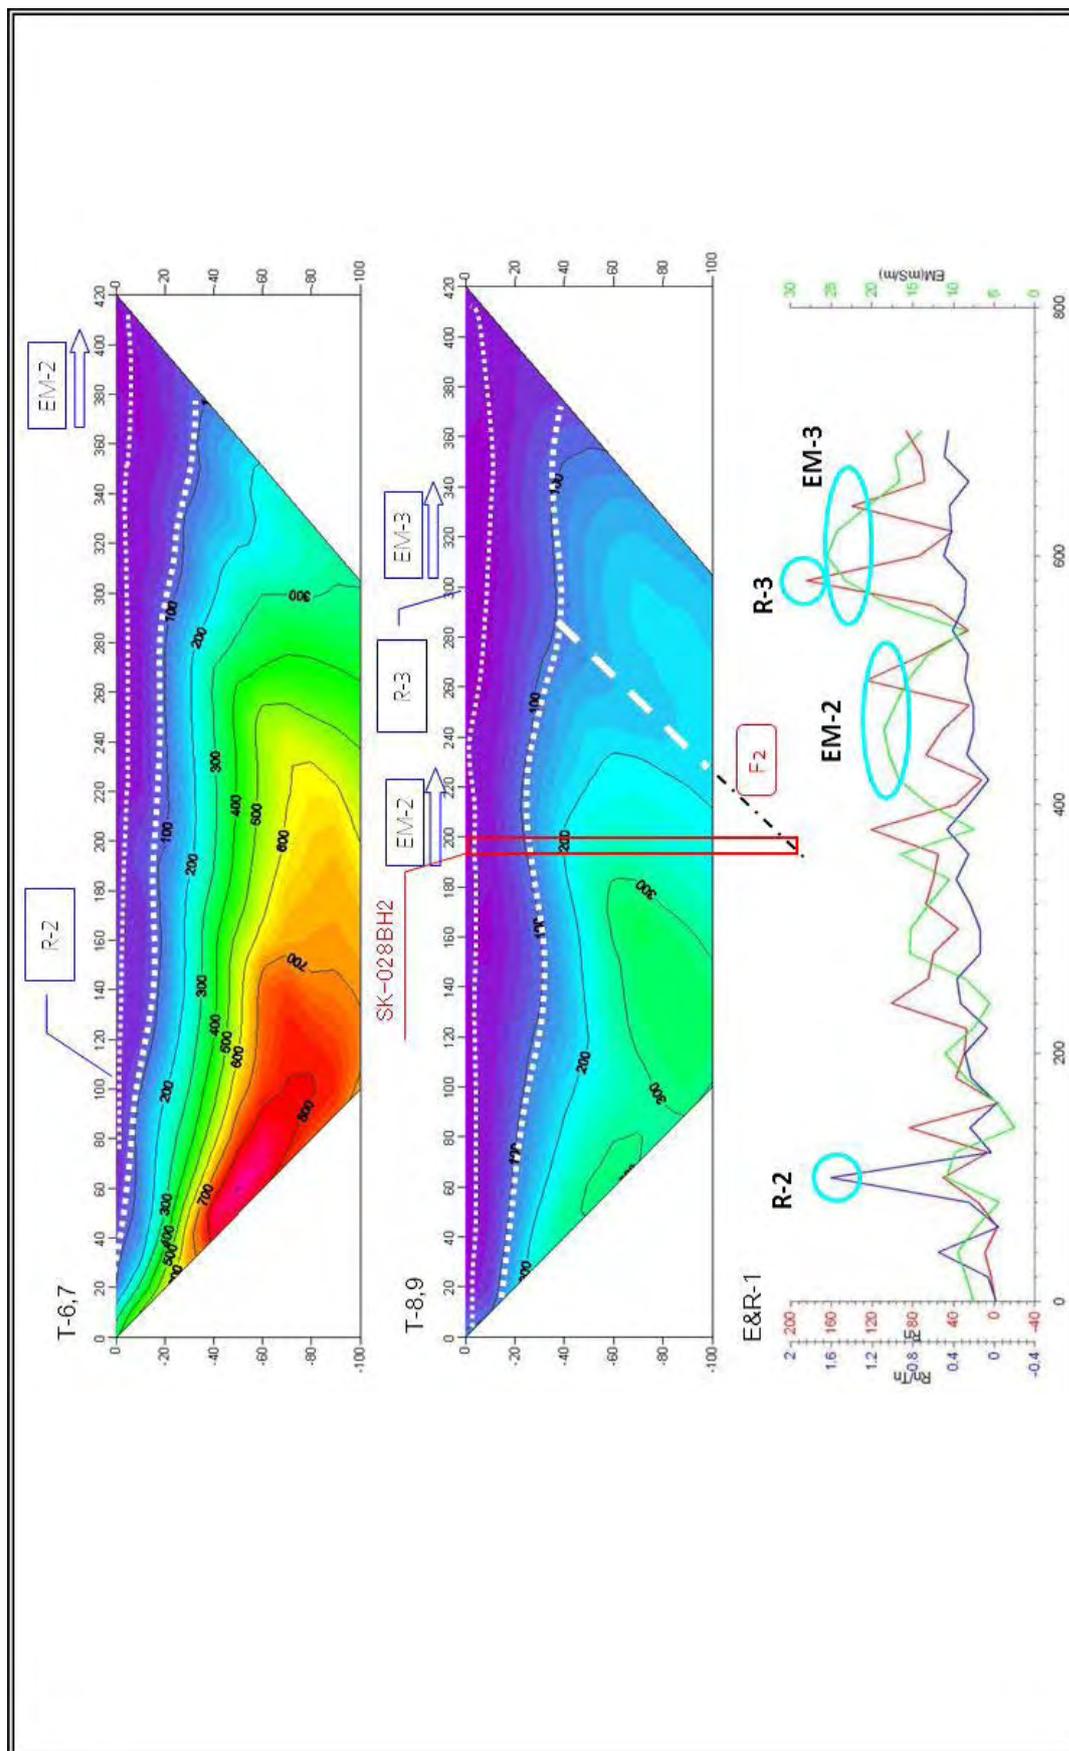
Figure 2.5.9 Results of Geophysical Exploration (Level-2:Usunga village Usage No.2)

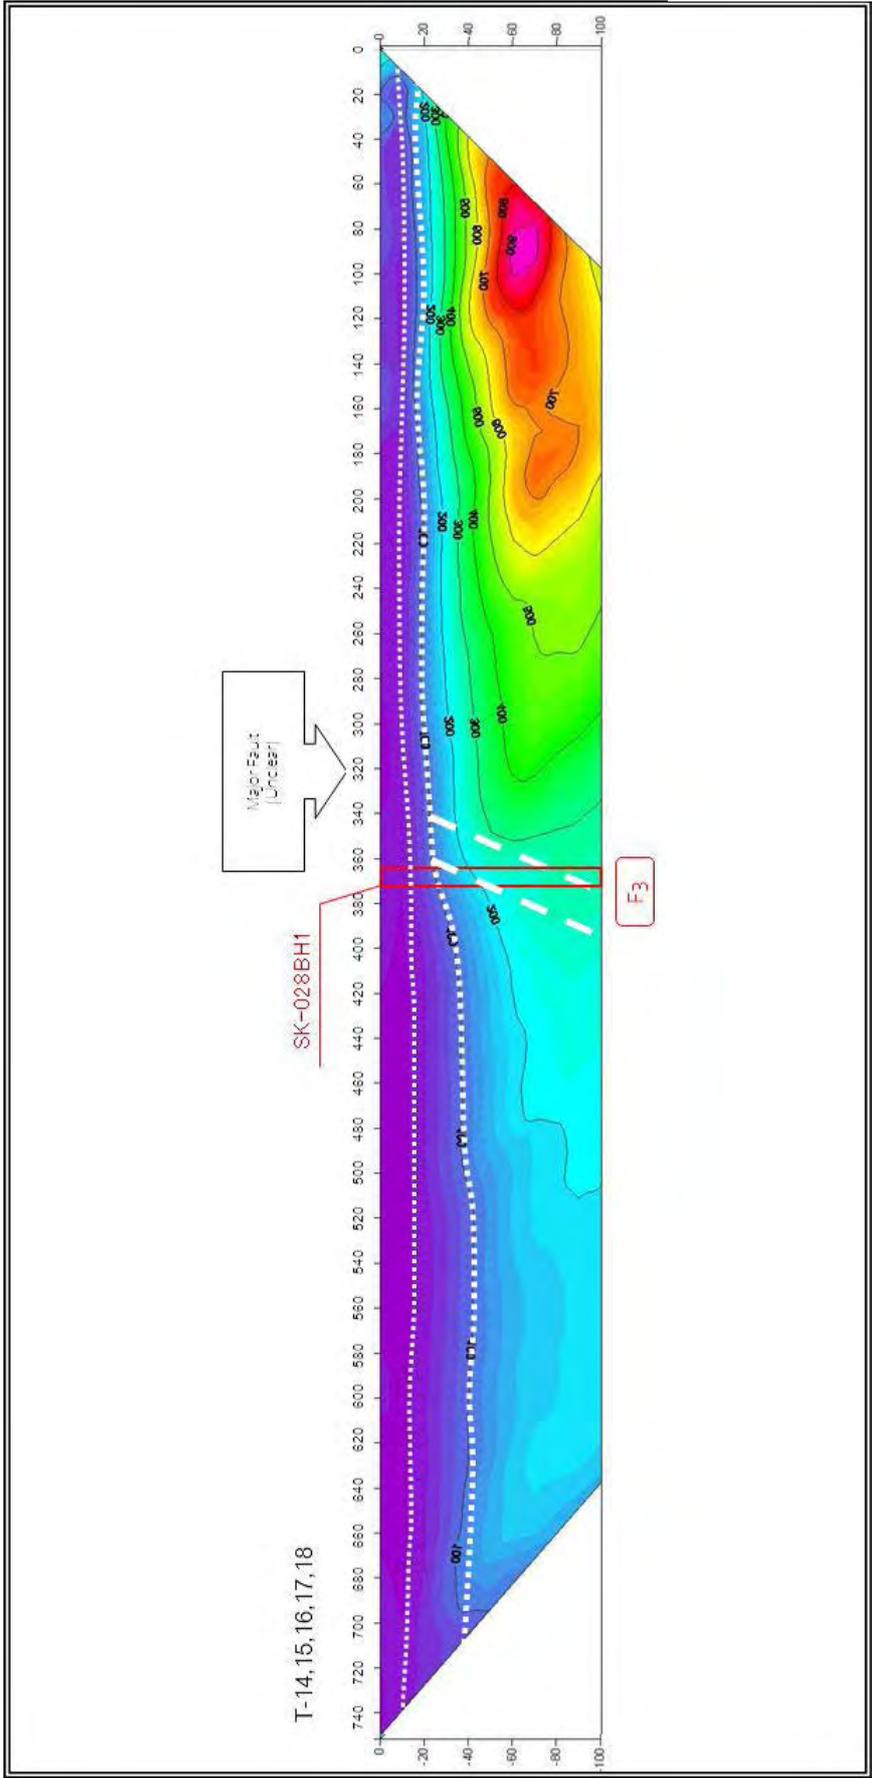
Figure 2.5.10 Results of Geophysical Exploration (Level-2: Usunga village The South-West of the village)
