2.6 RESULTS OF GEOPHYSICAL EXPLORATION OF WATER QUALITY CHECK SITE

Figure 3.3.1 Drilling Site Map
The Study on Rural Water Supply in Tabora Region

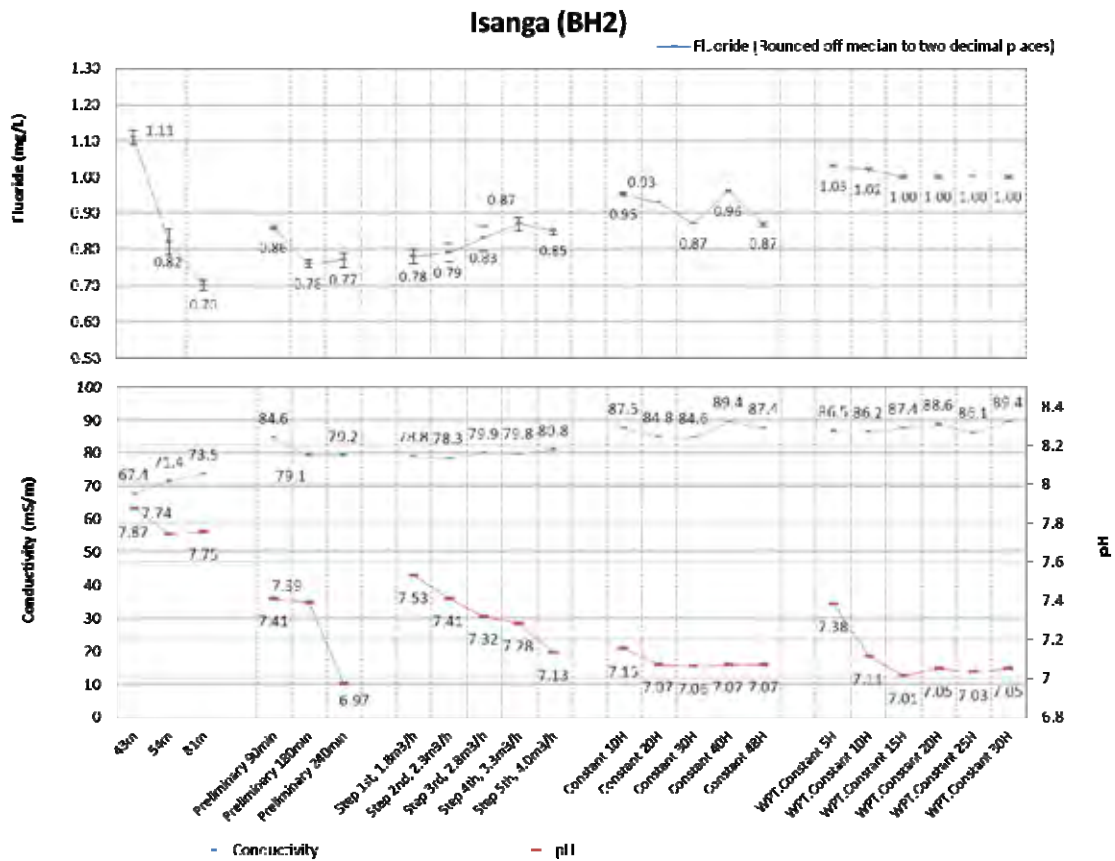
Figure 3.4.2 Water quality change through site works in Isanga Village BH2

Figure 3.4.2 shows the water quality change through site works.

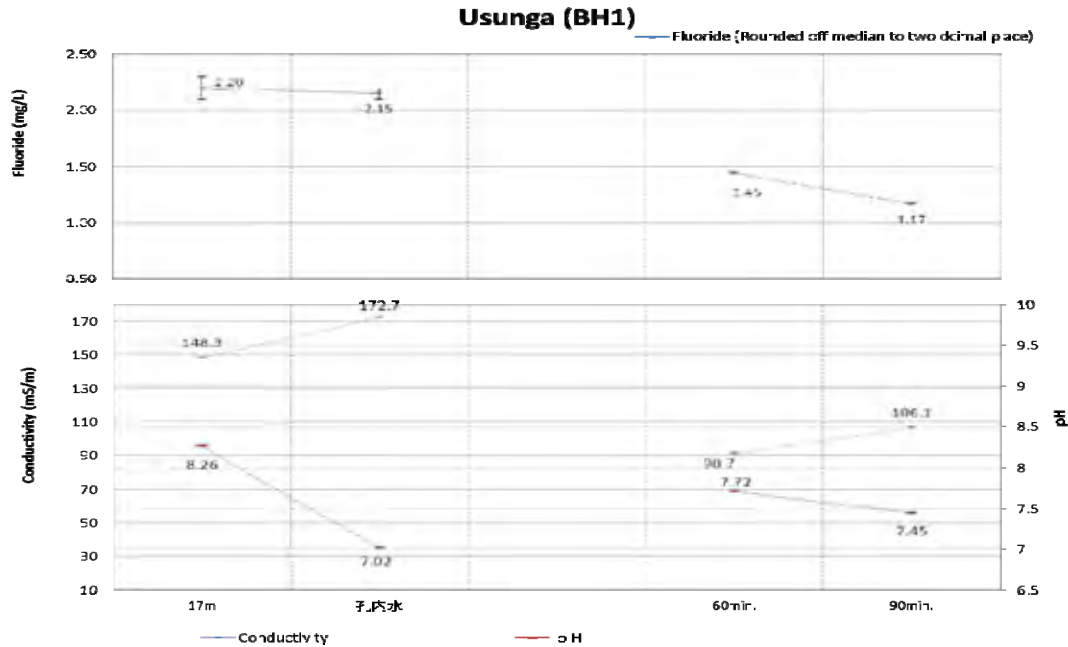
Figure 3.4.3 Water quality change through site works in Usunga Village (BH1)

Figure 3.4.3 shows the water quality change through site works.

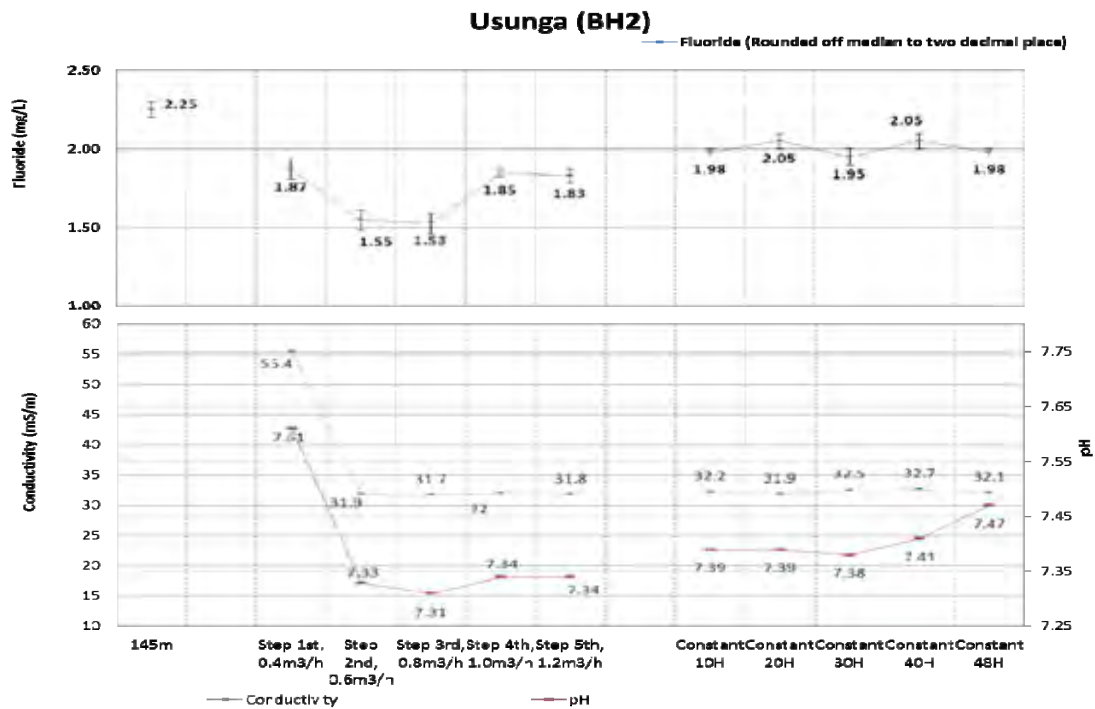
Figure 3.4.4 Water quality change through site works in Usunga village (BH2)

Figure 3.4.4 shows the water quality change through site works.

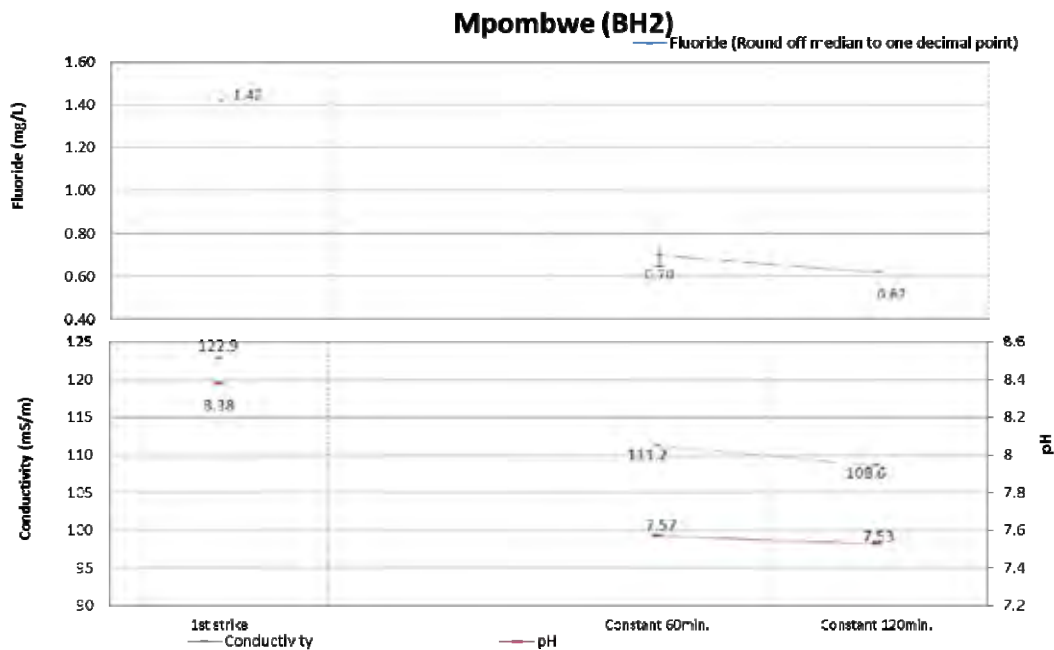
Figure 3.4.5 Water quality change through site works in Mpombwe Village (BH2)

Figure 3.4.5 shows the water quality change through site works.

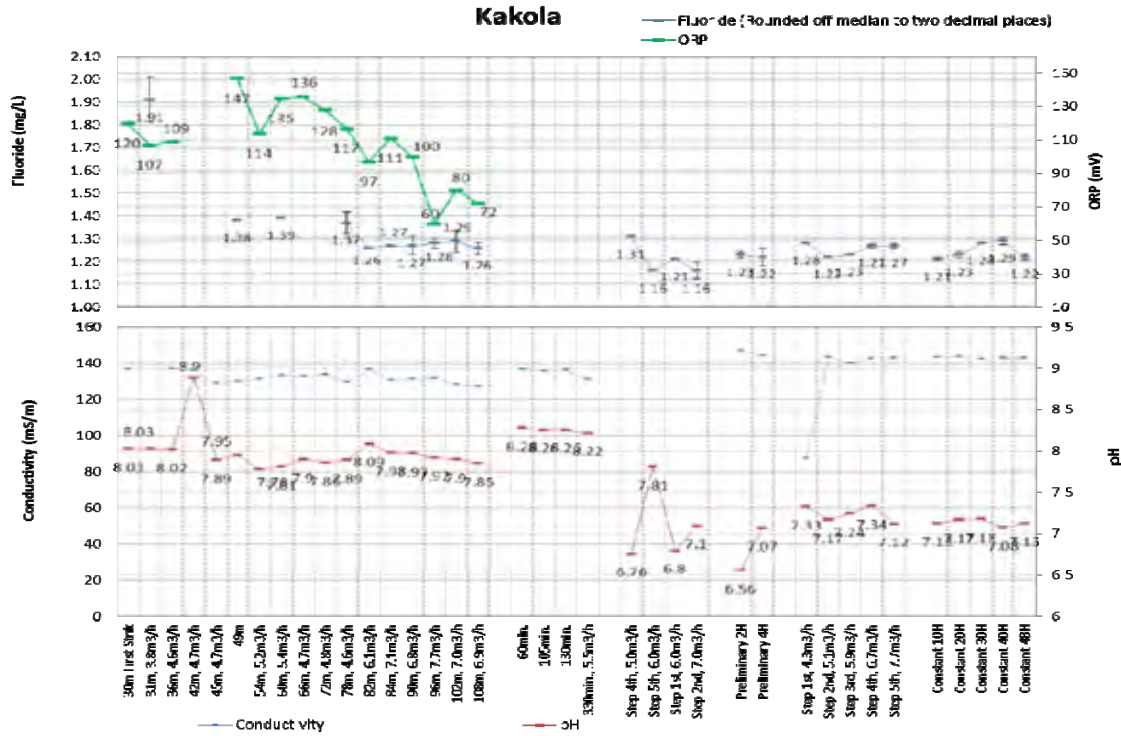
Figure 3.4.9 Water quality change through site works in Kakola village (BH1)

The concentration of Fluoride diminished obviously between 31m and 49m, and between 78m and 82m. ORP increased between 36 – 49m, 54 – 60m, 82 – 84m, 96 – 102. But as a whole, it decreased gradually along the works as a whole. A scatter graph of ORP and Fluoride shows 3 groups. It indicates that groundwater possibly consists of at least 3 water masses of 30-46m, 49-78m, 82-108m. See the Figure 3.4.9 and 3.4.10.

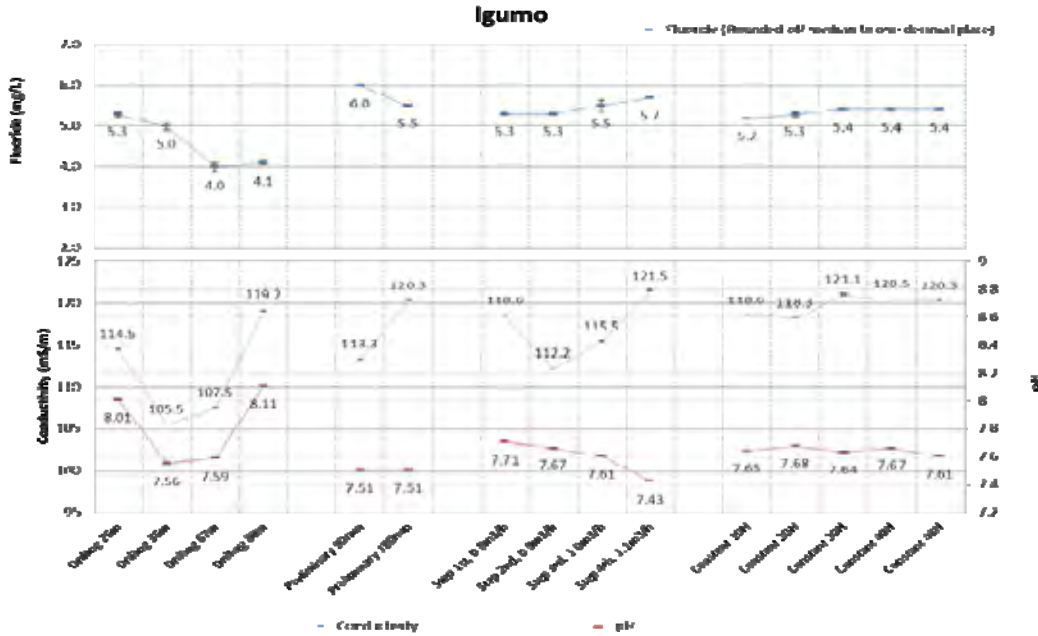
Figure 3.4.11 Water quality change through site works in Igumo Village BH1

Figure 3.4.11 shows the water quality change through site works.
