Figure -2 Cross Section Profiles of Two Dimensional Resistivity, Electro Magnetic and Radon Survey (1/8)

Figure-3 Drilling Report (1/8)

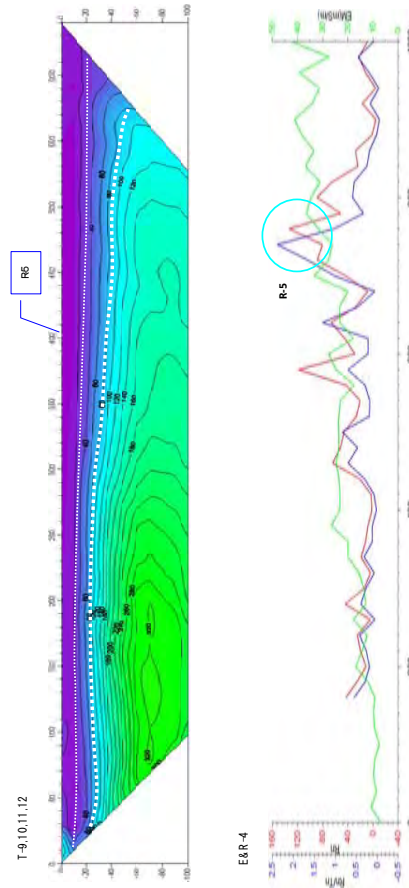
Level 2: Mabama Village Survey No.2

Figure -2 Cross Section Profiles of Two Dimensional Resistivity, Electro Magnetic and Radon Survey (5/8)
