(3) Topographic and Bathymetric Conditions

Site surveys were conducted during 10 to 13, August 2010 and results are shown in Figure-1.2(9) and Figure-1.2(10).

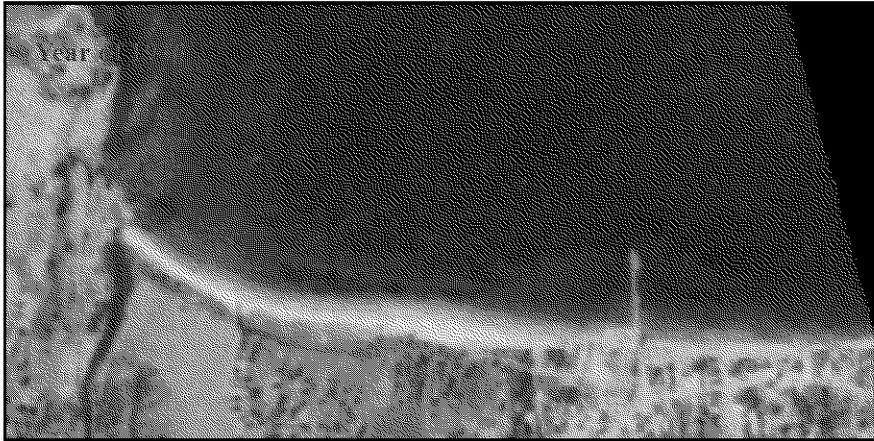
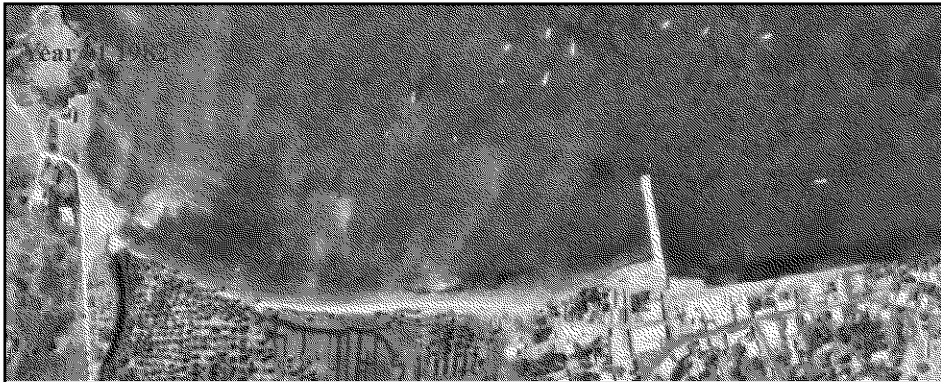
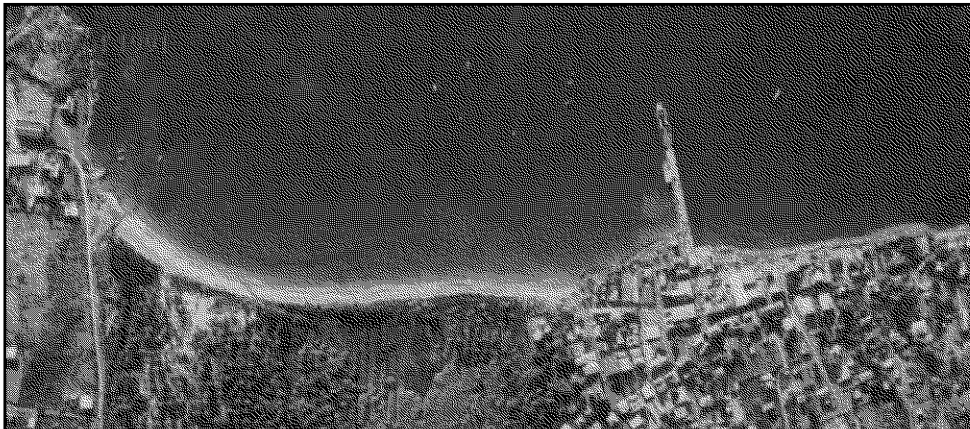
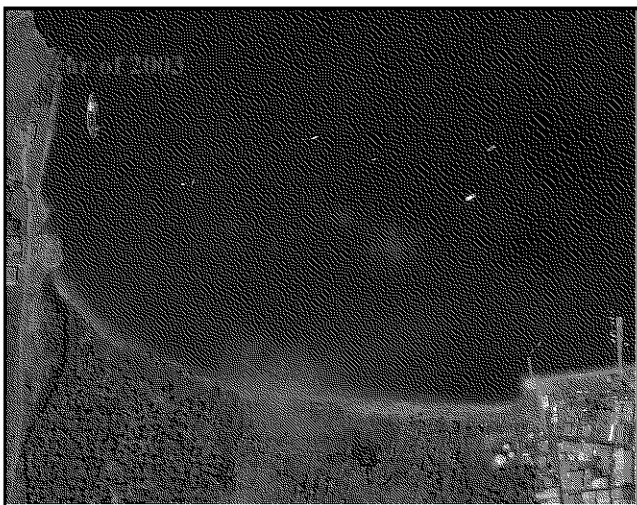
Photo-1.2(2) Aerial Photos of Gallows Bay

Judging from topographic change around project site seen on the aerial photos (years of 1946, 1982, 1991, 2003) obtained from Museum of Nevis History, the shoreline of Gallows Bay (project site) has been retreated by erosion generated at the time of hurricane but beach width has not been changed remarkably. Shore erosion from Penny Beach to Four Seasons Hotel became controversial after Ferry Dock has constructed in 1995. Therefore, the rubble mound revetment was constructed as the first one in Nevis Island and detached breakwaters have been constructed in front of Four Seasons Hotel.

In addition, it is seen that beach shape in Charlestown Ferry Dock constructed in 1995 land filling from Tourist Jetty to the backside of Fishery Jetty has not widely been changed.

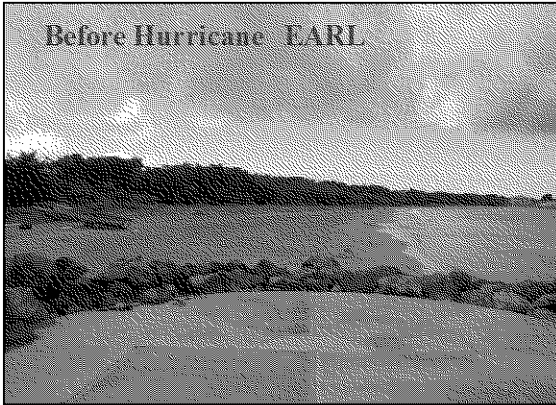
Photo-1.2(3-1) Beach (August 2010)

Beach width has become narrow to be about 20m by hit of Hurricane “EARL” in early September 2010, however it has recovered gradually after finish of hurricane season and returned back again in July 2011 as shown in Photo-1.2(3) and Photo-1.2(4). Since beach width has become narrow transiently after hurricanes and has recovered gradually, it is considered that seasonal change of beach width is continued after completion of the planed facilities.

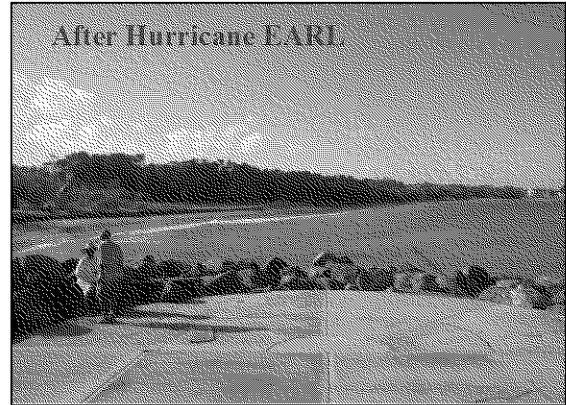
Photo-1.2 (3-2) Beach (September 2010)

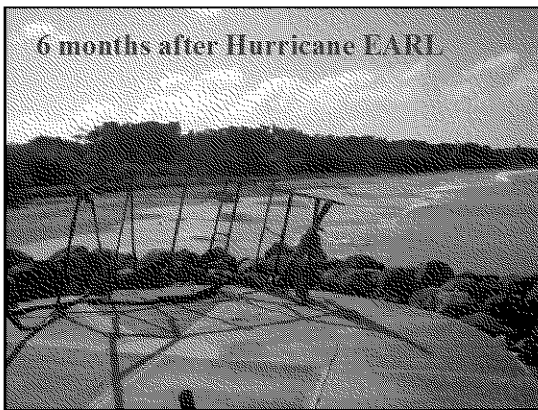
Photo-1.2 (3-3) Beach (February 2011)

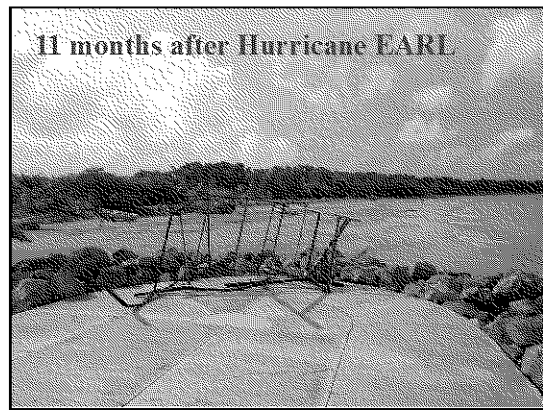
Photo-1.2(3-4) Beach (July 2011)

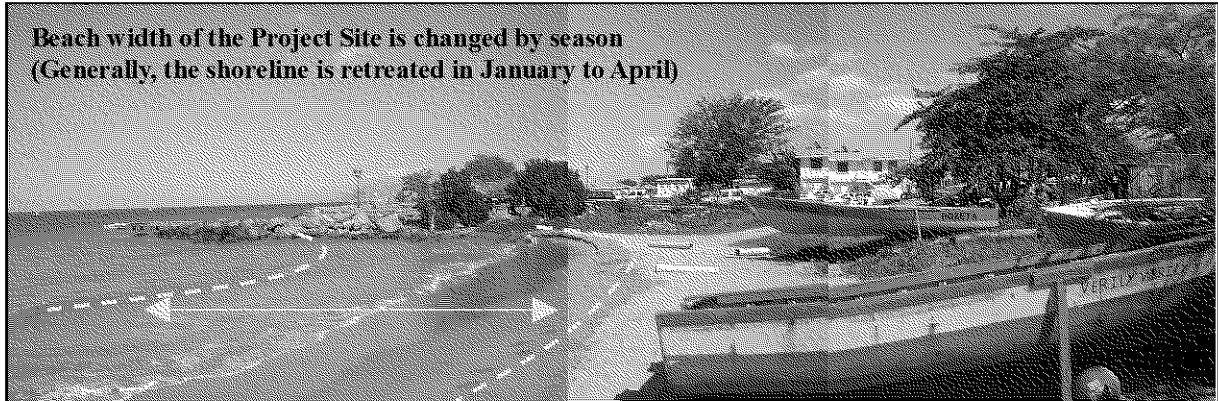
Photo-1.2 (4-1) Beach (February 2010)

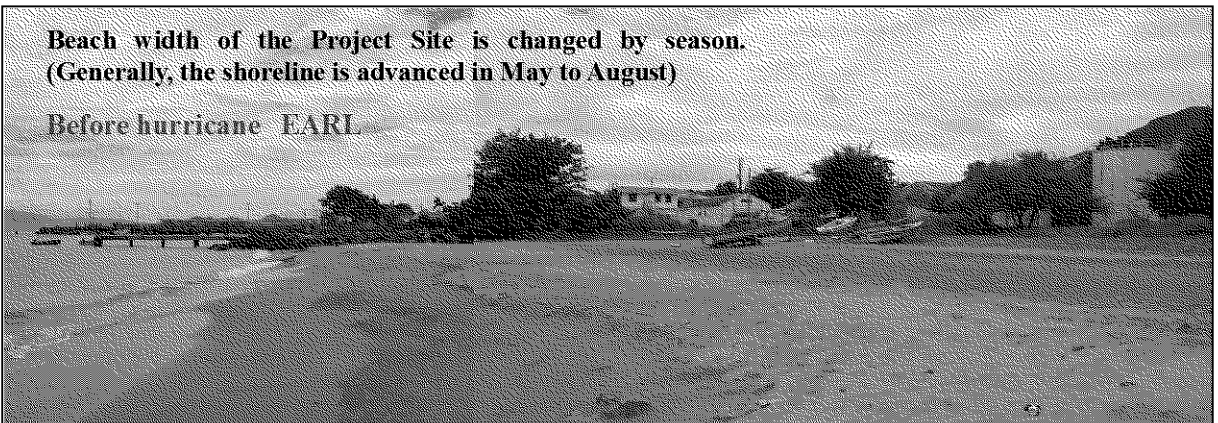
Photo-1.2(4-2) Beach (August 2010)

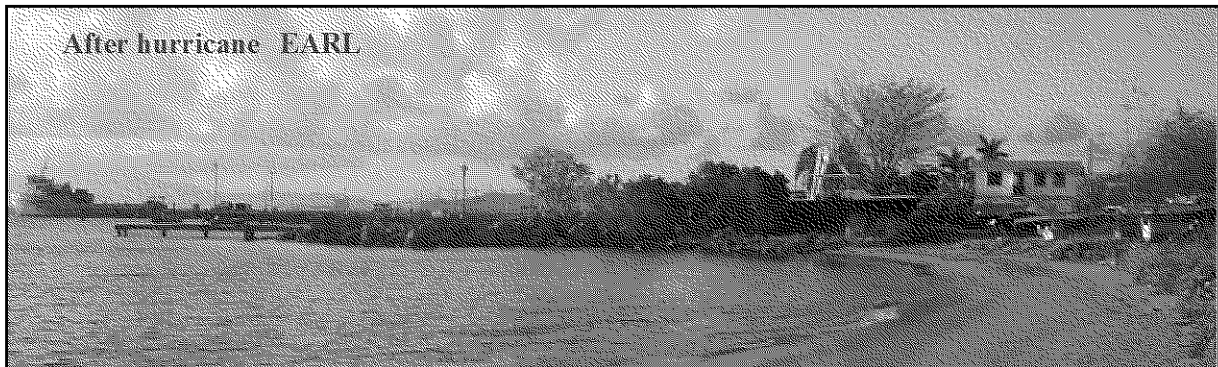
Photo-1.2(4-3) Beach (September 2010)

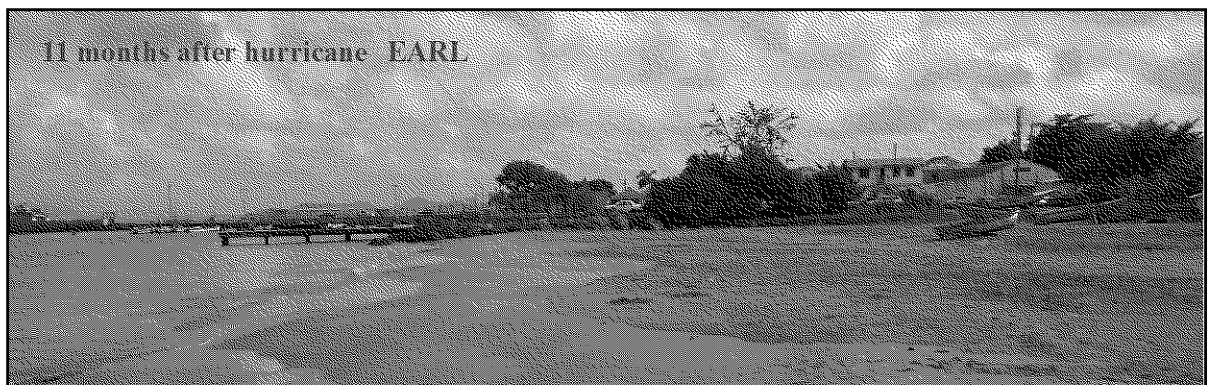
Photo-1.2(4-4) Beach (July 2011)

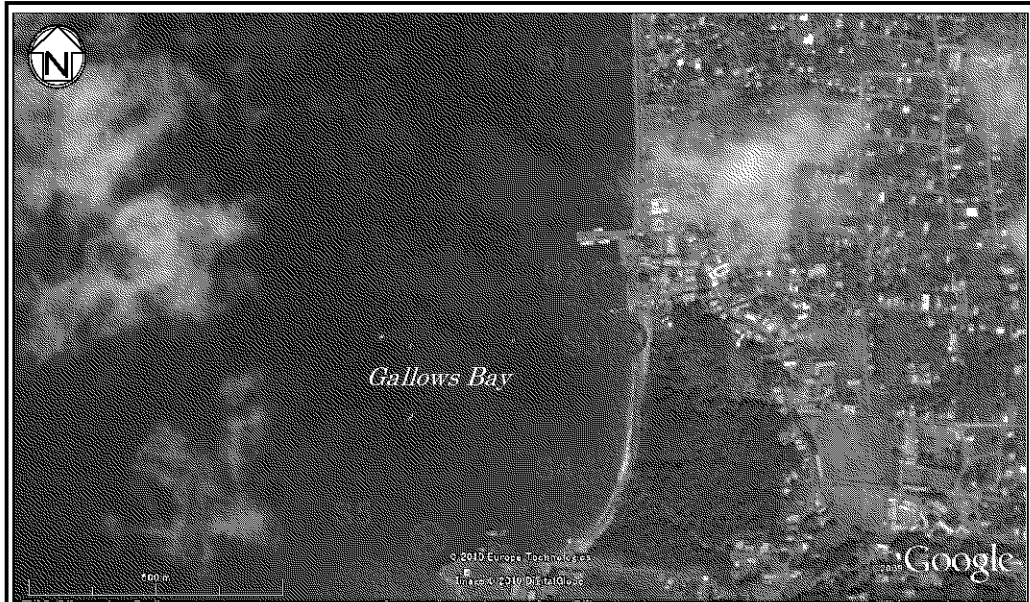
Figure-1.2(13) Sediment Sample Collection Location

5 sediment samples were collected on 17 August, 2010. Laboratory test results (Moisture Content, Specific Gravity, Sieve Analysis) are shown in Table-1.2(8).

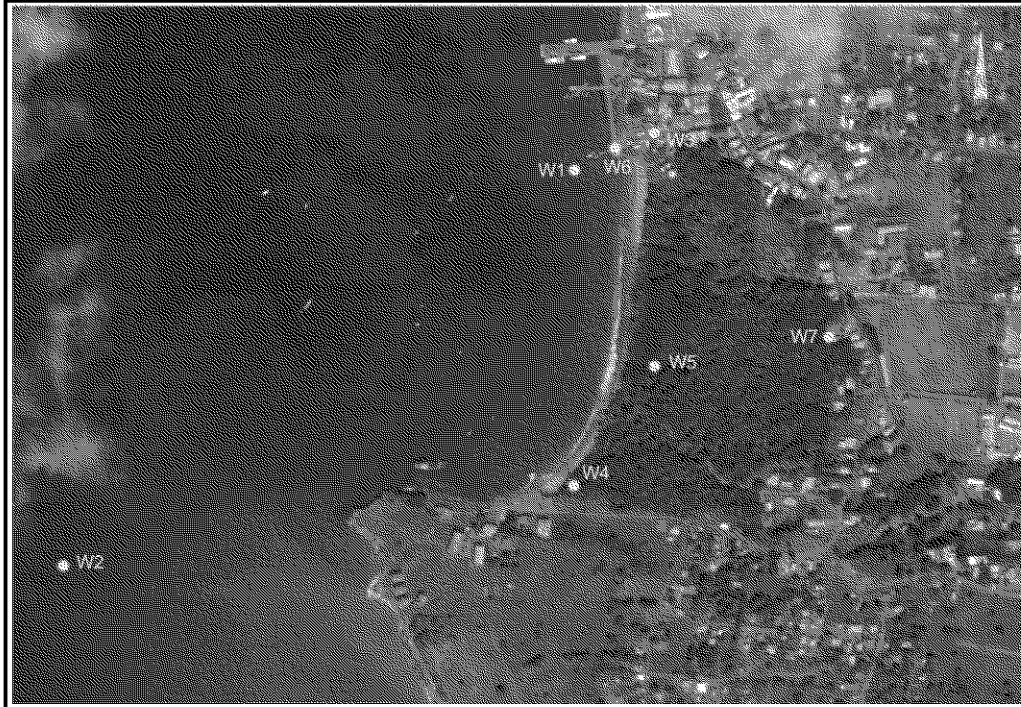
Figure-1.2(14) Water Sample Collection Location

W1 : Water area in front of project site

W2 : Open sea

W3 : Drain from urban area near project site

W4 : Small river at south end of Bath Bogs Protected Area

W5 : Small river at center of Bath Bogs Protected Area

W6 :City water at project site

W7 : Well water of Mineral Water Company

Collection location of water samples are shown in Figure-1.2(14) and laboratory test results are shown in Table-1.2(9).

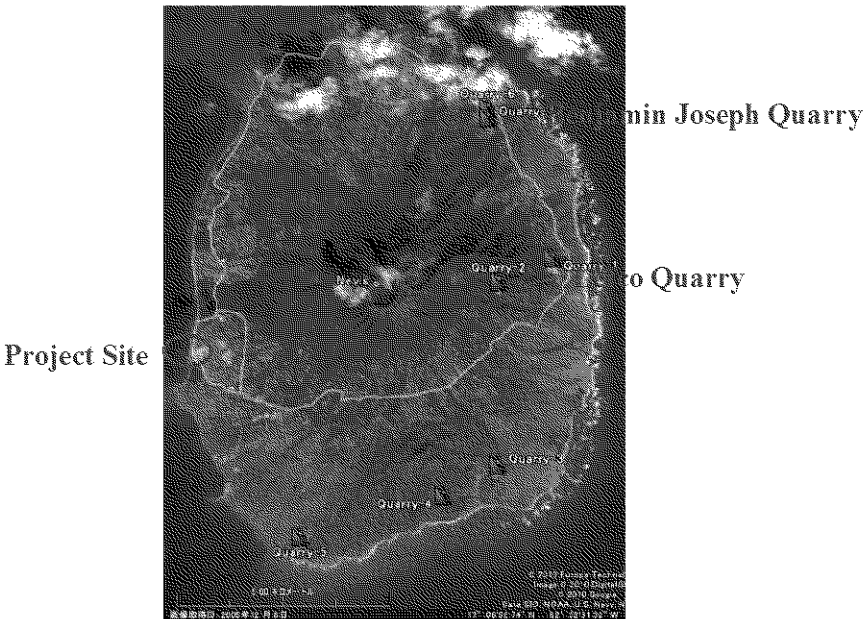
Figure-1.2(15) Location of Quarry

Samples of sand and stones were taken from the largest and the second quarries shown below selecting from 7 quarries in the island according to the hearing survey from Public Works Department and laboratory tests were executed. They were considered to be no problem as construction materials.

- 1) Lefco Quarry (Largest in Nevis) located at New River
- 2) Benjamin Joseph Quarry (Second in Nevis) located at Hicks Estate

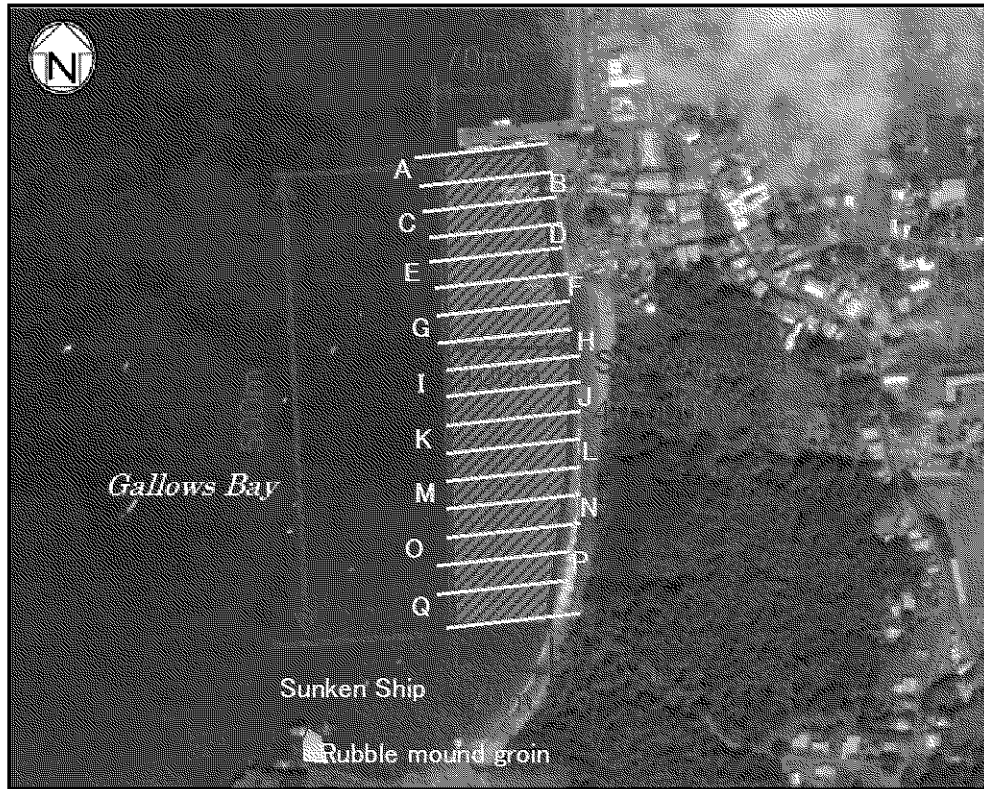
Remark: Sunken ship has been demolished.

Figure-1.2(16) Marine Spices and Biodiversity Survey Location

Submersible survey by diver was executed on 25 August, 2010. Submersible survey was done sorted out with area A to Q. Typical seabed photos are as shown in Photo-1.2(5) and most of the sea beds are covered by mud, sand, stone and a bit of rocks. Rubbish (bottles of beer, canned food, tires and etc.) is seen mixed with mud. The cause of above is considered that mud and stone were used to construct rubble mound groin for the purpose of demolish of sunken ship when hurricane hit in 2008 and this groin was swept away by hurricane in 2009 and ran through to Gallows Bay.
