# Supporting Report (C) Natural Condition and Landsliding Management Plan

#### PREPARATORY SURVEY FOR THE PROJECT ON DISASTER PREVENTION AND MITIGATION MEASURES FOR THE ITAJAI RIVER BASIN

#### FINAL REPORT

### **VOLUME III : SUPPORTING REPORT** ANNEX C : NATURAL CONDITION AND LANDSLIDE MANAGEMENT

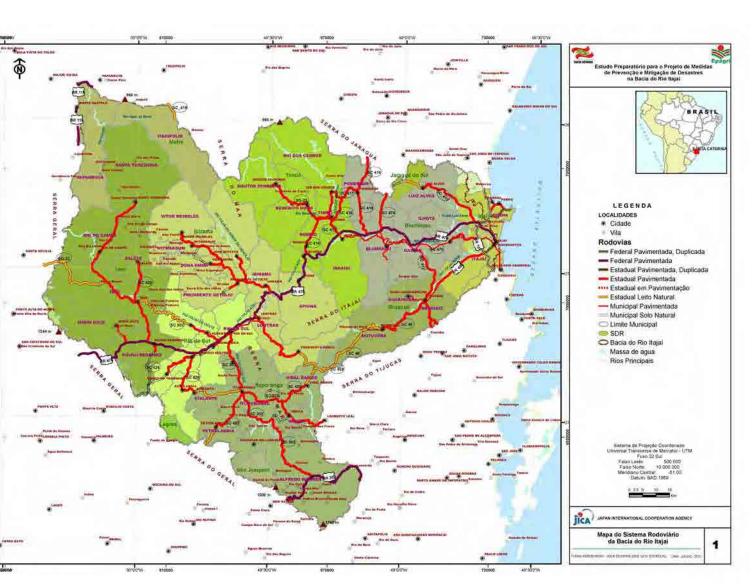
Figure 2. 1 .1 Location Map of Rivers, Mountain Ranges and Roads in Itajai River Basin Source: Material edited by JICA Survey Team based on 2009 DEINFRA, MAPA RODOVIÀRIO DO ESTADO DE SANTA CATARINA

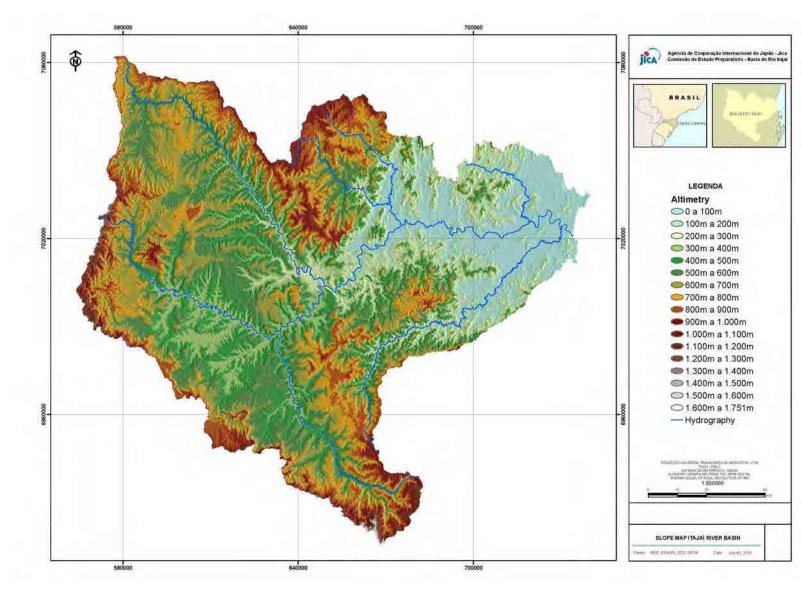
**Figure 2. 1 .2 Map of Elevation Ranges of Itajai River Basin** Source: IBGE,EPAGRI,SDS,SRTM

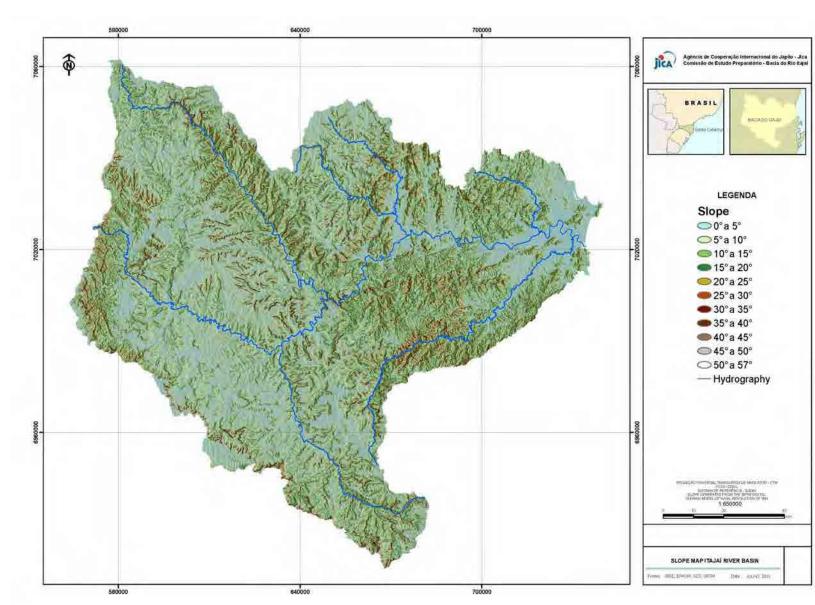
Figure 2. 1.3 Map of Gradient Ranges of the Itajai River Basin Source: IBGE, EPAGRI, SDS, SRTM

Figure 2.2.3 shows the surface gradient range distribution maps of Itajai River basin. Flat surfaces from 0 to 9 degrees are largely distributed throughout the Itajai River mouth area, and intermittently distributed on both banks of the river in the middle part. In general, hillsides have gentle gradients of 15 to 25 degrees. At the outlet of streams, there are small alluvial fans of 5 to 10 degrees gradient. Gradients with more than 25 degrees are distributed at the sides of streams, and just below part of the gentle mountain top slopes.

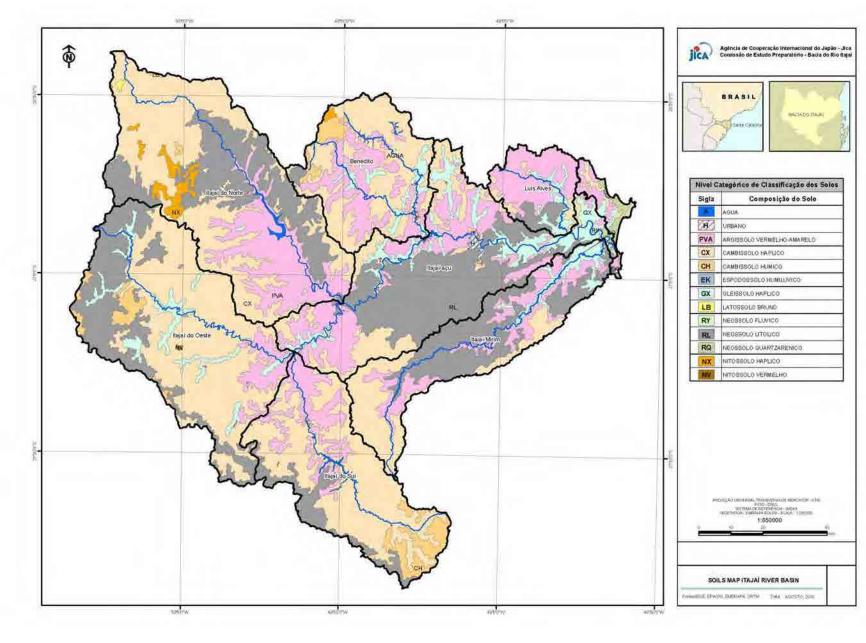
Figure 2.3.1 Soil Classification Map of Itajai River Basin Source: Embrapa Solos, 2004

Figure 2.3.1 shows the map of soil classification of Itajai River basin. Table 2.3.1 presents a comparison between the soil classification of this map and the soil classification of institutions from the UN, USA and Japan.

The dominant soil type in Itajai River Basin is the Ordinary cambisols, occupying 43% of the whole area and mainly distributed in the middle altitude of the hillside. The second dominant soil type is the Leptosols occupying 26% of the total area, mainly found in the peak and in the watershed of the Itajai-acu River and tributaries. The third dominant is the Red-Yellow Acrisols, occupying 20% of the whole area, distributed from the hillside with elevation below 500 m until the banks of the Itajai-Acu River and tributaries.

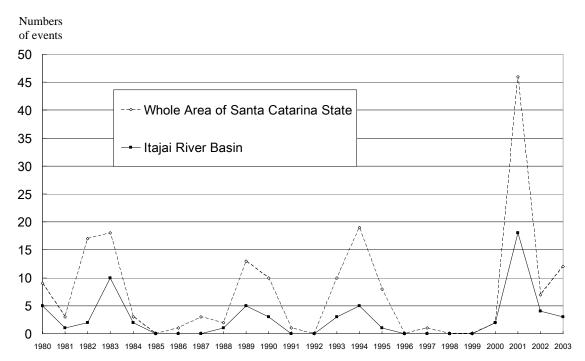
Figure 3.1.1 Changes of the AnualNumber of landslides in Santa Catarina State and in Itajai River Basin over the Years (1980 - 2003)

The number of landslide events in Itajai River Basin, based on SC state Civil Defense information, is shown in Table 3.1.1. The data of landslide occurrence is available in 23 years, between 1980 and 2003. The number of landslides disasters was 185 in the whole State of Santa Catarina. While in Itajai River Basin, this number is 65, corresponding to 35% of the total in Itajai River Basin.

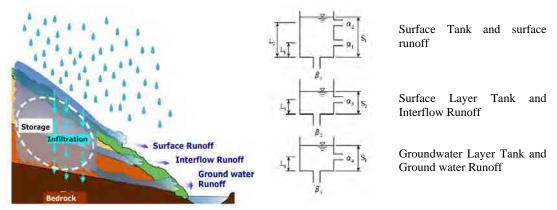
P	Parameters usually used in Japan for the alert of Landslide Disaster							
	Surface Tank	Surface Layer Tank	Underground water tank					
Height Runoff Hole (mm)	L1 15 L2 60	L3 15	L4 15					
Runoff Coefficient (mm/H)	A1 0.1 α2 0.15	α3 0.05	α4 0.01					
Infiltration Coefficient (mm/H)	B1 0.1	β2 0.05	β3 0.01

#### Figure 3.1.2 Soil Water Indexes used for the Alert of Landslide Disasters

The SWI used in the Meteorological Institute of Japan is estimated by the 3 story water tank model indicated as follows:

The maximum annual value of the soil water indexes were 132 mm (20 years return period) in Rio do Campo, in the northeast region of the basin, and 154 mm (30 years return period) in Indaial, in the center of the Basin. The landslide disasters in 2001 might occurred because of the heavy rainfalls of 20 -30 years return period.

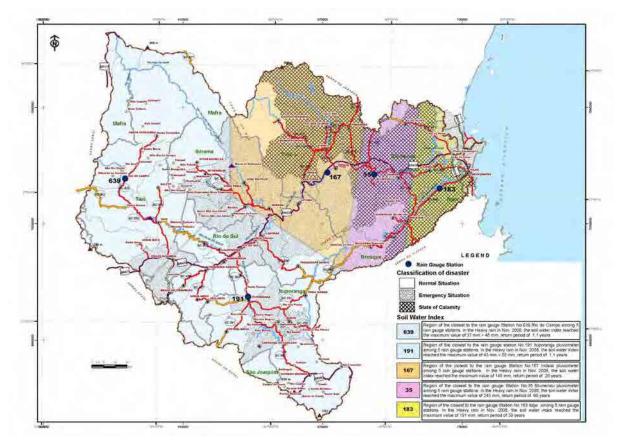
#### Figure 3.1.3 Soil Water Index and Statement of Emergency / Calamity of November 2008 Rainstorm

Figure 3.1.3 shows the area of soil water index (SWI), which is used for the landslide alert index in Japan, and the municipalities that declared emergency/calamity state in the November 2008 rainstorm. The houses destroyed and fatalities were only in the municipalities of emergency or calamity statement under November 2008 storm, were in area with peak SWI were above 145 mm of 20 years return period.

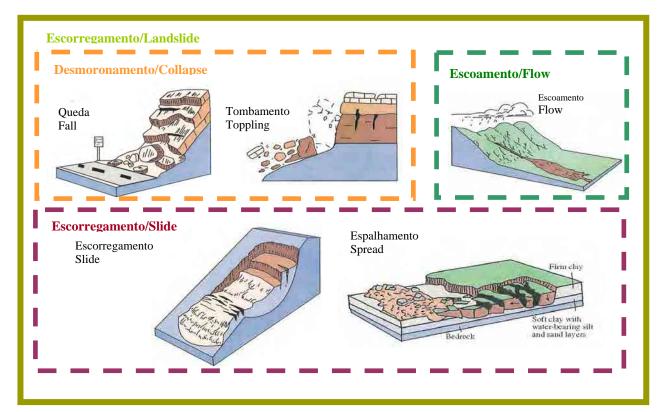
Figure 3.1.4 Classification per Movement Type of Landslide

Table 3.1.4 shows the landslide classification according to movement and materials. The failure mechanism of landslide and the appropriate measures vary according to the types of landslide. In

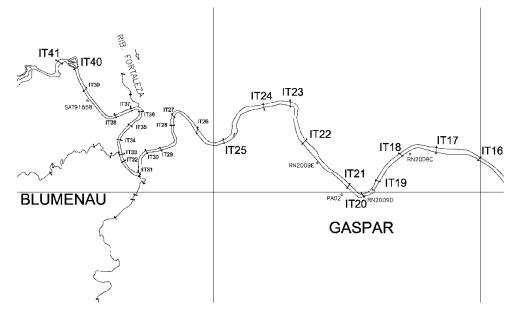
Figure 3.3.1 River Section of Analysis Target

From the above, regarding upper reach of Blumenau, there is no trend of rising riverbed. In Itajai Acu River of downstream from Gaspar and Itajai Mirim River, commercial sand extraction is conducted, and the port of Itajai is also dredging, so it becomes difficult to make assessments of the riverbed by comparing topographic survey data. Therefore, analysis section of the Itajai Acu River was set between Gaspar and Blumenau. In Figure 3.7.1, the locations of target river section and the surveying cross sections are shown in.

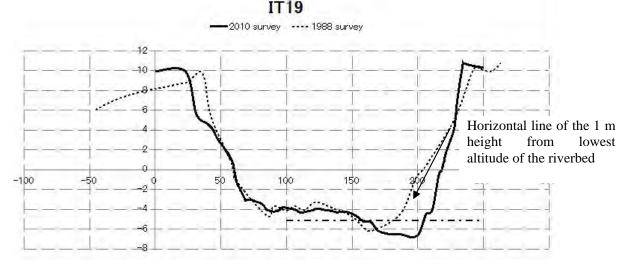
Figure 3.7.2 Example of Analysis of Variance of the Riverbed

The topographic survey data used to comparison of the section will be: The result of topographic survey conducted by the JICA Study in 1988 (Research for the flood control plan of the Itajaí River Basin - Feasibility Study (Plan of river improvement in Gaspar- Blumenau in January 1988) and the topographic survey result of this survey. The extension will be considered the stretch of 35 km in total, including Gaspar and Blumenau, shown in 3.3.2.

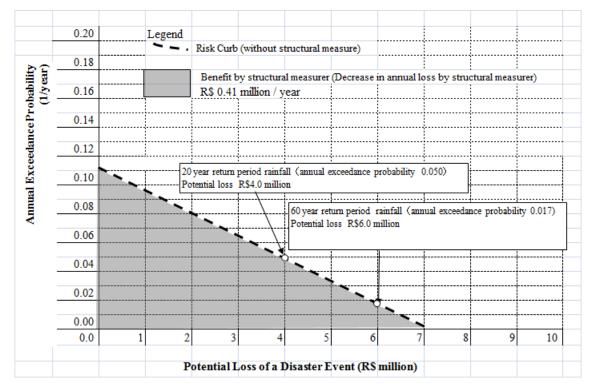
# Figure 3.4.2 Risk Curve of Landslide Disaster and Example of Potential Annual Loss Calculation

As shown in Figure 3.4.2, the potential annual loss (R\$/year) calculated by using possibilities of non exceedance of landslide occurrences (vertical axis) and the potential loss (horizontal axis).

In the case of road damage, possibilities of non exceedance of landslide occurrences and the potential loss are first calculated and then the potential annual loss are done considering two kinds of damage scale, that is, complete closure and partial closure (one lane closure).

The possibility of non-exceedance of compete and partial closures was evaluated on the basis of the scale (volume) of landslide disaster similar to the rainstorm of November 2008, and the estimated probability of soil humidity index most close to landslide site. Calculation item and procedure are detailed in Appendix Report.

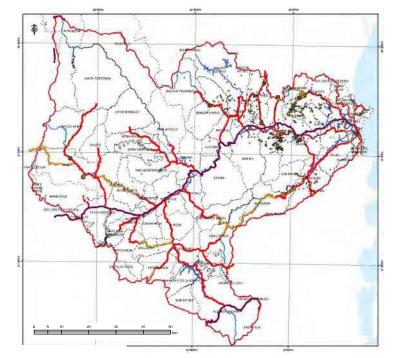
# Figure 3.4.3 Maps of Priority Landslide Risk Site with Different Level of Potential Annual Loss

Figure 3.4.3 shows the distribution of the priority landslide risk sites with different levels of the potential annual loss. F-6.3.4 gives an example of priority landslide risk maps. The base map is composed of 239 sheets with 1:30,000 Itajai topographical maps in A3 size. Each site has GIS information as listed below.

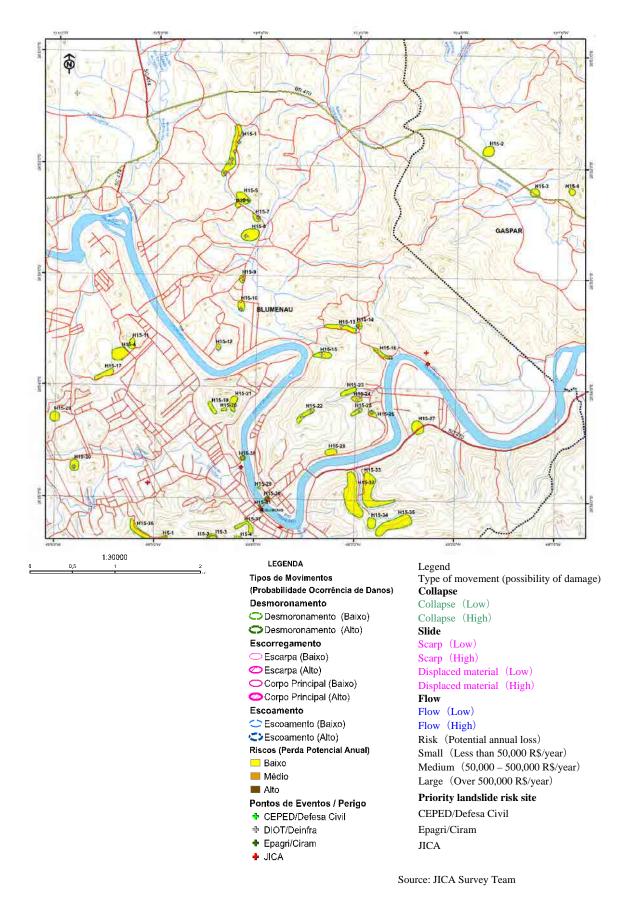
Figure 3.4.4 Example of Priority Landslide Risk Mapping

The priority locations identified which require measures are in number 68, being located on State Road 32 and 35 sites located in the municipal roads and the Port of Itajai.

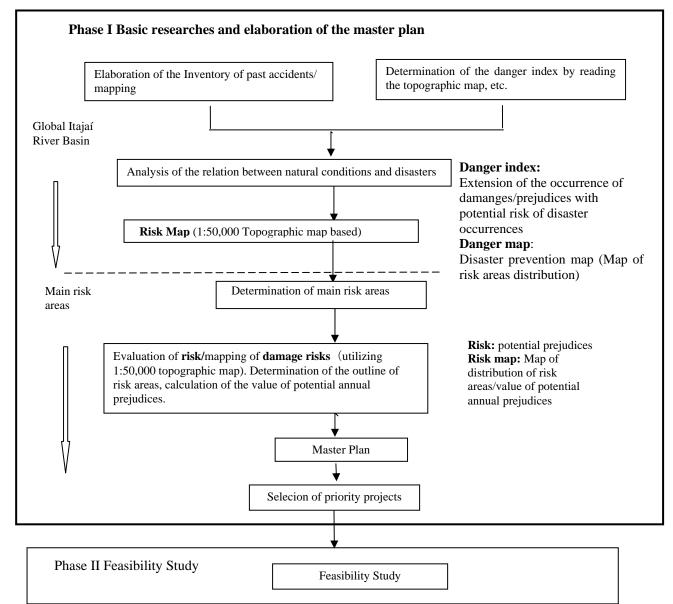
#### Figure 4.2.1 Flow of the landslide disaster study

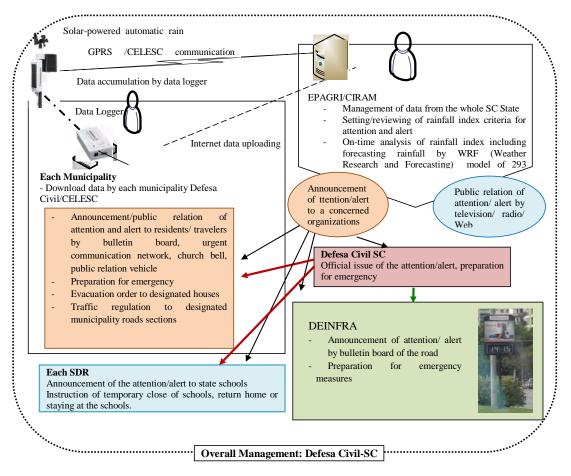
Figure 5.2.2 Schematic Diagram for Early Warning System of Landslide and Flash Flood

- The residents, who live in risk areas which are designated in hazard maps, evacuate to designated evacuation sites (schools or churches) by designated evacuation routes.
- The Municipality and DEINFRA will order road traffic regulation of designated disaster-prone road sections in alert-issued areas when the alert is issued by Defesa Civil SC.

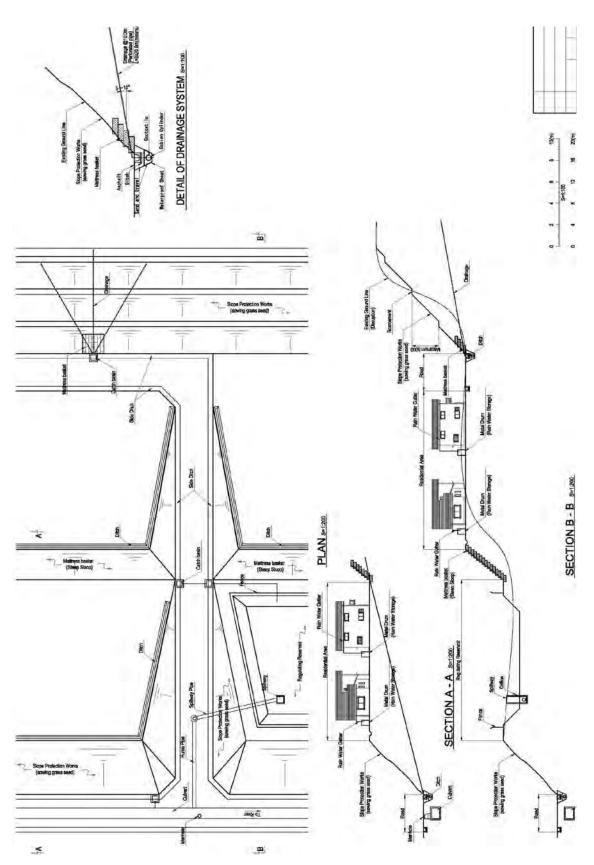
Figure 5.5.1 Example of Runoff Regulation Facilities by Reservoir

Measures for reducing flash floods are aiming to promote runoff regulation facilities for the purpose to reduce surface runoff.

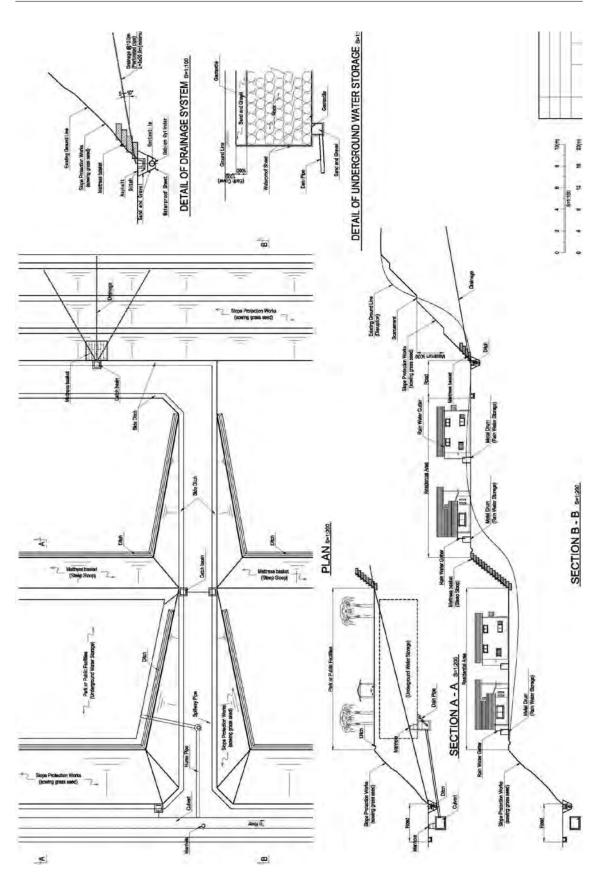
Figure 5.5.2 Example of Runoff Regulation Facilities by Underground Reservoir
