NATIONAL DRAINAGE AND IRRIGATION AUTHORITY

**PREPARATORY SURVEY FOR THE REHABILITATION
OF THE EAST DEMERARA WATER CONSERVANCY
IN THE REPUBLIC OF GUYANA**

SEPTEMBER 2011

**JAPAN INTERNATIONAL COOPERATION AGENCY
KENSETSU GIJUTSU CENTER, LTD.**

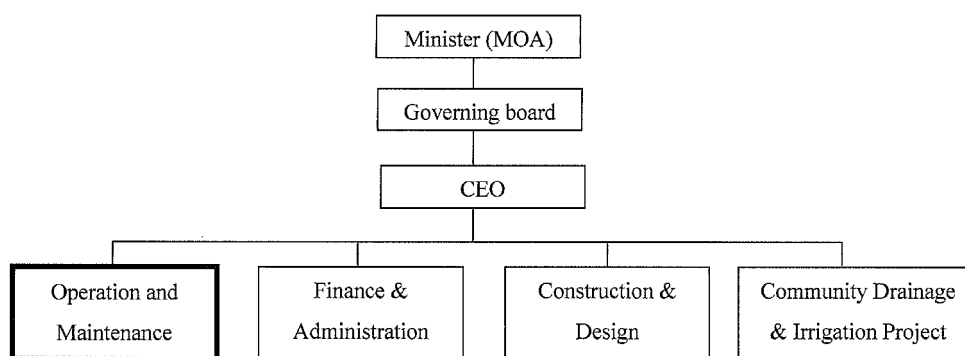
Figure 1: Organizational Chart of the NDIA

The workforce of the NDIA is some 40 people, of whom seven officials are engineers, and six officials are technicians. The NDIA consists of four sections: the Operation and Maintenance, the Finance & Administration, the Construction & Design and the Community Drainage & Irrigation Project Sections. Of these, the Operation & Maintenance Section is in charge of the

operation, maintenance and management of the facilities after the rehabilitation work is completed. This section shall station 17 staff members at a workshop to streamline the operation, maintenance and management of the four reservoirs in the country including the EDWC. At the management office built on the premises of the EDWC, one staff member and 22 security staff members under outsourcing contracts shall be stationed on a regular basis to engage in the operational, maintenance and management activities for the facilities. Staff members at the workshop shall be sent to the reservoirs if an emergency arises.

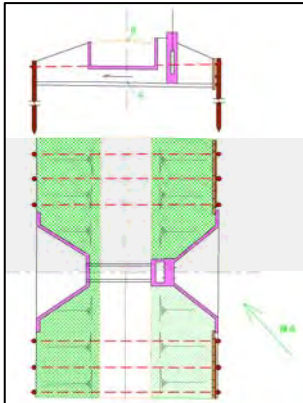
Typical INTAKE Plan and Cross Section

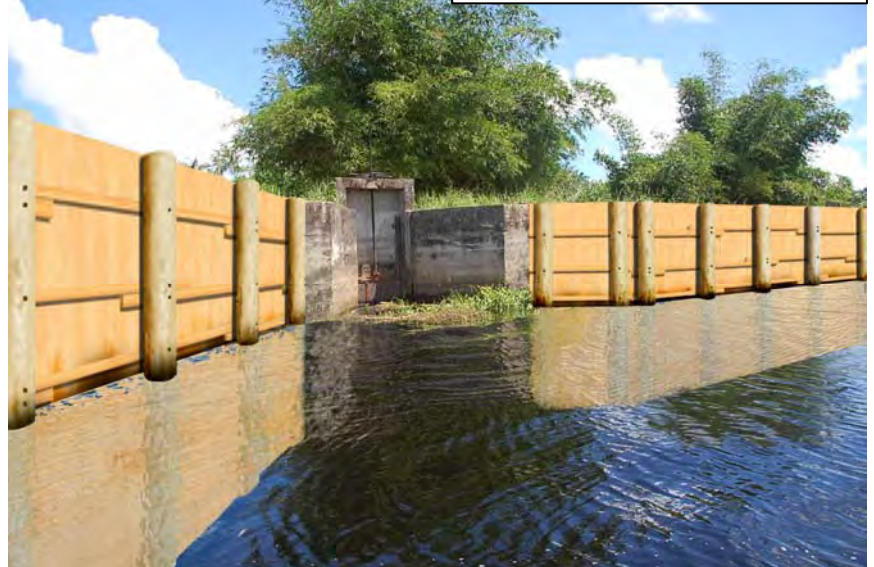
[REVETMENT REHABILITATION: Inlet-side of ANNANDALE INTAKE]

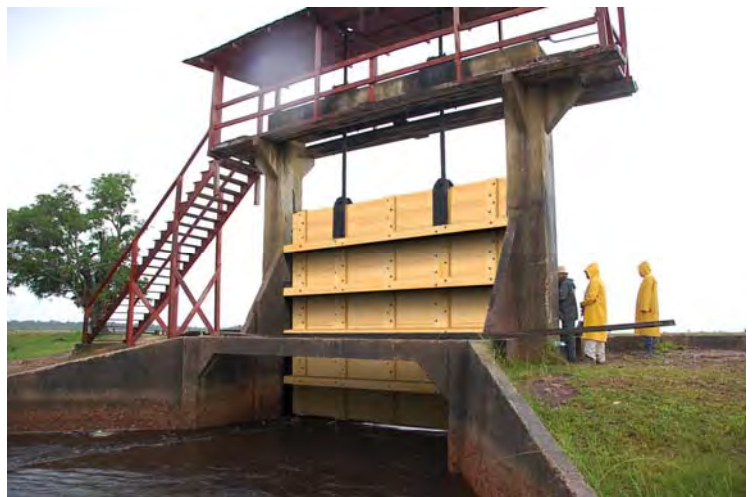
[MADUNI RELIEF SLUICE DOOR in NEW FABRICATION]

(Note: Wooden fabrications with Greenheart in montage above are to be subject to Antiseptic Agent application)

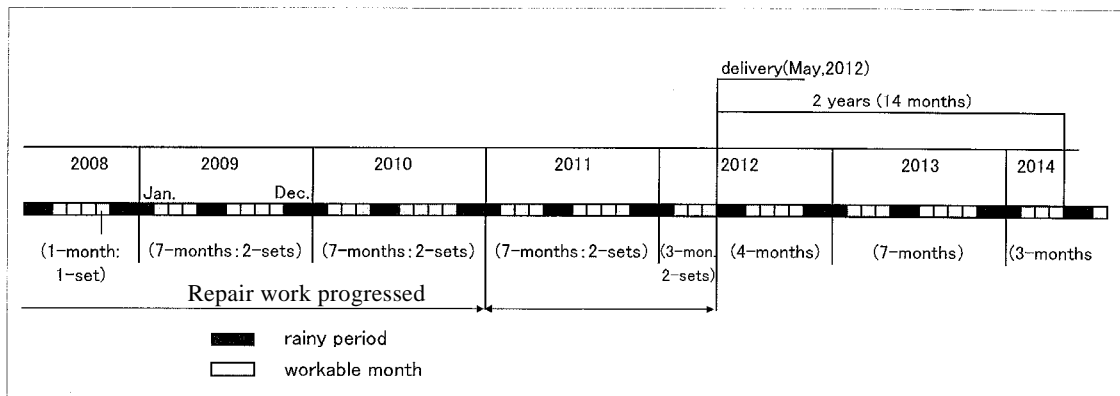
Figure 2.2.2 Embankment Rehabilitation Schedule

• Total number of sets and period engaged in rehabilitation work (T) (Figure 2.2.2)

• 2008: 1 set x 1 month (October):	rehabilitating performance =	1
• 2009: 2 sets x 7 months:	"	= 14
• 2010: 2 sets x 7 months:	"	= 14
		(total) T=29 sets/month

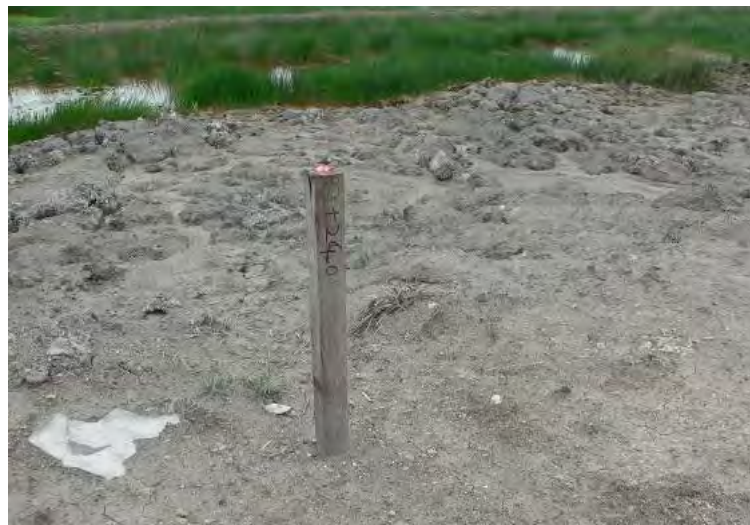
Picture 2.2.1 Slope of Embankment (Remained unrolled state)

Most of the rehabilitation work to be executed in the future will be filling work of the embankment on the downstream side (inner land side of embankment). Looking at the embankment on the downstream side that is remained premature state at present, the embankment material should be shaped properly before slope preparation (picture 2.2.1). The reason for this matter is the fact that the forming work is conducted at the limit of arm-reach of the super-long arm excavator, and that the operator's visibility to downstream side from the pontoon is blocked by the embankment crown (in general, embankment rehabilitation work was carried out during dry seasons when the conservancy water level is low).

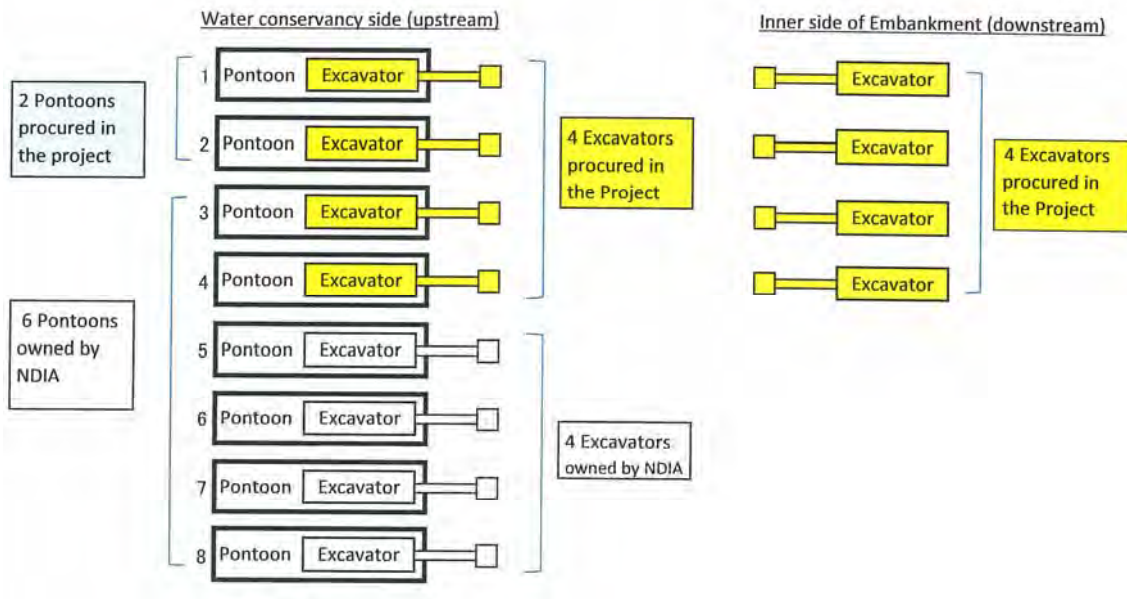
Figure 2.2.5 Excavators and Pontoons to be Procured

Six pontoons owned by NDIA are allocated at the EDWC, where four are already loaded with super-long arm excavators. Remaining two pontoons are used for transporting equipments or accommodation of the workers. These must be repaired and reorganized for normal use of pontoons, in order to use for loading the excavators to be procured in the project. Therefore, the pontoons for procurement in the Project are as shown in the figure 2.2.5.

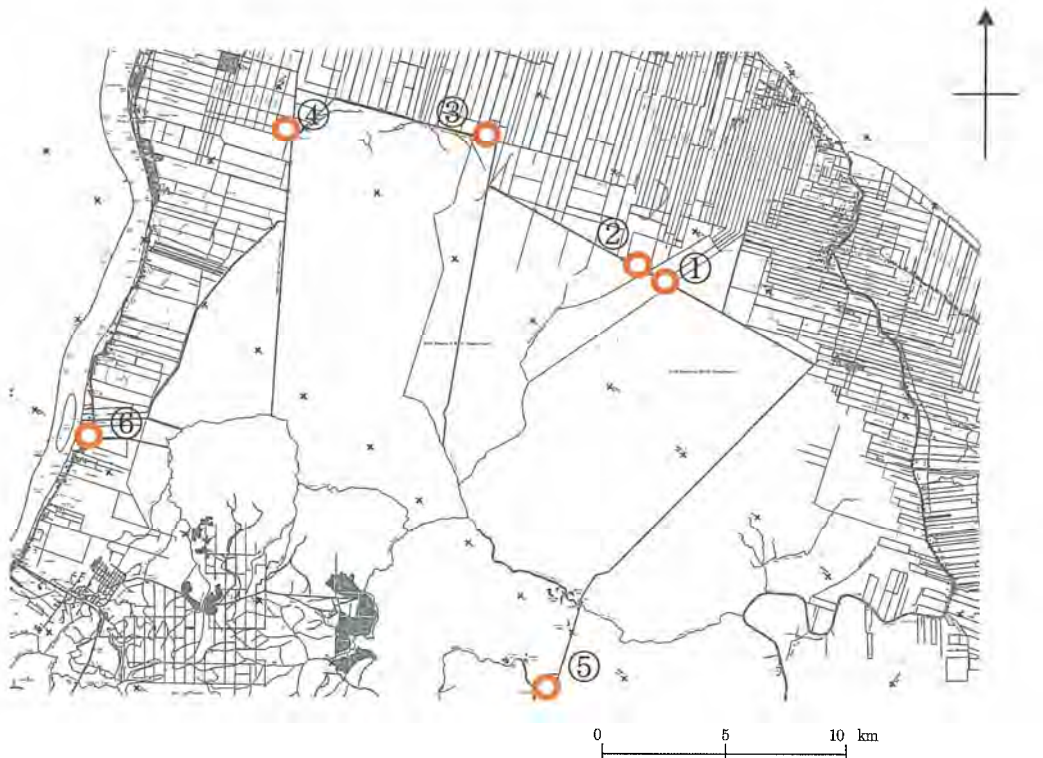
Figure 2.3.1 Location of the Requested Facilities

No	Name of Facilities	Type of Facilities
①	Ann's Grove	Intake
②	Hope	Intake
③	Annandale	Intake
④	Nancy	Intake
⑤	Maduni	Relief sluice
⑥	Sarah Johanna	Relief sluice

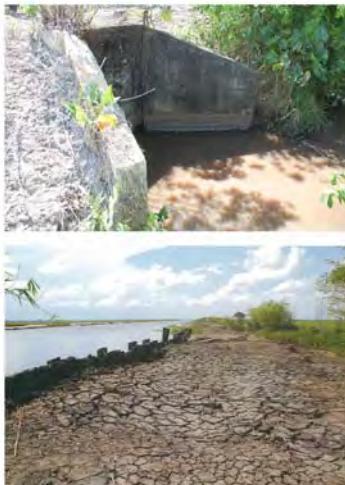
Facilities	Outline of the structure	Intended use	Existing state
<p>① Ann's Grove Intake</p>

<ul style="list-style-type: none"> Intake facility with a concrete pipe 900mm in diameter and 4.5m in length Although the structure shows local damage such as small cracks and irregularities due to aging, the main concrete structural part keeps its intake function. 	<p>Intake system for irrigation</p>	<ul style="list-style-type: none"> Although the main concrete structural part shows some degradation, it still performs the intake function and can serve in the future. There is a significant depression on the crest of the embankment in immediate proximity on west-side of the intake facility. As a result of the on-site visual investigation, the presence of water hole (piping) is confirmed in the embankment. Deterioration of timber revetments for extended part of the concrete wing walls (hereinafter called "wings") is obvious. As the embankment banking was conducted by Pegasse (blackish peat like acid mixture of clay), there are problems in water permeability and strength of the embankment.

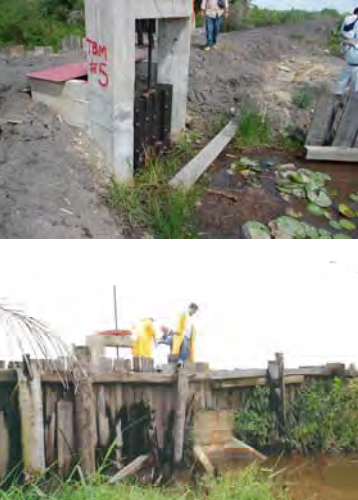
<p>② Hope Intake</p>

<ul style="list-style-type: none"> Additional reinforced concrete rigid frame and door have been attached on top of the wings, which are aging base structures. Timber piles and wooden sheet piles have been installed in outlet side as a temporary measure to hold the embankment. 	<p>Intake system for irrigation</p>	<ul style="list-style-type: none"> Piping phenomenon is seen just beneath the intake system. The parapet of outlet side wing is 1.0m lower than the crest of the embankment. To cope with the height difference, temporal structure using a wooden sheet pile has been employed. There is a problem in opening/closing operation of door as it lacks door guide devices. Deterioration of timber revetments of the extended part of wings is obvious. As the embankment banking was conducted by Pegasse, there are problems in water permeability and strength of the embankment.

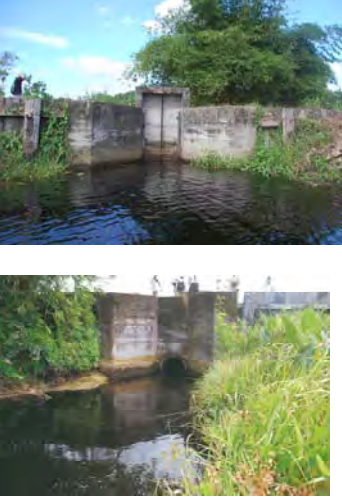
<p>③ Annandale Intake</p>

<ul style="list-style-type: none"> Intake facility with a concrete pipe 900mm in diameter and 5.5m in length The main concrete structural part has been made solid. The height of the embankment is 60 feet GD or more. 	<p>Intake system for irrigation</p>	<ul style="list-style-type: none"> No major factor to hinder intake function is seen on the concrete structure. The gate has a door guide and ditches for stop-log to prevent collision of floating matters, but there is breakage at the bottom plank of the wooden door. (There is water leakage when the door is closed.) Deterioration of the timber revetments of extended part of the wings is remarkably obvious. The earth slope of the embankment is collapsed because of lack of protection walls..

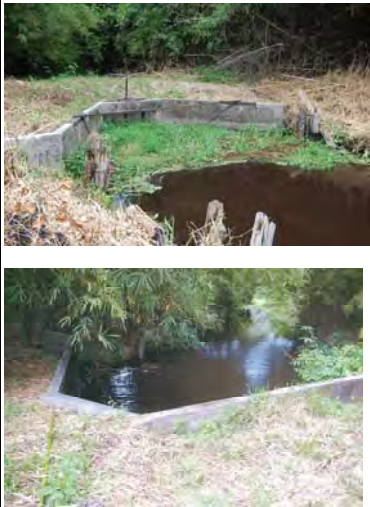
Facilities	Outline of the structure	Intended use	Existing state
<p>④ Nancy Intake</p>

<ul style="list-style-type: none"> Intake facility with a concrete pipe 900mm in diameter and 6.0m in length Outlet: both wings are long enough and broaden toward the end to reduce outflow water velocity, contributing to prevent scouring on both left/right side banks and bottom of the channel. 	<p>Intake system for potable water for the residents of Georgetown and for irrigation</p>	<ul style="list-style-type: none"> No major factor to hinder intake function is seen on the concrete structure of the system. However, there is a horizontal steel brace to prevent a wing from leaning forward at inlet. Door guides are well furnished for door opening/closing operation. Channel leading from the conservancy to the intake inlet is not wide enough, bringing insufficient water volume to the intake facility. Deterioration of the timber revetments of extended part of the wings is obvious, particularly at outlet side.

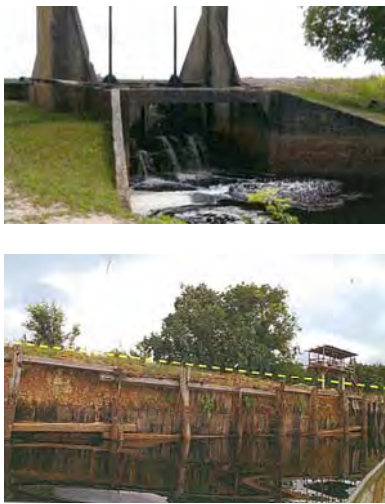
<p>⑤ Maduni Sluice</p>

<p>Single door with 4.84m in width, 4.20m in height and 0.23m in thickness</p> <ul style="list-style-type: none"> The concrete gate structure (frame) that supports the door is sound for continued use. 	<p>Water storage and discharge control systems to prevent overflow of the embankment and river flooding caused by raised water level</p>	<p><u>Gate door</u></p> <ul style="list-style-type: none"> There is significant water leak through the door. The projections on both columns support the water pressure applied to the door. <p><u>Embankment revetments</u> Deterioration of the timber revetments of the extended part of the wings is obvious in both sides of inlet and outlet.</p>
<p>⑥ Sarah Johanna Sluice</p>

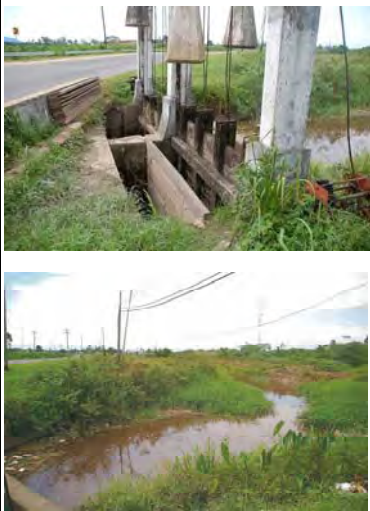
<p>Double door with 4.91m in width, 4.40m in height and 0.23m in thickness.</p> <ul style="list-style-type: none"> The frame (concrete structure) that supports the door is good for continued use. 	<p>Control system to prevent embankment overflow caused by raised water level of the conservancy and back flow in Demerara river.</p>	<ul style="list-style-type: none"> Door was repaired in 2010. Inlet: right-bank <ul style="list-style-type: none"> there is no retaining wall to protect banking fill at extended part of the concrete wing, thus remaining no measure to prevent the earth fill collapsing. Inlet: left-bank <ul style="list-style-type: none"> the timber revetment shows serious deterioration due to aging.

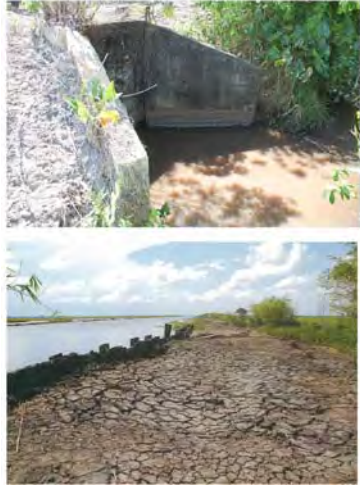
Facilities	Rehabilitation plan	Expected effect
<p>①Ann's Grove Intake</p>

<p>-As there is a concern about the stability of the surrounding embankment, repair work to gain stability of the embankment needs to be planned.</p> <p>-Specifically, revetments should be constructed along the surrounding embankment to reinforce it and also to stop water leakage through the embankment.</p> <p>-Considering that the existing revetments have been markedly deteriorated, the timber revetments shall be constructed at inlet and outlet sides</p> <p>-For the construction of the revetments, the existing method comprising timber piles, walings and wooden sheet piles shall basically be employed.</p> <p>-Design and stability analyses for revetment/anchoring reinforcement and embankment are required.</p>	<ul style="list-style-type: none"> • Further progression of the depression of the surrounding embankment would seriously impact the whole system. Therefore the rehabilitation plan will contribute to the increase of stability of the main structure. • If the structure gains stability, the water supply to irrigation area located downstream will become more stable.

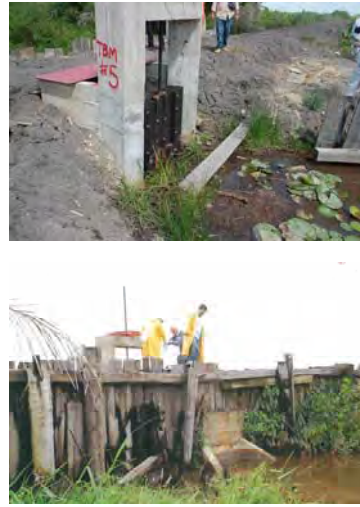
<p>②Hope Intake</p>

<p>-As there is a concern about the stability of the surrounding embankment, repair work to gain stability of it needs to be planned.</p> <p>-For the improvement of operability of door, door guides need to be furnished.</p> <p>-As for the concrete method to secure stability of the embankment, revetments along the surrounding embankment shall be constructed to reinforce it and also to stop water leakage.</p> <p>-Timber revetments shall be constructed on the right and left at the inlet and outlet sides.</p> <p>-Reconstruction of parapet to match the height with the embankment is required to be furnished.</p> <p>-Installation of cut-off walls to stop water inflow under the bottom slab is required. The locations of cut-off walls should be determined from comprehensive viewpoints based on the geological research result.</p>	<ul style="list-style-type: none"> • Further progression of the depression of the surrounding embankment would seriously impact the whole system. Therefore the rehabilitation plan will contribute to the increase of stability of the main structure. • If the structure gains stability, the water supply to irrigation area located downstream will become more stable. • Improved operability will increase the efficiency of the labor of the system user.

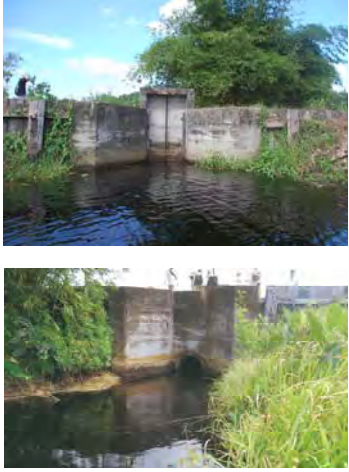
Facilities	Rehabilitation plan	Expected effect
<p>③ Annandale Intake</p>

<p>-Recovery of stability of the surrounding embankment and recovery of functions as an intake system need to be planned.</p> <p>-As a concrete method to repair the embankment, timber revetments shall be installed.</p> <p>-Installation of timber revetments at the following locations;</p> <ul style="list-style-type: none"> · on the right and left at the inlet side · on the right and left at the outlet side <p>-As for the repair of the bottom plank of the door, only the damaged portion will be replaced. However, if the whole of door planks is judged to be removed due to its deterioration, replacement of the whole door shall be considered.</p>	<ul style="list-style-type: none"> • Increased stability of the surrounding embankment is expected to increase the stability of the main structure. • If the structure gains stability, the water supply to irrigation area located downstream will become more stable. • Recovery of door cut-off function will improve water storage function.

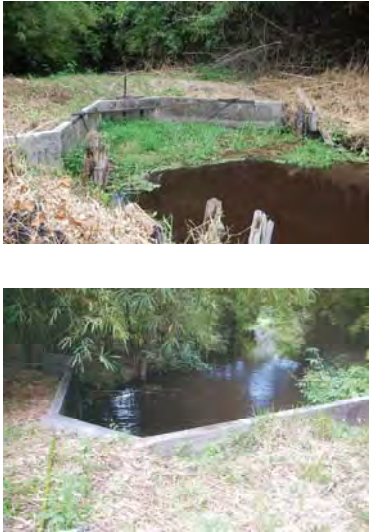
<p>④ Nancy Intake</p>

<p>-Recovery of stability of the surrounding embankment and recovery of functions as an intake system need to be planned.</p> <p>-To recover the stability of the embankment, timber revetments shall be installed.</p> <p>- The revetments shall be constructed on the right and left at the inlet and outlet sides.</p> <p>- As the canal width at inlet side is not wide enough, it needs to be increased by selecting appropriate execution location of timber revetment.</p>	<ul style="list-style-type: none"> • Increased stability of the surrounding embankment is expected to increase the stability of the main structure. • If the structure gains stability, the water supply to the residential area will become more stable.

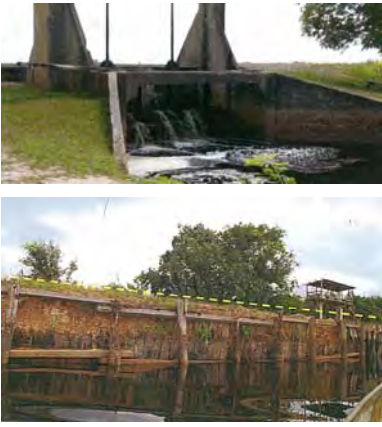
Facilities	Rehabilitation plan	Expected effect
<p>⑤ □ Maduni Sluice</p>

<p>-Recovery of stability of the surrounding embankment and recovery of functions as relief sluice system need to be planned.</p> <p>-To recover the stability of the embankment, revetments shall be executed. Installation location of revetments is at ;</p> <ul style="list-style-type: none"> · on the right and left at the inlet side · on the right and left at the outlet side <p>-As there are lots of water leakage all over the door surface, wooden parts shall be completely replaced.</p>	<ul style="list-style-type: none"> · Recovery of cut-off function will improve water storage function and prevention of flooding at river and its adjacent area.
<p>⑥ Sarah Johanna Sluice</p>

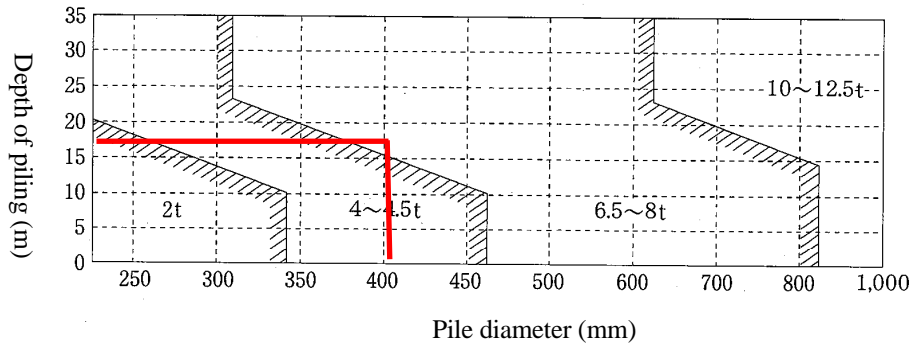
Figure-1 Load of pincer of precast concrete pile

- When pile diameter is 455mm and pile length is $L=15.24\text{m}$, the load of pincer is on the linear of $W=4.5\text{t} \sim 6.5\text{t}$ in Table 2, however, due to the soft ground and the research of Guyana, $W=5.0\text{t}$.

1. Use one rank larger pile when piling depth is more than 10m and under following conditions apply.
 - 1) When N value is larger than 15, and piling through intermediate layer of 3m or thicker sand and sand/gravel layer.
 - 2) When N value is larger than 15, and piling through layer of 3m or thicker cohesive soil.
2. Depth of piling (m) includes depth of pincer (m).

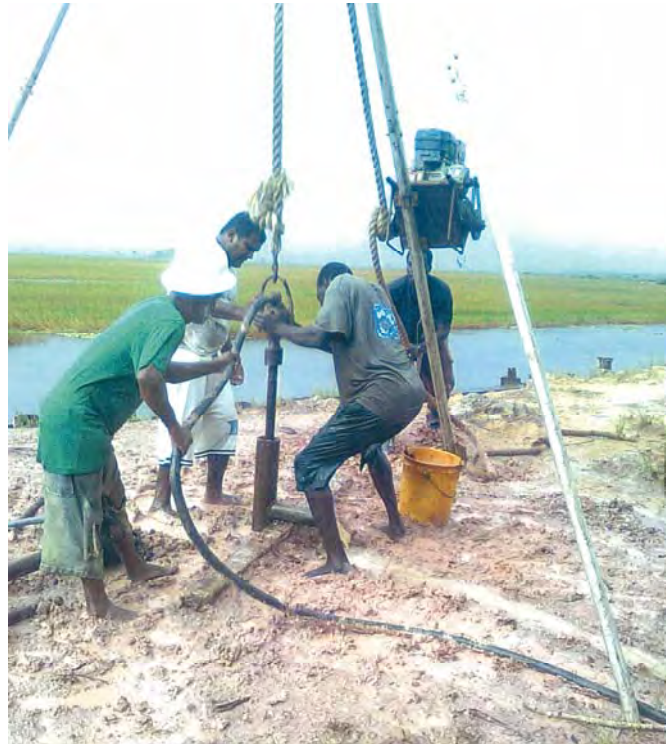
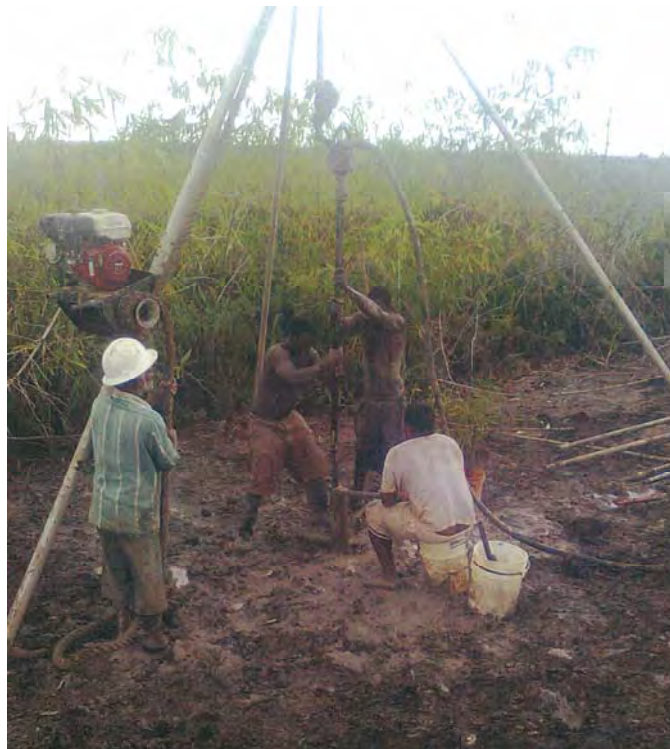
Drilling Operation at EDWC Embankment

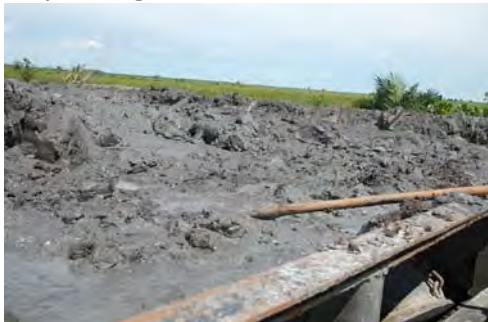
Excavated Soil stored in pontoon bucket at Field

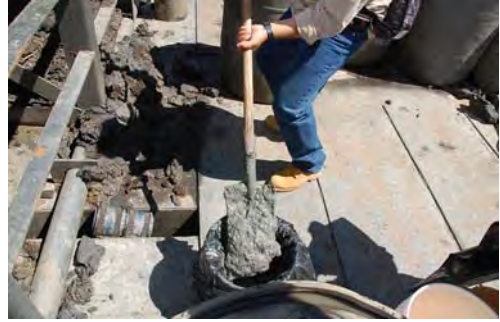
Soil sampling

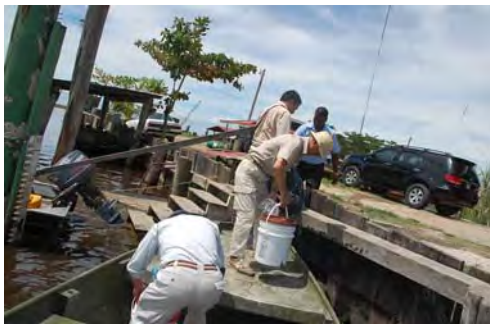
Soil Sample tightly sealed in bucket

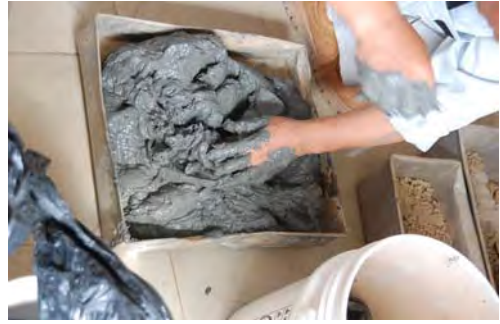
Soil Sample brought to the laboratory

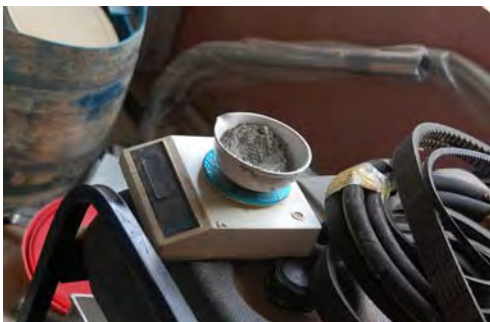
Cement : Weight measuring

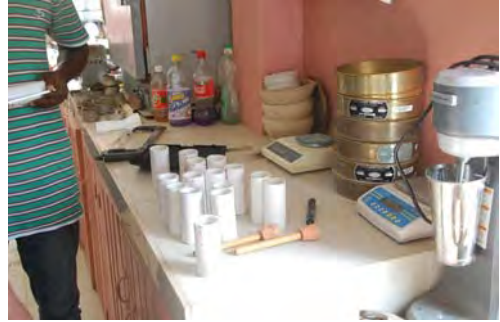
Moulds for the test

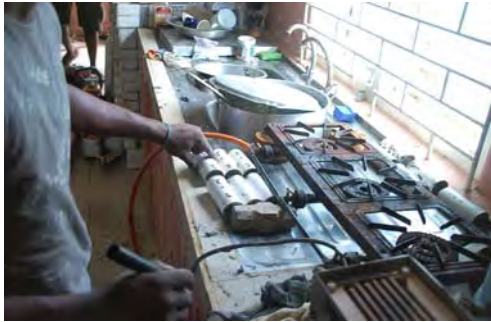
Numbering for the specimen

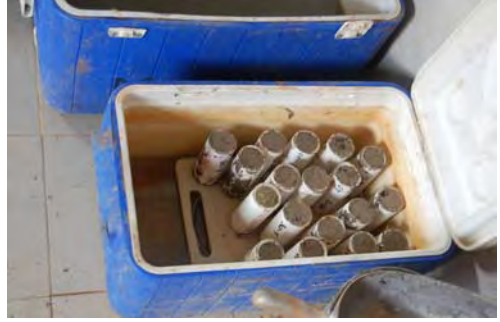
Curing (18-specimen in total)

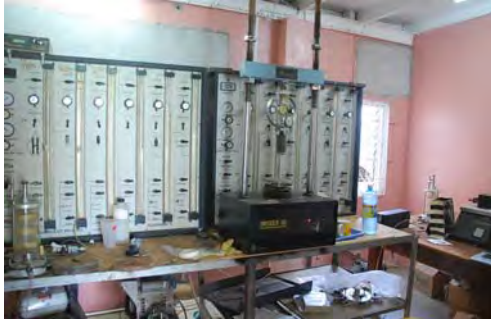
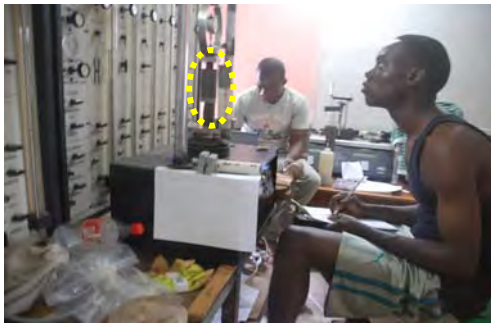
Compression test instrument
In process of testing

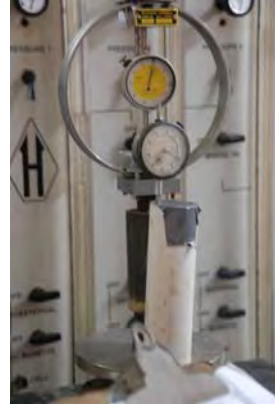
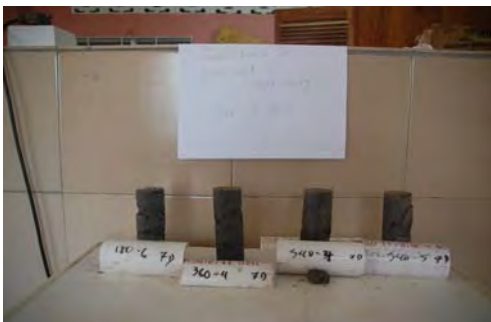
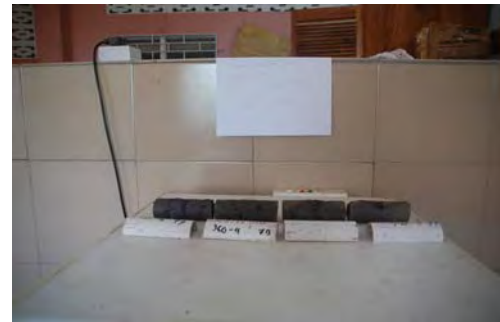
Specimen after testing (Nov. 13th)

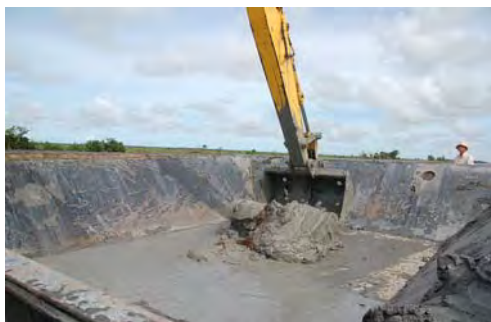
Excavated Soil in bucket on pontoon

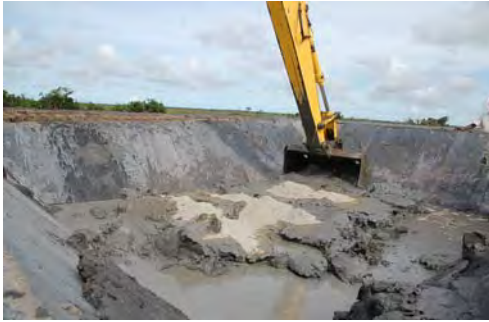
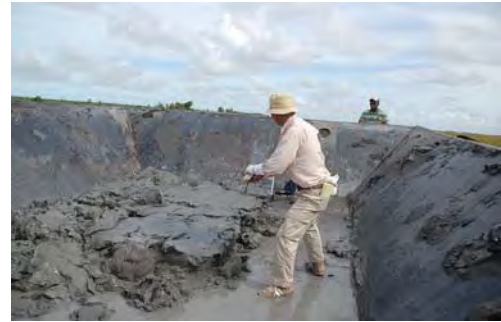
Soil Volume measuring

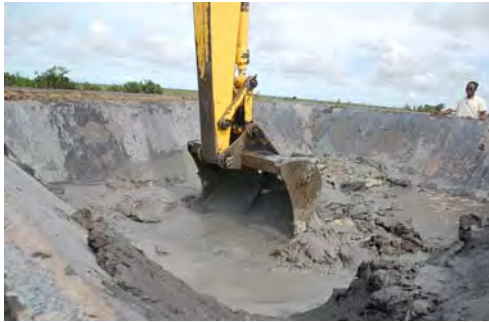
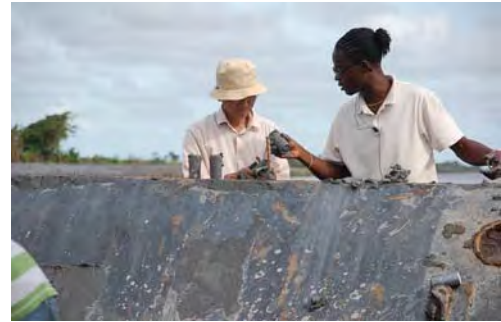
Sampling and specimen in mould

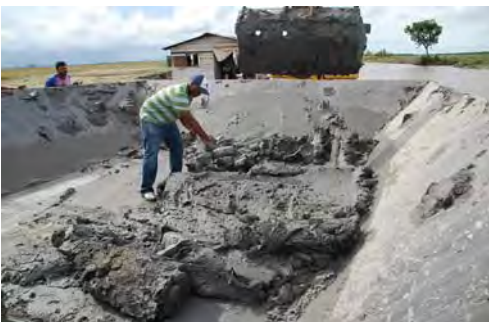
Cement adding and Mixing

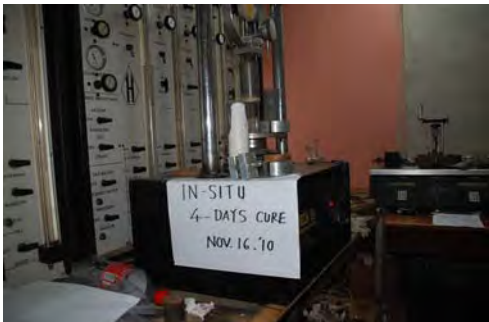
Test after 4-days curing

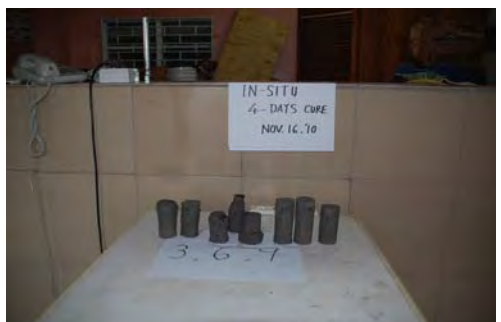
Specimen after testing (Nov. 16th)

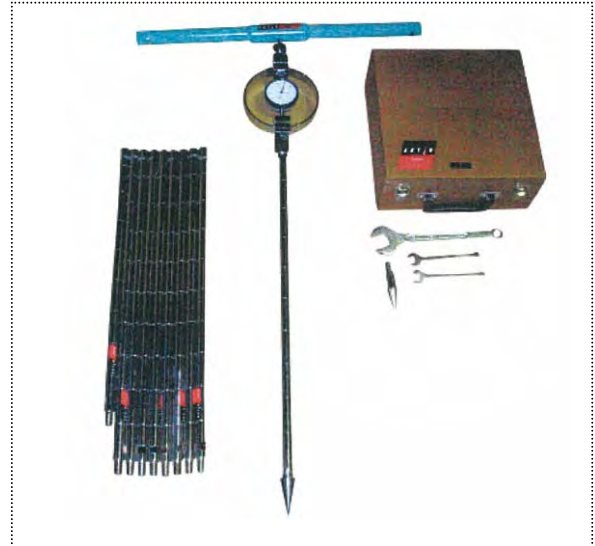
The CONE PENETROMETER shown in Plate-1 is a handy, portable instrument in which the device is consisted mainly of;

- cross handle,
- proving ring for capacity measure,
- cone with top angle of 30-degrees , and
- extension rods(10-nos./50cm long each).

Plate-1 Set of CONE PENETROMETER

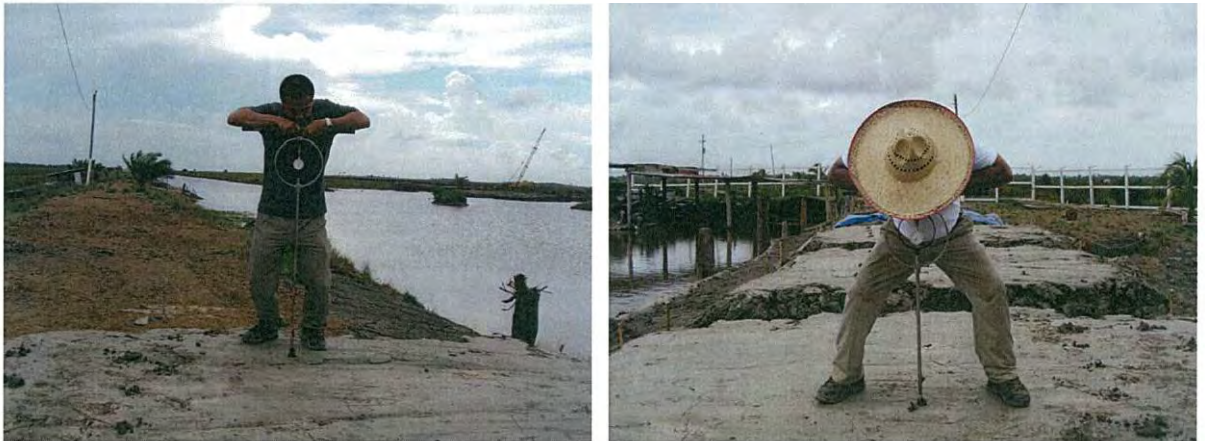
Actual handling of the Instrument is shown in Plate-2.

Plate-2 Handlings of CONE PENETROMETER
