17. Hazard map (Rank of landslide and debris flow by score)

The Project for Developing Countermeasures against Landslides in the Abay River Gorge
HAZARD RANK OF LANDSLIDE AND DEBRIS FLOW BY THE SCORE (FR January 2012)

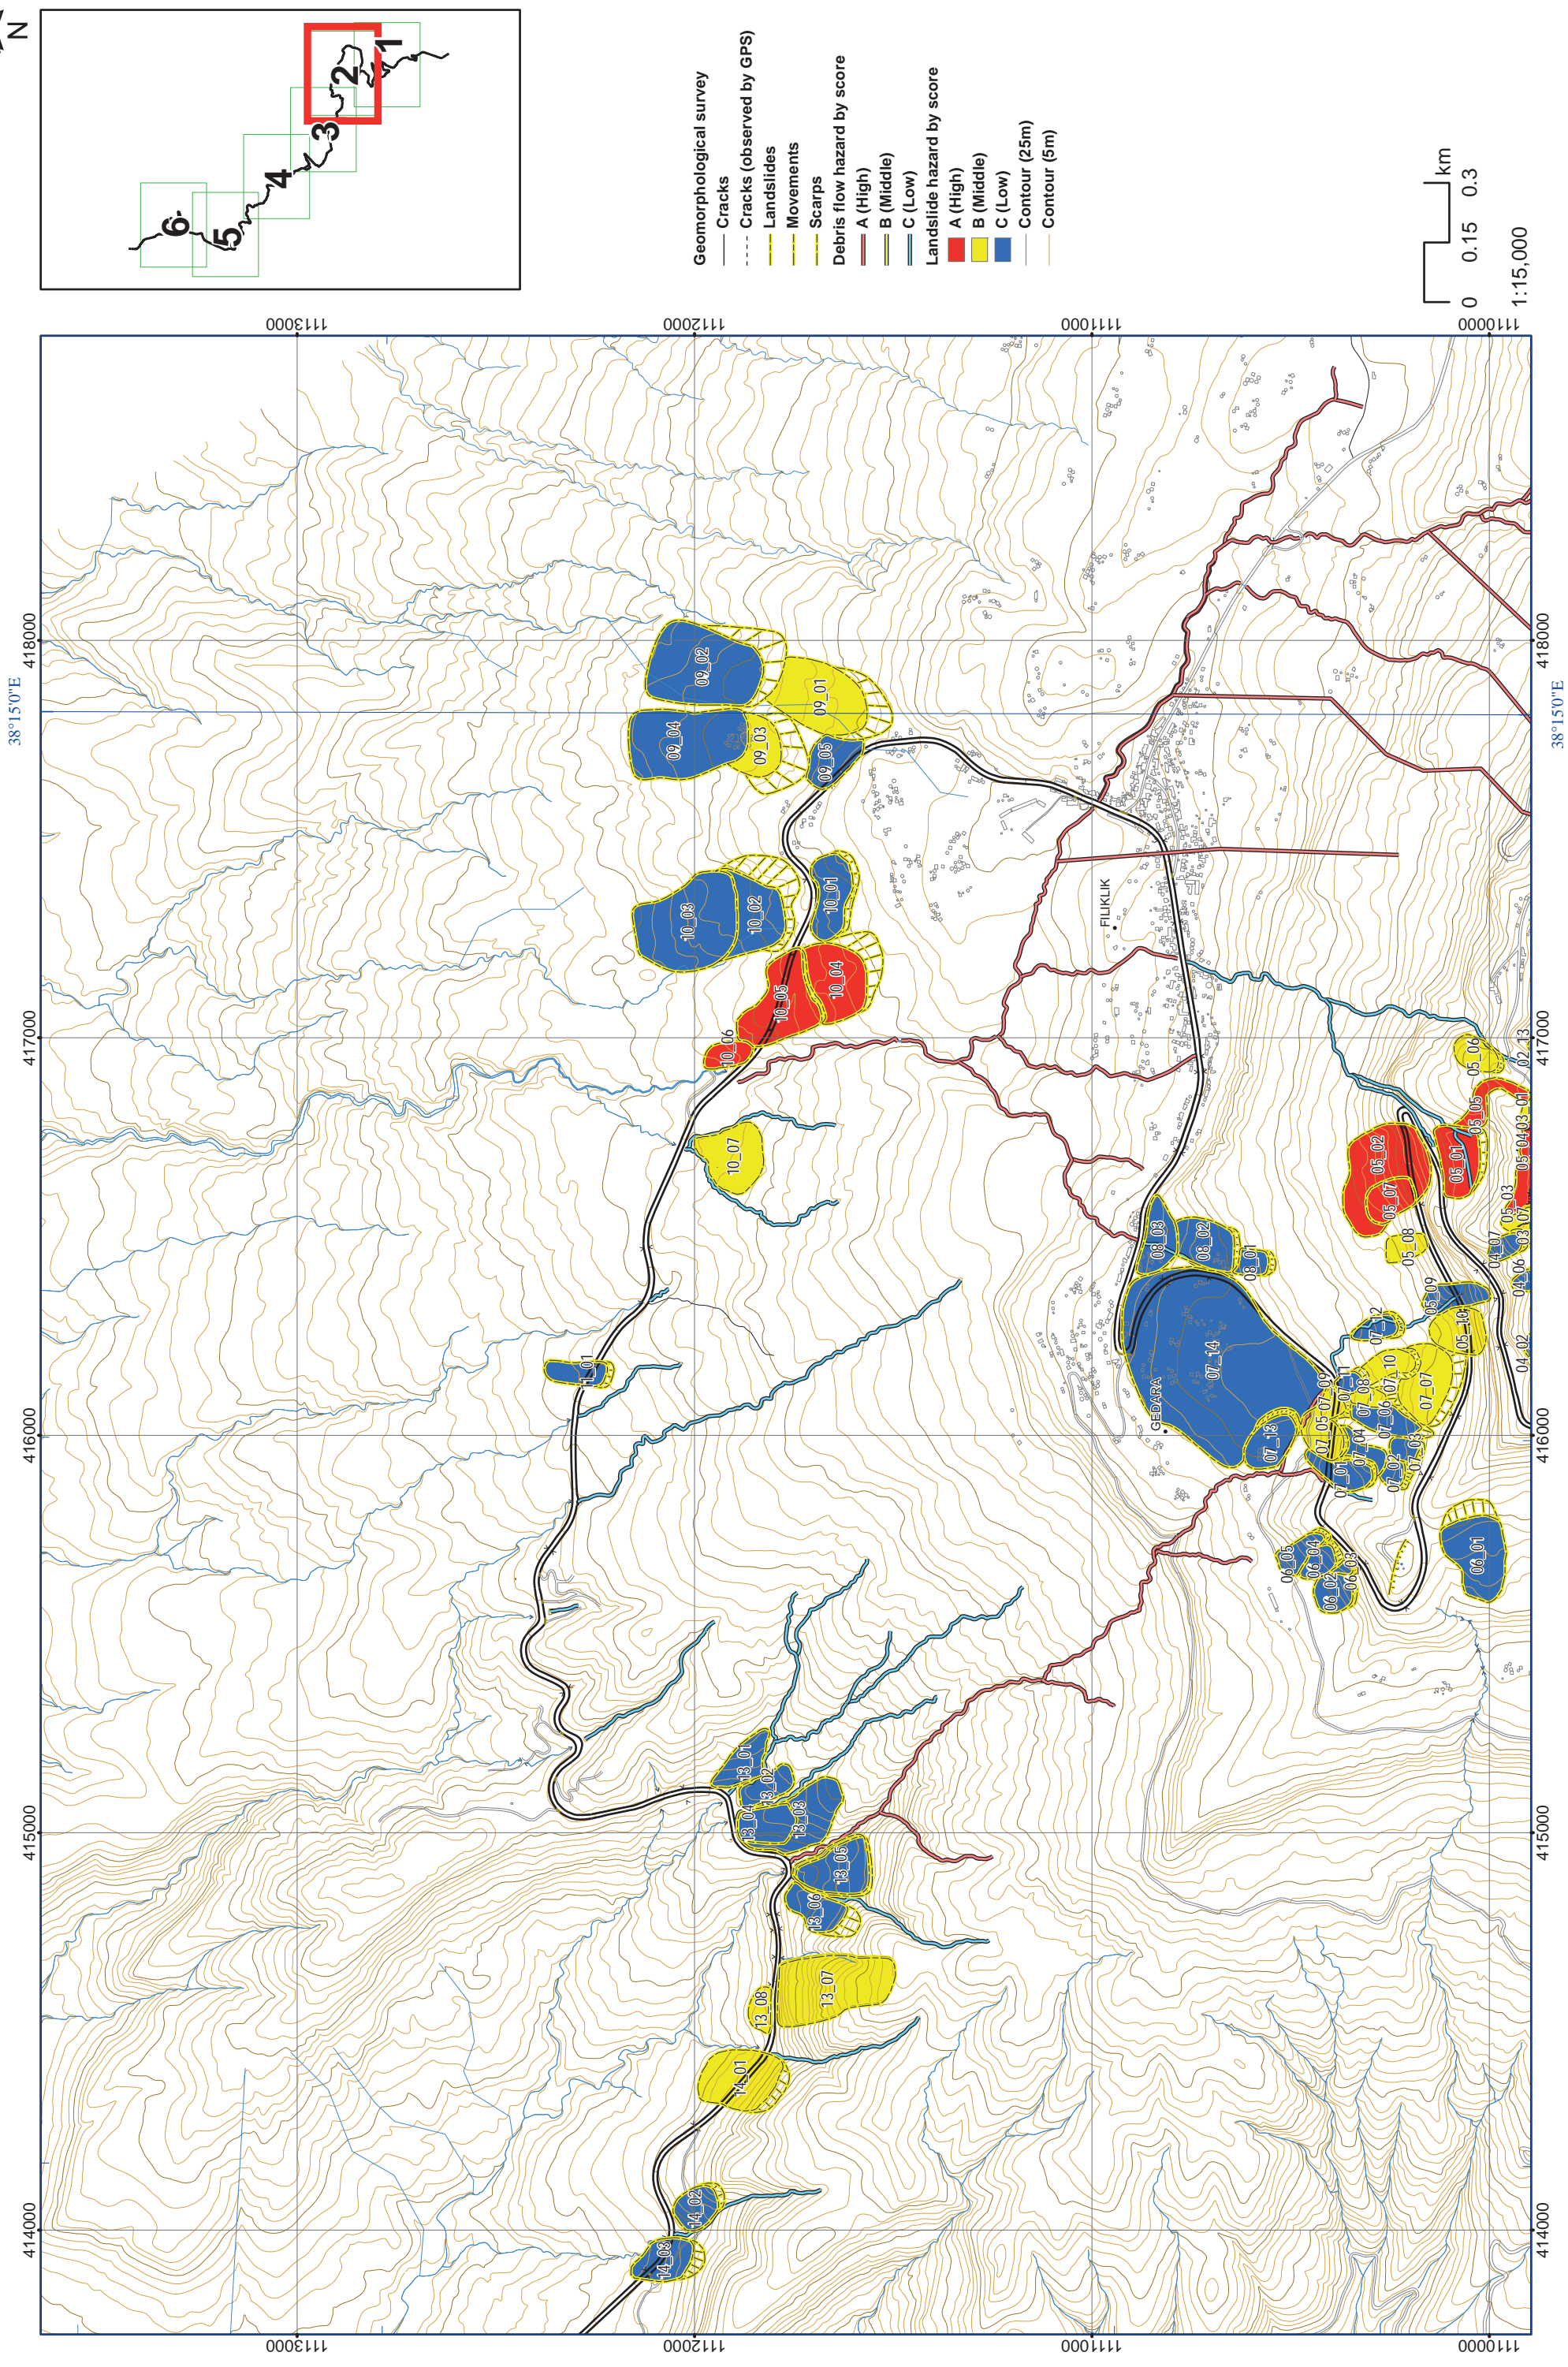
HAZARD RANK OF LANDSLIDE AND DEBRIS FLOW BY SCORE (FR January 2012)
