管路給水施設水源井戸調査結果

管路給水施設用の水源井戸の調査は、掘削地点を決めるための水平電気探査と垂直電気探査、試掘調査、既存井戸の揚水試験を実施した。これらの結果から、計画給水量に見合う井戸を選定し、それを元に給水施設の設計が行われた。

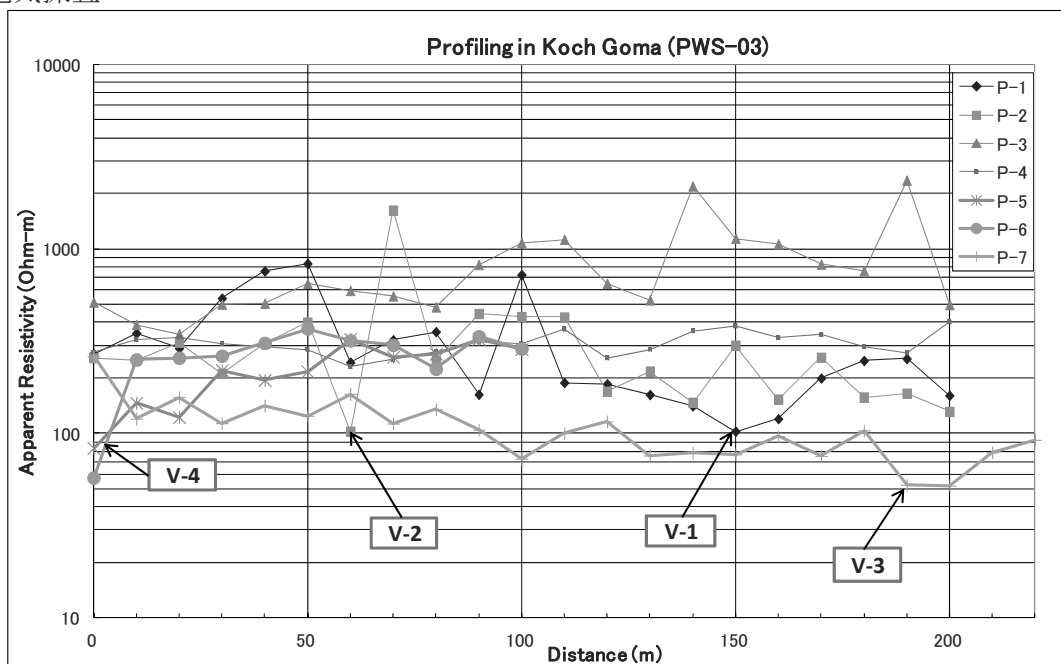
① 水平電気探査

P-1、P-2、P-5、P-7 測線の中から、それぞれの最も比抵抗の低い地点で垂直電気探査を実施した。P-3、P-4、P-6 測線は全体的に比抵抗が高く、目立った低比抵抗が無かった。

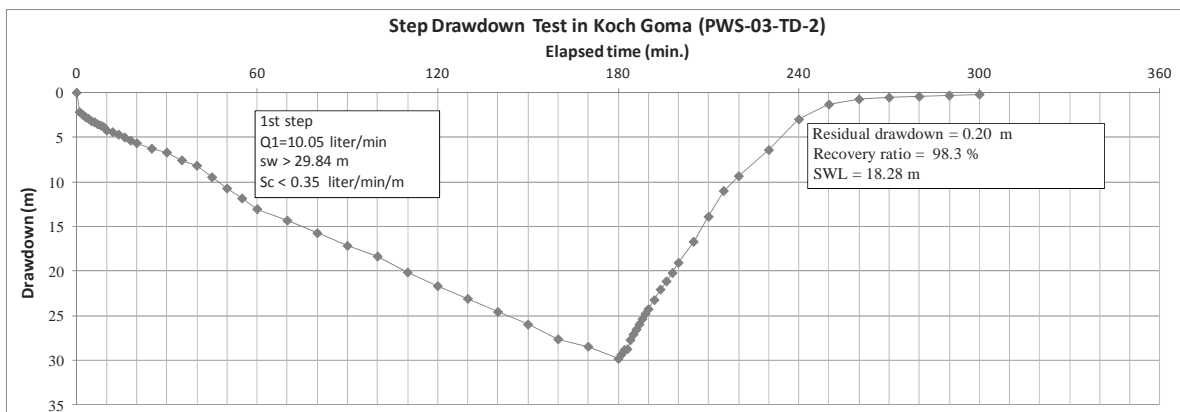
垂直電気探査 V-2 の地点で実施した試掘の柱状図と揚水試験結果、水質試験結果を以下に示す。この井戸では、深度 15m から新鮮な花崗岩が出現し、良好な帯水層には当たらなかった。そのため、比較的浅い 11.5m~17m にもスクリーンを設置したが、揚水試験では 10 リットル/分で揚水しても水位が下がり続けた。したがって、安全揚水量は 5 リットル/分程度と判断し、生産井としての使用は断念した。

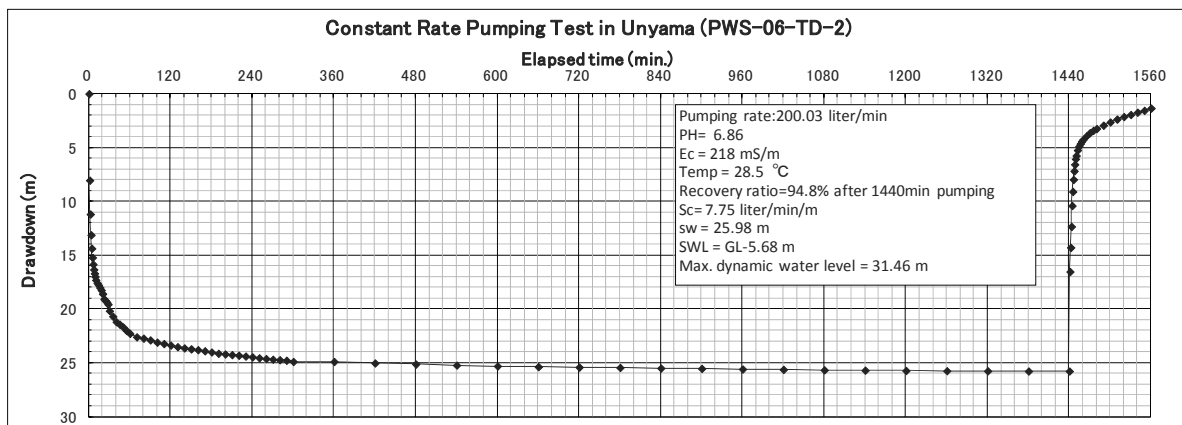
この井戸の揚水試験結果を以下に示す。上段は段階揚水試験の水位降下曲線、中段がその解析結果で、下段が連続揚水試験並びに回復試験の水位降下曲線を示している。

これらの結果より、安全揚水量を 12m³/hr (200 リットル/分) と判断した。

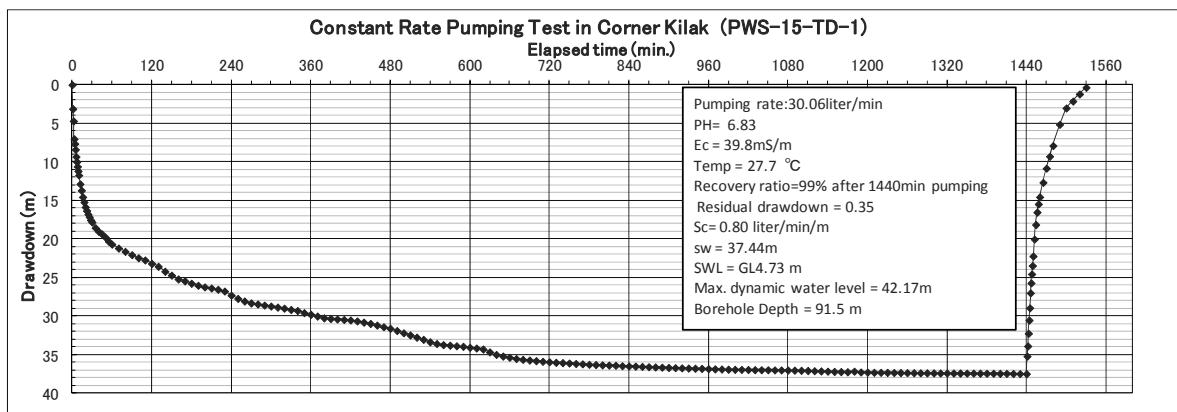
この井戸の揚水試験結果を以下に示す。上段は段階揚水試験の水位降下曲線、中段がその解析結果で、下段が連続揚水試験並びに回復試験の水位降下曲線を示している。

これらの結果より、安全揚水量を 1.5m³/hr (25 リットル/分) と判断した。

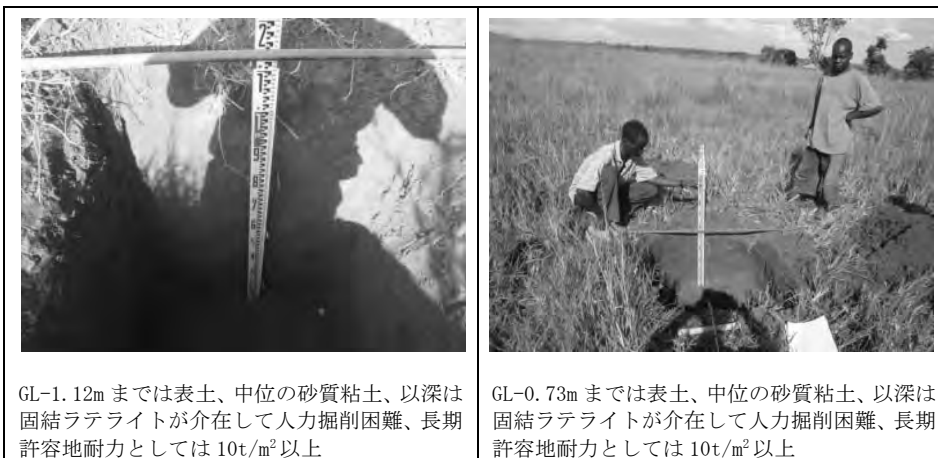
① グル県 Unyama RGC 高架タンク位置の地盤地耐力確認

GL-1. 12m までは表土、中位の砂質粘土、以深は固結ラテライトが介在して人力掘削困難、長期許容地耐力としては 10t/m² 以上

GL-0. 73m までは表土、中位の砂質粘土、以深は固結ラテライトが介在して人力掘削困難、長期許容地耐力としては 10t/m² 以上

RGC	長期許容地耐力度 (t/m ²)	備考
1. Unyama RGC	10 (現地貫入値 6～7)	0.73～1.12m 以深
2. Awere RGC	5 (現地貫入値 3 以上)	1.15m 以深
3. Koch Goma RGC	10 (現地貫入値 6～8)	0.7m 以深
4. Kitgum Matidi RGC	10 (現地貫入値 6～7)	0.85～0.95m 以深
5. Corner Kilak RGC	10 (現地貫入値 6～8)	0.6～1.3m 以深
6. Adilang RGC	10 (現地貫入値 6～8)	0.6～0.65m 以深

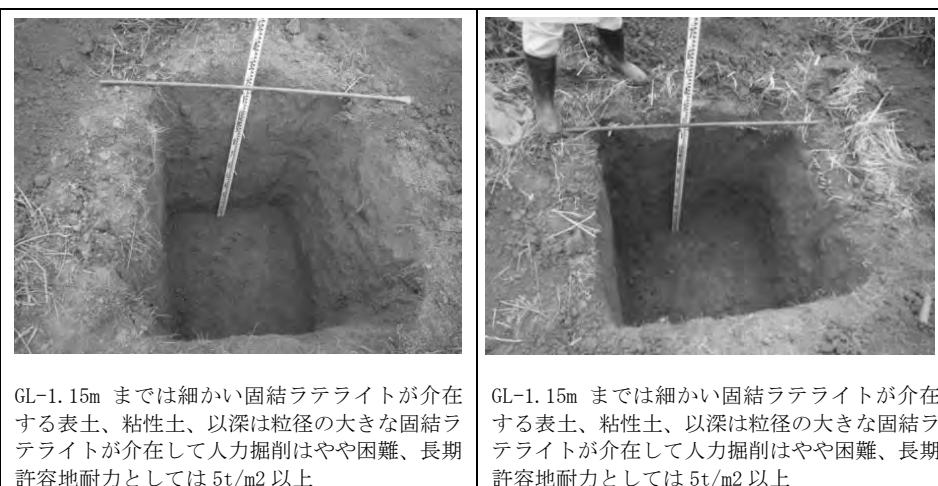
② グル県 Awere RGC 高架タンク位置の地盤地耐力確認

GL-1. 15m までは細かい固結ラテライトが介在する表土、粘性土、以深は粒径の大きな固結ラテライトが介在して人力掘削はやや困難、長期許容地耐力としては 5t/m² 以上

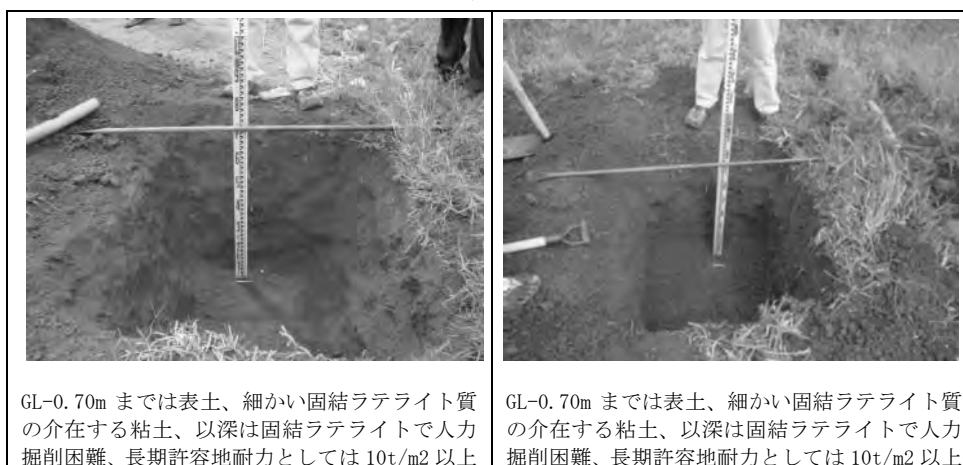
③ ヌウォヤ県 Koch Goma RGC 高架タンク位置の地盤地耐力確認

GL-0. 70m までは表土、細かい固結ラテライト質の介在する粘土、以深は固結ラテライトで人力掘削困難、長期許容地耐力としては 10t/m² 以上
