# Stable Water Supply with Leakage Control

—Retrace about 100years History—

Yukio NISHIKAWA  
City of Nagoya

# Renovation and maintenance of pipe network

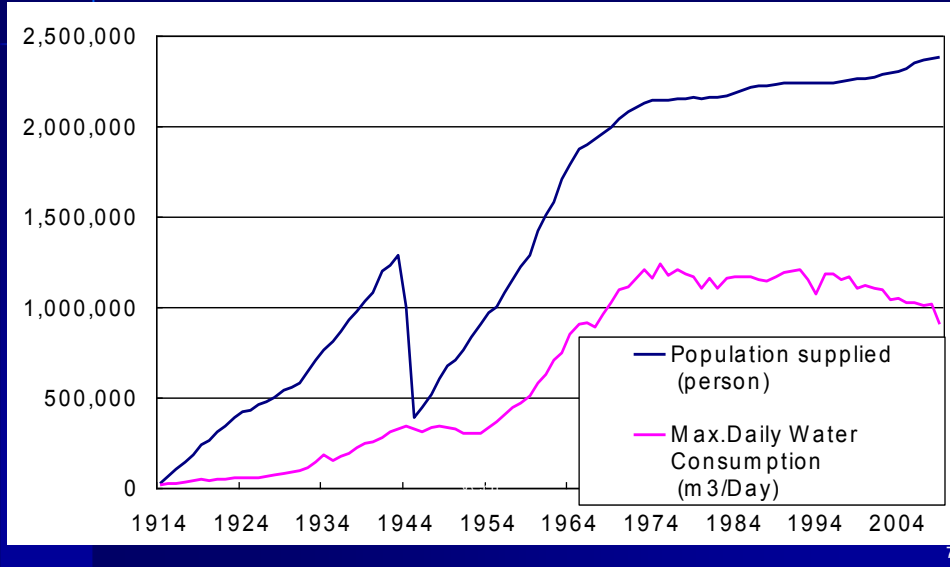
## Growth of Nagoya Waterworks [Population and Consumption]

Since 1914 in City of Nagoya, we constructed new waterworks facilities corresponded water consumption based on expand city area and increasing population.

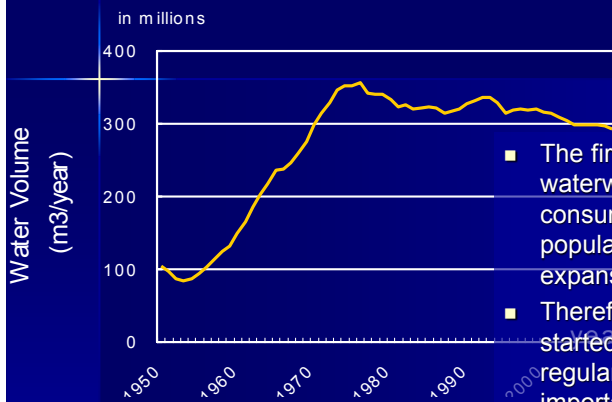
## Growth of Nagoya Waterworks [Yearly Water Volume]

- The first object was construction of waterworks for correspond to water consumption based on increased population from foundation to expansion.
- Therefore leakage control was started behind construction after regular spread, but we recognized important of leakage control.
- How did we decrease leakage and work on project?
- Show you trend of Leakage ratio.

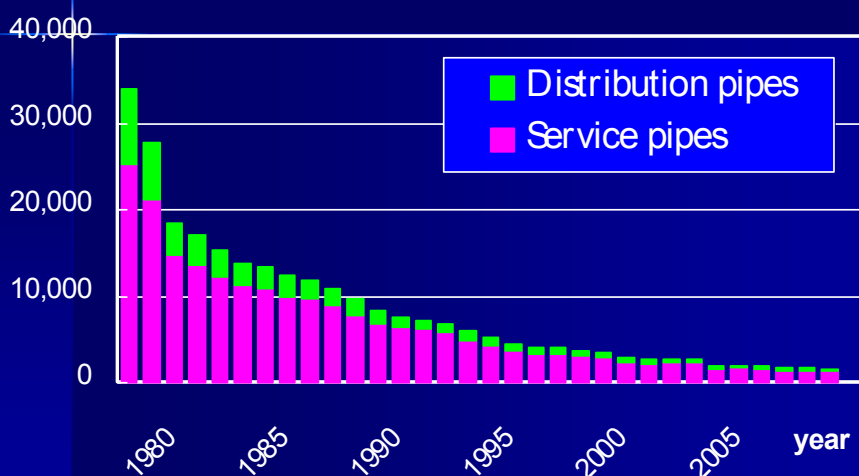
## Number of Repaired Pipes

About 80% of Leakage proceed from service pipe.

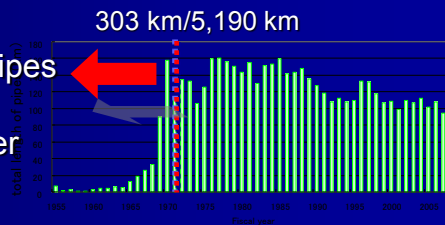
- 2011-2015
- Equalization replace against rapid increase.
- Important and high urgency mains replace move up.
- Normal cast-iron pipe sweep.
- Important distribution pipes replace aseismic.
- Aim for good taste water

Aged pipelines  
(Pipelines that have reached the end of their statutory useful life (40 years))

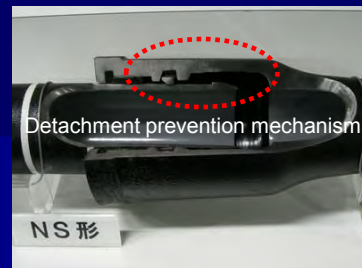
## Design

- Conventional
  - Ductile iron pipes
  - Adopt Joint improved
- Present
  - Joints with a detachment prevention mechanism
  - Covered with polyethylene sleeves
  - Steel pipes

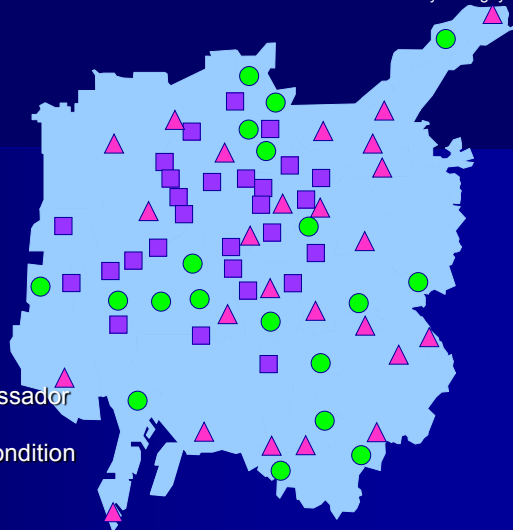
## Telemeters

- Water Pressure Telemeters  
16(at work)
- Water Flow and Pressure  
Telemeters 26(at work)
- ▲ Water Quality Telemeters  
27(at work)

Telemeters are set on ambassador  
of each distribution area for  
observation of distribution condition  
at all times.

For these provision,  
When distribution condition changes, we can check  
and manage the accident quickly.

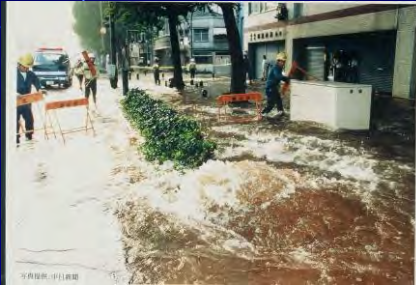
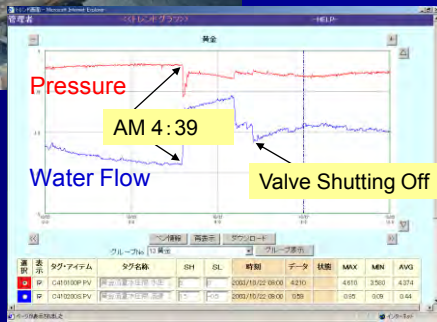
# For Example Burst of Water Distribution Mains - Quick Response to Rupture of Pipeline -

- Shut off after about 3hours
- Laying for 40 years
- Decline in pipe thickness because of corrosion from inner side

4:39am 22.August in 1998 37

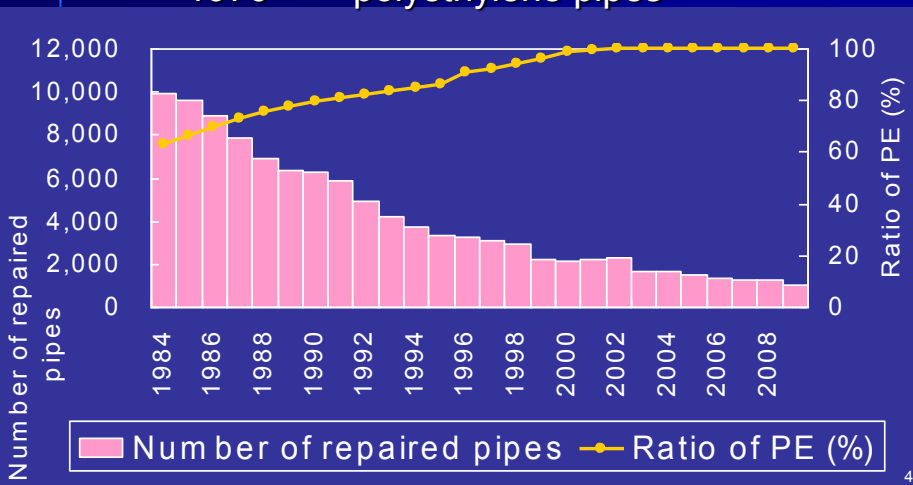
## Service Pipe Material

~1975      Lead pipes  
1976 ~      polyethylene pipes

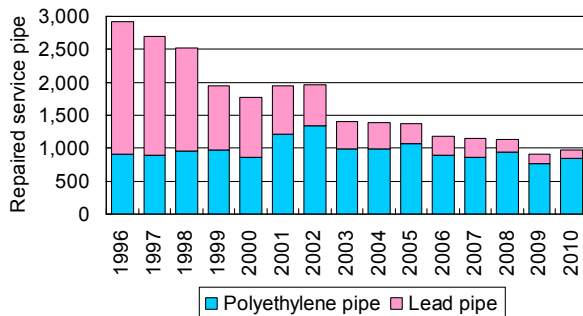
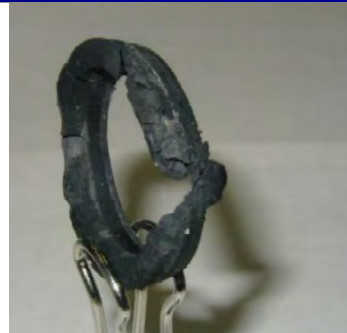
## Leakage of Polyethylene Pipes

Decrepit O-ring

- Old polyethylene pipes need to be replaced to reduce leakage more
