(8) Presentation Materials for Seminar Held on 28th February, 2012

Leak Management

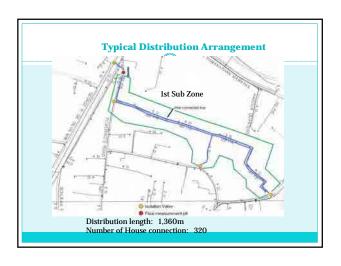
Valve Condition Survey

- Condition of boundary valves which are needed for the Isolation of the sub zone were checked.
- If they cannot completely close, they were replaced.
- > Installed additional valves when required.
- > Data sheet shall be filled.

Valve installation & placing Condition of boundary valves which are needed for the Isolation of the sub zone were checked. If they cannot completely close, they were replaced. Installed additional valves when required. Data sheet shall be filled. Valves detected by using valve locator, Metal pipes by using Pipe locator & PVC pipes by using leak detection instrument.
