Kingdom of Thailand
The Project for Bridge Master Plan and Bridge
Maintenance Ability in Rural Area

Report 2
Bridge Inspection and Evaluation Manual

July 2013

Japan International Cooperation Agency
CHODAI Co., Ltd
Metropolitan Expressway Company Limited

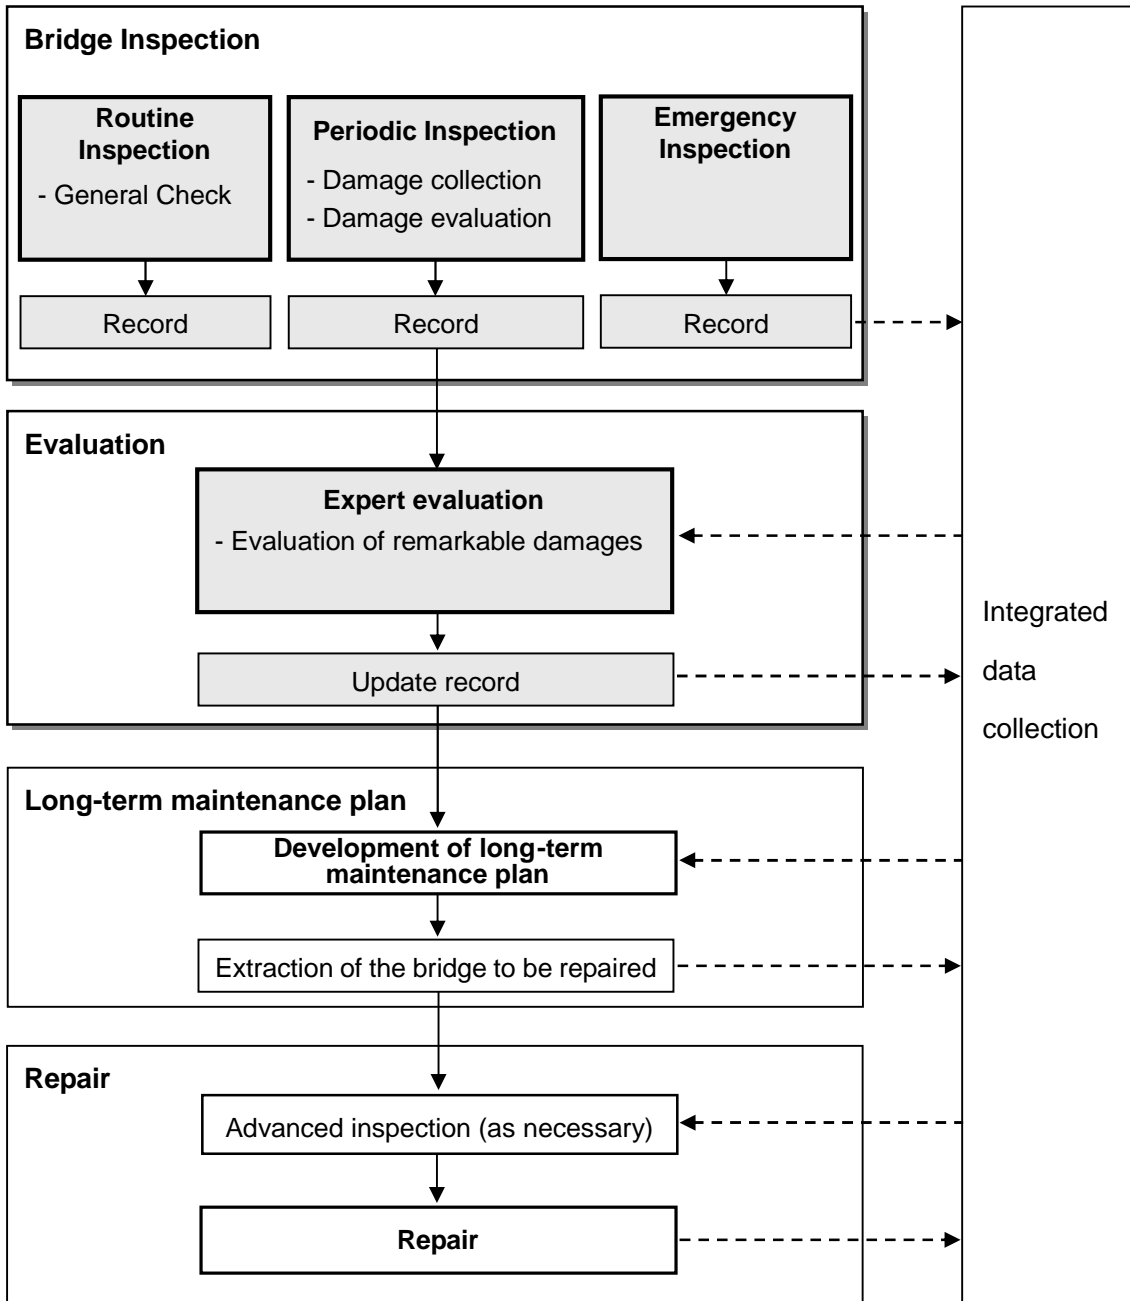
Figure 3.1: Scheme of inspection in the maintenance system

Besides periodic inspection there are different types of inspection and investigation in the maintenance system. This can be schematically demonstrated in the maintenance system as follows:

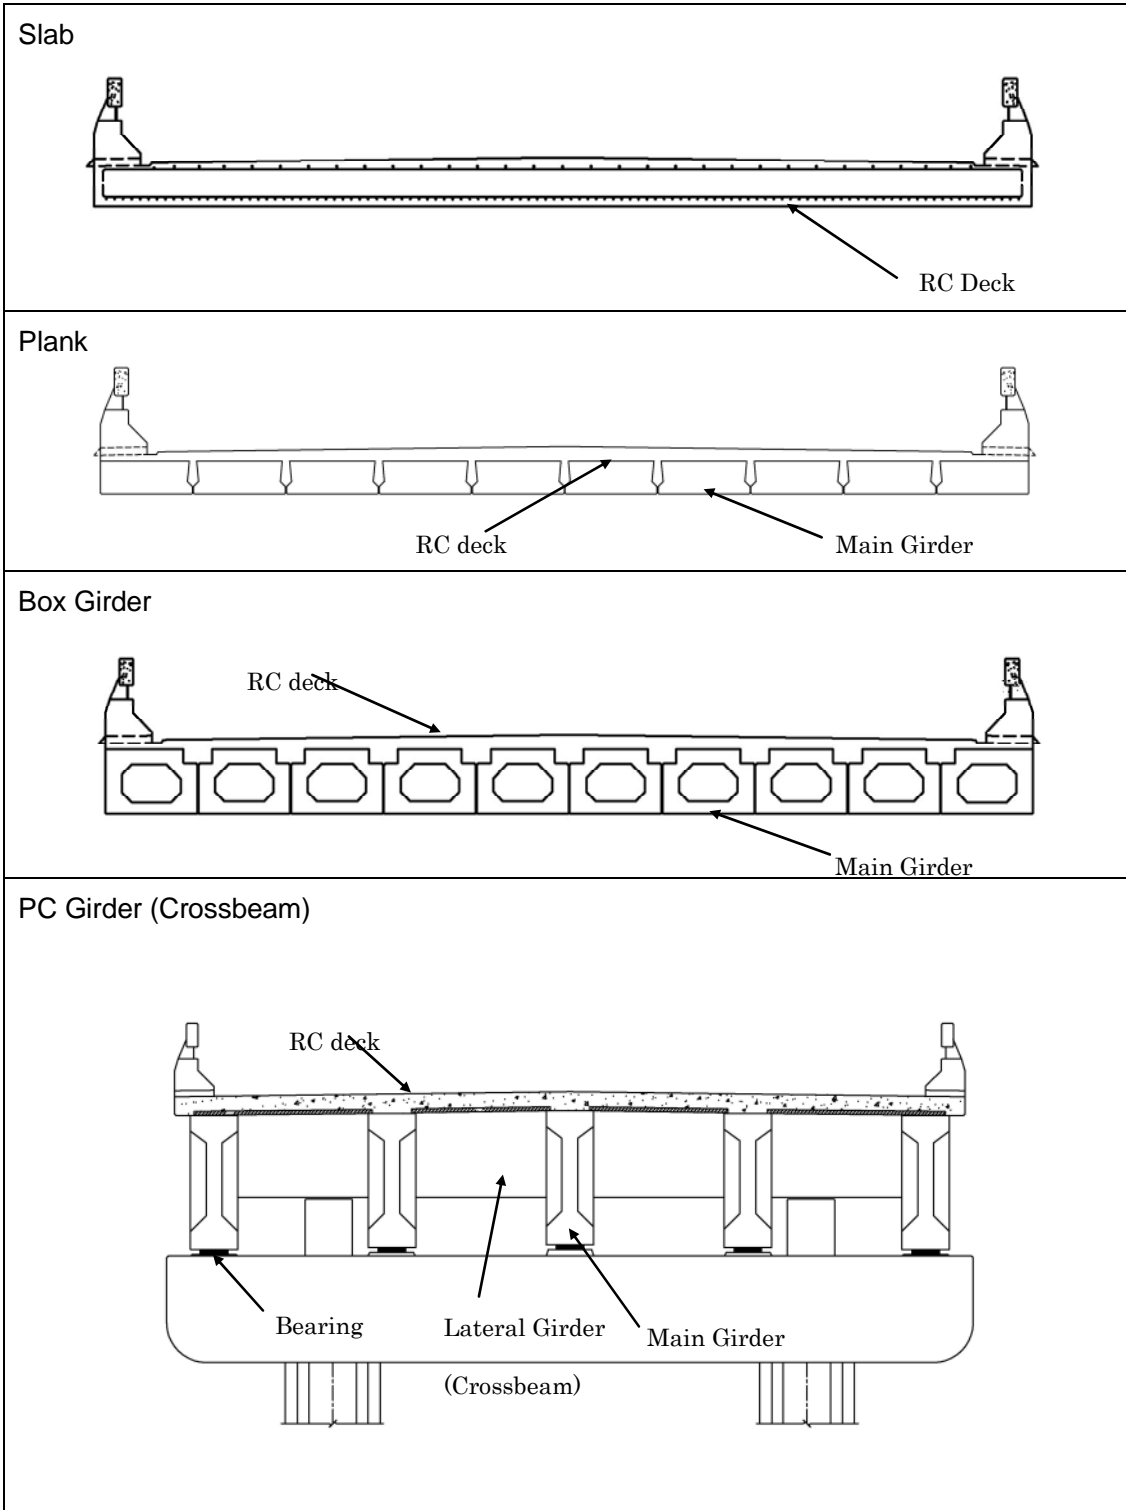
Figure 1.1: The structural types for which this manual is written (Superstructure)

Figures 1.1 and 1.2 show the structural types for which this manual is written. Damages in a concrete girder vary in crack direction, characteristics and also its location depending upon the causes. It is necessary to confirm the whole cracking area as close as possible, since cracks such as shear cracks may give a great influence on the bridge health.

In case of prestressed concrete girder the state of prestressing gives a great influence on the bridge health. Therefore it is preferable to confirm every anchorage zone where indicates the existence of the damage in a prestressing tendon if the inspection intends to grasp the rough health.

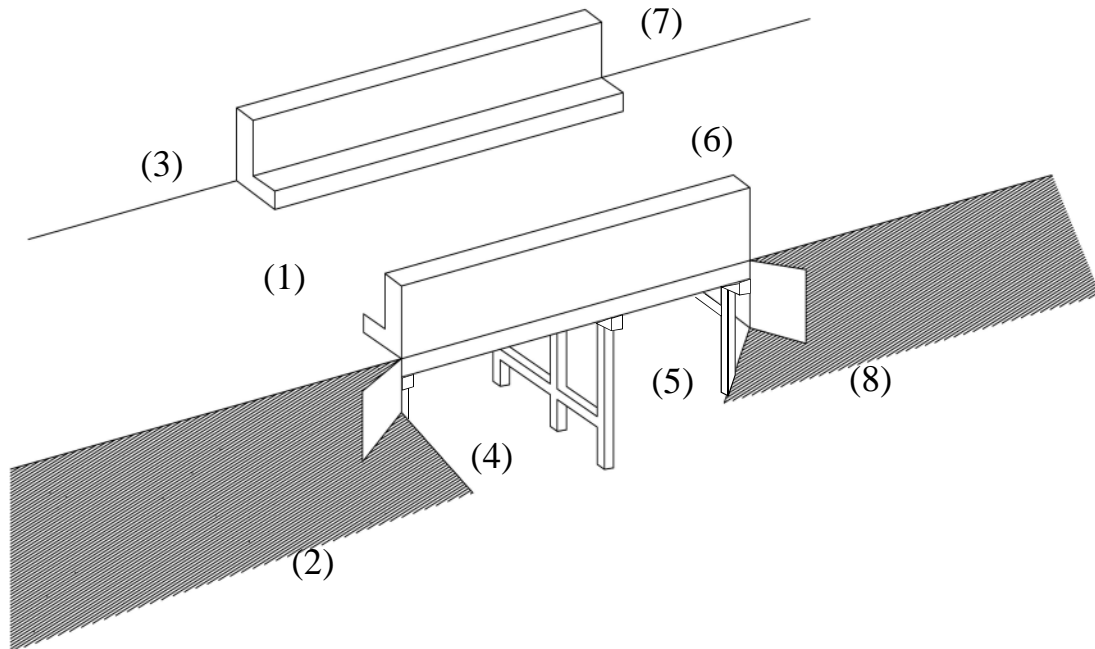
(1), (6) Near bridge, surface of bridge

Points to check: Entire bridge, surface of bridge (Road surface, expansion joints, barriers, sidewalk, drainages, attached facility), Approach road (road surface)

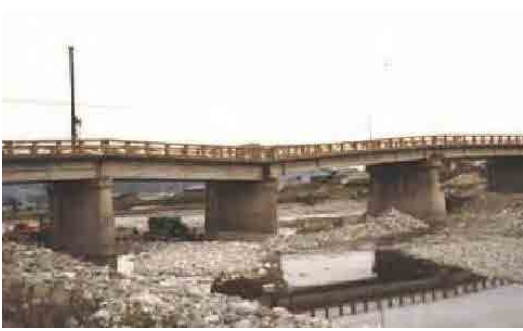
<p>Settlement/ inclination of substructure and remarkable scour of substructure</p>

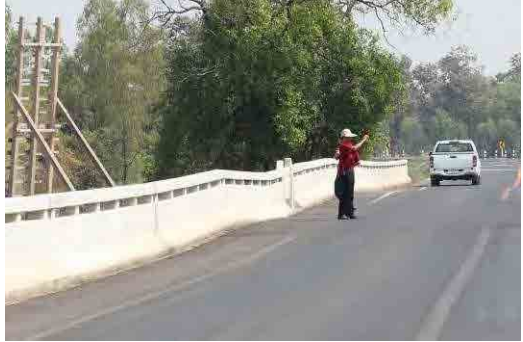
<p>Settlement of substructure and deformation on the bridge</p>
<p>Damage level 5</p>	<p>Damage level 5</p>
  <p>Collapse of bridge due to loss of substructure</p>

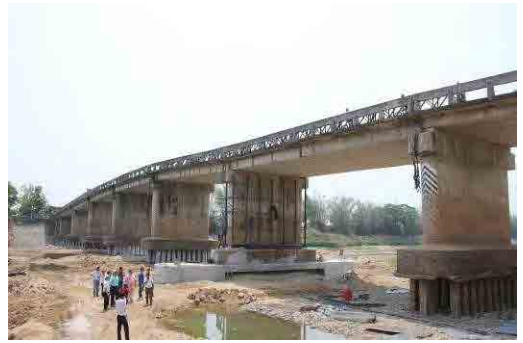
<p>Settlement of substructure</p>

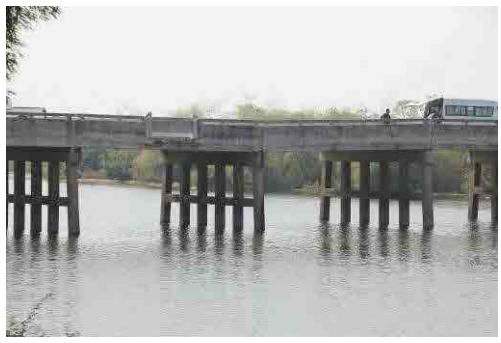
<p>Settlement of substructure</p>

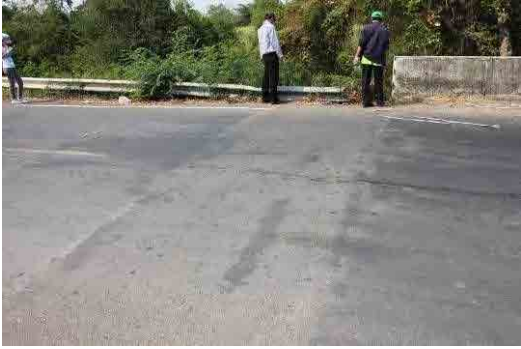
<p>Level difference < 20mm</p>

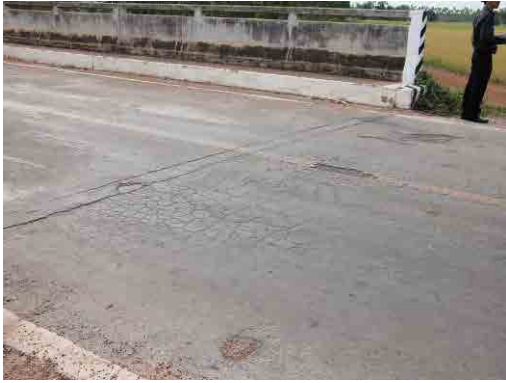
<p>Level difference < 20mm</p>
Damage level 5	Damage level 5

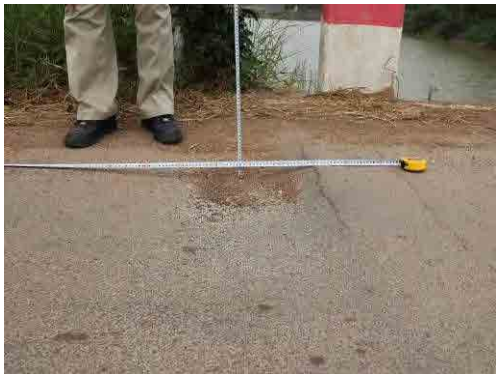
<p>Level difference \geq 20mm (behind abutment)</p>

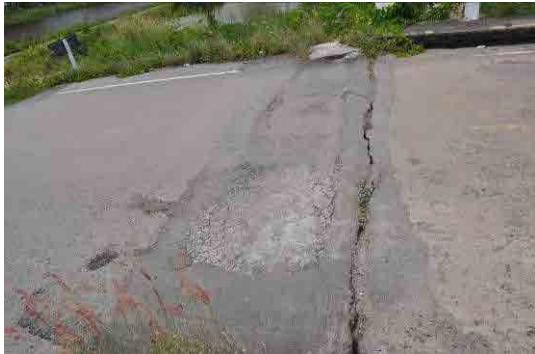
<p>Level difference \geq 20mm</p>

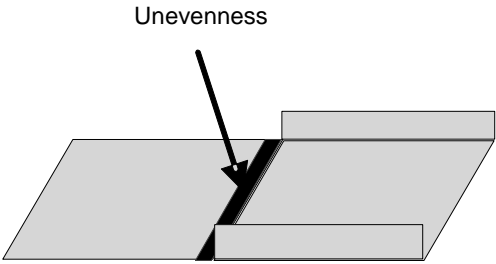
<p>Unevenness</p>

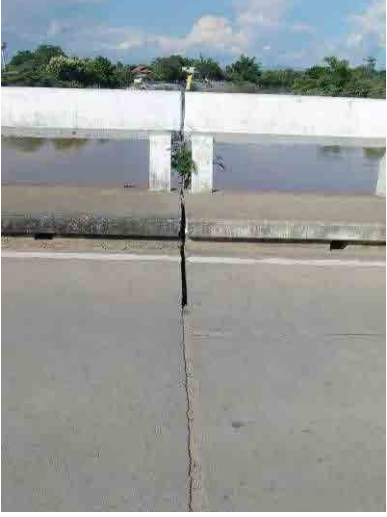
<p data-bbox="245 981 600 1012">Miner defects on expansion joint</p>

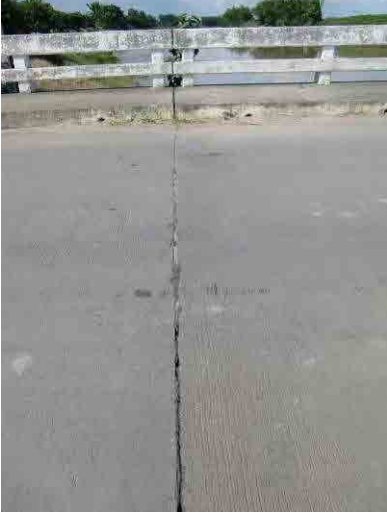
<p data-bbox="799 981 1153 1012">Miner defects on expansion joint</p>
Damage level 5

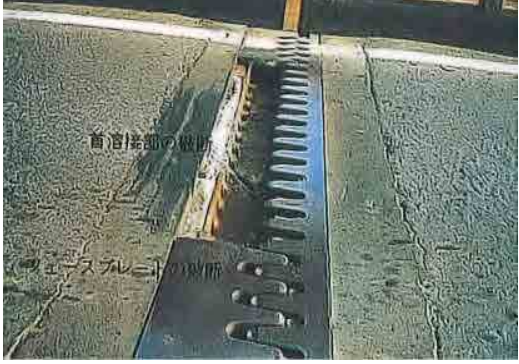
<p data-bbox="245 1507 671 1538">Remarkable defects on expansion joint</p>

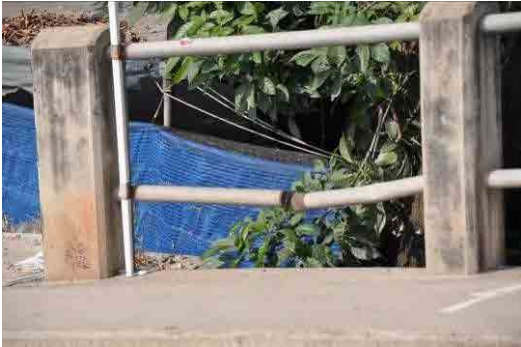
<p data-bbox="252 808 424 831">Minor loss of steel</p>

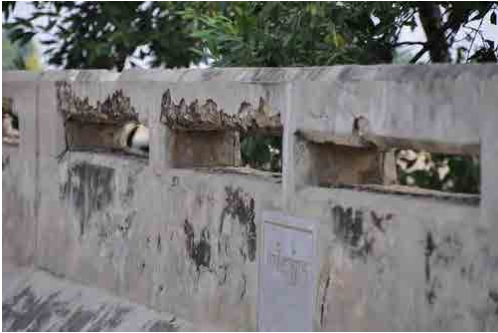
<p data-bbox="799 808 1010 831">Minor loss of concrete</p>
Damage level 5	Damage level 5

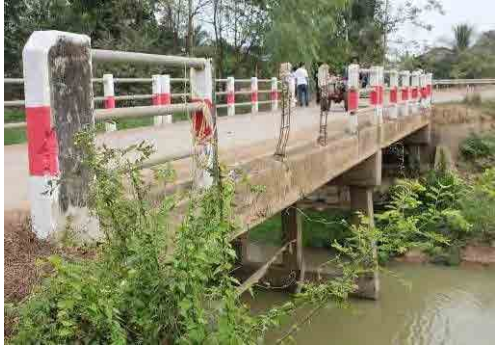
<p data-bbox="252 1279 735 1301">Breakage in large area. Dangerous traffic condition</p>

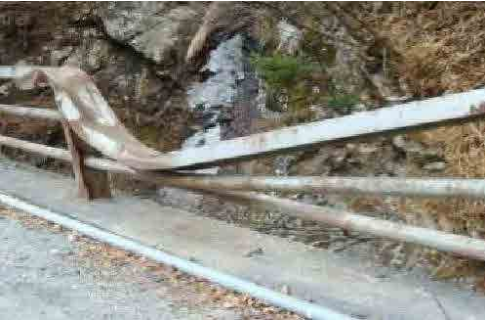
<p data-bbox="799 1279 1246 1301">Large deformation. Dangerous traffic condition.</p>

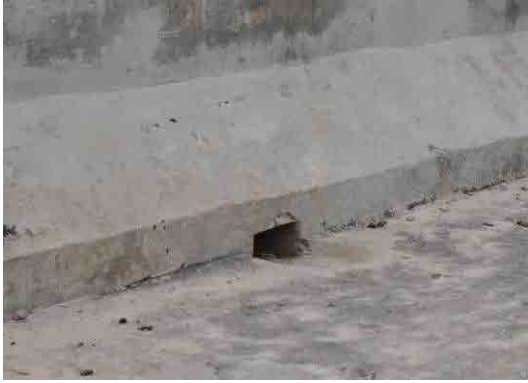
<p data-bbox="248 864 584 896">No obstruction in the drain pipe</p>

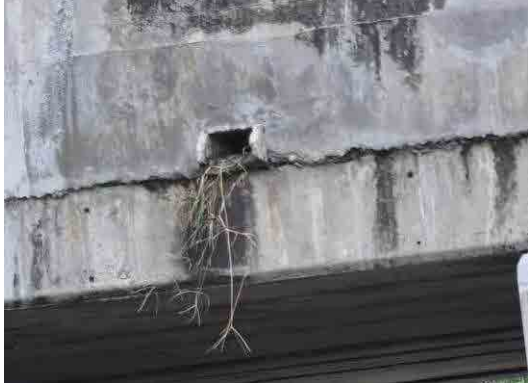
<p data-bbox="801 864 1311 896">The drain pipe is clogged with dust and gasses</p>

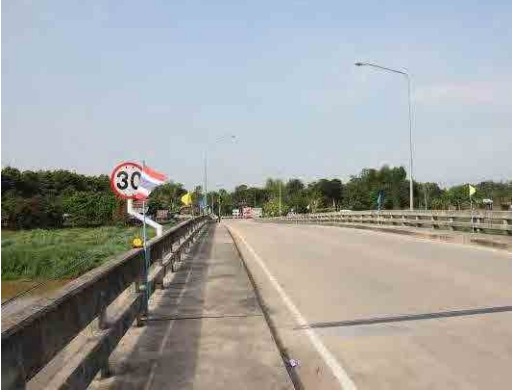
<p data-bbox="256 981 746 1010">No unusual condition such as level difference</p>

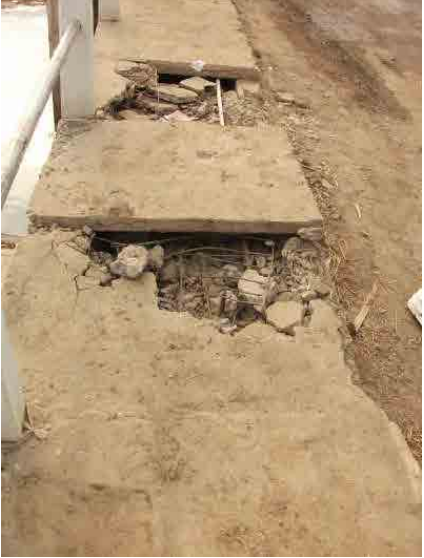
<p data-bbox="802 1041 1337 1126">Occurrence of level difference that leads difficult traffic condition</p>

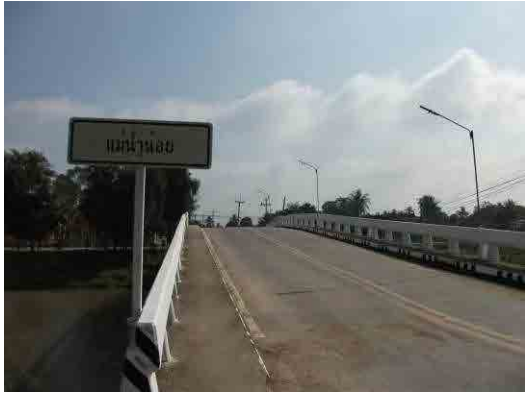
<p data-bbox="248 864 775 954">No unusual condition of lighting equipments and signs</p>

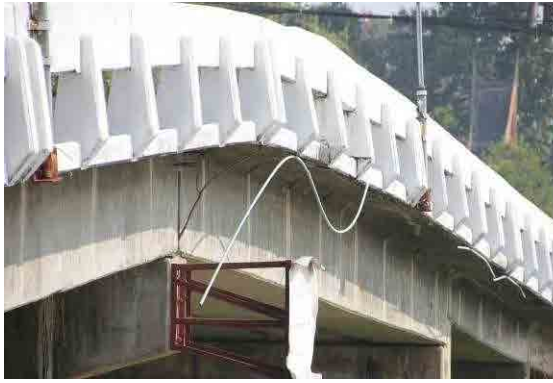
<p data-bbox="801 864 1356 898">Damages to piping</p>

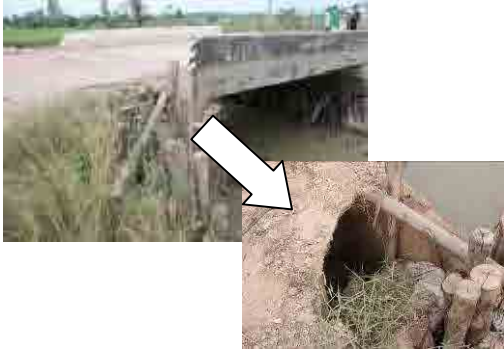
<p data-bbox="252 772 778 857">Deep pothole behind the abutment due to erosion/scour</p>

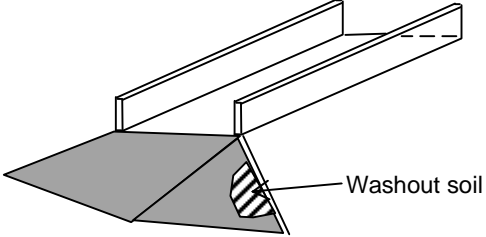
<p data-bbox="1153 667 1297 696">Washout soil</p>
Damage level 3	Damage level 3

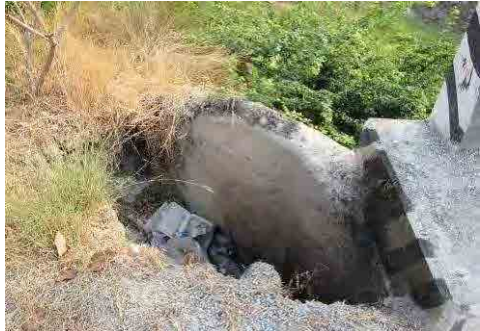
<p data-bbox="252 1301 778 1386">Deep pothole behind the abutment due to erosion/scour</p>

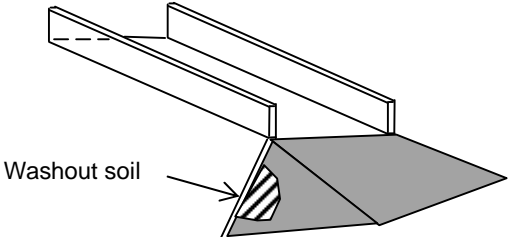
<p data-bbox="818 1205 962 1234">Washout soil</p>
Damage level 5	Damage level 5

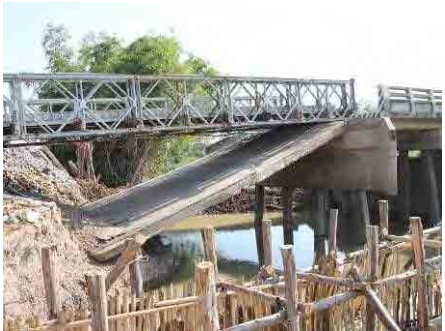
<p data-bbox="252 1827 778 1912">Concrete slab behind the abutment is fallen down due to erosion/scour</p>

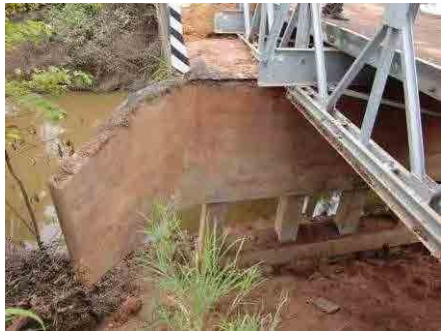
<p data-bbox="802 1827 1329 1912">Backfill material behind abutment is washed away due to erosion/scour</p>

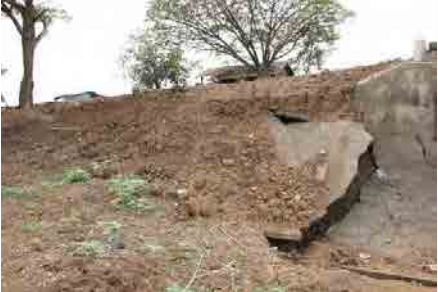
<p>The shoulder of approach road is wash away due to erosion/scour</p>

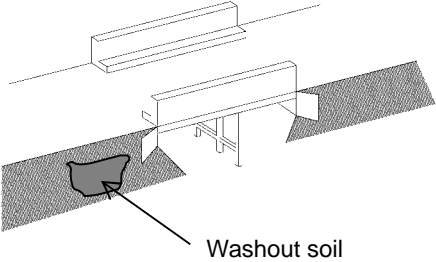
<p>Washout soil</p>
<p>Damage level 5</p>	<p>Damage level 5</p>

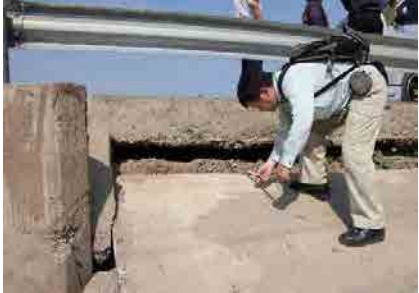
<p>Gap between concrete slab and bank behind abutment due to erosion/scour</p>

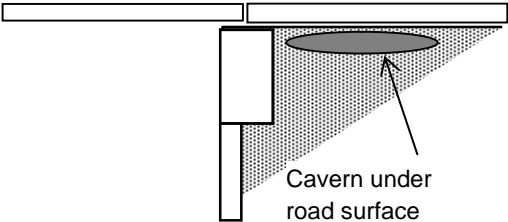
<p>Cavern under road surface</p>
<p>Damage level 5</p>	<p>Damage level 5</p>

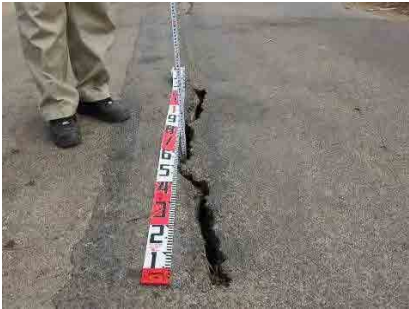
<p>Crack appeared on the surface of pavement due to void under the pavement</p>

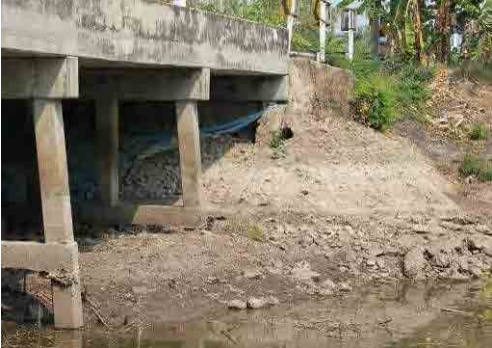
<p data-bbox="252 779 614 813">Minor damage on river revetment</p>

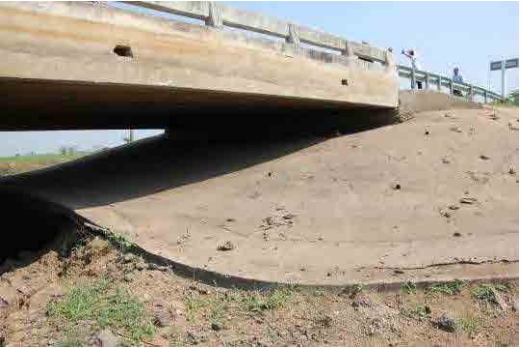
<p data-bbox="805 779 1168 813">Minor damage on river revetment</p>
Damage level 5	Damage level 5

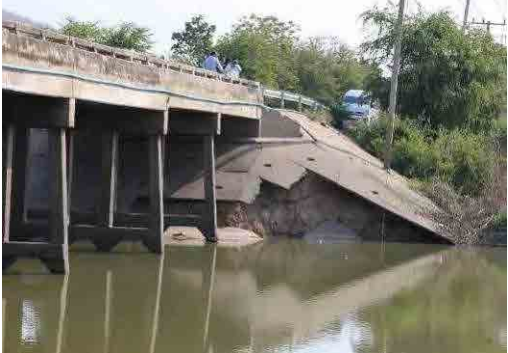
<p data-bbox="252 1272 782 1328">Remarkable damage on river revetment due to lack of backfill</p>

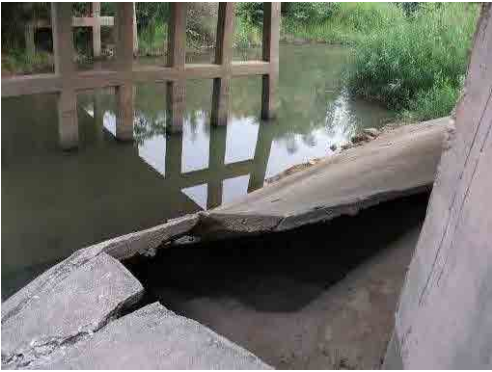
<p data-bbox="252 1787 782 1843">Remarkable damage on river revetment due to lack of backfill</p>

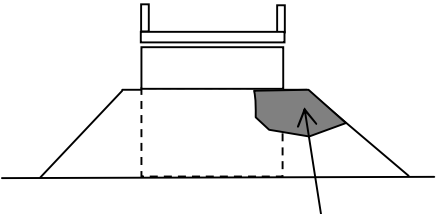
<p data-bbox="930 1720 1281 1753">Washout behind river revetment</p>

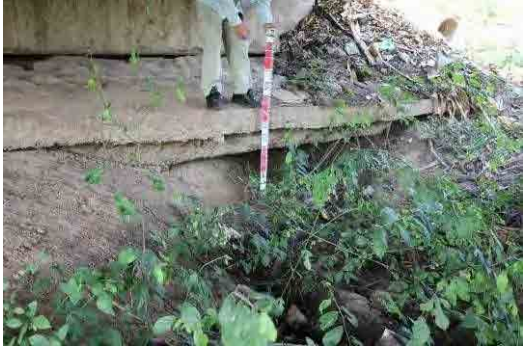
<p>Minor damage due to scouring</p>

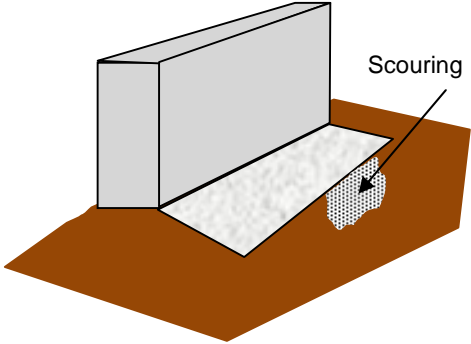
<p>Scouring</p>
Damage level 3	Damage level 3

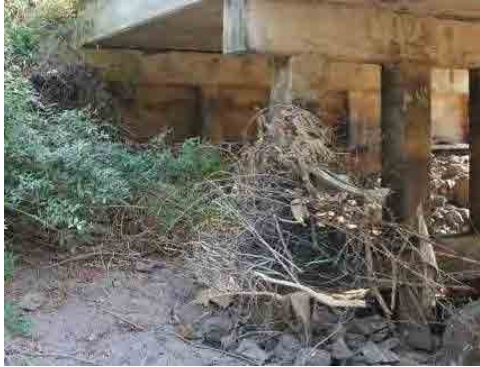
<p>Minor obstacles in the cross-sectional area of a river</p>

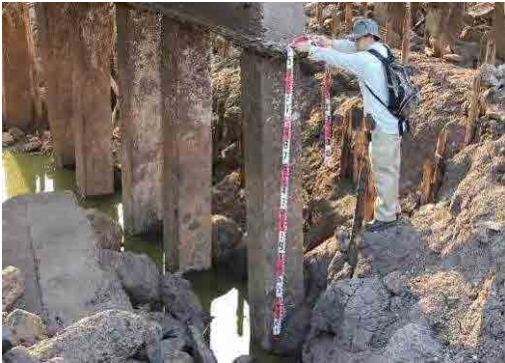
<p>Remarkable scouring around the substructure</p>

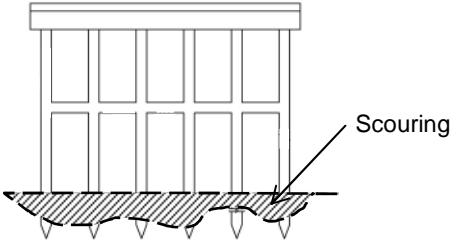
<p>Scouring</p>

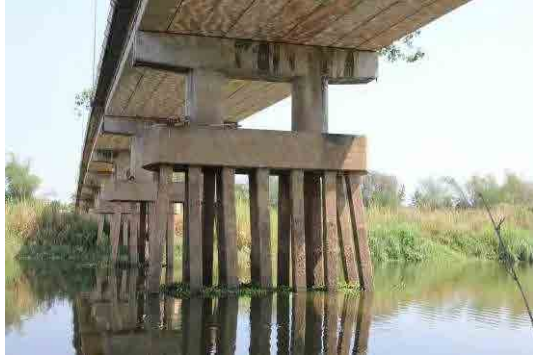
<p data-bbox="248 808 687 837">Remarkable scouring around the substructure</p>

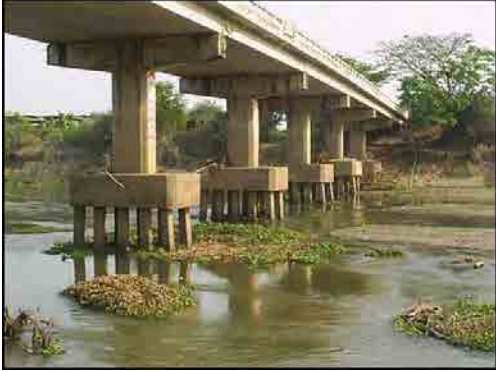
<p data-bbox="799 808 1238 837">Remarkable scouring around the substructure</p>

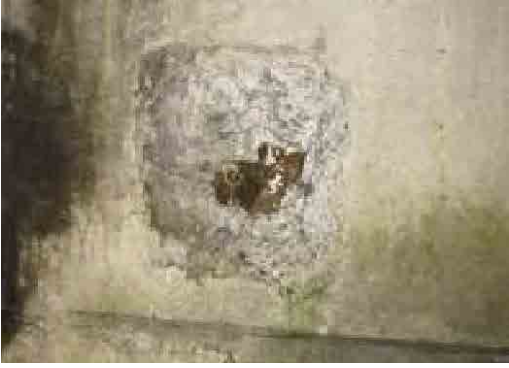
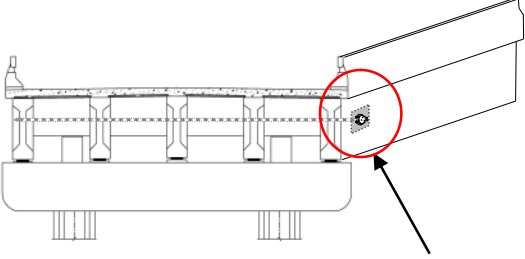
<p data-bbox="245 864 767 898">Spalling of the anchorage concrete and steel corrosion</p>

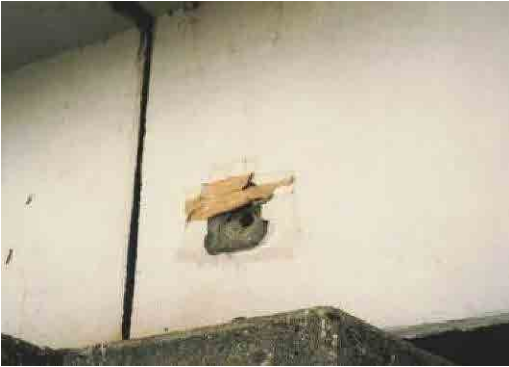
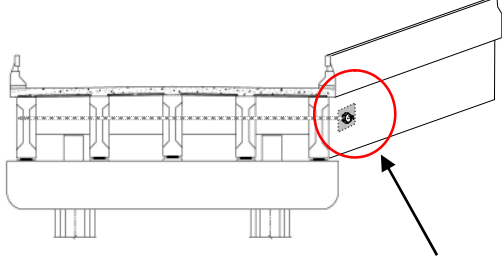
<p data-bbox="245 1391 767 1480">Spalling of the anchorage concrete and slip out of the PC tendon</p>

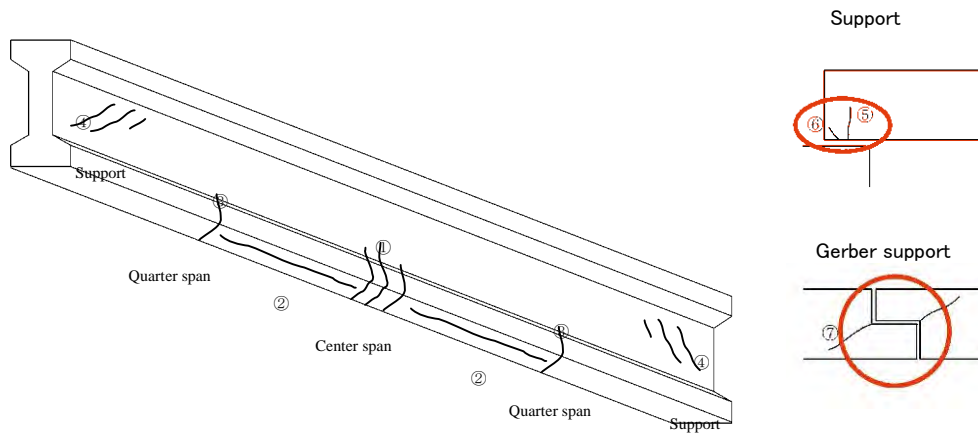
[common to PC/RC] PC: Prestressed concrete, RC: Reinforced concrete

Remarkably influential cracks (Girder)

No.	Location	Crack pattern
1	Center span	Cracks in the transverse direction on the bottom surface and vertical cracks on the side surface of the girder at the center span
2		Cracks in the longitudinal direction on the bottom surface of the girder
3	Quarter span	Cracks in the transverse direction on the bottom surface and vertical cracks on the side surface of the girder at the center span
4	Support	Diagonal cracks on the side surface in the vicinity of the support
5		Cracks on the bottom surface and vertical cracks on the side surface of the girder directly above bearings
6		Diagonal cracks on the side surface of the girder directly above bearings
7	Gerber support	Cracks at Gerber supports
8	Whole PC girder	Cracks along PC sheath and PC tendon

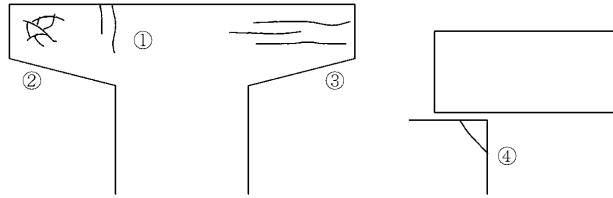
[T-shaped pier]

Remarkably influential cracks (Pier)

No.	Location	Crack pattern
1	T-shaped pier	Cracks at the top of the cantilever
2	Common	A number of cracks in the wide range
3		Several large cracks in the longitudinal direction
4	Beneath bearings	Cracks beneath the bearing area
5	Framed pier	Cracks on the lower chord at the beam center
6	Pile-bent pier	Cracks all around the pier

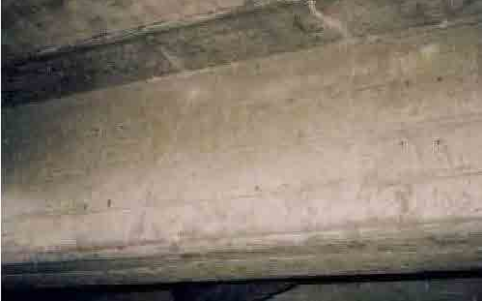
<p data-bbox="248 748 679 775">Cracks of small influence (marked with chalk)</p>

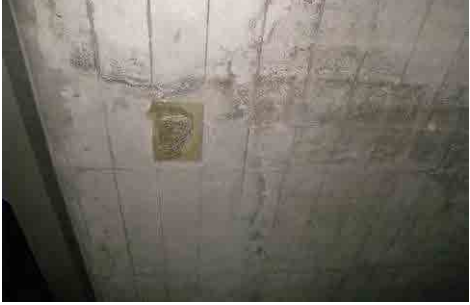
<p data-bbox="804 748 1235 775">Cracks of small influence (marked with chalk)</p>
Damage level 3	Damage level 3

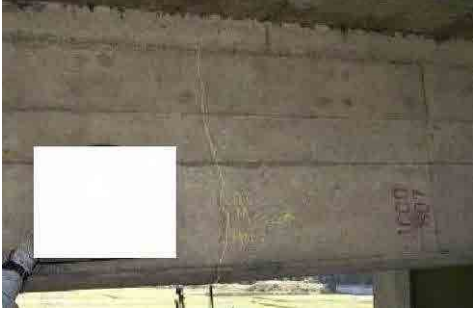
<p data-bbox="248 1218 679 1245">Cracks of large influence (marked with chalk)</p> <p data-bbox="555 1272 746 1299">Crack pattern No.1</p>

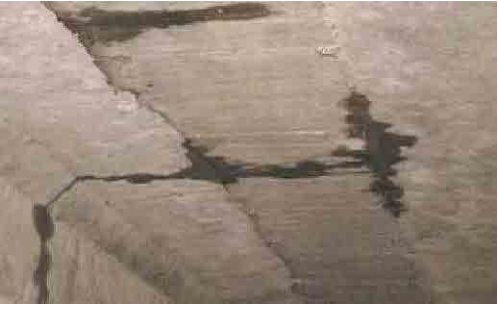
<p data-bbox="804 1245 1225 1272">Cracks of small influence with water leakage</p>

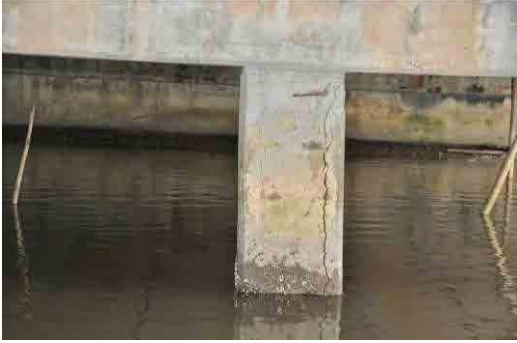
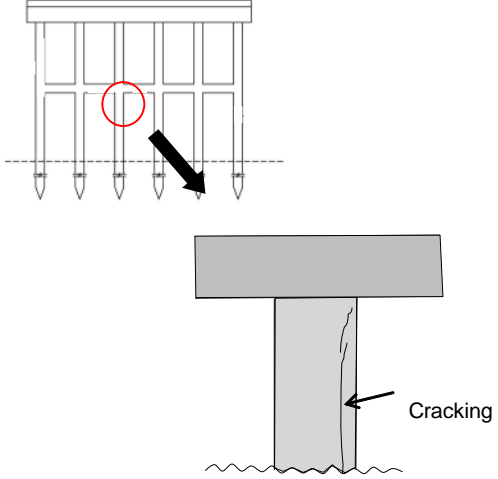
<p>Cracks of large influence (cracks propagated along the axial direction of column)</p> <p>Crack pattern No.3</p>

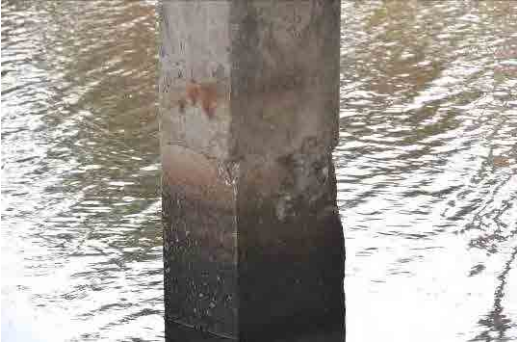
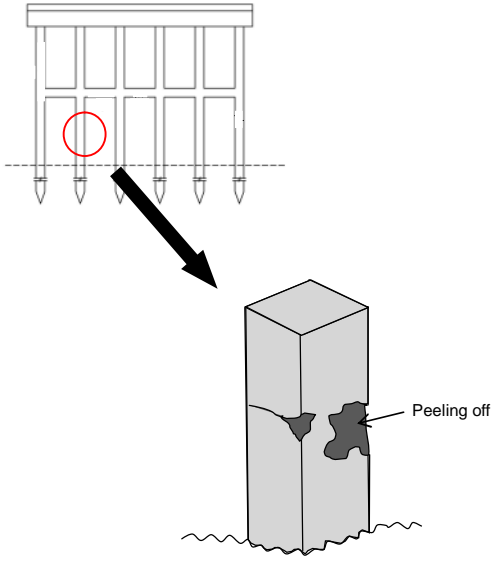
<p>Cracks of large influence (cracks propagated around column)</p> <p>Crack pattern No.6</p>

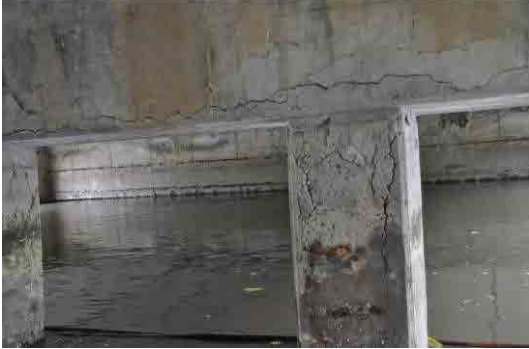
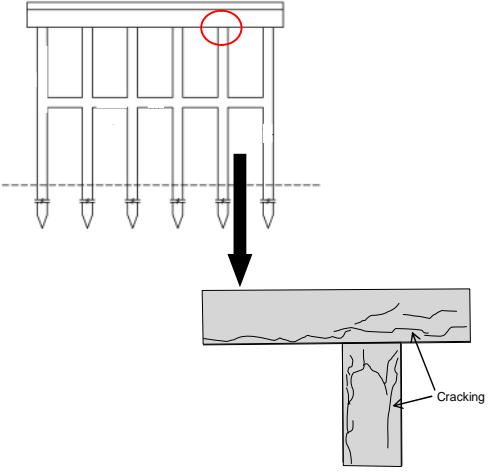
<p>Cracks of large influence (cracks propagated along the axial direction of column)</p> <p>Crack pattern No.3</p>

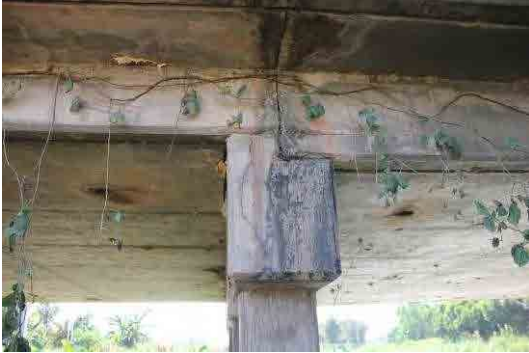
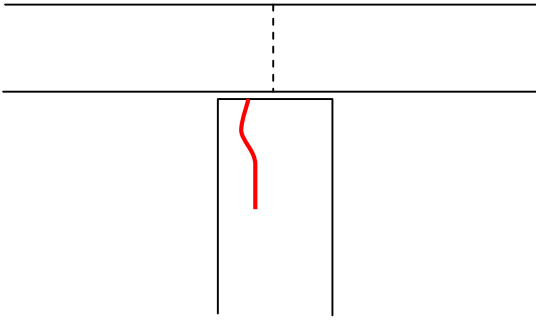
<p>Cracks of large influence (cracks propagated along the axial direction of column)</p> <p>Crack pattern No.4</p>

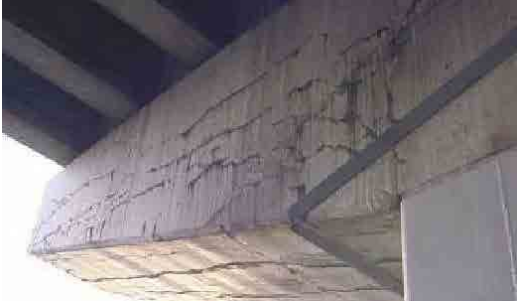
<p>Cracks of large influence with water leakage and free lime</p> <p style="text-align: right;">Crack pattern No.3</p>

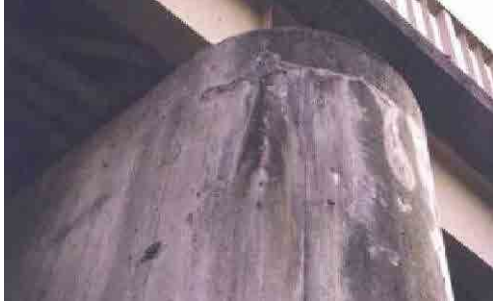
<p>Cracks of small influence with rust strain</p>
<p>Damage level 5</p>	<p>Damage level 5</p>

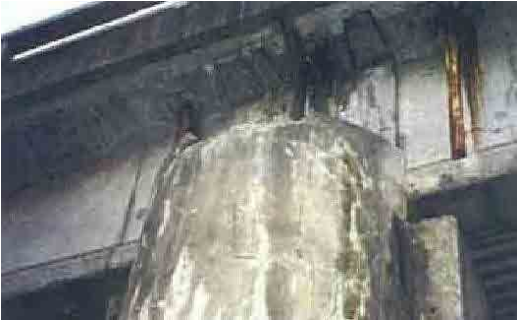
<p>Cracks of large influence with remarkable free lime</p> <p style="text-align: right;">Crack pattern No.6</p>

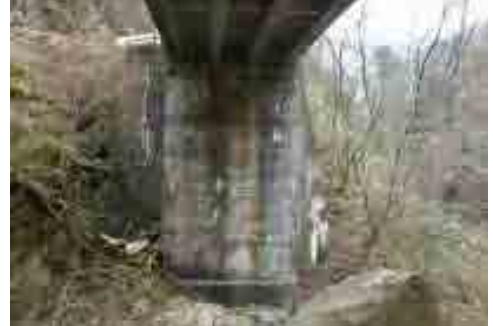
<p>Cracks of large influence with remarkable free lime</p> <p style="text-align: right;">Crack pattern No.6</p>

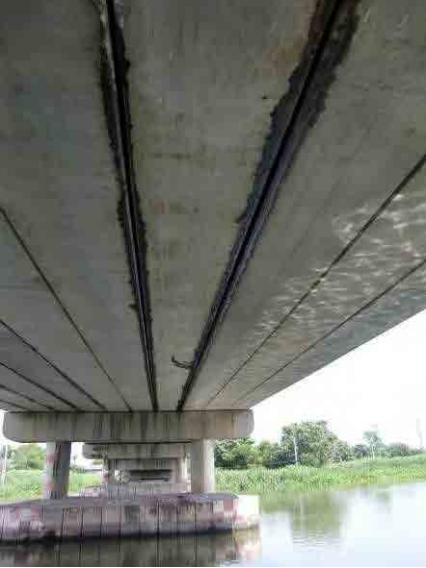
<p data-bbox="247 1041 619 1070">Leakage of water in the gaps of girders</p>

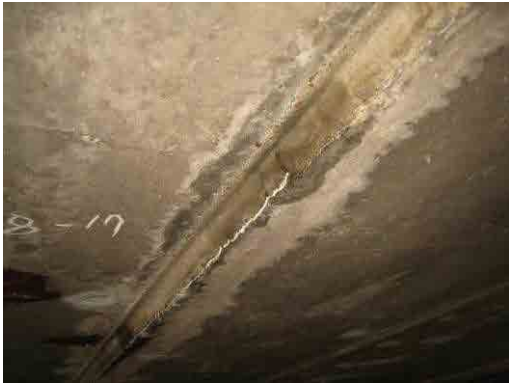
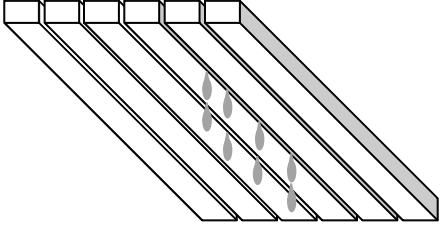
Damage level 3	Damage level 3

<p data-bbox="247 1568 619 1597">Leakage of water in the gaps of girders</p>

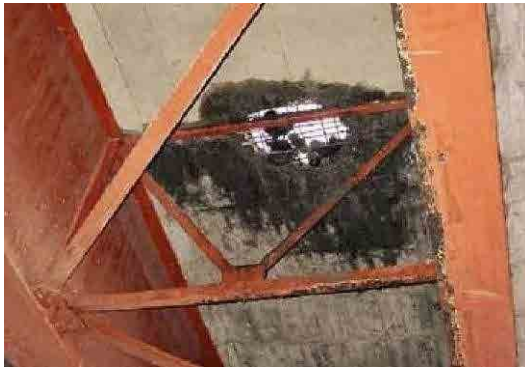
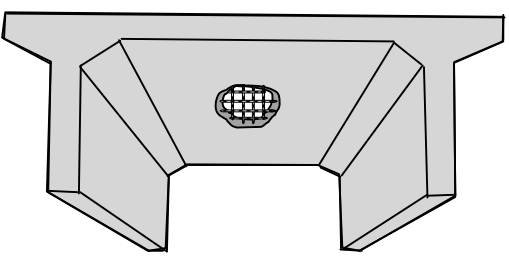
Pop-outs are conical fragments that break out of the surface of the concrete, leaving small holes in the concrete deck including cast-in-place (C.I.P) portion. In case of pop-outs lattice cracks often occur in the deck.

<p>Damage level 5</p>	<p>Damage level 5</p>

<p>Example of pop-outs</p>

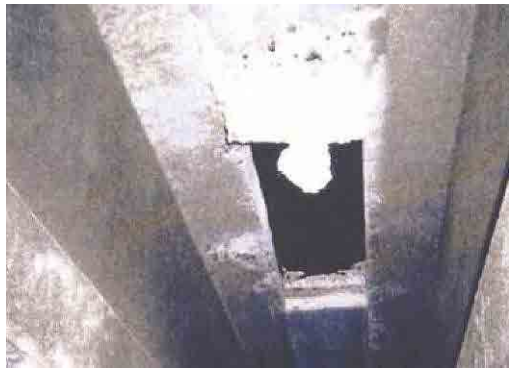
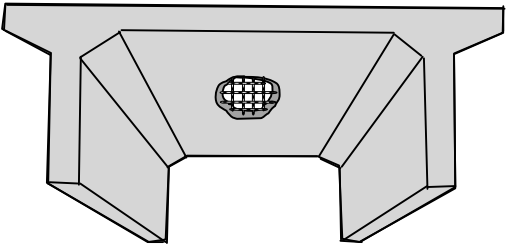
<p>Damage level 5</p>	<p>Damage level 5</p>

<p>Example of pop-outs</p>

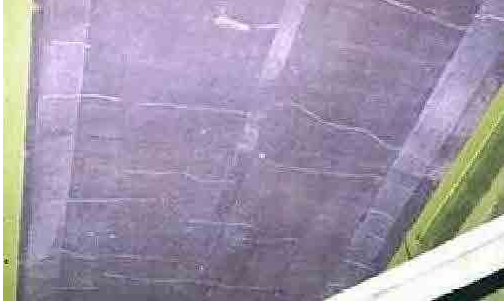
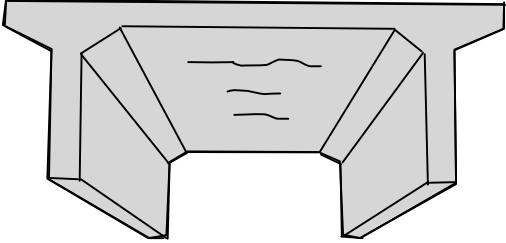
Damage level 2	Damage level 2

<p>Mainly cracks in one direction (marked with chalk)</p>

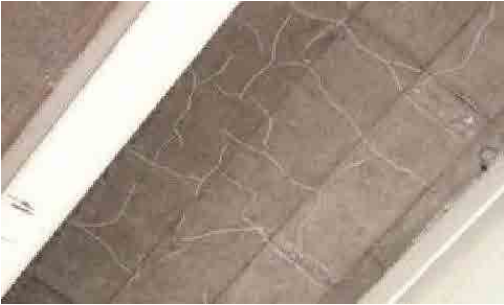
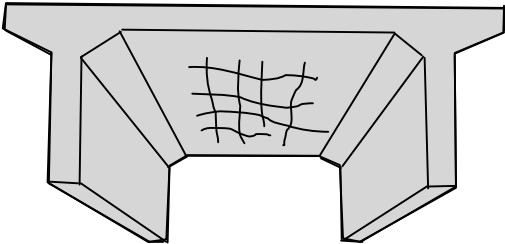
Damage level 3	Damage level 3

<p>Cracks in two directions (marked with chalk)</p>

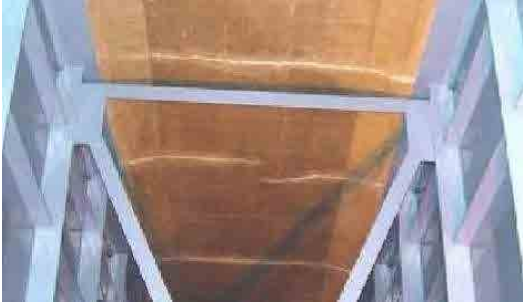
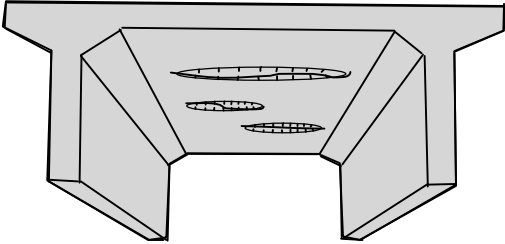
Damage level 3	Damage level 3

<p>Cracks in one direction with free lime</p>

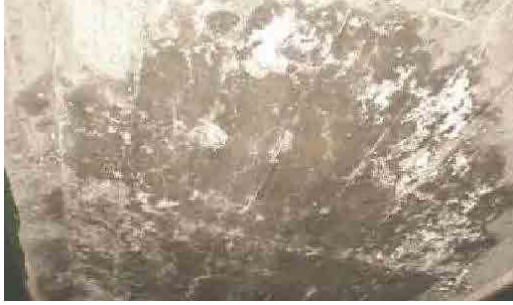
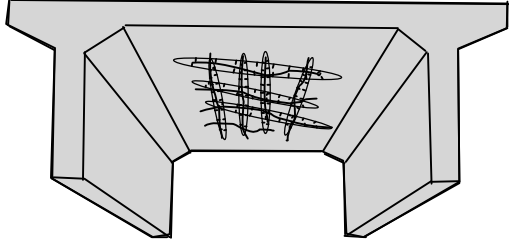
<p>Damage level 4</p>	<p>Damage level 4</p>

<p>Cracks in two directions with free lime</p>

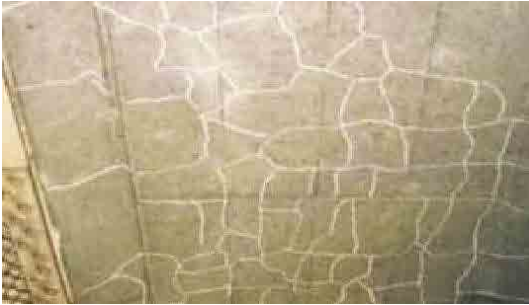
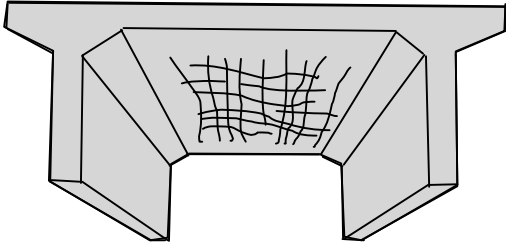
<p>Damage level 4</p>	<p>Damage level 4</p>

<p>Dense cracks in two directions partially chipped (marked with chalk)</p>

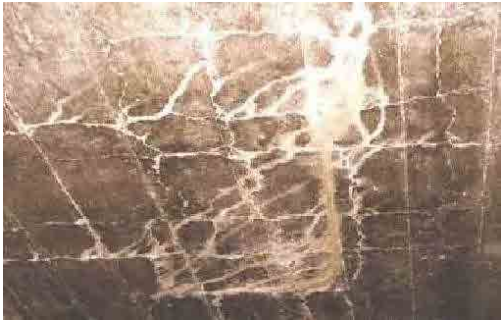
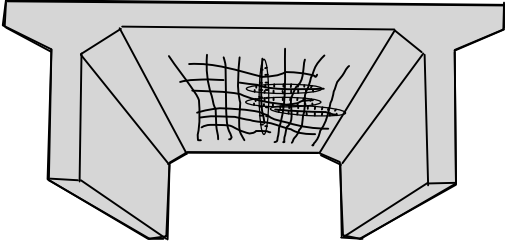
<p>Damage level 5</p>	<p>Damage level 5</p>

<p>Continuously chipped with free lime</p>

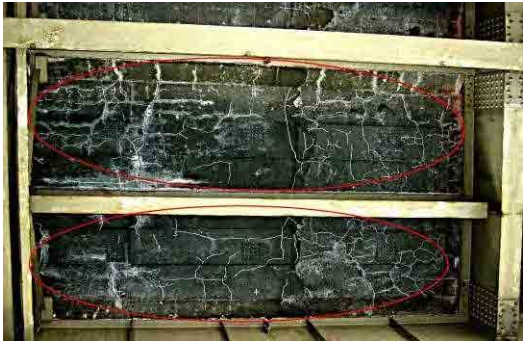
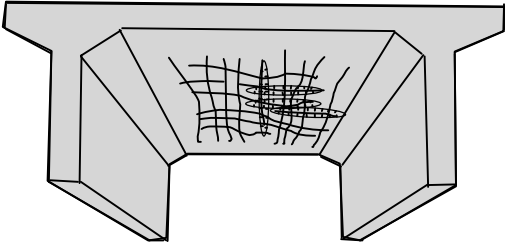
<p>Damage level 5</p>	<p>Damage level 5</p>

<p>Continuously chipped with free lime</p>

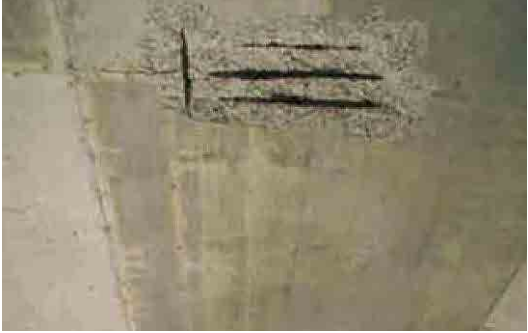
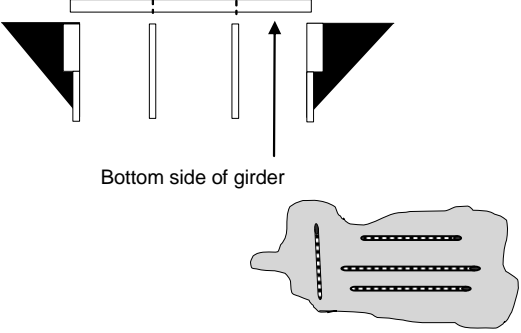
<p>Damage level 2</p>	<p>Damage level 2</p>

<p>Partial rebar exposure</p>

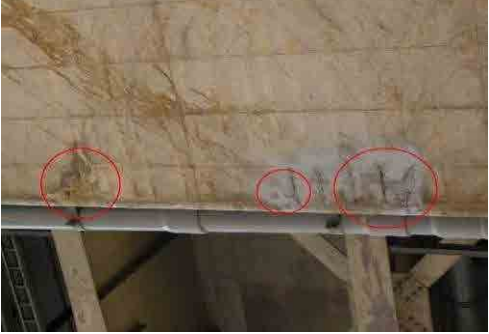
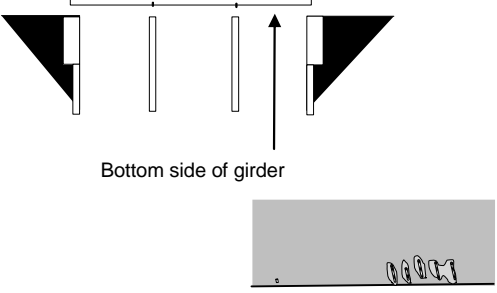
<p>Bottom side of girder</p>
<p>Damage level 2</p>	<p>Damage level 2</p>

<p>Partial rebar exposure</p>

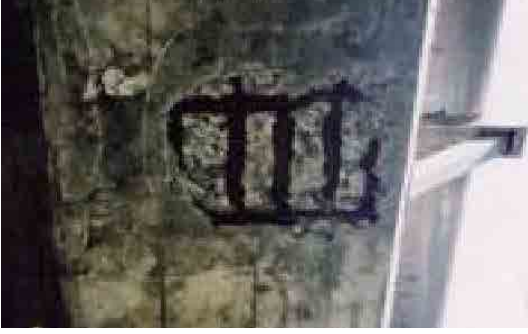
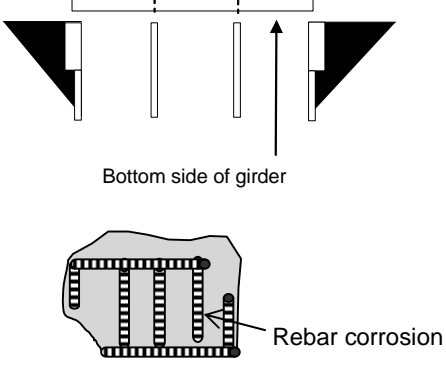
<p>Bottom side of girder</p>
<p>Damage level 3</p>	<p>Damage level 3</p>

<p>Partial rebar corrosion</p>

<p>Bottom side of girder</p> <p>Rebar corrosion</p>

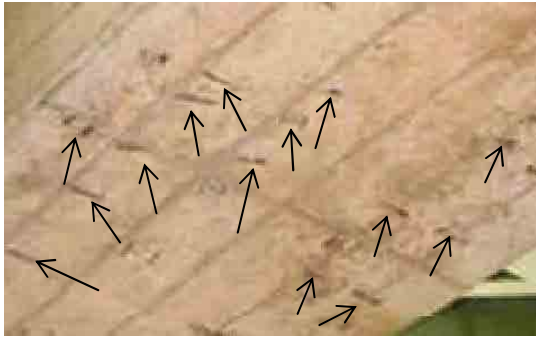
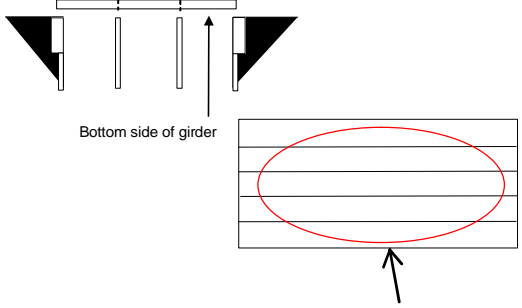
<p>Damage level 3</p>	<p>Damage level 3</p>

<p>Superficial rebar exposure in the wide range</p>

<p>Bottom side of girder</p> <p>Rebar exposure in the wide range</p>
<p>Damage level 3</p>	<p>Damage level 3</p>

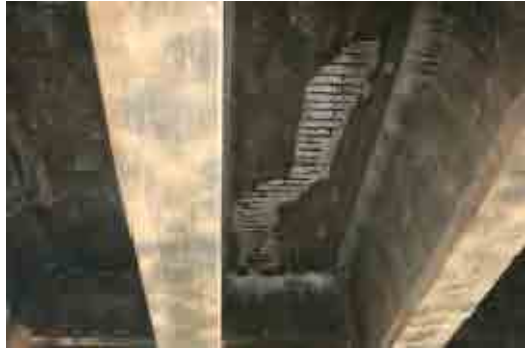
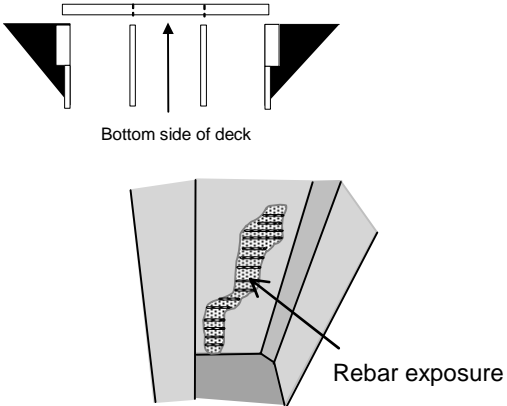
<p>Partial rebar corrosion</p>

<p>Bottom side of deck</p> <p>Rebar exposure</p>
<p>Damage level 5</p>	<p>Damage level 5</p>
