Kingdom of Thailand
The Project for Bridge Master Plan and Bridge
Maintenance Ability in Rural Area

Report 2
Bridge Inspection and Evaluation Manual

July 2013

Japan International Cooperation Agency
CHODAI Co., Ltd
Metropolitan Expressway Company Limited

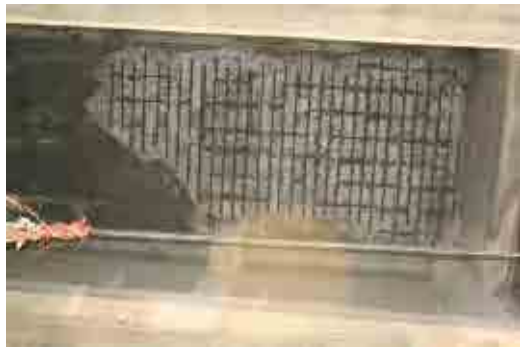
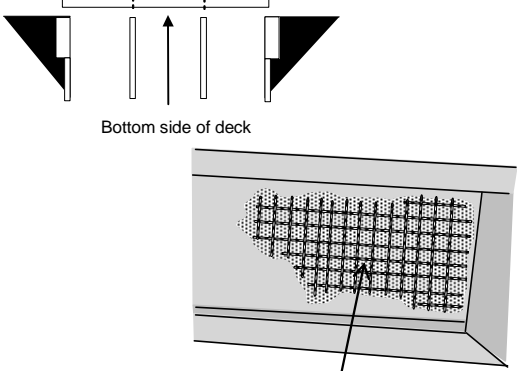
<p>Rebar corrosion in the wide range</p>

<p>Bottom side of deck</p> <p>Rebar exposure</p>

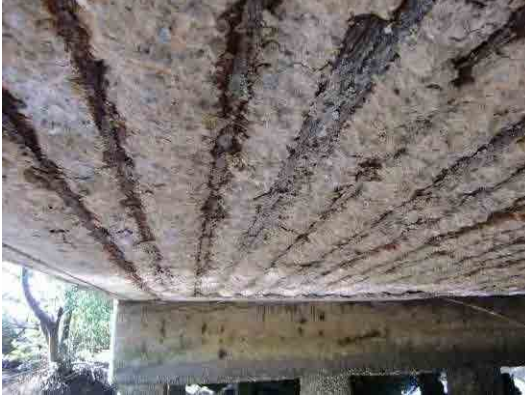
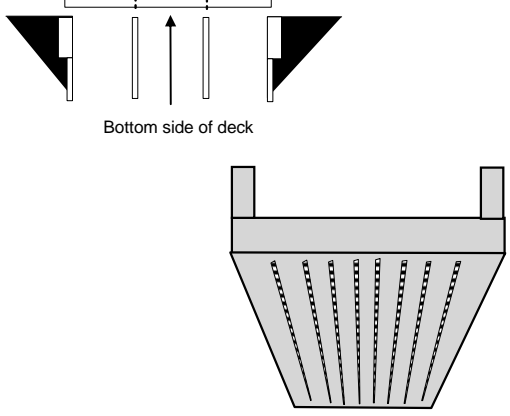
<p>Damage level 5</p>	<p>Damage level 5</p>

<p>Rebar corrosion in the wide range</p>

<p>Bottom side of deck</p>
<p>Damage level 5</p>	<p>Damage level 5</p>

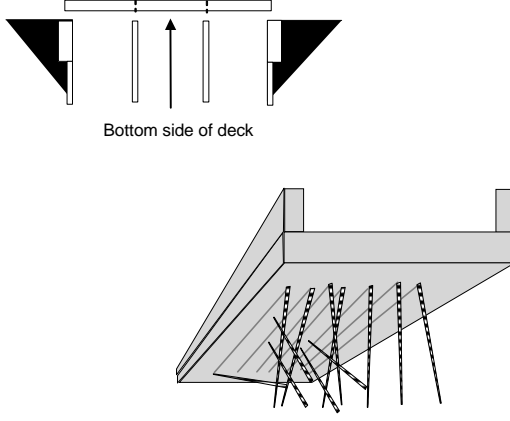
<p>Rebar corrosion in the wide range</p>

<p>Bottom side of deck</p>

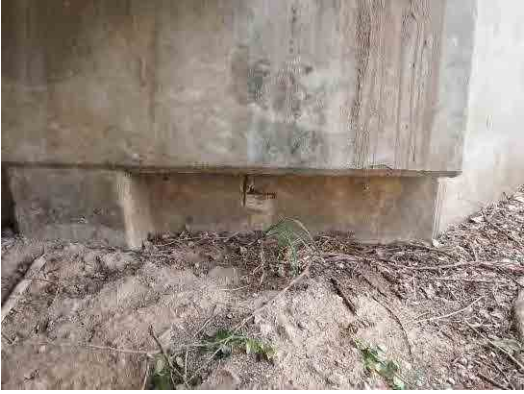
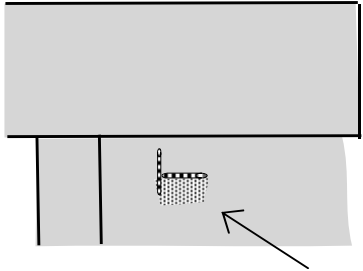
<p>Damage level 2</p>	<p>Damage level 2</p>

<p>Partial rebar exposure</p>

<p>Rebar exposure</p>
<p>Damage level 3</p>	<p>Damage level 3</p>

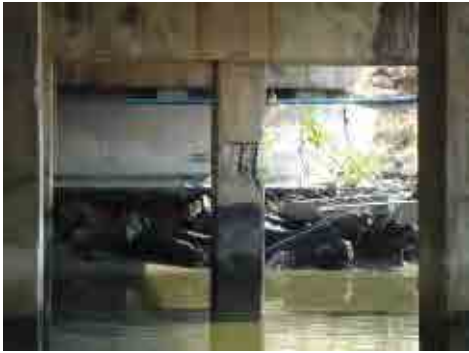
<p>Partial rebar corrosion</p>

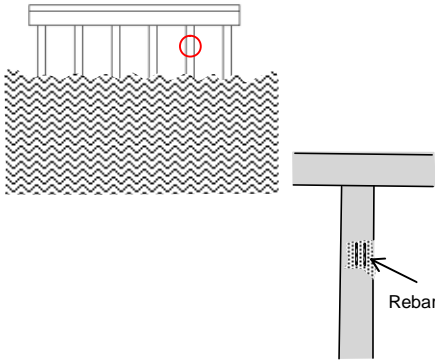
<p>Rebar exposure</p>
<p>Damage level 3</p>	<p>Damage level 3</p>

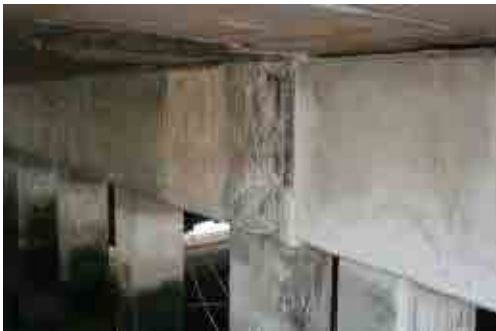
<p>Partial rebar corrosion</p>

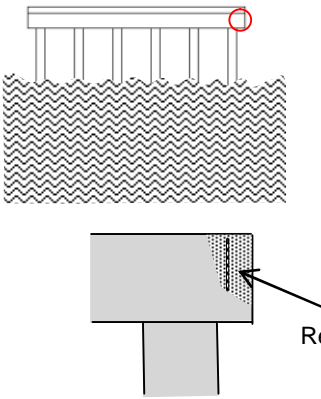
<p>Rebar exposure</p>

Damage level 5	Damage level 5

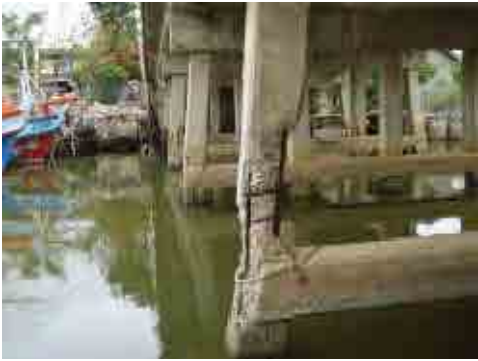
<p data-bbox="252 750 592 779">Rebar corrosion around column</p>

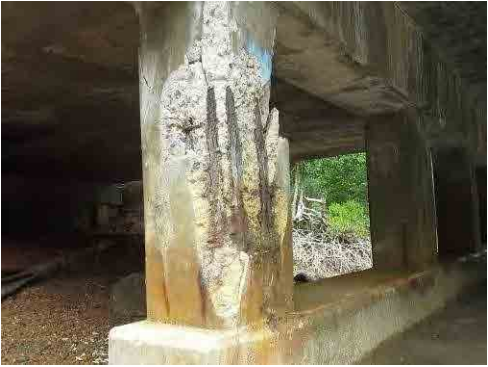
<p data-bbox="252 1279 592 1308">Rebar corrosion around column</p>

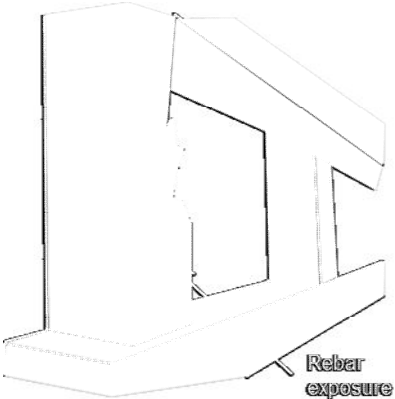
<p data-bbox="1161 1227 1254 1272">Rebar exposure</p>

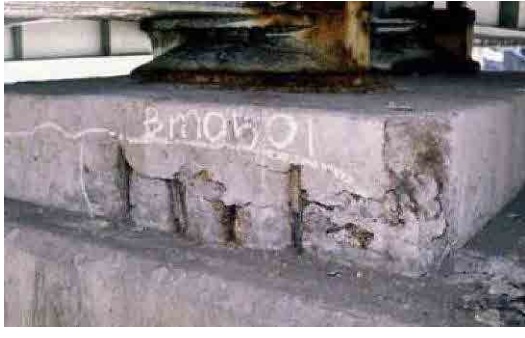
<p data-bbox="804 748 1299 837">Limited damages in bearing seat only (evaluated in cracks, water leakage, free lime or rebar exposure)</p>
Damage level 3	Damage level 3

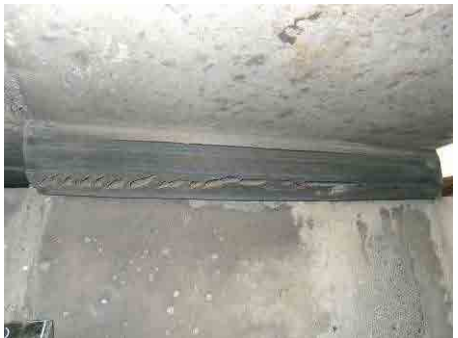
<p data-bbox="245 1272 737 1361">Bearing function is not restricted, even the rubber is deteriorated.</p>

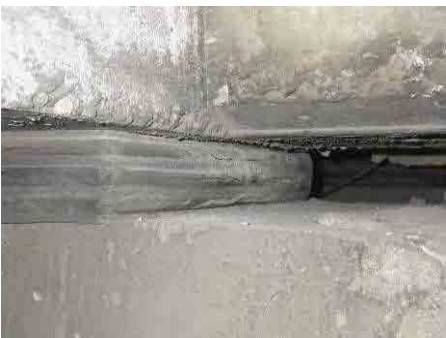
<p data-bbox="804 1272 1295 1361">Bearing function is not restricted, even the rubber is deteriorated.</p>

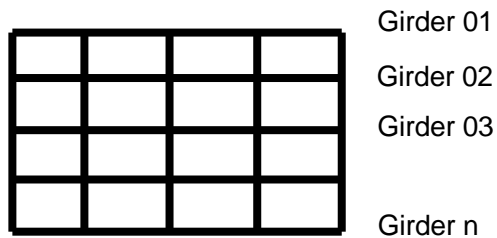
i) Concrete I-shaped girder

In principle these shall be defined in each girder.

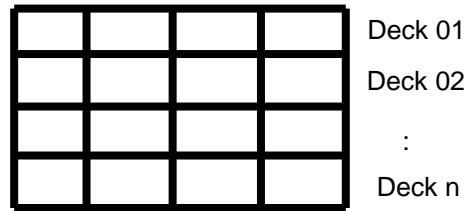
i) Concrete I-shaped girder

These shall be defined in each line between the girders.

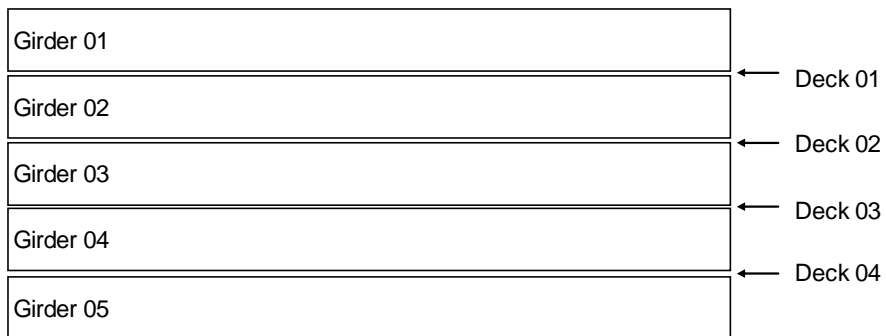
ii) Plank girder, Box girder etc.

For slab bridges, plank girder bridges, Box girder bridges etc., only the cantilevered deck and the CIP-slab parts shall be defined as a deck and the other parts as a girder.

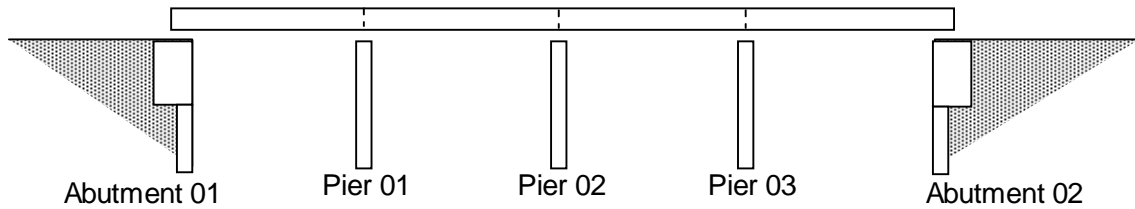
3) Substructures (pier, abutment)

These shall be defined in each pier and abutment.

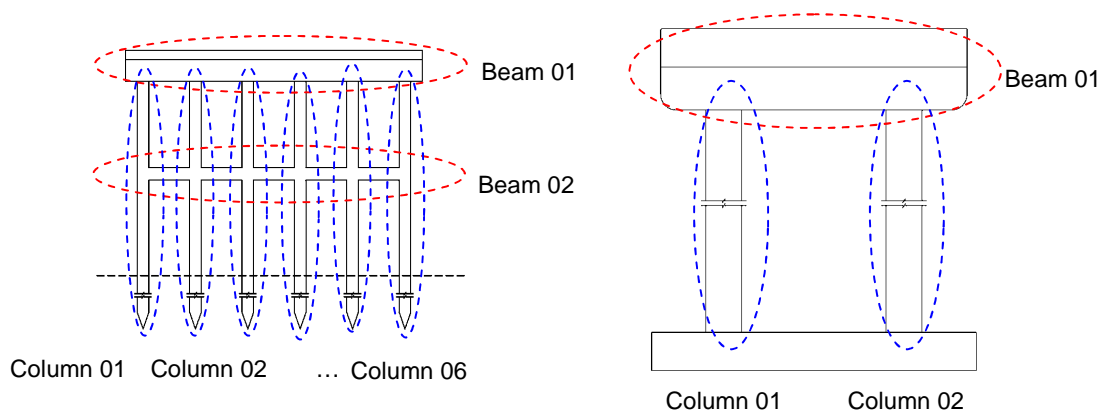
Pier shall be defined into column and beam.

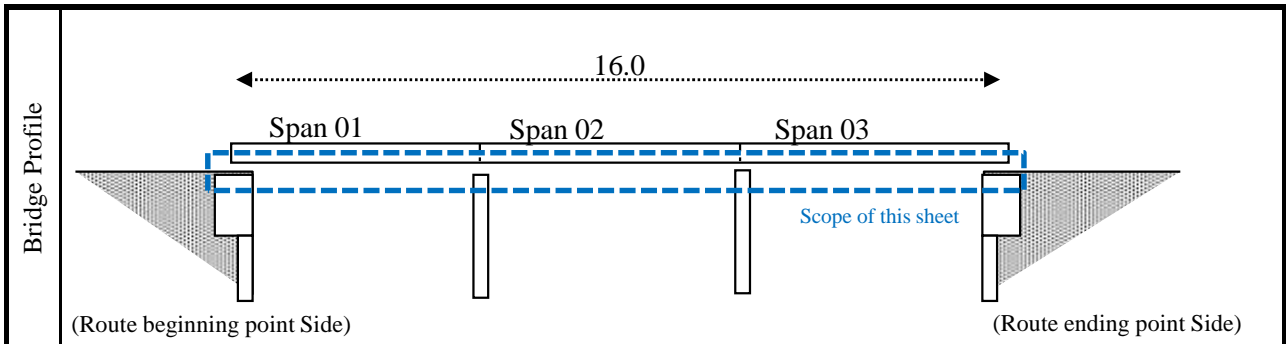
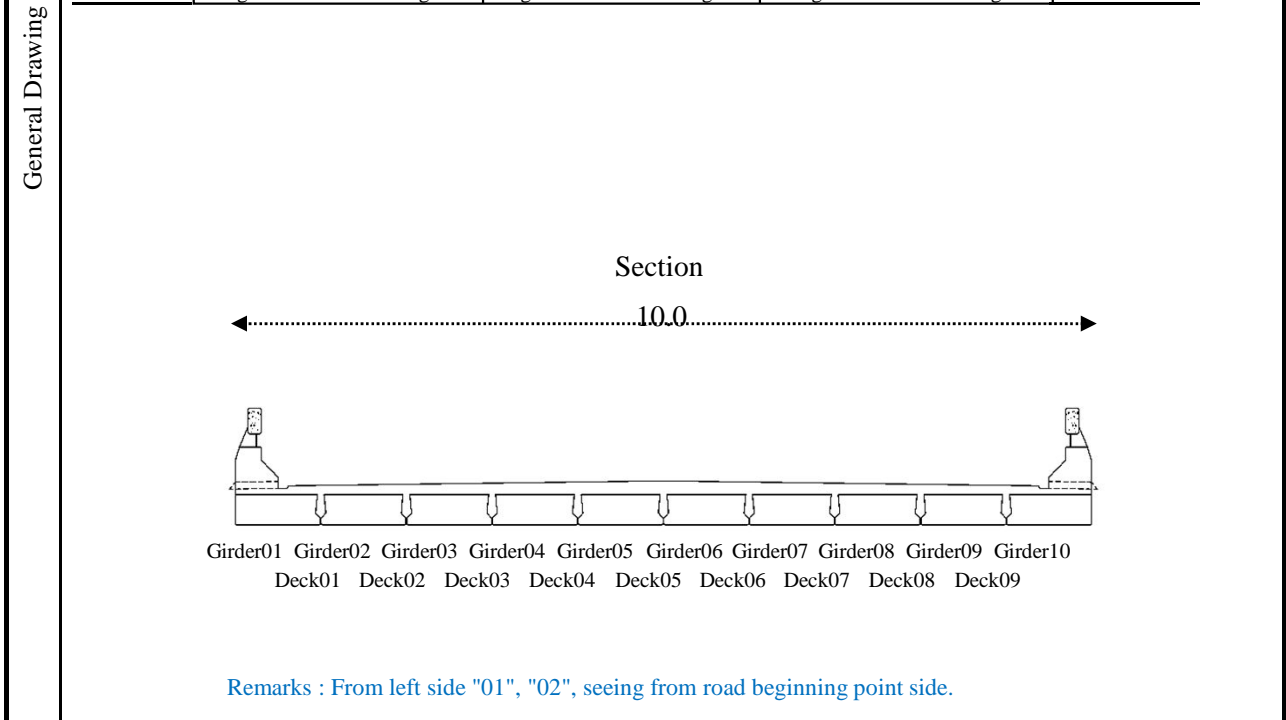
Bridge Data (Under bridge [Superstructure])

Plan

(Route beginning point Side) (Route ending point Side)

Span 01		Span 02		Span 03	
Bearing101	Girder01	Bearing201	Bearing101	Girder01	Bearing201
Bearing102	Girder02	Bearing202	Bearing102	Girder02	Bearing202
Bearing103	Girder03	Bearing203	Bearing103	Girder03	Bearing203
Bearing104	Girder04	Bearing204	Bearing104	Girder04	Bearing204
Bearing105	Girder05	Bearing205	Bearing105	Girder05	Bearing205
Bearing106	Girder06	Bearing206	Bearing106	Girder06	Bearing206
Bearing107	Girder07	Bearing207	Bearing107	Girder07	Bearing207
Bearing108	Girder08	Bearing208	Bearing108	Girder08	Bearing208
Bearing109	Girder09	Bearing209	Bearing109	Girder09	Bearing209
Bearing110	Girder10	Bearing210	Bearing110	Girder10	Bearing210

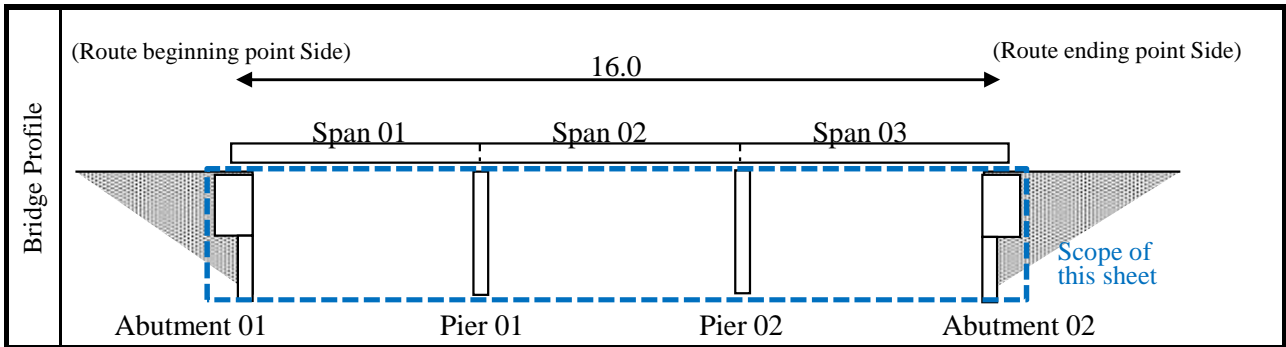
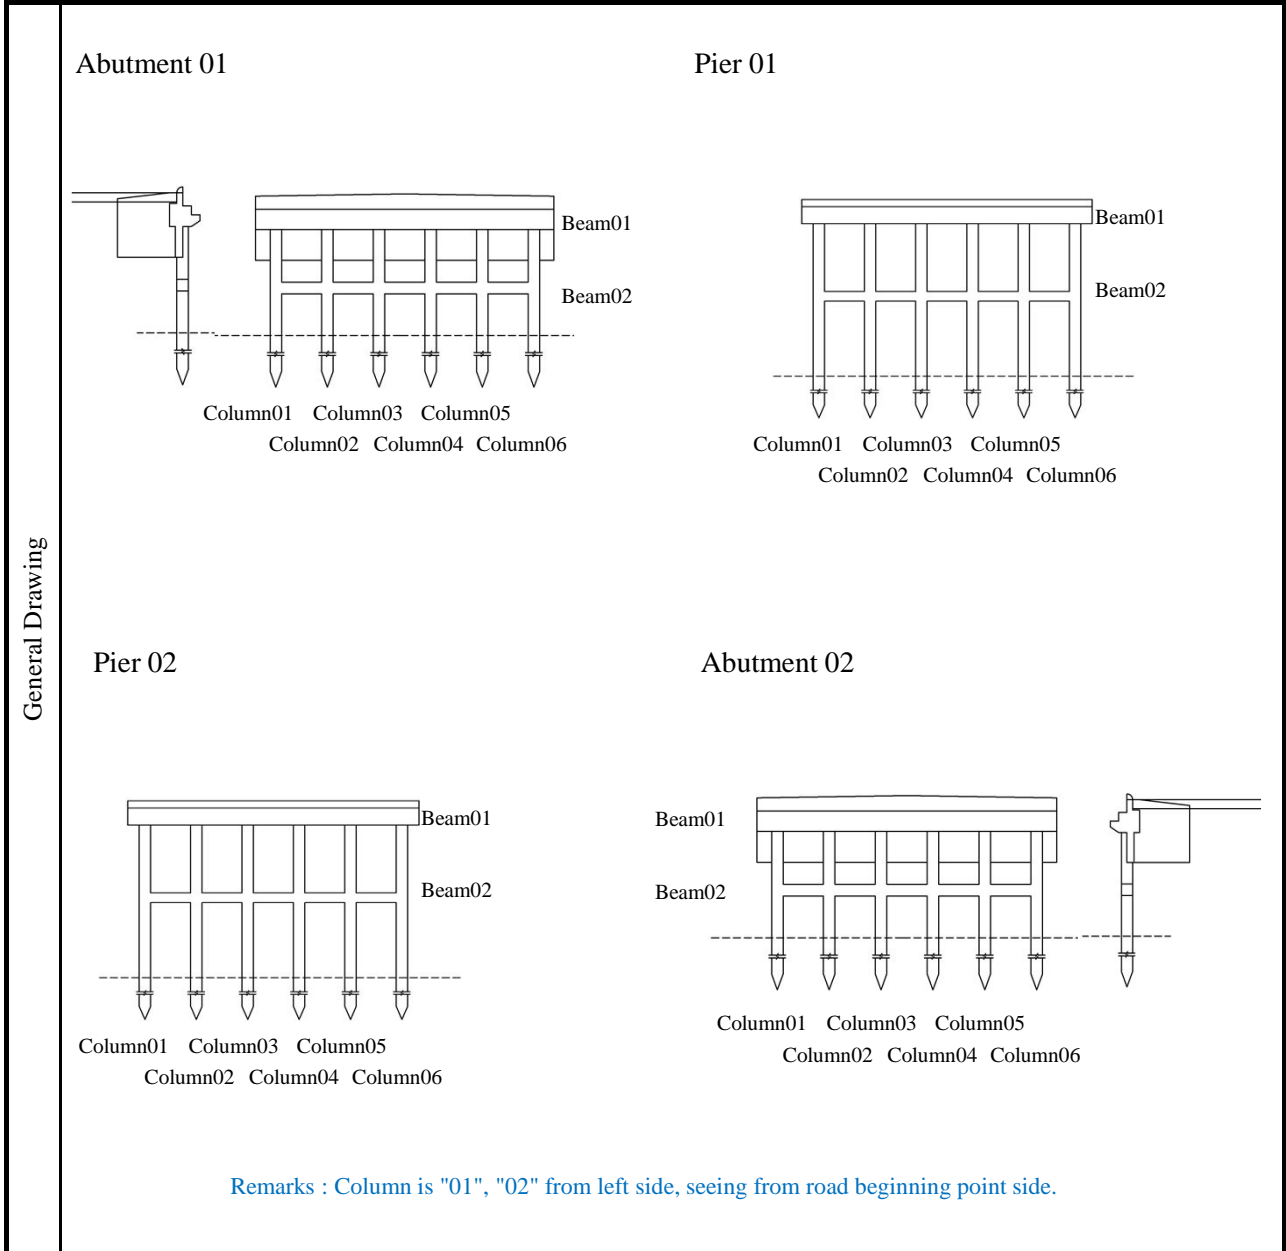
Bridge Data (Under bridge [Substructure])

Bridge Name	Sample (Temporary number : 1030-2)	Inspection Date	26/01/2012
Location	Thalung Lek, Khok Samrong, Lop Buri	Route Number	1030
Latitude	N 15.076	Province	Lop Buri
Longitude	E 100.675	Main Inspector	(name)

Inspector should write damage locations of substructures on side view and cross section view.

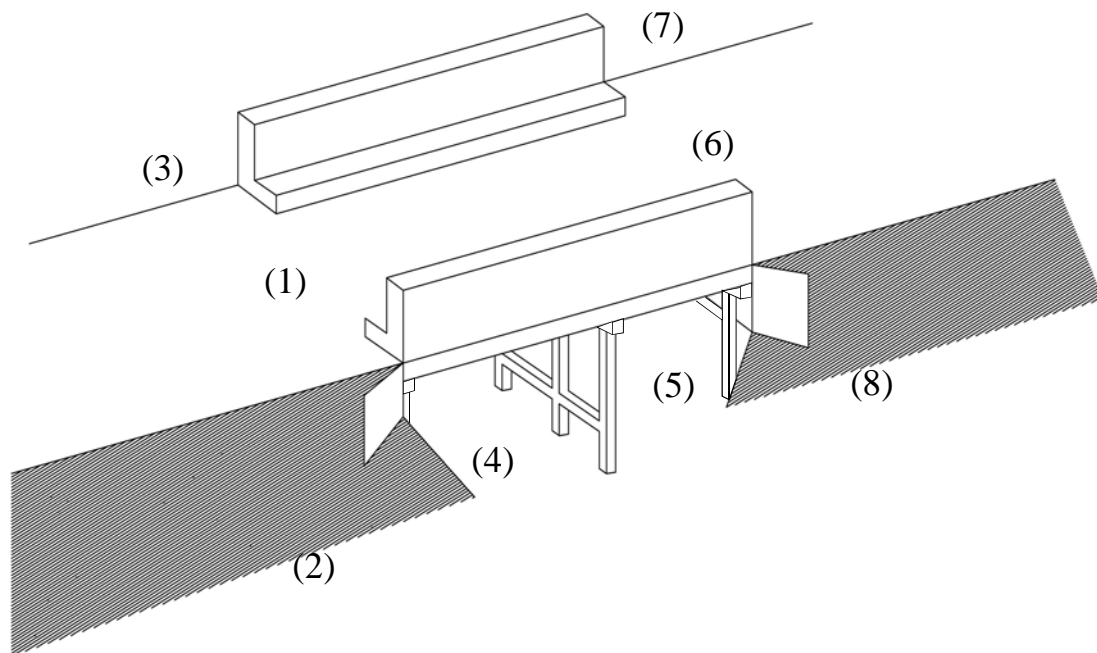
1. Bridge collapse
2. Settlement, movement and inclination of piers and abutments
3. Washout soil
 - Approach road
 - Around abutments
 - Base of pier
4. Damage in structural members
5. Cracking
 - Surface of concrete
 - Surface of pavement
6. Rebar Exposure
 - Surface of concrete
7. Water leakage
 - Surface of concrete

The number indicates where to stand.

(1), (6) Near bridge, surface of bridge

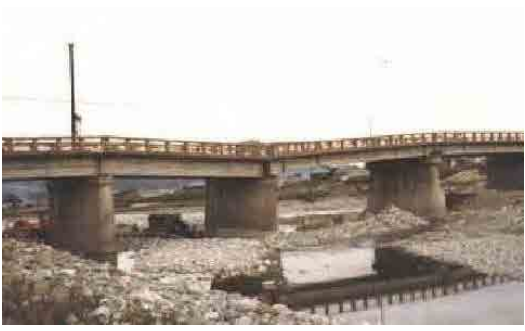
<p>Settlement/ inclination of substructure and remarkable scour of substructure</p>

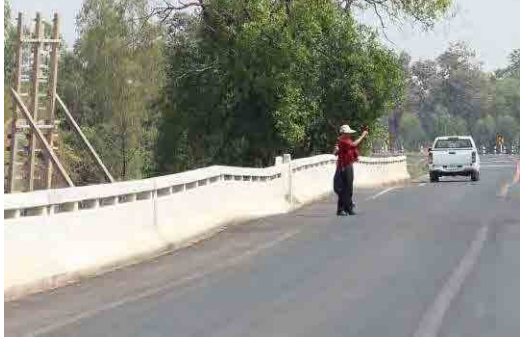
<p>Settlement of substructure and deformation on the bridge</p>
<p>Damage level 5</p>	<p>Damage level 5</p>

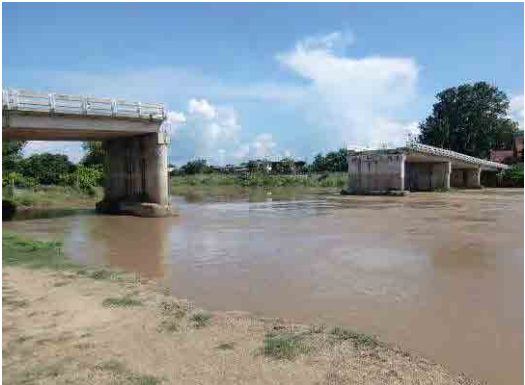
<p>Collapse of bridge due to loss of substructure</p>	  <p>Remarkable inclination of substructure</p>
<p>Damage level 5</p>	<p>Damage level 5</p>

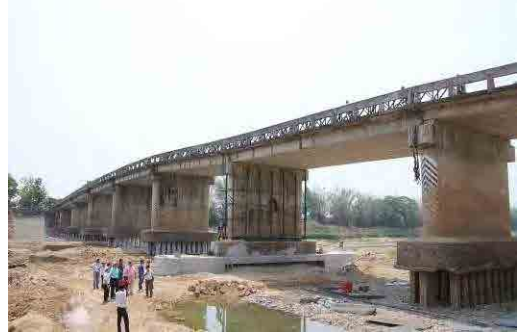
<p>Settlement of substructure</p>

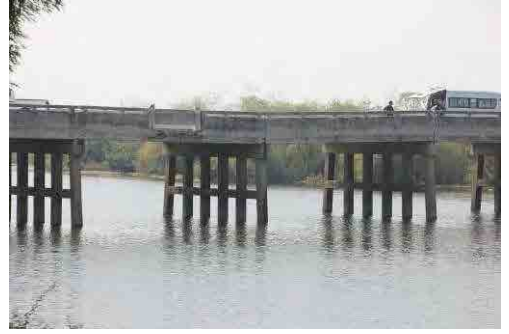
<p>Settlement of substructure</p>

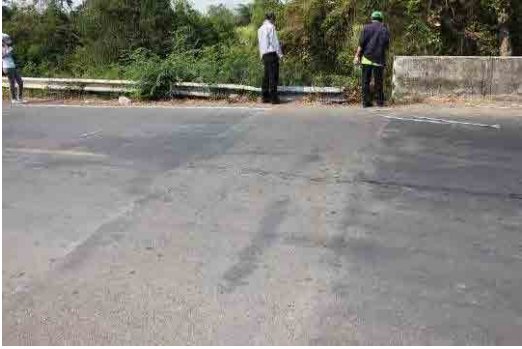
<p>Level difference < 20mm</p>

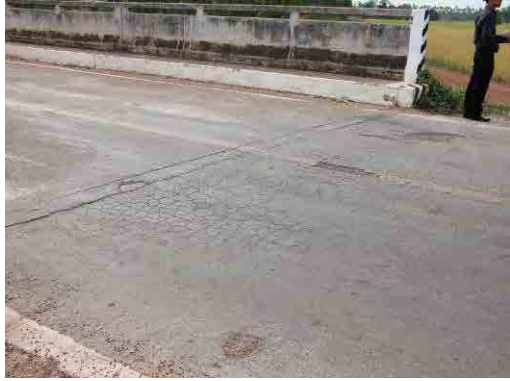
<p>Level difference < 20mm</p>
<p>Damage level 5</p>	<p>Damage level 5</p>

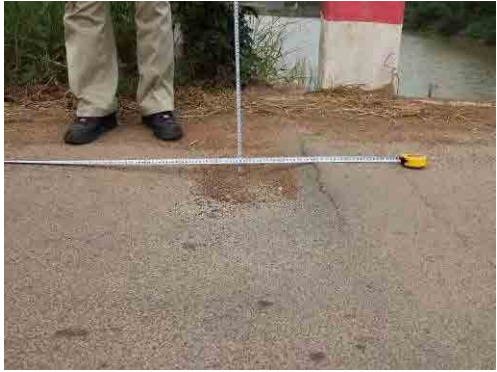
<p>Level difference \geq 20mm (behind abutment)</p>

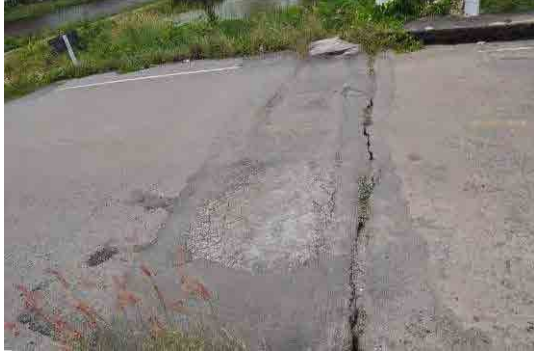
<p>Level difference \geq 20mm</p>

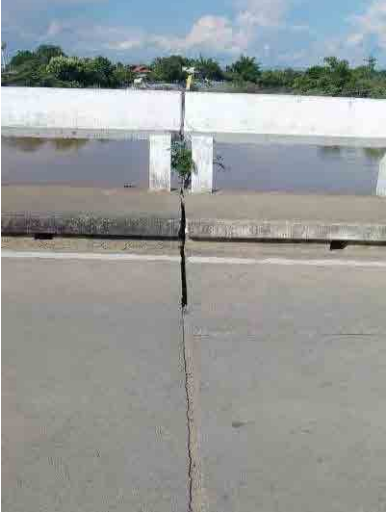
<p data-bbox="245 981 596 1014">Miner defects on expansion joint</p>

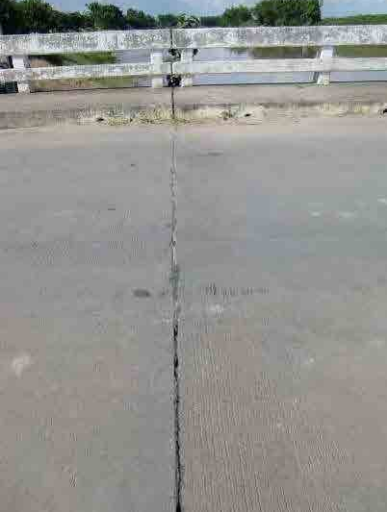
<p data-bbox="799 981 1150 1014">Miner defects on expansion joint</p>
Damage level 5

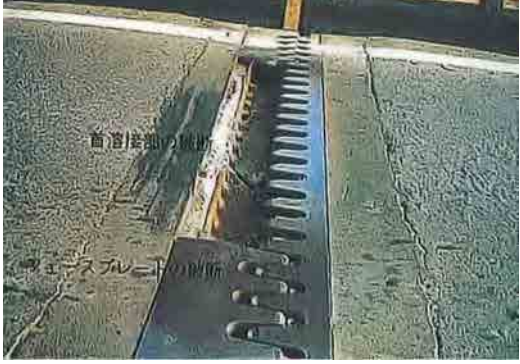
<p data-bbox="245 1507 667 1541">Remarkable defects on expansion joint</p>

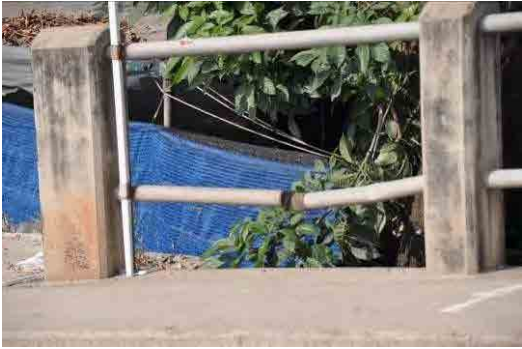
<p data-bbox="252 808 427 831">Minor loss of steel</p>

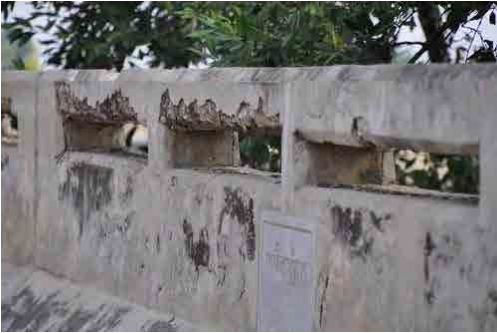
<p data-bbox="802 808 1015 831">Minor loss of concrete</p>
Damage level 5	Damage level 5

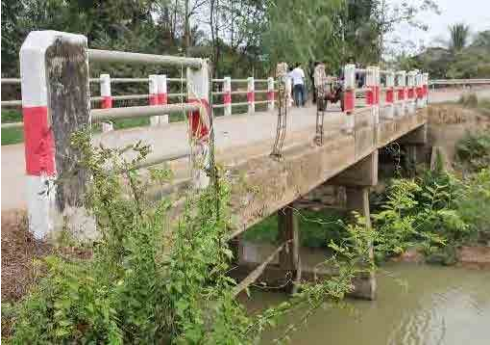
<p data-bbox="252 1279 738 1301">Breakage in large area. Dangerous traffic condition</p>

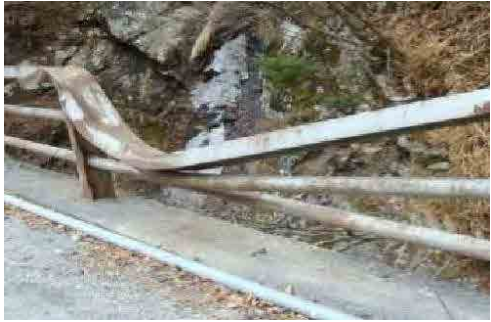
<p data-bbox="802 1279 1249 1301">Large deformation. Dangerous traffic condition.</p>

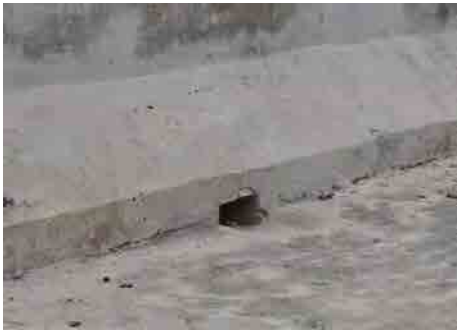
<p data-bbox="245 801 587 835">No obstruction in the drain pipe</p>

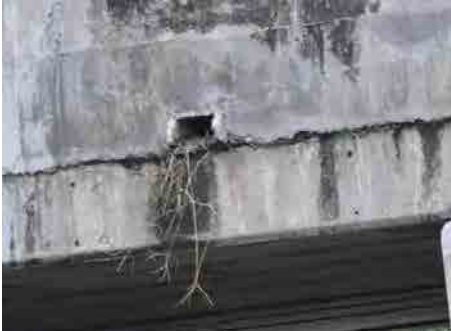
<p data-bbox="799 801 1305 835">The drain pipe is clogged with dust and gasses</p>

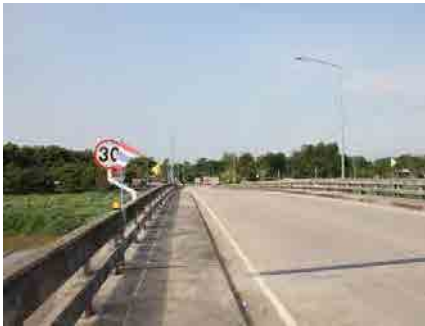
<p data-bbox="252 1332 743 1361">No unusual condition such as level difference</p>

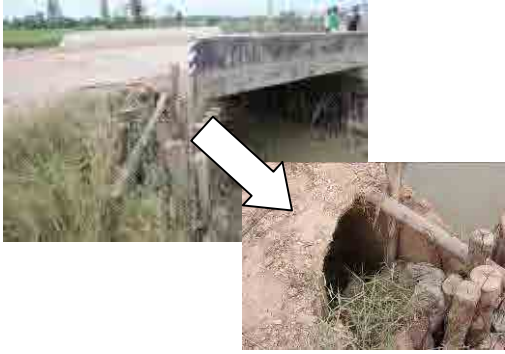
<p data-bbox="252 831 778 913">Deep pothole behind the abutment due to erosion/scour</p>

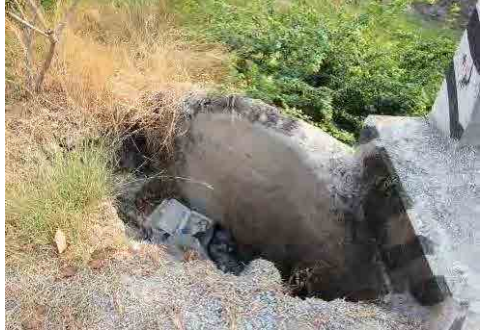
<p data-bbox="252 1357 778 1440">Deep pothole behind the abutment due to erosion/scour</p>

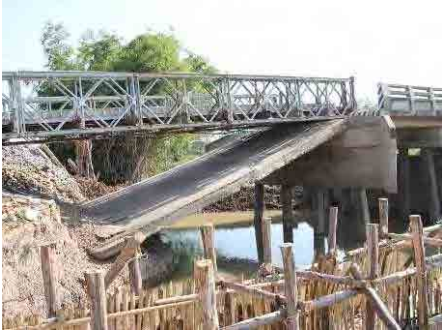
<p data-bbox="252 1883 778 1966">Concrete slab behind the abutment is fallen down due to erosion/scour</p>

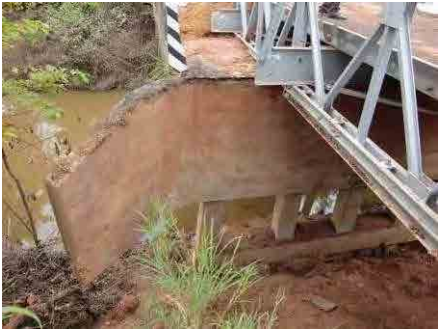
<p data-bbox="802 1883 1329 1966">Backfill material behind abutment is washed away due to erosion/scour</p>

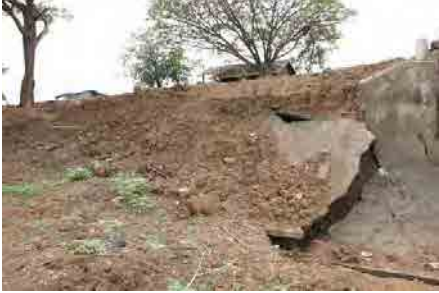
<p>The shoulder of approach road is wash away due to erosion/scour</p>

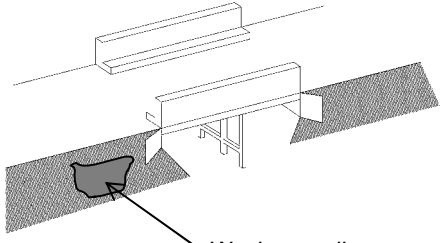
<p>Washout soil</p>
<p>Damage level 5</p>	<p>Damage level 5</p>

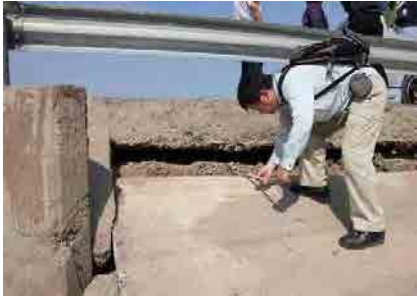
<p>Gap between concrete slab and bank behind abutment due to erosion/scour</p>

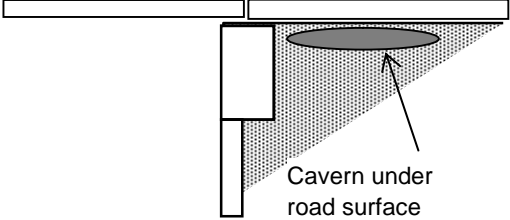
<p>Cavern under road surface</p>
<p>Damage level 5</p>	<p>Damage level 5</p>

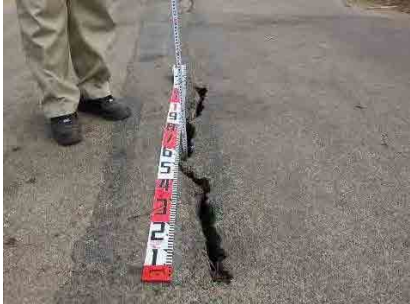
<p>Crack appeared on the surface of pavement due to void under the pavement</p>

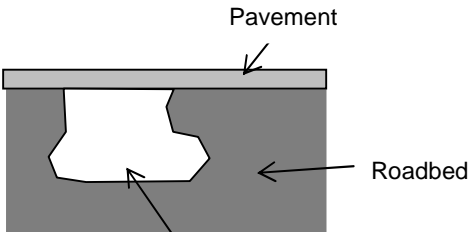
<p>Pavement</p> <p>Roadbed</p> <p>Cavern</p>

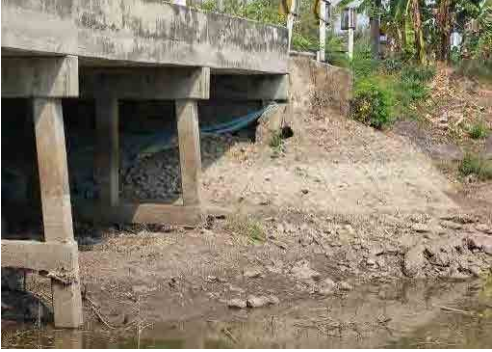
<p data-bbox="252 840 609 869">Minor damage on river revetment</p>

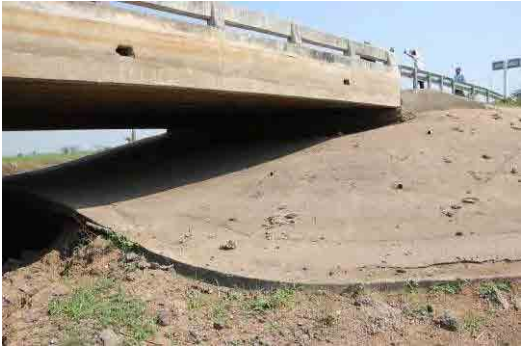
<p data-bbox="802 840 1160 869">Minor damage on river revetment</p>
Damage level 5	Damage level 5

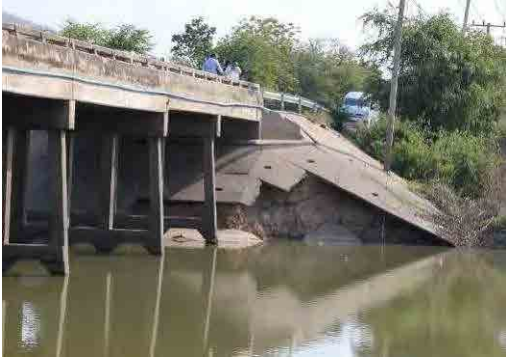
<p data-bbox="252 1330 778 1386">Remarkable damage on river revetment due to lack of backfill</p>

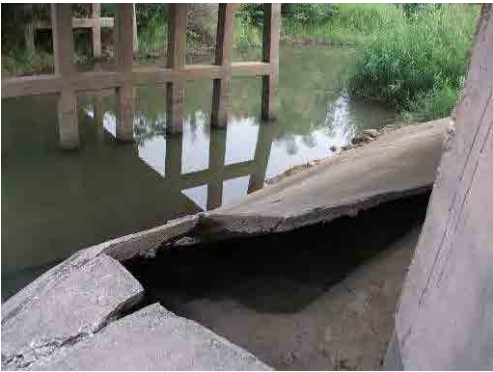
<p data-bbox="252 1845 778 1901">Remarkable damage on river revetment due to lack of backfill</p>

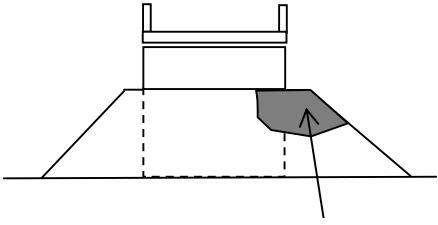
<p data-bbox="930 1776 1278 1805">Washout behind river revetment</p>

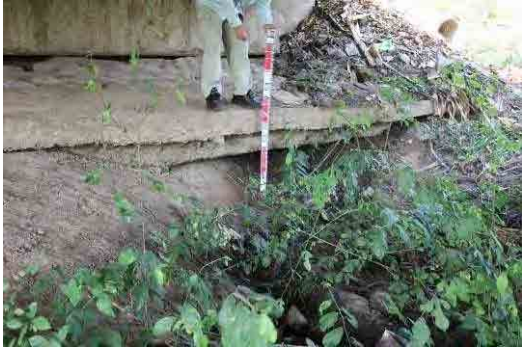
<p>Minor damage due to scouring</p>

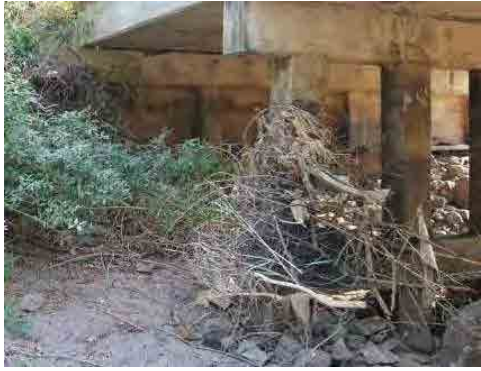
<p>Minor obstacles in the cross-sectional area of a river</p>

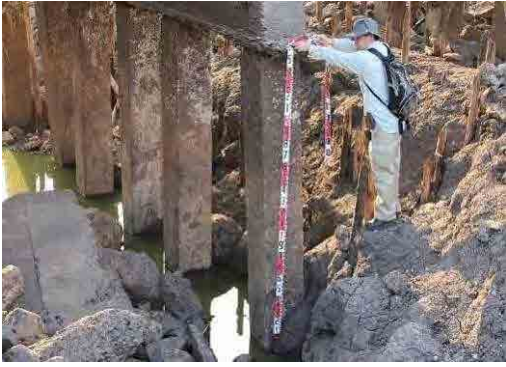
<p>Remarkable scouring around the substructure</p>

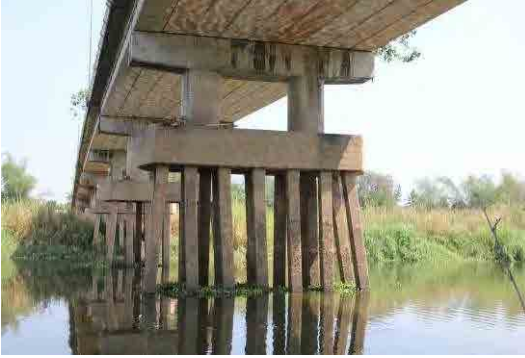
<p data-bbox="252 808 687 837">Remarkable scouring around the substructure</p>

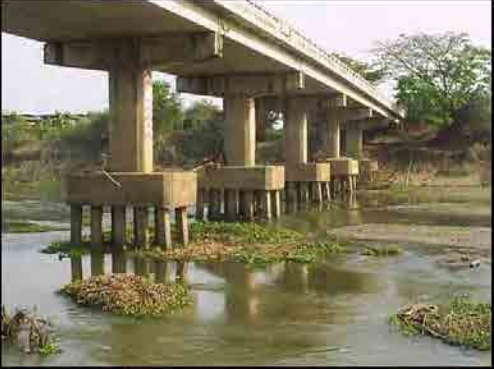
<p data-bbox="804 808 1240 837">Remarkable scouring around the substructure</p>

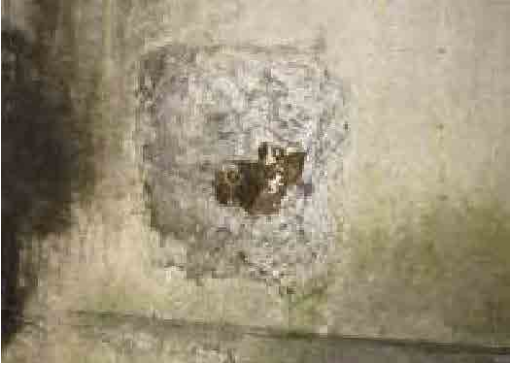
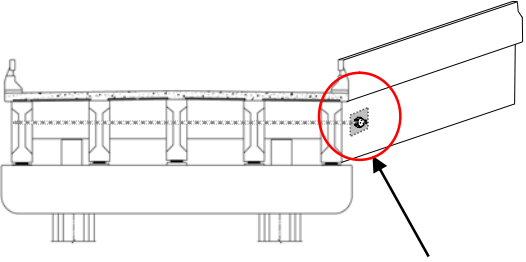
<p data-bbox="245 864 767 893">Spalling of the anchorage concrete and steel corrosion</p>

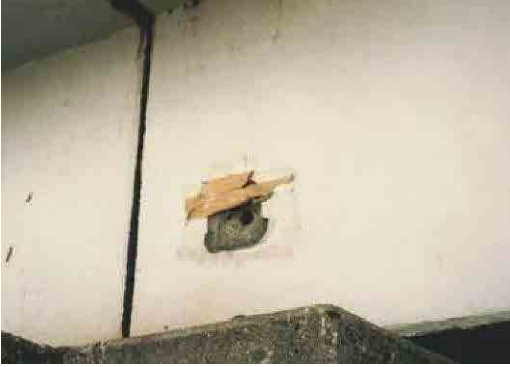
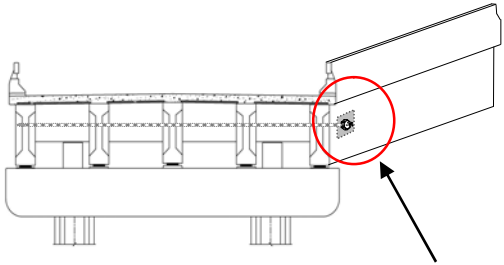
<p data-bbox="245 1391 767 1476">Spalling of the anchorage concrete and slip out of the PC tendon</p>

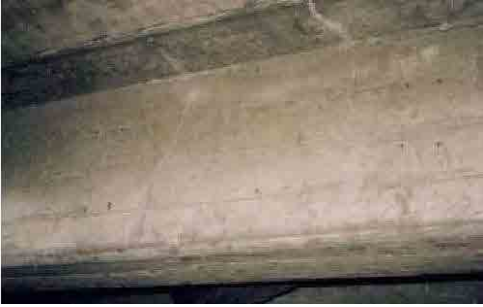
<p data-bbox="248 808 679 835">Cracks of small influence (marked with chalk)</p>

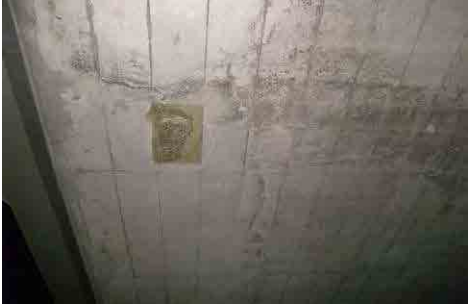
<p data-bbox="804 808 1235 835">Cracks of small influence (marked with chalk)</p>
Damage level 3	Damage level 3

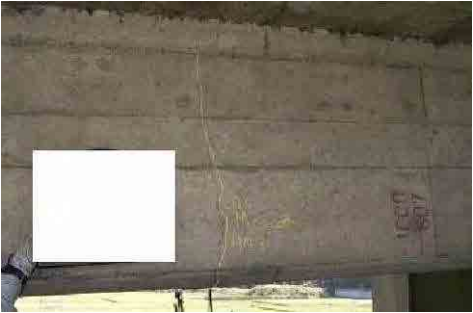
<p data-bbox="248 1279 679 1305">Cracks of large influence (marked with chalk)</p> <p data-bbox="555 1335 743 1361">Crack pattern No.1</p>

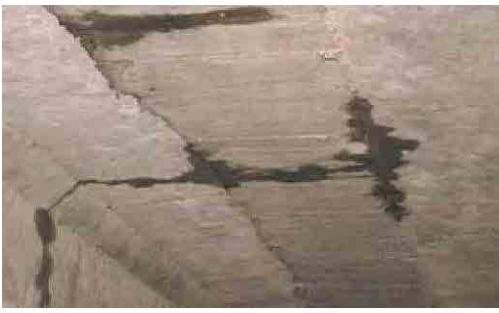
<p data-bbox="804 1305 1235 1332">Cracks of small influence with water leakage</p>

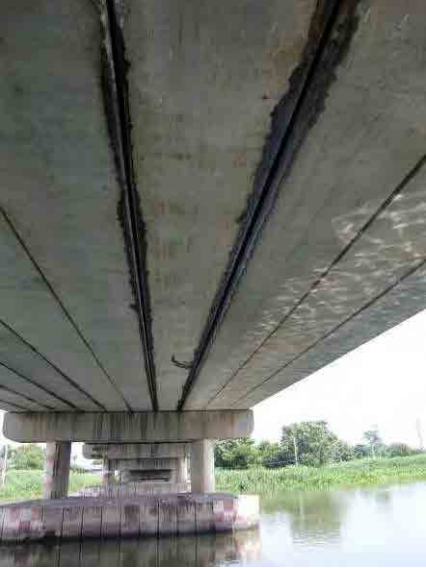
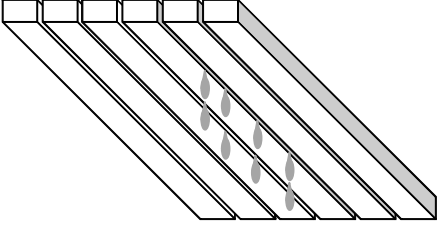
<p data-bbox="247 1041 622 1070">Leakage of water in the gaps of girders</p>

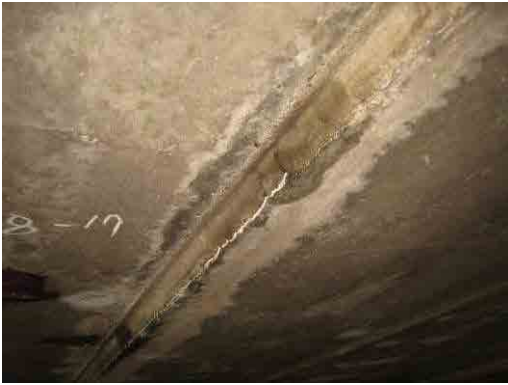
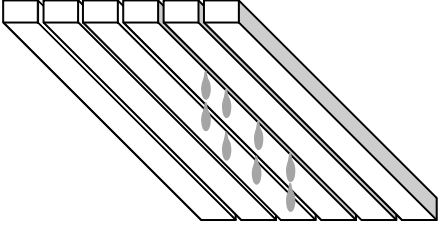
<p data-bbox="247 1568 622 1597">Leakage of water in the gaps of girders</p>

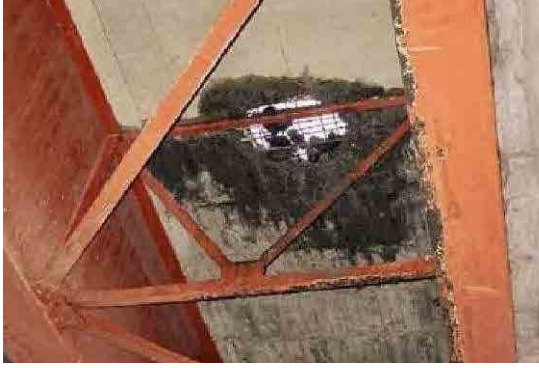
<p data-bbox="248 869 448 898">Example of pop-outs</p>

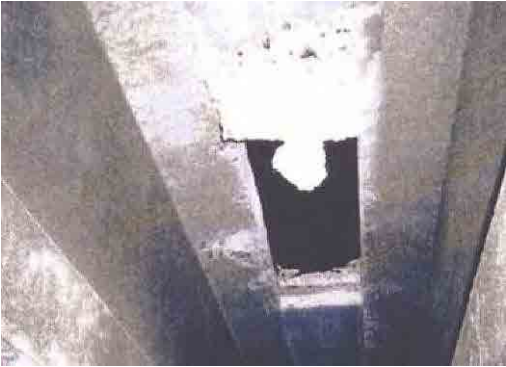
Damage level 5	Damage level 5

<p data-bbox="248 1393 448 1422">Example of pop-outs</p>

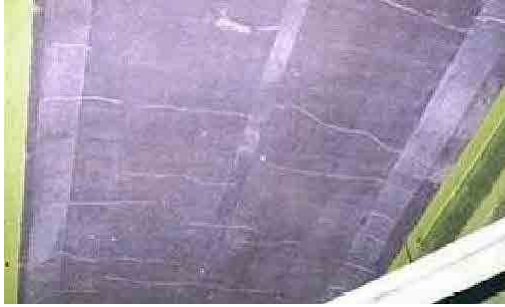
Damage level 2	Damage level 2

<p>Mainly cracks in one direction (marked with chalk)</p>

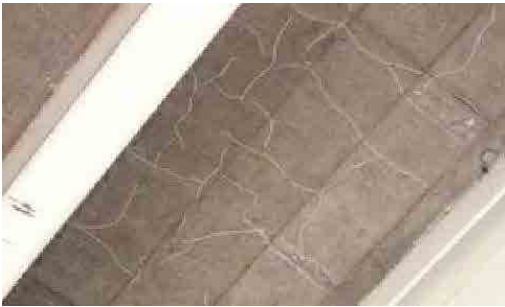
Damage level 3	Damage level 3

<p>Cracks in two directions (marked with chalk)</p>

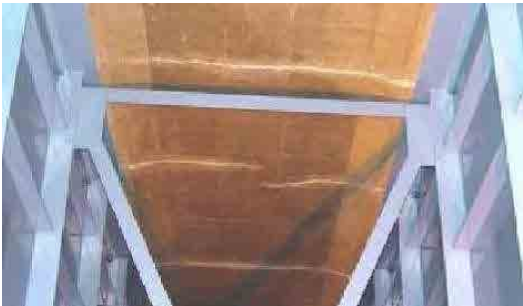
Damage level 3	Damage level 3

<p>Cracks in one direction with free lime</p>

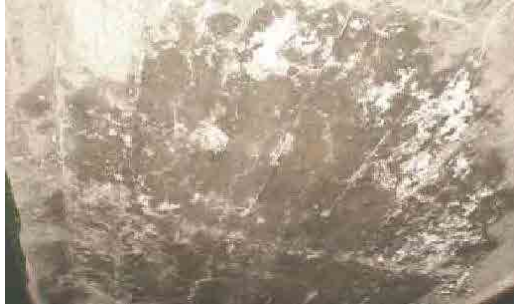
Damage level 4	Damage level 4

<p data-bbox="240 804 603 835">Cracks in two directions with free lime</p>

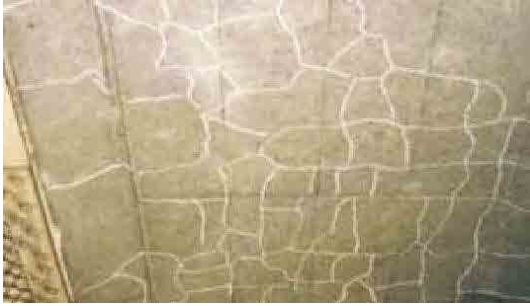
Damage level 4	Damage level 4

<p data-bbox="240 1274 778 1361">Dense cracks in two directions partially chipped (marked with chalk)</p>

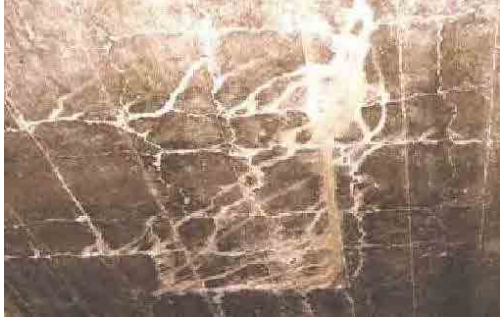
Damage level 5	Damage level 5

<p data-bbox="240 808 580 835">Continuously chipped with free lime</p>

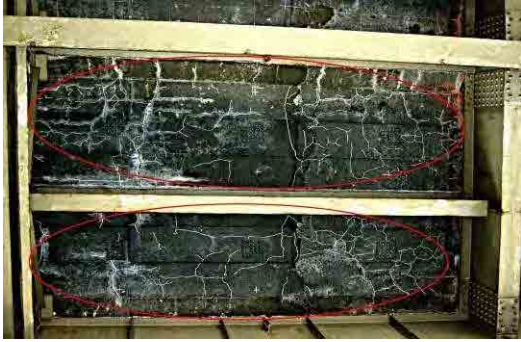
<p data-bbox="240 1279 580 1305">Continuously chipped with free lime</p>

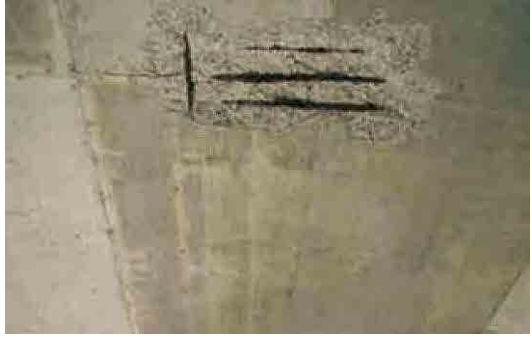
<p>Partial rebar exposure</p>

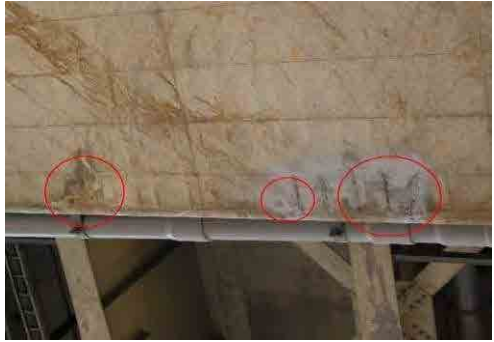
<p>Partial rebar exposure</p>

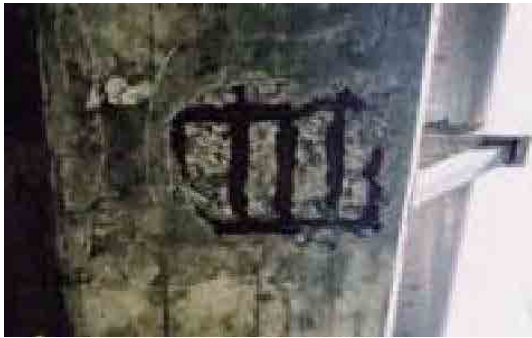
<p>Partial rebar corrosion</p>

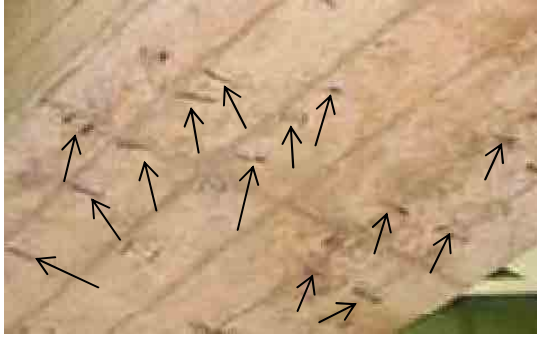
<p>Superficial rebar exposure in the wide range</p>

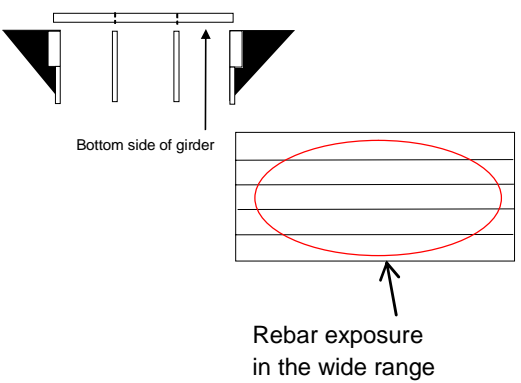
<p>Bottom side of girder</p> <p>Rebar exposure in the wide range</p>
<p>Damage level 3</p>	<p>Damage level 3</p>

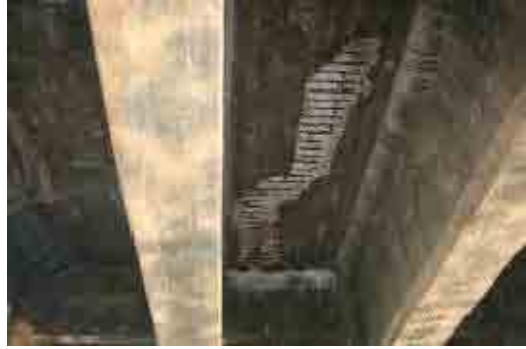
<p>Partial rebar corrosion</p>

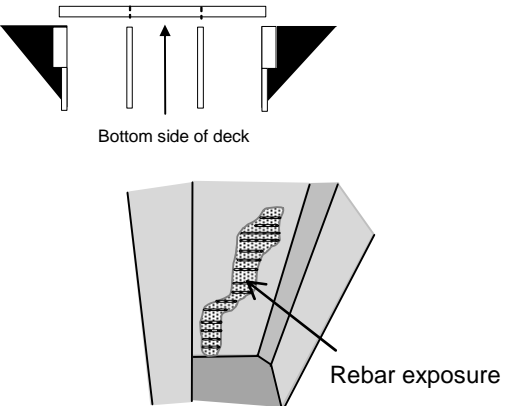
<p>Bottom side of deck</p> <p>Rebar exposure</p>
<p>Damage level 5</p>	<p>Damage level 5</p>

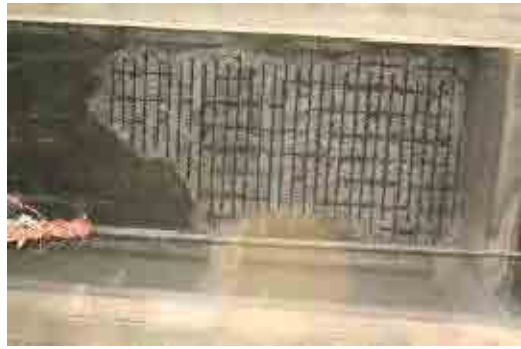
<p>Rebar corrosion in the wide range</p>

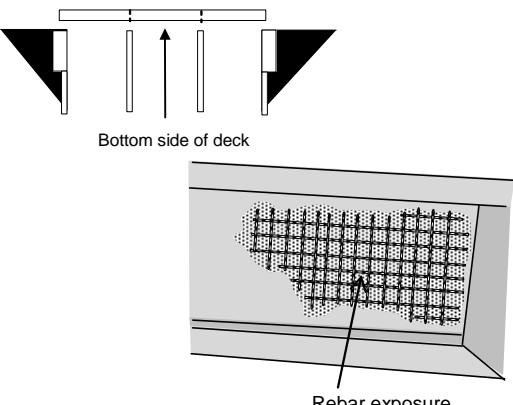
<p>Bottom side of deck</p> <p>Rebar exposure</p>

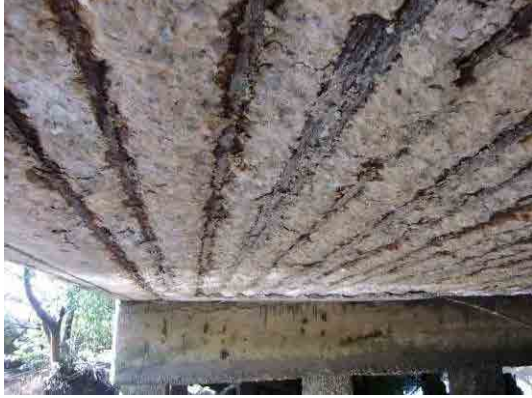
Damage level 5	Damage level 5

<p>Rebar corrosion in the wide range</p>

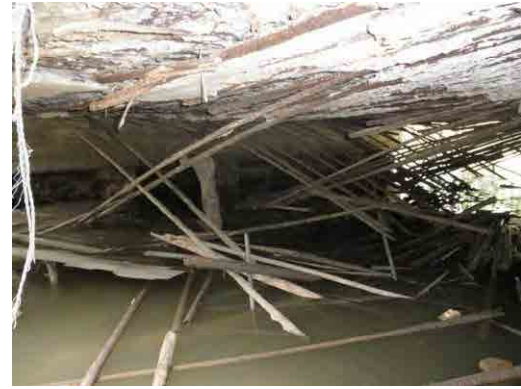
<p>Rebar corrosion in the wide range</p>

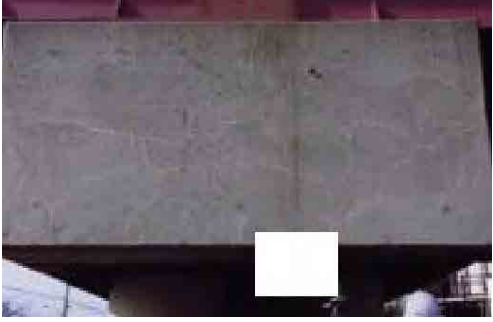
Damage level 2	Damage level 2

<p data-bbox="252 808 687 835">Cracks of small influence (marked with chalk)</p>

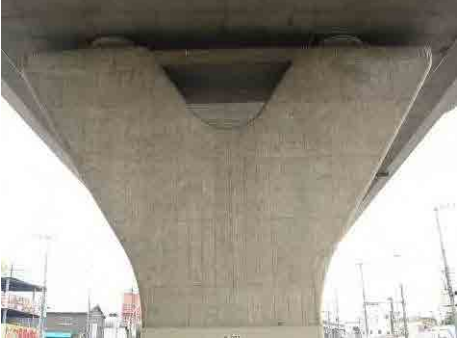
<p data-bbox="802 808 1238 835">Cracks of small influence (marked with chalk)</p>
Damage level 3	Damage level 3
