Kingdom of Thailand
The Project for Bridge Master Plan and Bridge
Maintenance Ability in Rural Area

Report 2
Bridge Inspection and Evaluation Manual

July 2013

Japan International Cooperation Agency
CHODAI Co., Ltd
Metropolitan Expressway Company Limited

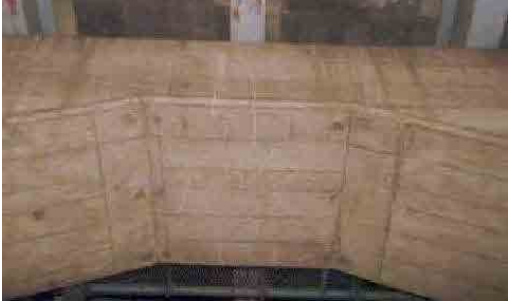
<p data-bbox="252 1279 687 1305">Cracks of large influence (marked with chalk)</p> <p data-bbox="563 1335 759 1361">Crack pattern No.5</p>

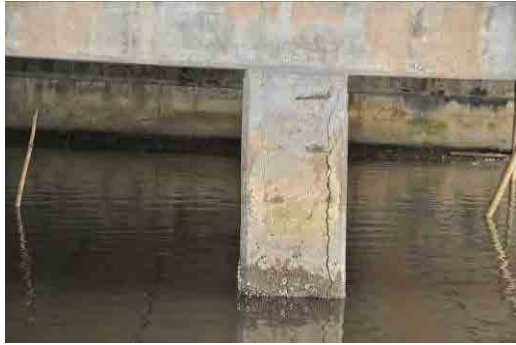
Damage level 3

Cracks of large influence (cracks propagated along the axial direction of column)

Crack pattern No.3

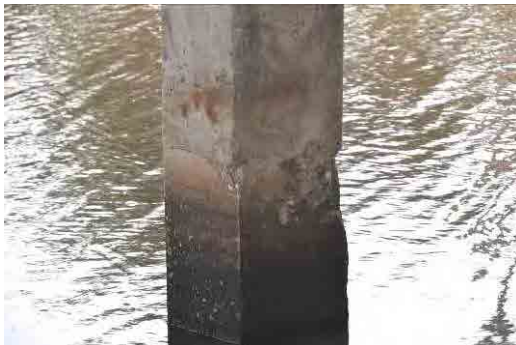
Damage level 3

Cracks of large influence (cracks propagated around column)

Crack pattern No.6

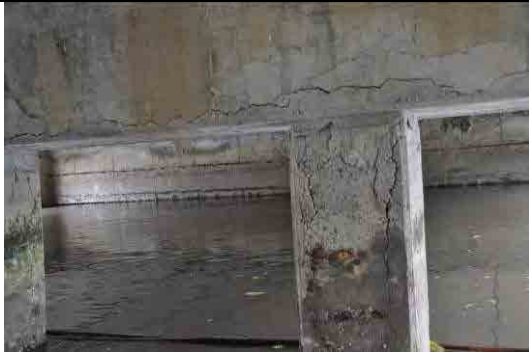
Cracking of pier

Damage level 3

Cracks of large influence (cracks propagated along the axial direction of column)

Crack pattern No.3

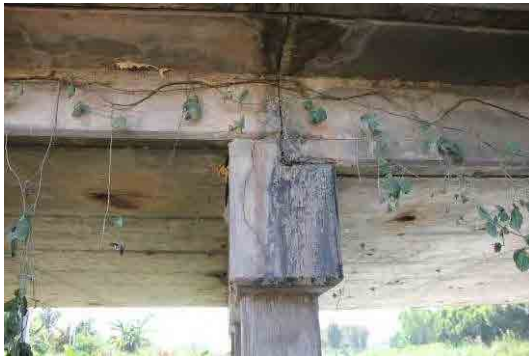
Damage level 3

Cracks of large influence (cracks propagated along the axial direction of column)

Crack pattern No.4

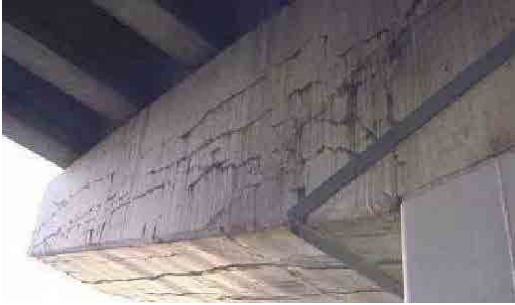
Cracking, water leakage and free lime of substructure

<p data-bbox="252 808 767 891">Cracks of large influence with water leakage and free lime</p> <p data-bbox="571 864 767 891">Crack pattern No.3</p>

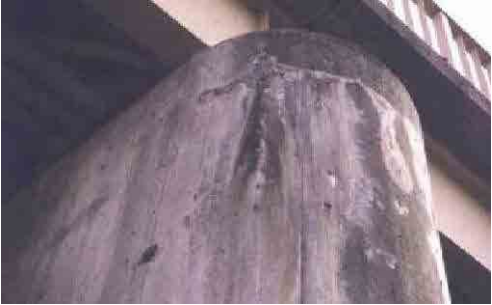
<p data-bbox="802 837 1185 864">Cracks of small influence with rust strain</p>
Damage level 5	Damage level 5

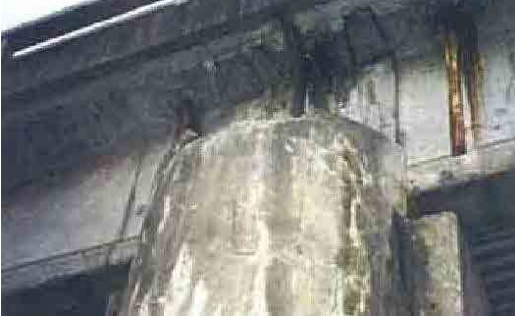
<p data-bbox="252 1335 767 1361">Cracks of large influence with remarkable free lime</p> <p data-bbox="571 1395 767 1422">Crack pattern No.6</p>

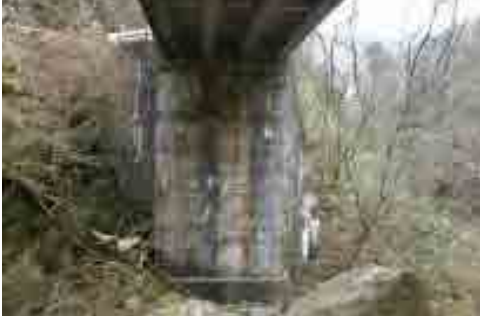
<p data-bbox="802 1335 1297 1361">Cracks of large influence with remarkable free lime</p> <p data-bbox="1102 1395 1299 1422">Crack pattern No.6</p>

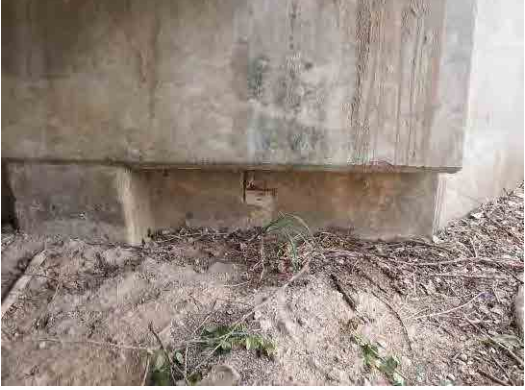
Damage level 2	Damage level 2

<p data-bbox="252 864 491 898">Partial rebar exposure</p>

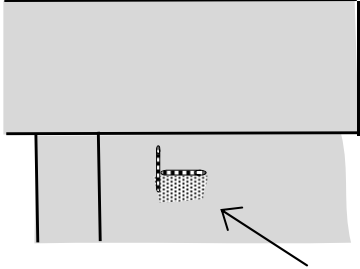
<p data-bbox="1145 819 1302 853">Rebar exposure</p>
Damage level 3	Damage level 3

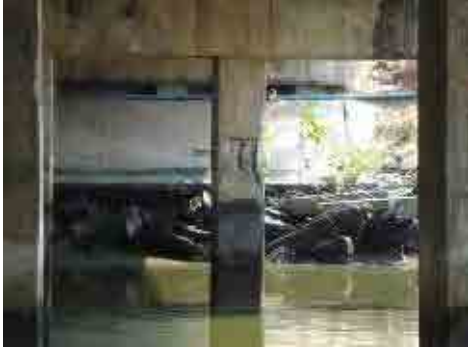
<p data-bbox="252 1395 491 1429">Partial rebar corrosion</p>

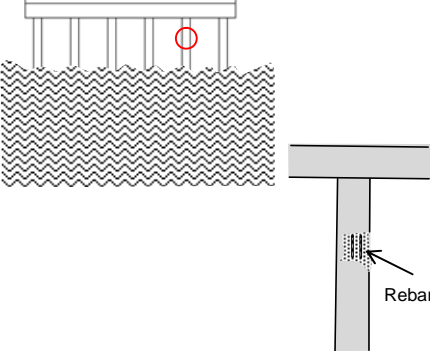
<p data-bbox="1209 1339 1347 1373">Rebar exposure</p>
Damage level 3	Damage level 3

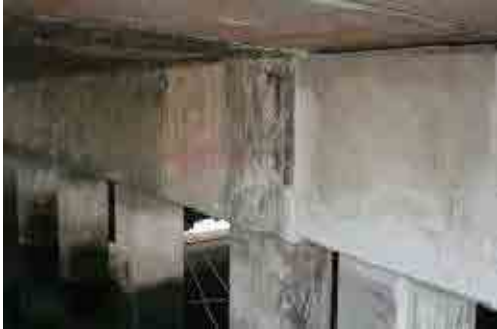
<p data-bbox="252 1921 491 1955">Partial rebar corrosion</p>

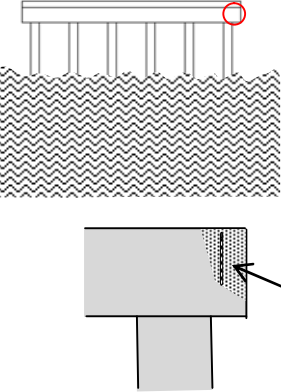
<p data-bbox="1129 1843 1302 1877">Rebar exposure</p>

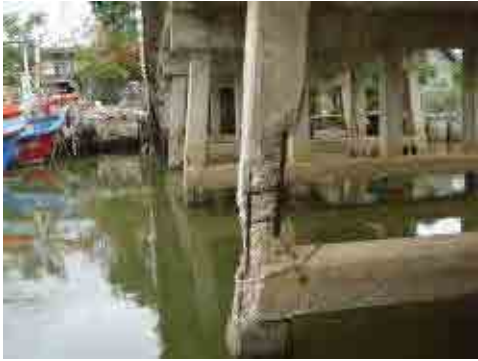
Damage level 5	Damage level 5

<p data-bbox="252 869 593 900">Rebar corrosion around column</p>

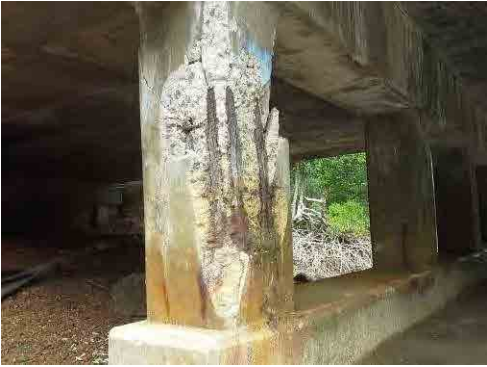
<p data-bbox="252 1393 593 1424">Rebar corrosion around column</p>

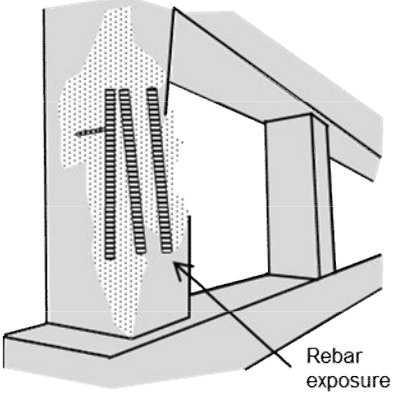
<p data-bbox="1161 1346 1257 1391">Rebar exposure</p>

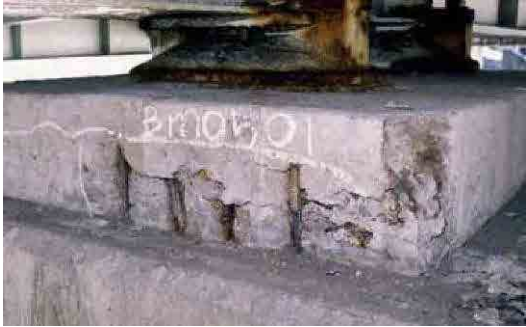
<p data-bbox="802 808 1297 891">Limited damages in bearing seat only (evaluated in cracks, water leakage, free lime or rebar exposure)</p>
Damage level 3	Damage level 3

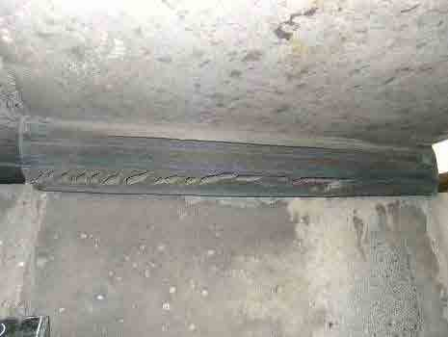
<p data-bbox="244 1335 738 1417">Bearing function is not restricted, even the rubber is deteriorated.</p>

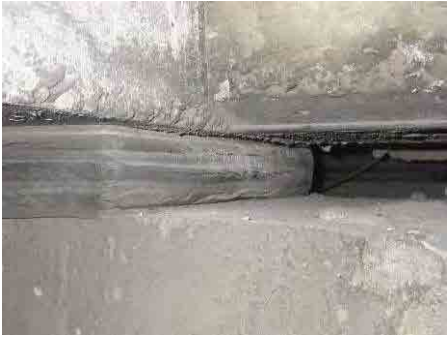
<p data-bbox="802 1335 1297 1417">Bearing function is not restricted, even the rubber is deteriorated.</p>
