## **CHAPTER 5 SELECTION FOR HIGH PRIORITY RIVER IMPROVEMENT SECTION**

**JAPAN INTERNATIONAL COOPERATION AGENCY  
(JICA)**

**YACHIYO ENGINEERING CO., LTD.  
NIPPON KOEI CO., LTD.  
NIPPON KOEI LATIN AMERICA –  
CARIBBEAN Co., LTD.**

**THE PREPARATORY STUDY ON PROJECT OF THE PROTECTION  
OF  
FLOOD PLAIN AND VULNERABLE RURAL POPULATION AGAINST FLOOD  
IN THE REPUBLIC OF PERU  
FEASIBILITY STUDY REPORT  
SUPPORTING REPORT**

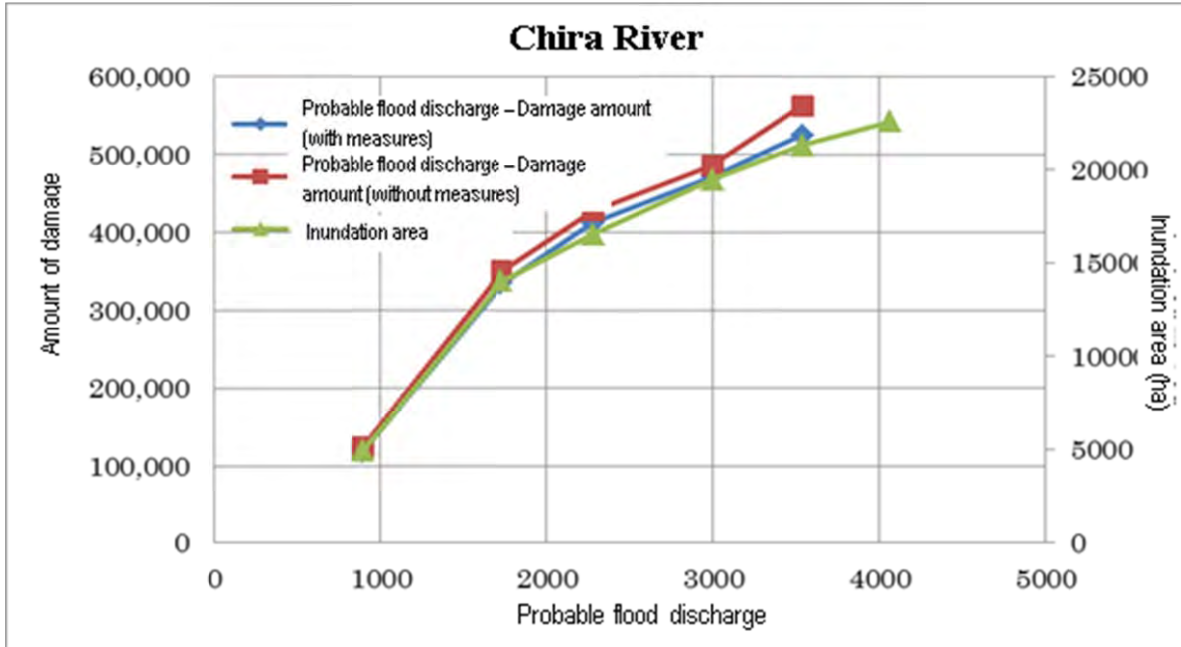
Damage amount of 1/2、1/5、1/10、1/25、1/50 year probable discharge  
 Inundation Area of 1/2、1/5、1/10、1/25、1/50、1/100 year probable discharge  
 Previous maximum discharge: 3600m<sup>3</sup>/s

According to increasing flood discharge, the amount of damage and the inundation areas are increasing. In these proposed improvement, the damage mitigation effects are low.

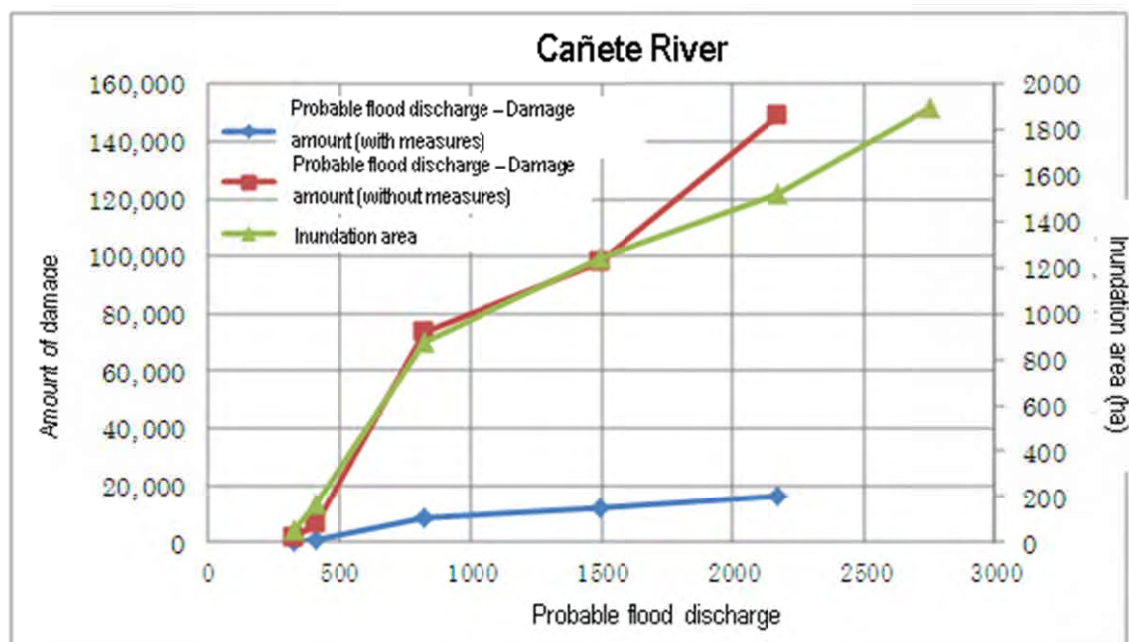
Damage amount of 1/2, 1/5, 1/10, 1/25, 1/50 year probable discharge  
Inundation Area of 1/2, 1/5, 1/10, 1/25, 1/50, 1/100 year probable discharge  
Previous maximum discharge: 1000m<sup>3</sup>/s

When the discharge exceeds about 2000m<sup>3</sup>/s, the amount of damage will go up remarkably, but the amount of damage will be greatly reduced by advancing the above-mentioned maintenance.

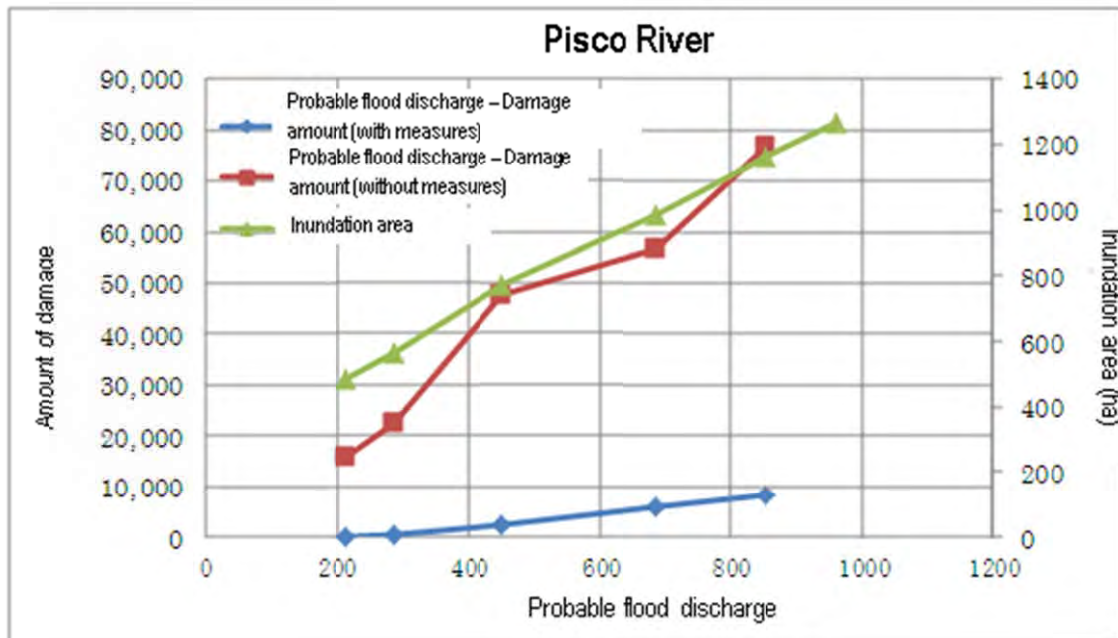
Damage amount of 1/2, 1/5, 1/10, 1/25, 1/50 year probable flood discharge  
Inundation Area of 1/2, 1/5, 1/10, 1/25, 1/50, 1/100 year probable flood discharge  
Previous maximum discharge: 950m³/s

When the discharge exceeds about 800m³/s, the amount of damage will go up remarkably, but the amount of damage is greatly reduced by advancing the above-mentioned improvement. However, it is thought that serious damage occurs to the discharge of 900m³/s or more.

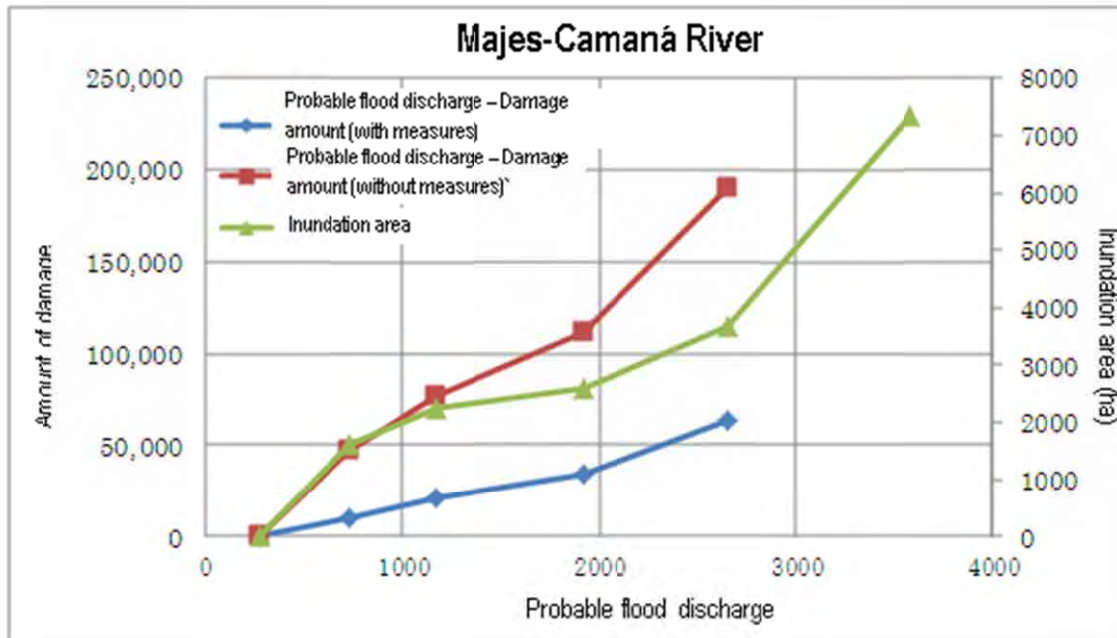
Damage amount of 1/2、1/5、1/10、1/25、1/50 year probable flood discharge  
Inundation Area of 1/2、1/5、1/10、1/25、1/50、1/100 year probable flood discharge  
Previous maximum discharge: 2020m<sup>3</sup>/s

Although, when the discharge exceeds about 2000m<sup>3</sup>/s, the amount of damage will go up remarkably, the amount of damage is greatly mitigated by advancing the above-mentioned maintenance. However, it is thought that the serious damage occurs in case of the discharge of 3000m<sup>3</sup>/s or more.

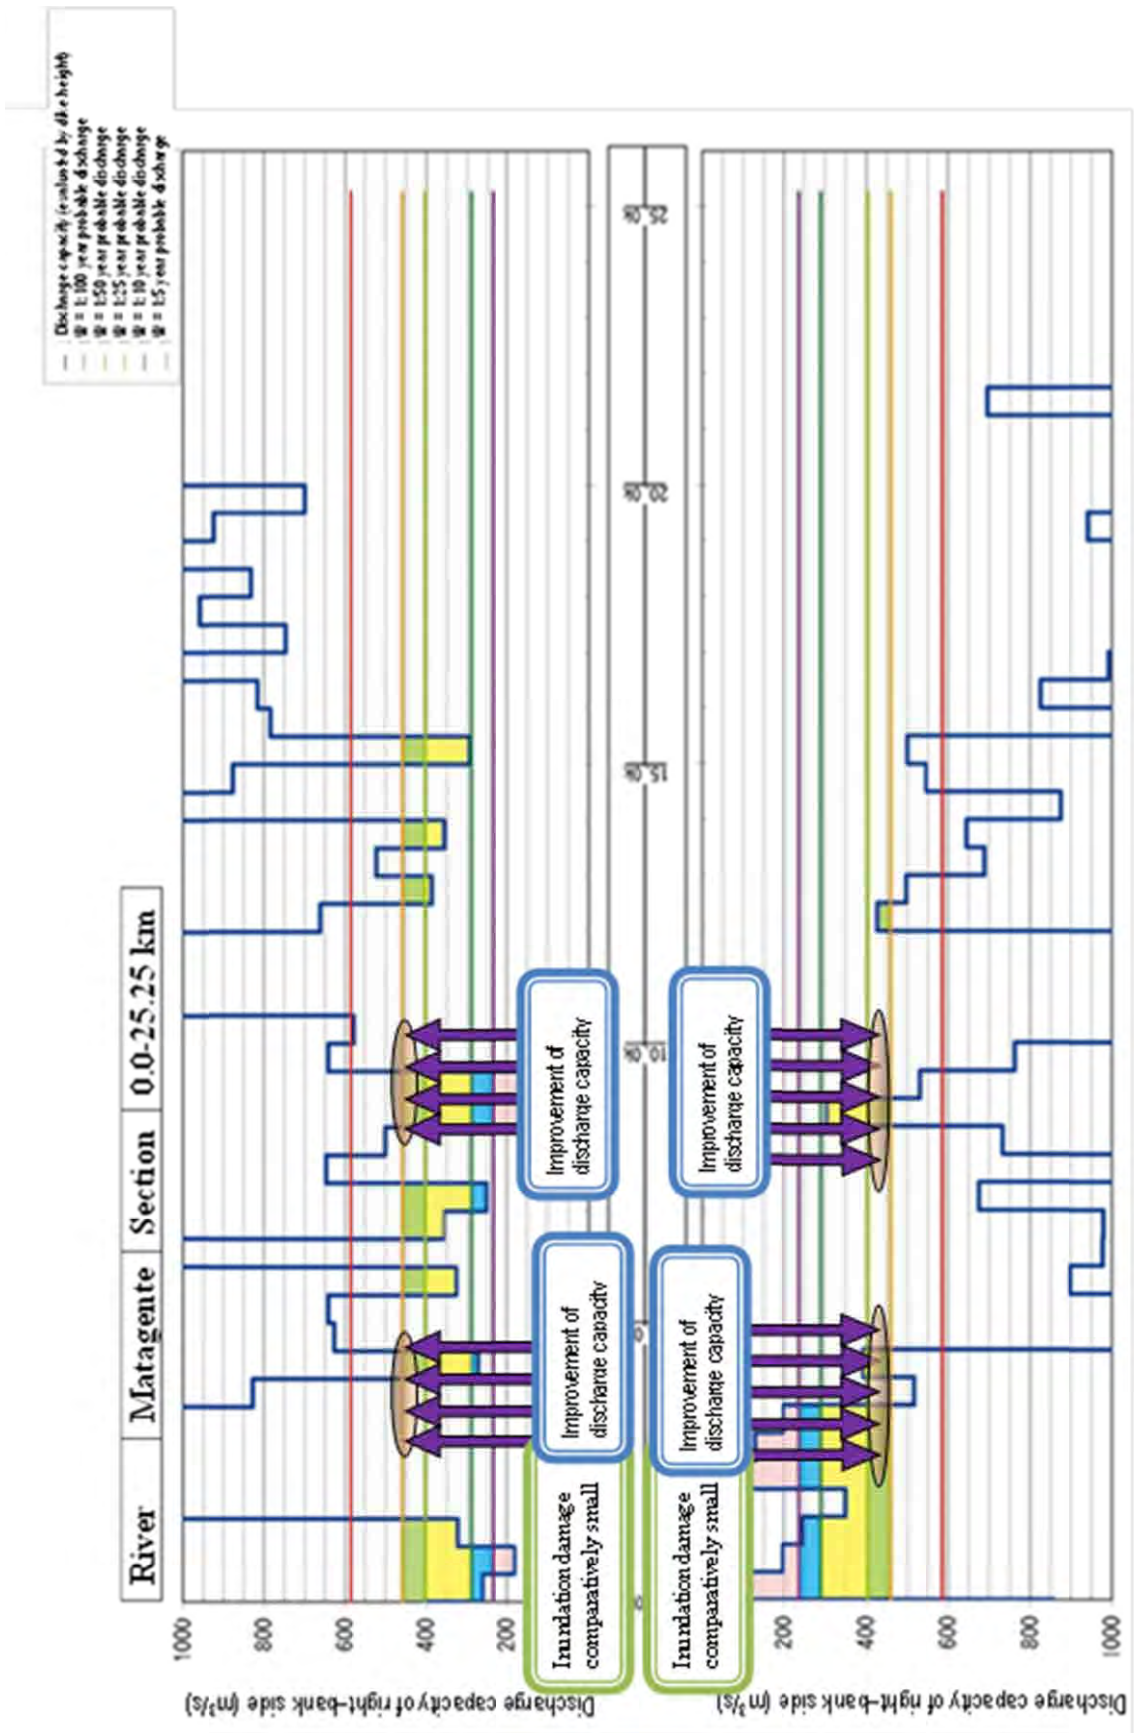
Figure 6.4 Mitigation Effects for Inundation by Improvement (Chincha (Matagente) River)

By construction of river facilities for flood mitigation, the discharge capacity in each river is enhanced up to 1/50 year probable discharge. Mitigation effects for inundation by river improvement such as embankment, revetment works increase remarkably as shown in following Figures as shown in *Figure 6.1* to *Figure 6.8*.

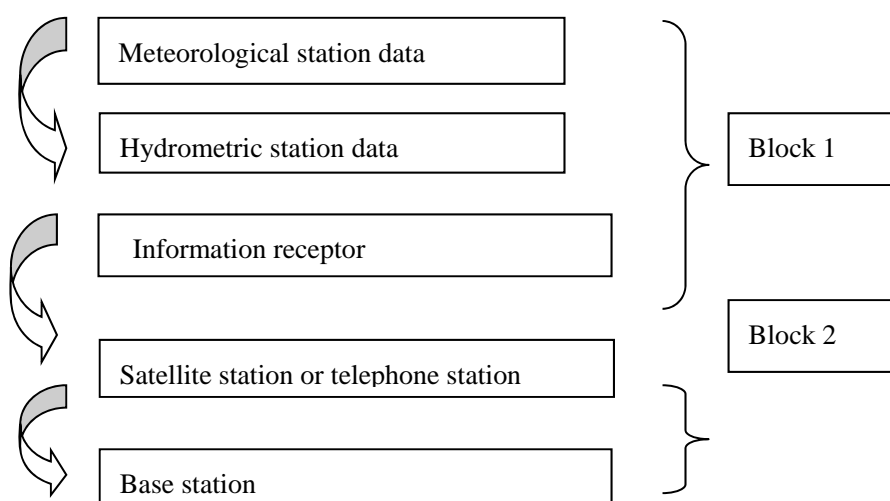
**Table 5.6 Station Network, as suggested by the Catamayo Chira Unit in 2010**

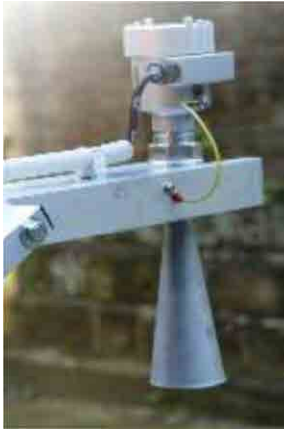
<p style="text-align: center;"><i>Figure 6.3.1</i> Level Measurement Sensor</p>	<p style="text-align: center;"><i>Figure 6.3.2</i> Pluviometer with Information Sensor</p>	<p style="text-align: center;"><i>Figure 6.3.3</i> Observed Data Recording Equipment</p>

#### 6.3.3 Equipment Models to be Purchased

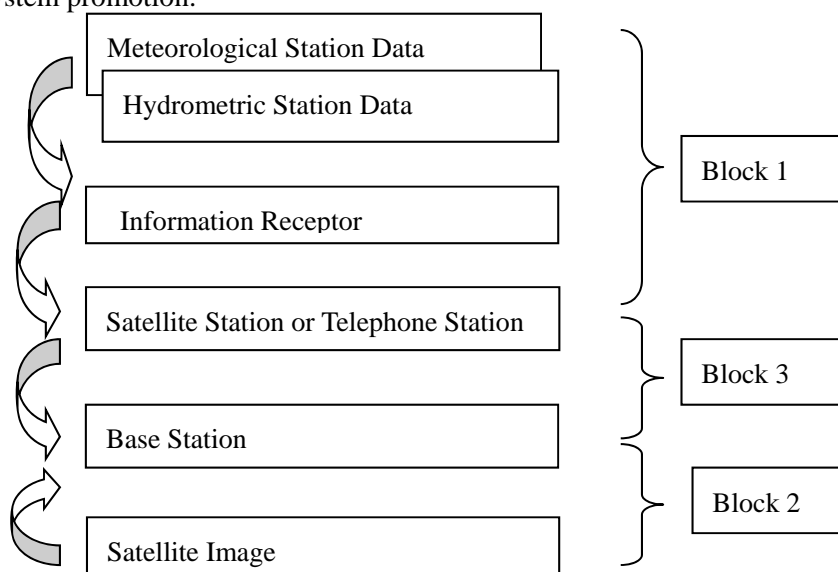
A second block will involve capturing or getting satellite GOES or TRMM images through the Internet and the base station.

The third and last block involves forecast generation process and information to the authorities for a warning system promotion.

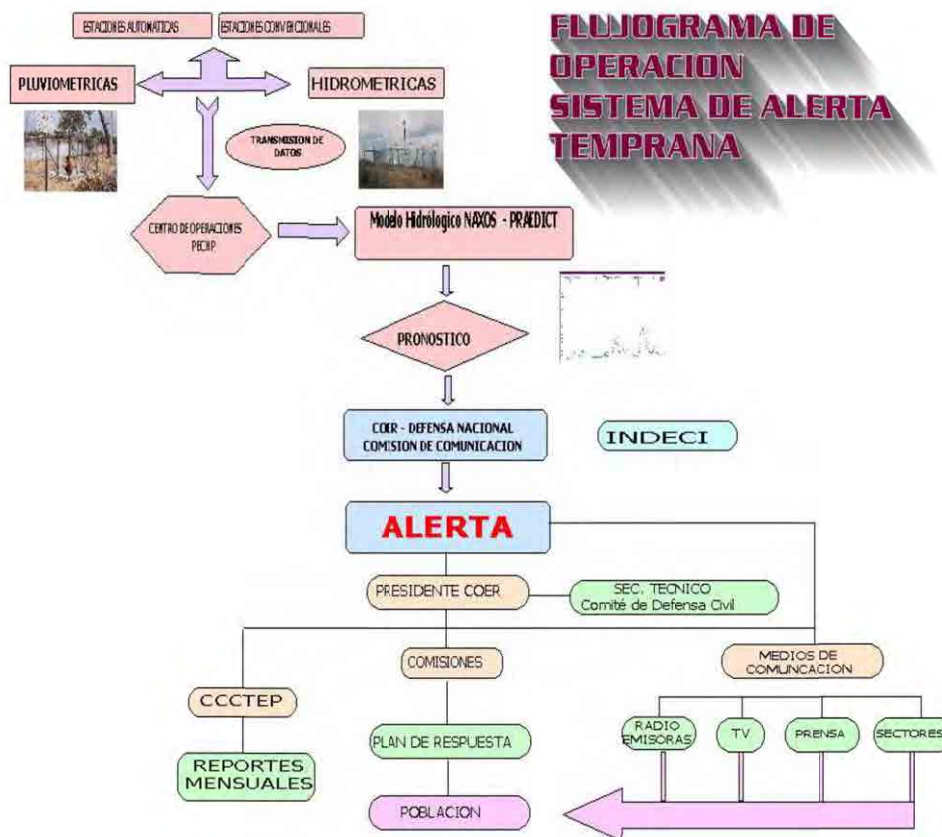
**Figure 7.1 Operation Distribution Diagram of Early Warning System**

**The Base Station:** Receives the information and captures satellite information, prepares the Hydrograph along with the Hydrological Model, releases the Flood Forecast, and reports to the Regional Emergency Committee.

**The Regional Emergency Committee (COER, in Spanish):** It activates the Civil Defense System that releases the WARNING SYSTEM, via the Civil Defense System.
