*The Preparatory Study on Project of the Protection of Flood Plain and Vulnerable Rural Population against Flood in the republic of Peru  
Feasibility Study Report, Supporting Report, Annex-8 Facility Plan and Design*

**Annex-8  
Facility Plan and Design**

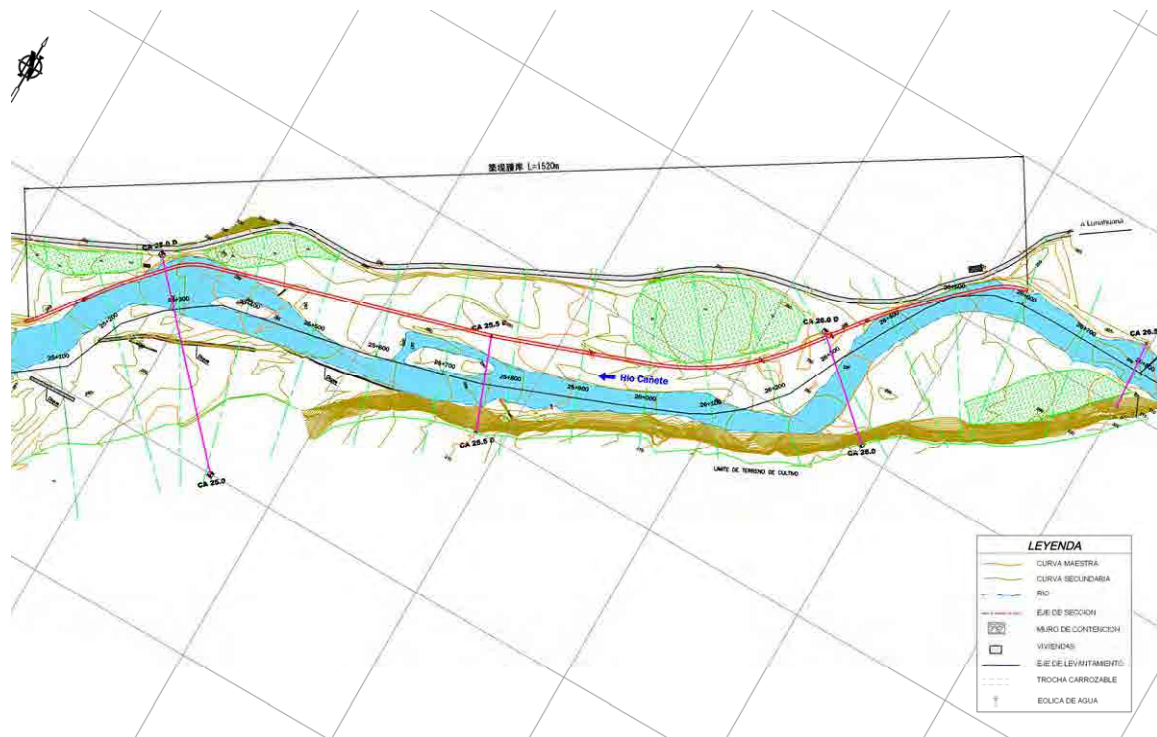
Figure 2.17 Facility Plan in Canete River-5

No	Sections for Improvement	Improvement Plan
Canete River-5	24.75km ~26.5km (Right-bank side)	<p>In the sections concerned, bank erosion is processing caused by flood flow and the influence of erosion has reached even near the local main road. If it is neglected as it is, road will be collapsed and impacts in regional economy will be large (especially for tourist industry), the measures for erosion should be implemented immediately.</p> <p><b>&lt;Characteristic of Sections for Improvement&gt;</b></p> <ul style="list-style-type: none"> <li>• Sections with high possibility that the local main road will collapse by bank erosion.</li> <li>• Sections which should carry out erosion control for riverbank and functional preservation for the local main road, simultaneously.</li> </ul> <p><b>&lt;Protected Areas&gt;</b></p> <ul style="list-style-type: none"> <li>○ The local main road located in the right-bank</li> </ul> <p><b>&lt;Improvement Plan &gt;</b></p> <ul style="list-style-type: none"> <li>▼ Since the impacts to the regional economies is large, caused by collapsing in the local main road, the safety measures is ensured even if El Nino, etc. (1/50-year probable scale) is occurred.</li> <li>▼ Although improving only the road part is to be considered for improvement plan, it is anxious that the farmland in the right-bank side during flood is eroded because of locating in the low land area. Improvement with easy flowing for discharge is the key measures.</li> </ul>

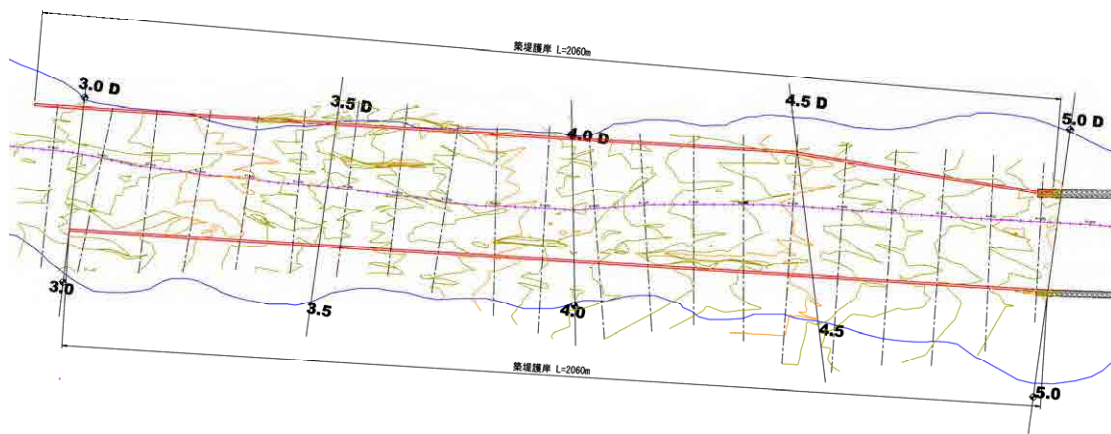
Figure 2.31 Facility Plan in Pisco River-1

No	Sections for Improvement	Improvement Plan
Pisco River-1	3.0km~5.0km (Right-bank side) + (Left-bank side)	<p>Sections concerned where the impacts to the regional economy should be considered in case of inundation flow reaches urban areas. Moreover, when the upstream section is improved, it is thought that flood also starts and expands in the right-bank side.</p> <p>Since it is meandering section, protection works for slope and foot of bank embankment shall be needed. For this reason, the embankment and the revetment in both sides are required. Moreover, it is also necessary to take notice that the existing dike near 5.0km-5.5km (right-and-left both sides).</p> <p><b>&lt;Characteristic of Sections for Improvement&gt;</b></p> <ul style="list-style-type: none"> <li>• Sections where it overflows by flood in the past and the Pisco City area was inundated</li> <li>• Sections which needs the embankment and the revetment in order to prevent the flood of the city area</li> <li>• Sections where the flood also expands to the right-bank side by improvement of the upstream</li> </ul> <p><b>&lt;Protected Areas&gt;</b></p> <ul style="list-style-type: none"> <li>○ Vast farmland which spreads to the both sides of the sections for improvement</li> <li>○ Pisco city area of the left-bank side</li> </ul> <p><b>&lt;Improvement Plan &gt;</b></p> <ul style="list-style-type: none"> <li>▼ Inundation will begin at the scale of 1/10 year probable discharge, and damage will become serious at the scale of 1/50 year probable discharge. For this reason, the improvement plan which can flow down the discharge of 1/50 year probable flood scale shall be adopted. The improvement shall be done so that the damage does not occurs at 950m<sup>3</sup>/s (equivalent of 1/50 year probable discharge scale) which brought serious damage in the past.</li> <li>▼ The embankment and the revetment works shall be carried out in consideration of rover condition in upstream section as well as in downstream section.</li> </ul>

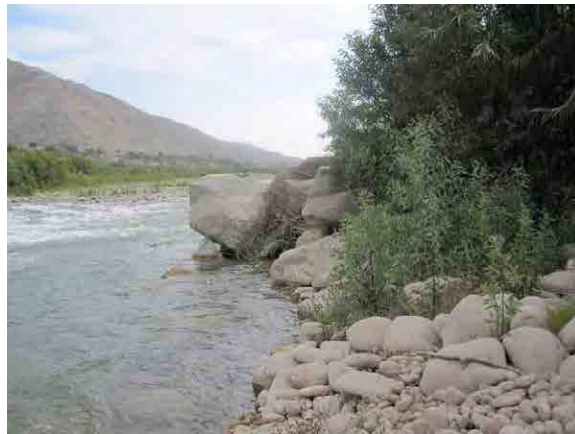
**Figure 3.1 Groin Work in Canete River**

- vi) Groins are placed in the Chira River and the Canete River, most of them are destroyed. Although groins consist of boulder, some of them were composed of earth and sand within it, and may have been destroyed by sucking of internal material.
- vii) There are revetments which consist of large boulders in the river mouth area of the Pisco River. According to information from manager, that structure is strong for dyke break. Boulder materials were conveyed from the quarry within the distance of about 10km. The photographs of typical dikes are shown below.

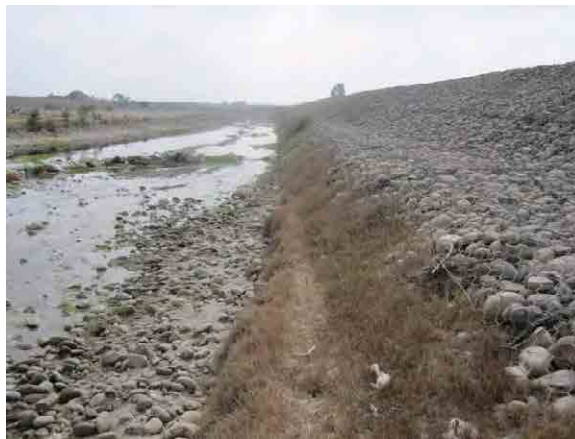
**Figure 3.2 Dike Revetment by Mattress Basket in Chincha River**

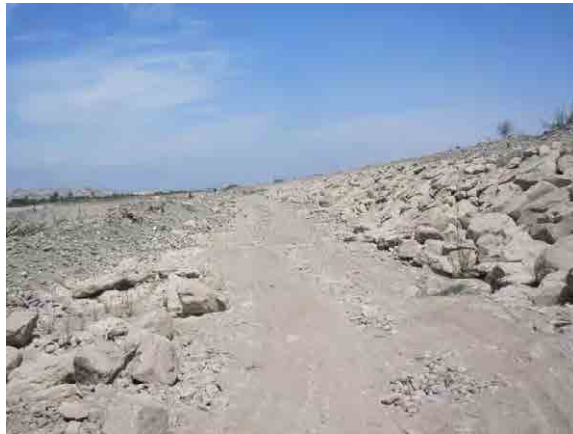
**Figure 3.3** Revetment Works by Boulder near the River Mouth in Pisco River

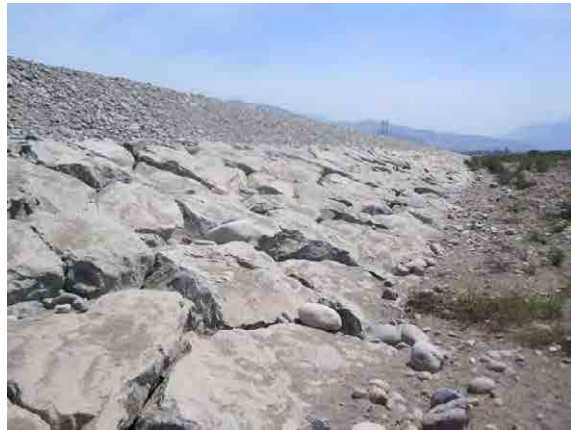
**Figure 3.4** Dike and Revetment Works by Boulders in the Upstream in Pisco River

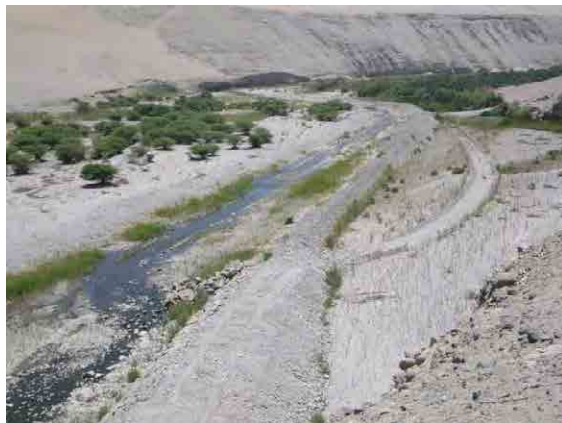
**Figure 3.5** Dike in Yauca River

- i) The slope gradient apply for about 1:2 gradient with vertical 1 to horizontal 2. Depend on the river characteristics and local condition, and slope gradient has little differences.

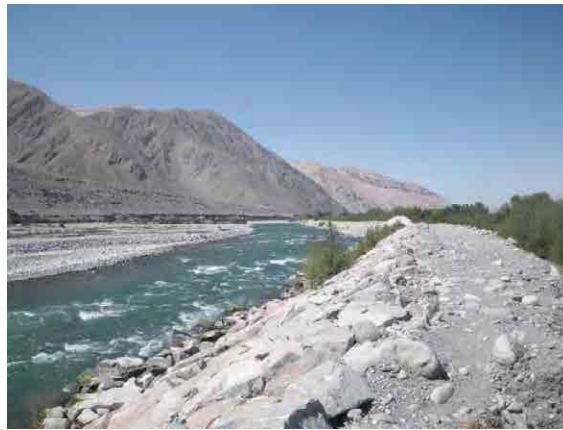
**Figure 3.6 Dike in Majes-Camana River**
