CHAPTER 3 RIVER CHANNEL PLAN

Based on the discharge capacity and the characteristics on floods, etc. for each object river, the optimal river channel plan is formulated.

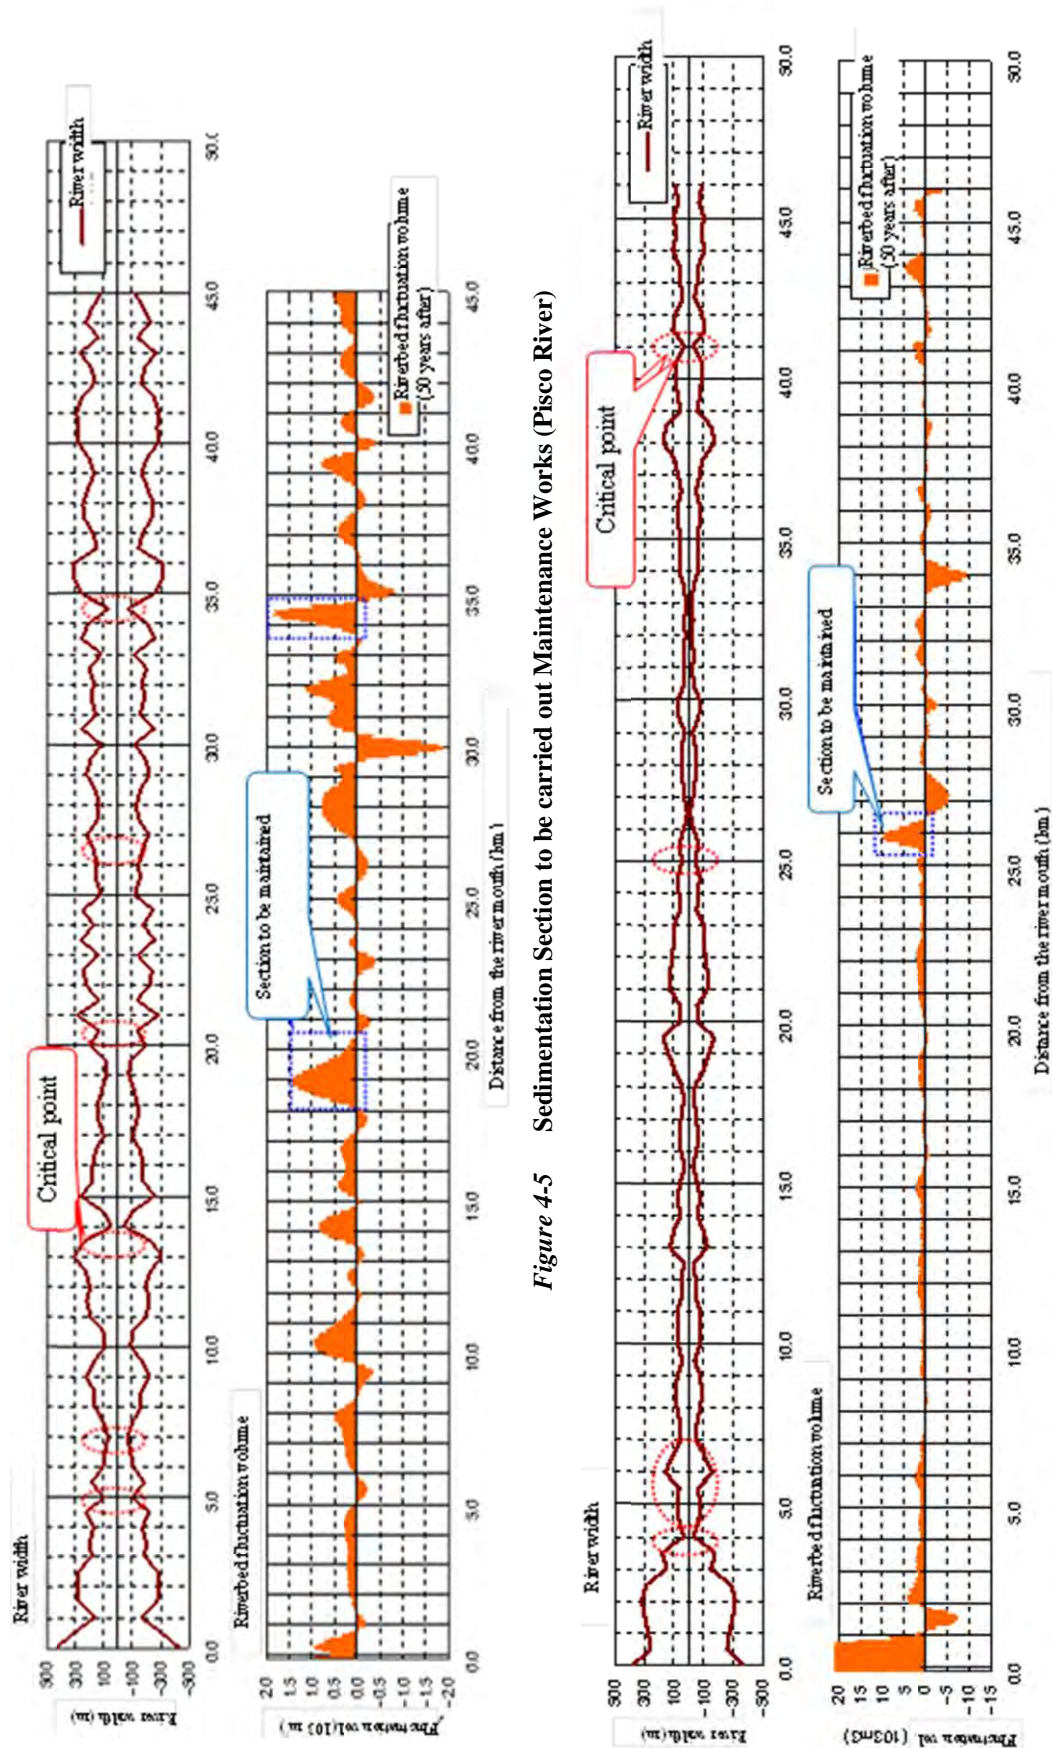
Figure 4-5 Sedimentation Section to be carried out Maintenance Works (Pisco River)

Figure 4-6 Sedimentation Section to be carried out Maintenance Works (Yauca River)

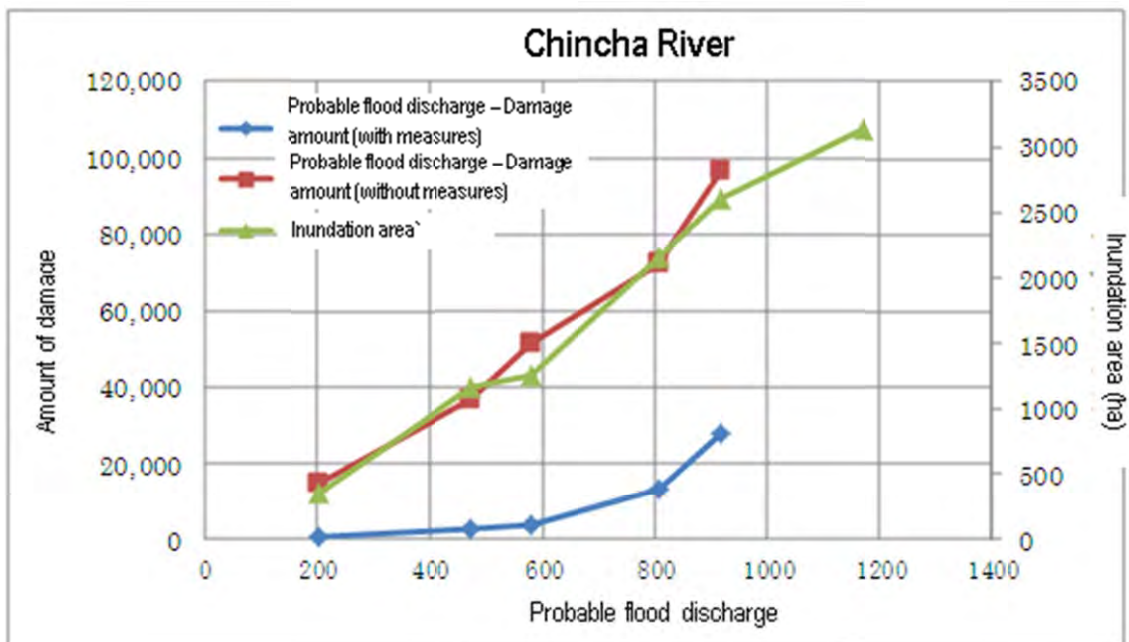
Damage amount of 1/2、1/5、1/10、1/25、1/50 year probable discharge
Inundation Area of 1/2、1/5、1/10、1/25、1/50、1/100 year probable discharge
Previous maximum discharge: 1270m³/s

When the discharge exceeds about 900m³/s, the amount of damage will goes up sharply. Although the amount of damage is greatly reduced by advancing the above-mentioned improvement, the mitigation effectiveness for floods becomes weak.

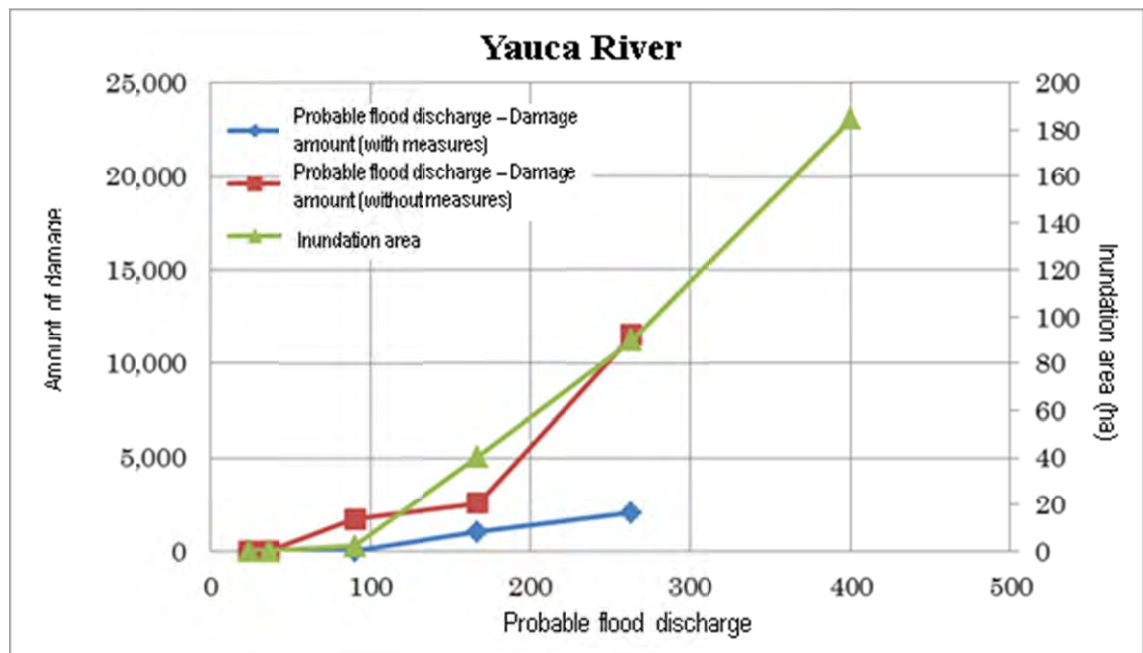
Damage amount of 1/2, 1/5, 1/10, 1/25, 1/50 year probable discharge
Inundation Area of 1/2, 1/5, 1/10, 1/25, 1/50, 1/100 year probable discharge
Previous maximum discharge: 210m³/s

When the discharge exceeds about 250m³/s, the amount of damage will go up remarkably. But the amount of damage is greatly reduced by advancing the above-mentioned improvement. However, it is thought that the damage increase further for the discharge of 300m³/s or more.

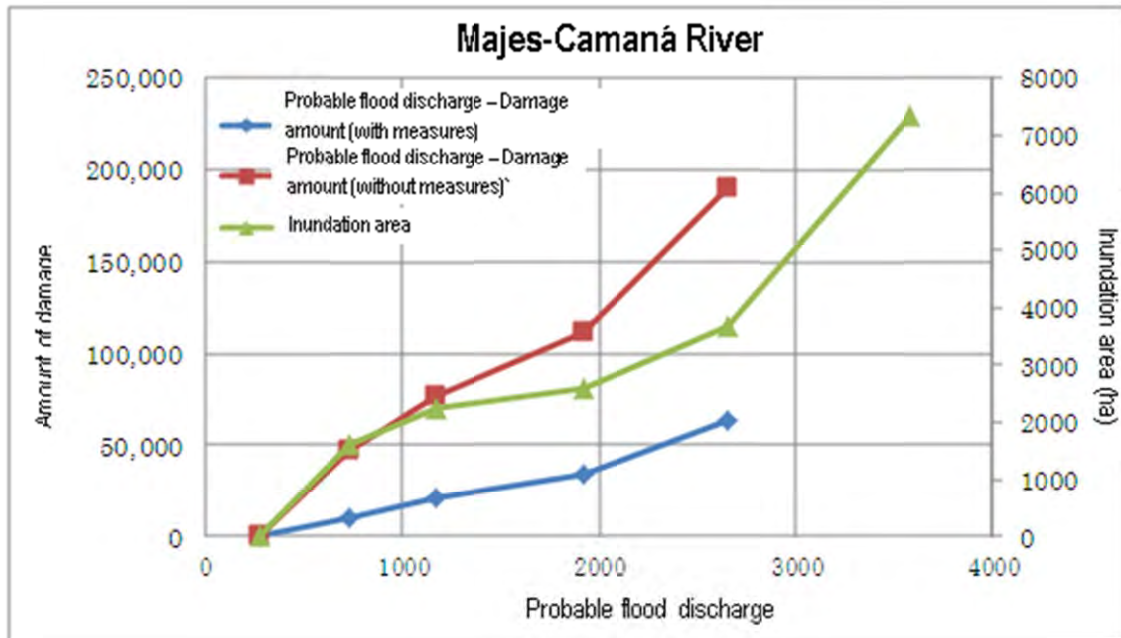
Damage amount of 1/2、1/5、1/10、1/25、1/50 year probable flood discharge
Inundation Area of 1/2、1/5、1/10、1/25、1/50、1/100 year probable flood discharge
Previous maximum discharge: 2020m³/s

Although, when the discharge exceeds about 2000m³/s, the amount of damage will go up remarkably, the amount of damage is greatly mitigated by advancing the above-mentioned maintenance. However, it is thought that the serious damage occurs in case of the discharge of 3000m³/s or more.
