**THE REPUBLIC OF THE PHILIPPINES
DEPARTMENT OF PUBLIC WORKS AND HIGHWAYS (DPWH)**

**THE PROJECT FOR STUDY
ON
IMPROVEMENT OF BRIDGES
THROUGH
DISASTER MITIGATING MEASURES
FOR LARGE SCALE EARTHQUAKES
IN
THE REPUBLIC OF THE PHILIPPINES**

FINAL REPORT

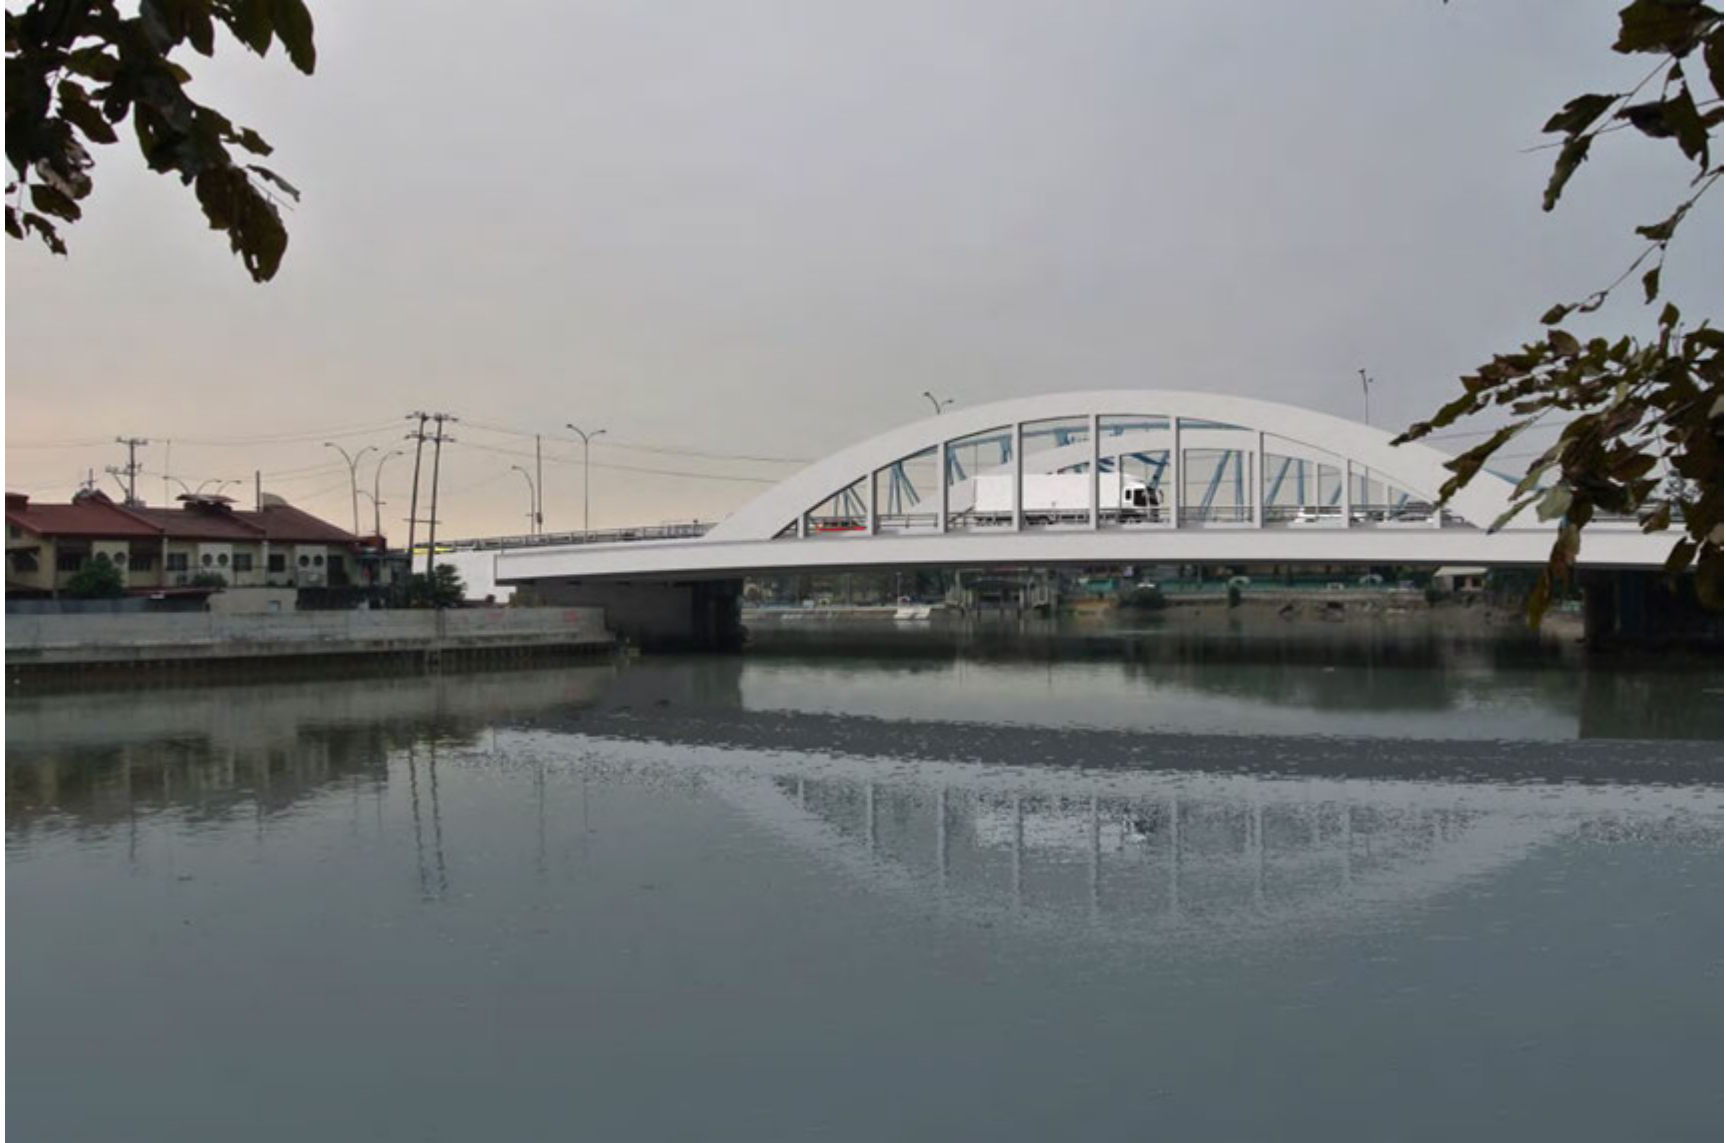
Perspective View of Lambingan Bridge (1/2)

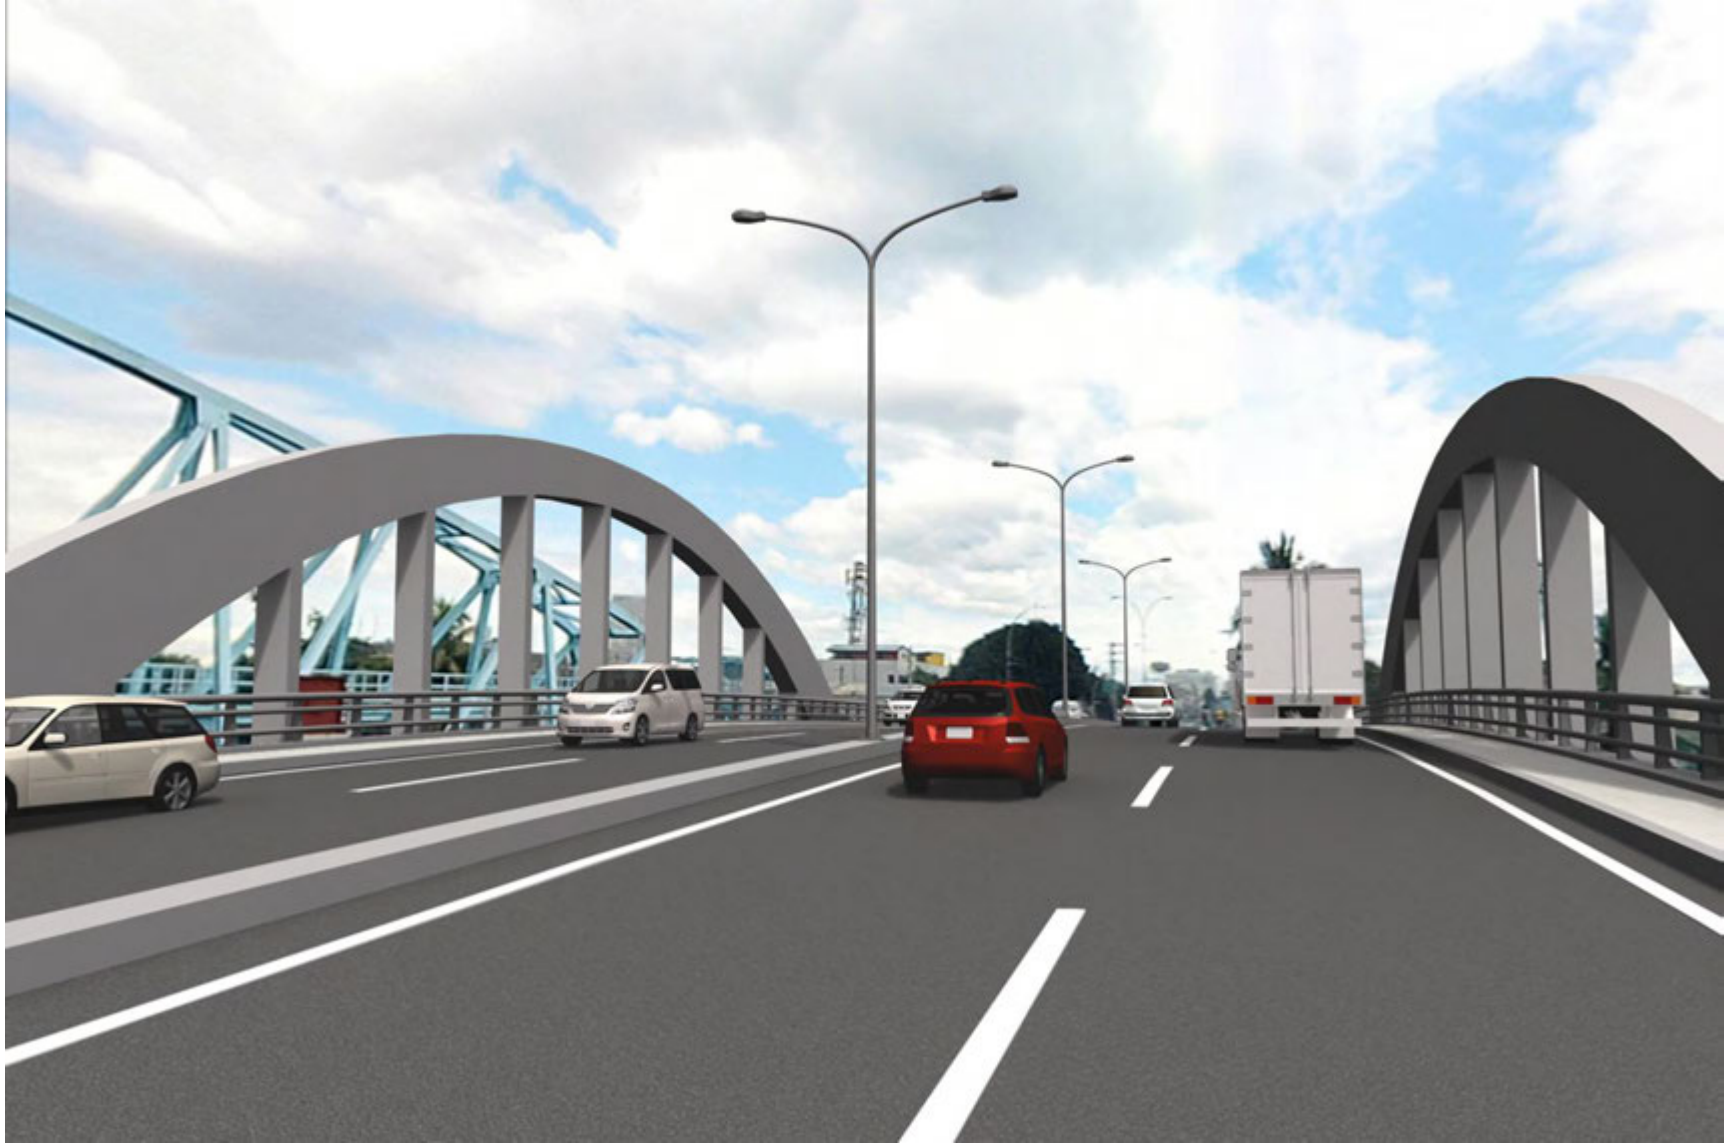
Perspective View of Lambingan Bridge (2/2)

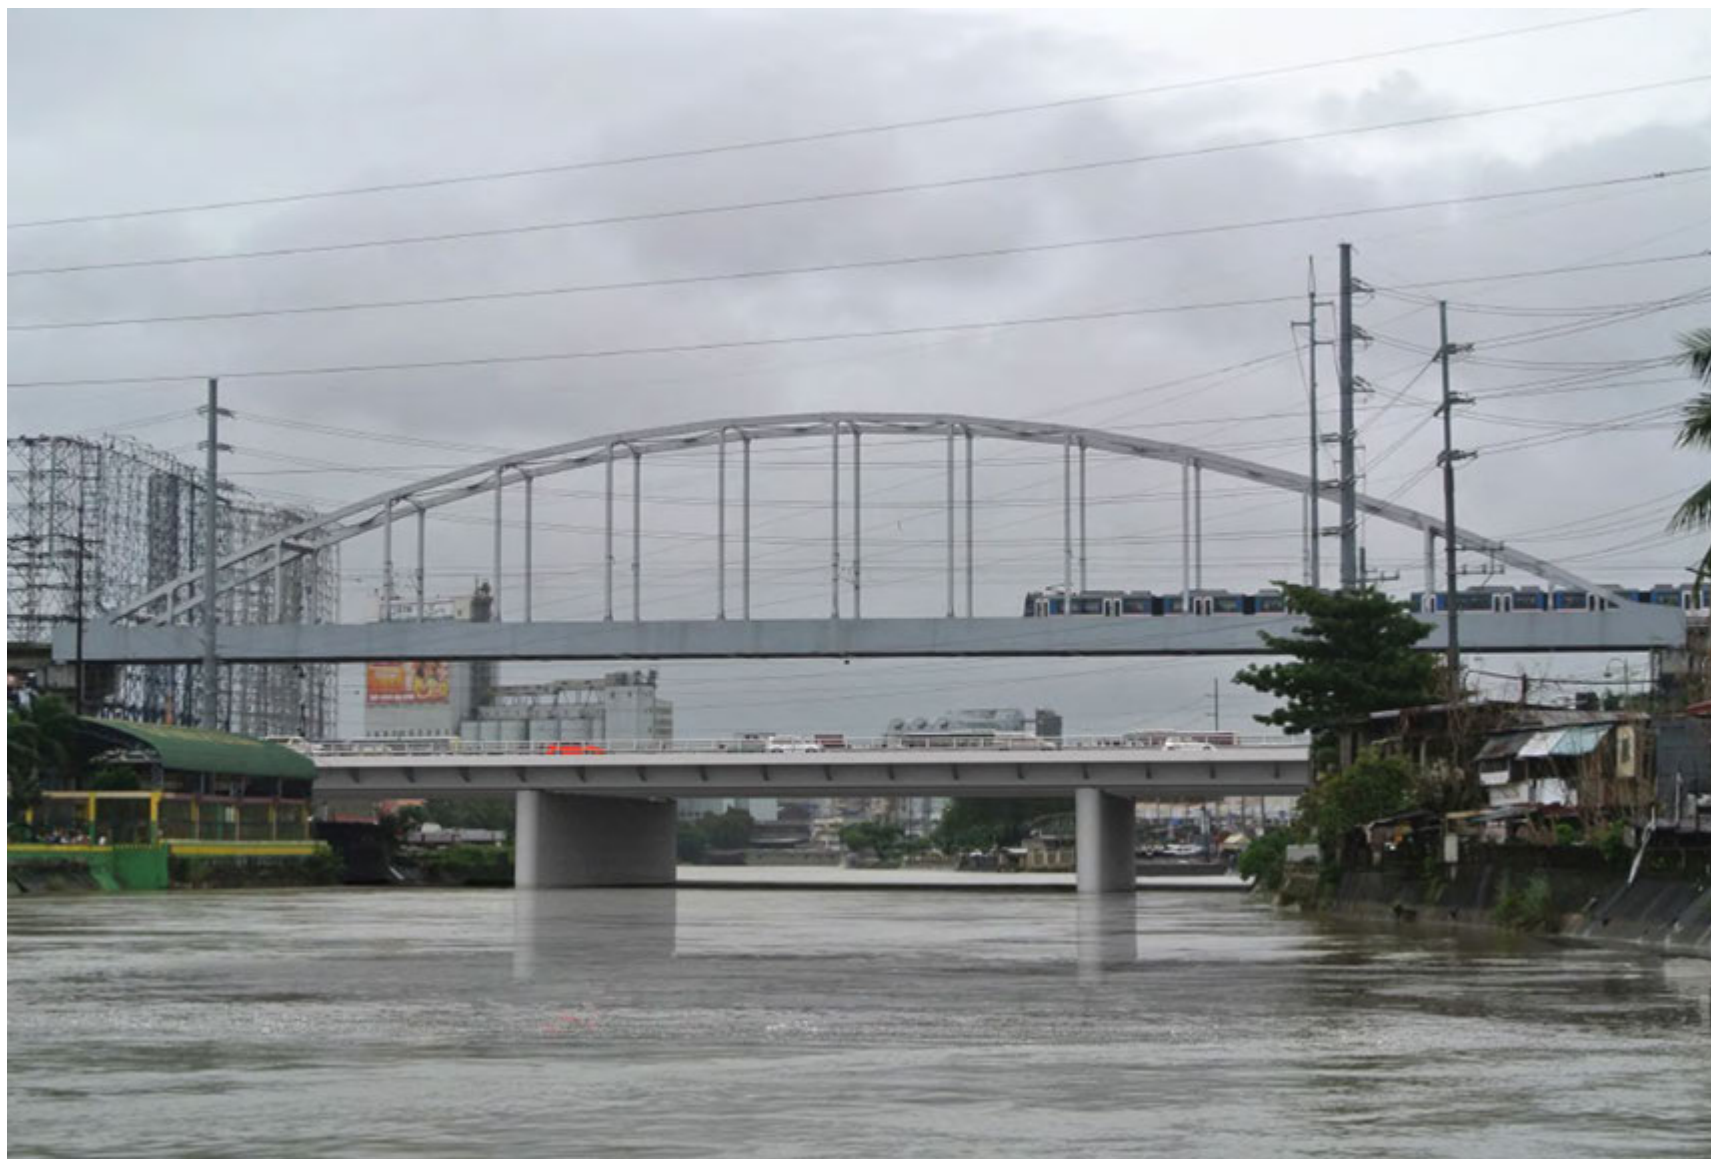
Perspective View of Guadalupe Bridge

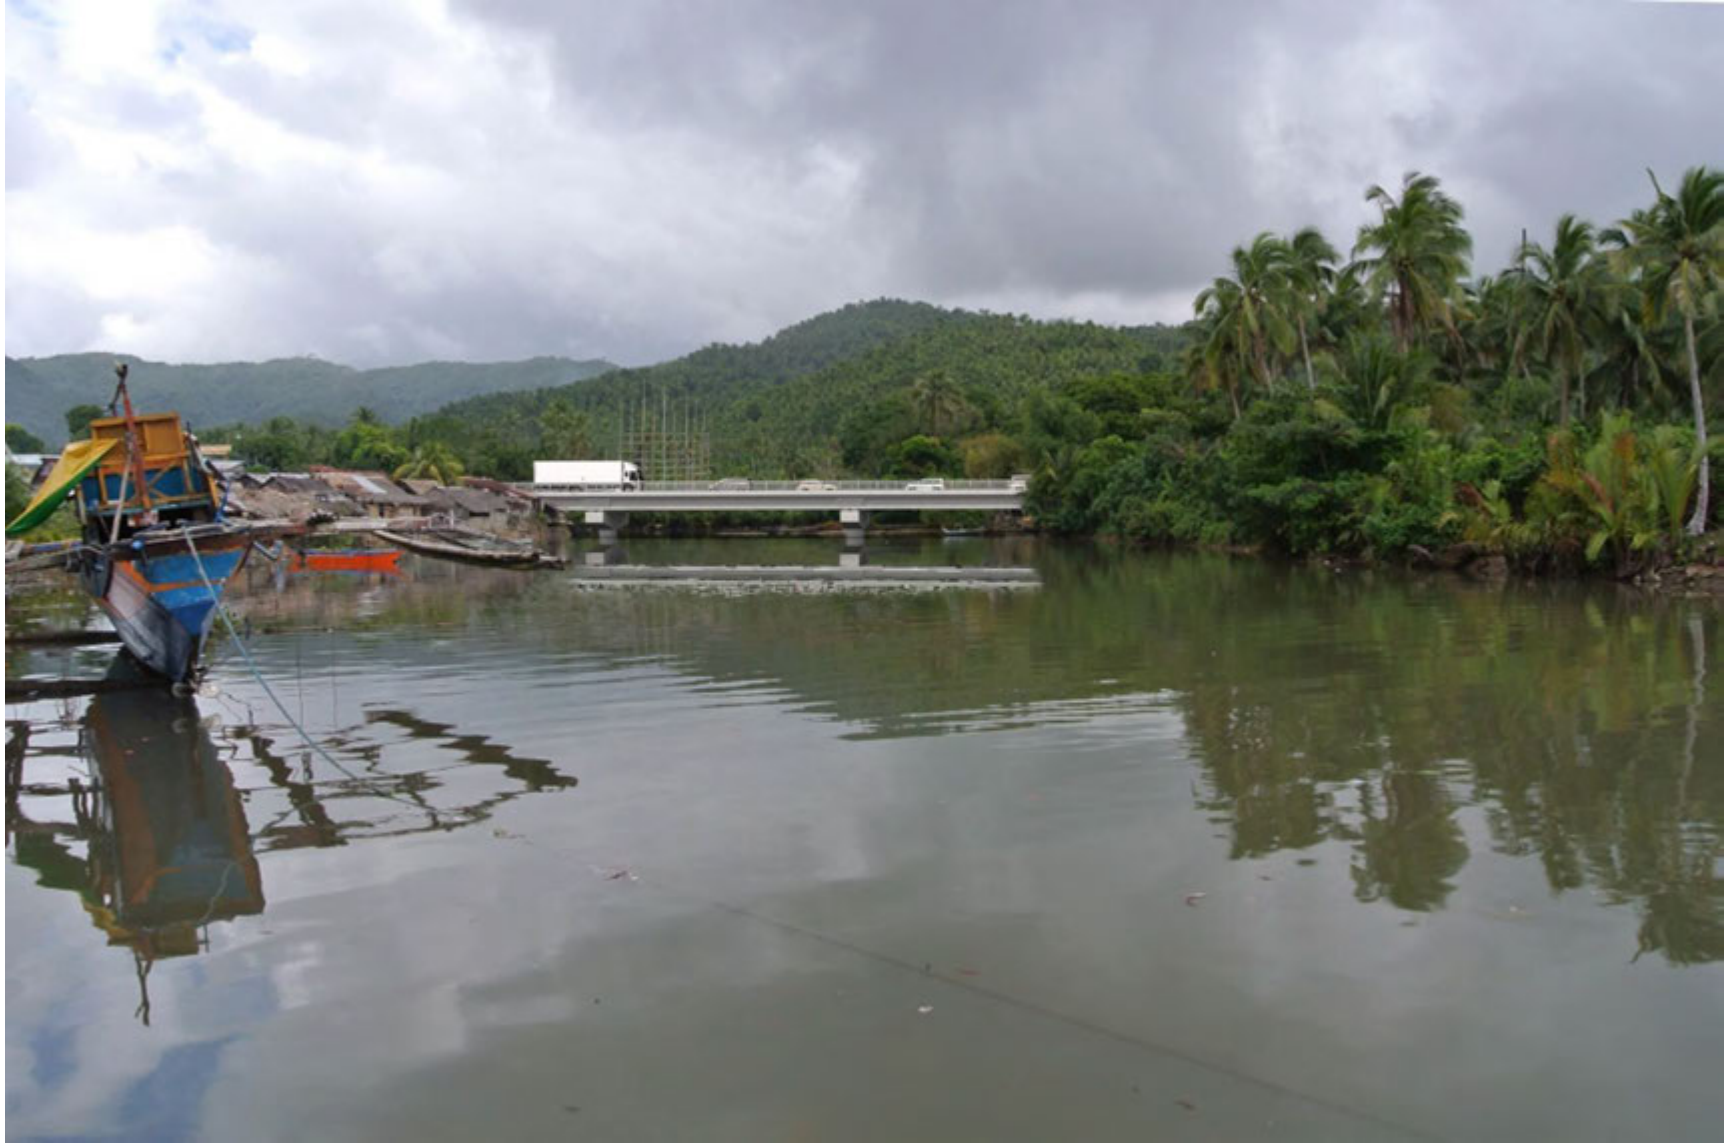
Perspective View of Palanit Bridge

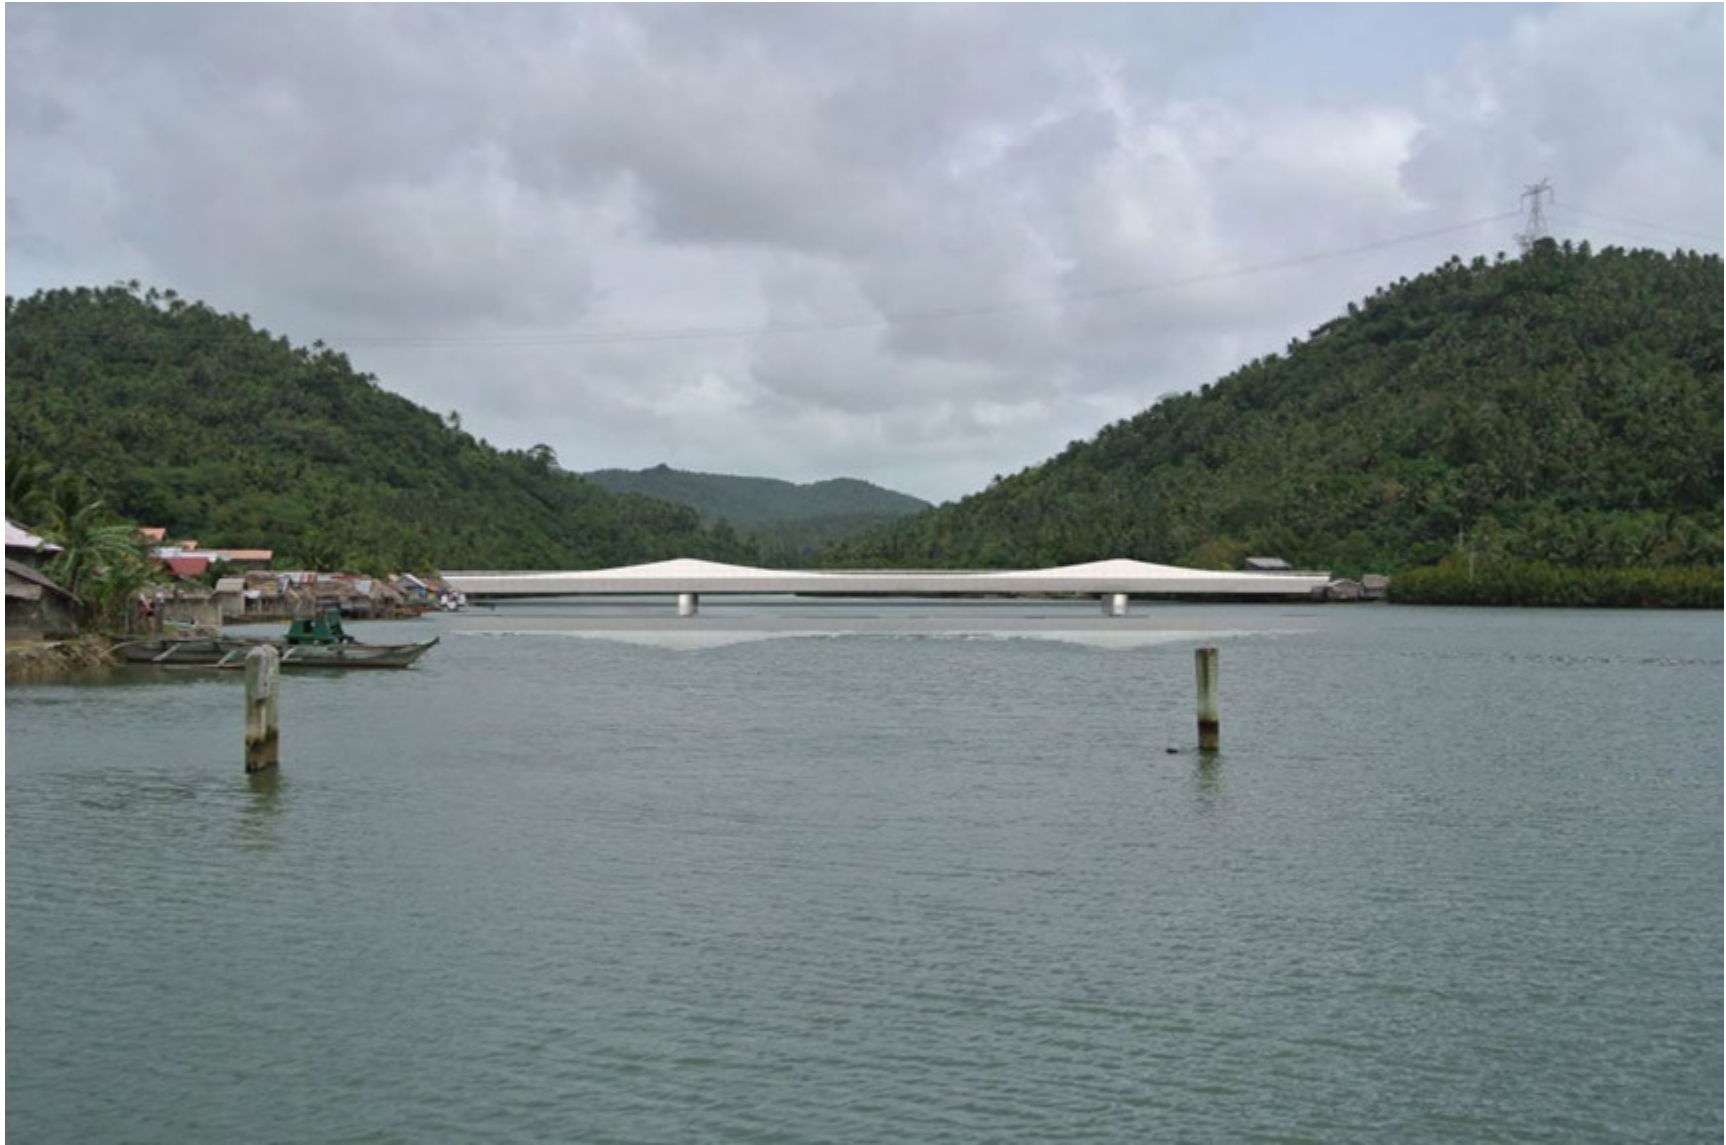
Perspective View of Mawo Bridge (1/2)

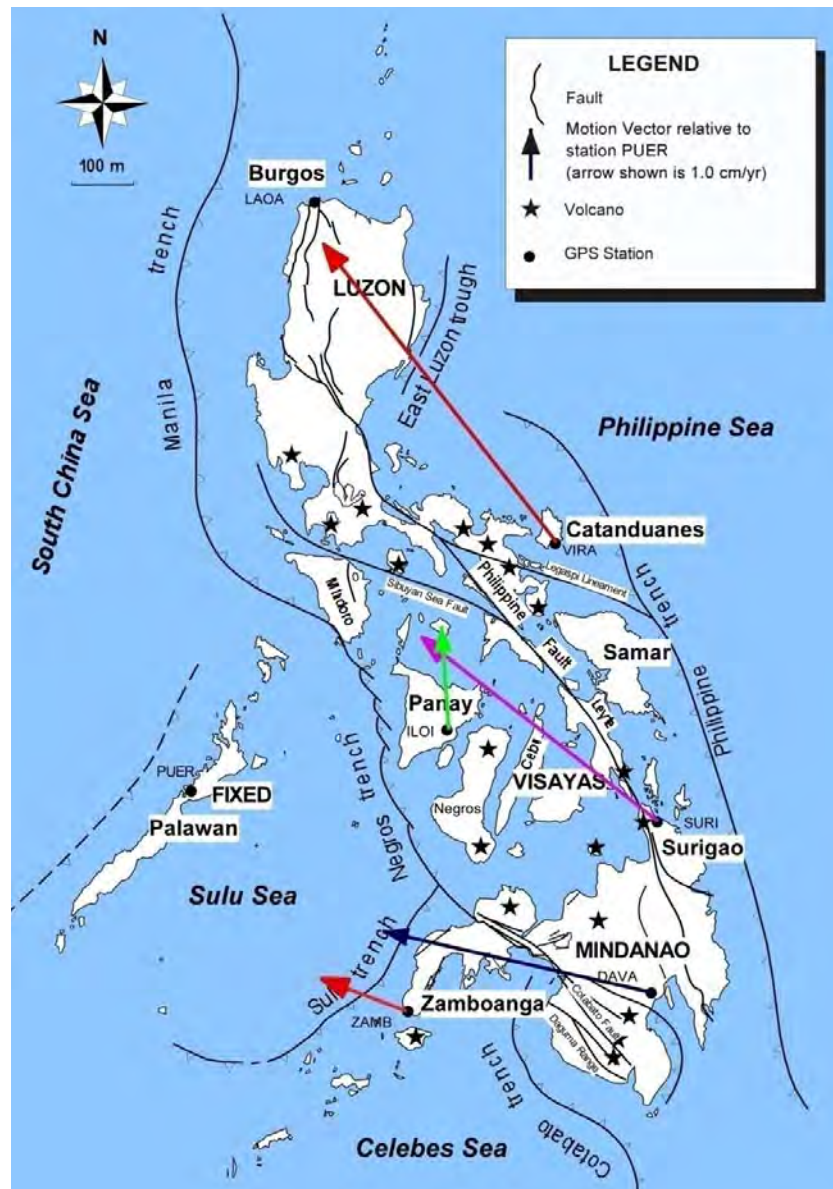
Figure 3.1.1-7 Motion Vectors in the Philippines Deduced from GPS Measurements.

Global Positioning System (GPS) data gathered every two years since 1994 over a 42-station network distributed in Southeast Asia under the acronym GEODYSSSEA to mean GEODYnamics of South and South East Asia have allowed the analysis of the present-day motion of tectonic blocks in and around the Philippines. Motion vectors in the archipelago and vicinity are in the order of a few to several cm/yr. When microcontinental Palawan is held fixed, the slowest movements can be detected in Zamboanga at less than 2 ± 0.15 cm/yr westwards (Figure 3.1.1-7). Virac Island moves the fastest at over 7 ± 0.17 cm/yr northwestwards.

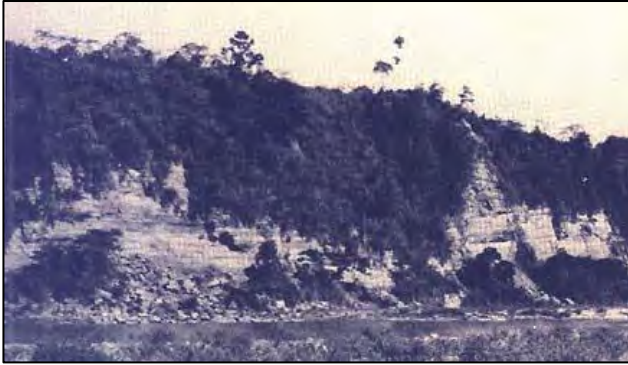
Landslide at bank of Manglad River

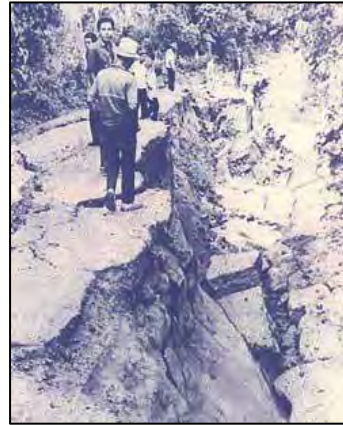
*Fissures on road from Casiguran to
Barrio Tabas*

In the epicentral area, around the town of Casiguran, cracks that were parallel to the nearest rivers were observed. Surface soil in this part is mostly loose deltaic sand. The length of the fissures varies from 10 to 20 meters but in some areas, it reached a length of 400 to 500 meters. The space between the cracks varies from 5 to 20 meters. Fissures on the road from Casiguran to Barrio Tabas produced a 0.5 meters crack and the surface subsidence varied to as much as two meters. This road is approximately 8 meters from the Casiguran River at the top of a steep bank approximately 2.5 meters high. Other fissure is on a logging road, 30 meters away from and parallel to river bank in Casiguran area.

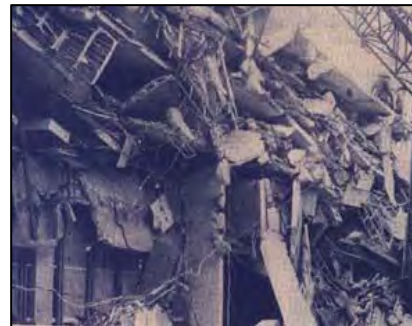
Ruby Tower collapse

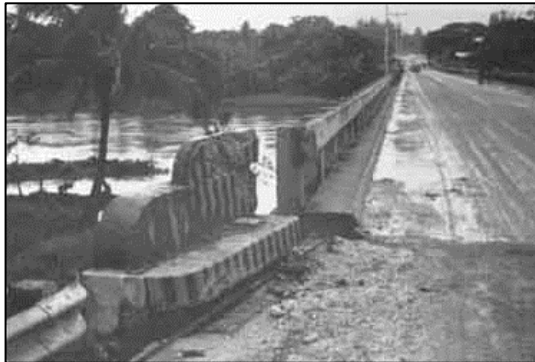
Centerline offset at Tamontaka Bridge

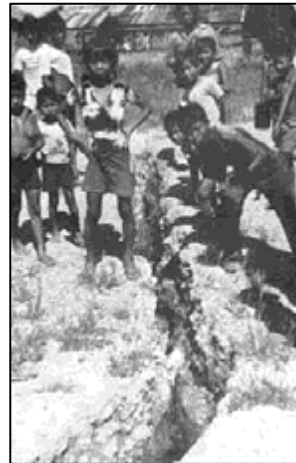
Ground fissure at Quirino Bridge

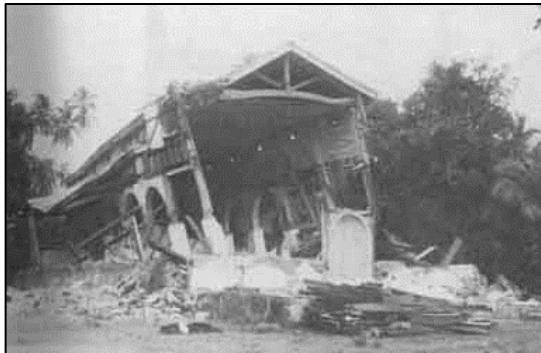
Collapse of Tamontaka Church

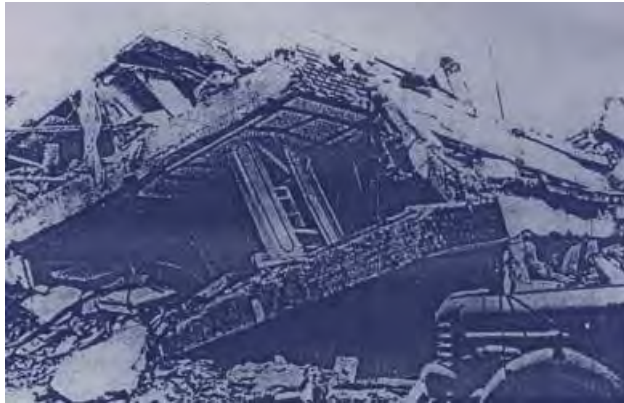
Shear and torsion failure of Denson Building (Laoag City)

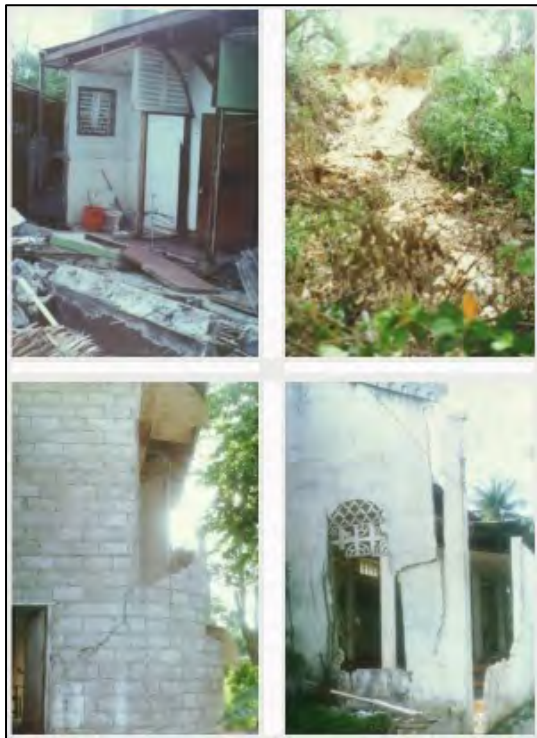
Partial collapse of building; shear cracks

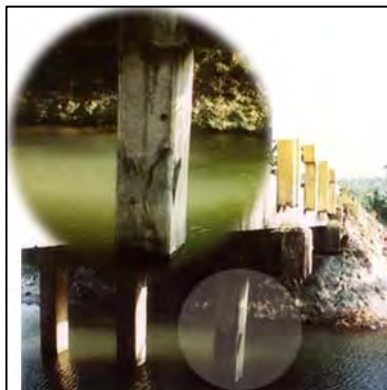
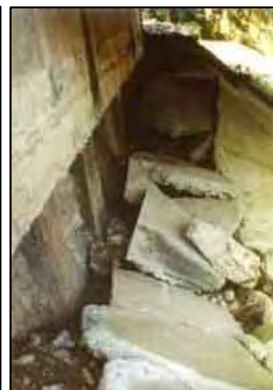
*The Nipa Bridge in Dimasalang (left photo) and the riprap structures
(right photo) that were damaged during the February quake.*

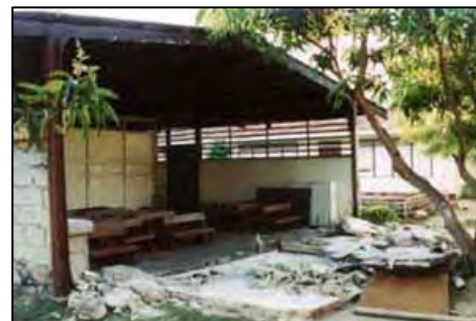
*Collapsed concrete wall of a school building in
Dimasalang, Masbate.*
