資料 9 試掘調查結果

Test Pit Investigation - Water Scheme, Apia, Samoa

Site:	In and around Apia, Samoa	Job No.:	615478.178	Client Ref.:	750556									
Client:	T&TI	Contractor:	Geotechnics Ltd											
Test Method Used: NZS 4402:1988 Test 6.5.2 Dynamic Cone Penetrometer														
TEST PIT INVESTIGATION LOG REPORT														
Project:	Samoa Water Treatment scheme		Sampled by:											
Location:	S 13° 52' 02.9" W 171° 44' 49.8"		Date sampled:											
Chainage:			Sampling method:											
House No.:			Sample condition:											
Pit No.:	1		Date recovered:											
Depth (mm)	Description	Estimated Field CBR												
0 - 400	Gravelly SAND with some silt; dark brown, mottled grey. Moist.	0.09	15	8	23									
400	Top of rock.	0.08	16	18	28									
400	End of pit.	0.07	13	16	33

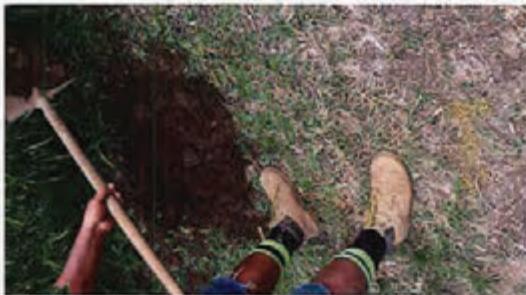
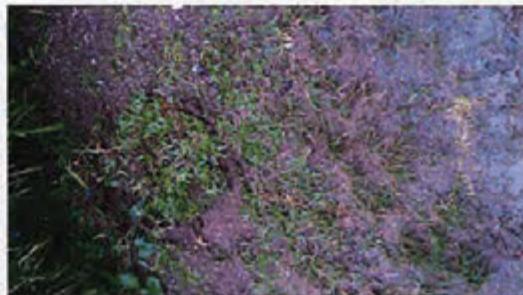
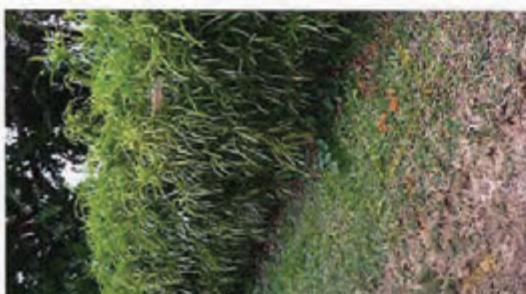
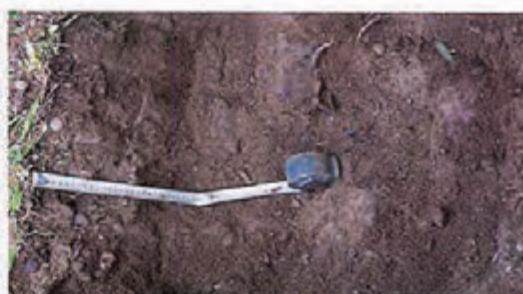
TP 1, Apia site plan

COMMENTS:
The estimated CBR values are based on Figure 5.3, Correlation of Dynamic Cone Penetration and CBR AUSTROADS (2004) "Pavement Design - A Guide to the Structural Design of Road Pavements"
IANZ Accreditation does not apply
Tested by: LZ Date: 5/07/2013 Checked by: IW Date: 16/07/2013

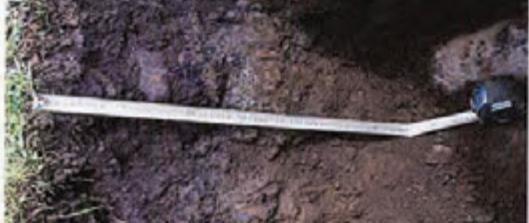
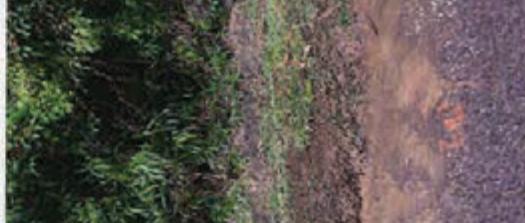
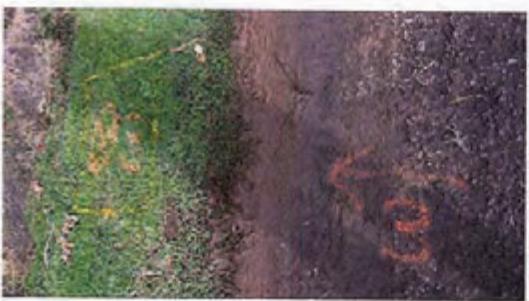
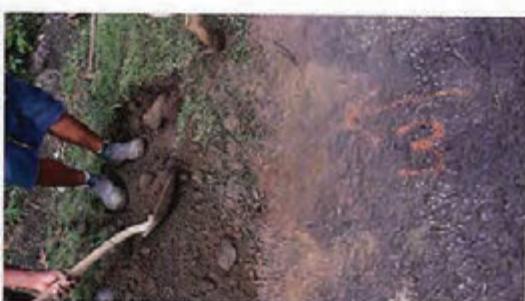
TP 3, as per site plan

Site:	In and around Apia, Samoa	Job No.:	615478.178	Client Ref:	750956
Client:	T&T	Contractor:	Geotechnics Ltd		
Test Method Used: Nzs 4402:1988 Test 6.5.2 Dynamic Cone Penetrometer					
TEST PIT INVESTIGATION LOG REPORT					
Project:	Samoa Water Treatment scheme		Sampled by:		
Location:	S 13°51'47.5"E W 171°44'49.3"S		Date sampled:		
Chainage:			Sampling method:		
House No.:			Sample condition:		
Pit No.:	3		Date Received:		
Depth (mm)	Description	Estimated Field CBR			
0 - 300	Sandy GRAVEL with trace of silt, dark brown, mottled grey. Moist.	3.6	8	13	18
300 - 700	Clayey SILT with some gravel, brown. Moist, Non-plastic.	13	23	33	45
700	Grey pipe, ~200mm diameter.	39	45	50	
700	End of pit.	0.06	0.08	0.08	0.08

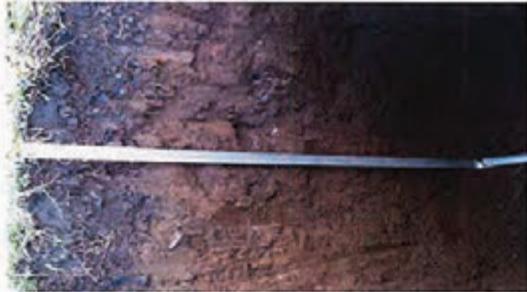
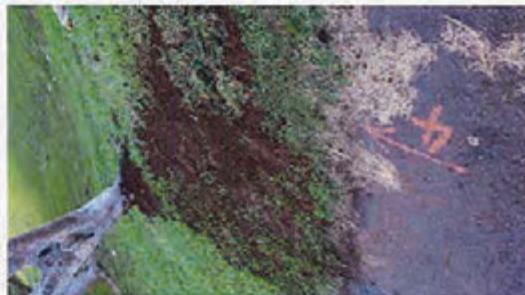
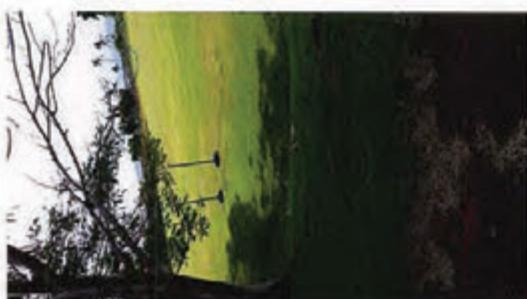
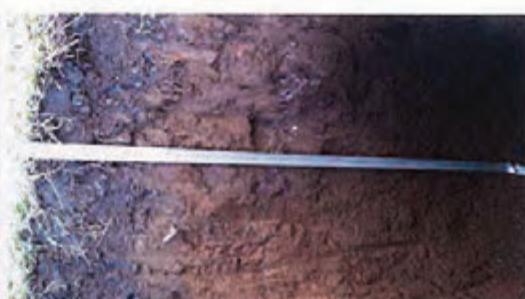
HP 4, as per site plan

TEST PIT INVESTIGATION LOG REPORT						Page 1 of 1	
Site:	In and around Apia, Samoa	Job No.:	615478-178	Client Ref.:	750956		
Client:	T&I	Contractor:	Geotechnics Ltd				
Test Method Used:	NZS 4402:1988 Test 6.5.2	Dynamic Cone Penetrometer					
Project:	Samma Water Treatment scheme	Sampled by:					
Location:	S 13° 51' 33.0" W 171° 44' 36.2"	Date sampled:					
Chainage:		Sampling method:					
House No.:		Sample condition:					
Pit No.:	4	Date Received:					
Depth (mm)	Description	Estimated Field CBR					
0 - 150	Sandy SILT with some gravel; dark brown. Moist, Non-plastic.	0.06	3.5	8	13	18	23
150 - 1200	Clayey SILT with minor gravel; brown. Moist, low plasticity.	0.06	28	33	38	45	50
1200	End of pit.	0.07

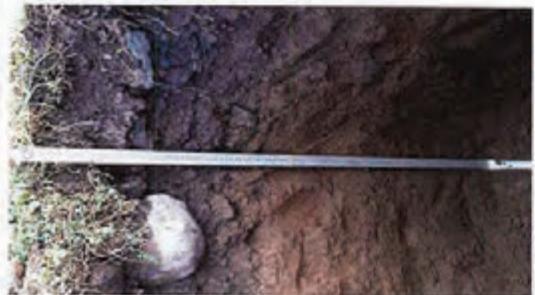
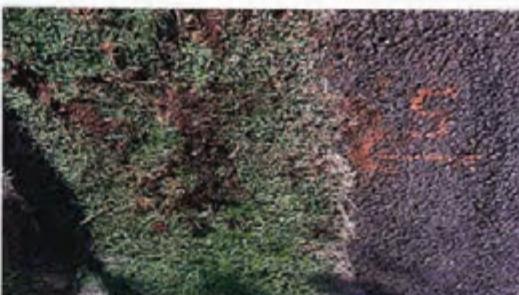
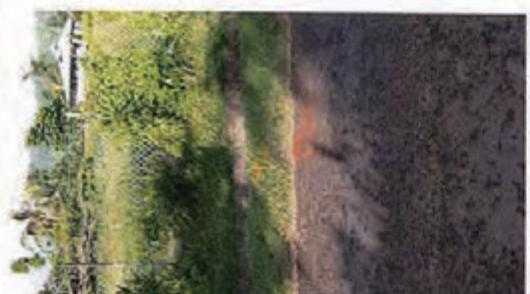
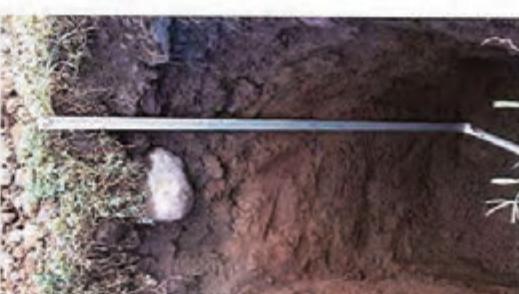
Site:	In and around Apia, Samoa	Job No.:	615478.178	Client Ref.:	750956	Page 1 of 1	
Client:	T&TI	Contractor:	Geotechnics Ltd				
Test Method Used:	NZS 4402:1988 Test 6.5.2 Dynamic Cone Penetrometer						
TEST PIT INVESTIGATION LOG REPORT							
Project:	Samoa Water Treatment scheme		Sampled by:				
Location:	S 13° 51' 22.5" W 171° 44' 30.0"		Date sampled:				
Chainage:			Sampling method:				
House No.:			Sample condition:				
Pit No.:	5		Date Received:				
Depth (mm)	Description	Estimated Field CBR					
0 - 300	Silty GRAVEL with some sand; dark brown. Moist.	3.5	8	13	18	23	28
300 - 1200	Clayey SILT with trace of gravel; brown to dark brown. Moist; low plasticity.	33	38	43	48	53	58
1200	End of pit	0.07

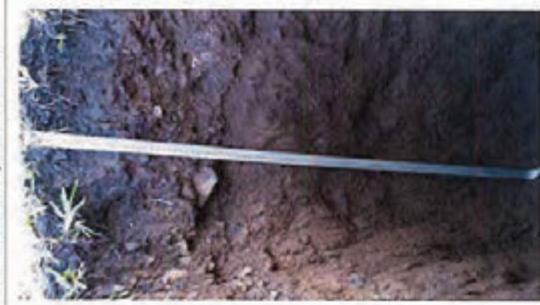
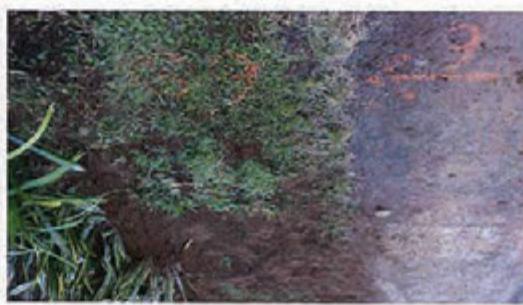
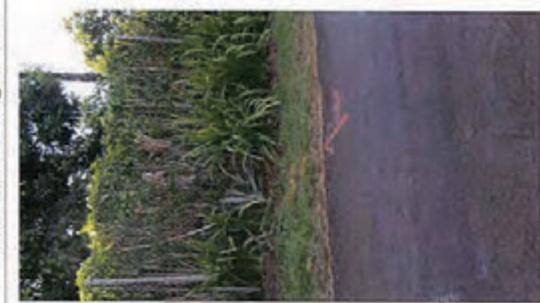
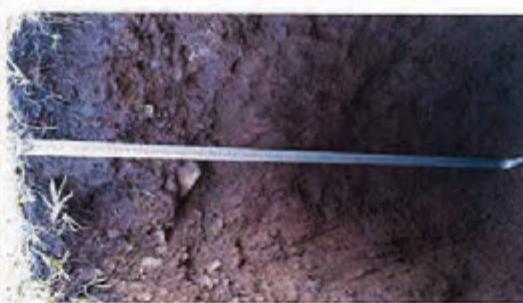
TP 6, as per site plan

Site:	In and around Apia, Samoa	Job No.:	615478.178	Client Ref:	750956		
Client:	T&T	Contractor:	Geotechnics Ltd				
Page 1 of 1							
TEST PIT INVESTIGATION LOG REPORT							
Project:	Samoa Water Treatment scheme						
Location:	S 13° 51' 13.8" W 171° 44' 32.9"						
Chainage:							
House No.:							
Pit No.:	6						
Depth (mm)	Description	Estimated Field CBR					
0 - 150	Gravelly SILT with minor sand; dark brown. Moist. Non-plastic.	0.06	3.5	8	13	18	
150 - 300	Gravelly SAND; brown, mottled grey. Moist.	0.08	23	28	33	39	
300 - 1200	Clayey SILT with trace of sand; brown. Wet, low plasticity.	0.07	45	50			
1200	End of pit.	0.09

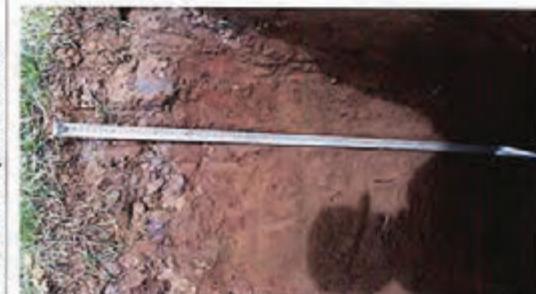
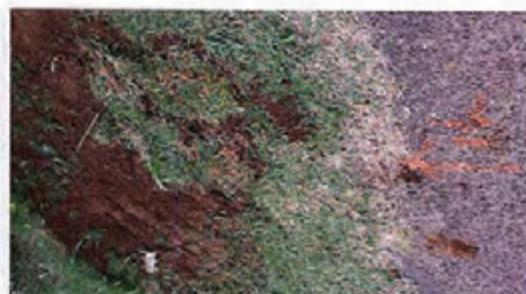
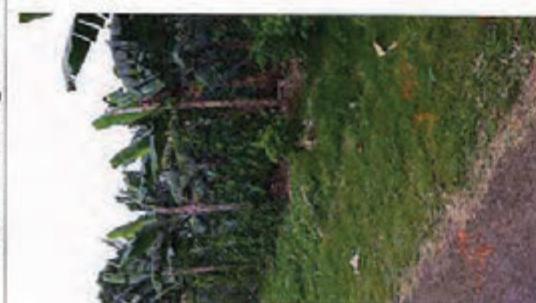
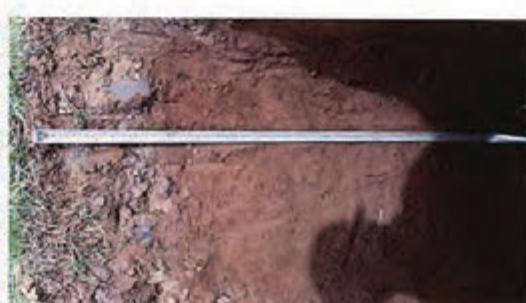
P7, as per site plan

Page 1 of 1													
Site:	In and around Apia, Samoa	Job No.:	615478.178	Client Ref.:	700956										
Client:	T&T	Contractor:	Geotechnics Ltd												
TEST PIT INVESTIGATION LOG REPORT															
Project:	Samoa Water Treatment scheme			Sampled by:											
Location:	S 13° 51' 25.0" W 171° 44' 40.4"			Date sampled:											
Chainage:				Sampling method:											
House No.:				Sample condition:											
Pit No.:	7			Date Received:											
Depth (mm)	Description	Estimated Field CBR													
0 - 250	Silty GRAVEL with some sand; brown, mottled grey, moist.	0.00	3.5	8	13	18	23	28	33	38	43				
250 - 1200	Clayey SILT with trace of gravel; brown, moist, Non-plastic.	0.08													
1200	End of pit.	0.07

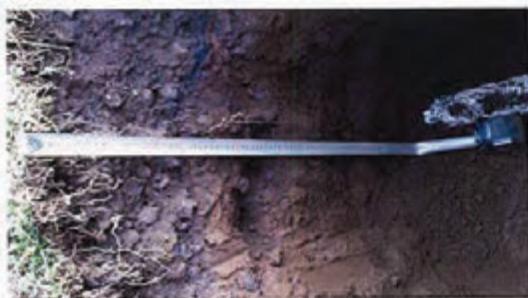
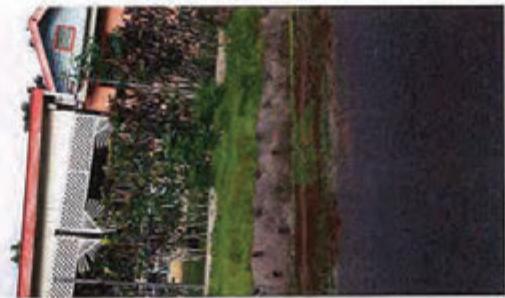
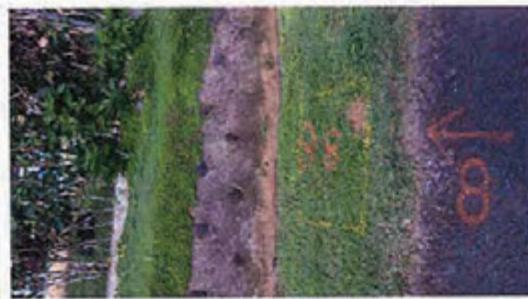
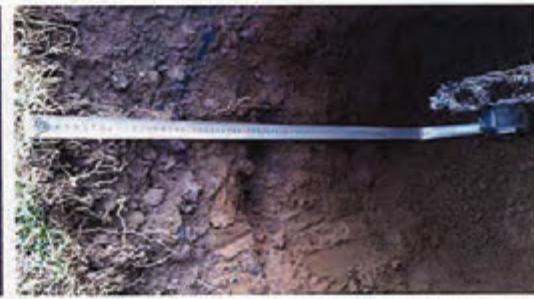
TP & TS per site plan

Site:	In and around Apia, Samoa	Job No.:	615478.178	Client Ref:	75056									
Client:	T&T	Contractor:	Geotechnics Ltd											
Test Method Used: NZS 4402:1988 Test 6.5.2 Dynamic Cone Penetrometer														
TEST PIT INVESTIGATION LOG REPORT														
Project:	Samoa Water Treatment scheme		Sampled by:											
Location:	S 13° 51' 22.8" W 171° 44' 48.1"		Date sampled:											
Chainage:			Sampling method:											
House No.:			Sample condition:											
Pit No.:	8		Date Received:											
Depth (mm)	Description	Estimated Field CBR

3.5	8	13	18	23	28	33	39	45	50			
0 - 200	Sandy GRAVEL with trace of silt; dark brown, mottled grey. Moist.	0.09												
200 - 350	Gravelly SILT with minor clay; brown, mottled grey. Moist, Non-plastic.	0.08												
350 - 800	Clayey SILT with trace of gravel; brown. Moist, Non-plastic.	0.07												
800	White pipe, ~100mm diameter.	0.06												
800	End of pit.	0.05

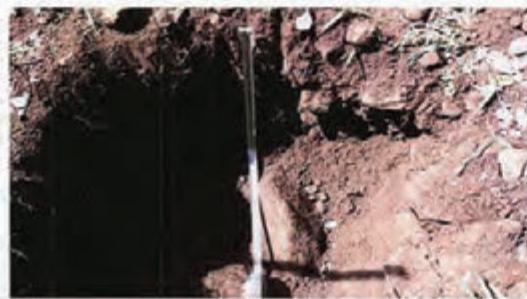
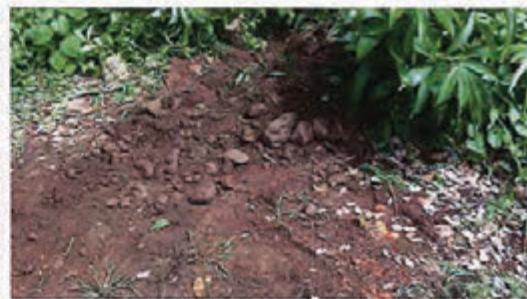
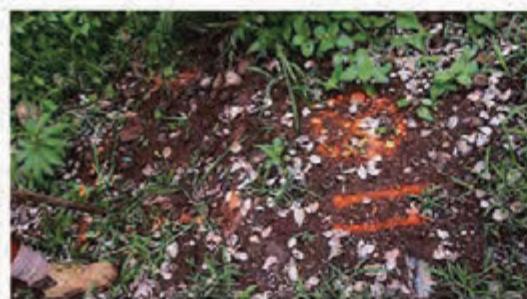
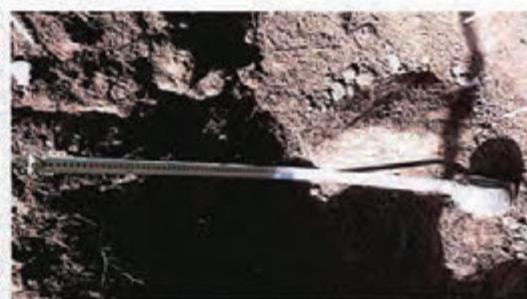
Site:	In and around Apia, Samoa	Job No.:	615478.178	Page 1 of 1
Client:	T&TI	Contractor:	Geotechnics Ltd	Client Ref: 750956
TEST PIT INVESTIGATION LOG REPORT				
Project:	Samoa Water Treatment scheme			Sampled by:
Location:	S 13° 52' 21.5" W 171° 46' 08.4"			Date sampled:
Chainage:				Sampling method:
House No.:				Sample condition:
Pit No.:	11			Date Recovered:
Depth (mm)	Description	Estimated Field CBR		
0 - 500	SILTY GRAVEL with some sand; dark brown. Moist;	3.5	8	13 18 23 28 33 39 45 50
500	Top of rock.	0.09		
500	End of pit.	0.08

0.07		
		0.06		
		0.05		
		0.04		
		0.03		
		0.02		
		0.01		
		0.00		
			0 1 2 3 4 5 6 7 8 9 10	Number of blows per 50mm
COMMENTS: The estimated CBR values are based on Figure 5.3, Correlation of Dynamic Cone Penetration and CBR AUSTRADS (2004) "Pavement Design - A Guide to the Structural Design of Road Pavements" IANZ Accreditation does not apply				
Tested by: LZ	Date: 30/07/2013	Checked by: IW	Date: 16/07/2013	Date: 16/07/2013

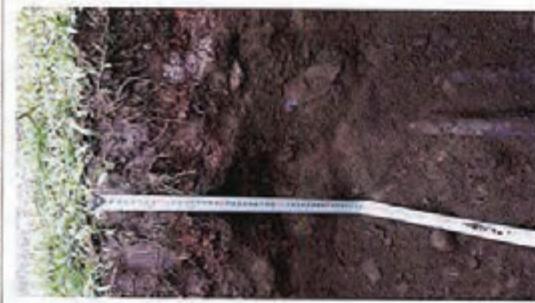
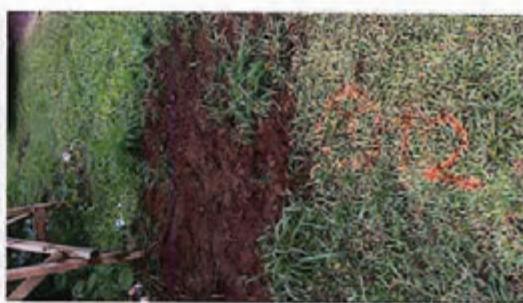
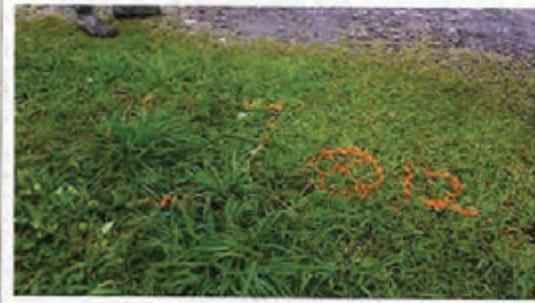
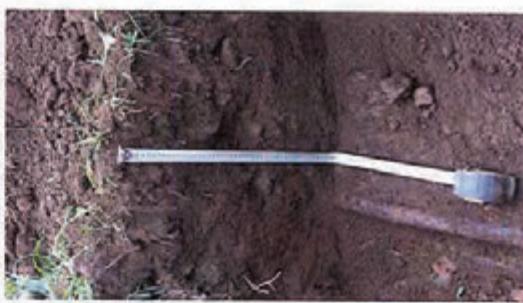
TP 12 : 05' core with plan

TEST PIT INVESTIGATION LOG REPORT											
Project:	Samoa Water Treatment scheme		Sampled by:	Estimated Field CBR									
Location:	S 13° 51' 28.8" W 171° 45' 42.5"		Date sampled:	3.6	8	13	18	23	28	33	39	45	
Client:	T&T	Contractor:	Geotechnics Ltd	Sampling method:	0.09	0.08	0.07	0.06	0.05	0.04	0.03	0.02	
Test Method Used:	NZS 4402:1988 Test 6.5.2	Dynamic Cone Penetrometer	Sample condition:	12	Date Received:	0.01	0.00	0.00	0.00	0.00	0.00	0.00	
Depth (mm)	Description	Depth (m)	Estimated Field CBR	3.6	8	13	18	23	28	33	39	45	
0 - 100	Gravelly SILT with some sand; dark brown. Moist, Non-plastic.	0.00	0.09	0.09	0.09	0.09	0.09	0.09	0.09	0.09	0.09	0.09	
100 - 200	Demolition rubbish: reddish brown.	0.02	0.08	0.08	0.08	0.08	0.08	0.08	0.08	0.08	0.08	0.08	
200 - 500	Sandy SILT with some gravel; brown. Moist, Non-plastic.	0.04	0.07	0.07	0.07	0.07	0.07	0.07	0.07	0.07	0.07	0.07	
500	2 steel pipes, ~40mm diameter.	0.06	0.06	0.06	0.06	0.06	0.06	0.06	0.06	0.06	0.06	0.06

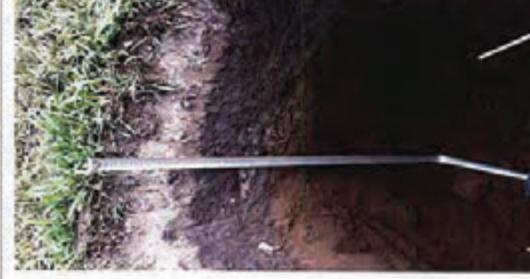
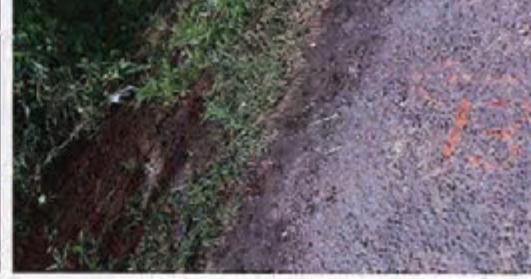
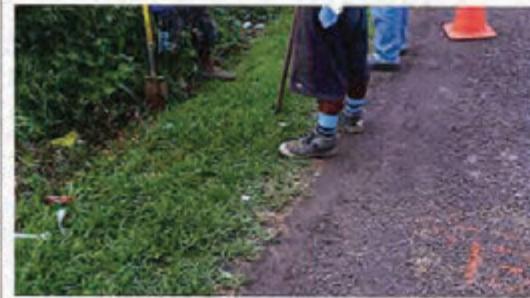
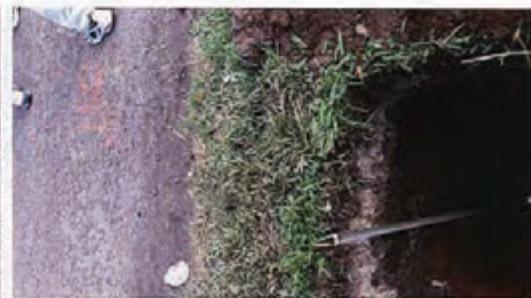
Site:	In and around Apia, Samoa	Job No.:	615478.178	Client Ref:	750856						
Client:	T&T	Contractor:	Geotechnics Ltd								
Test Method Used:	NZS 4402:1988 Test 6.5.2 Dynamic Cone Penetrometer										
TEST PIT INVESTIGATION LOG REPORT											
Project:	Samoa Water Treatment scheme	Sampled by:									
Location:	S 13°52'02.8" W 171°45'26.8"	Date sampled:									
Chainage:		Sampling method:									
House No.:		Sample condition:									
Pit No.:	13	Date Received:									
Depth (mm)	Description	Estimated Field CBR									
0 - 100	Sandy SILT with minor clay; dark brown. Moist, Non-plastic.	3.5	8	13	18	23	28	33	39	45	50
100 - 200	Gravelly SAND; light grey. Dry.	0.09									
200 - 400	Gravelly SAND with minor silt; dark brown. Moist.	0.08									
400 - 1200	Clayey SILT with minor gravel; brown. Moist, Non-plastic.	0.07									
1200	End of pit.	0.06

0.05									
		0.04									
		0.03									
		0.02									
		0.01									
		0.00	0	1	2	3	4	5	6	7	8
			Number of blows per 50mm								
						Density By Nuclear Densimeter					
Basecourse sample recovered at:	(mm)	Basecourse	Subgrade								
Sub-base sample recovered at:	(mm)			N/A	N/A						
Subgrade sample recovered at:	(mm)			N/A	N/A						
Depth from ground surface to commencement of penetration:	(mm)			0	0						
						Density					
Basecourse sample recovered at:	(mm)	Wet density (t/m³);									
Sub-base sample recovered at:	(mm)	Dry density (t/m³);									
Subgrade sample recovered at:	(mm)	Water content (%);									
COMMENTS:						The estimated CBR values are based on Figure 5.3, Correlation of Dynamic Cone Penetration and CBR					
AUSTRADDS (2004) "Pavement Design - A Guide to the Structural Design of Road Pavements"						I/ANZ Accreditation does not apply					
Tested by:	LZ	Date:	3/07/2013	Checked by:	IW	Date:	16/07/2013

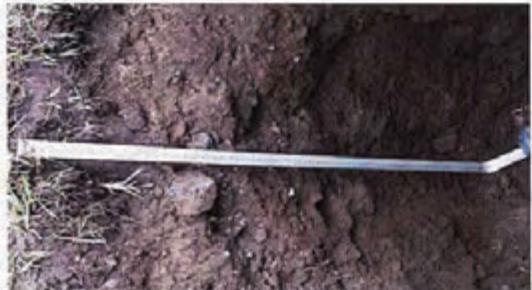
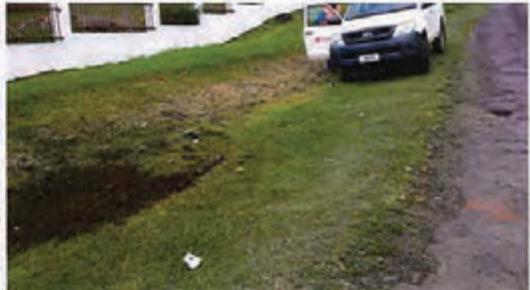
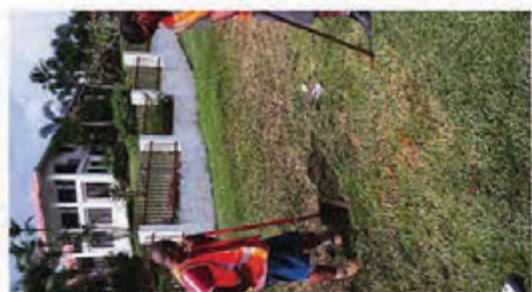
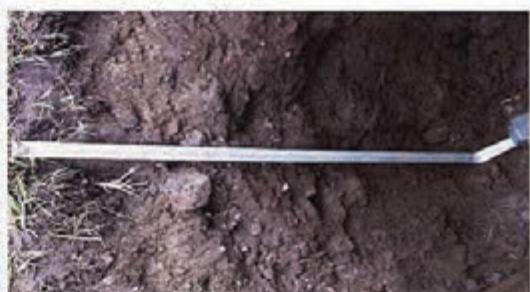
Site:	In and around Apia, Samoa	Job No.:	615478-178	Client Ref.:	750956	Page 1 of 1					
Client:	T&T	Contractor:	Geotechnics Ltd								
Test Method Used:	NZS 4402:1988 Test 6.5.2	Dynamic Cone Penetrometer									
TEST PIT INVESTIGATION LOG REPORT											
Project:	Samoa Water Treatment scheme		Sampled by:								
Location:	S 13° 51' 44.6" W 171° 45' 41.6"		Date sampled:								
Chainage:			Sampling method:								
House No.:			Sample condition:								
Pit No.:	14		Date Received:								
Depth (mm)	Description	Estimated Field CBR

3.5	8	13	18	23	28	33	38	45	50
0 - 150	Gravelly SILT; dark brown, Moist, Non-plastic.	0.09									
150 - 350	Sandy GRAVEL with some silt; brownish grey, Moist.	0.08									
350 - 900	Sandy SILT with some gravel; brown. Moist, Non-plastic.	0.07									
900 - 950	Top of rock.	0.06									
950	End of pit.	0.05

0.04									
		0.03									
		0.02									
		0.01									
		0.00	0	1	2	3	4	5	6	7	
									8	9	
									10		
Basecourse sample recovered at:		Density By Nuclear Densometer									
Sub-base sample recovered at:		Basecourse	Subgrade								
Subgrade sample recovered at:		N/A	N/A								
Depth from ground surface to commencement of penetration:		N/A	N/A								
		N/A (mm)	N/A (mm)								
		N/A (mm)	N/A (mm)								
		0 (mm)	0 (mm)								
		Wet density (t/m ³); Dry density (t/m ³); Water content (%);									
COMMENTS:		The estimated CBR values are based on Figure 5.3, Correlation of Dynamic Cone Penetration and CBR. AUSTRROADS (2004) 'Pavement Design - A Guide to the Structural Design of Road Pavements'									
Tested by:	LZ	Date:	3/07/2013	Checked by:	IW	Date:	16/07/2013

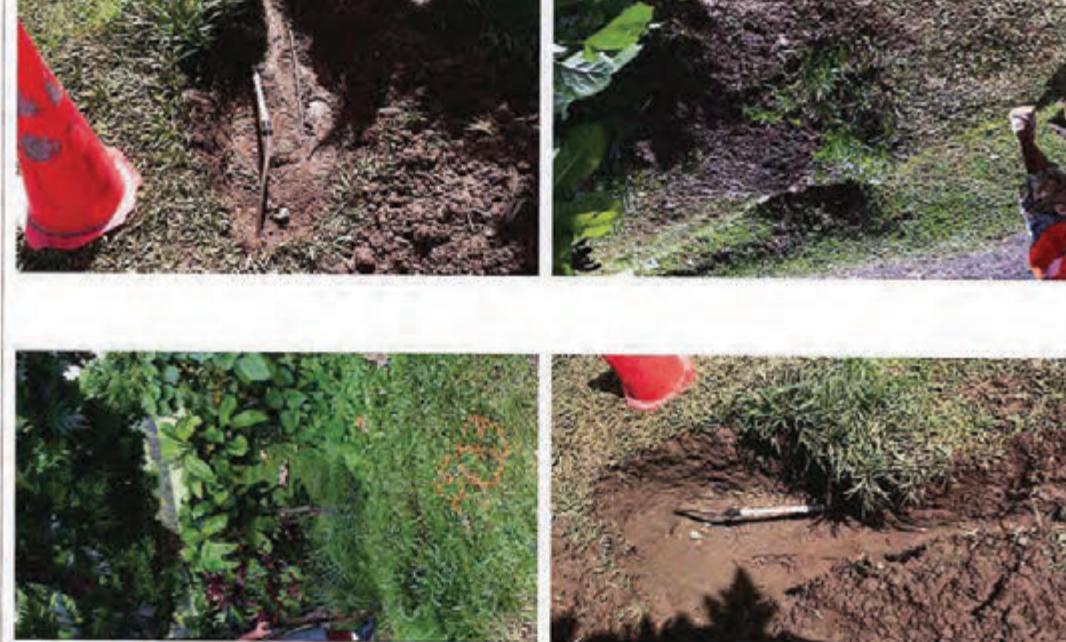
TP 15 : as per site plan

Site:	In and around Apia, Samoa	Job No.:	615478.178	Client Ref:	750956
Client:	T&T	Contractor:	Geotechnics Ltd		
Test Method Used: NZS 4402:1988 Test 6.5.2 Dynamic Cone Penetrometer					
TEST PIT INVESTIGATION LOG REPORT					
Project:	Samoa Water Treatment scheme		Sampled by:		
Location:	S 13° 51' 23.6" W 171° 45' 39.7"		Date sampled:		
Chainage:			Sampling method:		
House No.:			Sample condition:		
Pit No.:	15		Date Received:		
Depth (mm)	Description	Estimated Field CBR	Depth (m)	Number of blows per 50mm	
0 + 300	Sandy SILT with some gravel; dark brown. Moist, Non-plastic.	0.08	0.00	0	
300 - 350	2 black pipes, ~20mm diameter.	0.06	0.01	1	
350	End of pit.	0.07	0.02	2	
		0.08	0.03	3	
		0.09	0.04	4	
		0.05	0.01	5	
		0.04	0.02	6	
		0.03	0.01	7	
		0.02	0.00	8	
		0.01	0.00	9	
		0.00	0.00	10

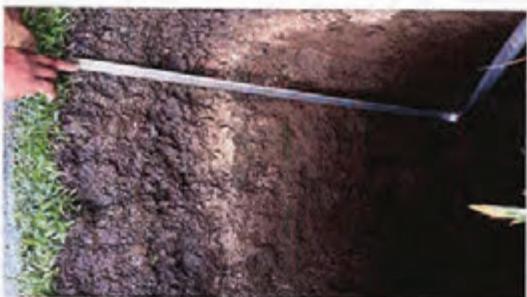
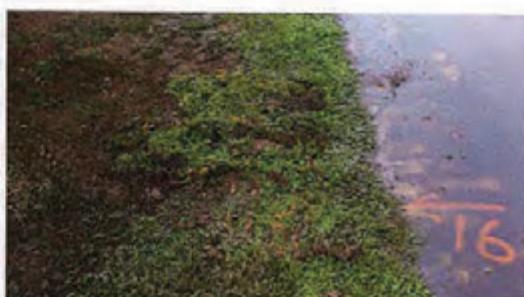
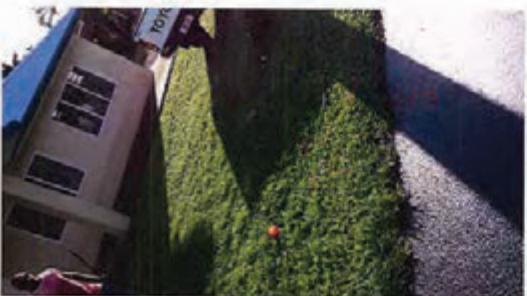
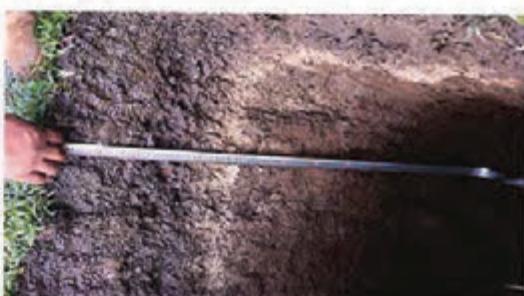
TP 16 - At test site plan

Site:	In and around Apia, Samoa	Job No.:	615478.178	Client Ref:	750956	
Client:	T&T	Contractor:	Geotechnics Ltd			
Test Method Used: NZS 4402:1988 Test 6.5.2 Dynamic Cone Penetrometer						
TEST PIT INVESTIGATION LOG REPORT						
Project:	Samoa Water Treatment scheme					
Location:	S 13° 51' 00.5" W 171° 45' 47.8"					
Chainage:						
House No.:						
Pit No.:	16					
Depth (mm)	Description	Estimated Field CBR				
0 - 300	Sandy SILT with some clay; dark brown, mottled black. Moist, Non-plastic.	3.5	8	13	18	23
300 - 400	Gravelly medium to coarse SAND; light brown. Dry, Non-plastic.	0.08	0.08	0.08	0.08	0.08
400 - 1000	Sandy SILT with some gravel; brown. Moist, low plasticity.	0.07	0.07	0.07	0.07	0.07
1000-1200	Sandy SILT with some gravel; dark brown. Wet, Non-plastic.	0.06	0.06	0.06	0.06	0.06
1200	End of pit.	0.04	0.04	0.04	0.04	0.04

0.03	0.03	0.03	0.03	0.03
		0.02	0.02	0.02	0.02	0.02
		0.01	0.01	0.01	0.01	0.01
		0.00	0	1	2	3
						Number of blows per 50mm
						4 5 6 7 8 9 10
						Density By Nuclear Densometer
Basecourse sample recovered at:	N/A (mm)	Subgrade sample recovered at:	N/A (mm)	Basecourse	Subgrade	
Sub-base sample recovered at:	N/A (mm)	Subgrade sample recovered at:	N/A (mm)	N/A	N/A	
Subgrade sample recovered at:	N/A (mm)	Subgrade sample recovered at:	N/A (mm)	N/A	N/A	
Depth from ground surface to commencement of penetration:	0 (mm)	Wet density (t/m³)	0 (mm)	Water content (%)	N/A	
	Dry density (t/m³)					
	Water content (%)					
COMMENTS:						
The estimated CBR values are based on Figure 5.3, Correlation of Dynamic Cone Penetration and CBR AUSTROADS (2004) "Pavement Design - A Guide to the Structural Design of Road Pavements" IANZ Accreditation does not apply						
Tested by:	LZ	Date:	3/07/2013	Checked by:	W	
		Date:		Date:	16/07/2013

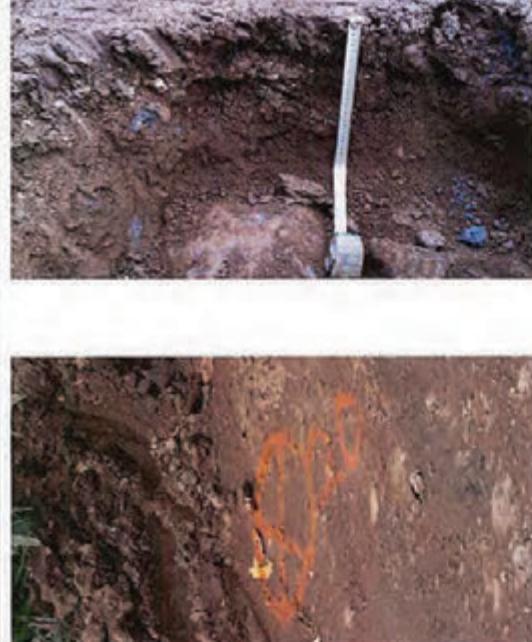
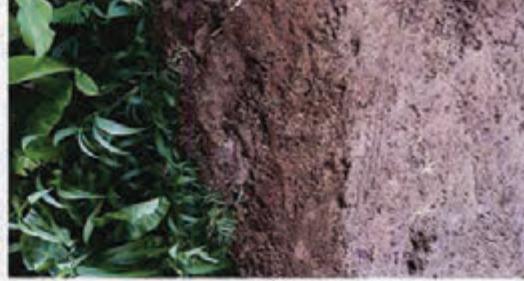
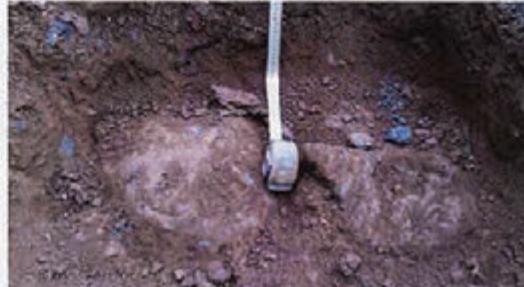
TP 20 - 36 per site plan

Site:	In and around Apia, Samoa	Job No.:	615478.178	Page 1 of 1
Client:	T&T	Contractor:	Geotechnics Ltd	Client Ref: 750956
Test Method Used: NZS 4402:1988 Test 6.5.2 Dynamic Cone Penetrometer				
TEST PIT INVESTIGATION LOG REPORT				
Project:	Samoa Water Treatment scheme		Sampled by:	
Location:	S 13° 53' 08.2" E 171° 49' 51.2"		Date sampled:	
Chainage:			Sampling method:	
House No.:			Sample condition:	
Pit No.:	20		Date Received:	
Depth (mm)	Description		Estimated Field CBR	
0 - 100	Sandy SILT with some gravel; dark brown, mottled white. Wet. Non-plastic.	0.08	1.5	8
100 - 300	Sandy SILT with some gravel; brown, mottled grey. Moist, Non-plastic.	0.08	1.3	18
300	Top of rock.	0.07	1.2	23
300	End of pit.	0.08	1.1	33

0.05	1.0	39
		0.04	0.9	45
		0.03	0.8	50
		0.02		
		0.01		
		0.00	0	
			1	Number of blows per 50mm
			2	
			3	
			4	
			5	
			6	
			7	
			8	
			9	
			10	
			Density By Nuclear Densometer	
			Basecourse	Subgrade
			N/A	N/A
			N/A	N/A
			Wet density (t/m ³):	
			Dry density (t/m ³):	
			Water content (%):	
COMMENTS:				
The estimated CBR values are based on Figure 5.3, Correlation of Dynamic Cone Penetration and CBR				
AUSTRROADS (2004) "Pavement Design - A Guide to the Structural Design of Road Pavements"				
IANZ Accreditation does not apply				
Tested by:	LZ	Date:	4/07/2013	Checked by:
			W	Date:
				16/07/2013

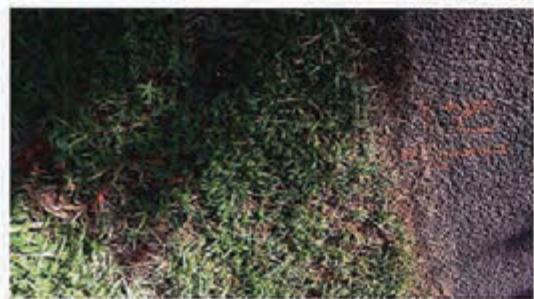
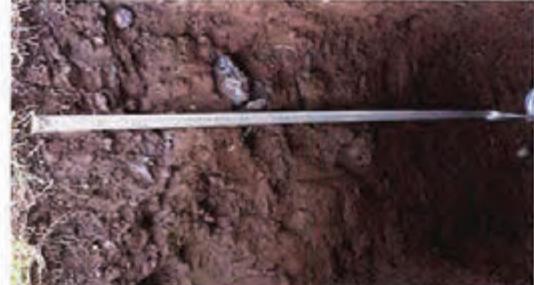
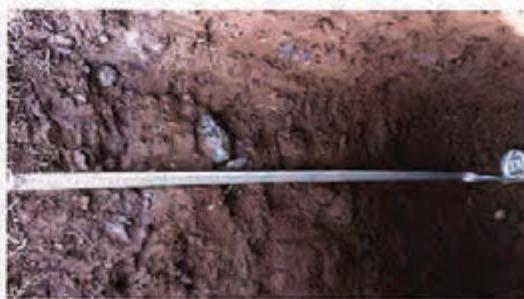
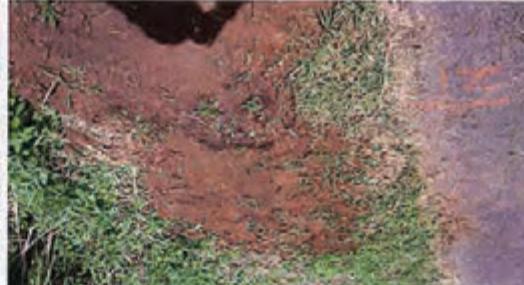
Site: In and around Apia, Samoa Job No.: 615478.178 Client Ref: 750956
 Client: T&T Contractor: Geotechnics Ltd
 House No.:
 Pit No.: 21
 Test Method Used: NZS 4402:1998 Test 6.5.2 Dynamic Cone Penetrometer

Project:	Samoa Water Treatment scheme	Sampled by:	
Location:	S 13° 52' 28.5" E 171° 49' 47.7"	Date sampled:	
Chainage:		Sampling method:	
House No.:		Sample condition:	
Pit No.:	21	Date Received:	
Depth (mm)	Description	Estimated Field CBR	
0 - 200	Gravelly SILT with some sand; brown. Moist, Non-plastic.	0.08	
200 - 1200	Clayey SILT with some gravel; brown. Moist to wet, low plasticity.	0.08	
1200	End of pit.	0.07	
		0.06	
		0.05	
		0.04	
		0.03	
		0.02	
		0.01	
		0.00	
			Number of blows per 50mm
			0 1 2 3 4 5 6 7 8 9 10

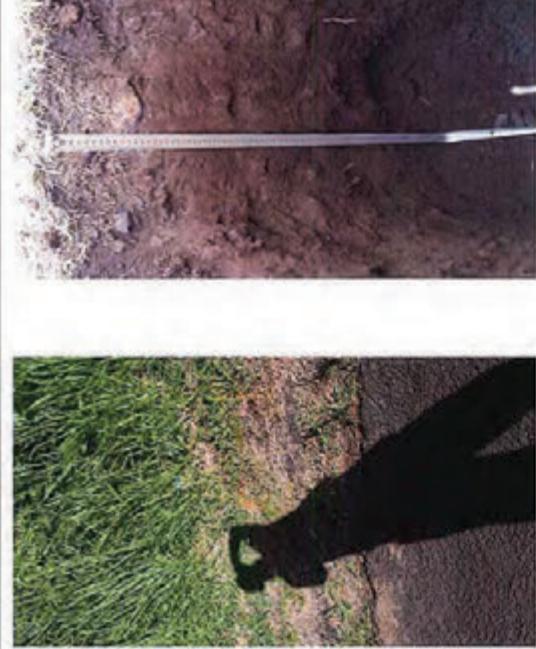
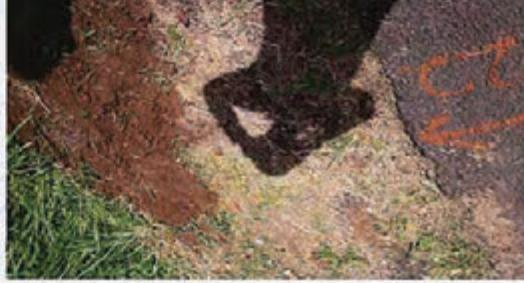
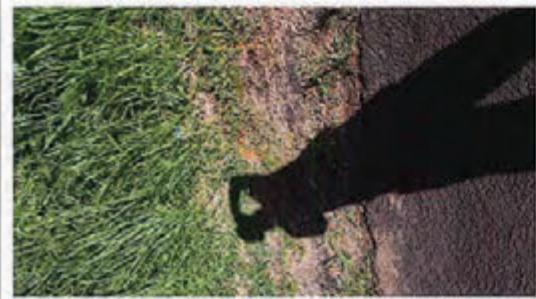
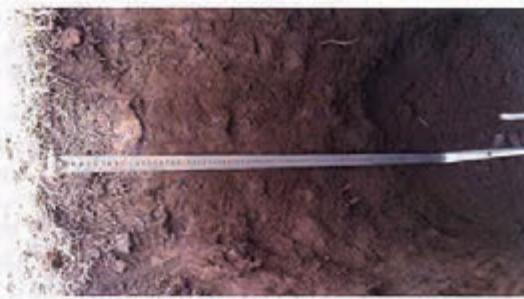
Project:	Samoa Water Treatment scheme	Sampled by:		Estimated Field CBR
Location:	S 13° 51' 56.1" W 171° 49' 32.7"	Date sampled:		.35 .4 .5 .6 .7 .8 .9 .10
Chainage:		Sampling method:		.36 .4 .5 .6 .7 .8 .9 .10
House No.:		Sample condition:		.37 .4 .5 .6 .7 .8 .9 .10
Pit No.:	22	Date Received:		.38 .4 .5 .6 .7 .8 .9 .10
Depth (mm)	Description			
0 - 150	Sandy SILT with some gravel; brown. Moist, Non-plastic.	Sampled at:	0.08	
150 -1000	Clayey SILT with trace of gravel; brown. Moist, low plasticity.	Sampled at:	0.08	
1000	Top of rock.	Sampled at:	0.07	
1000	End of pit.	Sampled at:	0.06	
		Depth (E)	0.05	
		Depth (E)	0.04	
		Depth (E)	0.03	
		Depth (E)	0.02	
		Depth (E)	0.01	
		Depth (E)	0.00	
			0 1 2 3 4 5 6 7 8 9 10	Number of blows per 50mm

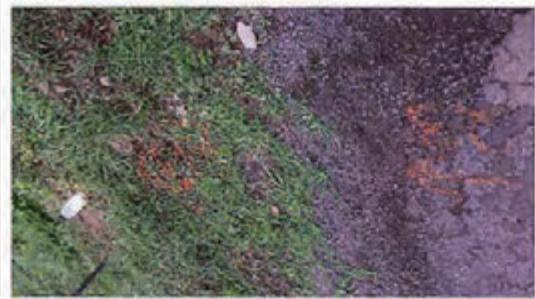
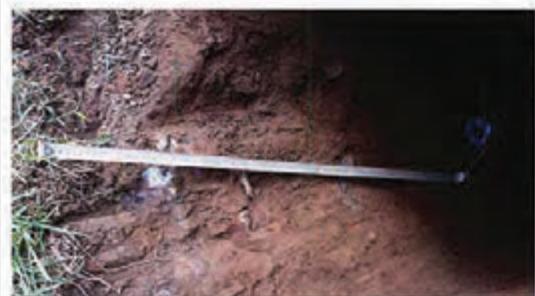
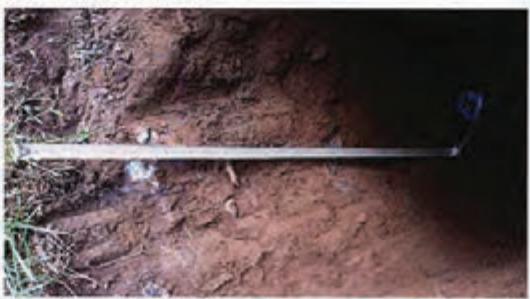
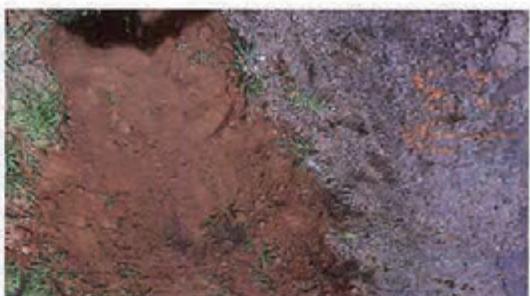
TP 72, as per site plan

TEST PIT INVESTIGATION LOG REPORT				
Site:	In and around Apia, Samoa	Job No.:	615478.178	Client Ref.:
Client:	T&T	Contractor:	Geotechnics Ltd	
Chainage:	S 13° 51' 26.1" W 171° 43' 22.2"	Sampling method:		
House No.:		Sample condition:		
Pit No.:	23	Date Received:		
Project:	Samoa Water Treatment scheme	Sampled by:		Estimated Field CBR
Location:	S 13° 51' 26.1" W 171° 43' 22.2"	Date sampled:		.5 .6 .7 .8 .9 .10 .11 .12 .13 .14 .15 .16 .17 .18 .19 .20 .21 .22 .23 .24 .25 .26 .27 .28 .29 .30 .31 .32 .33 .34 .35 .36 .37 .38 .39 .40 .41 .42 .43 .44 .45 .46 .47 .48 .49 .50
Depth (mm)	Description			
0 - 150	Clayey Silt with minor sand; dark brown. Moist, Non-plastic.	0.09		
150 - 300	Clayey Silt with some gravel; brown. Moist, Non-plastic.	0.08		
300 - 1200	Clayey Silt with trace of gravel; brown. Moist, Non-plastic.	0.07		
1200	End of pit.	0.06		
		Depth (m)

0.05		
		0.04		
		0.03		
		0.02		
		0.01		
		0.00		
				Number of blows per 50mm
				0 1 2 3 4 5 6 7 8 9 10
COMMENTS:				
The estimated CBR values are based on Figure 5.3, Correlation of Dynamic Cone Penetration and CBR AUSTROADS (2004) "Pavement Design - A Guide to the Structural Design of Road Pavements"				
IANZ Accreditation does not apply				
Tested by:	LZ	Date:	4/07/2013	Checked by:
			IW	Date:

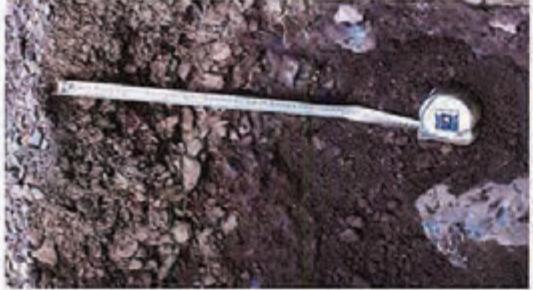
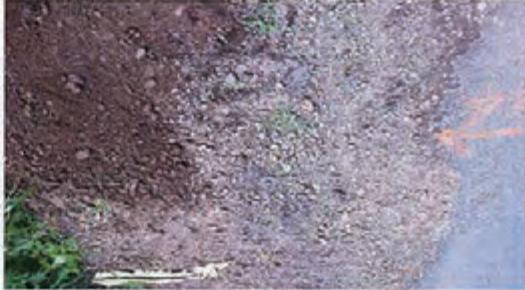
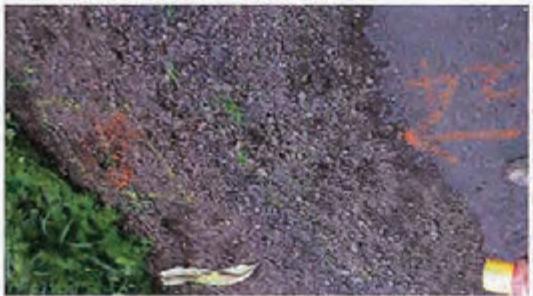
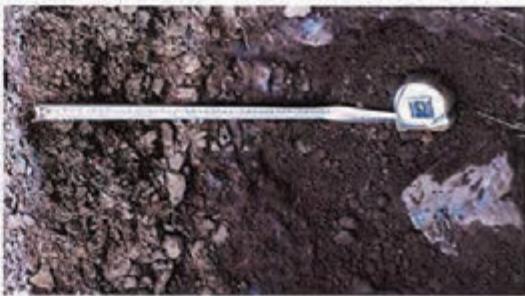
TP 24 - 06 pit site plan

Site:	In and around Apia, Samoa	Job No.:	615478-178	Page 1 of 1
Client:	T&T	Contractor:	Geotechnics Ltd	Client Ref: 750956
Test Method Used: NZS 4402:1988 Test 6.5.2 Dynamic Cone Penetrometer				
TEST PIT INVESTIGATION LOG REPORT				
Project:	Samoa Water Treatment scheme			
Location:	S 13° 51' 15.7" W 171° 49' 15.3"			
Chainage:				
House No.:				
Pit No.:	24			
Depth (mm)	Description	Sampled by:	Date sampled:	Estimated Field CBR
0 - 500	Sandy GRAVEL with some silt; dark brown, mottled grey. Moist.			0.08
500	Top of rock.			0.08
500	End of pit.			0.07

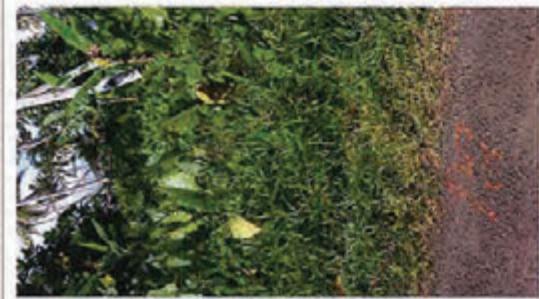
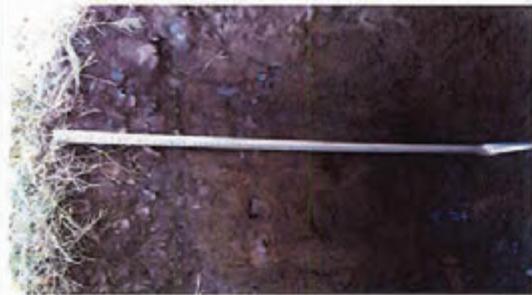
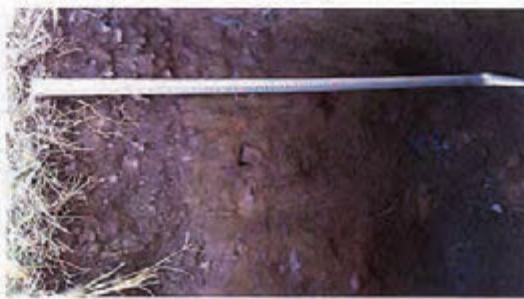
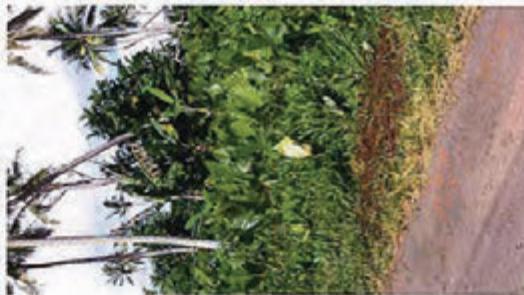
Site:	In and around Apia, Samoa	Job No.:	615478.178	Page 1 of 1
Client:	T&T	Contractor:	Geotechnics Ltd	Client Ref: 750956
Test Method Used:	NZS 4402:1988 Test 6.5.2 Dynamic Cone Penetrometer			
TEST PIT INVESTIGATION LOG REPORT				
Project:	Samoa Water Treatment scheme	Sampled by:		
Location:	S 13° 51' 07.5" W 171° 49' 22.4"	Date sampled:		
Chainage:		Sampling method:		
House No.:		Sample condition:		
Pit No.:	25	Date Received:		
Depth (mm)	Description		Estimated Field CBR	
0 - 200	Sandy GRAVEL with some silt; dark brown, mottled grey. Moist, Non-plastic.	0.00	14	18
200 - 900	Clayey SILT with minor gravel; brown. Moist, Non-plastic.	0.08	16	20
900	Top of rock.	0.07	22	28
900	End of pit.	0.06	33	39

0.05	45	50
		0.04		
		0.03		
		0.02		
		0.01		
		0.00	1	2
			3	4
			5	6
			7	8
			9	10
			Number of blows per 50mm	
Comments:				
<p>The estimated CBR values are based on Figure 5.3, Correlation of Dynamic Cone Penetration and CBR AUSTROADS (2004) "Pavement Design - A Guide to the Structural Design of Road Pavements"</p> <p>IANZ Accreditation does not apply</p>				
Tested by:	LZ	Date:	4/07/2013	Checked by:
			W	Date:
				16/07/2013

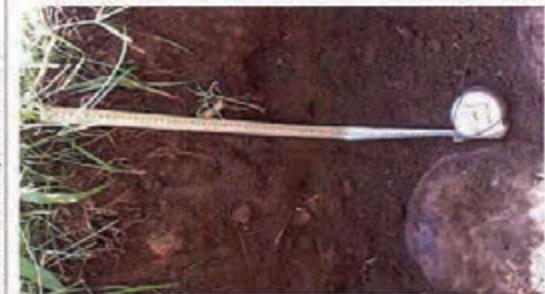
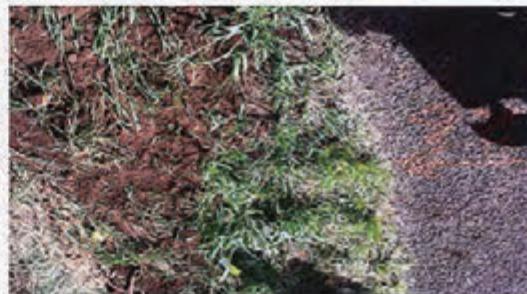
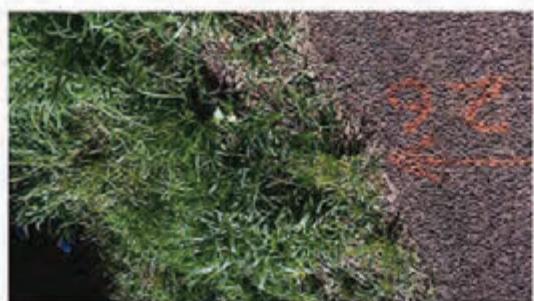
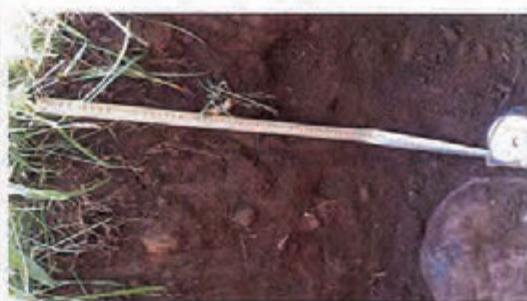
TEST PIT INVESTIGATION LOG REPORT		Page 1 of 1												
Site:	In and around Apia, Samoa	Job No.:	615478.178	Client Ref.:	750956									
Client:	T&I	Contractor:	Geotechnics Ltd.											
Test Method Used:	NZS 4402:1988 Test 6.5.2 Dynamic Cone Penetrometer													
Project:	Samoa Water Treatment scheme	Sampled by:												
Location:	S 13° 50' 45.2"E W 171° 49' 28.6"S	Date sampled:												
Chainage:		Sampling method:												
House No.:		Sample condition:												
Pit No.:	26	Date Received:												
Depth (mm)	Description													
0 - 600	Clayey SILT with trace of gravel; brown. Moist, Non-plastic.	Estimated Field CBR	35	38	43	48	53	58	63	68	73	78		
600	Top of rock.		0.08	0.08	0.08	0.08	0.08	0.08	0.08	0.08	0.08	0.08		
600	End of pit.		0.07	0.07	0.07	0.07	0.07	0.07	0.07	0.07	0.07	0.07

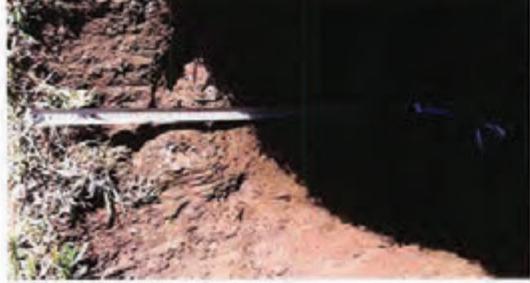
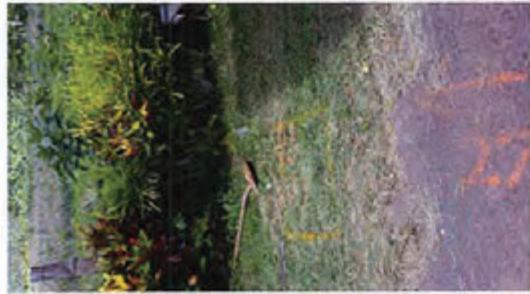
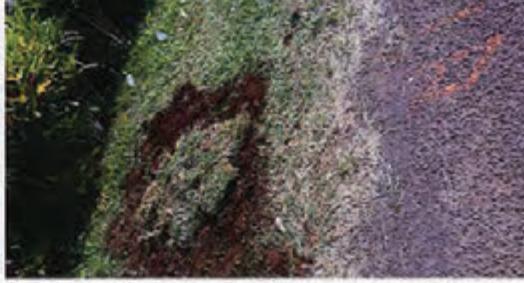
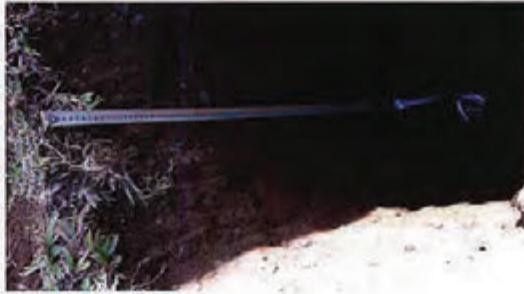
Site:	In and around Apia, Samoa	Job No.:	615478.178	Page 1 of 1
Client:	T&T	Contractor:	Geotechnics Ltd	Client Ref: 750956
Test Method Used: NZS 4402:1988 Test 6.5.2 Dynamic Cone Penetrometer				
TEST PIT INVESTIGATION LOG REPORT				
Project:	Samoa Water Treatment scheme		Sampled by:	
Location:	S 13° 50' 31.8"E W 171° 49' 53.9"S		Date sampled:	
Chainage:			Sampling method:	
House No.:			Sample condition:	
Pit No.:	27		Date Received:	
Depth (mm)	Description	Estimated Field CBR		
0 - 300	Silty GRAVEL with minor sand; brown, mottled grey, moist, Non-plastic.	14	8	13 18 23 28 33 36 46 50
300 - 900	Clayey SILT with some gravel; brown. Moist to wet, Non-plastic.	0.06	0.08	
900	Top of rock.	0.07	0.07	
900	End of pit.	0.06	0.06

0.06	0.06	
		0.04	0.04	
		0.03	0.03	
		0.02	0.02	
		0.01	0.01	
		0.00	0.00	0 1 2 3 4 5 6 7 8 9 10 Number of blows per 50mm
		Density By Nuclear Densometer		
Basecourse sample recovered at:		N/A	Subgrade	
Sub-base sample recovered at:		N/A	Basecourse	N/A
Subgrade sample recovered at:		N/A	Subgrade	N/A
Depth from ground surface to commencement of penetration:		0	Wet density (t/m^3)	N/A
		0	Dry density (t/m^3)	N/A
		0	Water content (%)	N/A

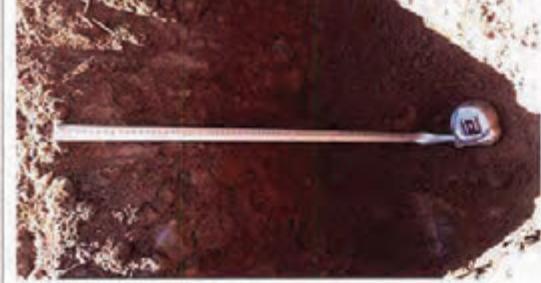
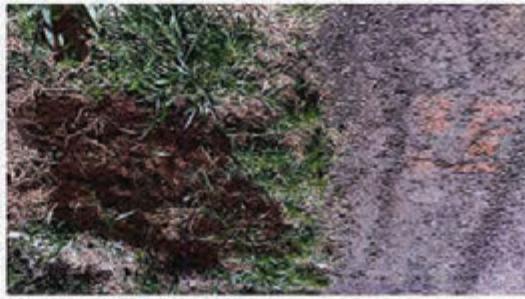
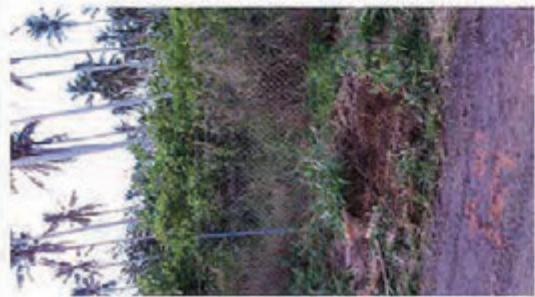
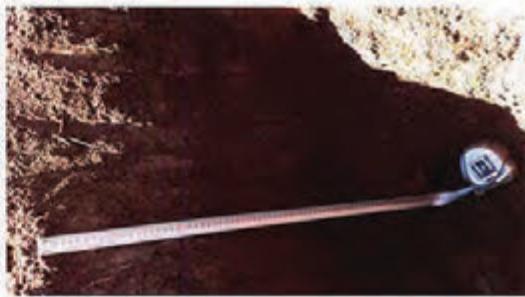
TP 28, As per site photo

Page 1 of 1														
		Client Ref: 750956														
Site:	In and around Apia, Samoa	Job No.:	615478.178		Client Ref: 750956											
Client:	T&T	Contractor:	Geotechnics Ltd													
Test Method Used: NZS 4402:1988 Test 6.5.2 Dynamic Cone Penetrometer																
TEST PIT INVESTIGATION LOG REPORT																
Project:	Samoa Water Treatment scheme		Sampled by:			Estimated Field CBR	1.5	8	13	18	23	28	33	39	45	50
Location:	S 13° 50' 26.9" W 171° 49' 44.2"		Date sampled:			0.08										
Chainage:			Sampling method:			0.08										
House No.:			Sample condition:			0.08										
Pit No.:	28		Date Received:			0.08										
Depth (mm)	Description	Estimated Field CBR	1.5	8	13	18	23	28	33	39	45	50				
0 - 100	Clayey SILT with minor gravel; dark brown. Moist. Non-plastic.	0.08														
100 - 600	Clayey SILT with some gravel; brown. Moist. Non-plastic.	0.08														
600 - 700	Top of rock.	0.07

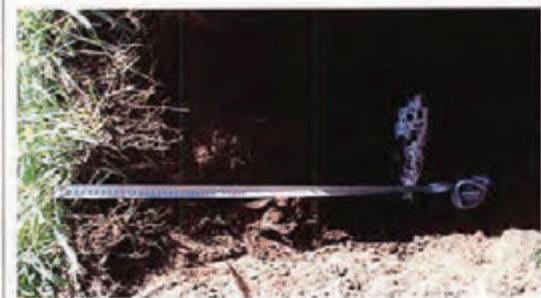
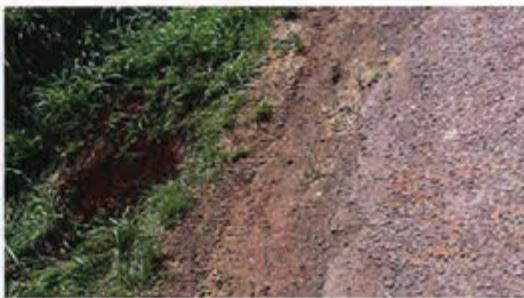
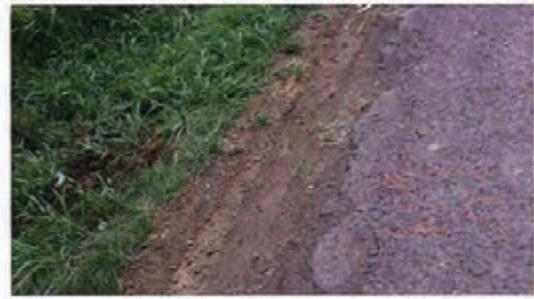
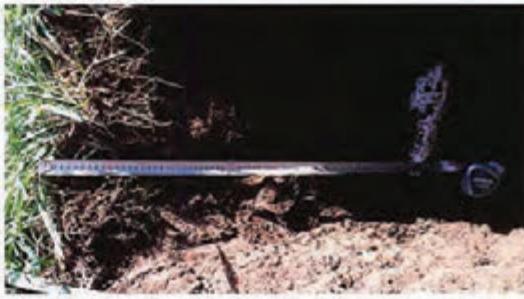
Site:	In and around Apia, Samoa	Job No.:	615478.178	Page 1 of 1
Client:	T&T	Contractor:	Geotechnics Ltd	Client Ref: 750956
Test Method Used: NZS 4402:1988 Test 6.5.2 Dynamic Cone Penetrometer				
TEST PIT INVESTIGATION LOG REPORT				
Project:	Samoa Water Treatment scheme	Sampled by:		
Location:	S 13° 50' 23.7" W 171° 50' 04.0"	Date sampled:		
Chainage:		Sampling method:		
House No.:		Sample condition:		
Pit No.:	29	Date Received:		
Depth (mm)	Description	Estimated Field CBR		
0 - 800	Clayey Silt with trace of gravel; brown. Moist to wet. Non-plastic.	0.09	13	33
800	White pipe, ~100mm diameter.	0.08	18	39
800	End of pit.	0.07	23	45

0.06	33	50
		0.05		
		0.04		
		0.03		
		0.02		
		0.01		
		0.00		
			0	Number of blows per 50mm
			1	2
			3	4
			5	6
			7	8
			9	10
		Density By Nuclear Densometer		
Basecourse sample recovered at:		N/A (mm)	Wet density (t/m³):	
Sub-base sample recovered at:		N/A (mm)	Dry density (t/m³):	
Subgrade sample recovered at:		N/A (mm)	Water content (%):	
Depth from ground surface to commencement of penetration:		0 (mm)		
COMMENTS: The estimated CBR values are based on Figure 5.3, Correlation of Dynamic Cone Penetration and CBR AUSTROADS (2004) "Pavement Design - A Guide to the Structural Design of Road Pavements" IANZ Accreditation does not apply				
Tested by:	LZ	Date:	4/07/2013	Checked by:
			IW	Date:
				16/07/2013

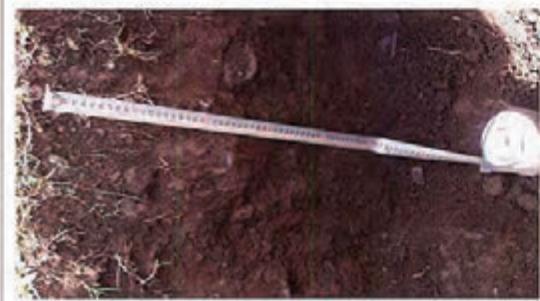
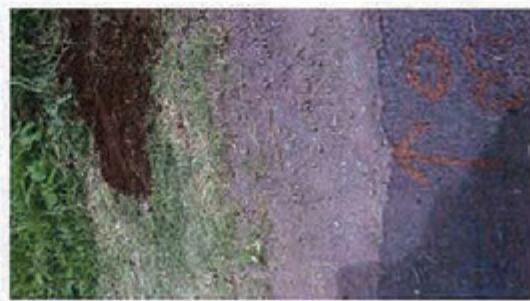
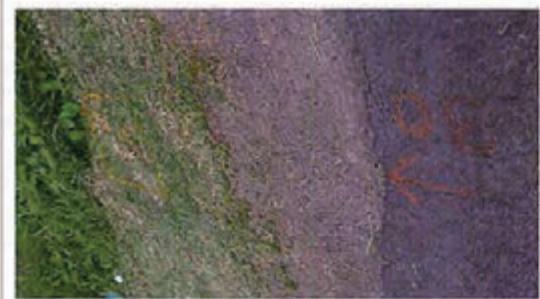
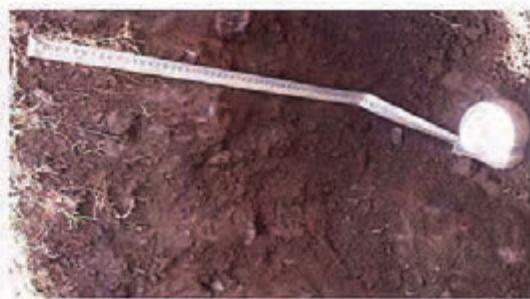
TP 25, as per One Plan

Project:	Samoa Water Treatment scheme	Sampled by:	
Location:	S 13° 49' 53.3"E W 171° 50' 03.3"S	Date sampled:	
Chainage:		Sampling method:	
House No.:		Sample condition:	
Pit No.:		Date Received:	
Depth (mm)	Description	Estimated Field CBR	Number of blows per 50mm
0 - 500	Gravelly SIL-T with trace of clay, brown. Moist, Non-plastic.	0.06	1 2 3 4 5 6 7 8 9 10
500	Top of rock.	0.08	
500	End of pit.	0.07	
		0.06	
		0.05	
		0.04	
		0.03	
		0.02	
		0.01	
		0.00
