ネパール国  
全国貯水式水力発電所マスタープラン調査

ファイナルレポート  
Appendix (2/2)

**Annex 1: Geological Survey Report**  
**Dudh Koshi Project (E-01)**

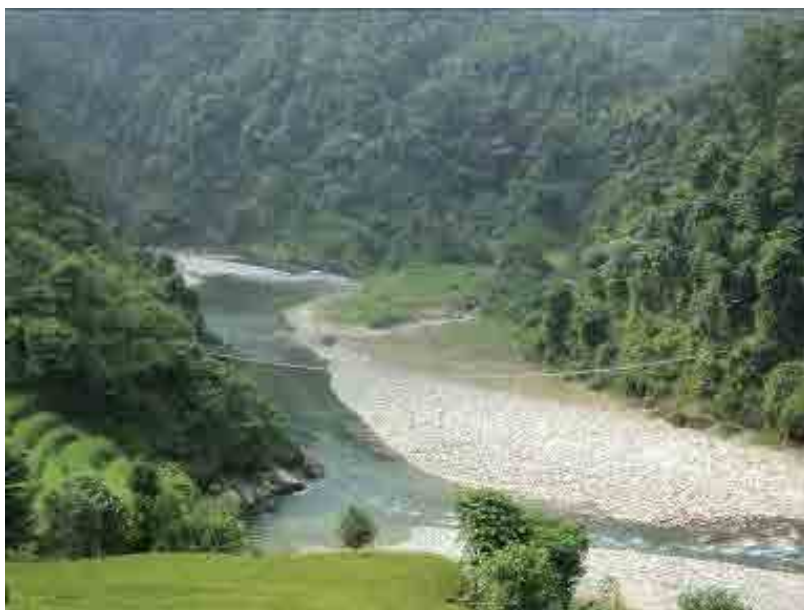
**Photo 1.1: General view of the Kokhajor Khola near Chakali**

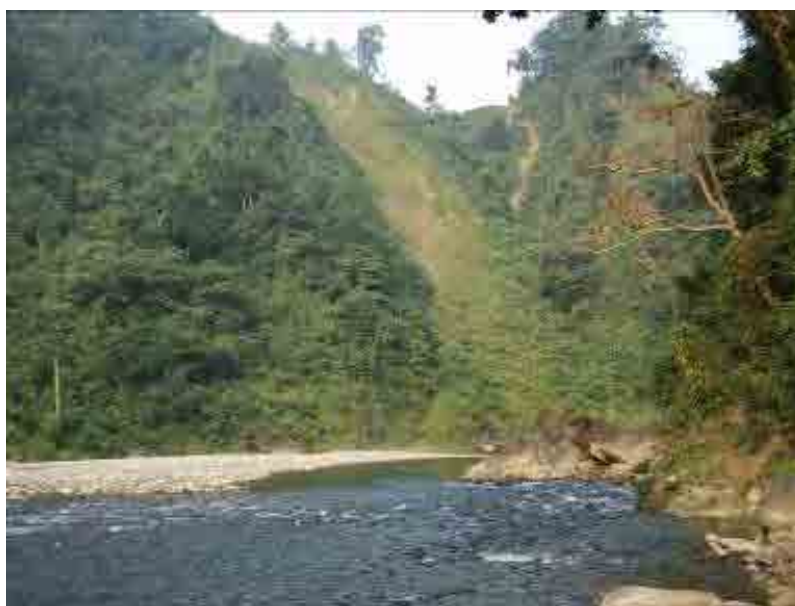
**Photo 1.2: Large landslide on the left bank of Kokhajor Khola at Anptar**

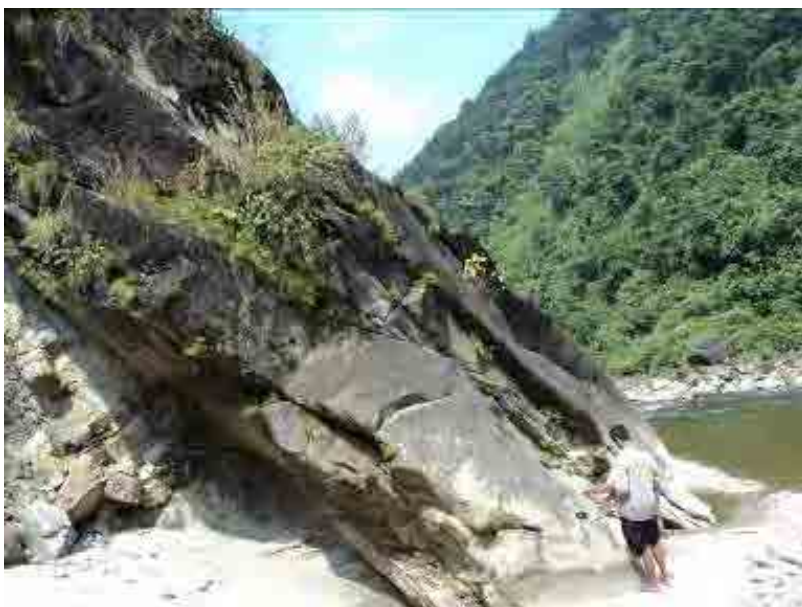
**Photo 1.3: Jointed sandstone on the left bank of Kokhajor Khola in intake area**

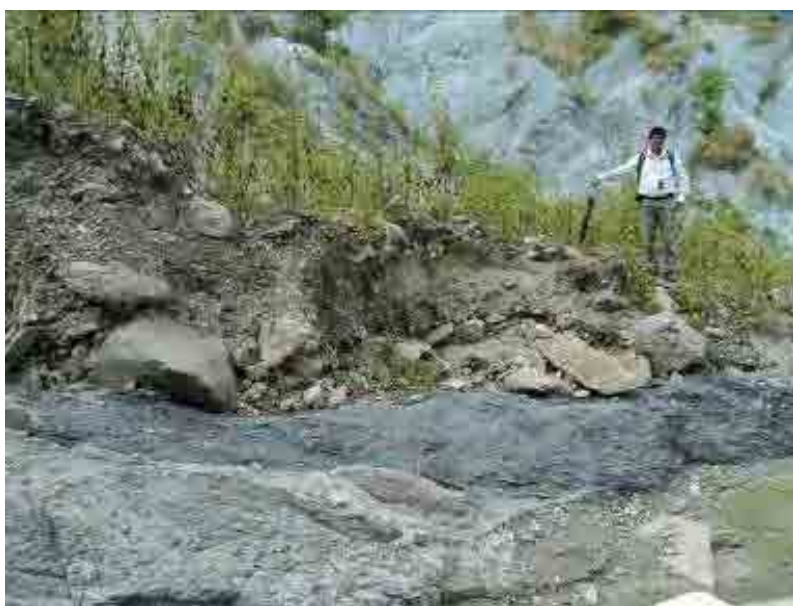
**Photo 1.4: Main Boundary Thrust (MBT) exposed at a large landslide near Majhigaun**

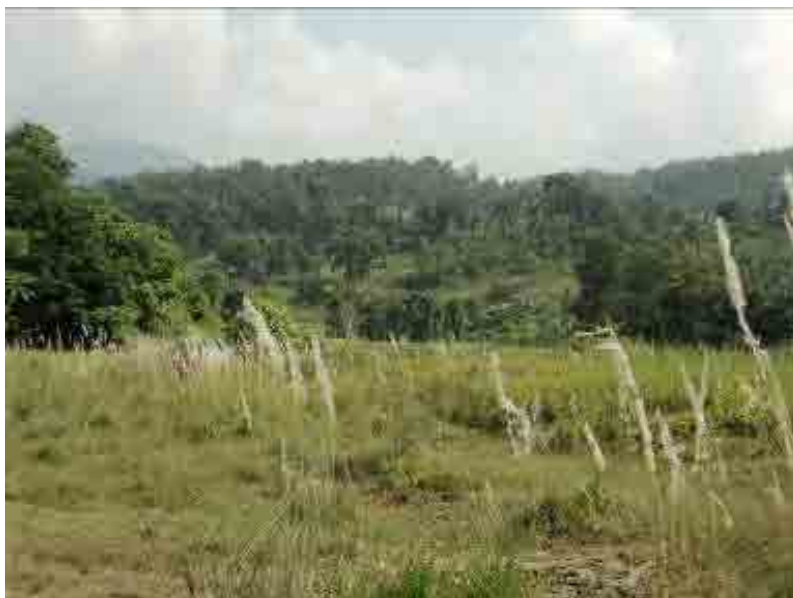
**Photo 1.5: Proposed powerhouse area at Sande. View to N**

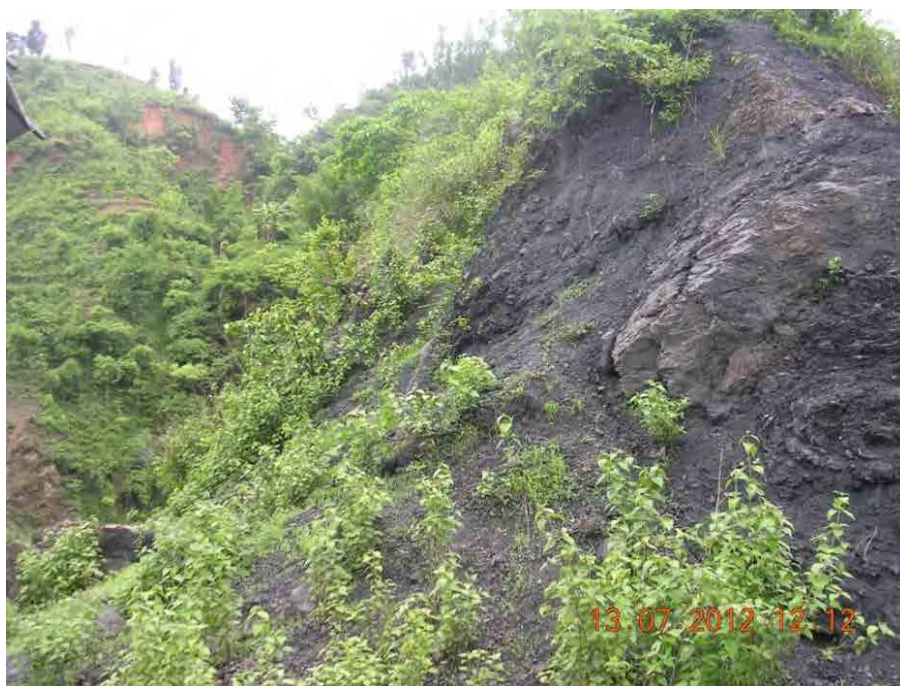
**Figure 1.4: Shear zone observed on the left bank of the Indrawati River, at location 259.**

Except the soil erosion from the huge volume of colluviums no other significant weak or vulnerable zones leading to dam collapse or large failures obstructing the reservoir are observed. The fault passing along the Indrawati River show narrow shear zone along the newly constructing Sahid Road from Bodgaun to Bisdevtar (Figure 1.4) but no significant landslide and other mass wasting phenomenon are observed on the surface.

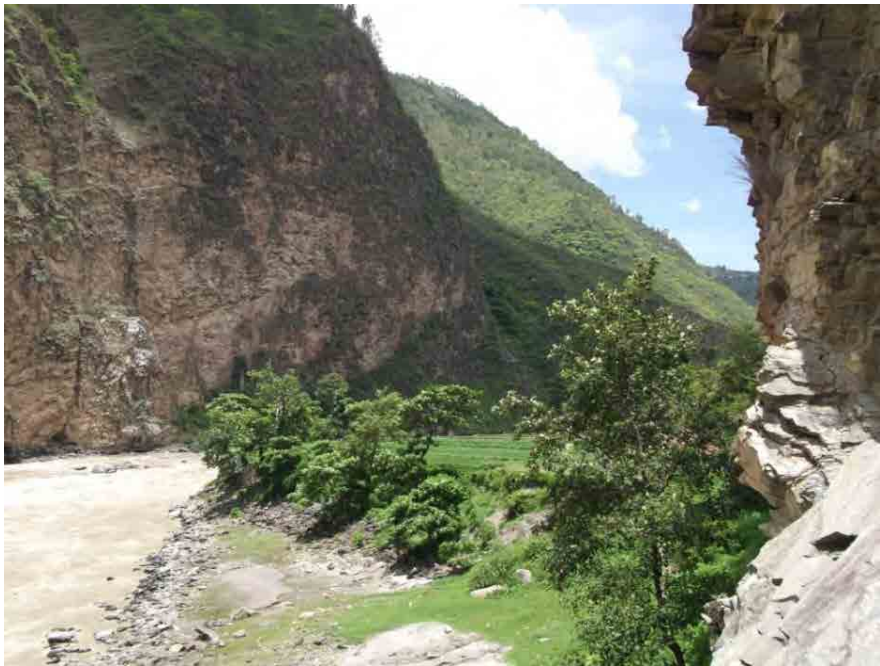
Figure 1.6: Dam site of the Sunkoshi HEP, at location 128.

The Dam site is located at about 500 m downstream from the confluence of the Chauri Khola and Sunkoshi River. The proposed dam axis (Figures 1.5 and 1.6) seems sound on the basis of rock type and nature of discontinuities. At the dam site, the rock is represented by medium-to thick-bedded medium-to coarse-grained light grey to white quartzite with partings and thin bands of phyllite. The dam foundation and the area around the dam axis are impervious and do not pose any serious threat of seepage. Three sets of joints are observed at the dam site (Figure 1.7). As the proposed dam axis lies in quartzite, the area shows high water tightness. Cross-section along the dam is shown in figure 1.8.

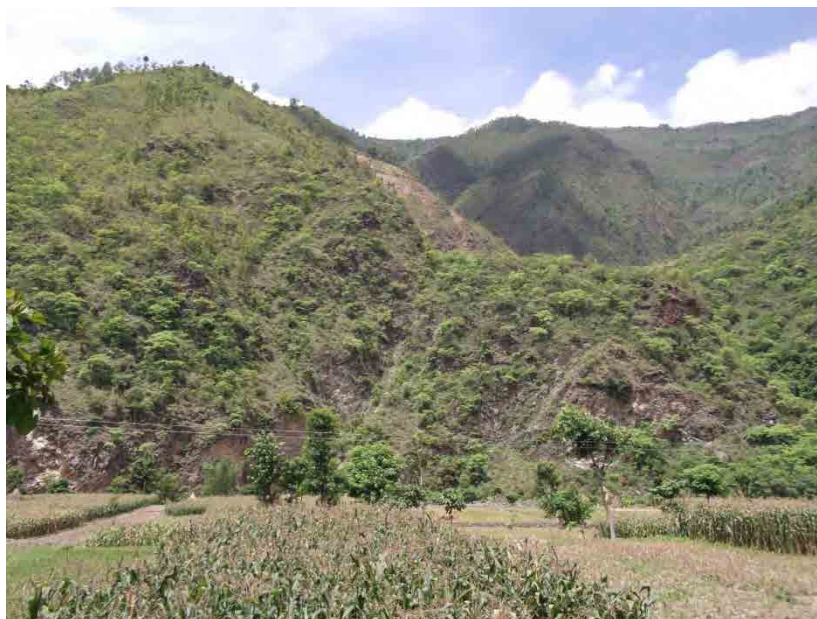
**Figure 1.10: Powerhouse site of the Sunkoshi HEP, at location 126.**

The Powerhouse is located at the terrace on the left bank of the Sunkoshi River. In the powerhouse site, there is a wide cultivated alluvial terrace (Figure 1.10) on which village is situated. Above the terrace there are some rock outcrops with colluviums. Rock consists of alternating bands of medium-to coarse-grained grey quartzite with few bands and partings of greenish grey phyllite. The stability condition of the powerhouse is ok but there may encounter some problem during the construction of Penstock as above the terrace there is some colluvium. So during the construction of penstock detailed study of the area is essential.

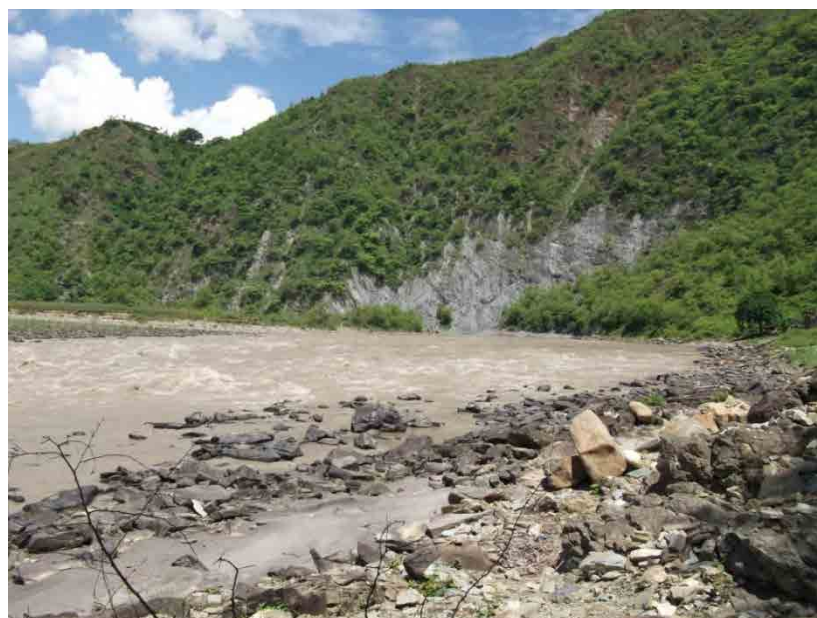
**Figure 1.11: Landslide along the Sunkoshi River between Jagate and Timreni Bensi, at location 153.**

A major fault with a thick shear zone passes along the left bank of the Indrawati River along the road from Bodgaun to Bisdevtar. No major landslides were observed on the project area except some small soil and rock slide due to man-made causes especially due to road construction. One of minor slide is shown in figure 1.11.

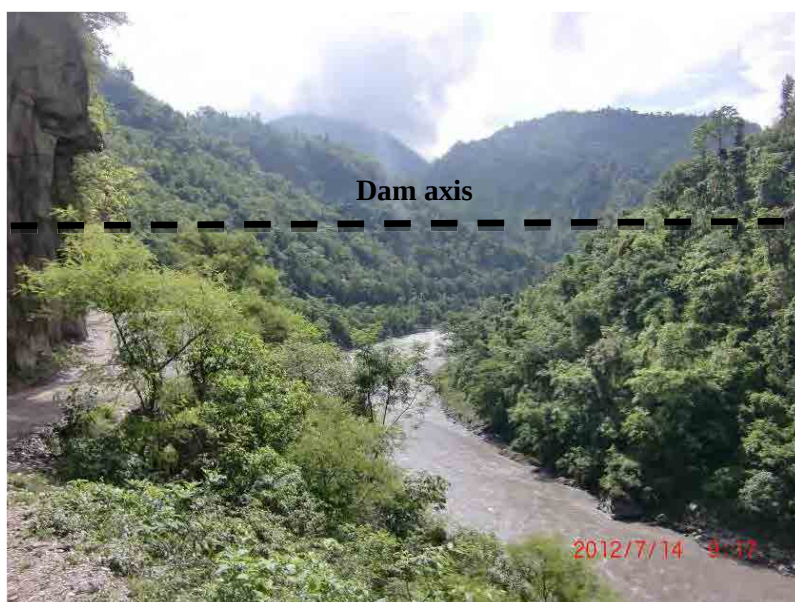
**Figure 1.9: Downstream view of the Lower Badigad dam site, at waypoint WPT088. View to S.**

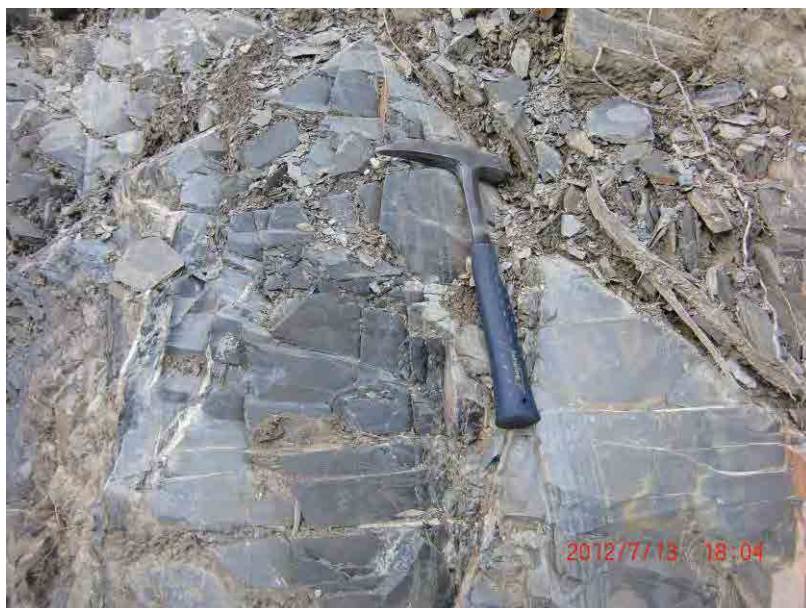
**Figure 1.10: Light grey, laminated and fractured shales at the dam site, at waypoint WPT081.**

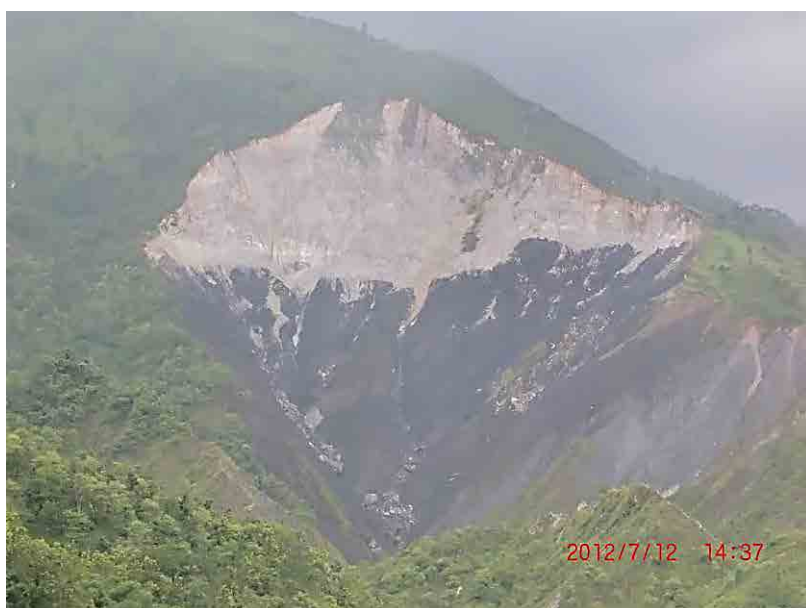
**Figure 1.11: Landslide (GhultungPahiro) shows dolomite overlying black shales in the reservoir area. Photo taken at waypoint WPT062 at Kimkot, View to N.**

Mostly landslides are common on quartzites, shale and limestones and colluvial terraces of the reservoir (Figures 1.3, 1.6 and 1.15). Mainly rockslides (wedge and plane failures) are observed on shales and quartzites. The landslide and other instability distribution in the reservoir and its vicinity were assessed from field observations and satellite image interpretations. GultungPahirois a large active landslide that poses threat to the local people as it brings huge amount of debris to the Badigad River (Figure 1.11).

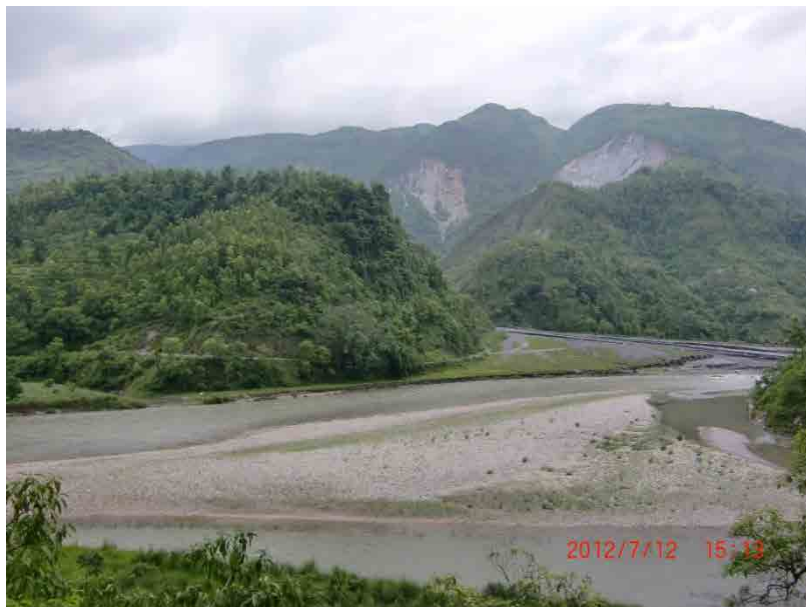
**Figure 1.12: Alluvial fan at the left bank of BadigadKhola near GultungPahiro, taken at waypoint WPT063. Note that Gultung Pahiro has deposited huge amount of sediment at the river valley of BadigadKhola. View to NE.**

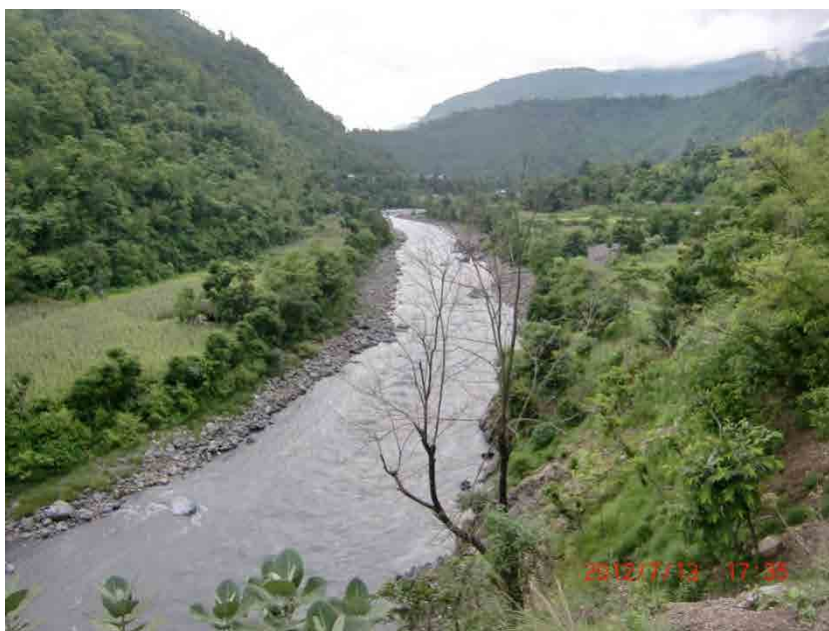
**Figure 1.13: The alluvial terrace, sand and gravel bar as a source of construction material, upstream of dam site, taken at waypoint WPT085. View to W from dam site.**

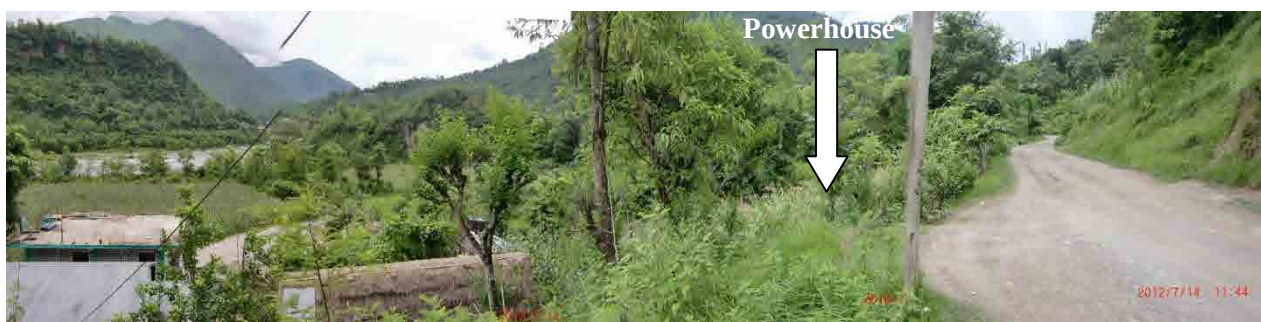
**Figure 1.14: Powerhouse site on the alluvial terrace of BadigadKhola at RudrabeniGaun, taken at waypoint WPT095. View to E.**

Powerhouse site is located on the right bank of BadigadKhola on the alluvial terrace at Rudrabeni which is about 400 m west to the confluence of BadigadKhola and Kaligandaki River (Figures 1.6 and 1.14). The alluvial terrace is about 300 m wide, 400 m long and about 30 m depth. Below the powerhouse site, there is about 300 m long (from the east to west) and about 100 m wide sand and gravel bar of the BadigadKhola. The bedrock that can be expected at the powerhouse site is at the depth of more than 40 m. The bedrock, joints and valley slope behind powerhouse shows stable slope conditions. However, there is some possibility of channel shifting and scouring of the alluvial terrace by both BadigadKhola and Kaligandaki River during high flooding events. Hence protective measures should be adopted during construction of powerhouse foundation.

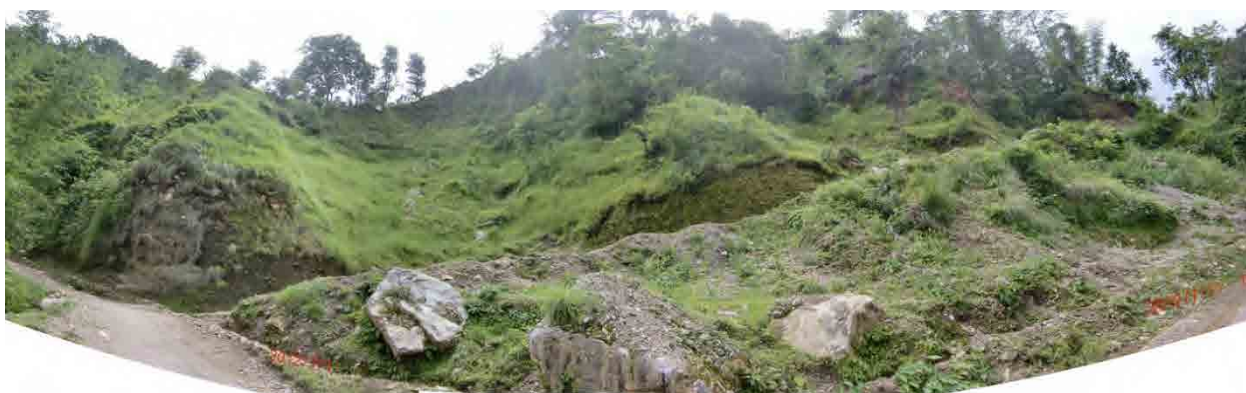
**Figure 1.15: Landslide on colluvial terrace observed on the left bank of the BadigadKhola near the village of Kumal, taken at waypoint WPT034. View to NE.**

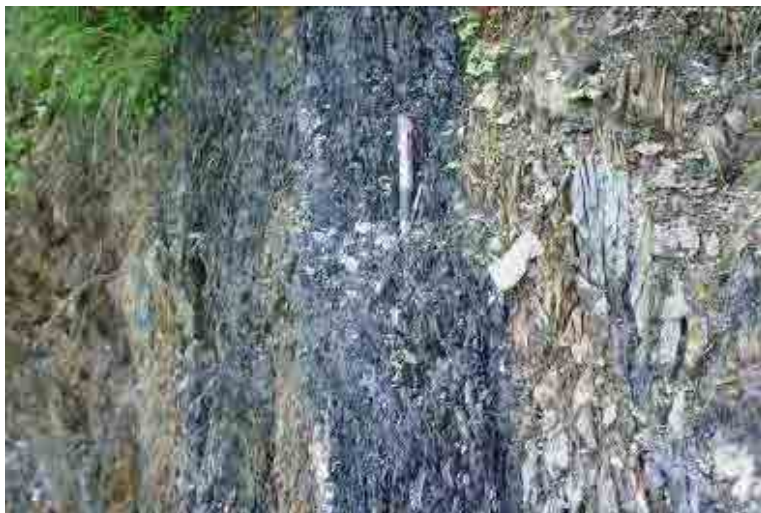
**Figure 1.4: Photograph showing the laminated slates on the Siddhartha Highway, near Galyang Bazaar (Location 28)**

**Lithology:** The main lithology is comprised of gray to dark, laminated slate with fewer intercalation of carbonate bands at the lower part (Figure 1.3). This lithology is comparable with the Benighat Slate with grey to dark grey laminated slate (Figure 1.4). The lithology gradually changes to a thick succession of thick bedded, bluish grey, stromatolitic dolomite correlatable with the Dhading Dolomite of Central Nepal. The contact between the Dhading Dolomite and the Benighat Slate is gradational (Figure 1.5) where small scale folds are abundant.

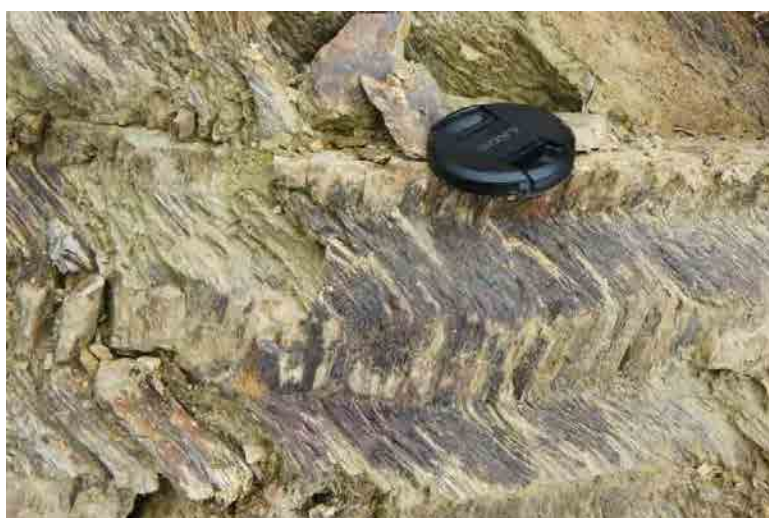
**Figure 1.6: Photograph illustrating crenulation cleavage in Benighat Slate near location no 32 (Figure 1.2 and Table 1.1).**

*Rock mass condition:* The dolomite in the upper reaches of the Andhi Khola is comparatively strong but it may suspect the water tightness due to the probable cavern structures. The rocks of the Benighat slate are highly fractured and fragile and very weak. The slates exhibit crenulation cleavage (Figure 1.6)

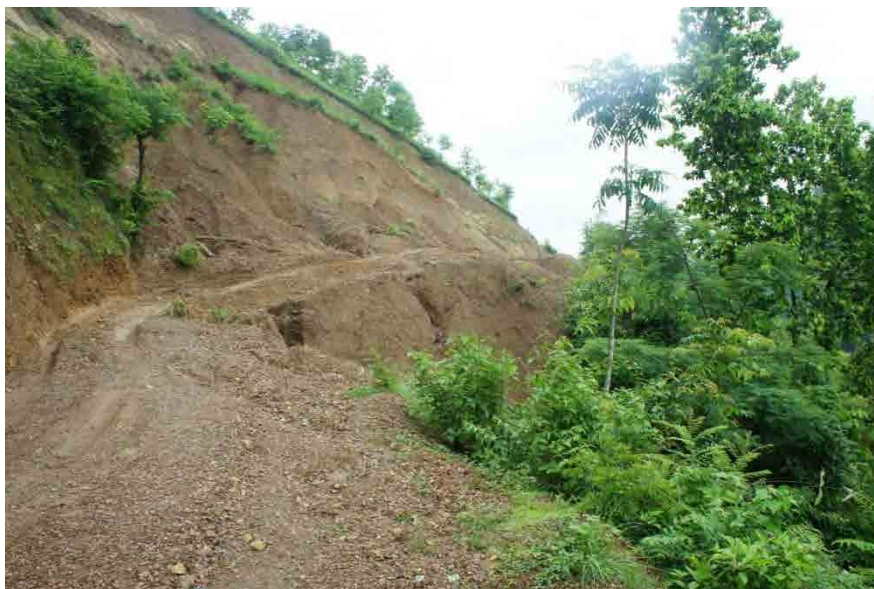
**Figure 1.14 Photograph showing a large landslide on highly weathered slate (almost converted to residual soil) near location 034 (Figure 7.2).**

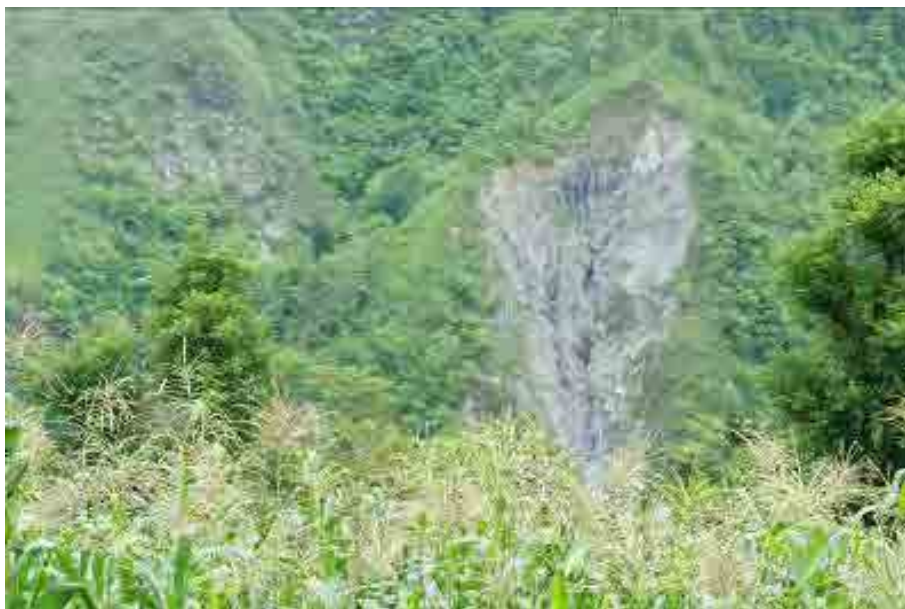
**Figure 1.15: Landslide about 50m upstream from the proposed dam site. View to Northeast**

Many small and large landslides are common in the reservoir area. The previously proposed dam site is located in an unstable zone with many landslides on the left bank of the Andhi Khola. The slates are highly fragile and intensely deformed such that many recent landslides are common along the newly constructed road alignments (Figure 1.14). A large landslide is also observed in the powerhouse site. A landslide near the proposed dam site has threatened the stability of the proposed dam (Figure 1.15).

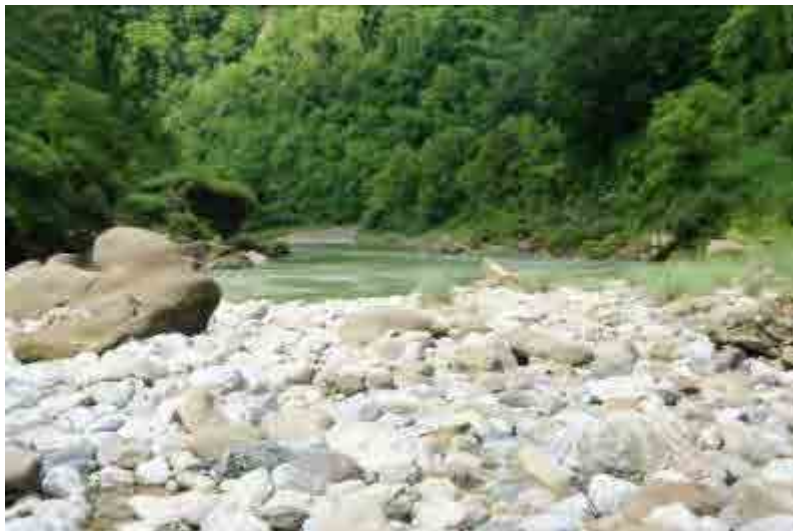
**Figure 1.16: Upstream view of the Andhi Khola near Matichaur showing coarse aggregates**

The required amount of coarse aggregate is available in the Andhi Khola near the Matichaur village about 500m upstream from the previously identified dam site (Figure 1.16). The fines should be obtained from the alluvial terraces of the Andhikhola River near Sera and Illunga. In the vicinity of dam site, boulders constitute about 40% of the total, whereas cobbles are also about 40%, and pebbles constitute the remaining 20% of the total volume. The coarse aggregate is composed mainly of quartzites, slates, and dolomites. The construction material is enough for building the dam and related structures.

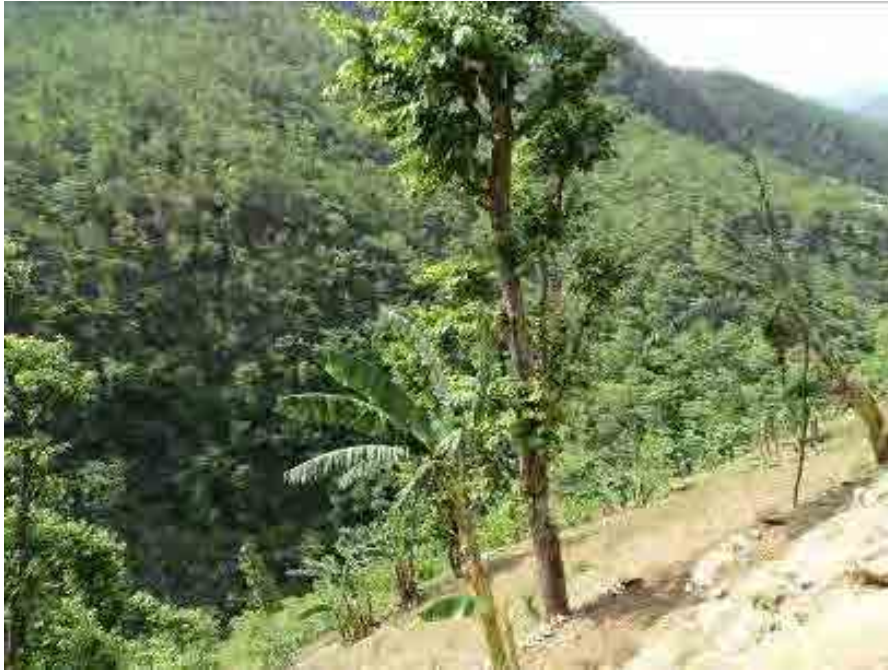
**Figure 1.7: Proposed dam axis at WPT 27. View to SE.**

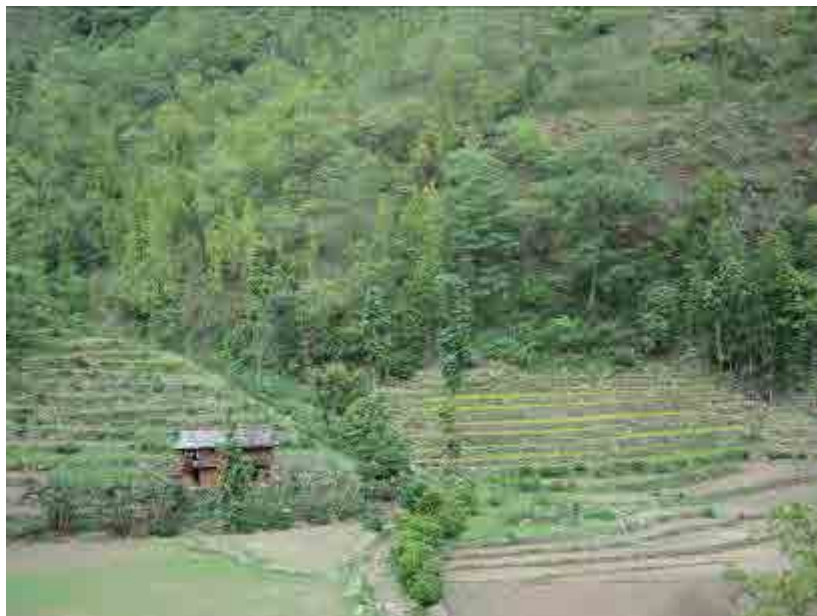
**Figure 1.13: Proposed powerhouse site on the right bank of the Chhera Khola (WPT 135). View to NE.**

The powerhouse site (Figures 1.11, 1.12, 1.13) is located about 8 km downstream, below Karkigaun, to the north of the Marka Bazaar, on the left bank of the Chhera Khola (Figure 1.14) at Karkigaun on an alluvial fan which is about 50 m wide and 100 m long. There about 50 m high quartzite cliff at the powerhouse site.

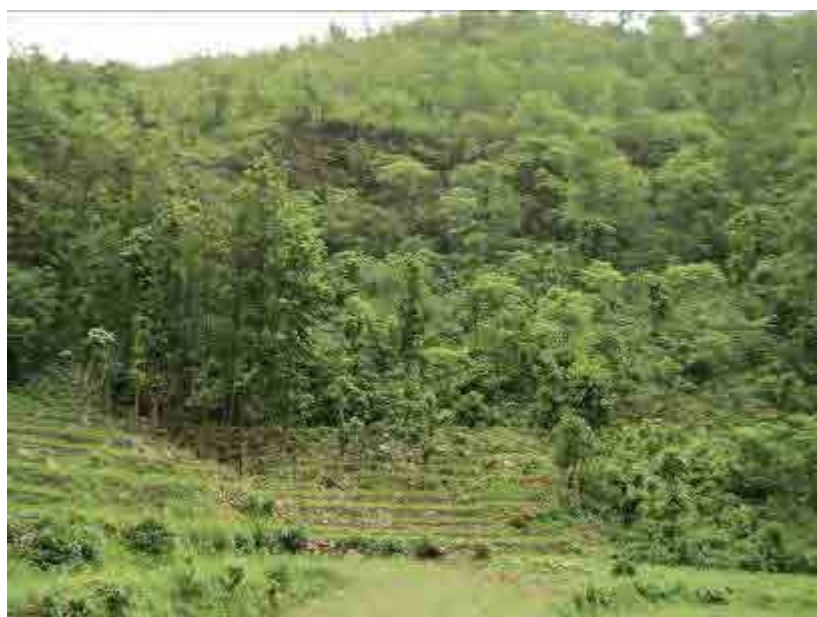
**Figure 1.14: A close-up view of the powerhouse site (near WPT 135). View to NE.**

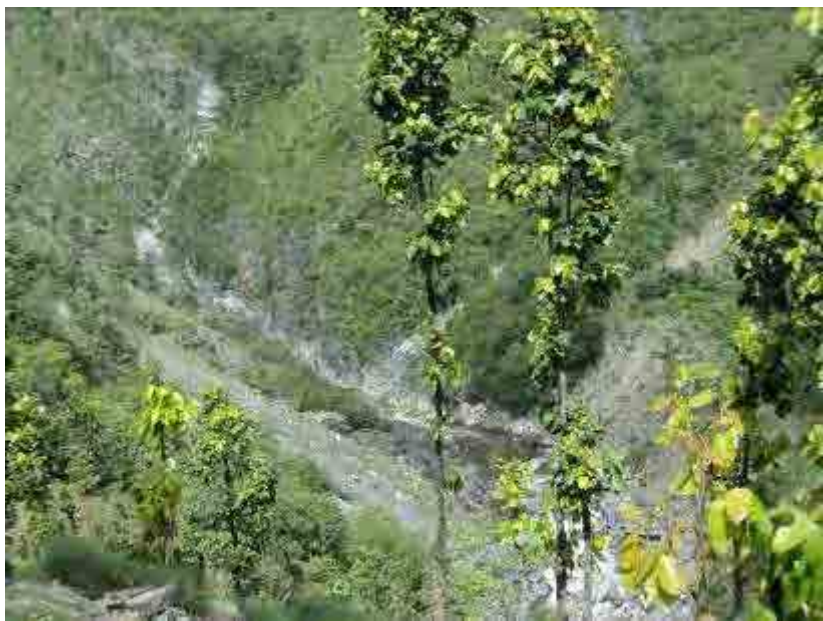
**Figure 1.16: Landslide on the both banks of the Chhera Khola at the Badaban village  
(WPT 30). View to E**

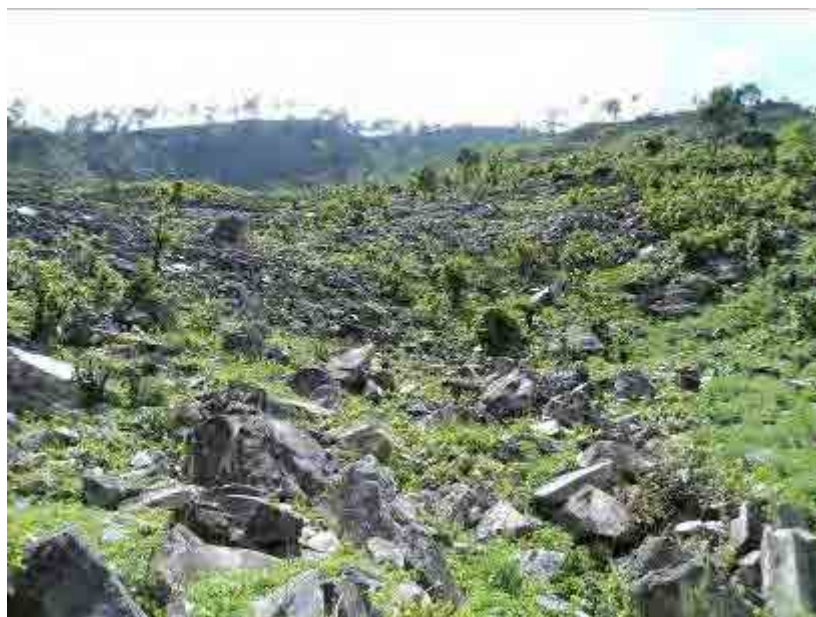
**Figure 1.17: Rock falls and slides at the Badaban village (near WPT 30). View to NW.**

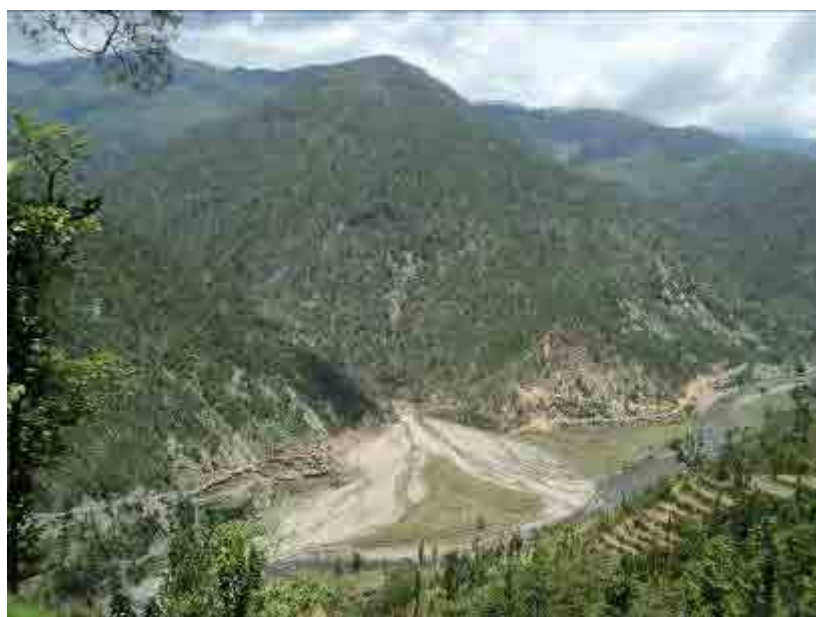
**Figure 1.18: Alluvial fan of the Salma Khola at Jyula as seen from the dam axis, left bank of the Cherra Khola (near WPT 36). View to N.**
