**Nepal Electricity Authority
Nepal**

**Nationwide Master Plan Study
on
Storage-type Hydroelectric Power
Development in Nepal**

**Final Report
Appendix (2/2)**

Annex 1: Geological Survey Report
Dudh Koshi Project (E-01)

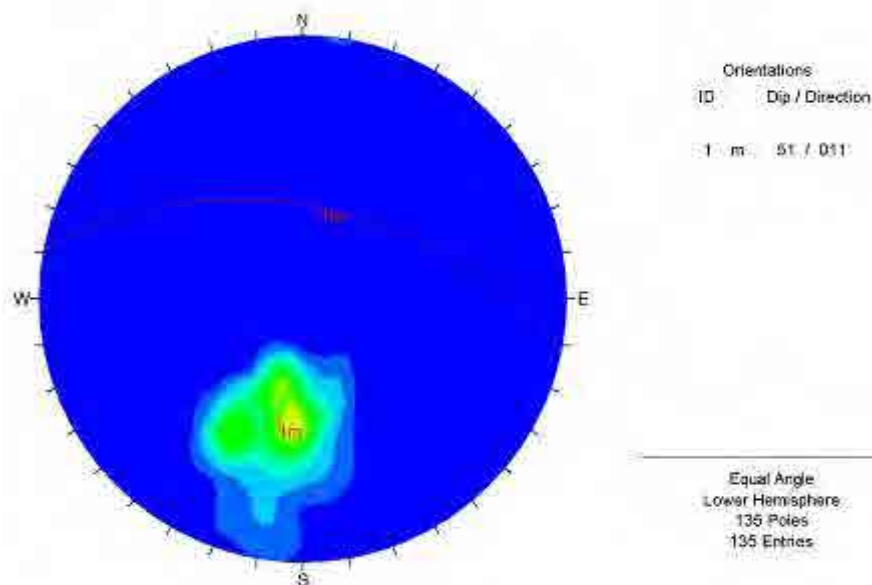
Figure 1.3: Stereographic plots of bedding and foliation from the project area.

The overall bedding and foliation of rocks is oriented due NE and their dip is moderately steep (i.e., 51 degrees). The stereographic projection of bedding and foliation is presented in Figure 1.3 where a strong concentration of of S-planes is observed.

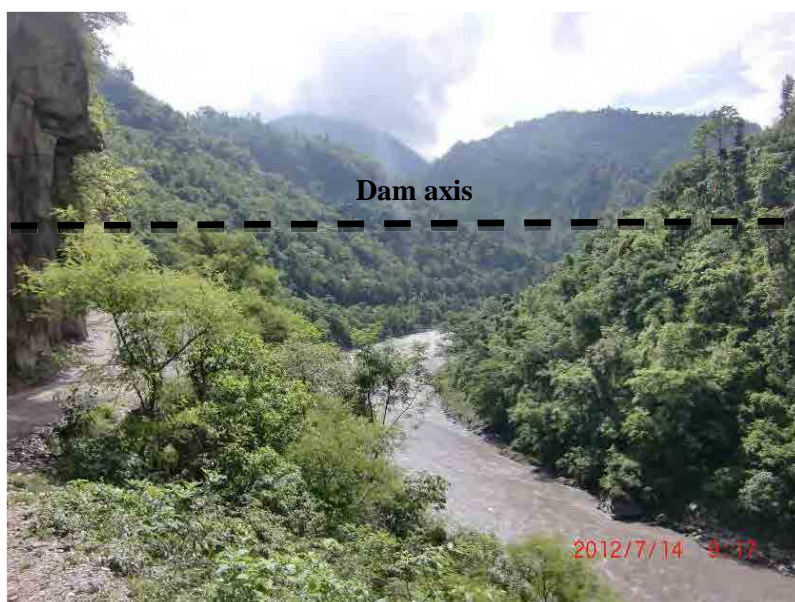
Figure 1.9: Downstream view of the Lower Badigad dam site, at waypoint WPT088. View to S.

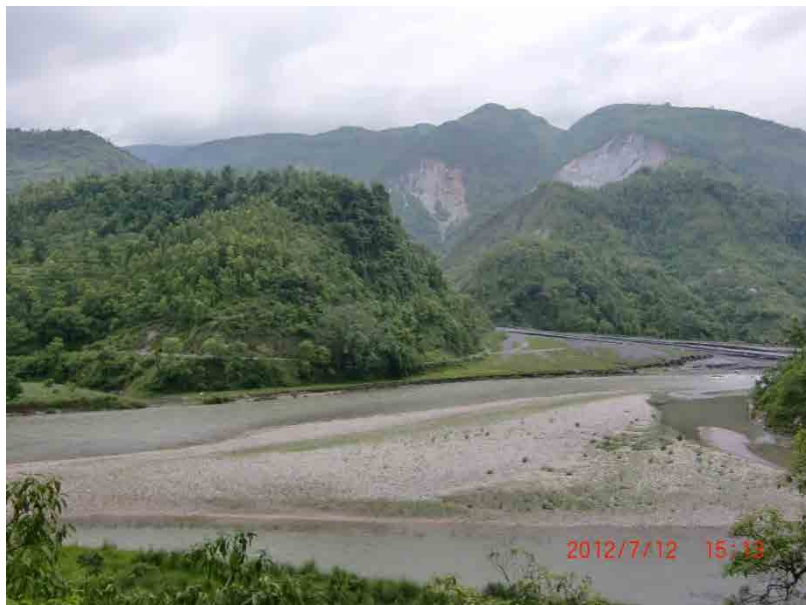
Figure 1.12: Alluvial fan at the left bank of BadigadKhola near GultungPahiro, taken at waypoint WPT063. Note that Gultung Pahiro has deposited huge amount of sediment at the river valley of BadigadKhola. View to NE.

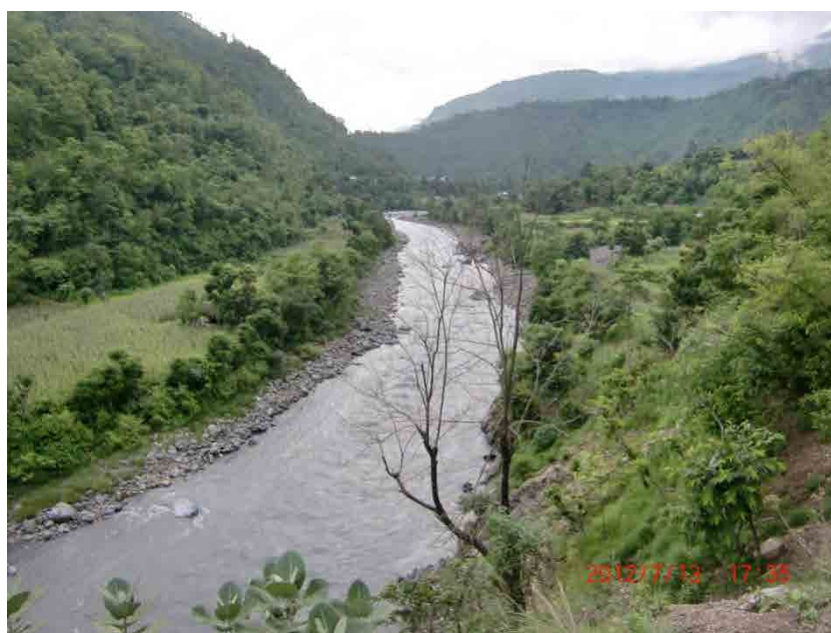
Figure 1.13: The alluvial terrace, sand and gravel bar as a source of construction material, upstream of dam site, taken at waypoint WPT085. View to W from dam site.

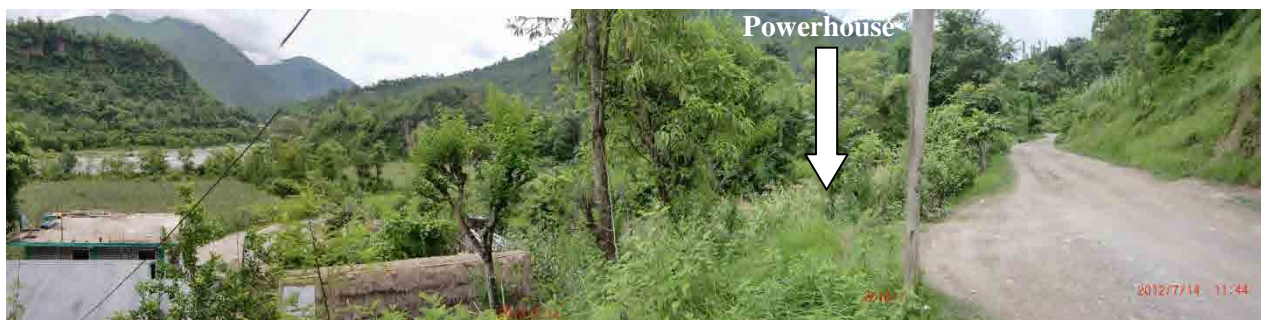
Figure 1.14: Powerhouse site on the alluvial terrace of BadigadKhola at RudrabeniGaun, taken at waypoint WPT095. View to E.

Powerhouse site is located on the right bank of BadigadKhola on the alluvial terrace at Rudrabeni which is about 400 m west to the confluence of BadigadKhola and Kaligandaki River (Figures 1.6 and 1.14). The alluvial terrace is about 300 m wide, 400 m long and about 30 m depth. Below the powerhouse site, there is about 300 m long (from the east to west) and about 100 m wide sand and gravel bar of the BadigadKhola. The bedrock that can be expected at the powerhouse site is at the depth of more than 40 m. The bedrock, joints and valley slope behind powerhouse shows stable slope conditions. However, there is some possibility of channel shifting and scouring of the alluvial terrace by both BadigadKhola and Kaligandaki River during high flooding events. Hence protective measures should be adopted during construction of powerhouse foundation.

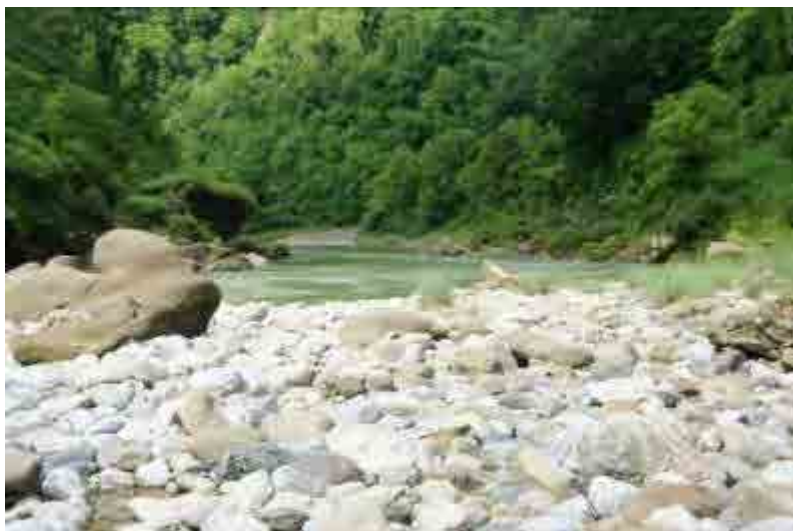
Figure 1.16: Upstream view of the Andhi Khola near Matichaur showing coarse aggregates

The required amount of coarse aggregate is available in the Andhi Khola near the Matichaur village about 500m upstream from the previously identified dam site (Figure 1.16). The fines should be obtained from the alluvial terraces of the Andhikhola River near Sera and Illunga. In the vicinity of dam site, boulders constitute about 40% of the total, whereas cobbles are also about 40%, and pebbles constitute the remaining 20% of the total volume. The coarse aggregate is composed mainly of quartzites, slates, and dolomites. The construction material is enough for building the dam and related structures.

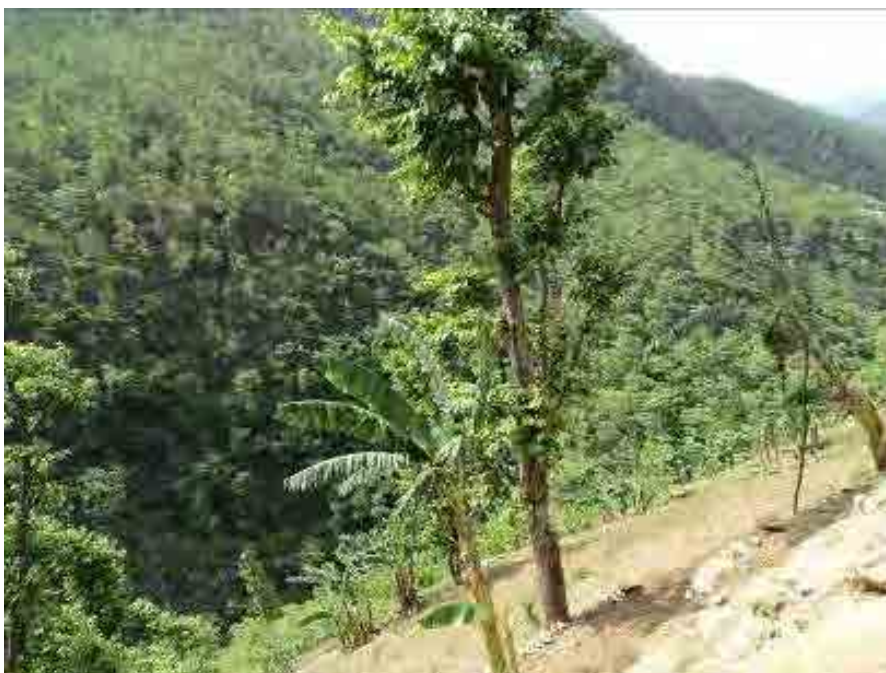
Figure 1.7: Proposed dam axis at WPT 27. View to SE.

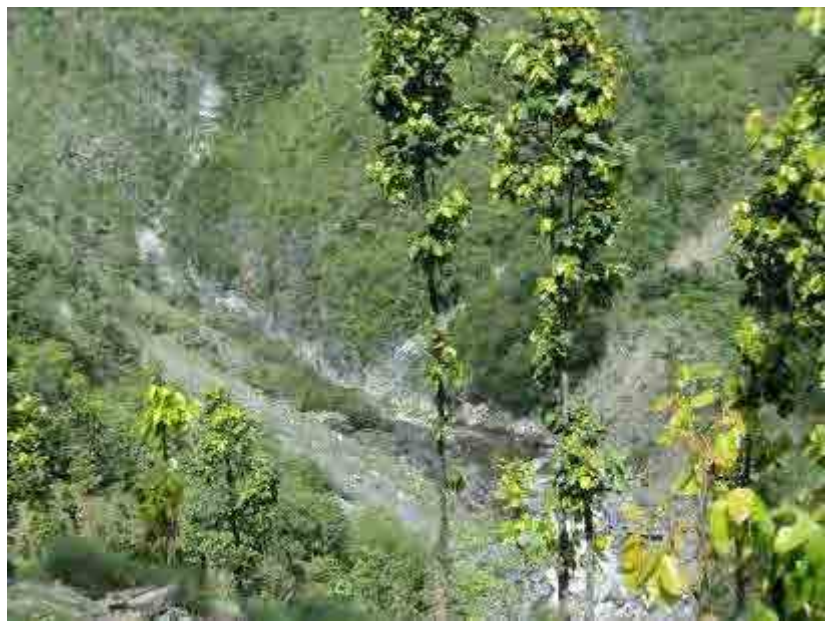
**Figure 1.16: Landslide on the both banks of the Chhera Khola at the Badaban village
(WPT 30). View to E**
