# **JICA Study Team Planning of the Nadi River Flood Control Structures Project**

## **Environmental Field Survey**

FRESHWATER ECOLOGICAL ASSESSMENT

Final Issue  
November 2015

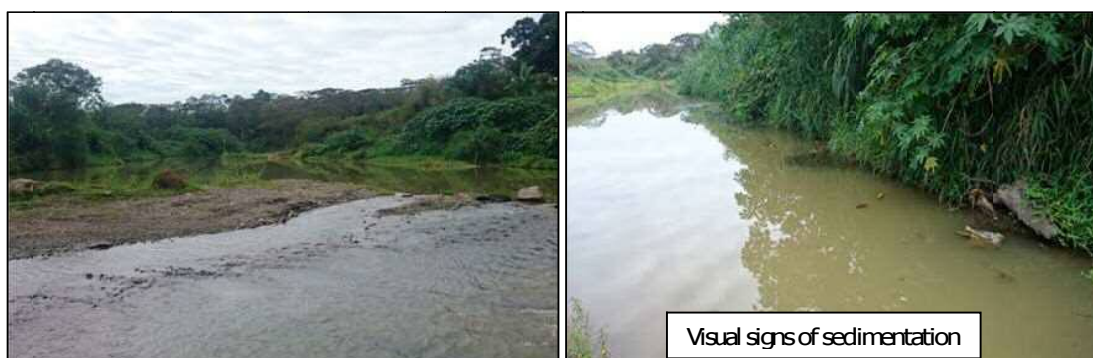
##### ■ Figure 2 Upper Catchment of Site 1

The first site surveyed was located on the top end of the tributary river. The site was dominated with sand and gravel, although soil could be located on both the sides of the River. The riverbed is estimated to have 60% gravel, 30% sand and 10% soil.

The riparian vegetation consisted of grassland and shrubs. The forest cover was estimated to be around 10% (very low) as most riparian vegetation has been removed for farming and mostly exotic and invasive grass dominate the riparian vegetation, thus resulting in high turbidity from runoff during heavy rain as shown in Figure 2. Also evident on site was the high degree of disturbance arising from gravel extraction operations upstream.

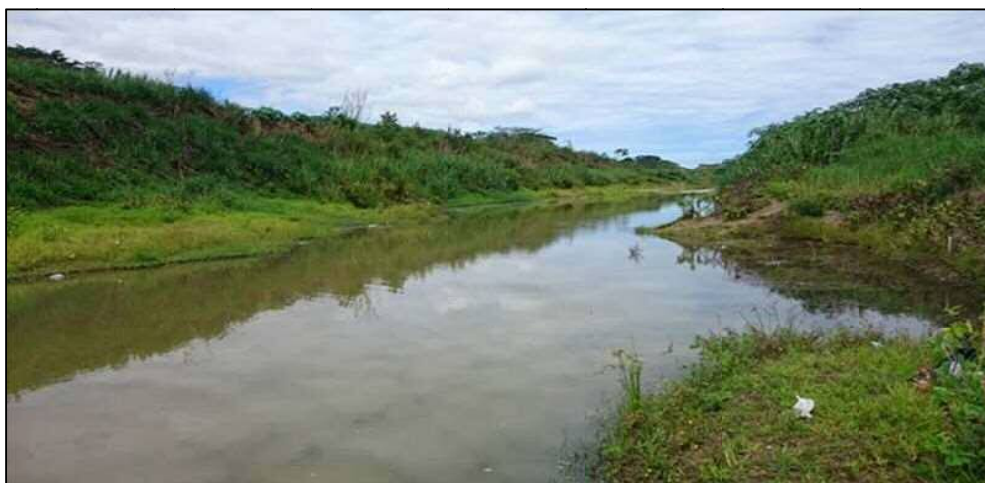
■ **Figure 3 Upper Catchment of Site 2**

The second site surveyed as shown in Figure 3 was located on the upper catchment of the river tributary. The substrate was dominated with sand, gravel and pebbles. An estimated riverbed percentage falls at 50% gravel, 30% sand and 20% pebble.

The riparian vegetation consisted of grassland and exotic plants with evidence of old farms. Also evident on site was the gravel extraction disturbances in the river. Household waste was also found to be scattered along the river bank indicating that residence living nearby disposed their rubbish into the river. This was obvious and the need to promote waste management with these residents is crucial in order to improve river conditions as well as to support aquatic life and livelihoods for the local community.

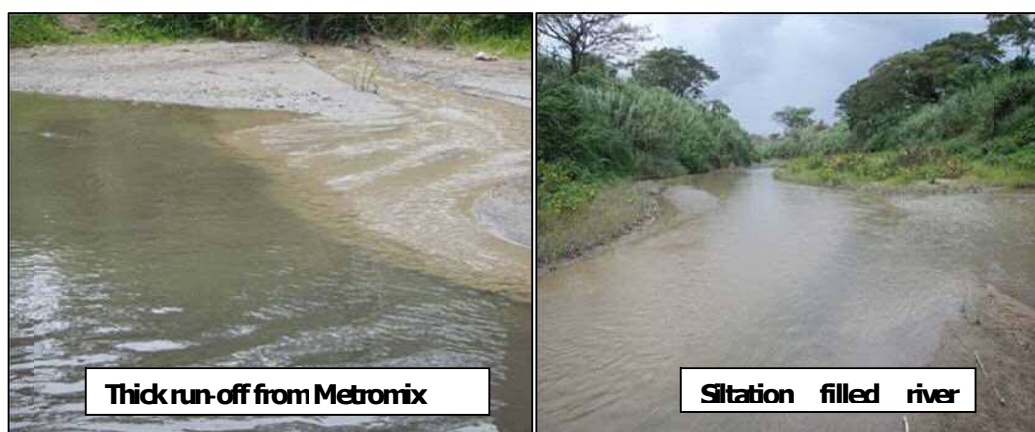
■ **Figure 4 Middle Catchment showing runoff from Metromix and siltation in the river**

The 3rd site surveyed was located below the old Queens Road bridge with Metromix (cement factory) located upstream. The river system was found to be very highly disturbed from the cement factory discharging waste water directly to the river causing significant impacts downstream as shown in **Figure 4**. It appears that habitats have been lost due to the amount of siltation covering the river system.

Sand is estimated to be around 30% as substrate was observed at around five meters off the bridge on one side of the river only and beyond that, was all silt which was around 80-90% of the substrate cover. Riparian vegetation was mainly grassland and shrubs estimated to be around 30-40%. The upper part of the bridge upstream of the outlet of the run-off was also surveyed and despite the disposal of household waste from local communities, it appeared that overhanging grass on the sides of the river seem to be providing home to some aquatic fauna which included an amphidromous fish from the Gobiidae family that was observed.

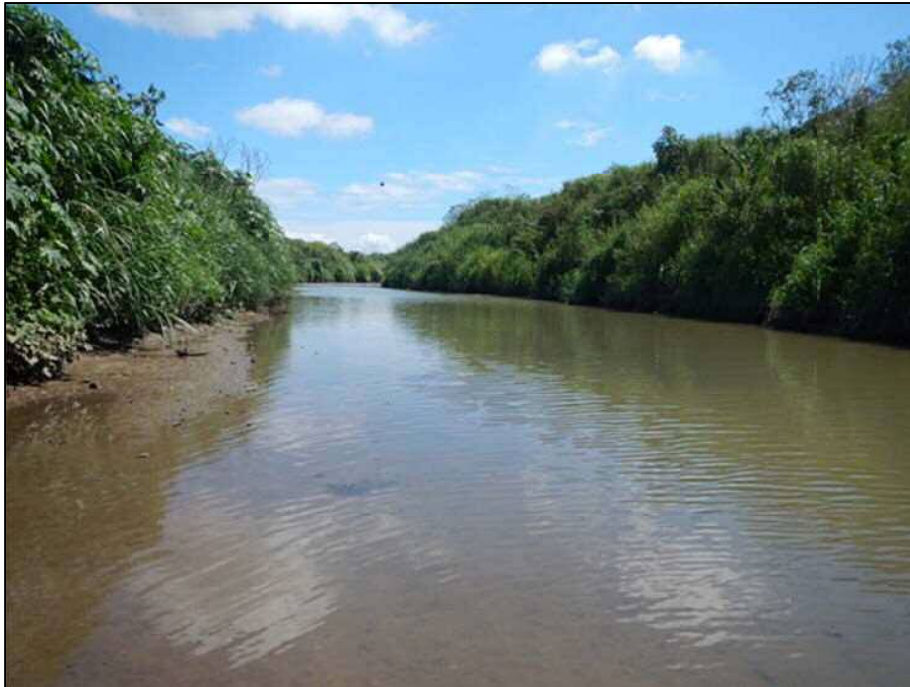
■ **Figure 5 Middle Catchment as Site 4**

The location of Site 4 was further downstream from the third site towards Nadi Town with the substrates consisting of 40% mud and 60% gravel.

The river bank vegetation was mainly covered with shrubs, grassland and exotic plants and 20 meters off the river bank were garden vegetables & tobacco farm shown in

**Figure 5.** Signs of disturbance could still be obvious as this was the continuation of the downstream impacts of the stormwater and sediment run-off from upstream. The impacts of were obvious with the low count of abundance and diversity of both macro-invertebrates and fish. The flow rate was slow and tidal change was experienced at this site considering its close proximity to where the river joins up with other main tributaries.

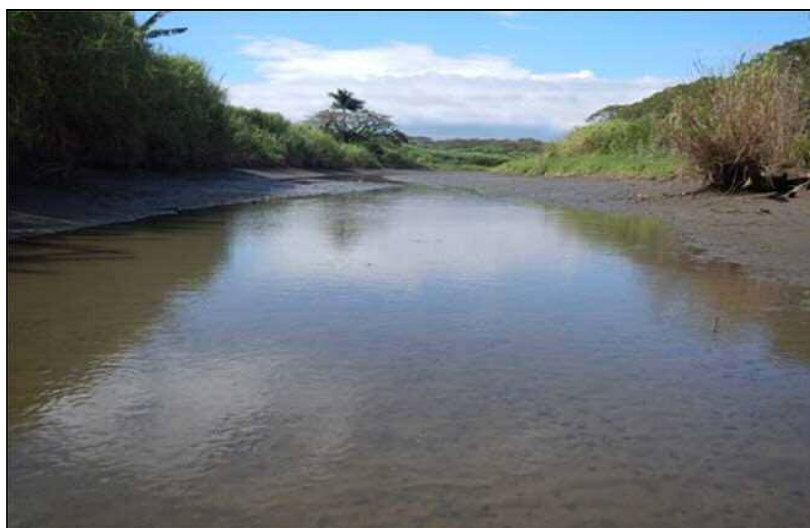
■ **Figure 6 Lower Catchment at Site 5**

Site 5 was located much closer to where a tributary merges with the Nadi River. Tidal change was more obvious at this site and substrate was predominately mud (90%) and 10% sand particularly on the sides of the river tributary.

The site lined with riparian vegetation mainly grassland with a few mango trees on either the side as shown in **Figure 6**. The high degree of disturbance from upstream could be found downstream as the survey team had to wade knee deep in mud and silts as a result of the upstream activities.

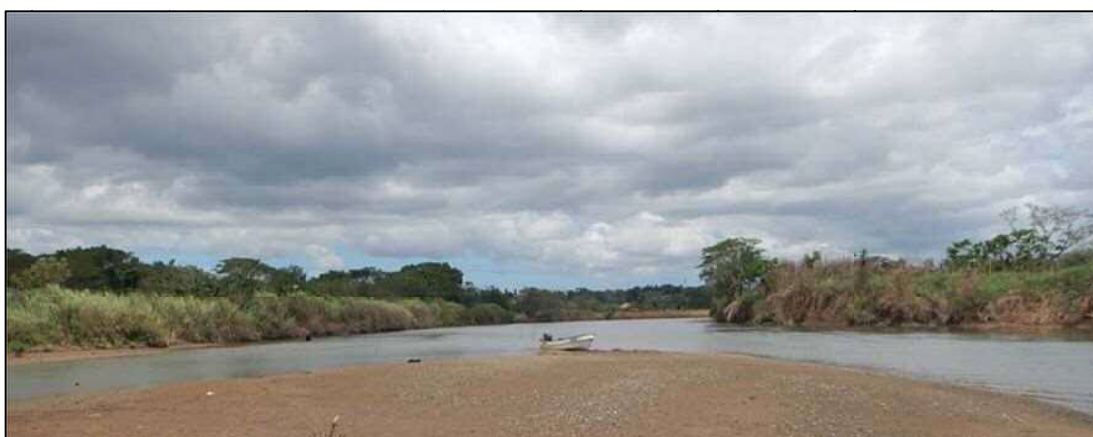
■ **Figure 7 Lower Nadi River**

The main substrate for Site 6 was mud and sand; with around 80% of mud and 20% sand. Riparian vegetation was mainly grassland and exotic trees with no forest cover as shown in **Figure 7**.

The site has undergone extensive dredging in order to deepen the Nadi River and this was obvious on site. One side of the river bank was covered with grass, growing on the deposited sand or spoil (as a result of dredging) while on the other side of the river bank comprised mainly of shrubs with few trees holding the bank together therefore preventing soil erosion. Tidal change was more obvious and flow could still be experienced during low tide. The only threat appeared to be the Navakai Sewerage Plant outfall shown in

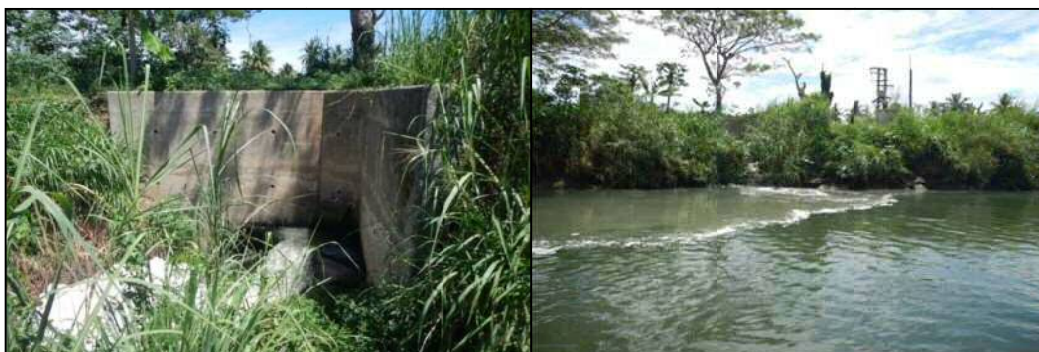
■ **Figure 8 Navakai STP Discharge Point into Nadi River**

**Figure 8** discharging directly into the River upstream from this sampling site.

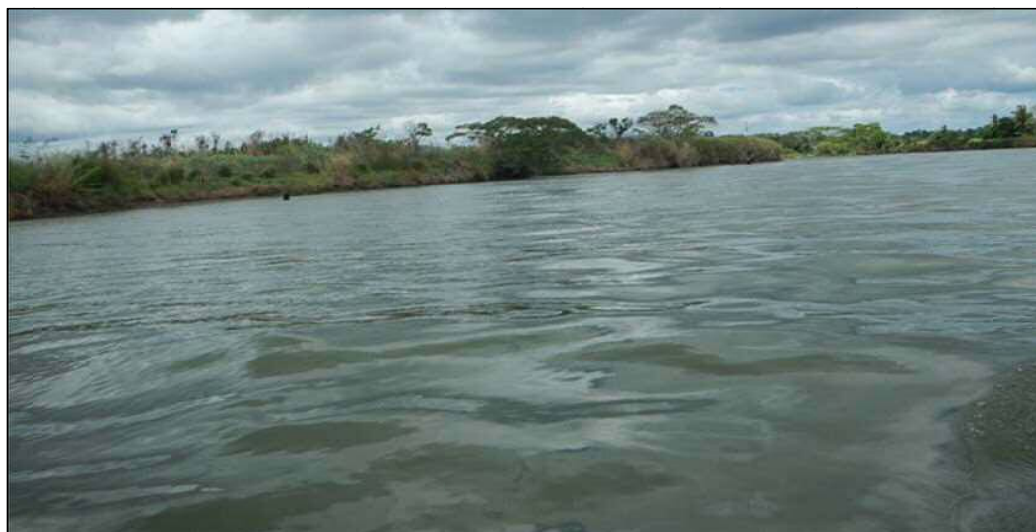
■ Figure 9 Site 7 Lower Nadi River

Similar to Site 6, the substrate at Site 7 as shown in Figure 9 was mainly mud (90%) and the other 10% was sand particles. Forest cover was noted as 30% comprising of riparian vegetation mainly grassland and native trees. A high degree of disturbance from sedimentation and siltation was evident downstream and this could be attributed to upstream activities such as farming, logging, gravel extraction operations and stormwater run-off. This area is also largely affected by the dredging that took place in the Nadi Town area a few years ago, as the banks of Site 7 was used to dump the dredged spoil which over time is being washed back into the Nadi River as the banks were not bunded to contain the spoil.

The width of the river at this point was 60 metres inclusive of the flood plain area, with average depths of 2.5 metres and water velocity of 0.29m/sec as shown in Table 7 below.

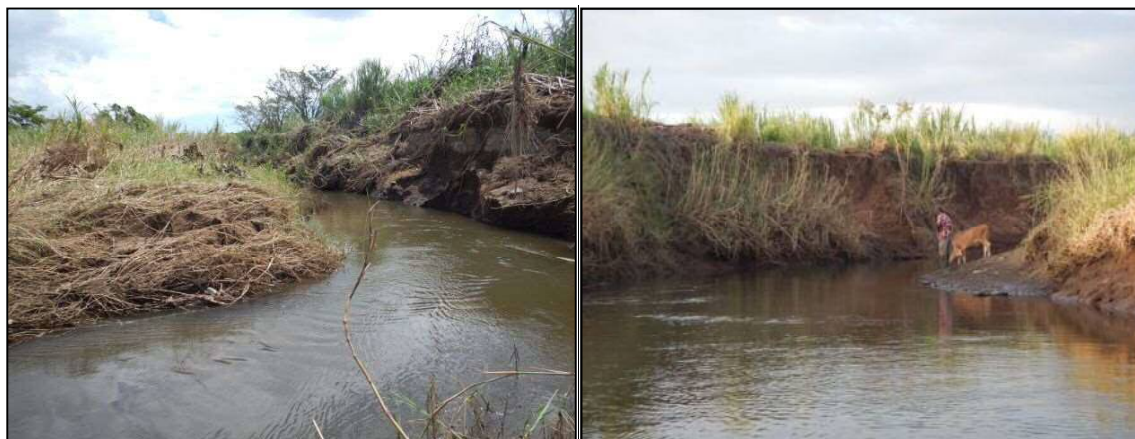
**Figure 3 Evidence of High Turbidity and Floating Debris Along Nadi River**

Throughout the sampled area, it was established that downstream of the two rivers are the most turbid area. The high turbidity downstream is mainly due to vegetation clearing for agriculture purposes as well as soil erosion along the river banks. From Site 5 and above the Nawaka Bridge, there seems to be slightly better clarity in the water as there was a significant sign of good water flow with fishes and other invertebrate present.

The level of turbidity at Site 1, Site 2, Site 3 and Site 5 were above the recommended guideline value with Site 5 recording the highest of 25.9 NTU.

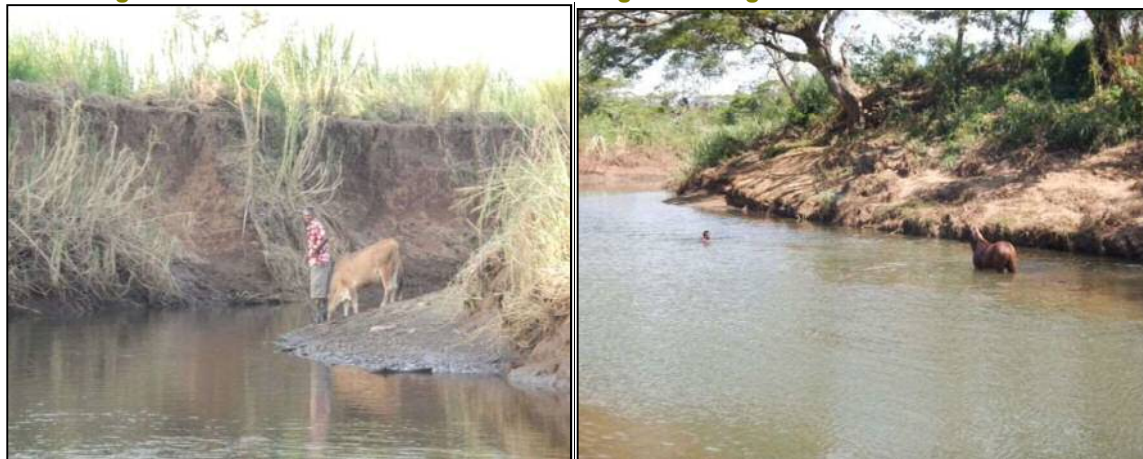
Pollution also contributes to either organic or inorganic depending on the source. During river sampling, the cause of suspended solids to name a few are due to agricultural land runoff during rainy weather, soil erosion along river bank, vegetation clearing too close to the river bank for farming, etc. Animals such as cows and horses are tied close to the river bank to graze as well as bathing of animals. Cow and horse dung was found close to the river which also contributes to the rise in suspended solids.

■ **Figure 4 Animals Use the River for Drinking & Bathing**

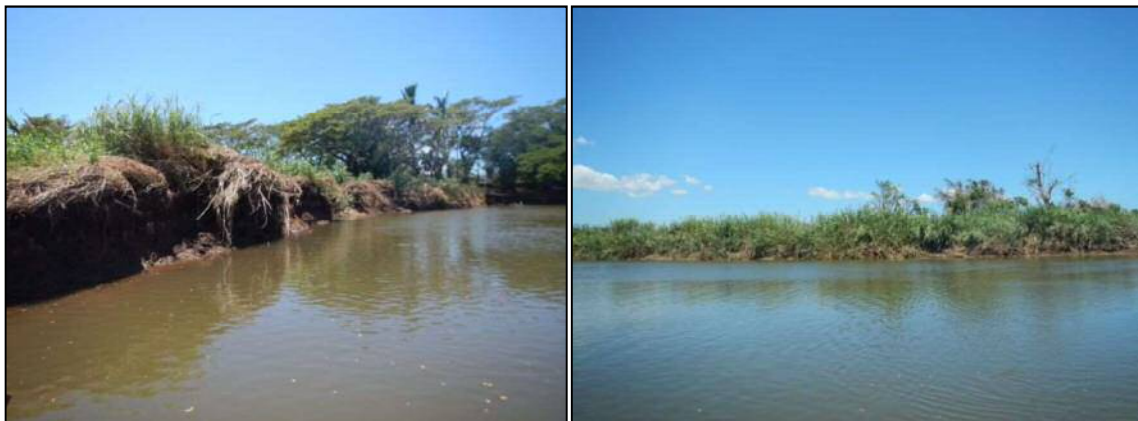
##### ■ Figure 2 Lower Catchment of Nawaka River as Site 1

The bank stability on both banks is categorized as unstable with high erosion potential during floods as shown in **Figure 2**. The river at the time of sampling was generally flat with no riffles and shows a very poor habitat. There is evidence of channel alterations due to the frequency in flooding of the river. The sediment deposition in the river was very high with heavy deposit of fine materials. On the left side of the river there has been a slight increase in bar formation mostly from gravel with little bits of sand and fine sediment. The abundance and diversity of habitat at Site 1 was very poor with substrate unfavorable for invertebrate colonization. The fish cover was very rare or absent due to high turbidity, although one type of small fish, the mosquito fish was caught using a net during the field survey. There were no periphytons

The first site surveyed was located approximately 80m above from the tributary of Nadi River. The site's riparian zone of both banks consisted mainly of invasive grasses, shrubs and plants including saplings tree of an introduced species known as *Anil indigo* (vaivai) and coconut trees. The river bank was very much exposed with no standing trees observed providing riparian cover over the river as they had been removed by the recent cyclone and previously for farming which therefore has resulted in high turbidity. It was observed that the riparian vegetative zone width has mostly been healed over from rise in flood water level and also with the presence of pathways and/or stock access to stream.

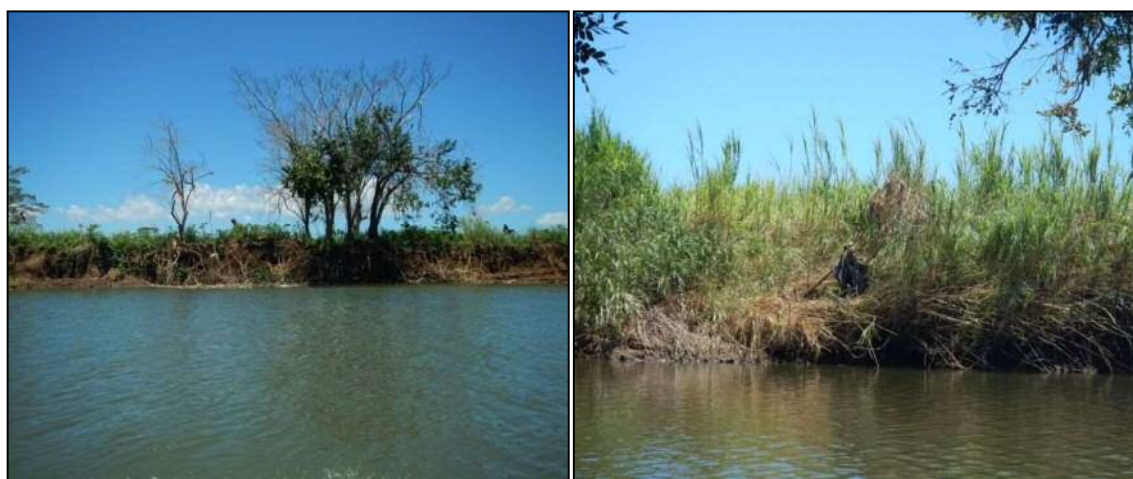
The second site surveyed as shown in **Figure 3** was located at the lower catchment of Malakua River just below the Malakua Bridge going into Nadi Town from Suva. The riparian vegetation comprised of invasive para grass, shrubs and an introduced rain tree (vaivai ni valagi), pawpaw trees with few vines and climbers and a riparian cover of 1%. The riparian vegetative zone width was very poor with evidence of human activity with both banks mostly been healed over. The bank stability is rated as poor and unstable showing many eroded areas with high erosion potential during flooding. The left river bank had severely eroded showing exposed tree roots with some fallen into the river.

■ **Figure 3 Catchment of Site 2**

The study site shows poor frequency of riffle as well as habitat with substrate unfavorable for invertebrate colonization as the substrate was unstable where present or lacking. The sediment deposition is high with heavy deposits of fine material into the river which has caused the formation of a bar in the middle of the river mostly composed of gravel, sand and fine sediments. There was also no fish cover observed at the site as the habitat had no macrophytes present as well as no periphyton.

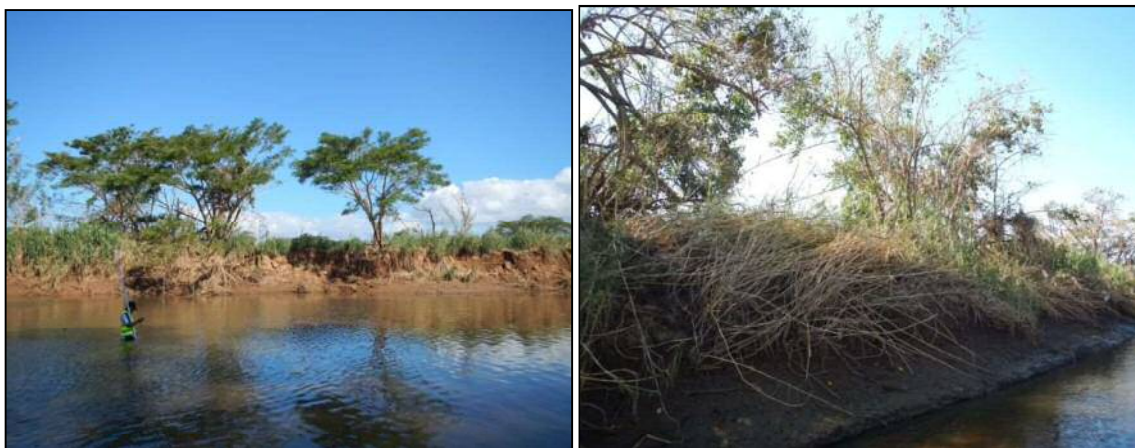
The 3rd site surveyed as shown in **Figure 4** was located above the Malakua Bridge (entering Nadi Town from Suva). The riparian vegetative zone width was very poor with minimal tree presence acting as a buffer and this is similar throughout the study sites upstream and downstream on both banks. The bank surfaces of both sides are covered by grass and shrubs and disruption of stream bank vegetation was very high.

■ **Figure 4 Above the Malakua Bridge Before Nadi Town**

The vegetation observed was a rain tree (vaivai) and a lemon tree with riparian cover of 2% but paragrass dominated both sides of the bank. The river banks were also heavily grazed by cows and horses. The bank stability is categorized as poor with many eroded areas and is considered unstable as flood water continuously wash away river banks, exposing tree roots and over time causing the trees to fall into the river.

The frequency of riffles was rated as poor since river water was generally flat/calm with no riffles and poor river habitat observed. The river/stream reach was heavily deposited with fine materials with evidence of bar formation on the left side of the river mostly from gravel, sand and fine sediments. The abundance and diversity of habitat was very poor with substrate unfavorable for invertebrate colonization. There was no fish cover sighted as well as no macrophytes or periphytons spotted.

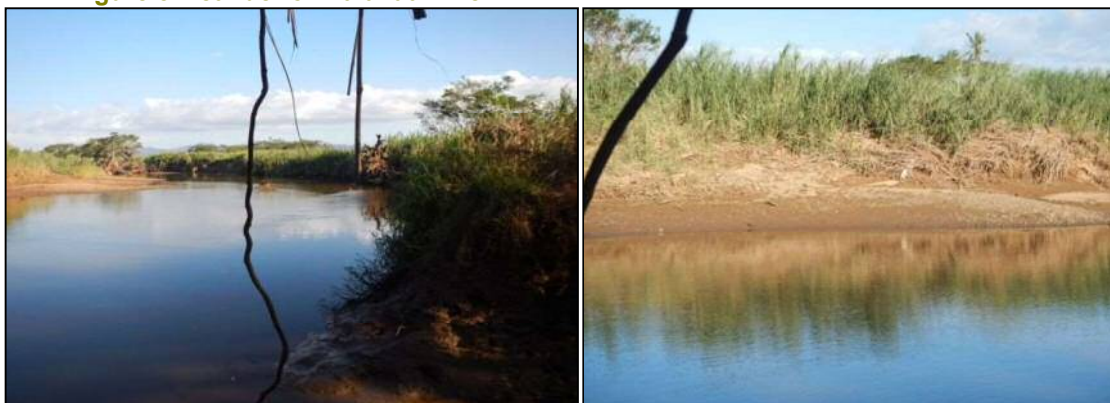
The location of Site 4 as shown in **Figure 5** was situated at the meander, 170 metres upstream of Site 3. The site assessment found that the riparian vegetative zone was very poor with evidence of human activity as communities were observed to be living close to the river along Vuniyasi Road.

■ **Figure 5 Meander of Malakua River**

There were presence of pedestrian pathways, dumped rubbish and livestock accessing the stream. Both bank surfaces are covered by grasses, shrubs and trees such as rain tree providing very poor riparian cover to the river of about 3% only. It was noted that the vegetation of the stream's bank has been highly disrupted by human activity as well as through frequent flooding that occurs in Nadi. Both banks were noted to be moderately unstable with moderate erosion potential during flooding. To the left of the river bank is a small tributary covered mostly with silt, mud and debris which join up into the main Malakua River and thus contributing to the very high turbidity levels of the stream reach.

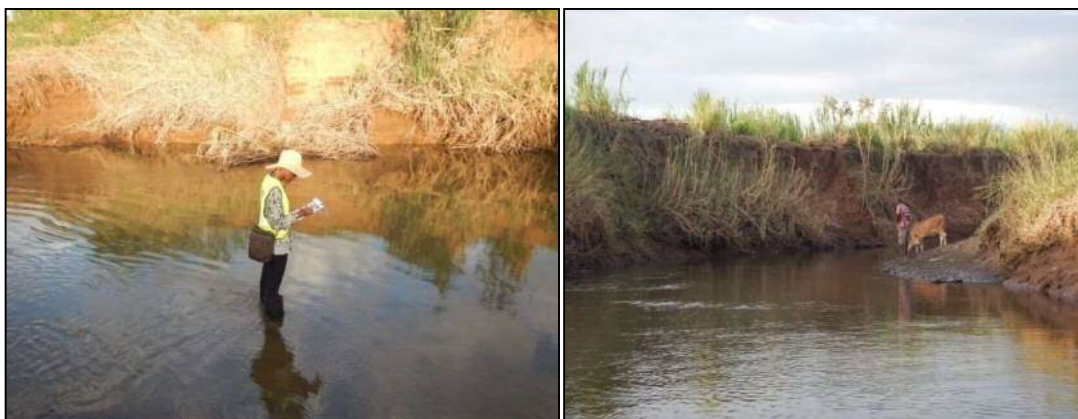
The 5<sup>th</sup> site surveyed was located upstream of Site 4 at the second meander of Malakua River. Locating the site was difficult due to the large cane farm that was used to access the river and another 50-60m before reaching the river bank. At most places along the river, the height of the bank was too high so alternative accesses to the stream had to be considered. During the survey, it was observed that the river banks and riparian was densely covered with paragrass and weeds and was therefore, widely used for grazing of animals. The riparian vegetative zone width is mostly healed over and there is presence of pathways for livestock access to stream as shown in Figure 6.

#### ■ **Figure 6 Malakua River**

The bank surfaces are also covered by shrubs and trees such guava with no riparian cover to shade the river. There were also root crops and vegetable farming evident near the river which survived the floodwaters during TC Winston whilst others were destroyed. The river banks were mostly exposed, eroded and unstable.

The river was generally flat with no riffle and the stream reach was significantly poor in habitat with no substrate favorable for invertebrate colonization or fish cover. The river habitat also lacked macrophytes and periphyton whether visible or prolific. The surveyed area was heavily deposited with fine sediments in particular at the left bank side, however as you move in the middle, there were deposition of gravel of about 20%, 10% pebbles, 5% cobbles, 5% sand while 50% were silt and mud and 10% were debris trapped along the water's edge of river bank.

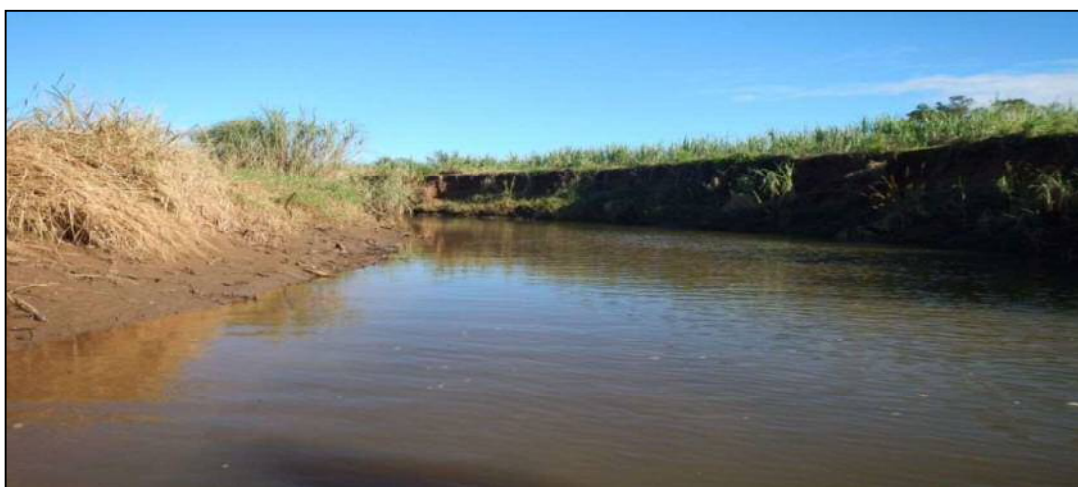
Site 6 was located at the lower bend or meander downstream from Site 5 as shown in [Figure 7](#) and reaching the site was via wading through the stream water.

#### ■ **Figure 7 Meander of Malakua River**

The riparian vegetative width is obvious affected by human activity as the presence of pathway and animal access to stream for drinking is evident. Both bank surfaces comprised mainly of paragrass, shrubs and weeds and appear highly disrupted. The banks are rated as unstable with high erosion potential during flooding. There were no trees growing on both sides of the banks to prevent the soil from eroding.

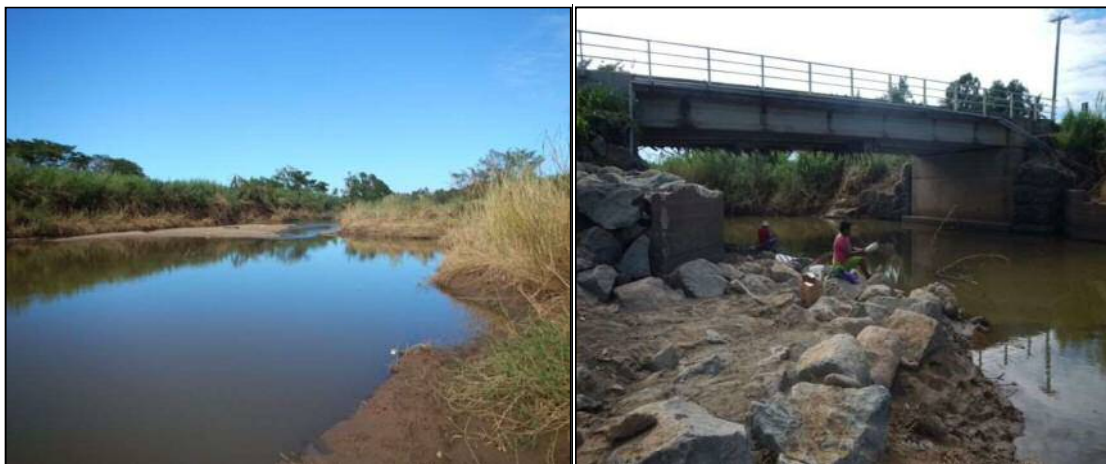
The location of Site 7 was situated below Nawaka Bridge as shown in [Figure 8](#).

■ **Figure 8 Downstream of Nawaka River (below the bridge)**

The riparian vegetative zone of the surrounding is mostly dominated by paragrass and shrubs which appear continuous and dense along the river bank width with no standing trees though a few can be seen further away from the river. Also noted were pathways for accessing the river for fishing and other activity. The banks appear unstable with significant eroded areas with other areas having high erosion potential particularly, during flooding. Generally the river is flat with occurrences of infrequent riffles and is indicative of a fair habitat for invertebrates showing patchy fish cover during survey. There were submerged logs and snags that provided habitats for fish and substrate that were favorable enough for invertebrate colonization.

The river bed comprised 35% gravel, 10% cobbles, 15% pebbles, 10% sand, 20% silt and 10% debris. It was observed that there was an increase in bar formation on the left side of the river mostly from gravel, sand and fine sediments.

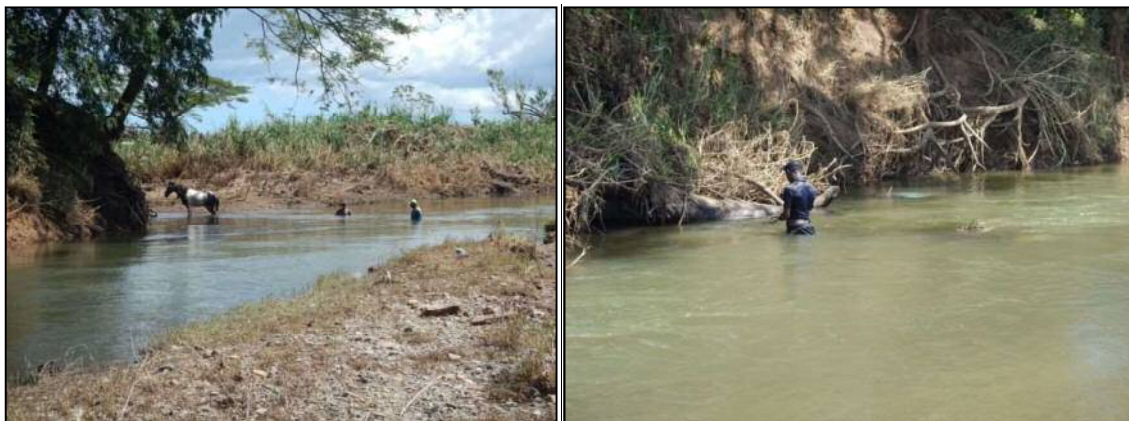
■ **Figure 9 River Used for Bathing of Animals, Diving and Fishing**

There were pathways to the river observed serving mostly the nearby communities to access the stream and was observed that the area has been actively used for fishing, swimming and bathing of their animals as shown in **Figure 9**.

The bank surfaces were covered with grasses, shrubs and trees such as raintree (vaivai) with riparian cover of 5%. The stream bank vegetation was highly disrupted with exposed tree roots and flattened paragrass and shrubs indicating the high level of flood waters the area receives. Both banks were moderately unstable with high erosion potential during flooding however, the river had relatively frequent riffles signifying a good habitat of 10-30% substrate favorable for invertebrate colonization and with patchy fish cover. Due to the recent flood, the river lacked macrophytes as well as having no presence of periphyton and prolific.

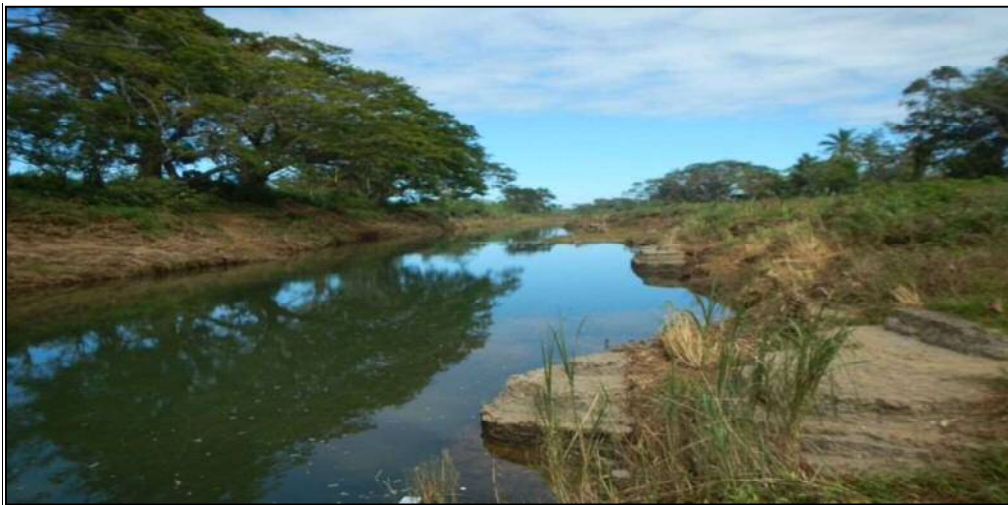
The last site surveyed was located upstream of Nawaka River adjacent to Nakawa Village as shown in **Figure 10**. The riparian vegetative zone width is mostly disturbed as the river has been accessed daily by the villagers for washing of clothes and dishes, swimming and bathing of villagers and animals. Upstream of the surveyed site along the stream bank were mostly covered with plantation.

■ **Figure 10 Site 7 Nawaka River (village located on the right bank)**

Both bank surfaces were covered with grass and shrubs while most trees were present on the left bank of the river with the tree roots holding the bank together. The riparian cover on site was 5% as most were damaged due to flooding that occurred during TC Winston. The bank stability was rated as moderately stable with infrequent, small area of erosion which has mostly healed over.

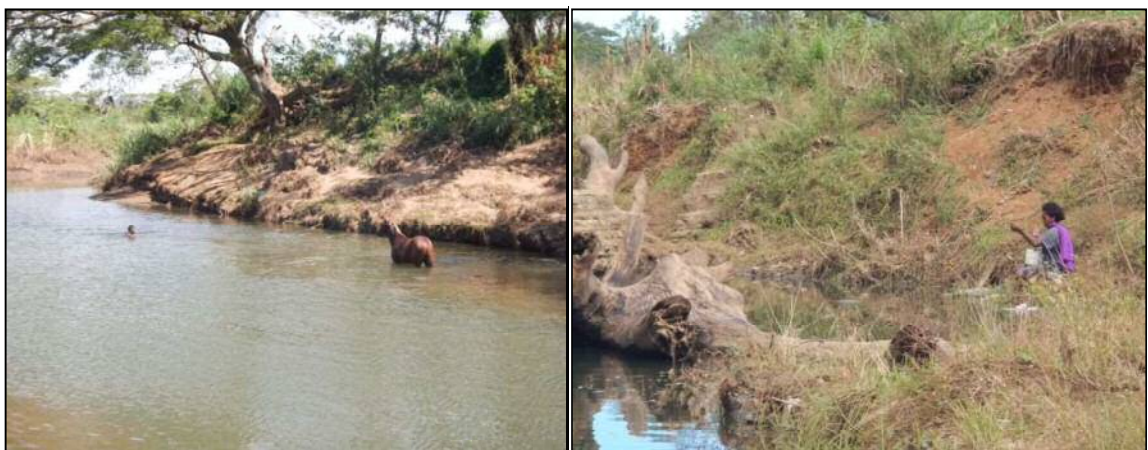
The surveyed site was observed to have relatively frequent riffles indicating that the habitat is good with 10-30% substrate favorable for colonization of invertebrates with patchy fish cover. It was noted during the survey that villagers use the river for fishing too as shown in Figure 11.

■ **Figure 11 Site 7 River Used for Swimming, Bathing and Fishing**

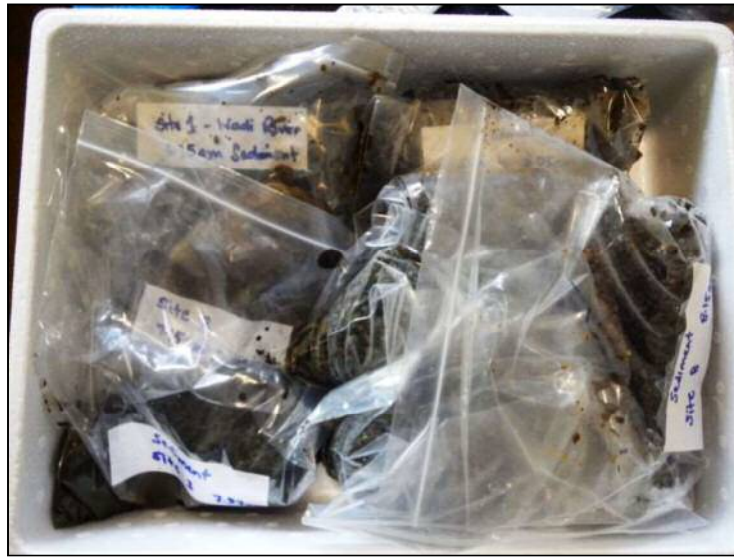
■ **Picture 1 Samples packed in Styrofoam Esky**

Samples were sealed in air-tight sealed plastic bags, labelled and placed in a styrofoam esky and delivered to the courier service company, DHL, at the Nadi International Airport for delivery to Hills Laboratory in Hamilton, New Zealand. All customs clearance documentation as required was completed, scanned and emailed to Hills Laboratory for ease of clearance once received.

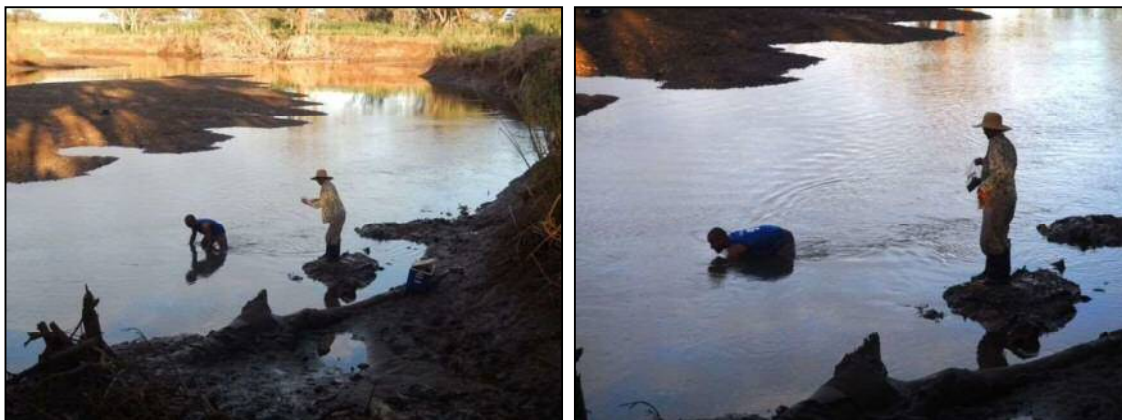
■ **Picture 2 L & R** Sampling behind the Nadi town industrial zone.

The river in this area is mainly influenced by the tides; thus river depth at this location was not very deep as sampling was undertaken during falling tide, and samples were collected from knee-deep water (Picture 2L). Preliminary observation of the sample indicated it comprised of more silt and clay.

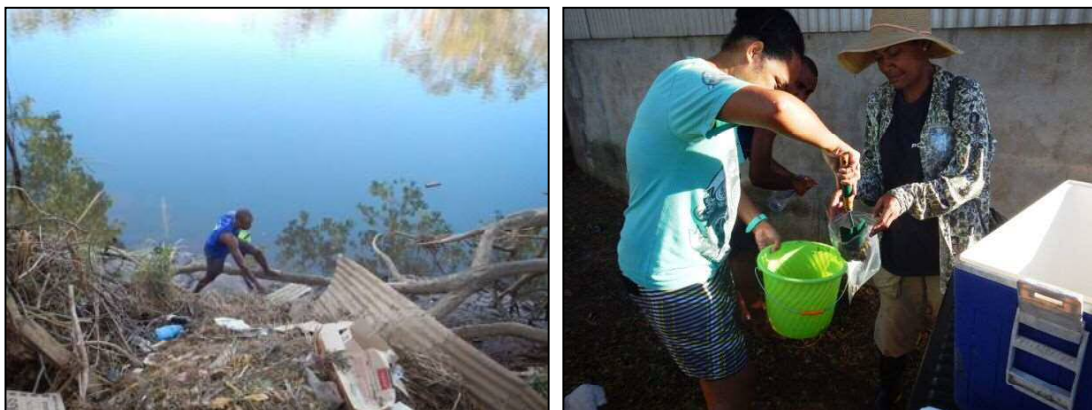
Samples were collected at 7.15 a.m. Access to the site was via a narrow track on the outskirts of the industrial area. Sampling proved difficult as the river surface was situated approximately 5 meters below the edge of the riverbank.

■ **Picture 3 Left – Access to the Site via Tree Roots. Garbage and Woody Debris Strwn along the Riverbank; Right – Sediment Sample being Transferred to the Sample Bag from the Bucket**

Riverbank vegetation on both sides were similar to Site 1, comprising thick para grass and raintrees, and observation of the sample indicated it was very similar to Sample 1 which comprised a lot of silt and clay. A sizeable amount of household and industrial litter as well as woody debris were observed on the riverbank (Picture 3L).

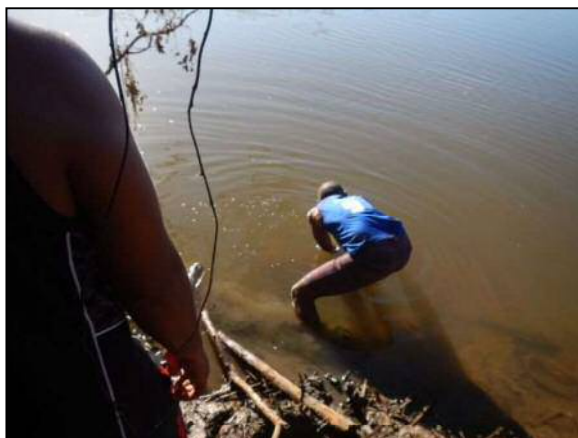
■ **Picture 4 – Sediment Sampling at Site 3**

Riverbank vegetation on both sides comprised of large stands of para grass and shrubs, and observation of the sample indicated it comprised much of silt and clay. The river bank was quite slippery with a lot of mud observed on the bank and the riverbed. There was quite a lot of household rubbish observed on the riverbank.

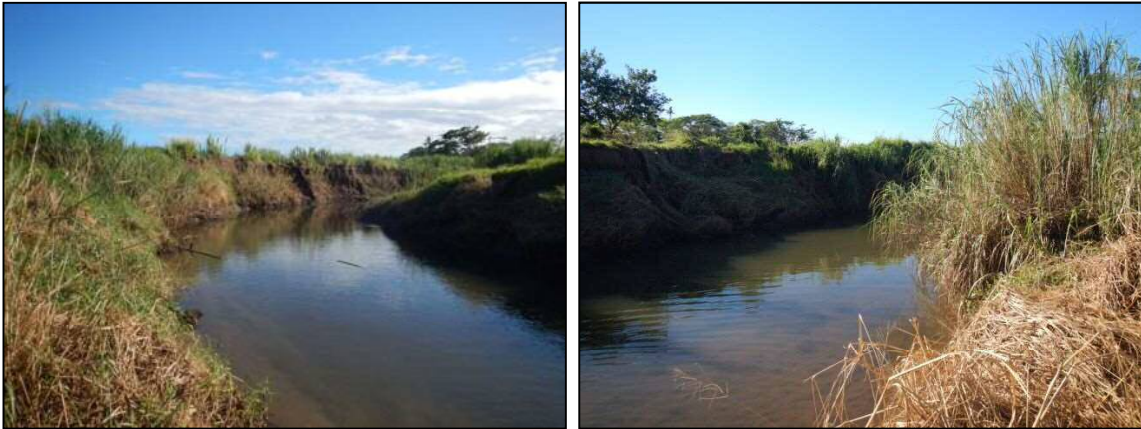
Riverbank vegetation on both sides comprised thick para grass and riparian vegetation with some eroded, exposed areas. Sediment samples at this site were very similar to those found at the first three sites, comprising silt and clay.

- **Picture 5 – Riverbank Vegetation Showing Thick Para Grass and Eroding Riverbank Areas Where Exposed**

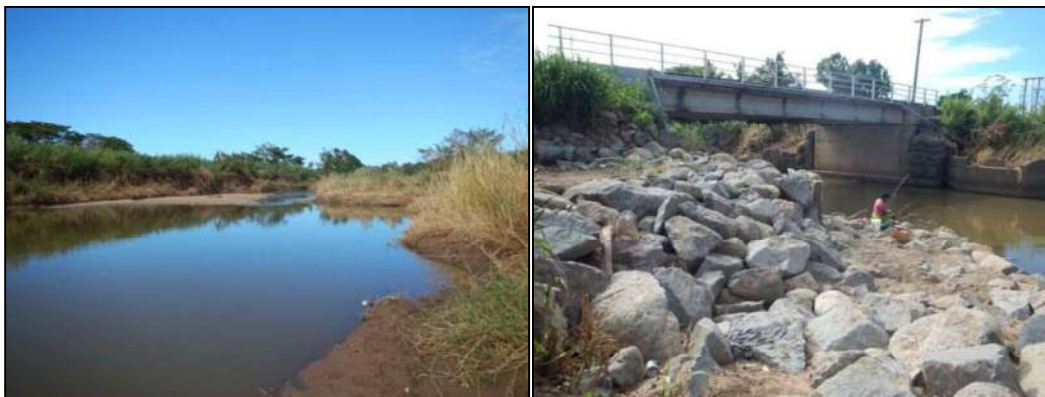
The river was quite wide and deep at the sampling site, and riverbank substrates comprised of silt, sand and mud on one side and sand and gravel on the other side. Large rock boulders were also observed next to the bridge to assist in protecting the banks from erosion. Women from nearby communities were observed fishing onsite.

- **Picture 7 Left – Sampling Site Showing Silt and Sandy Mud on One Bank and Sand and Gravel on the Other Side; Right – Local Women Fishing Next to Large Rock Boulders Placed Near Bridge**

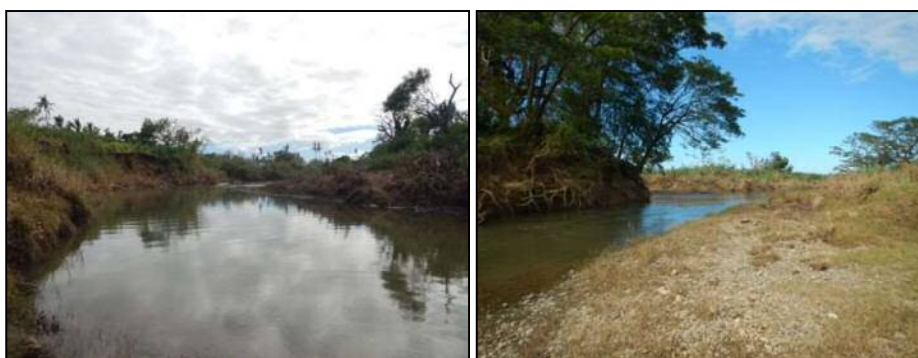
The river widened in some areas and narrowed further down where a narrow inlet joined the river. Riverbank substrate comprised of sand and gravel, as did the riverbed sample. Riverbank vegetation comprised of para grass, shrubs and big rain trees that had their roots exposed on the riverbank, indicating riverbank erosion.

- **Picture 8 Sampling Site Showing Sand and Gravel Riverbanks and Rain Trees Growing on Opposite Bank with Roots Exposed Due to Bank Erosion**

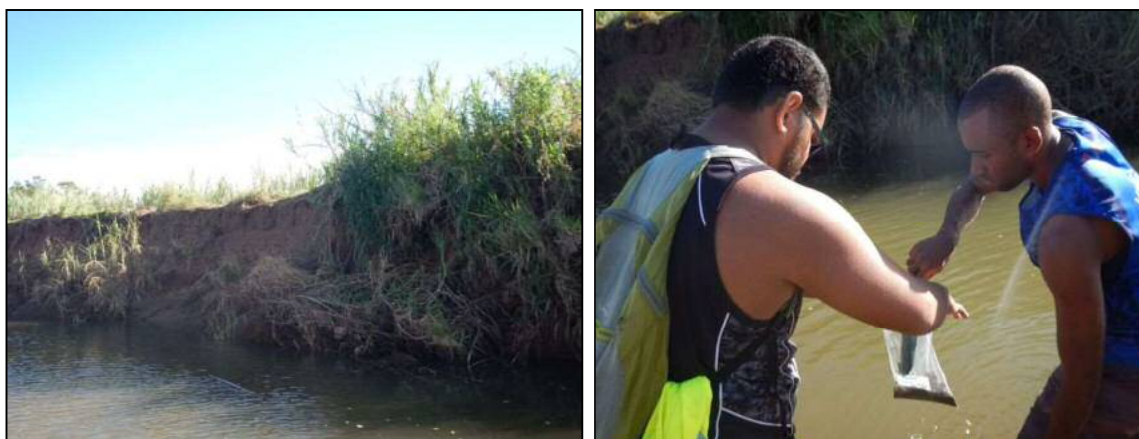
Riverbank vegetation comprised of thick para grass and shrubs, and some exposed areas displayed eroded river banks. Riverbank substrates indicated clay soil, as did the riverbed sample.

- **Picture 13 Left – Exposed River Bank Displaying Soil Erosion; Right – SCOPE Team Undertaking Sediment Sampling**

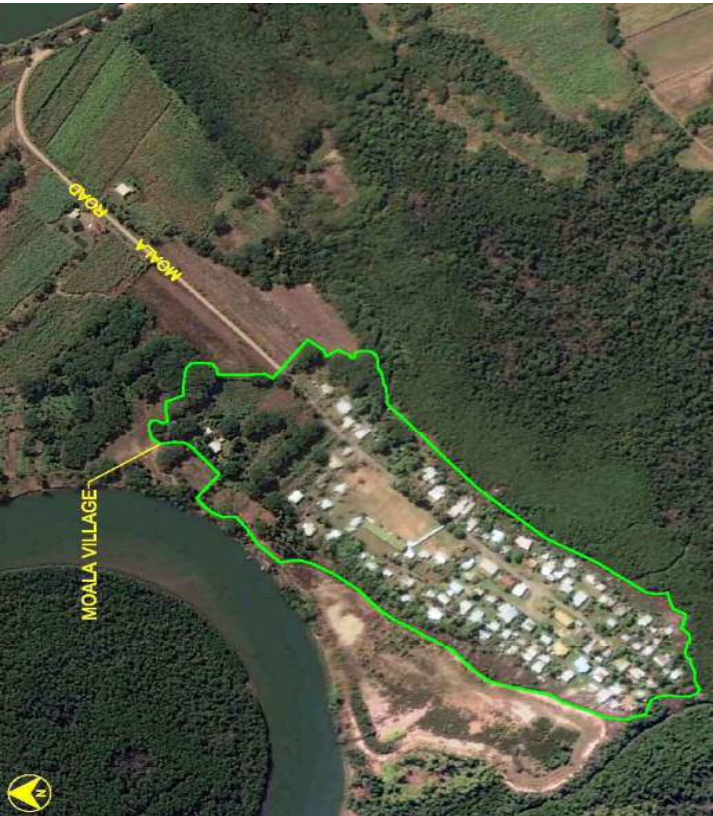
■ Figure 1 Locality Maps Showing Terrestrial Survey Areas

The terrestrial ecological assessment was undertaken on differing sides of the Malakua and Nawaka Rivers, and an aerial photograph was used to randomly identify and select the different types of vegetation cover along the river banks within the study area. The areas covered in the surveys are depicted in **Figure 1**. Methodology for the surveys comprised of visual observation, analysis and inventory-taking to record the types of vegetation (flora), animals (fauna) and birds (avifauna) present on-site whilst walking the entire length of riverbanks within the study area. Descriptions of the physical terrain and surrounding land uses were also noted down.

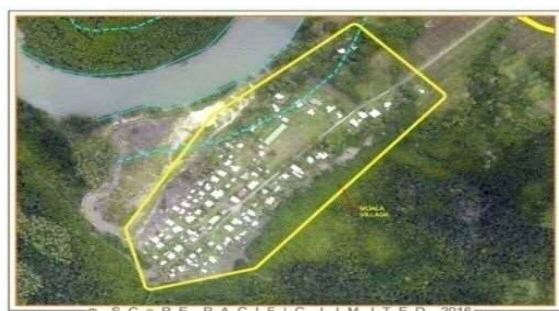
#### ■ Figure 2 Properties within the Boundaries of Moala Village

A total of seventy-six (76) households were surveyed in Moala village, although eighty-five (85) properties had been selected using aerial imagery. The remaining nine (9) properties that were excluded from the household surveys were observed to be the village hall, houses whose owners owned more than one house, and vacant houses and student lavatories within the Ralet Primary School compound.

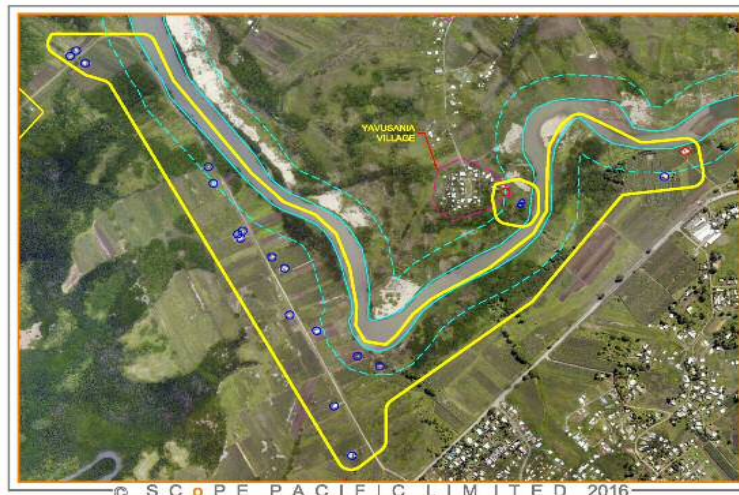
- **Figure 3** Location of Properties along Moala Road and One Property in Yavusania Village

A total of sixteen (16) properties situated along Moala Road as well as two properties belonging to one owner which was counted as one household situated across the river at Yavusania village were selected for the household surveys. The two properties in Yavusania village will be displaced.
