# **JICA Study Team Planning of the Nadi River Flood Control Structures Project**

## **Environmental Field Survey**

FRESHWATER ECOLOGICAL ASSESSMENT

Final Issue  
November 2015

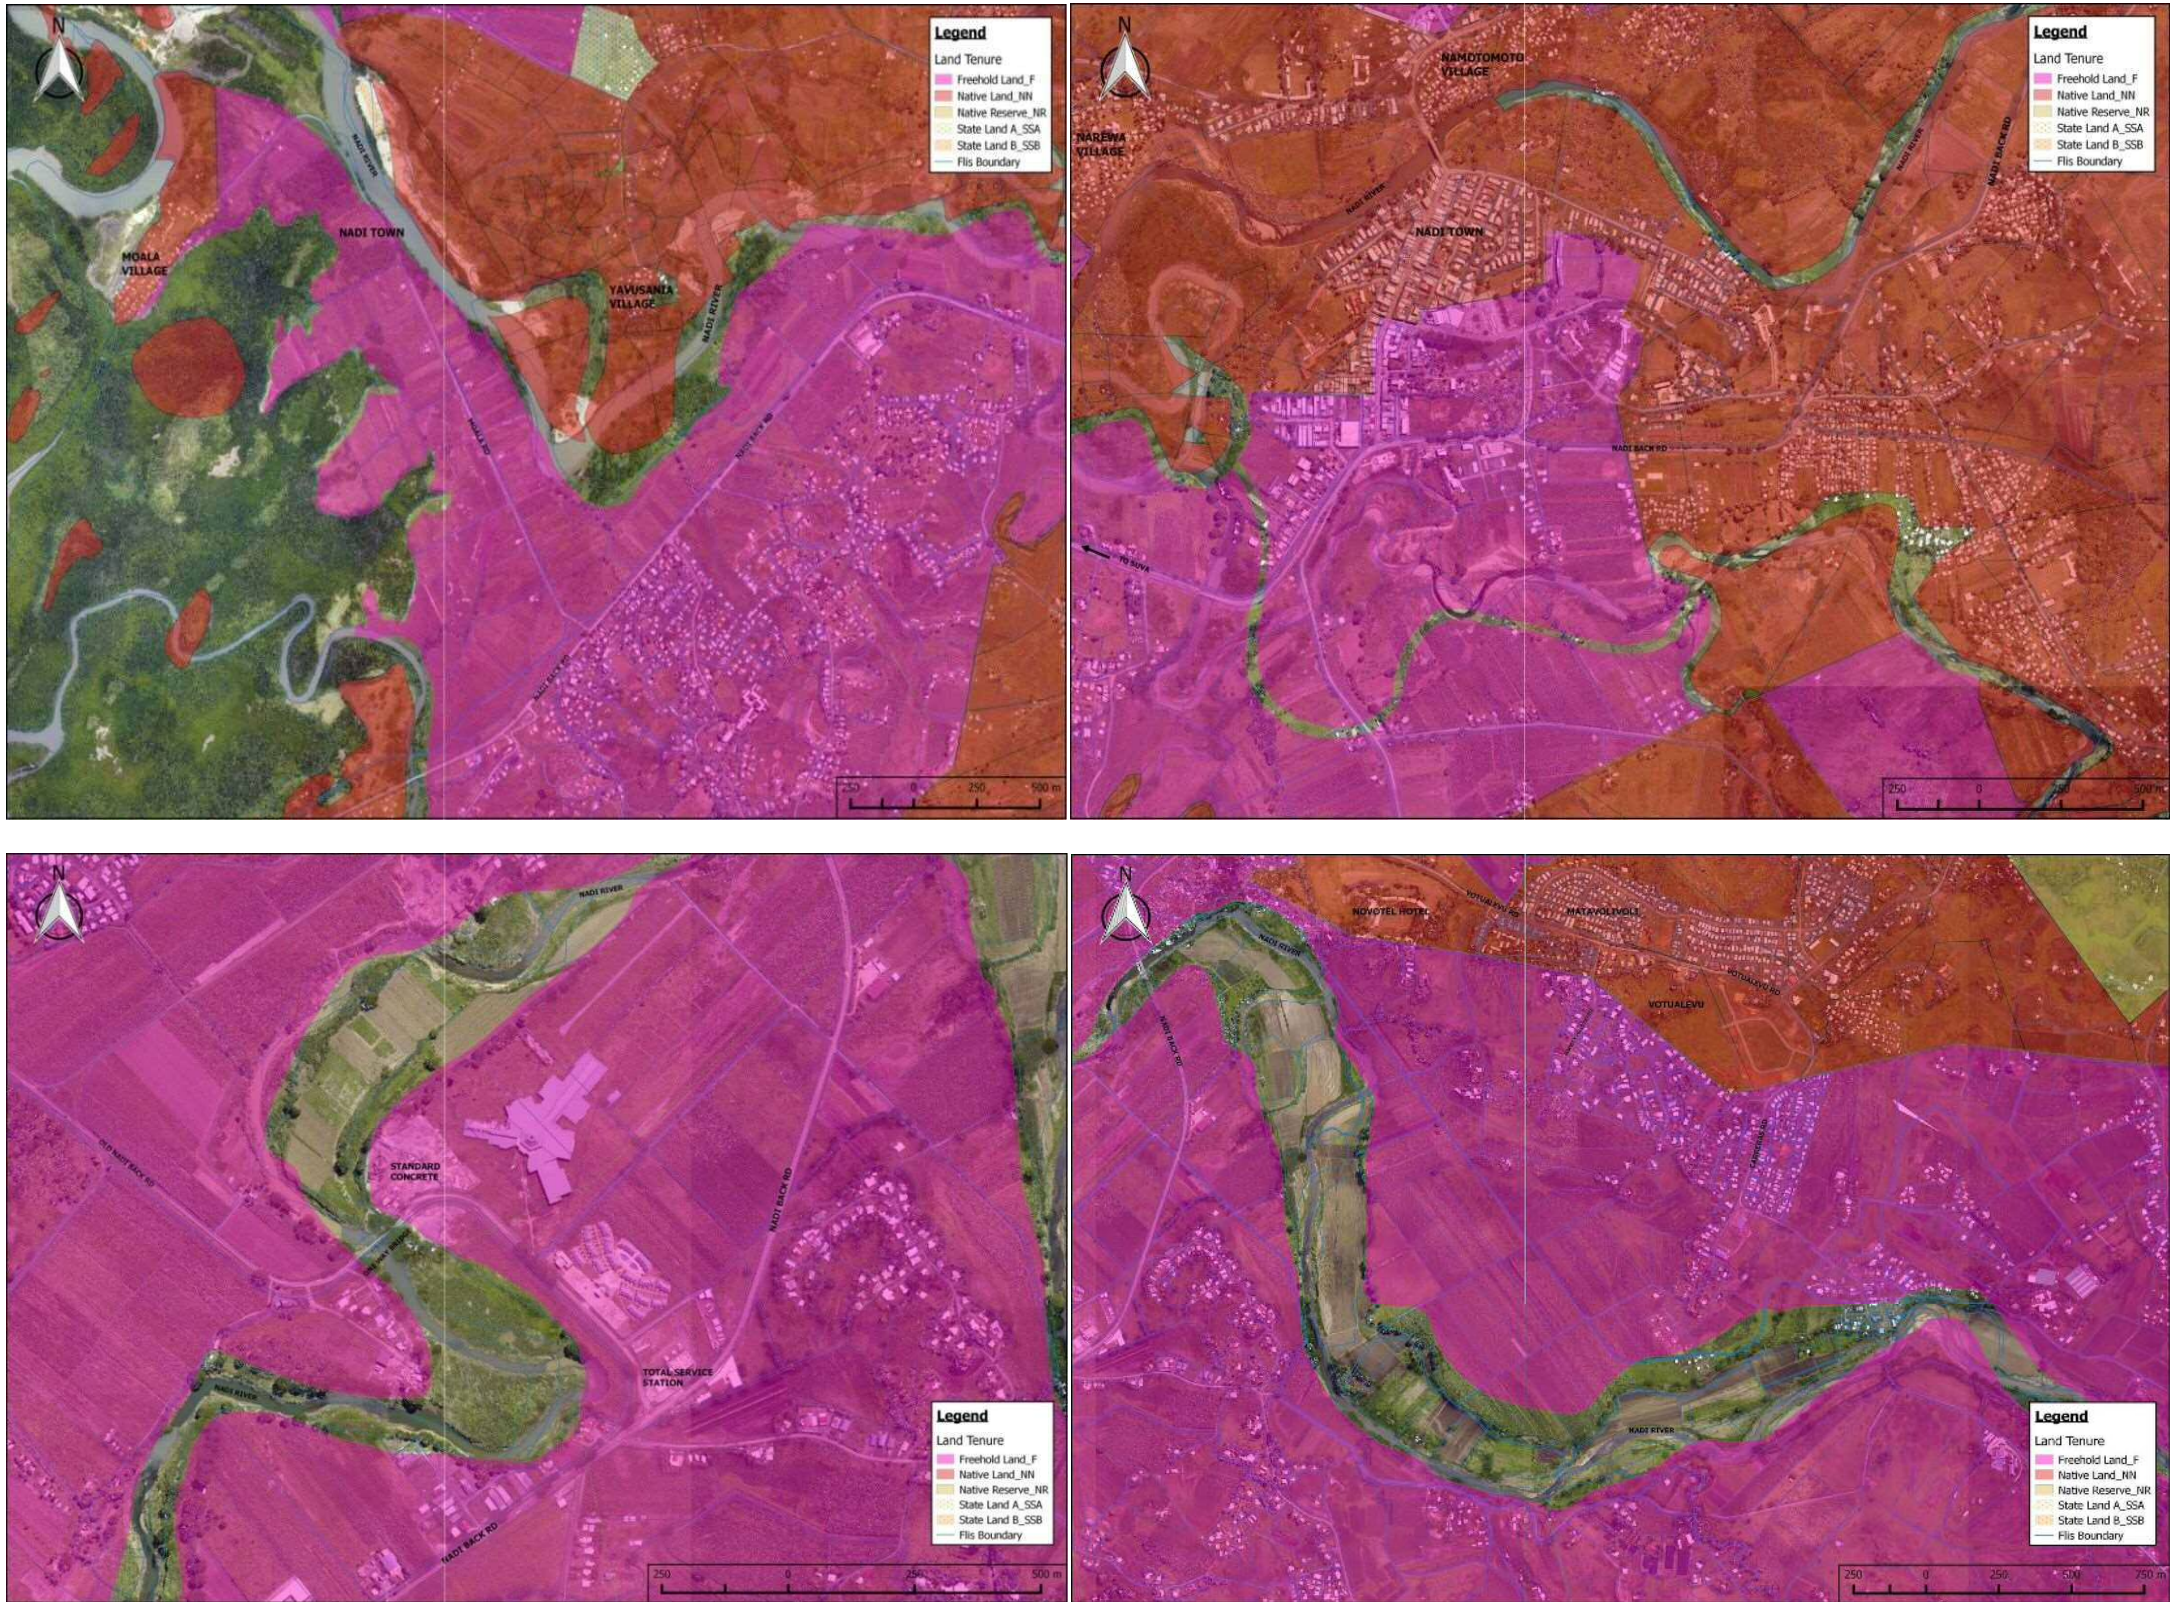
■ Figure 8 Land tenure maps for Moala Village and Moala Road (top left), Nadi town (top right), Off Nadi Back Road (bottom left) and Votualevu (bottom right).

However, land tenure maps acquired from the Department of Town and Country Planning (DTCP) indicated that all areas surveyed fell under either native land or freehold land as shown in Figure 8 on page 19.

Despite the land tenure information received from DTCP indicating that surveyed areas were situated on native or freehold land, some interviewees indicated that they resided on State land (9%) while a very small number indicated that they were not sure of the type of land tenure their residences were situated on (4%).
