**PREPARATORY SURVEY  
ON  
THE PROJECT FOR CONSTRUCTION  
OF DARDANELLES STRAIT CROSSING  
AND MOTORWAY UNDER PPP SCHEME  
IN  
THE REPUBLIC OF TURKEY**

**FINAL REPORT**

**JULY 2016**

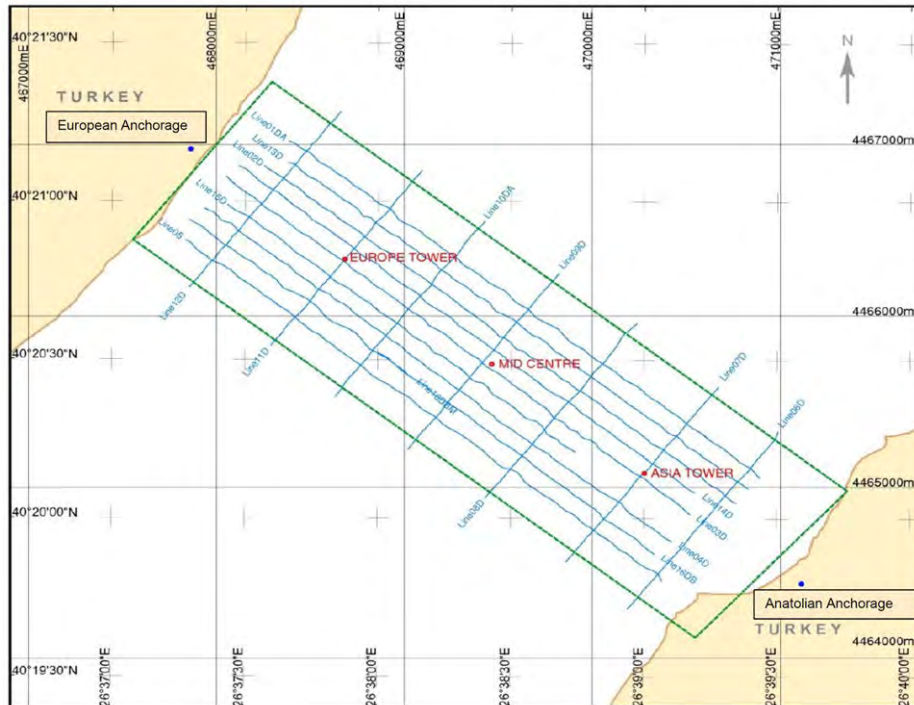
**Figure 3.3.7 Offshore bathymetric survey track lines**

Offshore bathymetric survey was performed on a corridor of 4.5km length and 1.0km width, crossing Canakkale strait, from the European shore to the Anatolian shore.

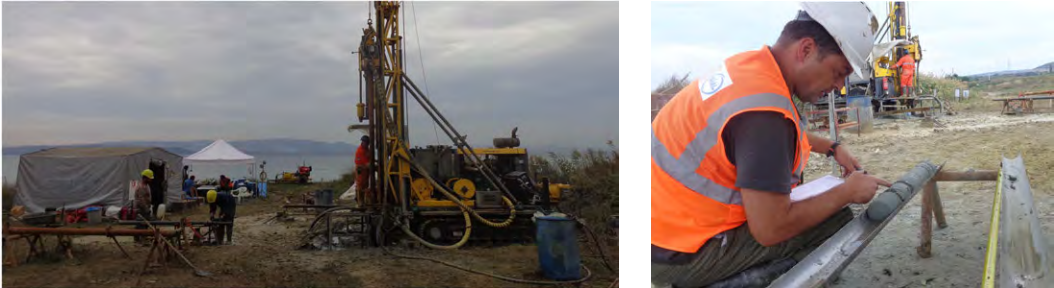
**Figure 3.3.15 Drilling and Core logging operations**

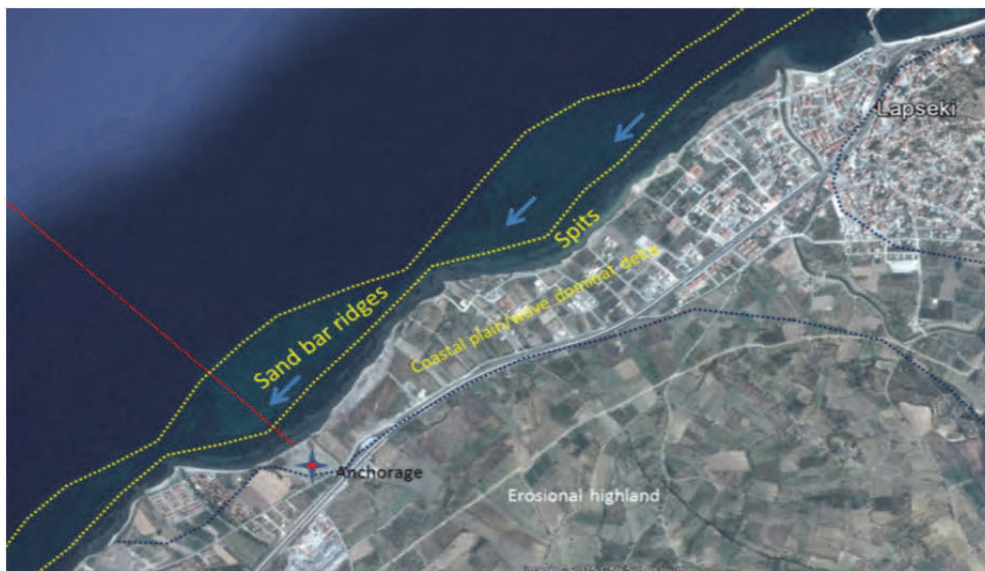
(Arrows show current direction)

**Figure 3.3.17 Main geomorphological units of Asian coast**

In contrast to the European side the Anatolian side of the CS along the Lapseki section displays a linear trend. Wave-dominant small deltas and coastal plains are the characteristic geomorphic features of the Anatolian coast. Longitudinal sand bars parallel to the shoreline, spits, lagoons and back-swamps indicate that currents are the dominant process affecting the formation of landforms along the coast (Figure 3.3.17).

The Anatolian side anchorage is located on the narrow coastal plain between the Lapseki-Çanakkale high way and the shoreline. The geomorphology of the plain is represented by a beach and a back-swamp behind it. To the North, the coastal plain merges to the Lapseki delta which is a wave-dominant delta. Actual sandbars and spits suggest that delta materials are transported towards the Southwest along the coast.

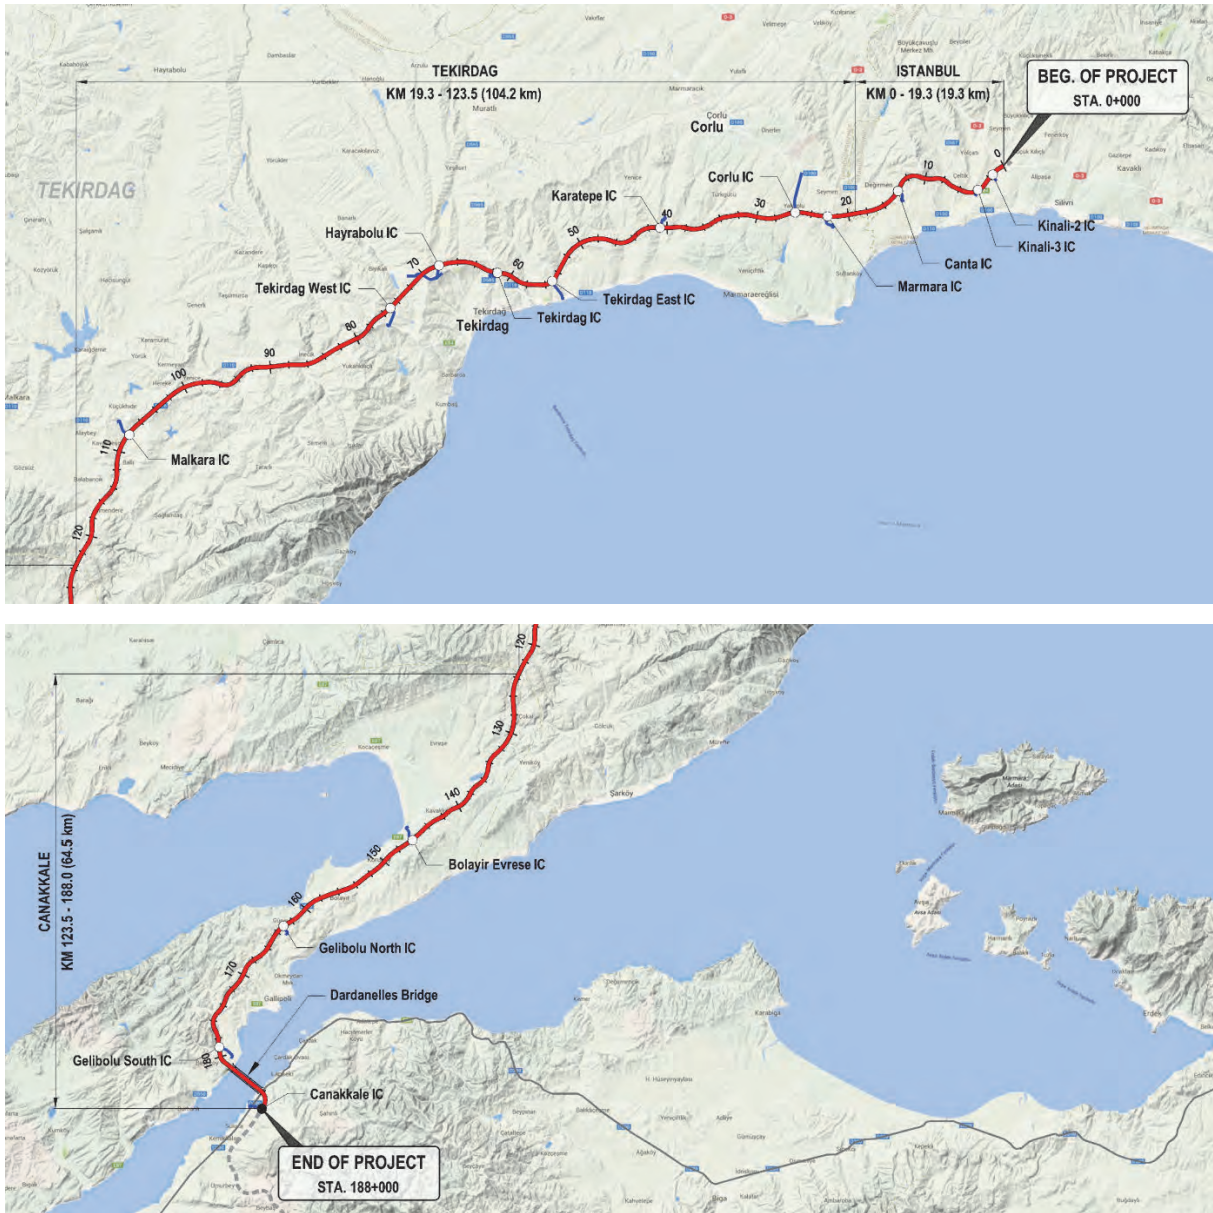
**Figure 3.4.1 Proposed Alignment of Motorway Based on Disclosed Route Map**

According to the disclosed route map of the proposed motorway, which was presented at Stake Holders' Meetings, the terrain conditions along the alignment and the outline of the alignment are summarized as shown in the table below.

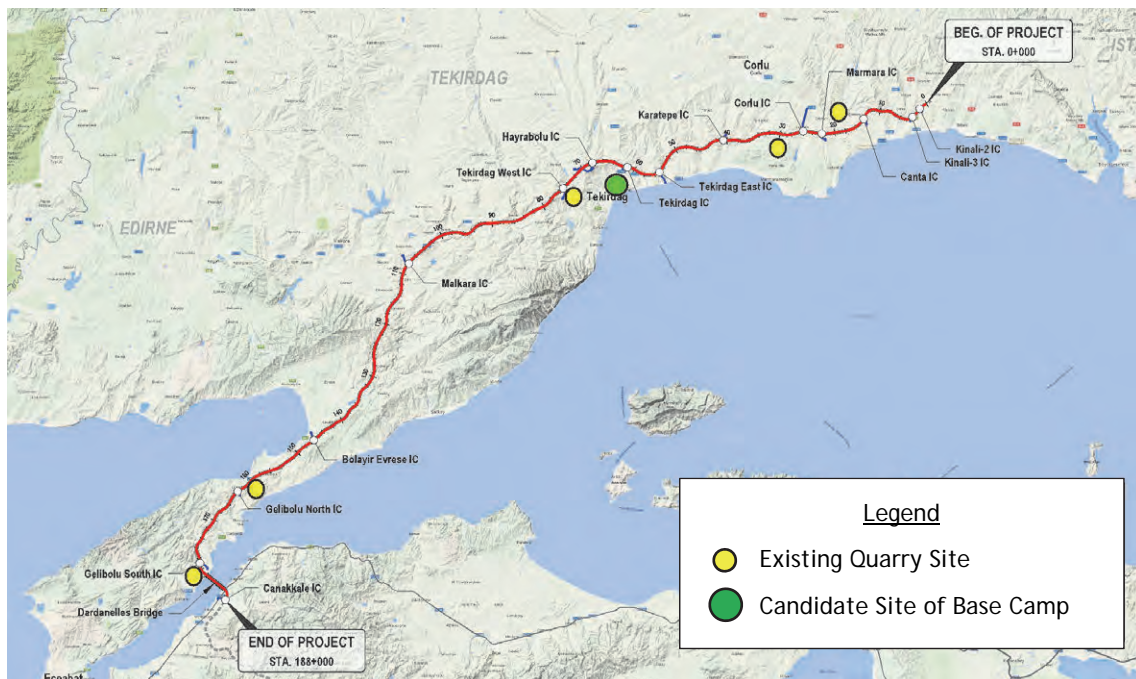
Figure 3.5.2 Location of existing quarry site and candidate site of Base Camp

As shown in Figure 3.5.2, existing quarry plants are scattered along planned route. Thus, it can be utilized these existing facilities.

In addition, the port of Tekirdag with gantry crane is located almost center of the route and near. Hence, this port can be utilized for loading of imported materials and equipment by sea transport.

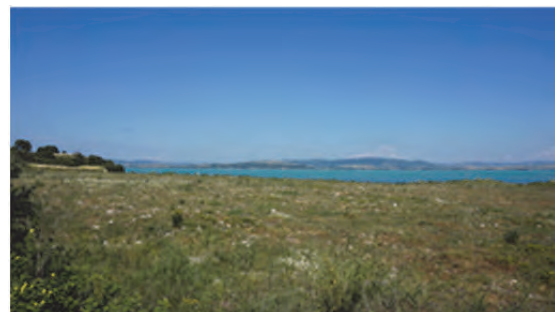
Present situation at a point where the bridge  
will be constructed: Canakkale side  
(Grassland)
