**MINISTRY OF PUBLIC  
WORKS AND TRANSPORT**

General Directorate of Techniques  
Road Infrastructure Department

# **Bridge Inspection Handbook**

**2017**

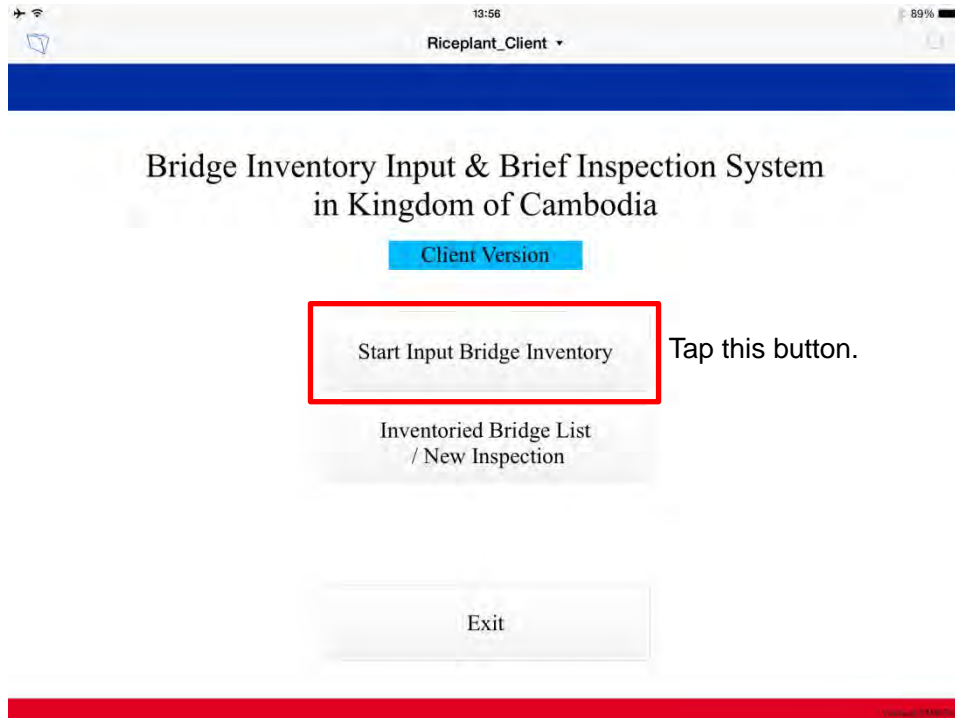
Fig-1 First screen of the iPad system (Front screen)

At first, bridge inventory data collection is started.

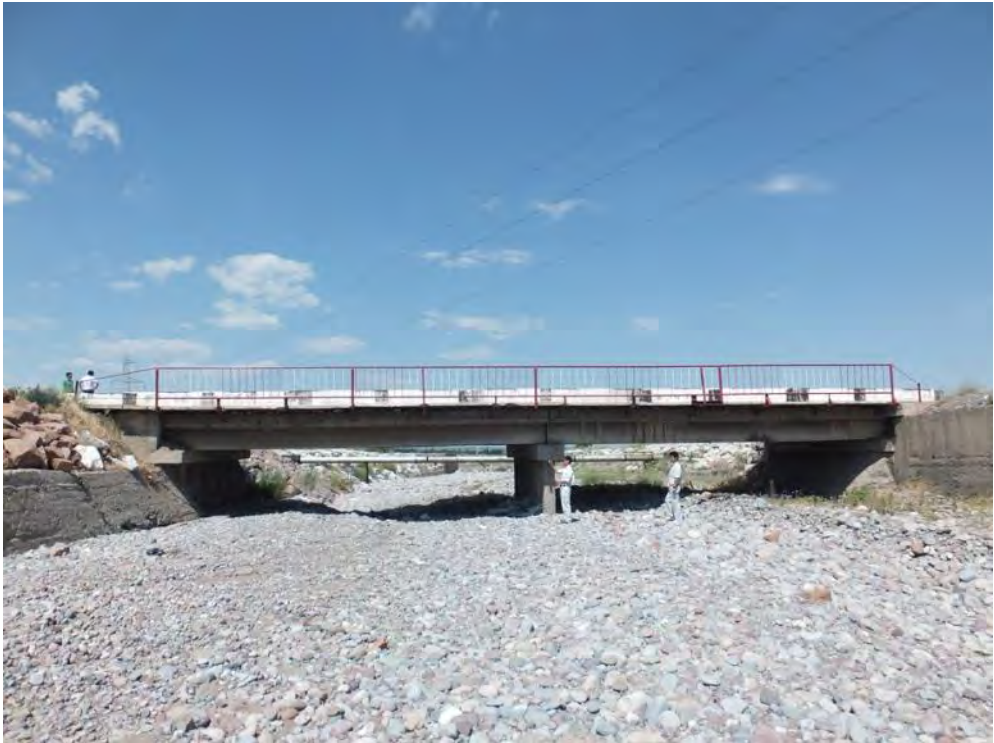
- 1) Overview (including abutment to abutment)

Sample picture is below.

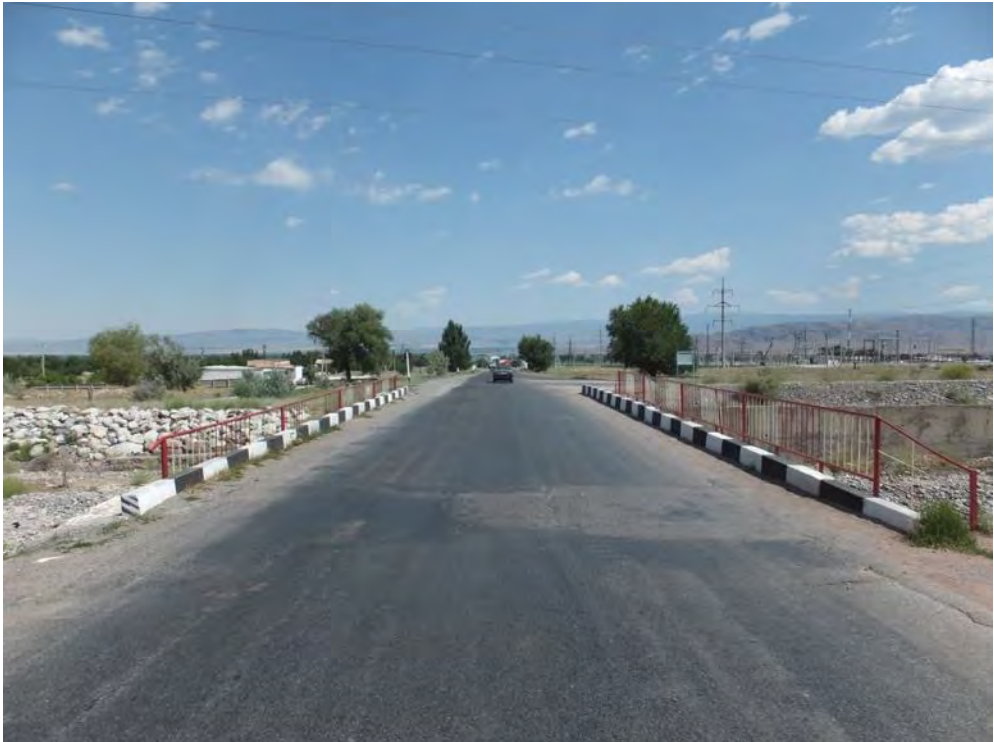
- 2) Road Surface

Sample picture is below.

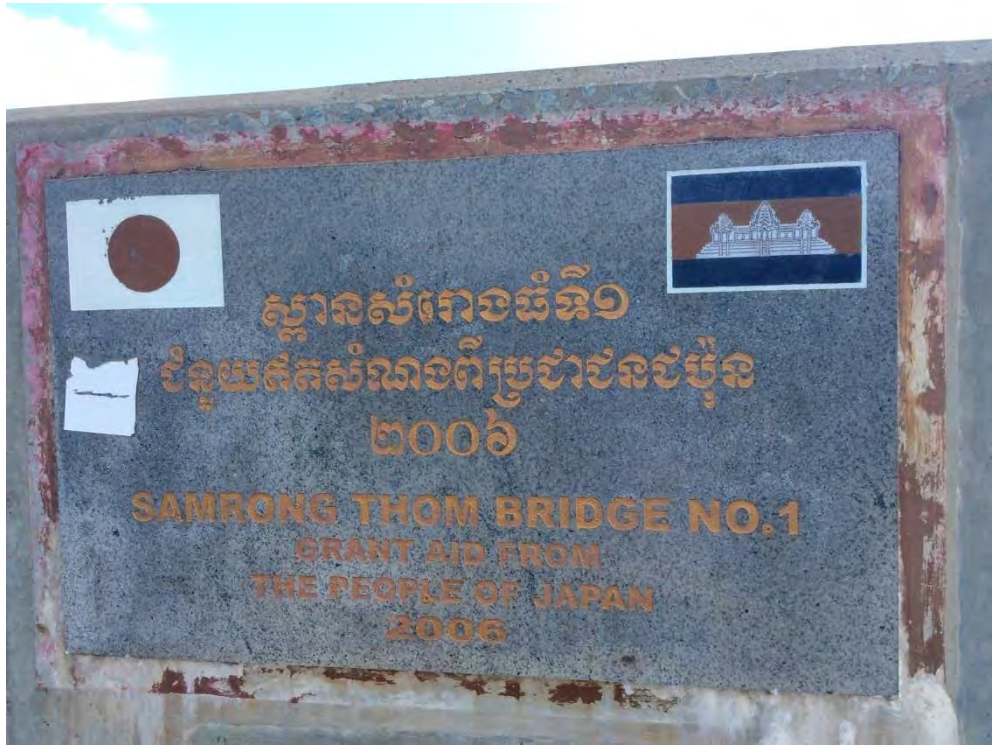
3) Bridge Nameplate (If present)

Sample picture is below.

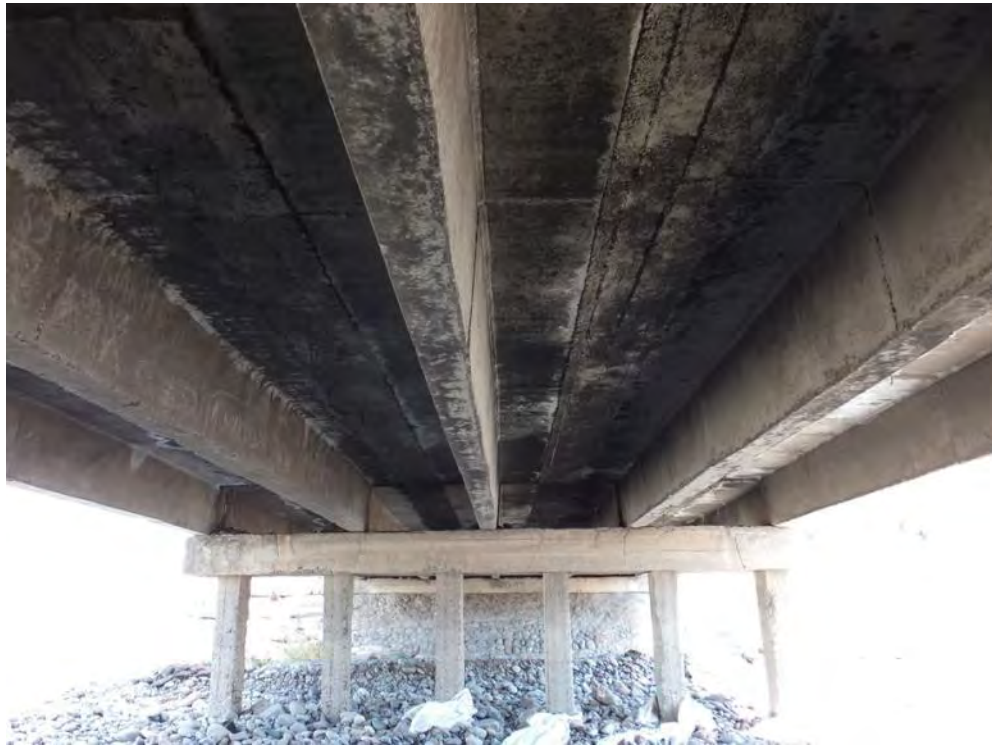
Firstly, tap the area of red square, then take a photo of the bridge from underside.

Sample picture is below. It should be taken care to take a photo including deck slab and substructure.

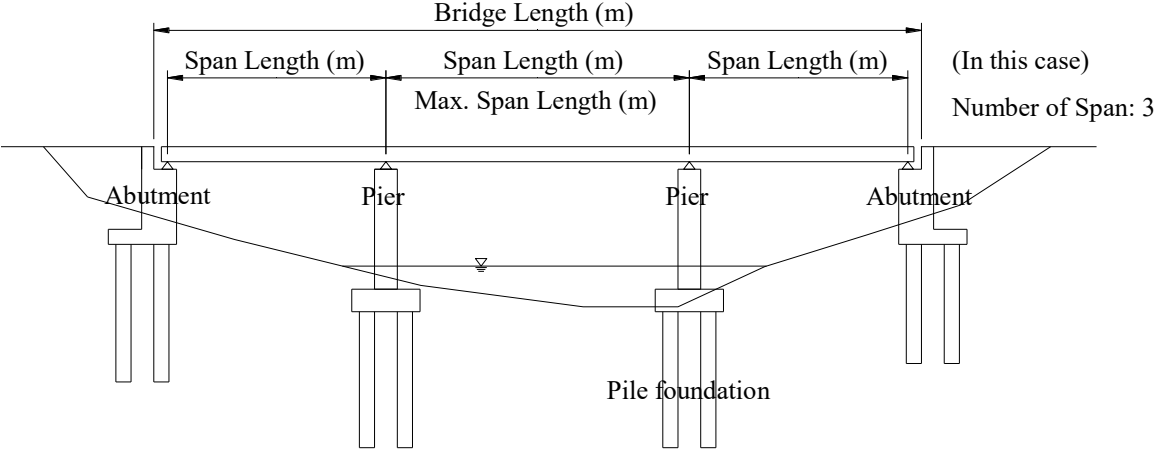
Fig-6 Length

1) Each Length and Each Width

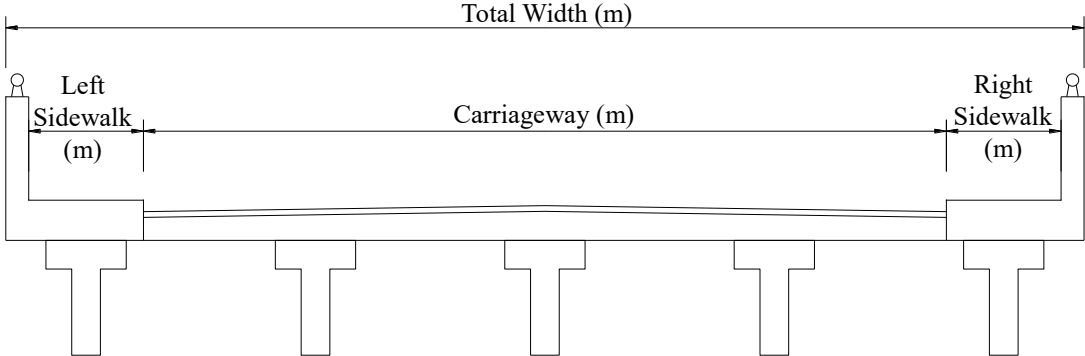
Fig-7 Width

(In this case) Number of Girder: 5

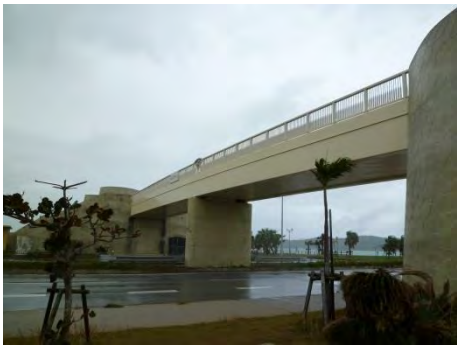
<p>(5) Others</p>

<p>Above bridge is a bridge for pedestrian which is made from Glass Fiber Reinforced Plastic.</p>

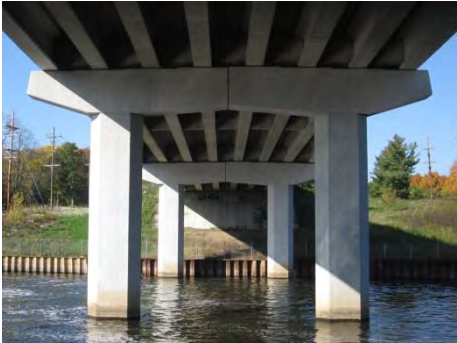
<p>A photograph showing several concrete bridge piers supporting a bridge deck over a body of water. The piers are rectangular and spaced evenly along the bridge.</p>

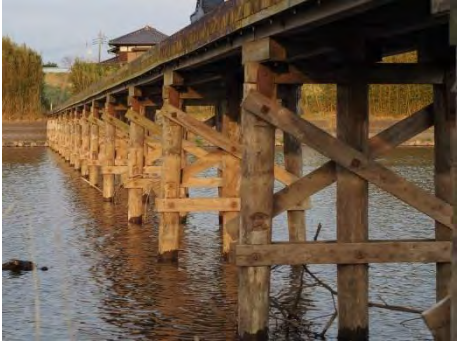
<p>A photograph of a long wooden bridge spanning a river. The bridge is supported by numerous wooden piers and cross-braces, creating a complex lattice structure.</p>

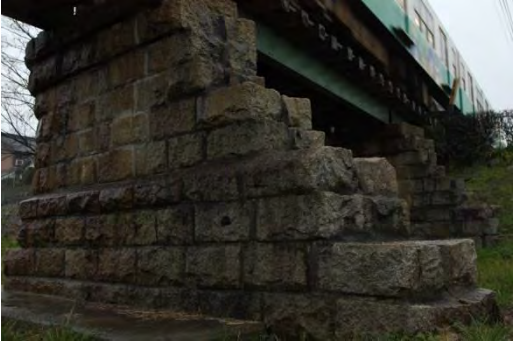
<p>A close-up photograph of a masonry bridge pier. The pier is constructed from large, rectangular stone blocks stacked in a regular pattern, supporting a bridge deck above.</p>
<p>(5) Others (If present)</p>

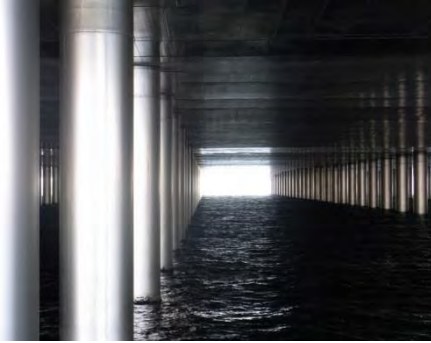
<p>A photograph showing a series of vertical, cylindrical piers made of a shiny, metallic material (titanium) supporting a bridge deck over water. The piers are arranged in a long, straight line, receding into the distance.</p> <p>These piers are made of titanium.</p>

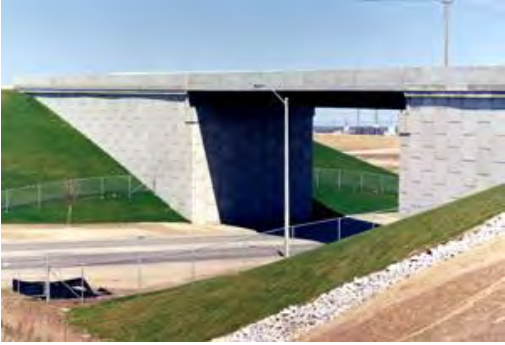
(1) Full-Retaining ( $h > 5m$ )	(2) Semi-Retaining ( $h < 5m$ )

As structure type of abutment in pull down menu is prepared 4 items below.

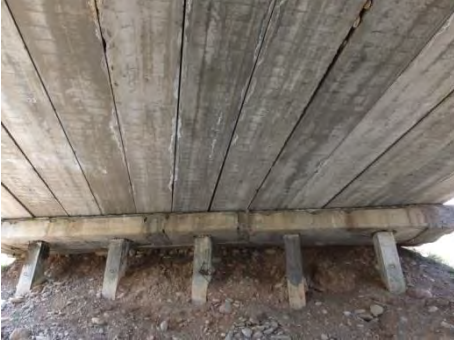
(3) Spill Through (Open)	(4) Others

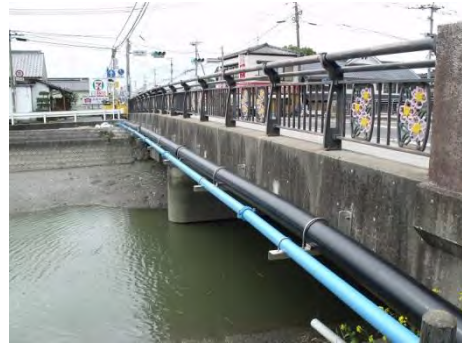
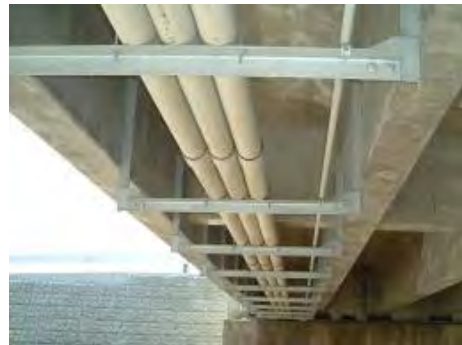
(4) Attachment

Ex) Electric Cable, Water supply line,  
Communication Cable, etc.

As bridge accessories, it should be checked that 4 items below is existed or not.
