# Road Development Authority Japan International Cooperation Agency

# **Bridge Inspection and Diagnosis Manual**

October 2017

The Project for Capacity Development on Bridge Management In The Democratic Socialist Republic of Sri Lanka

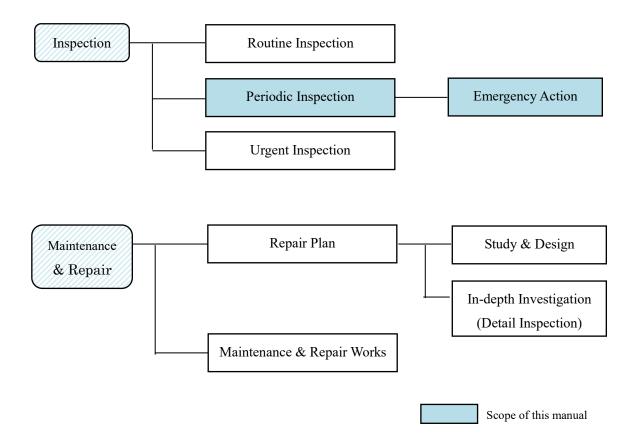
Figure 1.1 Flow of Inspection and Maintenance & Repair

In general, there are 3 types of bridge inspections: Routine Inspection, Periodic Inspection and Emergency Inspection. This manual provides the details of "Periodic Inspection". It is necessary to understand properly the contents of this manual when bridge inspection is executed.

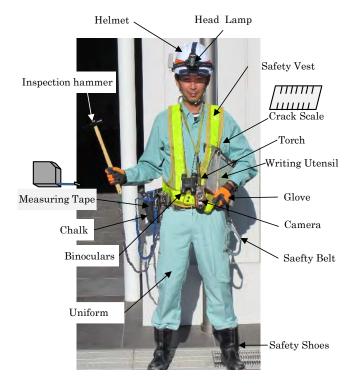
Figure 1.5 Gear and Protective Clothes

- 1. During inspection, it is necessary to protect the inspector's head (helmet), hand (gloves), foot (safety boots) and further safety belt to prevent falling from high positions and safety vest for vehicle drivers also required.
- 2. In case traffic restriction is required at the site, coordination with local police in advance is necessary for security and efficient control of traffic. And it is required to install signboards and other equipment that clearly inform the inspection activity or repair works to road users.

Basic safety gears required in the inspection are shown in Figure 1.4 and Figure 1.5.

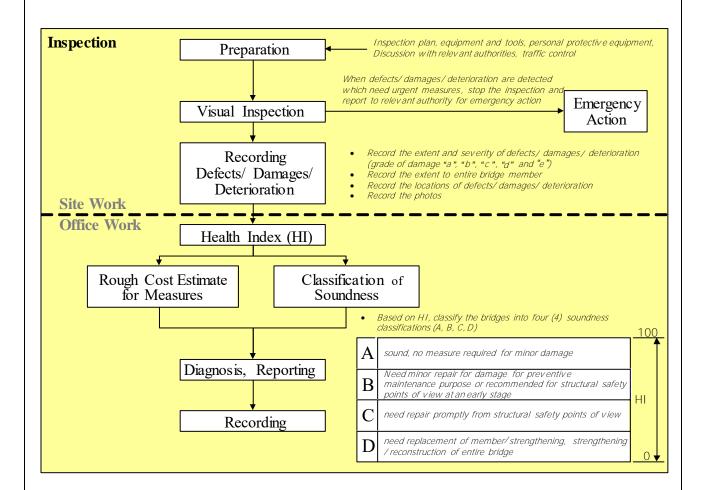
Figure 2.1 Flow of Periodic Inspection Activity

In principle, the periodic inspection shall be executed in accordance with Figure 2.1.

Figure 2.1 shows the basic flow of periodic inspection.

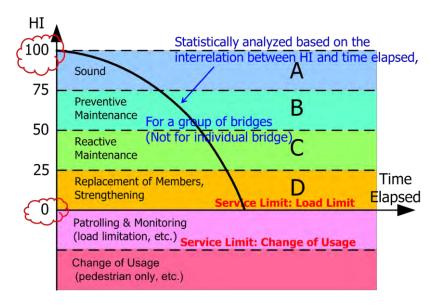
Figure 2.2 Diagram of HI Image

- HI of the span and the bridge that can be obtained by integrating HI of the members are taken as one of the indices for prioritization of repairs.
- (2) In this Manual, HI is a quantitative representation of performance and functions required for a concerned member. In other words, HI is considered as one hundred (100) at completion of construction (new construction). HI is considered as zero (0) when the initial performance and functions are degraded due to the damage, leading to some restrictions such as lane closures, loading restrictions and speed limit.

(3) HI shall be an aggregate total of the following 2 items: (a) Evaluation point of multiple damages based on the degree of damage (severity and extent), and (b) Weighing factor concerning the following evaluation items: significance of the damage type, significance of the member and significance of the structure

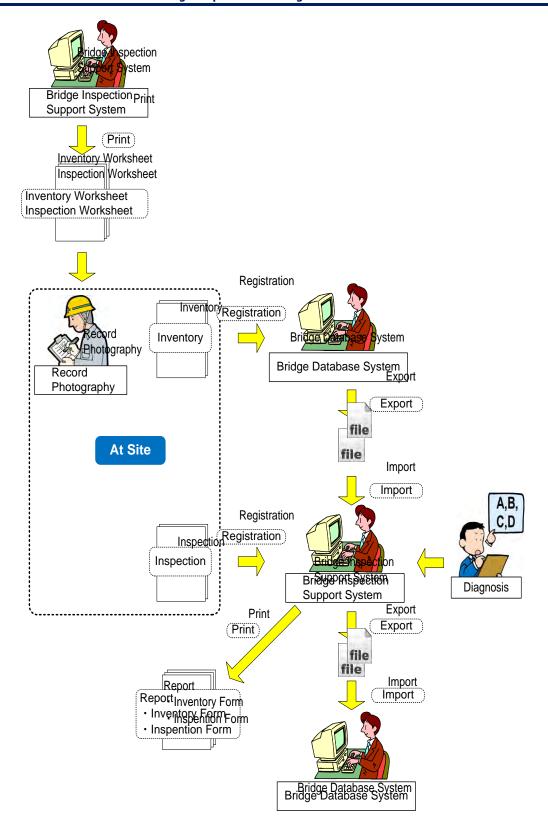
Figure 2.3 Record of Bridge Inspection Results

- 4) To carry out inspection. The results shall be recorded in the output of "Bridge Inspection Record Sheet" and the basic data shall be updated in the "Bridge Database System".
- 5) To update the inventory in "Bridge Database System".
- 6) To input inspection results into "Bridge Inspection Support System" with review of HI (A, B, C and D) using bridge diagnosis manual
- 7) To make the report by printing out the Inventory form and Inspection form from "Bridge Inspection Support System".

All the records will be registered in "Bridge Database System" automatically.

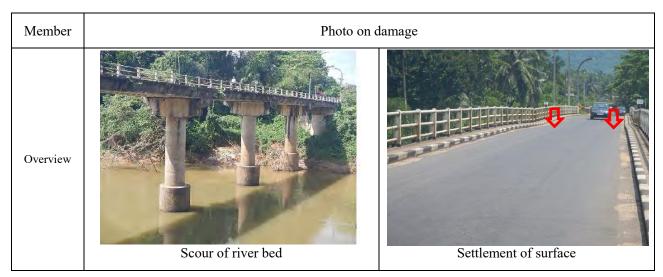
**Photo 2.2** Damage to the Whole Bridge

Practical sample which requires immediate measures is as follows, and it needs temporary support by bent or saddle, installation of steel plate, traffic restriction (speed, number of carriageway, closing traffic and etc.): detailed explanation is shown in Attachment of diagnosis.

- Possibility of falling bridge due to serious damage of superstructure or substructure
- Possibility of falling pedestrian or vehicles from road surface due to lack of handrail or guardrail
- Possibility to damages to vehicles or driving hazards due to serious damage to expansion joint
- Possibility of falling concrete block from curb, handrail, or deck slab will cause damages to vehicles or pedestrians beneath the bridge
- Possibility of road surface subsidence due to serious damage of deck slab
- Unusual noise and vibration occurs at inspected girder or deck, and it affects the residents of near vicinity of the bridge

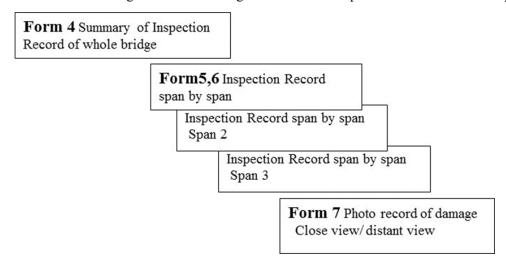
Components of Inspection record

- Form 4 Summary sheet of Inspection Record for the whole bridge: Soundness index, classification of soundness, standard repair cost for each span/member. As a result, low soundness span or members can be easily found out.
- Form 5 &6, Inspection Record of each span: record of damage objectively/mark the diagram (Confirm damage at site, evaluation of progress of damage, estimation of cost of damage)
- Form 7 Photo record of damage: For each damage close and distant photos are taken for record purposes.

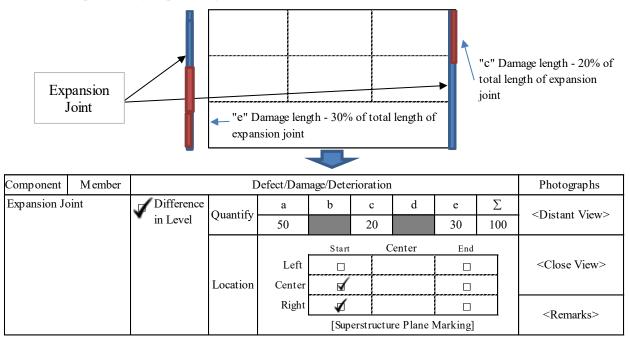
Figure 6 Difference in Level on Expansion Joint

As for the target for recording damage, grade of damage "a, c and e" and percentage of damage and total shall be counted. The results shall be recorded in the columns of Quantity in the Bridge Inspection Sheet. The location of worst grade shall be recorded with check mark  $(\checkmark)$  on the Location in the Bridge Inspection Sheet.

In case of a multi span bridge, i.e. 2 span bridge, the damage on A1 and P1 shall be recorded in the inspection sheet of A1-P1 and the damage on A2 shall be recorded in the inspection sheet of P1-A2. Record sample for single span bridge is as follows.

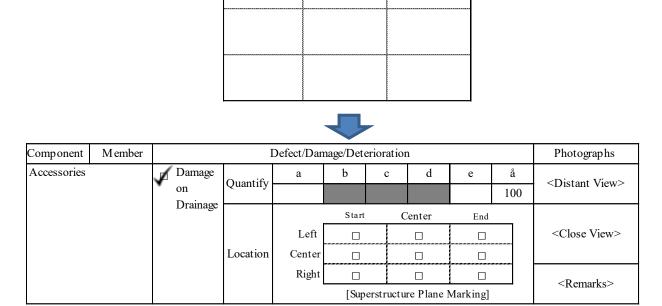
Figure 7-2 Damage on Drainage (No drainage)

In case, there is no drainage on the bridge, the record shall be as follows:

In the column of Remarks, no drainage shall be written.

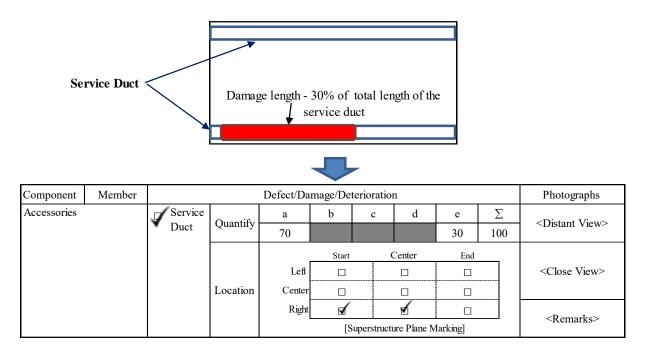
Figure 8 Damage on Service Duct

The quantity of elements is percentage in length of service duct (total percentage of damaged service duct in length / total percentage of service duct in length = 100%.)

As for the target of recording damage, grade of damage "a" and "e" and percentage of damage and total shall be counted. The results shall be recorded in the columns of quantity in the Bridge Inspection Sheet. The location of worst grade shall be recorded with check mark  $(\checkmark)$  on the Location in the Bridge Inspection Sheet.

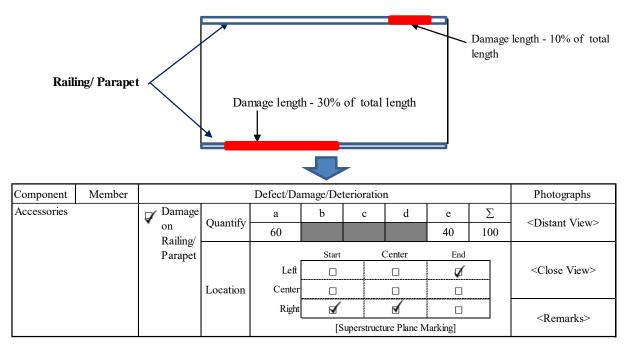
Figure 9 Damage on Railing / Parapet

The quantity of elements is percentage in length of handrail (percentage of total damage in length /total length of handrail = 100%).

As for the target of recording damage, grade of damage "a" and "e" and percentage of damage and total shall be counted. The results shall be recorded in the columns of Quantity in the Bridge Inspection Sheet. The location of worst grade shall be recorded with check mark  $(\checkmark)$  on the Location in the Bridge Inspection Sheet.

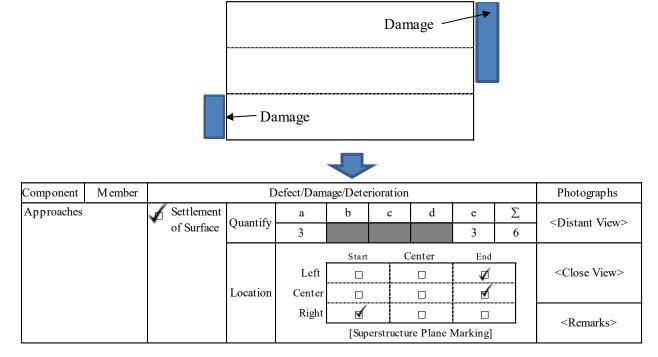
Figure 10 Settlement of Surface

The quantity of elements is 3 in transverse direction of bridge width.

In case of a multi span bridge, i.e. 3 span bridge, the damage behind A1 shall be recorded in the inspection sheet of A1-P1 and the damage behind A2 shall be recorded in the inspection sheet of P2-A2. Record sample for single span bridge is as follows.

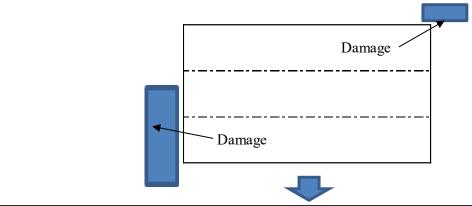
Figure 11 Approach Bank/ River Bank

In case of a multi span bridge, i.e. 3 span bridge, the damage behind A1 shall be recorded in the inspection sheet of A1-P1 and the damage behind A2 shall be recorded in the inspection sheet of P2-A2. Record sample for single span bridge is as follows.

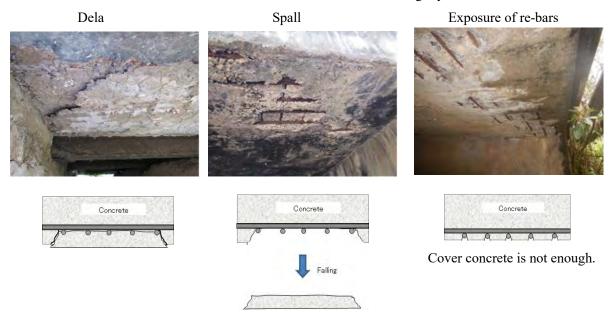
Spall: Falling off of concrete surface and main corroded re-bar is exposed.

Exposure of re-bars: Outside re-bars can be seen with exfoliation/detachment of concrete cover caused by thin concrete cover. Re-bar is rusted or slightly corroded.

In General, the damage of concrete progress is as follows.

- i) Crack (refer damage No.12)
- ii) Water affects the re-bar inside of concrete, it then becomes dela.
- iii) Spall of concrete.

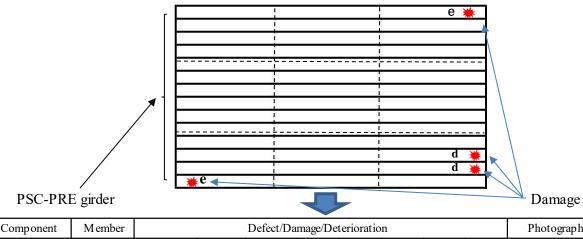
Figure 12-1 PSC-PRE

As for the target of recording damage, grades of damage "a, b, c, d and e" and numbers of each element for each grade shall be counted. The results shall be recorded in the columns of Quantity in the Bridge Inspection Sheet.

The location of worst grade shall be recorded with check mark ( $\checkmark$ ) on the Location in the Bridge Inspection Sheet.

Component	M ember		Defect/Damage/Deterioration									Photographs
Superstructure	Main Beam	•	Spall/	Quantify	a	b	С	d	e	å		<distant view=""></distant>
			DCIa/	Quantify ·	10	0	0	2	2	14		\Distant view>
			Ex- Rebars			Start	(	Center	End			
					Left				⊄			<close view=""></close>
				Location	Center							
					Right	₹						<remarks></remarks>
					[Superstructure Plane Marking]							\Kemarks>

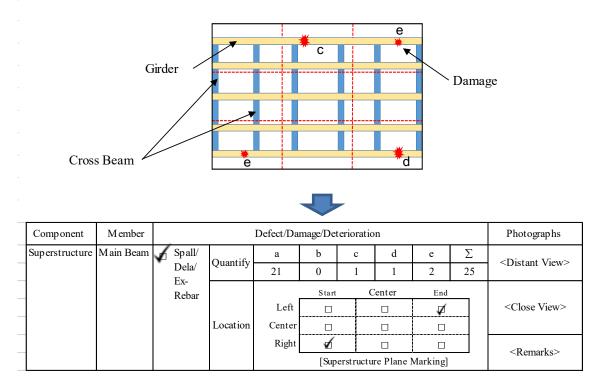
Figure 12-3 Main Beam of PSC-POS, RCS-RCB

The elements are main girder divided by cross beam. In case, there are 5 main girders and 6 cross beams, total numbers of elements are 25 (5 x 5).

As for the target of recording damage, grades of damage "a, b, c, d and e" and numbers of each element for each grade shall be counted. The results shall be recorded in the columns of Quantity in the Bridge Inspection Sheet.

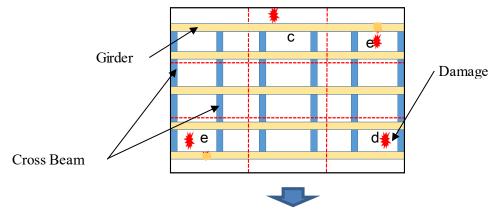
Figure 12-4 Deck Slab of PSC-POS, RCS-RCB

The elements are slab panel divided by main girder and cross beam. In case there are 5 main girders and 6 cross beams and cantilever slab on both sides, the total number of elements is 22 (4 x 6)

As for the target of recording damage, grades of damage "a, b, c, d and e" and numbers of each element for each grade shall be counted. The results shall be recorded in the columns of Quantity in the Bridge Inspection Sheet.

Component	M ember				Photographs					
Superstructure	Deck Slab	✓ Spall/	Quantify	a	b	С	d	e	Σ	<distant view=""></distant>
		Dela/ Ex-	Qualitity	18	0	1	1	2	22	*Distant view>
		Rebar			Start		Center	End		
				Left				✓		<close view=""></close>
			Location	Center						
				Right	✓					<remarks></remarks>
					[Sup	erstruct	ure Plane	Marking]	<u>-</u>	\\Ciridiks>

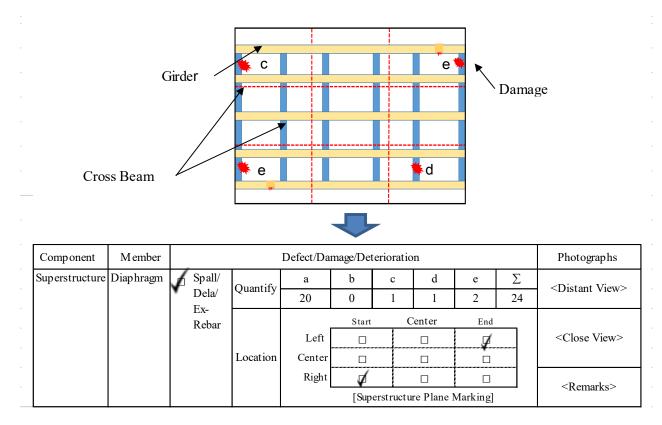
Figure 12-5 Diaphragm of PSC-POS, RCS-RCB

The elements are diaphragm divided by main girder. In case there are 5 main girders and 6 cross beams, total numbers of elements are 24 (4 x 6).

As for the target of recording damage, grades of damage "a, b, c, d and e" and numbers of each element for each grade shall be counted. The results shall be recorded in the columns of Quantity in the Bridge Inspection Sheet.

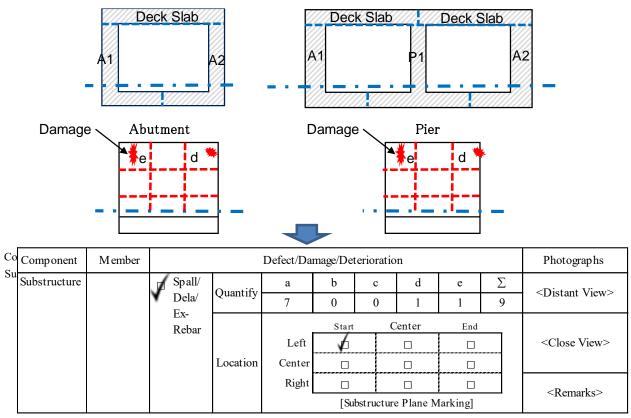
Figure 12-7 RC Bridge

As for the target of recording damage, grades of damage "a, b, c, d and e" and numbers of each element for each grade shall be counted. The results shall be recorded in the columns of Quantity in the Bridge Inspection Sheet.

The location of worst grade shall be recorded with check mark ( $\checkmark$ ) on the Location in the Bridge Inspection Sheet.

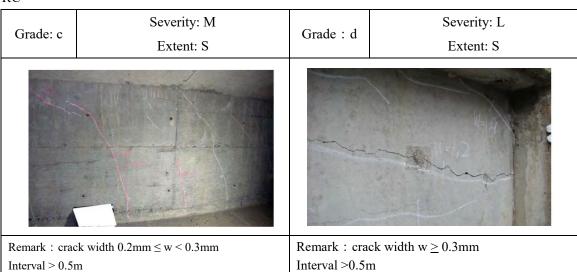
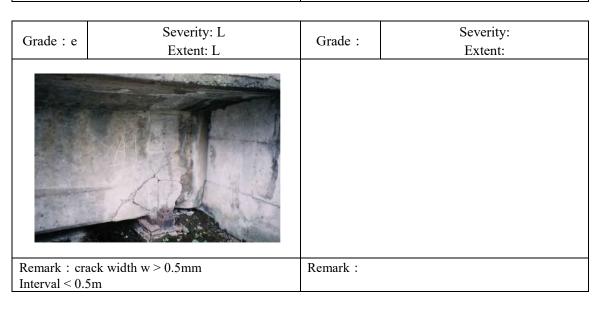
#### RC

Classification	General Condition
	(PC) Width of crack is about 0.2mm or more
Large	(RC) Width of crack is about 0.3mm or more
	(Arch: stone masonry) Width of crack is about 30mm or more
	(PC) Width of crack is about 0.1mm ≤ Width < 0.2mm
Middle	(RC) Width of crack is about $0.2 \text{mm} \le \text{Width} < 0.3 \text{mm}$
	(Arch: stone masonry) Width of crack is about 10mm ≤ width < 30mm
	(PC) Width of crack is less than about 0.1mm
Small	(RC) Width of crack is less than about 0.2mm
	(Arch: stone masonry) Width of crack is less than about 10mm

Grade: d	Severity: L Extent: S	Grade: c	Severity: M Extent: S
The state of the s	0.3	01+-	a= faz faz faz faz
cracl	SC-PRE, PCS-POS s width $w \ge 0.2$ mm. al $> 0.5$ m		SC-PRE, PCS-POS $0.1 \ge w > 0.2$ mm is existed in

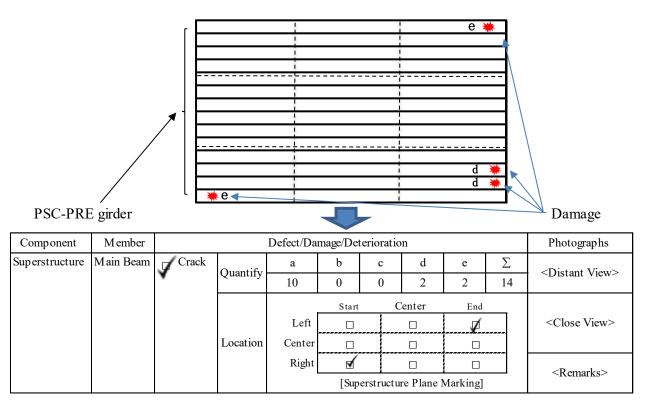
Figure 13-1 PSC-PRE

The total numbers of elements are numbers of main girder.

As for the target of recording damage, grades of damage "a, b, c, d and e" and numbers of each element for each grade shall be counted. The results shall be recorded in the columns of Quantity in the Bridge Inspection Sheet.

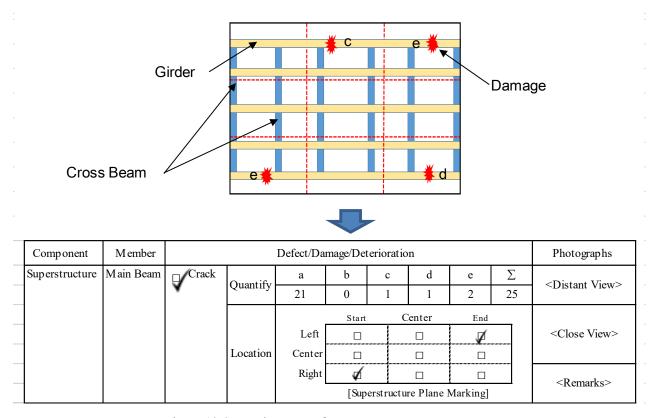
Figure 13-3 Main Beam of PSC-POS, RCS-RCB

The elements are main girder divided by cross beam. In case, there are 5 main girders and 6 cross beams, total numbers of elements are 25 (5 x 5).

As for the target of recording damage, grades of damage "a, b, c, d and e" and numbers of each element for each grade shall be counted. The results shall be recorded in the columns of Quantity in the Bridge Inspection Sheet.

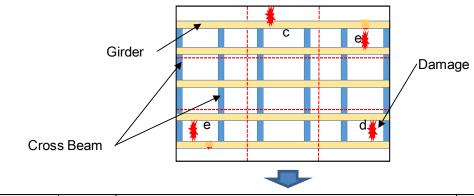
Figure 13-4 Deck Slab of PSC-POS, RCS-RCB

The elements are slab panel divided by main girder and cross beam. In case, there are 5 main girders and 6 cross beams and cantilever slab on both sides, total numbers of elements are 22 (4 x 5 + 2).

As for the target of recording damage, grades of damage "a, b, c, d and e" and numbers of each element for each grade shall be counted. The results shall be recorded in the columns of Quantity in the Bridge Inspection Sheet.

Component	Member				Photographs					
Superstructure	Deck Slab	✓ Crack	Quantify	a	b	c	d	e	Σ	<distant view=""></distant>
		•	Quantity	18	0	1	1	2	22	\Distant view>
					Start	(	Center	End		
				Left				ø		<close view=""></close>
			Location	Center						
				Right	✓					<remarks></remarks>
					[Sup	erstructu	re Plane	Marking]		\text{\text{Citial KS}}

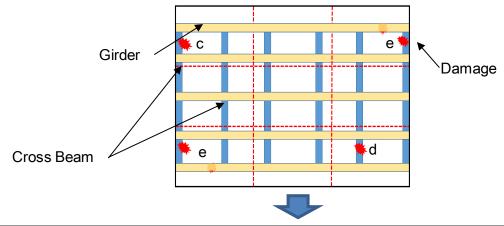
Figure 13-5 Diaphragm of PSC-POS, RCS-RCB

The elements are diaphragm divided by main girders. In case, there are 5 main girders and 6 cross beams, total numbers of elements are 24 (4 x 6).

As for the target of recording damage, grades of damage "a, b, c, d and e" and numbers of each element for each grade shall be counted. The results shall be recorded in the columns of Quantity in the Bridge Inspection Sheet.

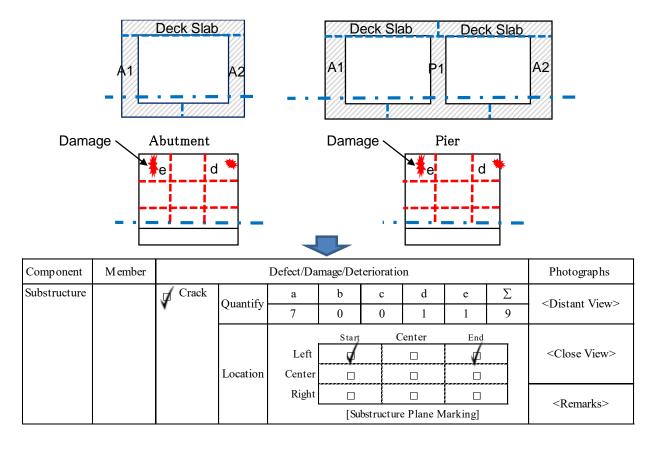
Figure 13-7 RC Bridge

The total numbers of elements are  $9 (\sum = 9)$  in vertical plane.

As for the target of recording damage, grades of damage "a, b, c, d and e" and numbers of each element for each grade shall be counted. The results shall be recorded in the columns of Quantity in the Bridge Inspection Sheet.

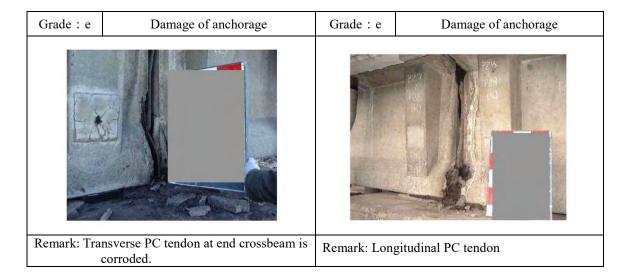
Grade of Damage	General Condition								
a	Does Not Exist								
b	-								
c	Crack on plug concrete.								
d	-								
e	Trace of rust or broken plug concrete or remarkable damage on anchorage part etc.

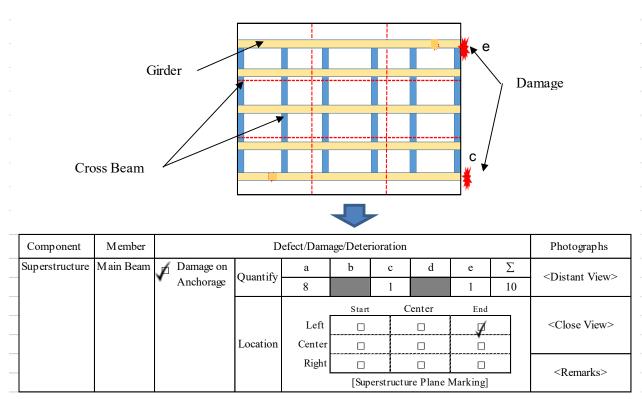
Figure 14 Diaphragm of PSC-PRE, PSC-POS

The elements are numbers of main girder. In case, there are 5 main girders, total numbers of elements are 10 (5x 2). As for the target of recording damage, grade of damage "a, c and e" and numbers of each element for each grade shall be counted. The results shall be recorded in the columns of Quantity in the Bridge Inspection Sheet.

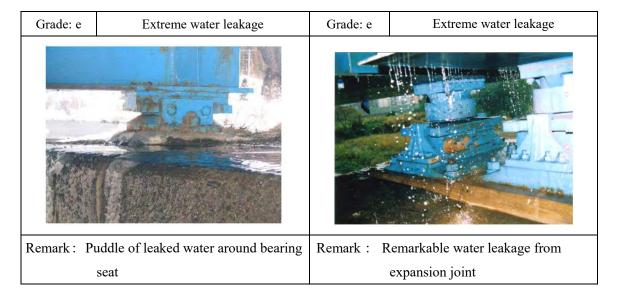
Grade of Damage	General Condition
a	Does Not Exist
b	-
c	Water leakage has existed.
d	-
e	Extreme water leakage from expansion joint and/or there is pond at bearing seat.

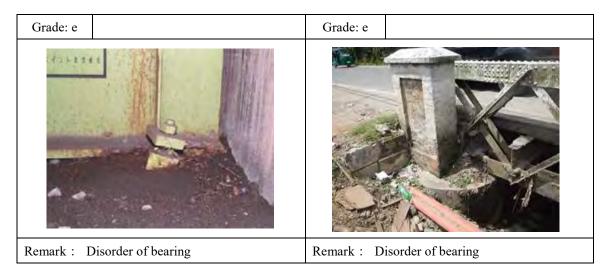
Grade of Damage	General Condition
a	Does Not Exist
b	-
С	Slight damage, which does not affect bridge function such as corrosion of bearing, crack on bearing seat.
d	-
e	There is lack of bearing function such as broken bearing.

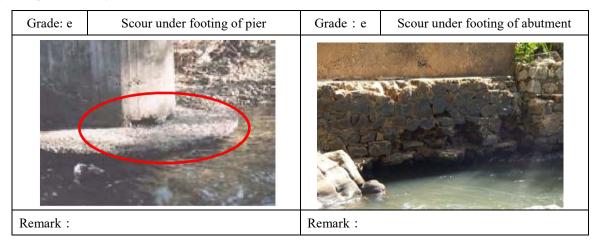
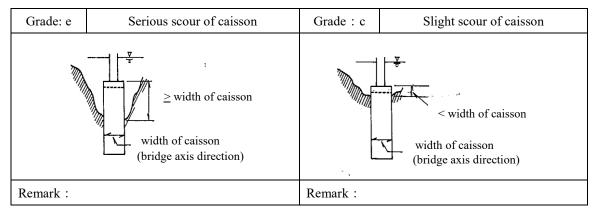
Scouring means that the foundation itself or soil surrounding the foundation is eroded due to the flow of water from stream/river. There are 2 types of scour, namely i) local scouring caused by the pier and ii) common scouring caused by whole bridge structure such as narrow open space and many piers on river bed.

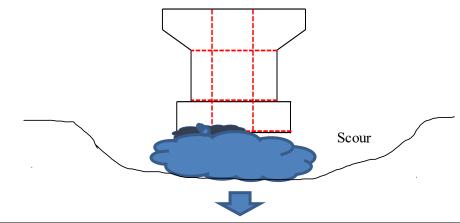
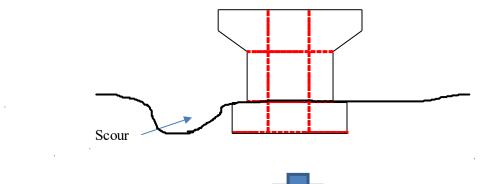
Figure 17 Scour

The quantity of element is 1.

As for the target of recording damage, grades of damage "a, c and e" and numbers of each element for each grade shall be counted. The results shall be recorded in the columns of Quantity in the Bridge Inspection Sheet.

Component	M ember		Defect/Damage/Deterioration							
Substructure		✓ Scour	Quantify	a	b	С	d	e	Σ	<distant view=""></distant>
		*	Quantify -	0		0		1	1	Solution views
					Start	C	Center	End		
				Left						<close view=""></close>
			Location	Center	Ω,			<u></u>		
				Right	₩		✓	⋪		<remarks></remarks>
					[Su	ostructur	e Plane M	[arking	_	\Ciridi K\$>

Component	M ember		Defect/Damage/Deterioration							
Substructure		✓ Scour	Quantify	a	b	c	d	e	Σ	<distant view=""></distant>
		*	Quantity	0		0		1	1	Distant view>
					Start		Center	End		
				Left						<close view=""></close>
			Location	Center	□,					
				Right	⊭					<remarks></remarks>
					[Su	ostructi	re Plane M	[arking]		\Keinarks>

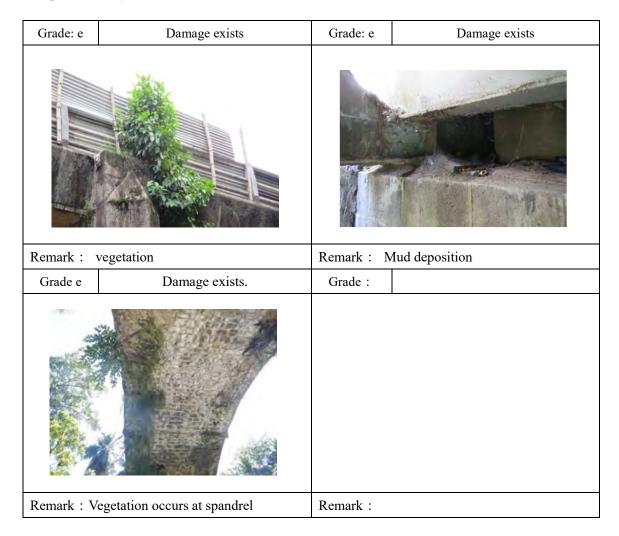
Grade of Damage	General Condition
a	Does Not Exist
b	-
c	-
d	-
e	Damage exists at substructure, truss girder, steel girder, arch rib and spandrel.

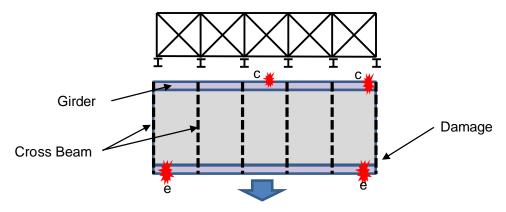
Figure 18-1 Mud Deposition/Vegetation (Truss)

The elements are main girder divided by cross beam. In case there are 2main girders and 6 cross beams, total numbers of elements are  $10 (2 \times 5)$ .

As for the target of recording damage, grade of damage "a" and "e" and numbers of each element for each grade shall be counted. The results shall be recorded in the columns of Quantity in the Bridge Inspection Sheet.

Component	M ember		Defect/Damage/Deterioration							Photographs
Superstructure	Main Beam	Mud Deposition/ Vegitation	Quantify	a 6	b 0	c 2 Cont	d 0	e 2	Σ 10	- <distant view=""></distant>
		vegitation	Location	Left Center	Start		Center	End		<close view=""></close>
				Right	√ [Su	bstructu	□ re Plane M	farking]		<remarks></remarks>

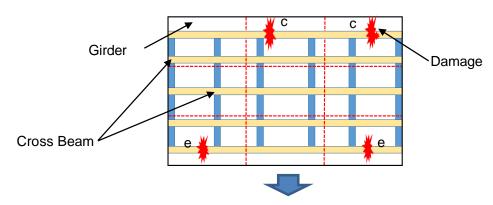
Figure 18-2 Mud Deposition/Vegetation (Steel Girder)

The elements are main girder divided by cross beam. In case, there are 5 main girders and 6 cross beams, total numbers of elements are 25 (5 x 5).

As for the target of recording damage, grades of damage "a, c and e" and numbers of each element for each grade shall be counted. The results shall be recorded in the columns of Quantity in the Bridge Inspection Sheet.

Component	M ember		Defect/Damage/Deterioration								Photographs		
Superstructure	Main Beam	1	Mud	Quantify	a	b	c	d	e	Σ		<distant view=""></distant>	
		٧	Deposition/ Vegitation	Quantify –	21	0	2	0	2	25	;	- \Distant view>	
			vegitation			Start		Center	End				
												<close view=""></close>	
				Location	Center				□				
					Right				⋪			<remarks></remarks>	
						[Sul	bstruct	ure Plane M	[arking]			\realians>

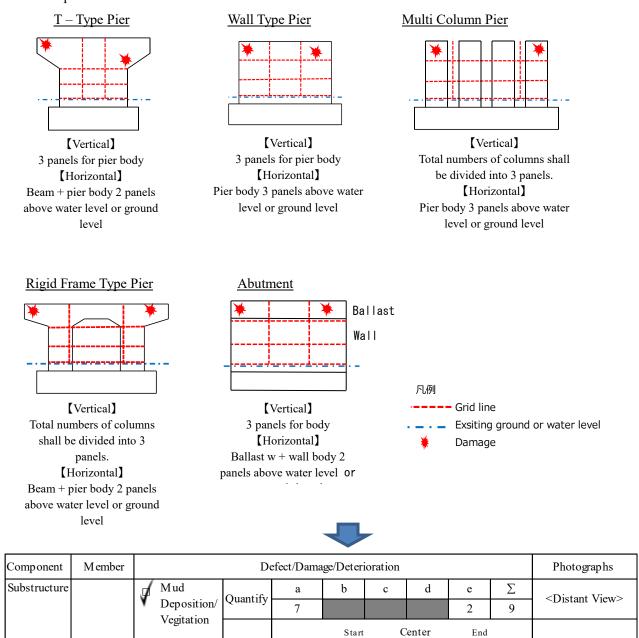
Figure 18-3 Mud Deposition/ Vegetation (Substructure)

As for the target of recording damage, grade of damage "a" and "e" and numbers of each element for each grade shall be counted. The results shall be recorded in the columns of Quantity in the Bridge Inspection Sheet.

The location of worst grade shall be recorded with check mark  $(\checkmark)$  on the Location in the Bridge Inspection Sheet.

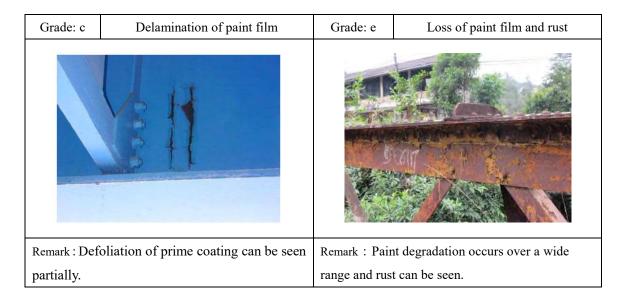
Note: Classification of large area is roughly more than 50% of surface area of element.

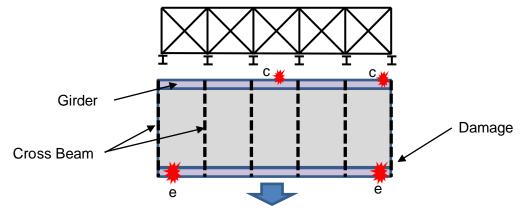
Figure 19-1 Paint Degradation (Truss Girder)

The elements are main girder divided by cross beam. In case there are 2main girders and 6 cross beams, total numbers of elements are  $10 (2 \times 5)$ .

As for the target of recording damage, grades of damage "a, c and e" and numbers of each element for each grade shall be counted. The results shall be recorded in the columns of Quantity in the Bridge Inspection Sheet.

Component	M ember		Defect/Damage/Deterioration							Photographs	
Superstructure	Main Beam		Quantify	a	b	c	d	e	Σ	Distant Views	
		Degradation	Quantity	6	0	2	0	2	10	<distant view=""></distant>	
					Start		Center	End			
				Left						<close view=""></close>	
			Location	Center							
				Right	<b>4</b>			✓		<remarks></remarks>	
					[Sup	erstruc	cture Plane	Marking]	-	\Keiliai KS/

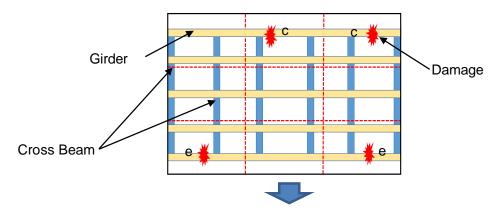
Figure 19-2 Paint Degradation (Steel Girder)

The elements are main girder divided by cross beam. In case, there are 5 main girders and 6 cross beams, total numbers of elements are 25 (5 x 5).

As for the target of recording damage, grade of damage "a, c and e" and numbers of each element for each grade shall be counted. The results shall be recorded in the columns of Quantity in the Bridge Inspection Sheet.

Component	M ember		Defect/Damage/Deterioration						Photographs			
Superstructure	Main Beam	✓	Paint	Quantify	a	b	c		d	e	Σ	<distant view=""></distant>
			Degradation	Quantity	21	0	2		0	2	25	\Distant view>
					_	Start		Cer	nter	End		
					Left			[				<close view=""></close>
				Location	Center			[				
					Right	✓		[		✓		<remarks></remarks>
						[Sup	erstru	cture	Plane N	Marking]		\CCITICING KS>

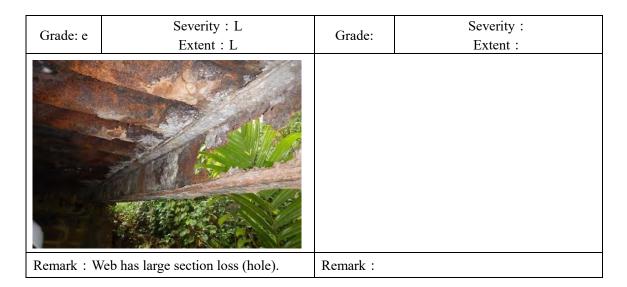
Grade: b	Severity: S Extent: S	Grade: c	Severity: S Extent: L			
Remark: A	Ithough there is some rusting, it is	Remark: Rus	ting can be seen, and the area of the			
lin	mited and loss of steel section	damage is larger than 50% of				
ca	annot be seen.	el	ement.

Grade: c	Severity: S Extent: L	Grade: e	Severity : L Extent : L
Remark: A	lthough loss of steel section is	Remark: Ren	narkable corrosion can be seen, and
co	onfirmed clearly, it is limited. Crack	th	e area of the damage is more than
01	n steel shall also be checked.	50	0% of element.

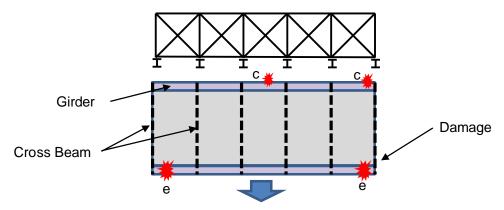
Figure 20-1 Corrosion (Main Girder of Truss)

The elements are main girder divided by cross beam. In case there are 2 main girders and 6 cross beams, total numbers of elements are 10 (2x 5).

As for the target of recording damage, grades of damage "a, b, c, d and e" and numbers of each element for each grade shall be counted. The results shall be recorded in the columns of Quantity in the Bridge Inspection Sheet.

Component	Member		Defect/Damage/Deterioration							
Superstructure	Main Beam		Quantify	a	b	c	d	e	Σ	<pre><distant view=""></distant></pre>
		'	Quantity	6	0	2	0	2	10	Distant view
					Start	(	Center	End		
				Left						<close view=""></close>
			Location	Center						
				Right	<b>4</b>			✓		<remarks></remarks>
					[Sup	\rcmarks>

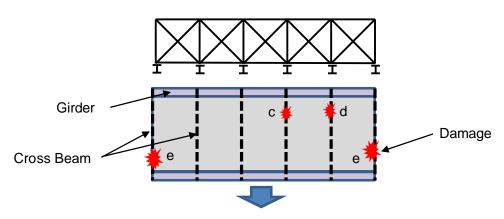
Figure 20-2 Corrosion (Cross Beam of Truss)

As for the target of recording damage, grades of damage "a, b, c, d and e" and numbers of each element for each grade shall be counted. The results shall be recorded in the columns of Quantity in the Bridge Inspection Sheet.

The location of worst grade shall be recorded with check mark ( $\checkmark$ ) on the Location in the Bridge Inspection Sheet.

Component	M ember		Defect/Damage/Deterioration							
Superstructure	Cross Beam	Corrosion	Quantify	a	b	c	d	e	Σ	<distant view=""></distant>
		'	Quantity	2	0	1	1	2	6	Distant view
					Start		Center	End		
				Left						<close view=""></close>
			Location	Center	9			<u></u>		
				Right	⋪			⋪		<remarks></remarks>
					[Sup	erstruc	ture Plane	Marking]	<u>-</u>	<remarks></remarks>

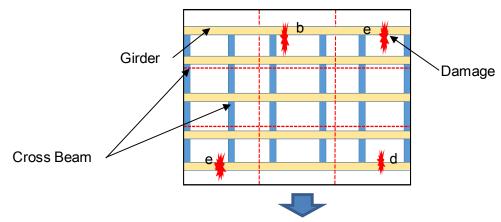
Figure 20-3 Corrosion (Main Girder of Steel Bridge)

The elements are main girder divided by cross beam. In case there are 5 main girders and 6 cross beams, total numbers of elements are 25 (5x 5).

As for the target of recording damage, grades of damage "a, b, c, d and e" and numbers of each element for each grade shall be counted. The results shall be recorded in the columns of Quantity in the Bridge Inspection Sheet.

Component	Member	Defect/Damage/Deterioration									Photographs
Superstructure	Main Beam		a	b	c		d	e	Σ	ĺ	<distant view=""></distant>
		Quantity	Quantify 21	1	0		1	2	25		Distant view>
				Start		Се	enter	End			
			Left					₩			<close view=""></close>
		Location	Center								
			Right	■							<remarks></remarks>
				[Sup	erstru	ctur	e Plane	Marking]			\Remarks>

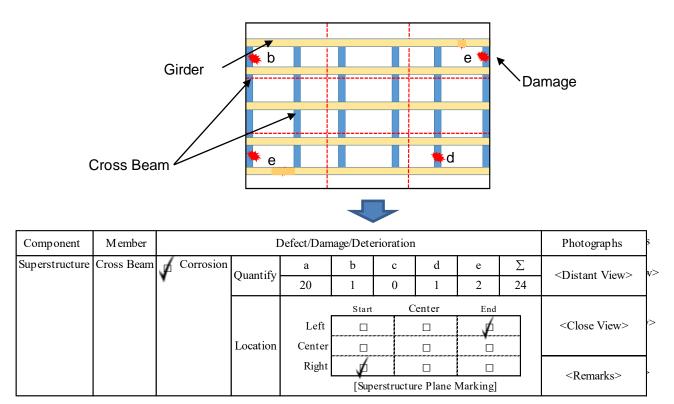
Figure 20-4 Corrosion (Cross Beam of Steel Bridge)

The damage shall be marked on the surface of bridge component/ member and recorded by camera. Photo taken at a distance.

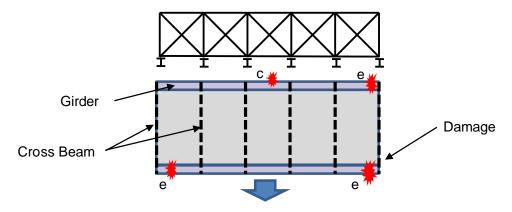
Figure 21-1 Damage (Rivet / HSFG) (Main Girder)

The elements are main girder divided by cross beam. In case there are 2 main girders and 6 cross beams, total numbers of elements are 10 (2x 5). The bolts/ rivet at splice joints are places to be inspected. As for the target of recording damage, grades of damage "a, c and e" and numbers of each element for each grade shall be counted. The results shall be recorded in the columns of Quantity in the Bridge Inspection Sheet.

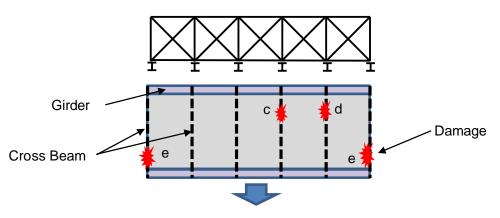
Figure 21-2 Damage (Rivet/ HSFG) (Cross Beam)

As for the target of recording damage, grades of damage "a, b, c, d and e" and numbers of each element for each grade shall be counted. The results shall be recorded in the columns of Quantity in the Bridge Inspection Sheet.

The location of worst grade shall be recorded with check mark ( $\checkmark$ ) on the Location in the Bridge Inspection Sheet.

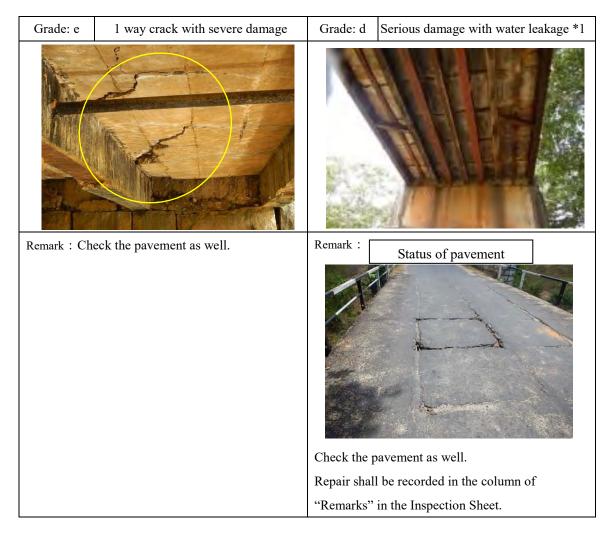
Grade: d	2 way crack, mainly w<0.2mm  Water leakage/ free lime	Grade: d 2 way crack, cell pattern size 0.5m - 0.2m, mainly w<0.2mm  No water leakage					
Remark: Pot	hole and pavement crack shall also be	Remark:					
che	cked.

Note \*1) The deck slab is precast panel type. The pavement on the slab is cracked along joint of deck slab with water leakage. Therefore, this damage is evaluated as serious damage with water leakage. The slab was reinforced by additional new girders between existing girders. Considering these, the grade is amended "e" to "d".

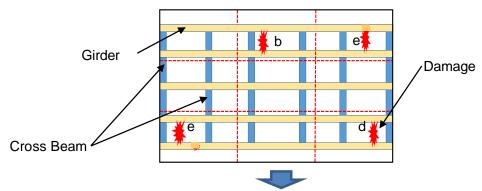
Figure 22-1 Damage on Deck Slab (RC)

As for the target of recording damage, grades of damage "a, b, c, d and e" and numbers of each element for each grade shall be counted. The results shall be recorded in the columns of Quantity in the Bridge Inspection Sheet.

The location of worst grade shall be recorded with check mark ( $\checkmark$ ) on the Location in the Bridge Inspection Sheet.

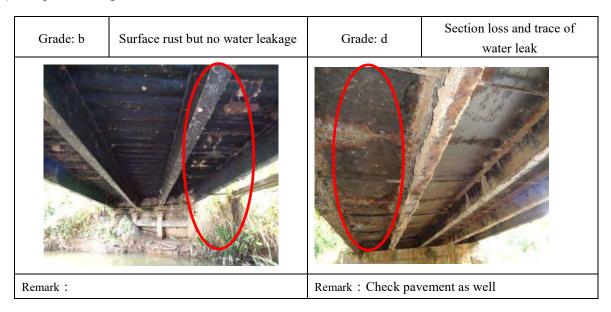
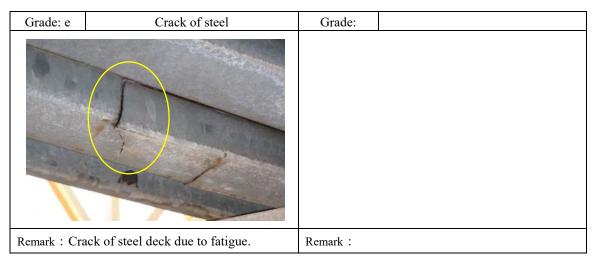
Grade of Damage	General Condition
a	Does Not Exist
b	Surface rust and no water leak
c	Surface rust and water leak
d	Loss of section and slight water leak
e	Loss of section and remarkable water leak or other serious damage such as crack of steel

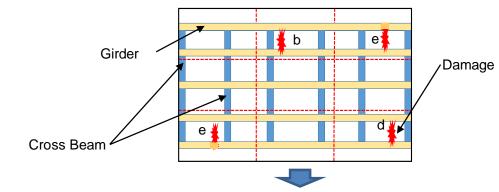
Figure 22-2 Damage on Deck Slab (Steel)

The elements are steel slab panel divided by main girder and cross beam. In case there are 5 main girders and 6 cross beams, total numbers of elements are 20 (4 x 5). In case there are 10 main girders and no cross beam, total number of elements is 10.

As for the target of recording damage, grades of damage "a, b, c, d and e" and number of each element for each grade shall be counted. The results shall be recorded in the columns of Quantity in the Bridge Inspection Sheet.

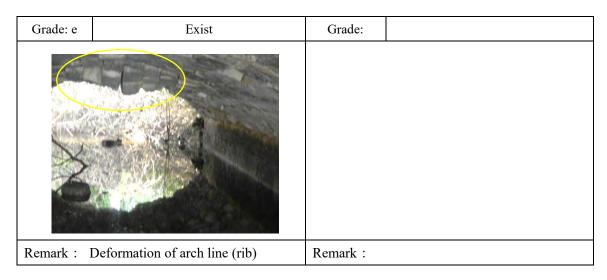
Grade of Damage	General Condition
a	Does Not Exist
ь	-
c	-
d	-
e	Deformation at Arch line (rib)

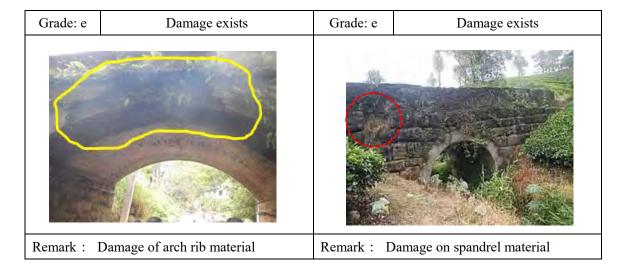
There is loose or missing arch rib and spandrel materials.

Grade of Damage	General Condition
a	Does Not Exist
b	-
c	-
d	-
e	Loose or missing material of arch rib and spandrel

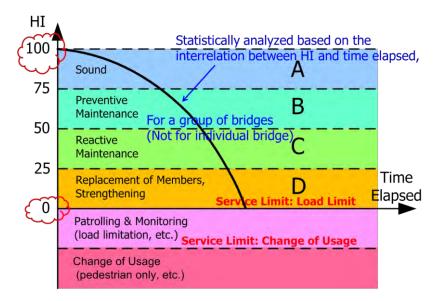
In this manual, HI shall be an index to represent the bridge conditions as the "performance" in a composite relation to load capacity and repair scale.

The "performance" is considered lost (HI=0) when the damage degrades the "performance" initially available at the time of construction and causes some restrictions (lane closure, loading restriction, speed limit).

In other words, HI represents the level of required treatment against the damage (degree of urgency and scale of repair).

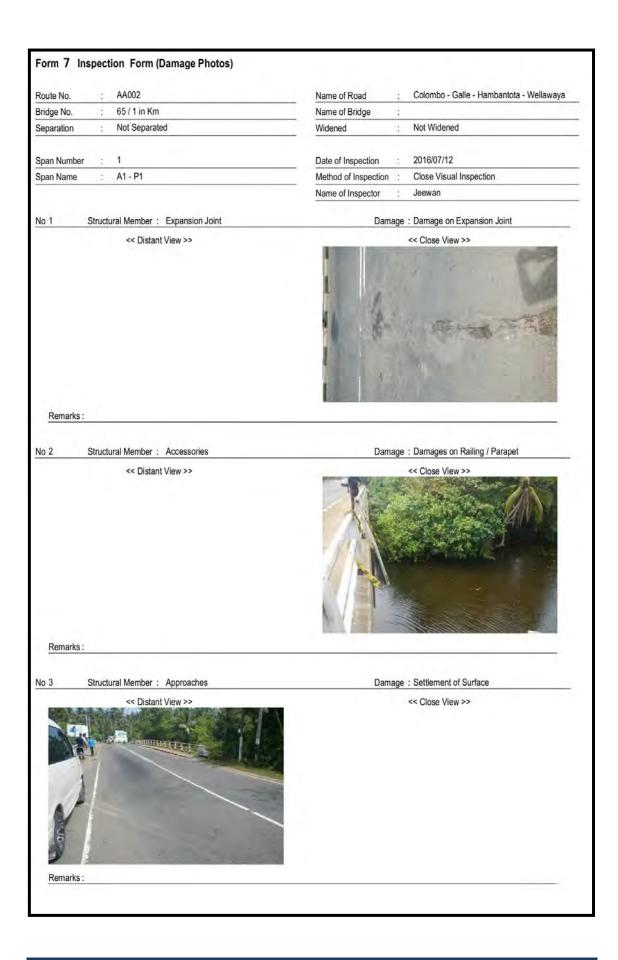
# Form 7 Inspection Form (Damage Photos) AA002 Name of Road Colombo - Galle - Hambantota - Wellawaya Route No. 65 / 1 in Km Bridge No. Name of Bridge Not Separated Not Widened Separation Widened Date of Inspection 2016/07/12 Span Number A1 - P1 Close Visual Inspection Span Name Method of Inspection : Name of Inspector Jeewan No 4 Damage: Spall / Dela / Ex-Rebar Structural Member: Main Beam << Distant View >> << Close View >> Remarks: No 5 Structural Member: Main Beam Damage : Crack << Distant View >> << Close View >> Remarks: No 6 Structural Member: Bridge Bearing Damage: Water Leakage from Expansion Joint << Distant View >> << Close View >> Remarks:

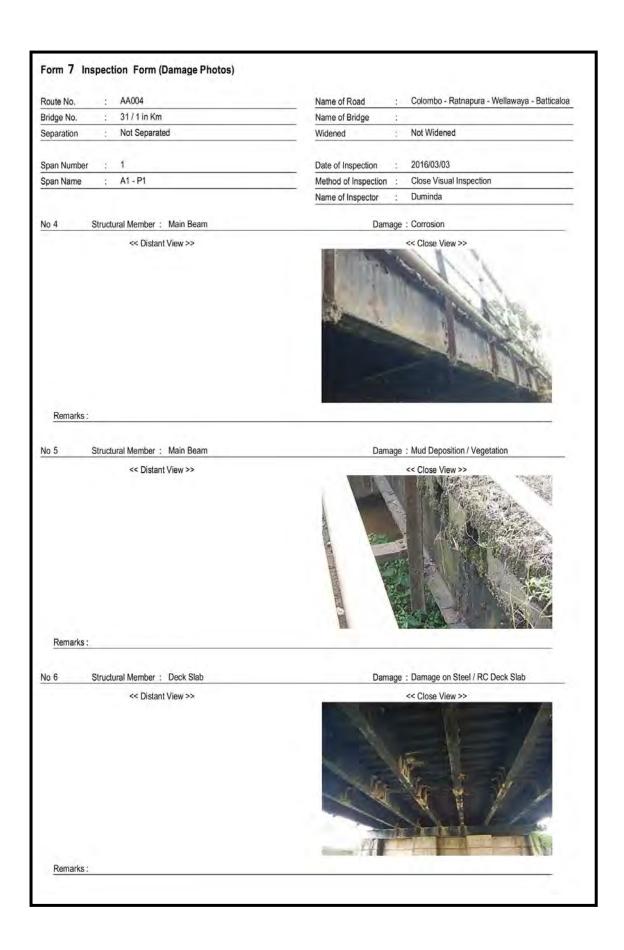
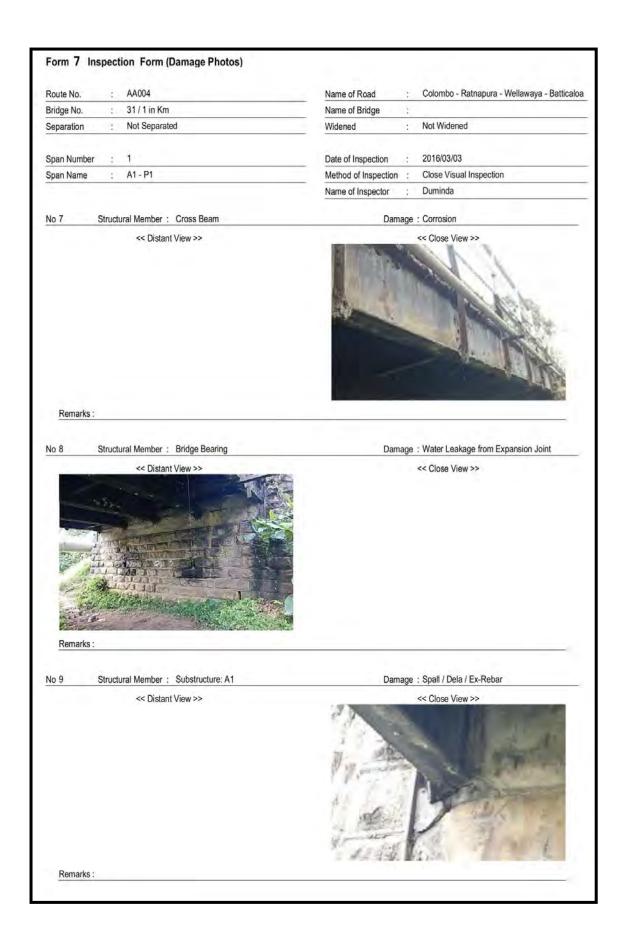
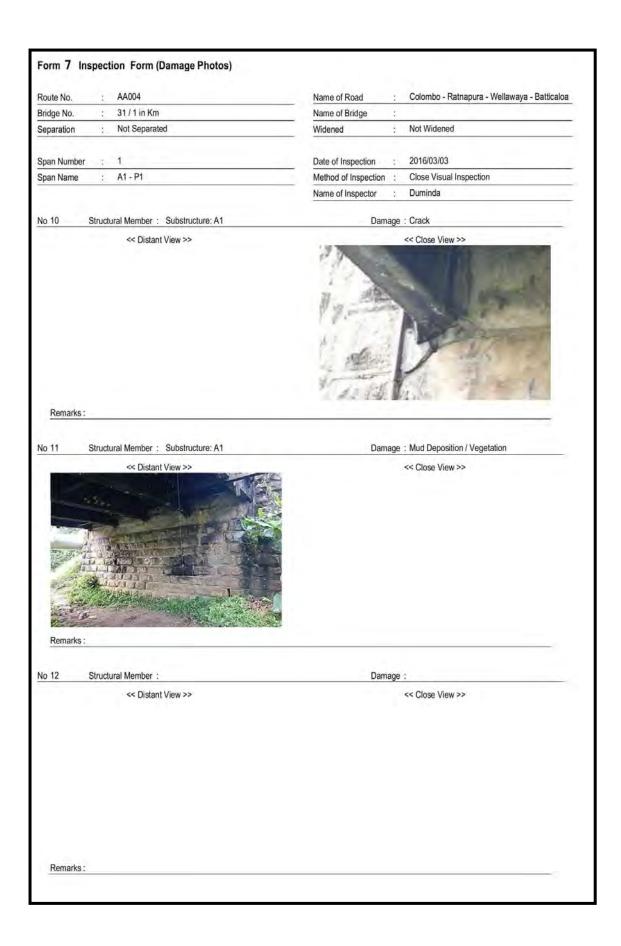
Route No.	8.	AA004						Name o	Road	12.	Colombo - F	latnapura	- Wellaw	aya - Batti	caloa
Bridge No.	1	31/1 in	Km					Name o	f Bridge	a					
Separation	1	Not Sepa	arated					Widene	-	:	Not Widene	d			
Span Number		2							Inspection		2016/03/03	(V) 1 5 W	,		_
Span Name	1	P1 - A2					_		of Inspect	_	Close Visua Duminda	Inspection	n		_
								Name o	f Inspecto	r. 15	Duminga				_
< <pavement>&gt;</pavement>	_		Soundne	ess Grade	: В		Healthin	a marine	58						
Damage Type>			<a>&gt;</a>	<b></b>	<c></c>	<d>=</d>	xtent of I	Damage <Σ>	<rem< td=""><td>arks&gt;</td><td></td><td></td><td></td><td></td><td></td></rem<>	arks>					
Pothole			8	- 38	0	- 6	1	9							
Crack			3	-12-	5		1	9							
Rutting			9	- × -	0	17.0	0	9							
Waving	_		9		0		0	9							
<damage type=""></damage>	-		<11>	<21>	<31>	<12>	Local <22>	<32>	<13>	<23>	<33>		Start	Contor	End
Pothole			2015	1217	2012	-12	-22	0	7137	-23	-00"	Left	11	Center 12	13

Crack								•				Center	21	22	23
Rutting								_				Right	31	32	33
Waving											_	, ugin		tructure Pla	
< <expansion joint="">&gt;</expansion>			Soundne	ess Grade	: D		Healthin	dex:	0						
The state of the						E	xtent of I	Damage							
<damage type=""></damage>			<a>&gt;</a>	<b></b>	<c></c>	<q></q>	<e></e>	<Σ>	<rem< td=""><td>arks&gt;</td><td></td><td></td><td></td><td></td><td></td></rem<>	arks>					
Damage on Expansion	n Joi	nt	0	- 6	16.0	1.5	100	100							
Difference in Levels			100	-	0		0	100
