CHAPTER 7. PRE-FEASIBILITY STUDY OF PARAÑAQUE SPILLWAY

7.1 Geological Condition

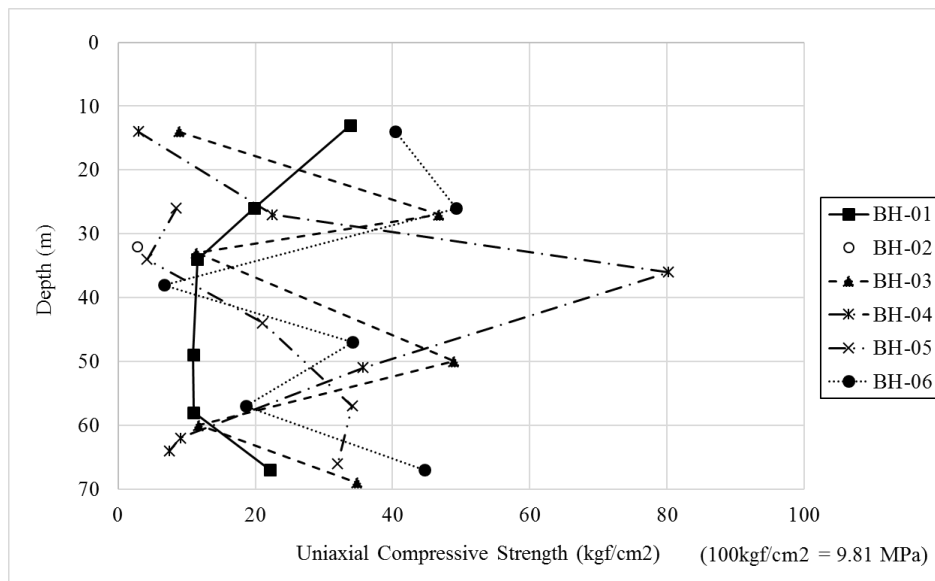
Figure 7.1.13 Uniaxial Compressive Strength of Rock Specimen

Figure 7.1.13 shows the relation between uniaxial compressive strength of the Guadalupe Formation as well as the depth from the ground surface at each borehole. This figure indicates that most of the uniaxial compressive strength are under 50 kgf/cm² (4.91 Mpa). Compared with Figure 7.1.14, the Guadalupe Formation is relatively soft in the soft rock classification.

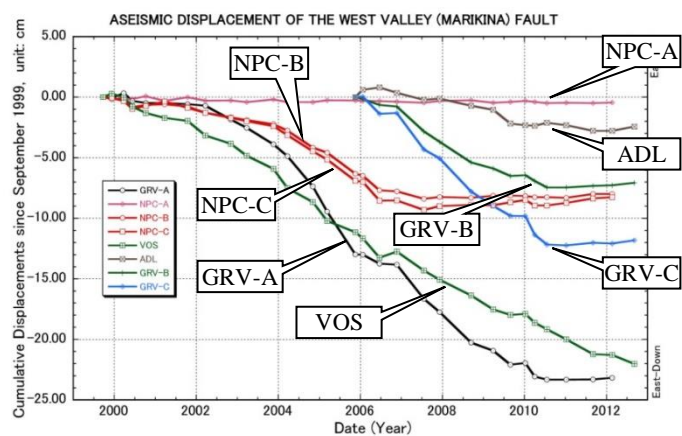
Figure 7.1.17 Movement of the Ground Observed by Repeated Leveling Survey in Metro Manila

Result: The Levelling Survey suggests that the average slip rate is from 1.77 cm/year to 2.45 cm/year between September 1999 and January 2010. Vertical displacement caused by creep in several locations has accelerated since 2004. Most of the movements have ceased since 2010.

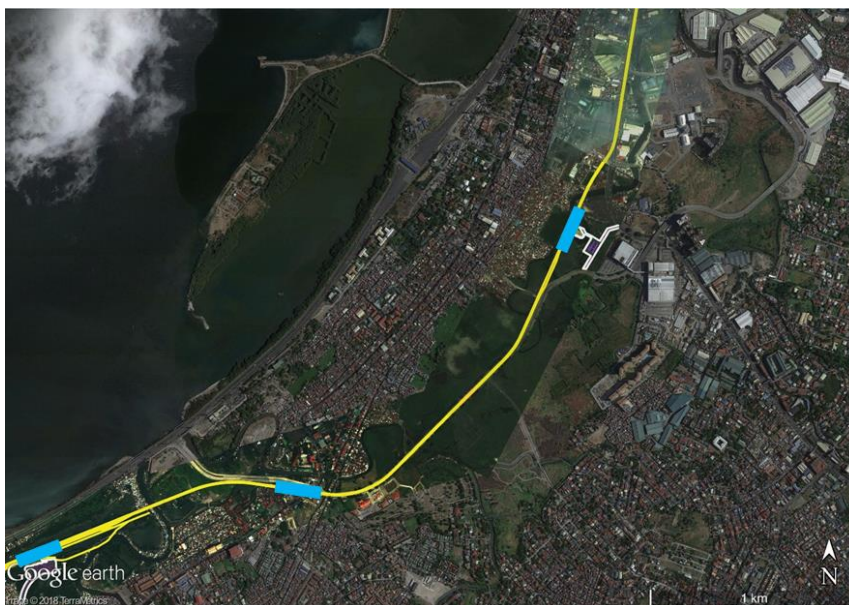
Figure 7.2.3 Plan of LTR-1 Cavite Extension around Parañaque River System and Zapote River

- The LTR-1 Cavite Extension is planned to locate at the left bank side of San Dionisio River. Therefore, there is no competition problem with regard to the Parañaque River System. As regards Zapote River, there are some competitions, namely; partial overlap with the railway station at the left bank side and with the rail line at the right bank side, as shown in Figure 7.2.3.
- Hence, the drainage facility maybe planned at the right bank side near the river mouth to avoid competition with the LRT facilities.

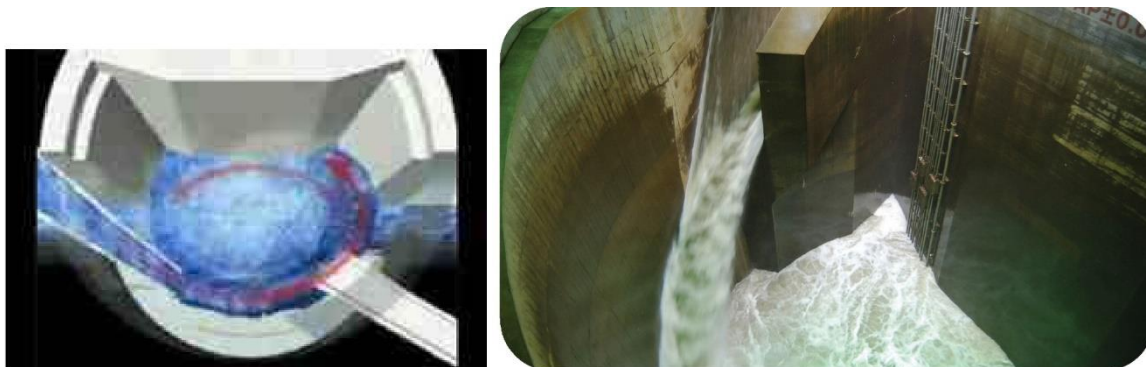
Figure 7.2.9 Vortex Drop Shaft of Metropolitan Area Outer Underground Discharge Channel in Japan

Examples of the Vortex Drop Shaft of the Metropolitan Area Outer Underground Discharge Channel are shown in Figure 7.2.9 (from the Homepage and brochure of the Metropolitan Area Outer Underground Discharge Channel).

a) Explanation of Vortex Drop Shaft; b) Inflow Situation of August 2005 Flooding (No. 3 Vertical Shaft)
 Source: <http://www.ktr.mlit.go.jp/edogawa/gaikaku/intro/02shuyou/shu-05.html> and “Sairyu no Kawa, Metropolitan Area Outer Underground Discharge Channel”

The dimension of the Vortex Drop Shaft should be determined by a more detailed hydraulic study, including a hydraulic model test, because the phenomena of hydraulic condition of the Inlet Shaft are very complicated and totally different. In the Survey, the dimension of the Vortex Drop Shaft is roughly calculated in accordance with the Milwaukee Experiment Report, as follows:

Slit Width $e = D / 4 = 1.375 \text{ m}$
 Approach Channel Width $B = 3D / 4 = 3 \times 5.5 / 4 = 4.125 \text{ m}$
 Assumed Reduction Angle $\theta = 16.8 \text{ degree}$
 Reduction Channel Length $L1 = \left(\frac{B - e}{\tan \theta} \right) = 9.108 \text{ m} \Rightarrow L1 = 10 \text{ m}$

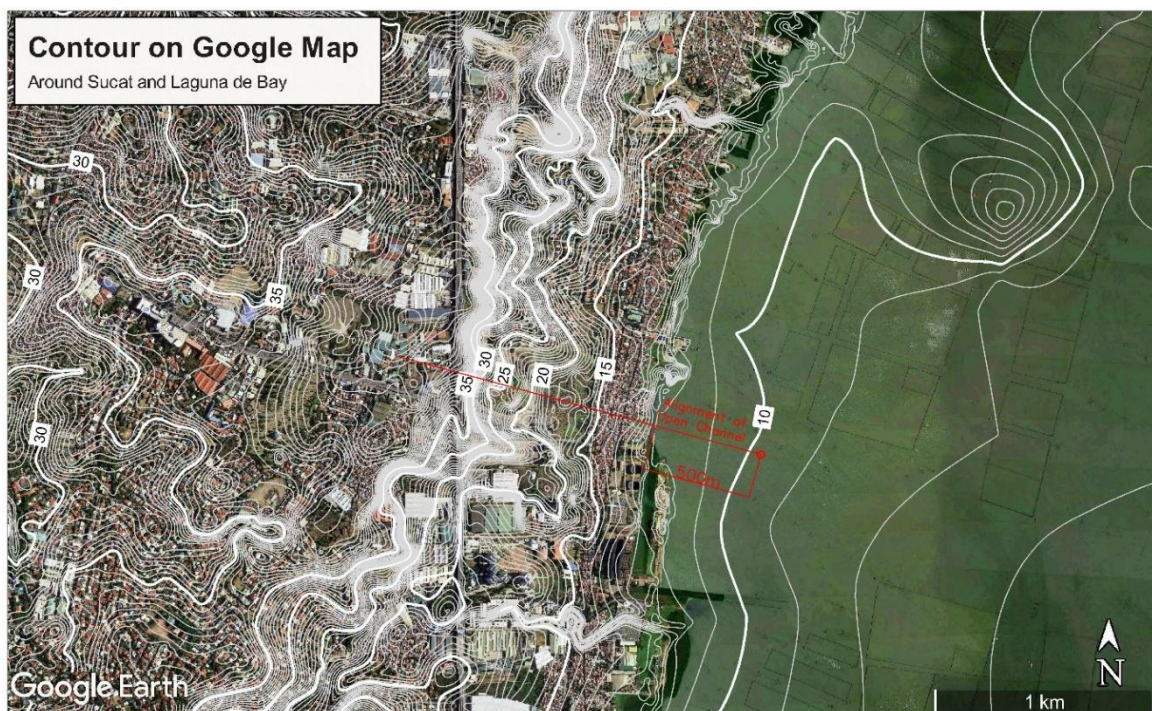
Figure 7.2.13 Contour Drawing of Sucat and Lake Bottom of Laguna de Bay

The contour drawing of Sucat and Laguna de Bay in Figure 7.2.13 shows the condition of the lake's bottom of Laguna de Bay.

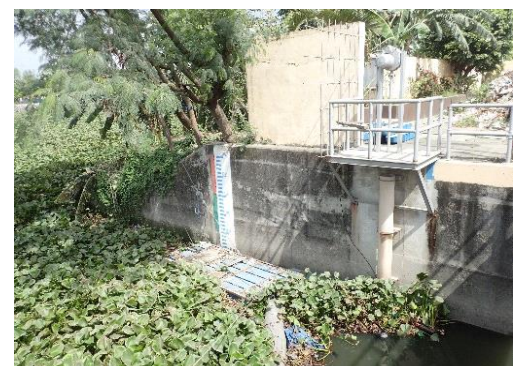
Figure 7.2.24 Water Hyacinth at Suction Side of Pumping Station

Water Hyacinth growing abundantly along the lakeshore of Laguna de Bay and rivers may obstruct the inflow at the intake. Based on the field investigation on drainage pump stations in Metro Manila, a part of floating debris could pass through the trash-rack rake and caught in the bar screen at pump suction side since it is a rear-lowering and front-raising type. In

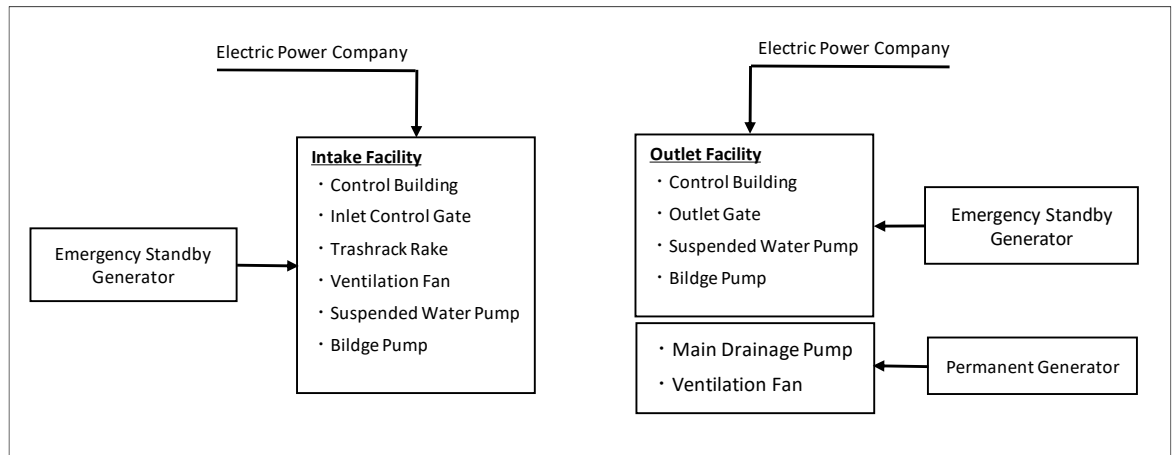
Figure 7.2.27 Basic Concept of Electric Power Supply System

As for main drainage pumps and ventilation fan in the outlet facility, electricity supply to the equipment shall be designed to enable supply by in-house power generator instead of the electric power company. Since the equipment is estimated to operate for a short period annually, it is possible to reduce the fixed charges generally imposed for power received from the electric power company. On the other hand, lighting and air-conditioning of office building and auxiliary equipment will be operated by power received from the electric power company. The basic concept of an electric power supply system is shown in Figure 7.2.27.

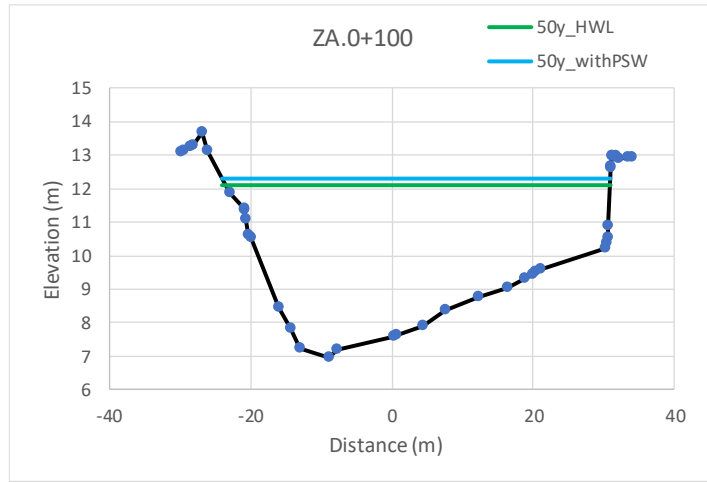
The river water level changes and drainage discharge of Parañaque Spillway is organized at the cross section (ZA.0+100) which is near outlet facility.

The drainage discharge of Parañaque Spillway is changing due to the river water level at downstream river channel (Zapote River). In addition, the downstream boundary is set design tide level (11.87m).

Figure 7.3.8 River Water Level at ZA.0+100 (HWL of 50-year Return Period and 50-year Flood + with Parañaque Spillway)

The calculation result of river water level and river discharge is shown in Table 7.3.3, Figure 7.3.8 to Figure 7.3.14.

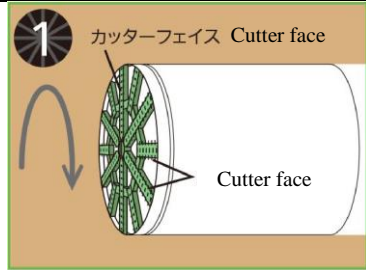
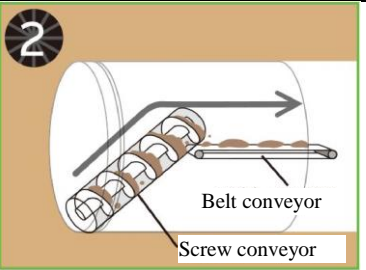
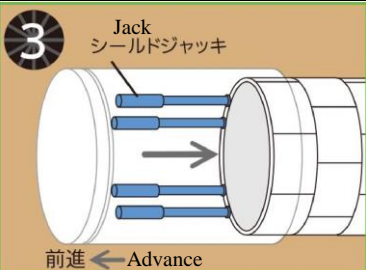
Step-1: Excavation		
Cutting	Transporting excavated soil	Advancing Shield Machine

Revolve the cutter face to cut the ground	Load excavated soil into the machine by a screw conveyor and transport it to the outside	Apply reaction force with jacks installed in the machine against segments and advance the machine accommodating the speed of excavation
Step-2: Segment Assembly

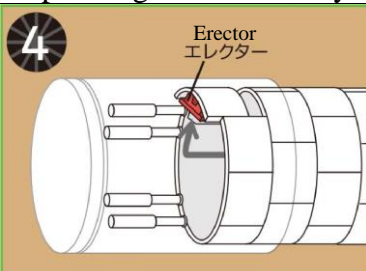
Secure the space to assemble segments by shortening jacks situated at the element to assemble and insert the segment using an erector.

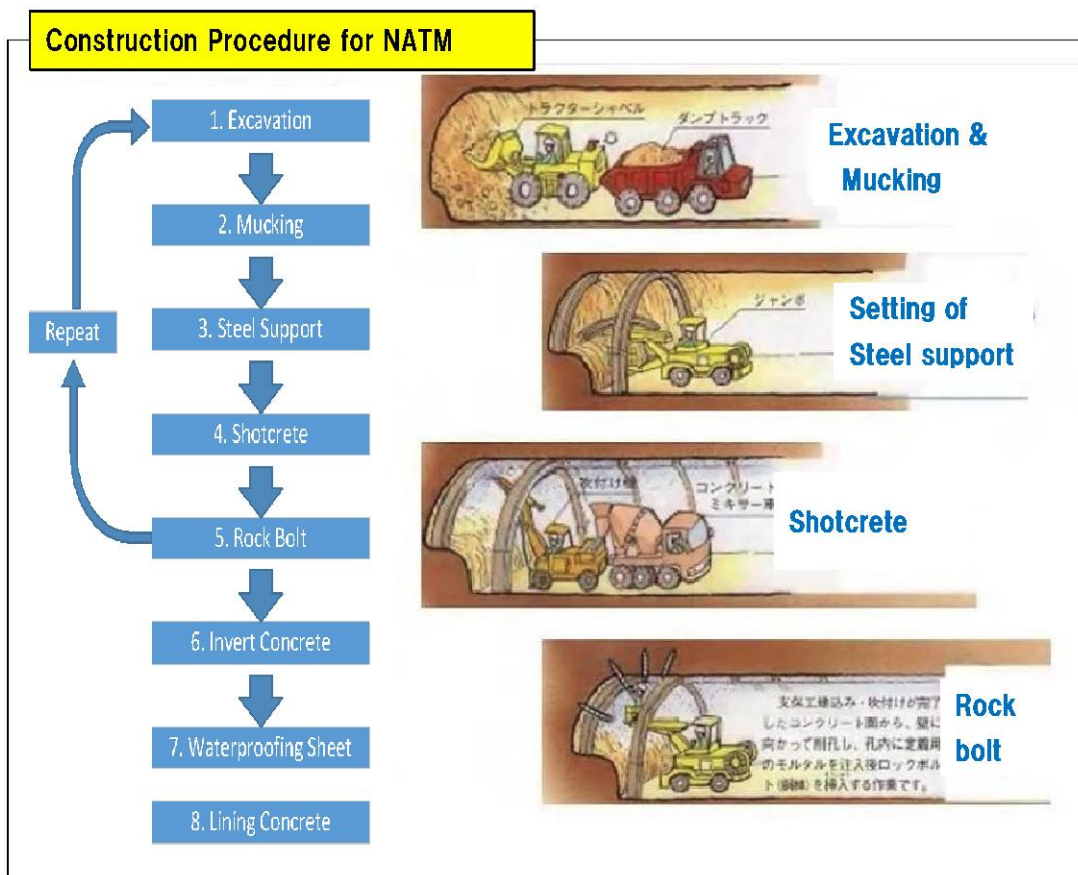
Figure 7.5.4 Procedure of NATM

The New Austrian Tunneling Method (herein called as NATM) utilizes the retention force (ground arch) of the surrounding ground to support the tunnel and hence the excavation proceeds by applying shotcrete as soon as possible, positioning steel support, arranging rock bolts, and securing stability of the ground. Equipment used for the construction is general-purpose heavy equipment such as excavators to excavate the face and dump trucks to transport surplus soil. Compared to the Shield Tunneling Method which uses expensive shield machines, the cost of this method is generally much cheaper. However, in case of leakage in the ground, in order to stop the water, auxiliary measures such as chemical grouting is necessary, but the cost of this method will be relatively expensive. Therefore, when selecting NATM, boring survey should be thoroughly conducted to understand the details of the ground. The ground in which NATM can be applied is hard ground and ground stronger than soft rock, and the face has to be stable.

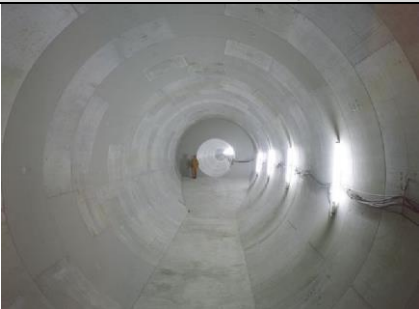
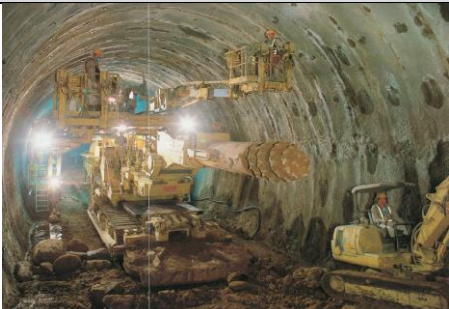
Item	Shield Tunneling	NATM
Photo

Summary of Method	Excavate with the shield machine by stabilizing the face against earth pressure and water pressure using mud pressure or muddy water pressure and assemble segments to retain the ground.	Excavate by stabilizing the ground using shotcrete, rock bolts and steel support, etc., utilizing the support function of surrounding ground. If formation of a ground arch with the surrounding ground and stability of the face when excavating is not ensured, auxiliary measures are necessary.
Ground to apply (Standard application and adaptability to changes such as the ground condition)	Generally applied to the ground with very soft alluvium, diluvium and soft rocks from Neogene period. Relatively easy to adopt to changes of the ground. There are also many cases with hard rocks.	Generally applied to the ground with hard rocks and soft rocks from Neogene period. Depending on the requirements, applicable to unconsolidated ground. The changes of ground can be handled by changing support works, excavation methods, and auxiliary measures.

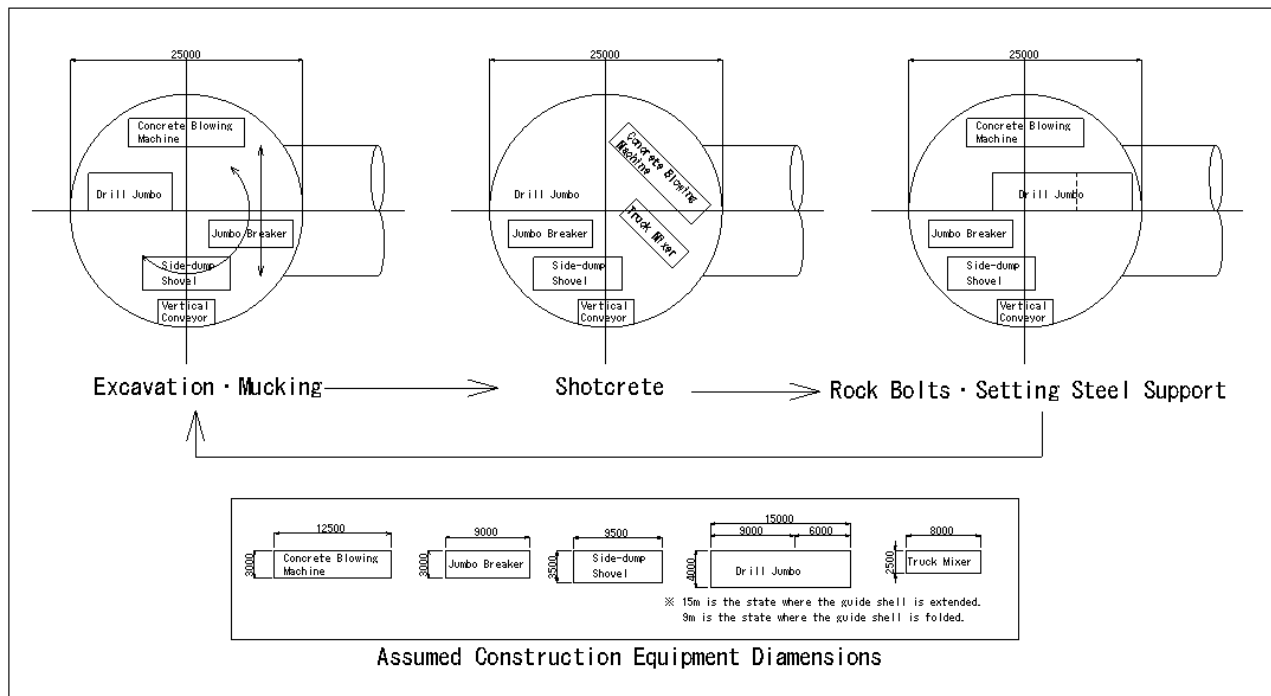
Figure 7.5.7 Minimum Size for NATM Shaft

Since this planning tunnel is presupposed to secure overburden of 50 m or more, the construction will be carried out of the tunnel excavation by hanging down the construction equipment into the shaft about GL-70 m from ground level. The NATM separate the construction steps for “Excavation and Mucking”, “Shotcrete” and “Rock bolts and Setting of steel support” and each step is carried out by different construction equipment. Therefore, tunnel construction is carried out by replacing the construction equipment at each step. However, considering the depth of shaft, there is the problem of cycle time and safety. For this reason, the plane scale for shaft is decided at $\phi 25$ m from

minimum space of arrangement for the construction equipment for first excavation and the rearrangement. The basis for setting up the shaft of the NATM is shown in Figure 7.5.7.

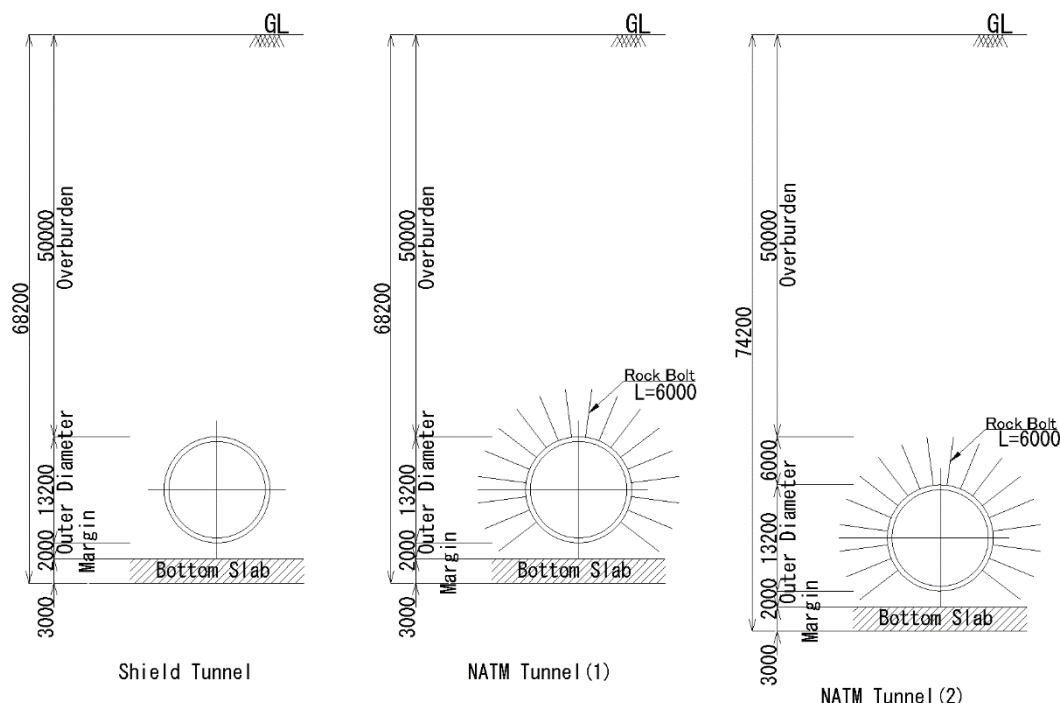
Figure 7.5.8 Depth Plans of Bottom Slab

Shield Tunnelling	NATM (1) When rock bolts are not a part of tunnel structure	NATM (2) When rock bolts are a part of tunnel structure
Overburden	50 m (Common)	50 m (Common)	50 m (Common)
Tunnel Outer Diameter (height)	13.2 m	12.4 m	12.4 + 6.0 = 18.4 m
Height of Allowance	5.0 m (Common)	5.0 m (Common)	5.0 m (Common)
Thickness of Bottom Slab	5.0 m (Common)	5.0 m (Common)	5.0 m (Common)
Total Depth	73.2 m	72.4 m	78.4 m

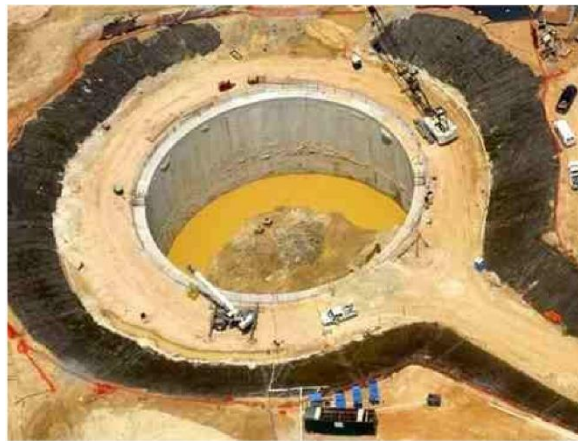
Figure 7.5.10 Case of RC Diaphragm Wall Circular Shaft

The RC diaphragm wall is constructed by inserting reinforcement cages into drilling grooves excavated using slurry and replacing slurry with concrete to cast continuous RC wall. Maximum depth of 140m and maximum wall thickness of 3.0 m are possible in this construction. This can be applied to any ground condition including soft ground and rock ground.

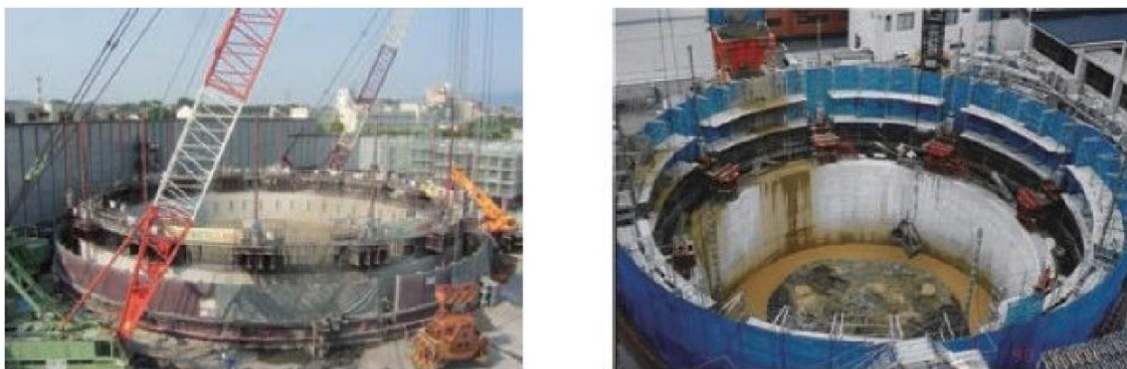
Figure 7.5.13 Photo of Press Caisson Construction

In this method, the main frame of caisson is constructed with reinforced concrete on the ground and it is installed into the ground by using reaction force of dead weight and ground anchors while proceeding with the excavation of the ground at the bottom surface of the caisson. There seems no sump water in the area planned for construction and even if there is, sump, treatment will be enough to cope with the sump water. Excavation will be done with backhoes and breakers and soil is gathered with a bucket-type machine

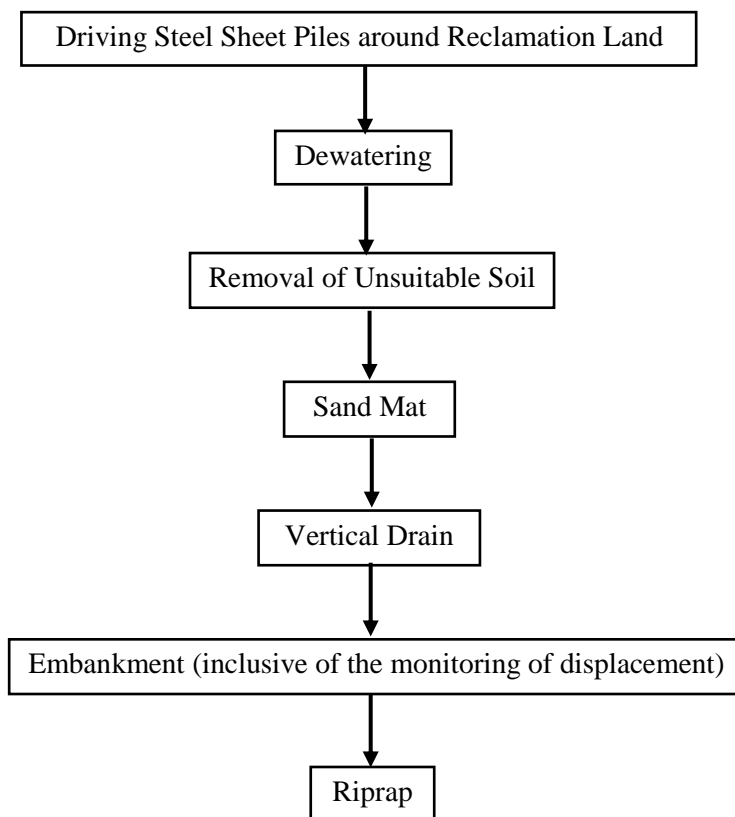
Figure 7.5.17 Work Flow of Re-use of Excavated Material

As stated above, in this survey, the plan for disposal of excavated surplus soil considers up to transportation and subsequent disposal into the designated disposal yard for Laguna de Bay. However, there is another option where excess excavated soil is reused for the reclamation of Laguna de Bay to create new land area. In this case, it is necessary to consider countermeasures to

minimize the consequence such as settlement and horizontal displacement of land that will be newly created. Working procedure for the reuse of excavated material is as follows.

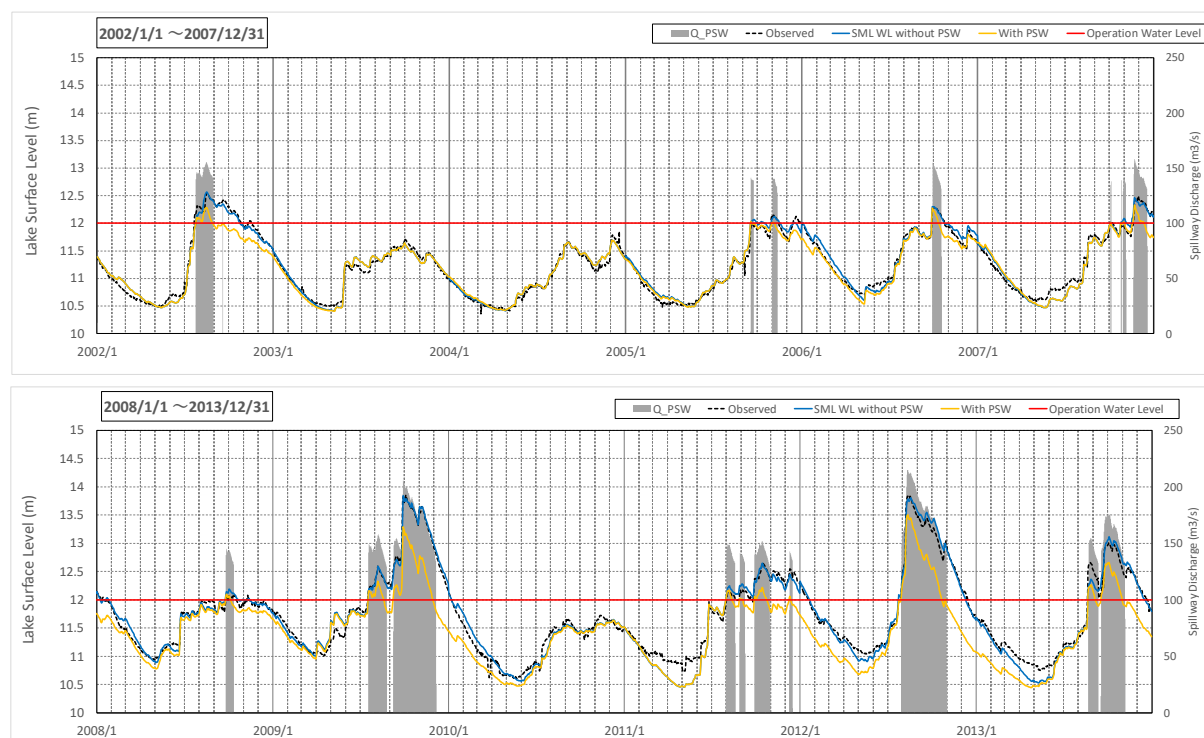
Figure 7.6.2 Results of Long-Term Reproduction Calculation of the Laguna de Bay Lake Water Level Change from 2002 to 2013

Based on the results of the long-term reproduction calculation of the Laguna de Bay lake water level change from 2002 to 2013 as mentioned in Subsection 3.4.1, basic data of the spillway operation is assessed. The results of calculation are presented in Figure 7.6.2.

Parañaque Spill Way control level=12.0m

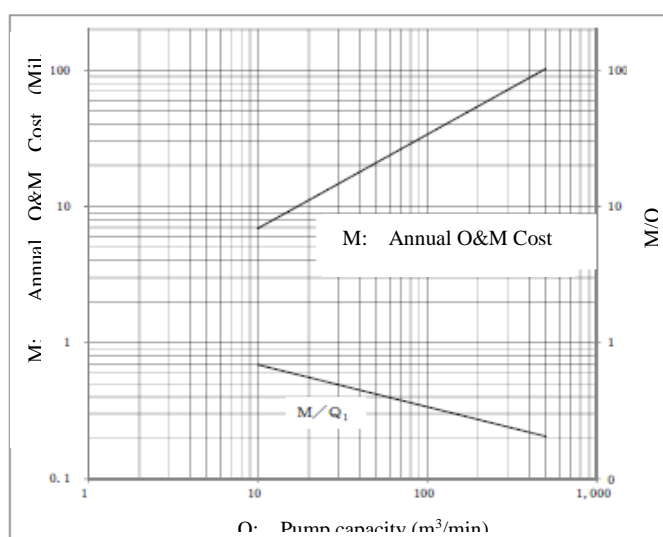
Figure 7.6.8 Operation Cost by Cost Function Curve in Japan

M: Annual operation and maintenance cost of pumping station (million yen/year)

Q: Hourly Maximum Pump Capacity (m³/min)

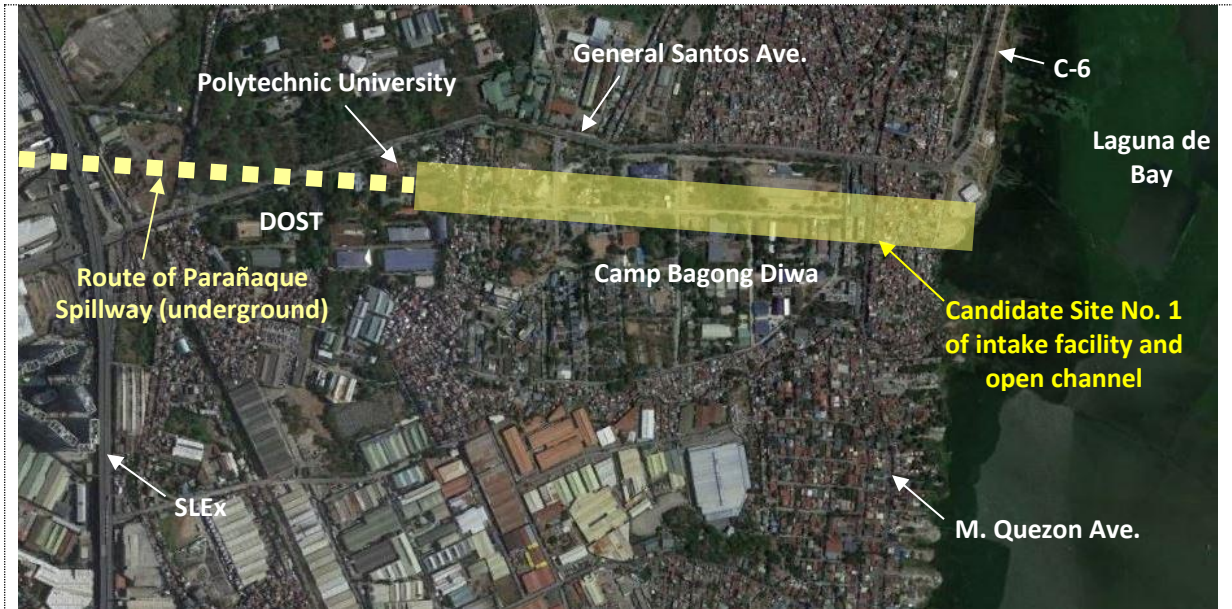
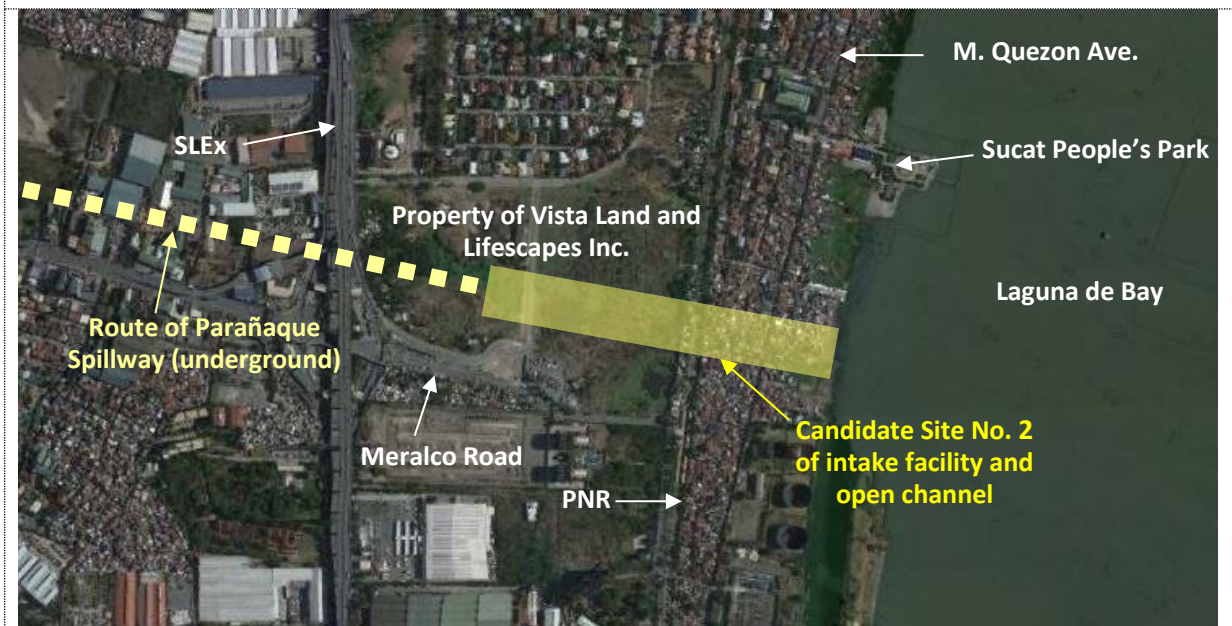
Figure 7.9.2 Current Status along the Candidate Sites of Intake Facility and Open Channel

<p>Candidate Site No. 2: Barangay Sucat, Muntinlupa City</p>	<p><u>Traffic Condition:</u> M. Quezon Avenue and the Philippine National Railways (PNR) run in north-south direction and Sucat Road runs in east-west direction.</p> <p><u>Land Use/Existing Facility:</u> Residential areas exist along both sides of M. Quezon Avenue. There is the real-estate property of Vista Land and Lifescapes, Inc. west of PNR. The current status of the estate is open space.</p> <p><u>Natural Environment:</u> Vegetation in the residential area is limited. The open space owned by the real estate company is occupied with grasses and bushes. This Candidate Site No. 2 is covered with aquatic plants in Laguna de Bay as with Candidate Site No. 1.</p> <p><u>Water Area Use:</u> Aquatic culture facilities (fish pens and fish cages) exist offshore in the Laguna de Bay at the distance of several hundred meters from the shoreline.</p>

Aero Photo 1 : Candidate Site No. 1 of Intake Facility and Open Channel (Barangay Lower Bicutan, Taguig)

Aero Photo 2 : Candidate Site No. 2 of Intake Facility and Open Channel (Barangay Sucat, Muntinlupa)

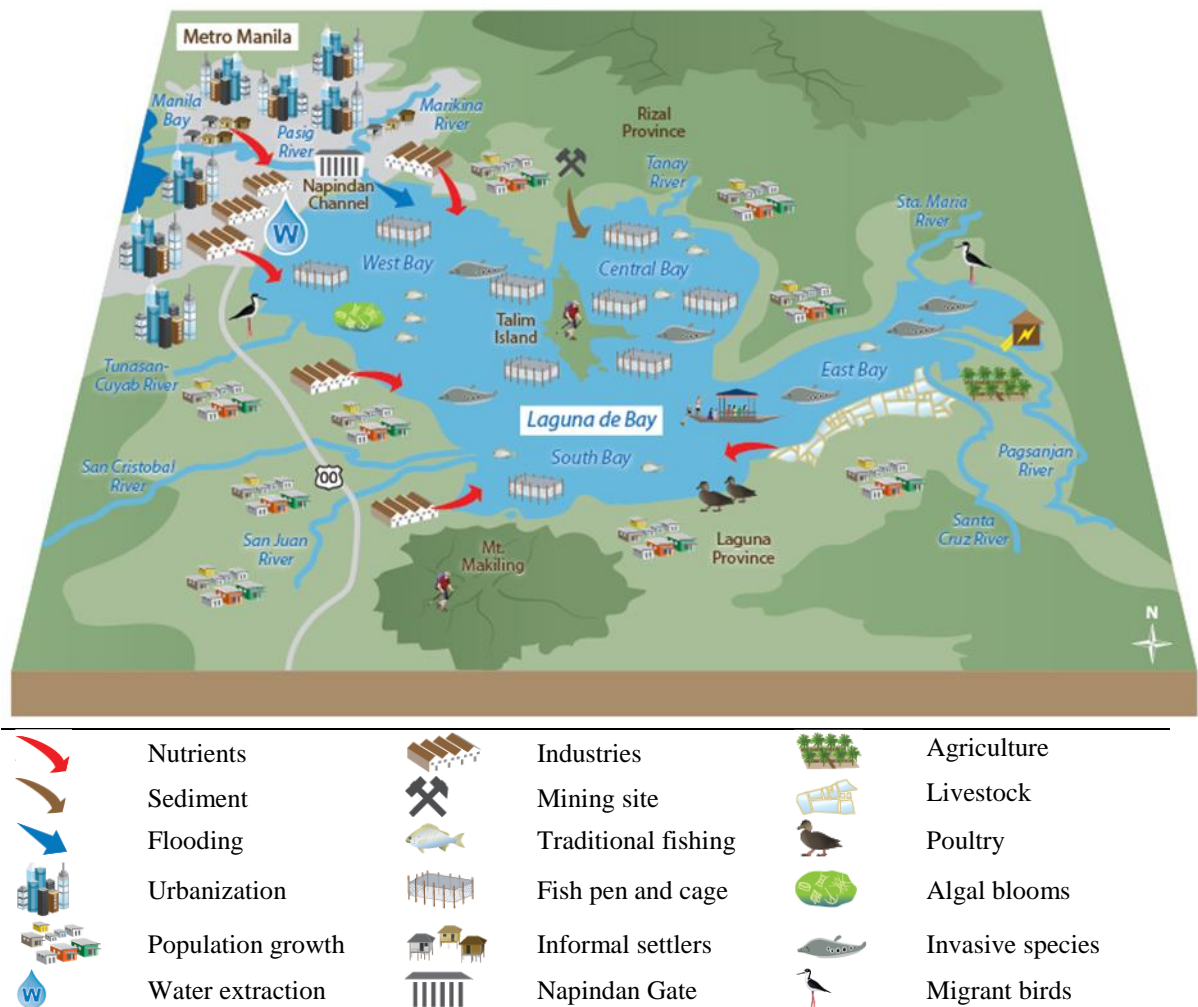
Figure 7.9.13 Natural Resource Values and Human Activity Threats

mainly from urban/industrial areas located in north-western to western side of Laguna de Bay. Nutrient also flows in from the livestock facility located in the south-western side of the lake. In addition, sediment enters the central bay from the mining site on the north side.

The water quality monitoring result described in Table 7.9.9 is consistent with the figure. At the monitoring stations located in the west bay, BOD is relatively higher and DO is lower and the concentration of Ammonia, and Oil & Grease is higher. Ammonia is also relatively higher in the east bay due to inflow from the livestock farming area. Regarding TSS, it is relatively higher in the central bay where sediment enters from the mining site, and the east bay which is surrounded by mountains.

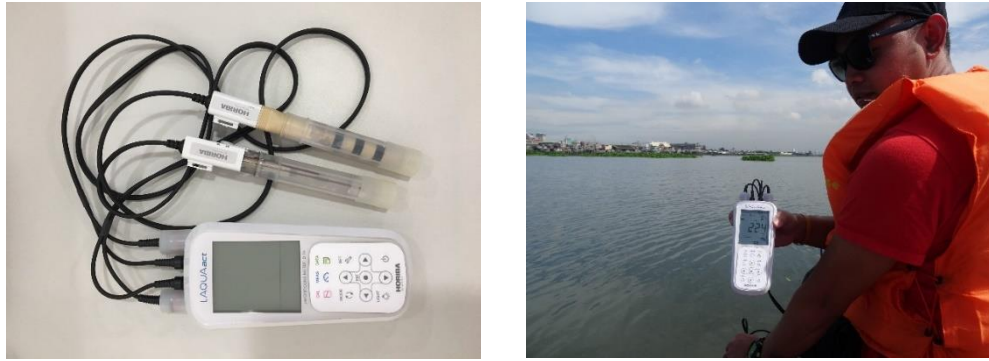
Figure 7.9.16 Measurement Device (Left) and Measurement (Right)

However, salinity is not monitored around LPPCHEA and no observation data exists. Therefore, the JICA Survey Team carried out the salinity measurement around LPPCHEA monthly from August 2017 to February 2018. The device used for the measurement was LAQUAact74D with pH electrode 9625-10D and electric conductivity cell 9382-10D from HORIBA Ltd.

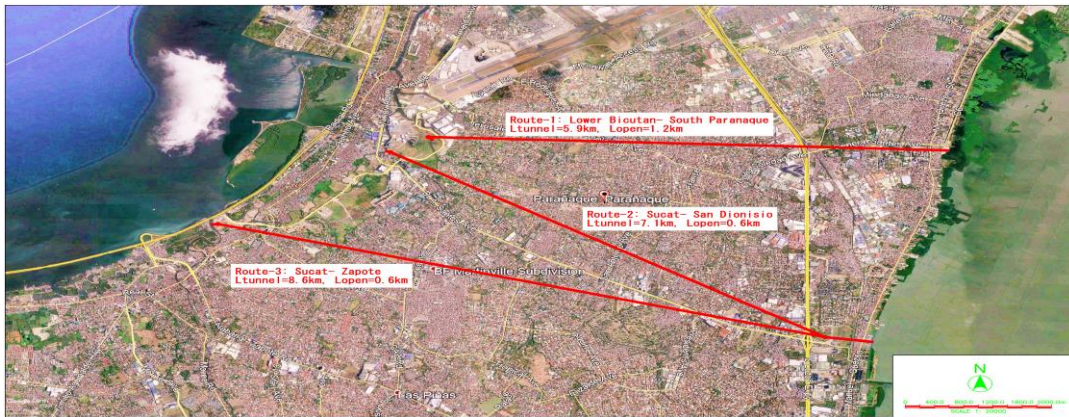
Figure 8.1.1 Alignment Alternatives of Parañaque Spillway

Since August 2017, “Data Collection Survey on Parañaque Spillway in Metro Manila” has been implemented by JICA as Japanese ODA. The comprehensive flood management plan of Laguna de Bay Lakeshore Area and Preliminary Feasibility Study (Pre-F/S) of Parañaque Spillway, which was approved as a priority project by the 4th Steering Committee Meeting held on 23 January 2018, has been executed. In this survey, there were three (3) routes for the Parañaque Spillway and two (2) types of tunnel construction methods for the underground spillway (Shield Tunneling Method and NATM).
