Republic of Zambia Road Development Agency (RDA)

DATA COLLECTION SURVEY ON TRANSPORT AND INFRASTRUCTURE DEVELOPMENT ALONG NACALA CORRIDOR

FINAL REPORT

Japan International Cooperation Agency

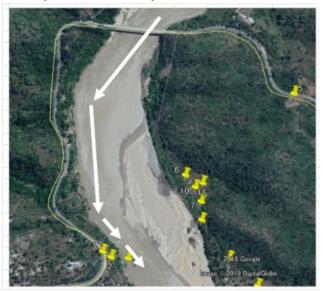
Photo 5.1-1 Mainstream alignment of Luangwa River

Figure 5.1-2 shows the cross-section of the river measured near the location where a new bridge may be built. Downstream of the existing Luangwa Bridge, the water course of the Luangwa River curves to the left. Because of inertia force applied to the river water, the water speed becomes faster on the right side, and the water course becomes deeper along the right bank. According to the results of measurements in this survey, the deepest riverbed point at the location for a new bridge lies at a depth of about 10m in the river course along the right bank on the Lusaka side. The water speed on the right bank side is fast at about 3.5m/s. The water speeds at points between the river center and the left bank side are slow at around 1.5 to 1.0m/s. Because a rock protrudes into the river on the right bank side immediately upstream of the location for a new bridge, the river's mainstream collides with this rock then changes its course to the left.

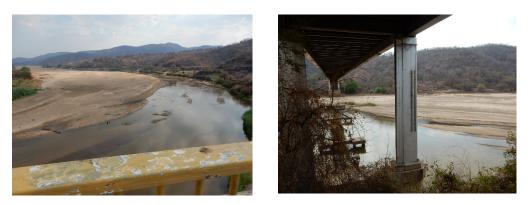
Photo 5.1-2 Luangwa River in the dry season

In a photograph taken in October 2016 close to the end of the dry season, sand riverbed appeared across about one-third of the river width at the location of the existing Luangwa Bridge on the Lusaka side, and the width of the water course narrowed to approximately 100m at the location for a new bridge. Judging from these data, the cross-section of the Luangwa River changes significantly between the rainy season and the dry season.

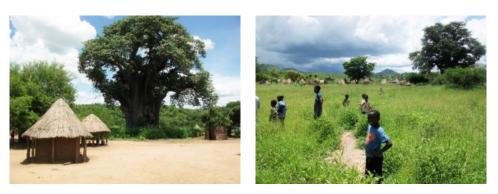
Photo 5.1-5 The villages on the river terrace on the left bank side (Malawi side)

When a new bridge is built in the future, it is recommended to exclude the section of the undercut slope areas. The recommended location for a new bridge would be approximately 1km downstream of the existing Luangwa Bridge. On the other hand, there is a small-scale river terrace (6 to 8m above the riverbed level) approximately 0.5 to 1.5km downstream of the Luangwa Bridge on the left bank side (Malawi side) (**Photo 5.1-4**). On the river terrace, there are two villages, each of which has 10 to 15 huts (simple houses) and several cornfields (**Photo 5.1-5**).

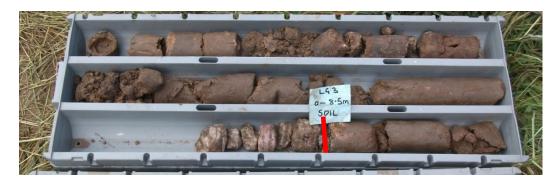
Photo 5.1-14 (BH-3) Boring core (fine sand and silty sand, weathered gneiss occurring along cracks at depths of GL-8.5 m or more)

At BH-3 (left bank), the accumulation of Holocene terrace deposits (silty to clayey sand) can be seen at depths between ground surface and GL-9.0 m. Those deposits are underlain by weathered gneiss at depths down to GL-20.0 m, and weakly weathered gneiss has been found at depths of 20.0 m or more.

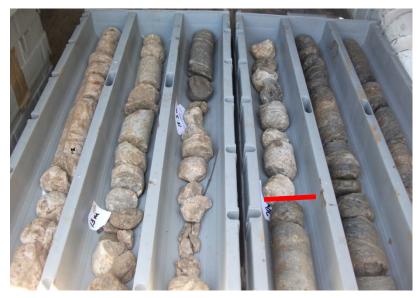
Photo 5.1-15 (BH-3) Boring core (gneiss, cracky hard rock at depths down to GL-20.0 m, hard rock at depths greater than GL-20.0 m)

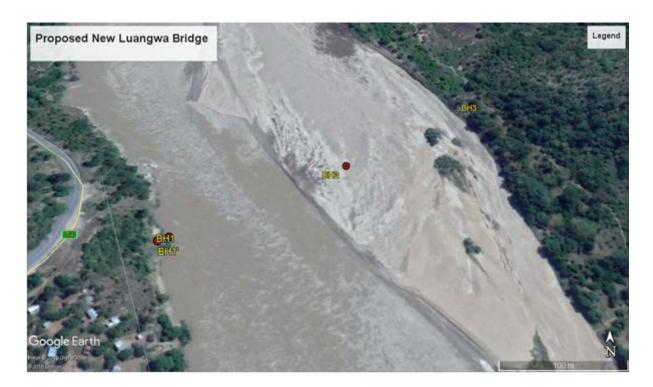
Figure DP.1-1 Boring site

The Boring survey position is shown below. Drilling of BH2 in the river was interrupted by rising water level.

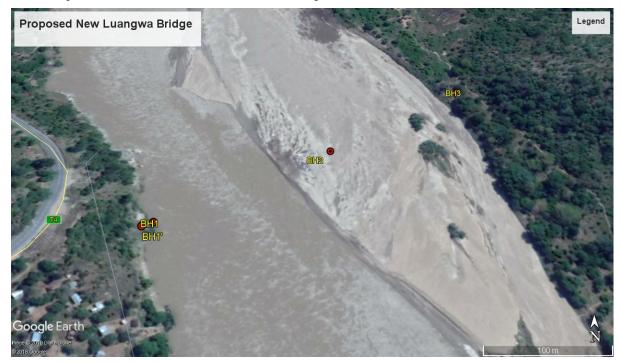
Figure 3: Four Bore Hole Point

The site is located between the Luangwa Bridge Market and the Existing Luangwa Bridge. The testing locations are all located on the Eastern Province side. From the western side the terrain drops steeply into the project site and the eastern side can be accessed by crossing the Luangwa River by way of the Luangwa Bridge and passing under the bridge. The middle point BH-2 is accessible from BH-3; it is located on drifting sand and is occasionally reclaimed by the river in the rain season. The river's level covered up BH-1 and BH-2 whilst we were on site. Fig. 1

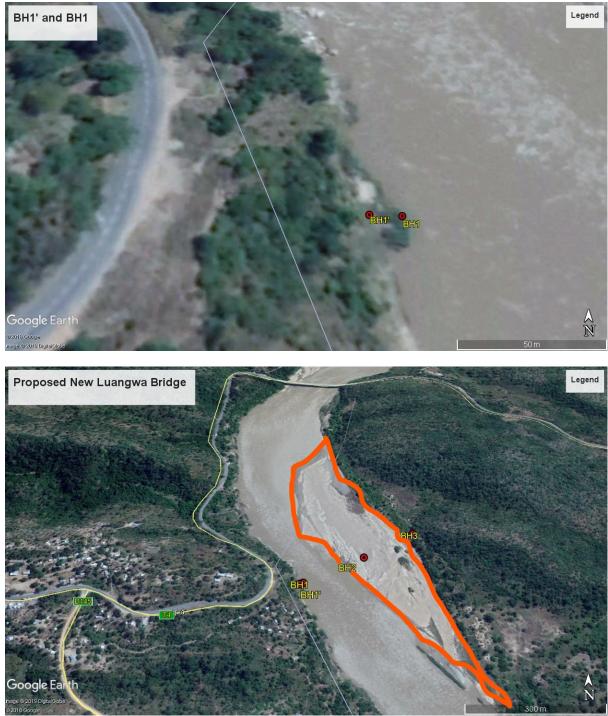
Sandbank area – this was reclaimed by the river during the site investigation works.

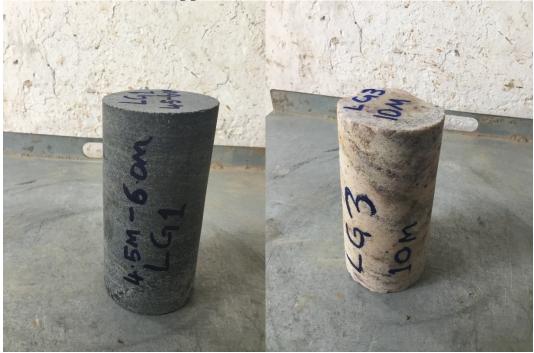
BH1' - 4.5m

BH3 - 10m

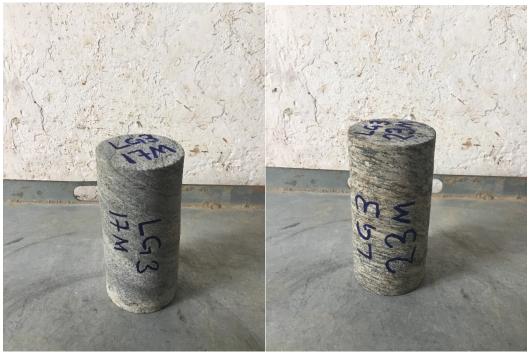
BH3 - 17m

BH3 - 23m

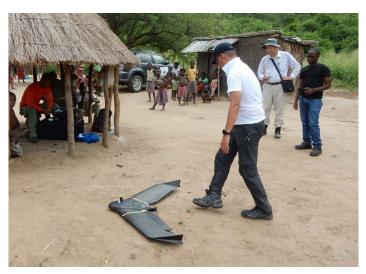
Photo EP.1-1 Fixed Wings UAV

Item	Specifications, Accuracy
Coordinate system	UTM Zone 36 South
Datum	ARC 1950 Datum
Projection	Transverse Mercator
Camera model	SODA_10.6_5472X3648 (RGB)
Average ground sampling distance (GSD)	6.99cm
Covered area	4,653 km2
Approximate flying height	212.5 m
Number of ground control points	9
Accuracy of images	Media of 78119 key points per image
Dataset	786 out of 804 images calibrated (97%)
Camera optimization	0.72% relative difference between initial and
	optimal camera parameter
Matching	Media of 4263.5 matches per calibrated image
