**The Republic of Indonesia
Directorate General of Water Resources
Ministry of Public Works**

**The Project for Capacity Development
of Mt. Semeru Volcanic Disaster
Structural Measure Planning
in The Republic of Indonesia**

**Project Completion Report
Annex (7)
Final Report**

Japan International Cooperation Agency (JICA)

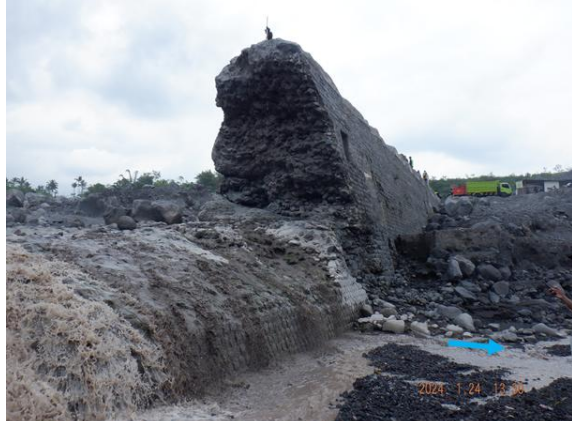
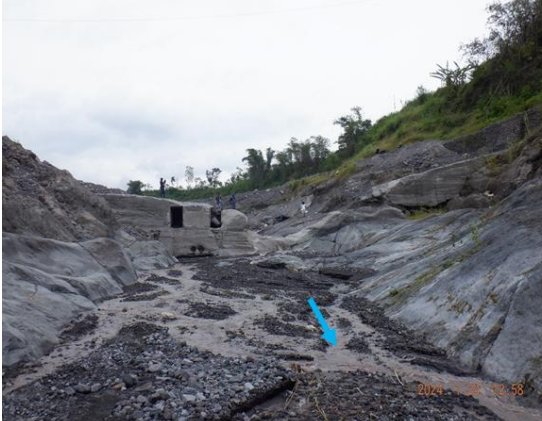
<p>Figure 3 S2-1 CD Kobokan 5 The main dam has collapsed. The structure was constructed with stone masonry.</p>	<p>Figure 4 S2-2 CD Pelintas Curah Lenkong 2 The main dam has collapsed.</p>

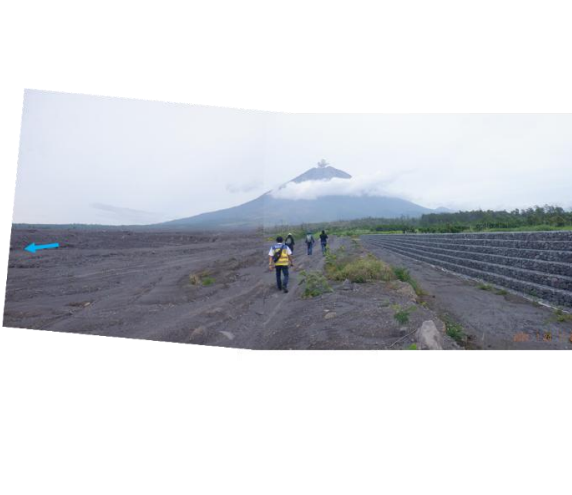
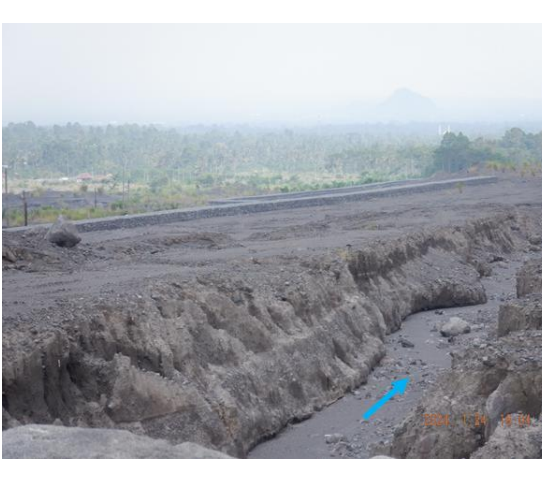
<p>Figure 5 S2-3 Tanggul Curah Lengkong A dike with gabions has been constructed as an emergency measure. A flow channel has been formed along the arrow on the left-hand side of the photo.</p>	<p>Figure 6 S4-1 Tanggul Leprak 26 An emergency dike has been constructed with gabions. The river-side sedimentation level is several meters higher than the dike crest.</p>

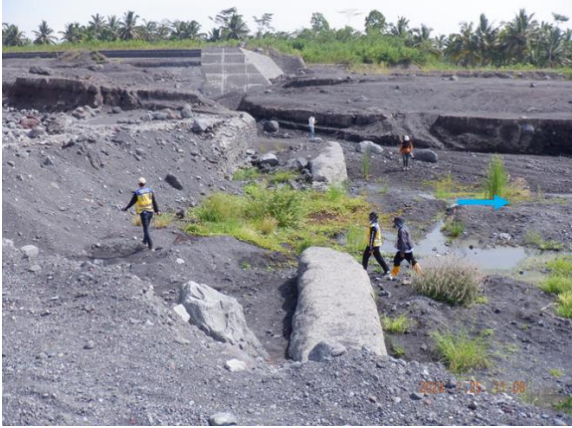
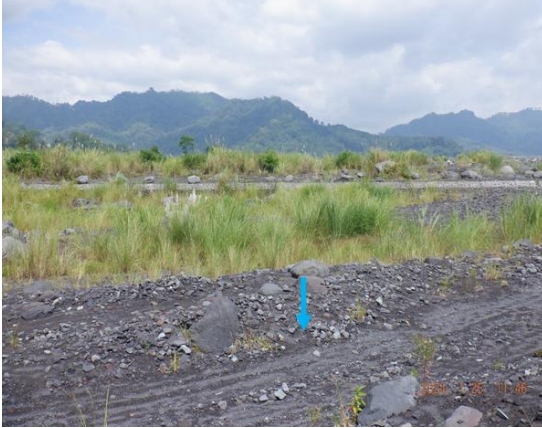
<p>Figure 7 S4-3 DD Leprak 2 Both main dam and sub-dam have collapsed.</p>	<p>Figure 8 S4-3 DD Leprak 3 The dispersion dam structure is almost completely buried, and only the crest is visible.</p>

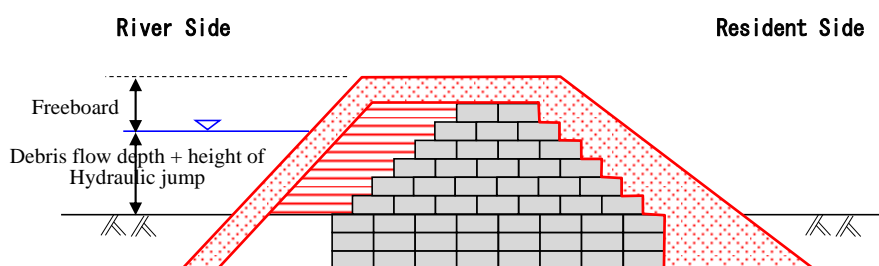
In areas where debris flow overflow is concerned, the training dikes shall be safe against overflow by ensuring a height that takes into account the hydraulic jump. A new sabo dams of open type are constructed upstream of the existing sabo dam, so that the debris flow capturing function is achieved at an early stage.

Figure -1 Basic shape of training dike

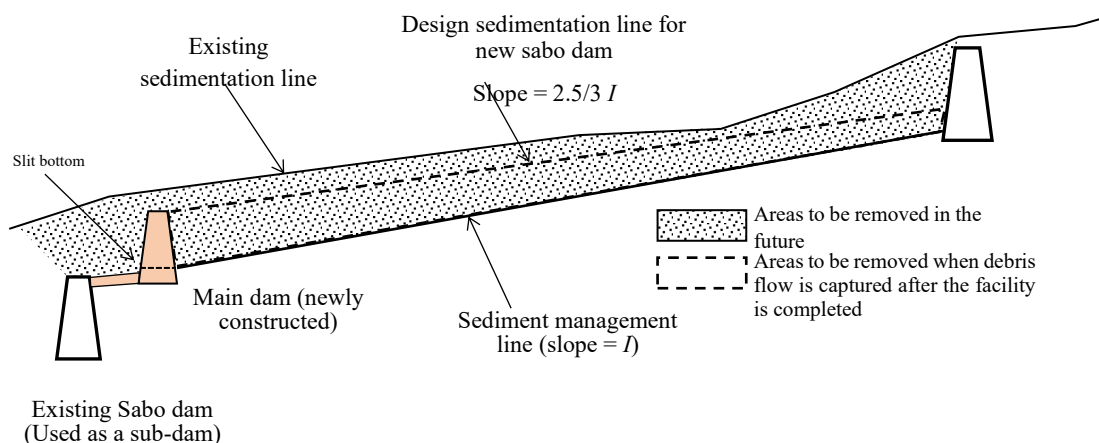
Sediment removal shall be implemented by the sediment mining companies under the control of the Ministry of Energy and Mineral Resources (ESDM), and BBWS Brantas to the extent that it does not affect the safety of sabo facility. Sediment removal shall be carried out to the sediment management line in each area. Emergency sediment removal will be carried out after pyroclastic flow deposition. To ensure efficient implementation of sediment removal, access roads to the sediment deposition area shall be secured by making effective use of existing roads.

Figure -2 Schematic diagram of the sediment management policy

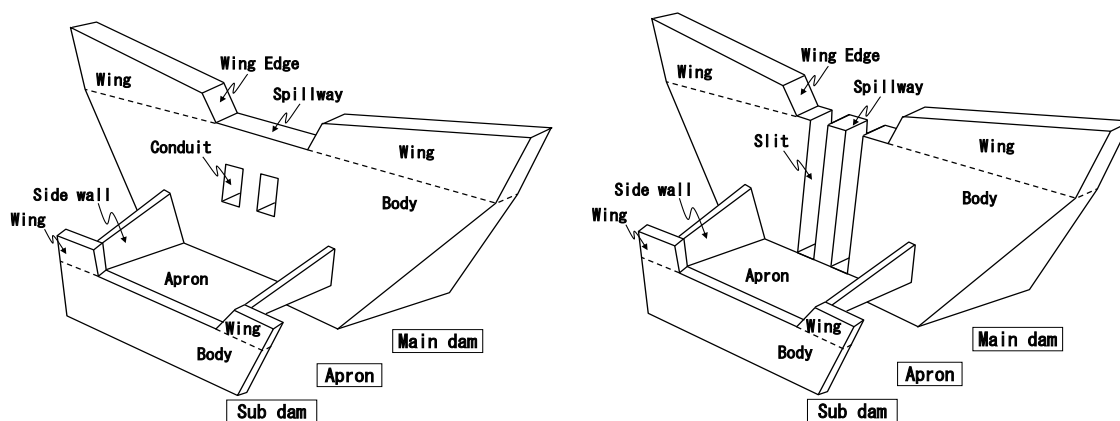
The main dams are newly constructed and of the open type (S2 area: conduit type, S4 area: slit type). The existing dams will be utilized as sub-dams. In S2 area, road function as a river crossing structures will be added to the crest of the sabo dams. The dam height shall be set such that debris flow inundation may not take place upstream.

Figure -3 Schematic diagram of open-type sabo dams (left: conduit type, right: slit type)

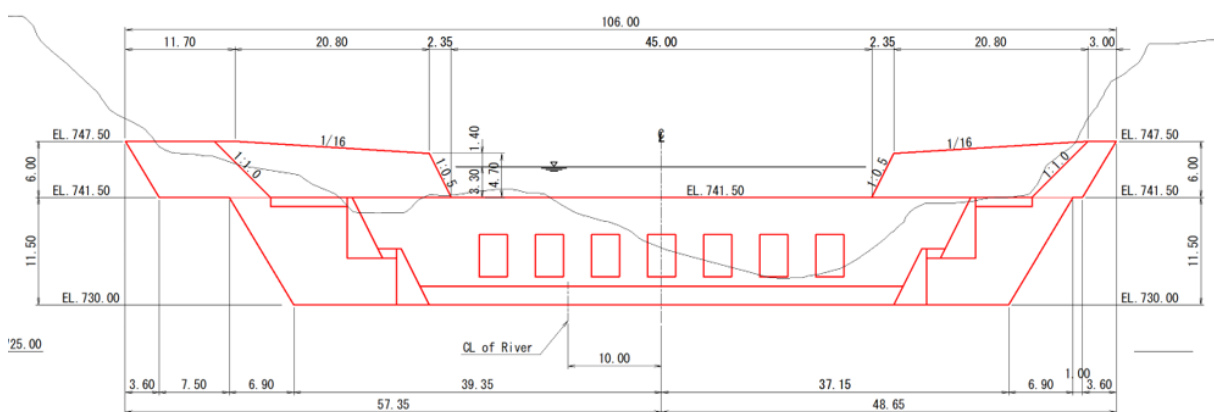
Figure -4 Drawing of sabo dam (open-type(conduit type) (Front view of CD Pelintas Curah Lengkong 2)

Construction package	Facility name	Total crest width	Downstream Slope	Upstream Slope
S2 Area	CD Kobokan5	10.0m (Road Width 6.0m)	0.2	0.2
	CD Pelintas Curah Lengkong2	10.0m ((Road Width 6.0m)	0.2	0.2
S4 Area	KD Leprak3	3.0m	0.2	0.5
	DD Leprak3	3.0m	0.2	0.4
	DD Leprak2	3.0m	0.2	0.3

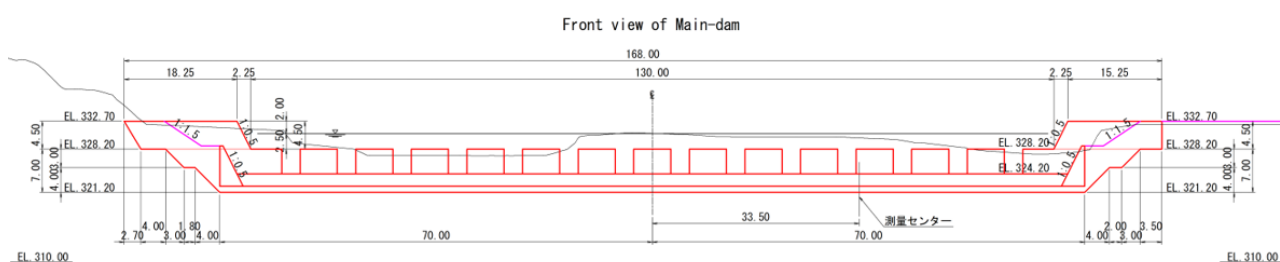
Figure -5 Drawing of sabo dam (open-type (slit type) (Front view of KD Leprak3)

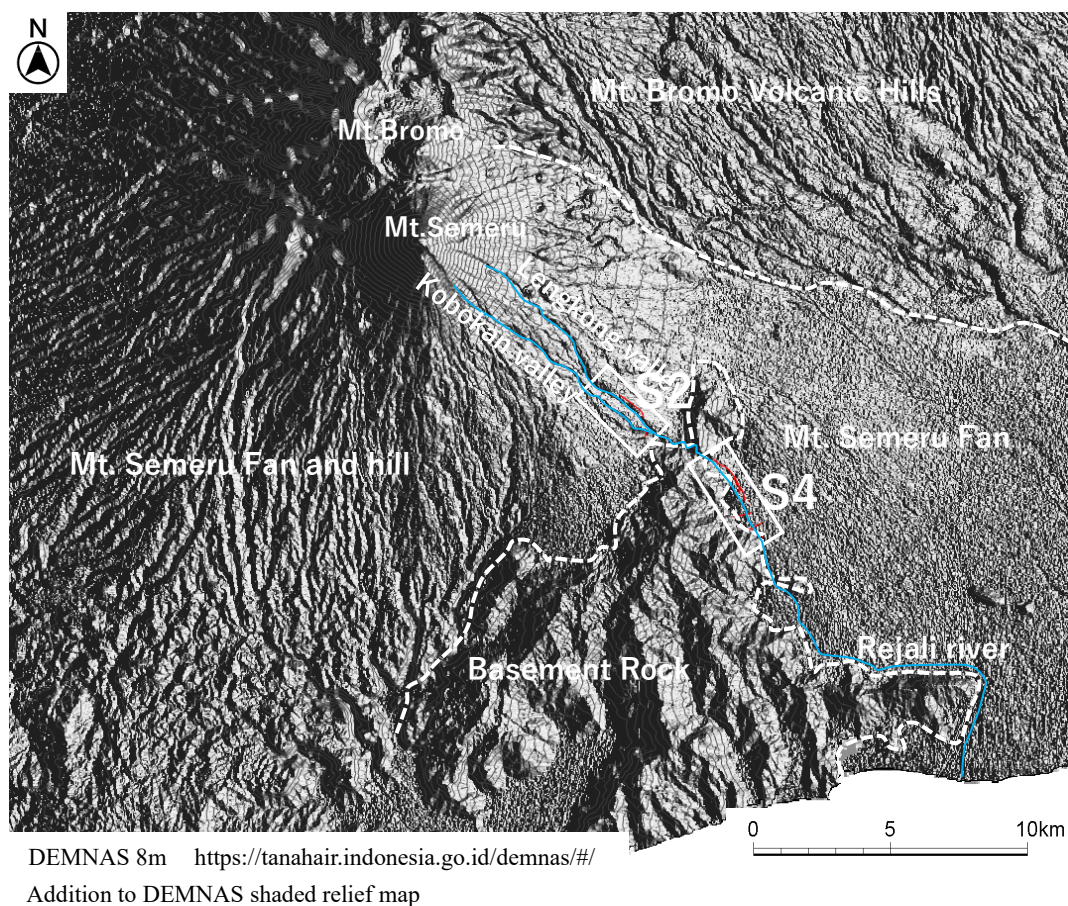
Figure 2-2 Overview of the topography of Mt. Semeru and the target river

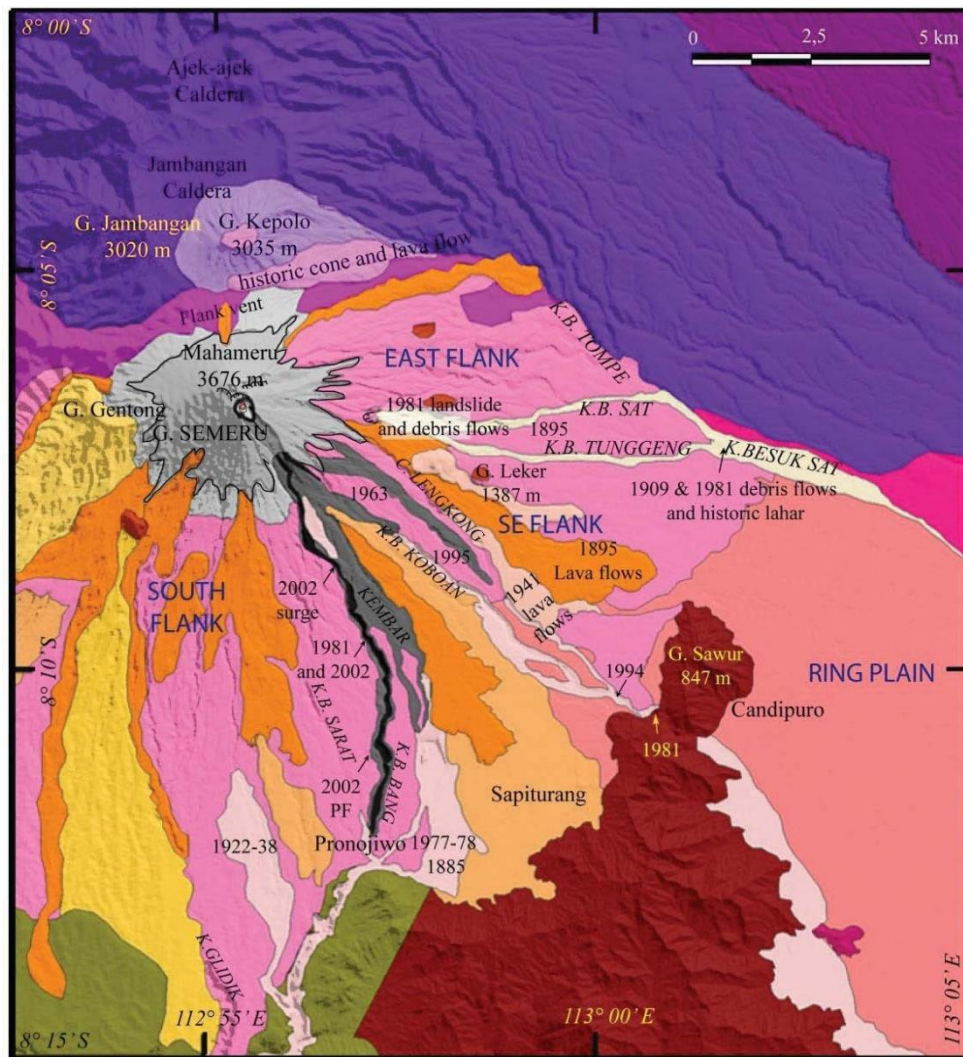
Semeru Volcanic complex

Figure 2-3 Geological map of the Semeru volcano³⁾

The geology of Mt. Semeru is composed of the Semeru volcanic complex and bedrocks (Figure 2-3)³⁾. The bedrocks consist of volcanic and sedimentary rocks from the Oligocene to the Miocene, and formed an erosion mountain range that is different from Mt. Semeru. They are distributed on the southeastern foothill slope of Mt. Semeru, more than 12 km from the summit.

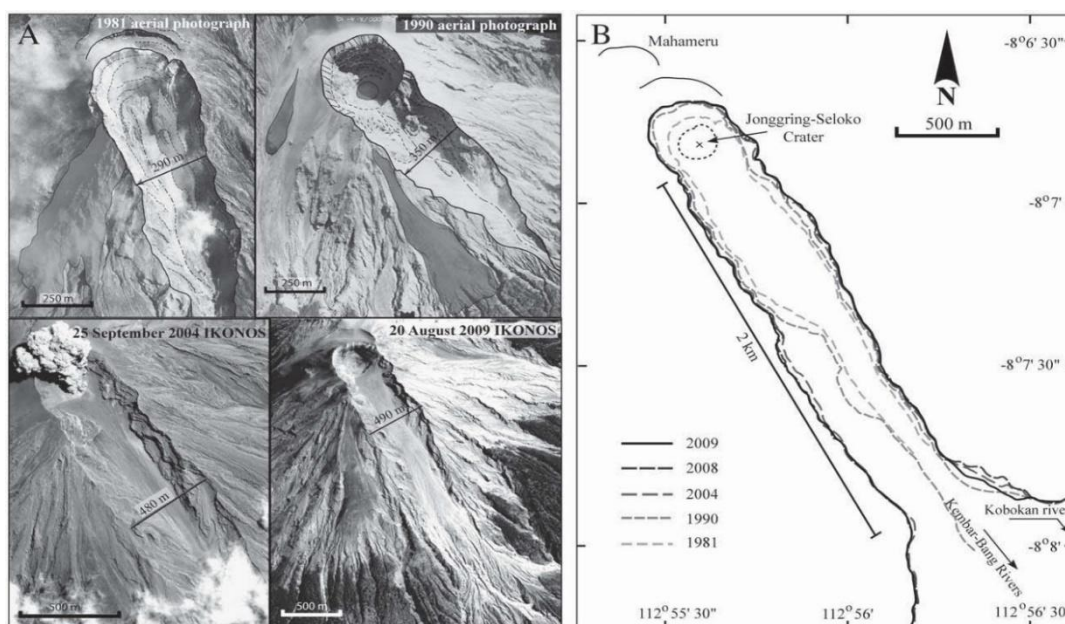
Figure 2-4 Changes in the crater (aerial photographs from 1981 and 1990, and satellite images from 2004 and 2009)³⁾

The outflow and transport routes of the crater lava that generates pyroclastic flows and lahars have been analyzed using satellite data, microtremor analysis result, etc. Since the crater of Mt. Semeru shifted from the Mahameru crater to the southeast, it has been reported that there has been a collapse of the crater, lava flows, and the expansion of erosion valleys due to the collapse of the crater wall on the southeast side (Figure 2-4)³⁾.

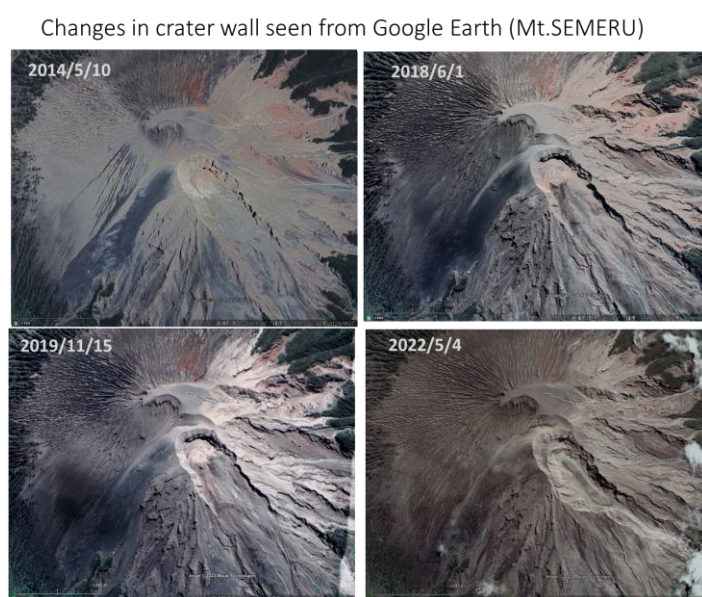
Figure 2-5 Changes in the crater since 2014 (Google Earth satellite images)

Comparing Google Earth satellite images since 2014, it can be seen that the erosion valley had been flowing down in a straight line to the south-southeast between 2019 and 2022, it changed direction to the south-east, and that the pyroclastic flow and lahars disasters since December 2021 were concentrated in the Rejali River basin (Figure 2-5).

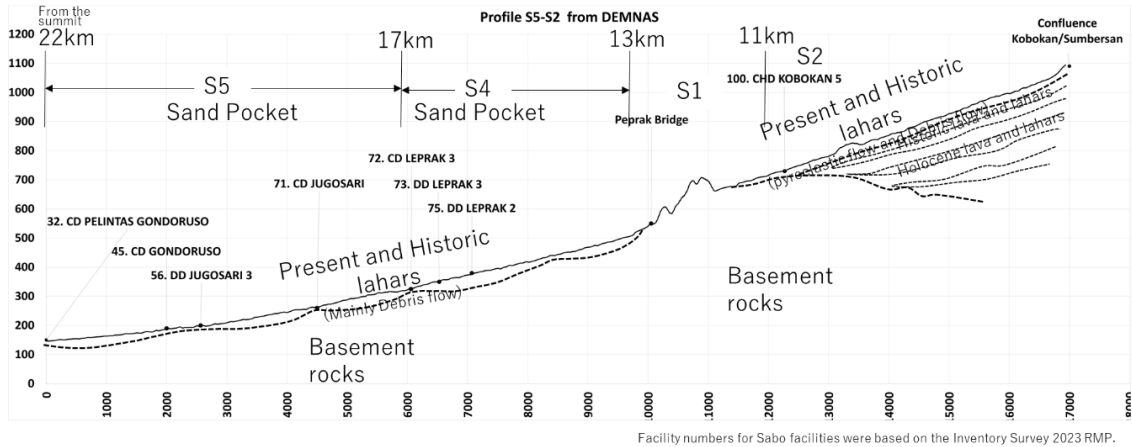
Figure 2-9 Geological longitudinal profile along the Rejali River (image)

Figure 2-9 shows a geological cross-section (image) along the Rejali River. S2, S4, and S5 are divided by the bedrock mountains, but bedrock is also distributed in shallow areas (less than 100 m) in S4 and S5, and there are several constrictions in the bedrock. The main Sabo facilities were installed in these narrow sections at around 1990.

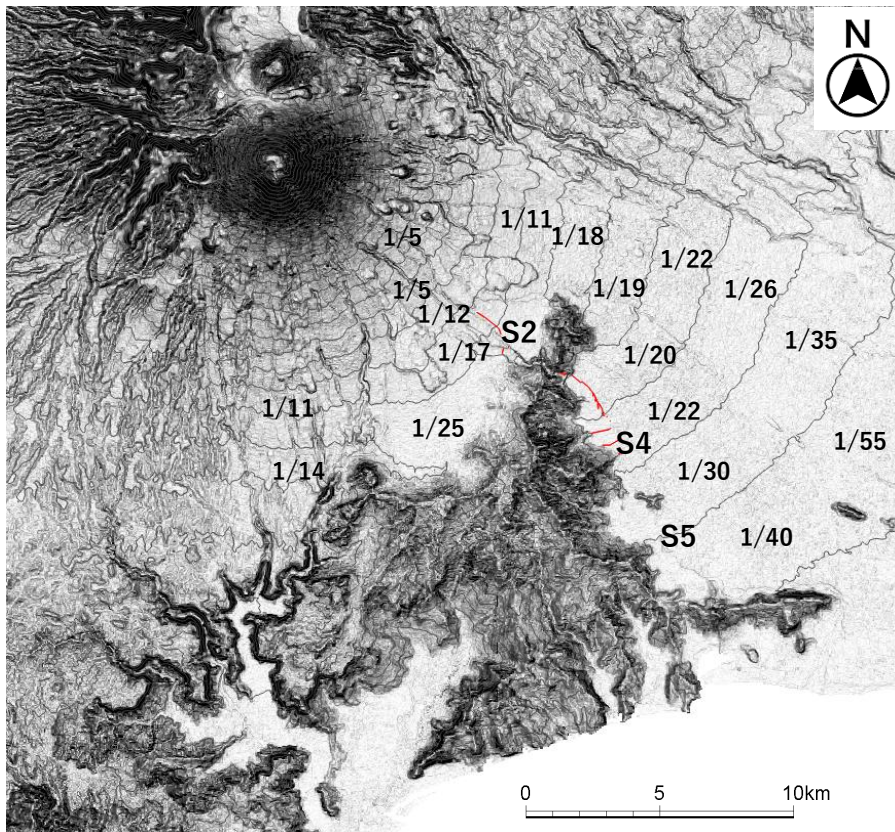
Figure 2-10 Topographic gradient of the fan of Mt. Semeru

Looking broadly at the slope gradient of the fan-shaped alluvial fan from the DEMNAS 8 m mesh topographic map, the gradient of the volcanic alluvial fan, except for the summit cone of Mt. Semeru, becomes gentler from upstream to downstream (Figure 2-10). In areas where the flow is obstructed by the bedrock mountains, the slope is locally gentler. In the geological map shown in Figure 2-3, the fan slope (upper part) is mainly made up of pyroclastic flow deposits, and the slope of the fan with a gradient of less than 1/20 is mainly made up of lahars. The slope gradient is 1/17 to 1/20 near S2 in the upstream area, 1/20 to 1/22 at S4, and 1/30 to 1/40 at S5.

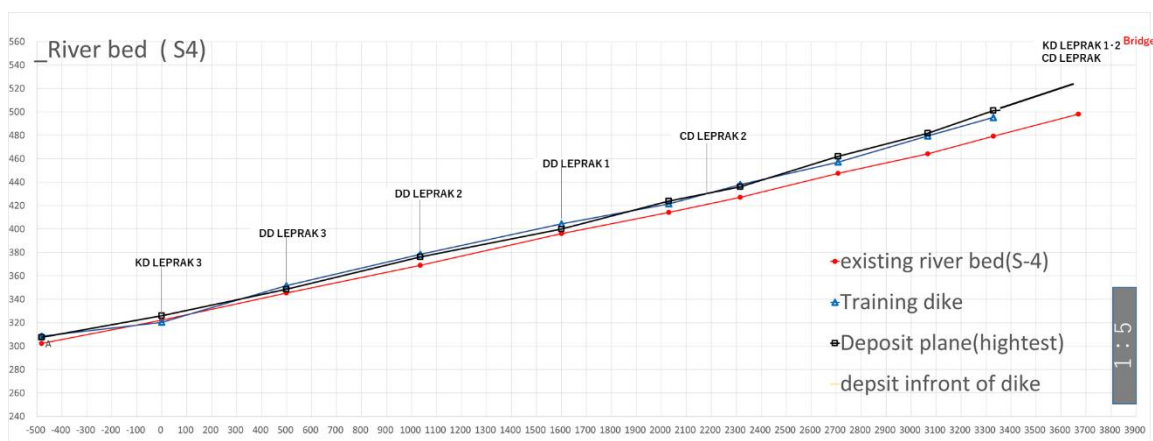
Figure 2-12 Longitudinal gradient of S4 sand pocket using LiDAR data obtained by BINTEK

Using topographic data acquired by LiDAR in October 2023, the heights of the high-level surface, the current riverbed surface, and the river side of the dike were measured for the S4 sand pocket (Figure 2-12, Figure 2-13). It has been about two years since the pyroclastic flow deposits were deposited in December 2021, but a large amount of sediment remains in the sand pocket, and erosion has begun to occur only in the stream area, which is about 100 m wide.

Looking at the difference in elevation between the high-level surface of the sediment in the sand pocket and the current riverbed, the difference in elevation is only a few meters at the downstream Sabo dam KD Leprak 3. However, at the upstream from the dispersion dam DD Leprak 1, the difference in elevation between the current riverbed and the high-level surface of the sediment and the height of the front of the training dike tends to be larger. In addition, the top of the spillway crest of the Sabo facilities located within S4 is buried at least from immediately after the pyroclastic flow occurred to October 2023. Furthermore, the facilities located upstream of S4 were buried deeper.

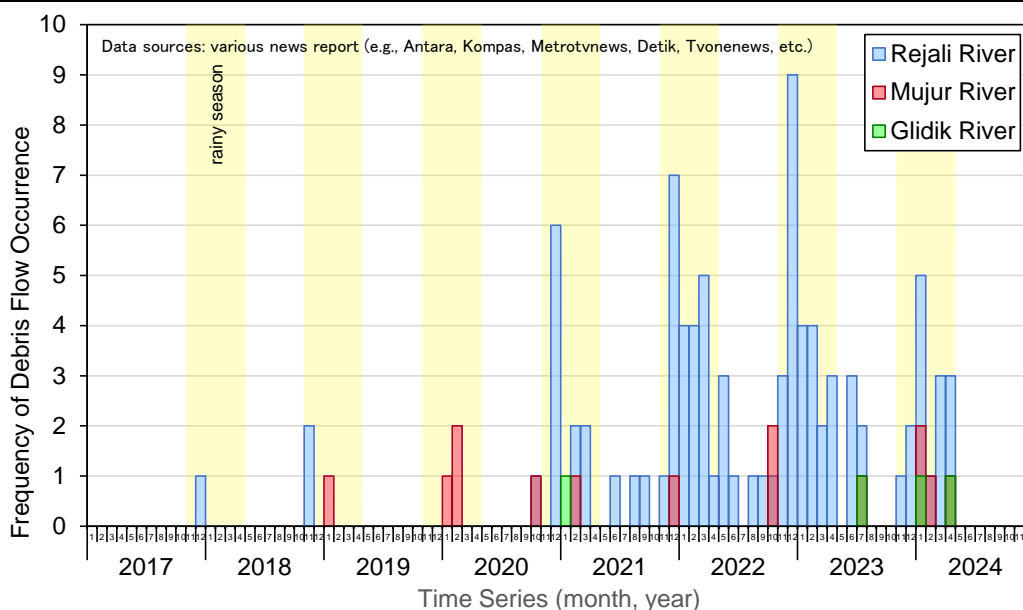
Figure 2-14 Occurrence of debris flows and volcanic mudflows

The occurrence of debris flows was collected from various media reports (Antara, Kompas, Metrotvnews, Detik, Tvonenevents, etc.) for the period of 2017-2024. There are few data before 2017, and of the 109 cases (81%) of the debris flows occurred during the rainy season (Figure 2-14, Table 2-2). Of the three rivers, the Rejali River had the most debris flows (91 times), followed by the Mujur River (14 times), and the Glidik River (4 times). The occurrence of debris flows has increased again since the December 2020 eruption, and since the December 2021 and December 2022 pyroclastic flow eruptions, debris flows have been concentrated in the Rejali River. The frequency of debris flows is very high immediately after an eruption, and then gradually decreases over time, but as of April 2024, they still occur multiple times a month.

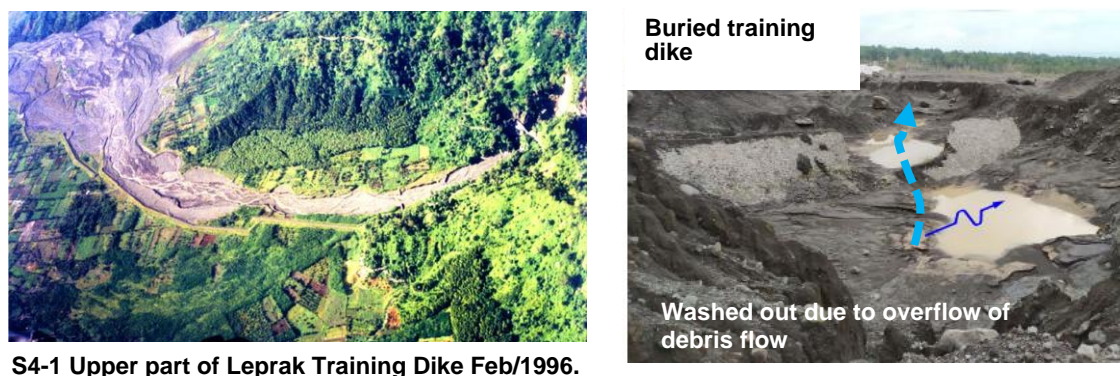
Figure 2-19 Overall view of Leprak training dike immediately after construction and dike eroded by debris flow (Dec 2021)

Figure 2-19 shows an aerial photograph (taken in 1996) of the Leprak training dike constructed in the upstream area of S4, and the condition of the training dike scouring in the section where the debris flow flooded the dike in December 2021. The Leprak training dike at S4 was constructed as a raised dike on the left bank alluvial fan when it was built in 1990. At that time, the riverbed was 20 m below the alluvial fan. The 2 km section north of the S4 training dike was once filled by pyroclastic flow in December 2021. The debris flow that occurred a few hours later changed course to the east after passing the Gladak Perak Bridge, where the pyroclastic flow had filled the valley and formed a hill. The debris flow crossed the northern end of the S4-1 dike, which had been buried by pyroclastic flow, and flowed down while scouring the dike (Figure 2-19, right). Since then, emergency work has been carried out to divert the river and excavate the accumulated pyroclastic flow, and the river has been restored to its original course (S4).

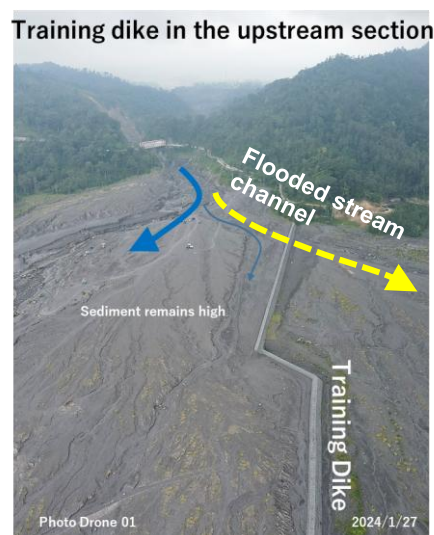
Figure 2-20 Leprak bird's view of the dike (northern half, Jan 2024)

Approximately two years after the debris flow, a temporary gabion dike was built on the existing dike location as an emergency response. The river, which had been flooded, had eroded downwards and was flowing 10 to 20 meters below the dike (Figure 2-20).

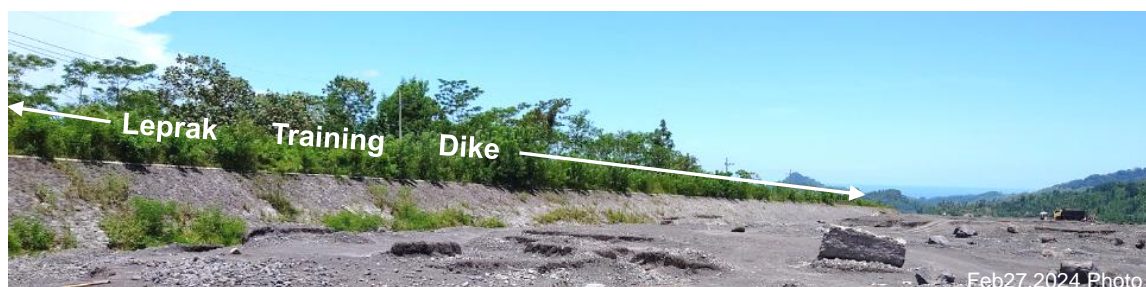
Figure 2-21 Photo of the LEPRAK training dike (southern half, Feb/2024)

Figure 2-21 shows a bird's eye view of the southern half of the Leprak training dike. The base of the dike has been buried due to the 1-2 m rise of the sedimentation surface, but a 3 m margin of height at the top remains. Near the suspension bridge at the lowest point, a section of the dike was raised using a gabion after a portion of the dike was washed away by a debris flow in July 2023. Although some parts of the river side of the training dike have been damaged by scouring, most sections show no signs of deformation or damage.

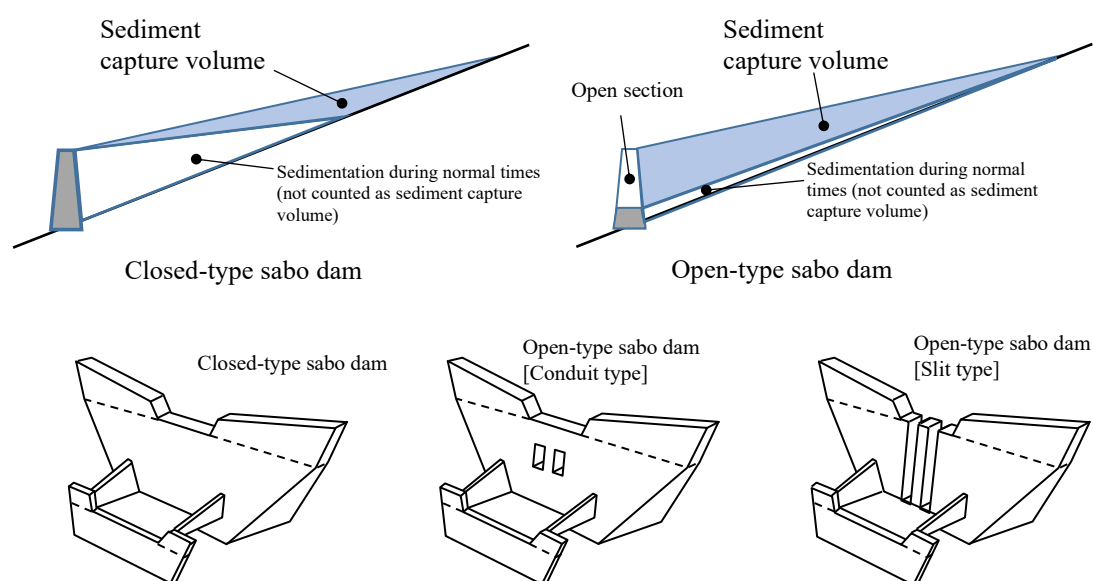
Figure 3-3 Closed-type/open-type sabo dam effects and conceptual diagrams of closed-type/open-type (conduit type/slit type) sabo dams

Sabo dams and dispersion dams will be open-type (conduit type, slit type) to maintain the capacity of the dam during normal times when debris flows do not occur (Figure 3-3). As a general rule, the existing closed-type sabo dams, groundsills, and dispersion dams will be changed to open-type sabo dams (conduit type, slit type if road functions are not added) that have a large sediment capture capacity (design sediment capture volume). The open-type dam to be adopted shall not be a backwater type, but a blockage type. In addition, since it is necessary to keep the water level higher than the upper end of the spillway, the sabo facility with a water intake system shall not be converted to an open-type type.

For sabo dams with wide openings in their body used as bridges, it is necessary to narrow the opening width when the dams are converted to conduit type. This reduces the amount of sediment released through the opening, resulting in a large amount of sediment accumulating upstream. Therefore, to avoid flooding from the upstream training dike, the dams will not be converted to conduit type sabo dams unless the riverbank heights on both banks are more than 10 m higher than the top height of the dam's overflow section.

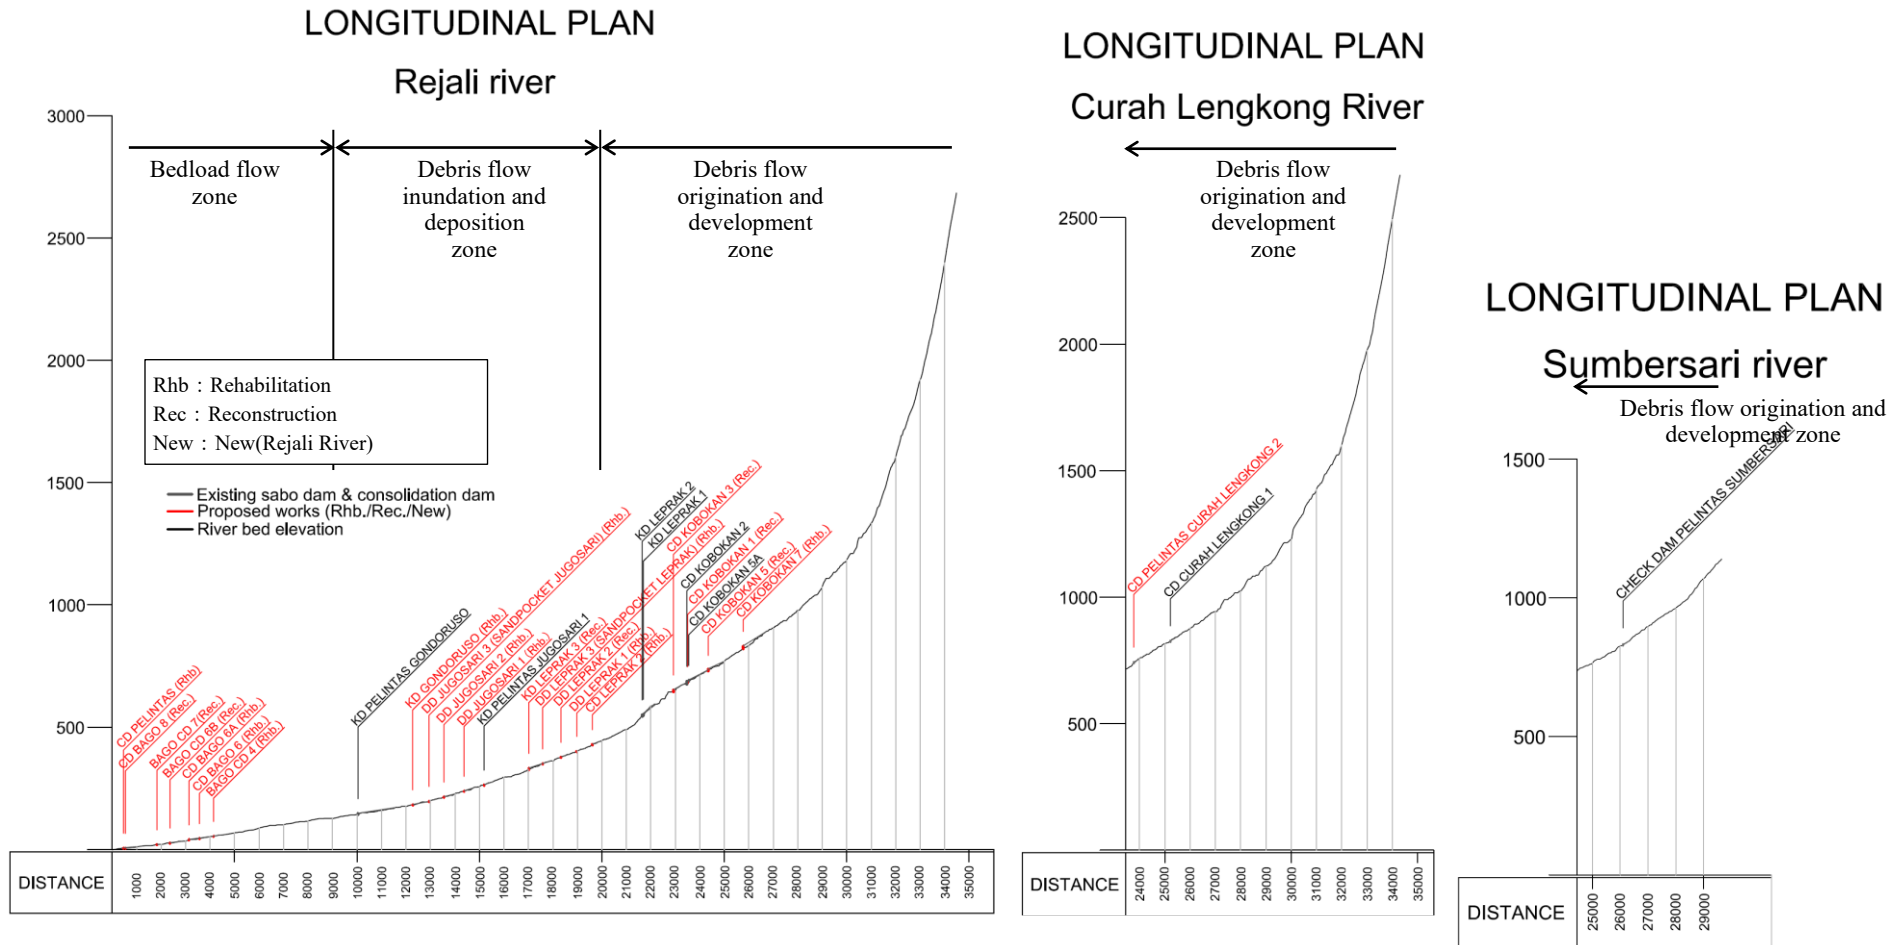
Figure 3-5 Longitudinal profile with sabo facilities (Rejali river)

The longitudinal map of the proposed sediment control facility is shown in Figure 3-5.

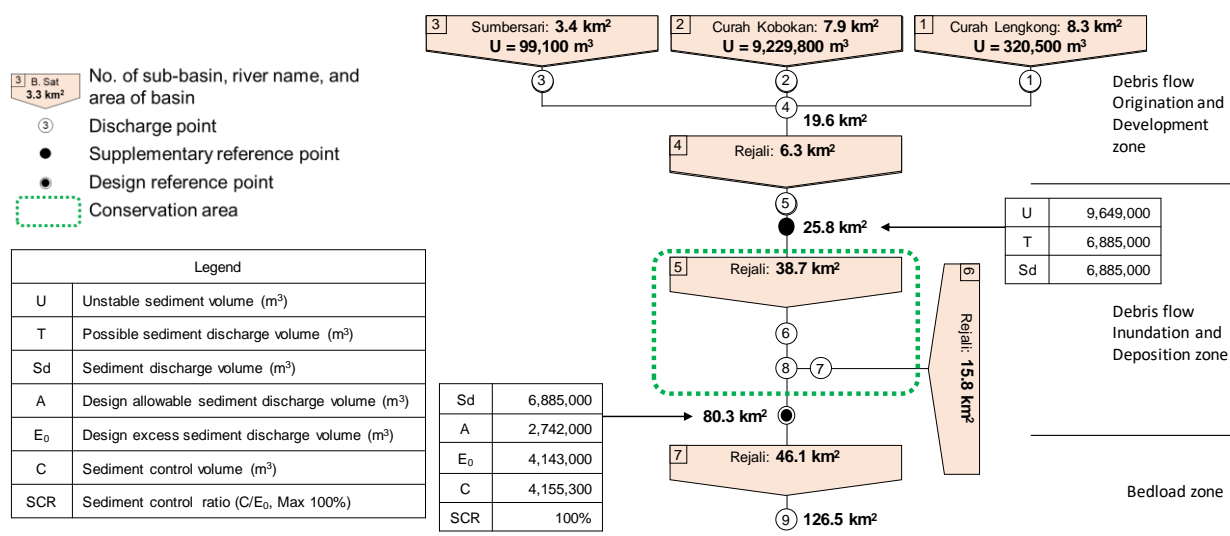
Figure 3-6 Sediment balance diagram after completion of the sabo facility in the review master plan (2024)

Table 3-13 shows the effects of sediment maintenance by sabo facilities in the Review Master Plan (2024). The sediment balance map of the Rejali River is shown in Figure 3-6.

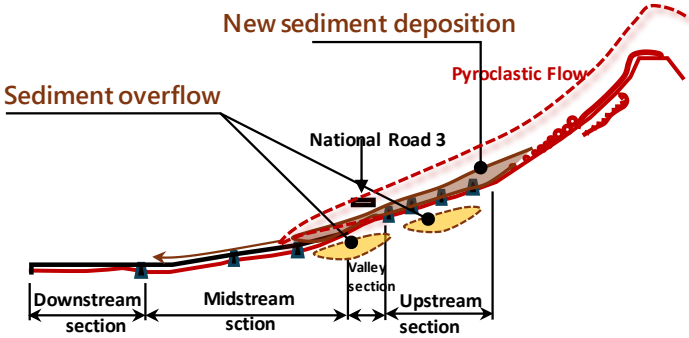
Overview Diagram	Comment
<p>Phase 1: December 2021 Eruption</p>

<ul style="list-style-type: none"> • The pyroclastic flow generated during the eruption flowed down to the upper part of the midstream. A large amount of sediment was deposited in the river channels in the upper and middle reaches of the river. • Subsequent debris flows, following the deposition of pyroclastic materials, flowed through the upstream and midstream regions. Due to the significant accumulation of sediment in the river channels, these debris flows caused flooding in both the upstream and midstream areas.
<p>Phase 2: Rainfall after the eruption in August 2022</p>

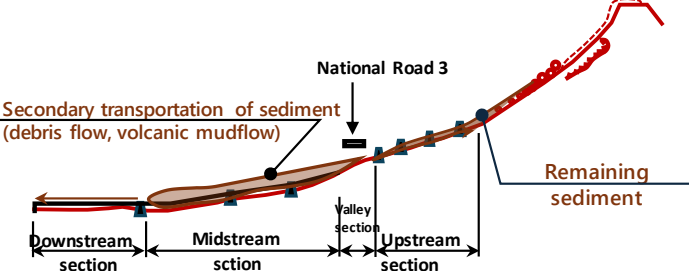
<ul style="list-style-type: none"> • Sediment accumulated in the upper reaches of the river was eroded by rainfall and moved to the middle reaches of the river as debris flows. Some remained intact in the upper reaches.
<p>Phase 3: December 2022 When the volcano erupts again</p>

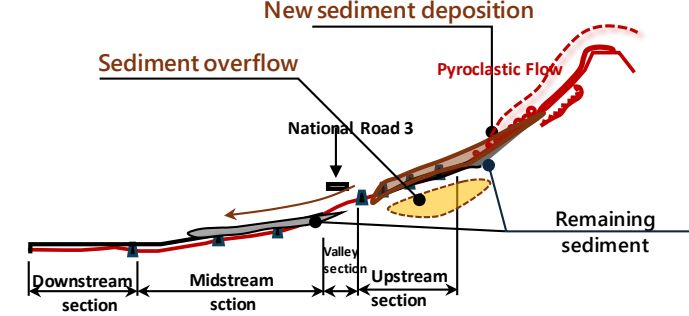
<ul style="list-style-type: none"> • Pyroclastic flows from the eruption reached and deposited near the uppermost part of the upstream region. • Debris flows occurring after the pyroclastic flows flowed into the upstream region. Since sediment remained in the river channels, these debris flows caused flooding in the upstream area.

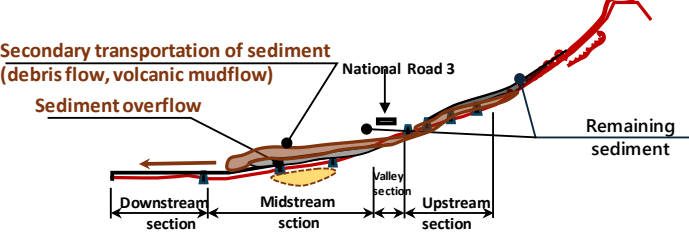
<p>Phase 4: Rainfall in March 2024</p>

<ul style="list-style-type: none"> • Sediment that had accumulated in the upstream region was eroded by rainfall and transported downstream as debris flows, depositing in the midstream region. Some sediment remained in the upstream area. • In the midstream region, sediment remained in the river channels, which caused partial flooding of debris flows as it traveled through the midstream area.

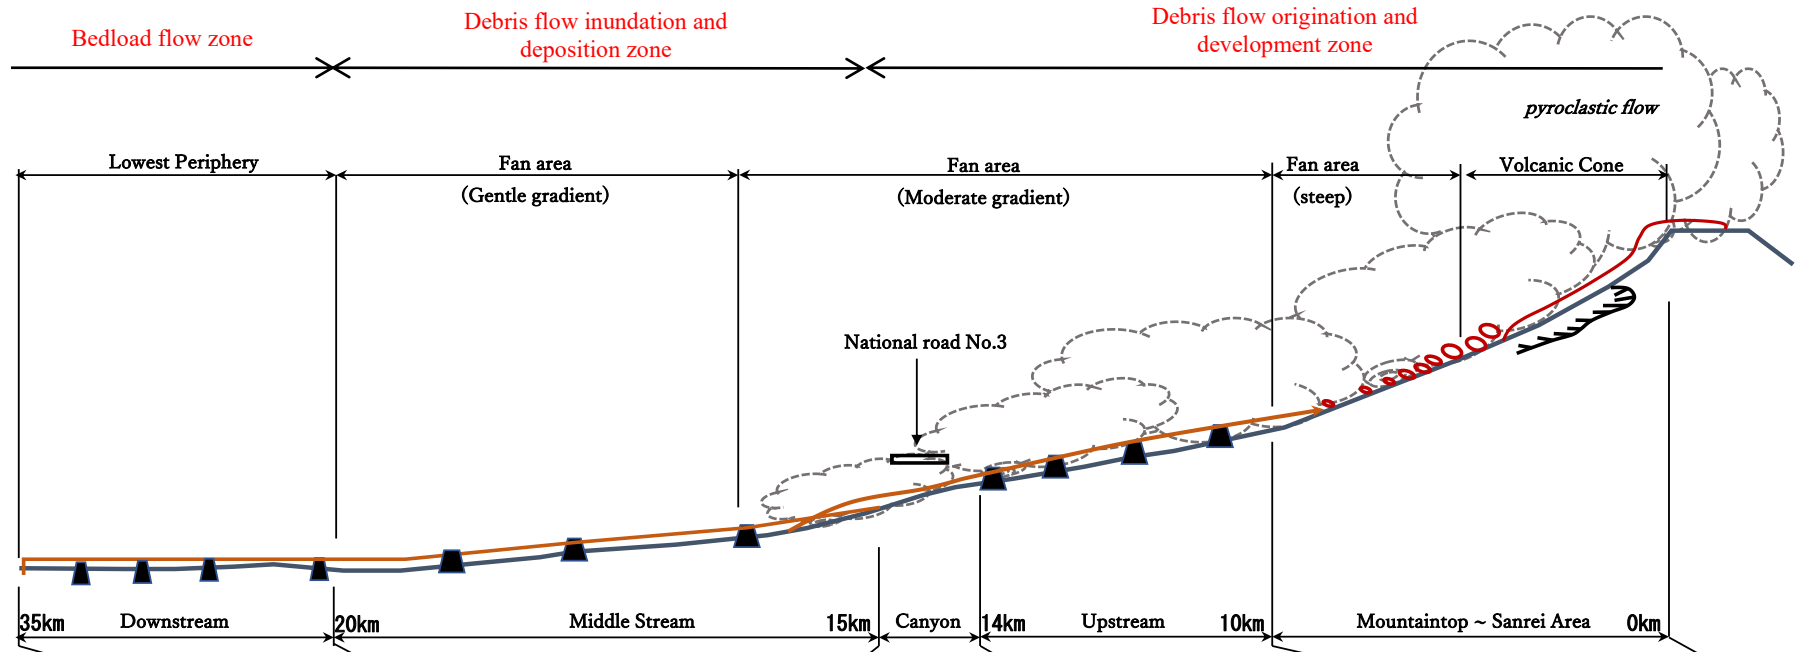
Figure 3-7 Current status of sediment movement in Rejali river

The sediment movement in the Rejali River can be categorized into five sections: downstream, midstream, gorge/canyon, upstream, and summit-to-foothill. For each section, factors such as channel gradient, sediment transport characteristics, bed variation, flow characteristics, existing facilities, and sabo function evaluations have been assessed. The current state of sediment movement in the Rejali River is shown in Figure 3-7.

Downstream	Middle Stream	Canyon (Meandering section)	Upstream	Mountaintop ~ Foothill Area
Riverbed gradient	~1%	1%~5%	25%~35%	5%~25%	25%~
Sediment movement morphology	Sediments	Sediments, debris flows, volcanic mudflows	Pyroclastic flows, debris flows, volcanic mudflows	Pyroclastic flows, debris flows, volcanic mudflows	[Sediment Source] Pyroclastic Flow
Amount of riverbed variability	1m ~ 2m	2m ~ 5m	Up to 15 m or more	10m	-
Features of the flow	Meandering in a river	Drift in sand pocket There is a history of sediment flooding.	Severe disturbances due to meandering and falling	Drift, confluence, and diversion in rivers There is a history of sediment flooding.	Gully erosion develops
Condition of Existing Facilities	Damage and Corruption	Damage (including wear), collapse spillage, Buried	Damage (including wear), collapse spillage, Buried	Damage (including wear), collapse, spillage, burial	-

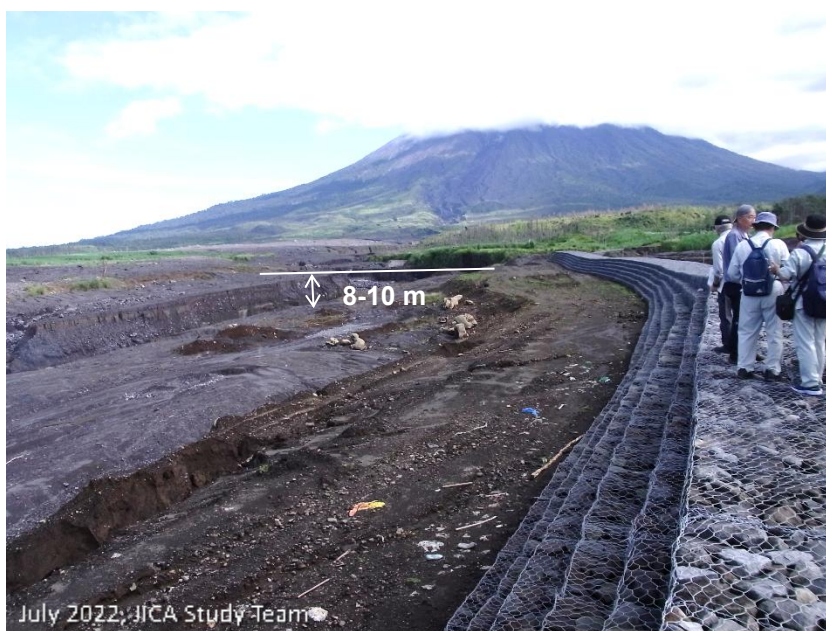
Figure 3-9 River channel erosion status in Curah Kobokan (photographed in July 2022)

The P point in the upper left figure is the position where the upper right figure was taken, and this figure is a photograph showing the P point, which is the shooting position.

- 4) In the narrow section of the river channel about 15 km from the summit, thick sediment carried by pyroclastic flows and debris flows was deposited (Figure 3-9). After that, the riverbed fluctuated greatly due to frequent debris flows, lowering the riverbed by 10 to 15 m (Figure 3-10).

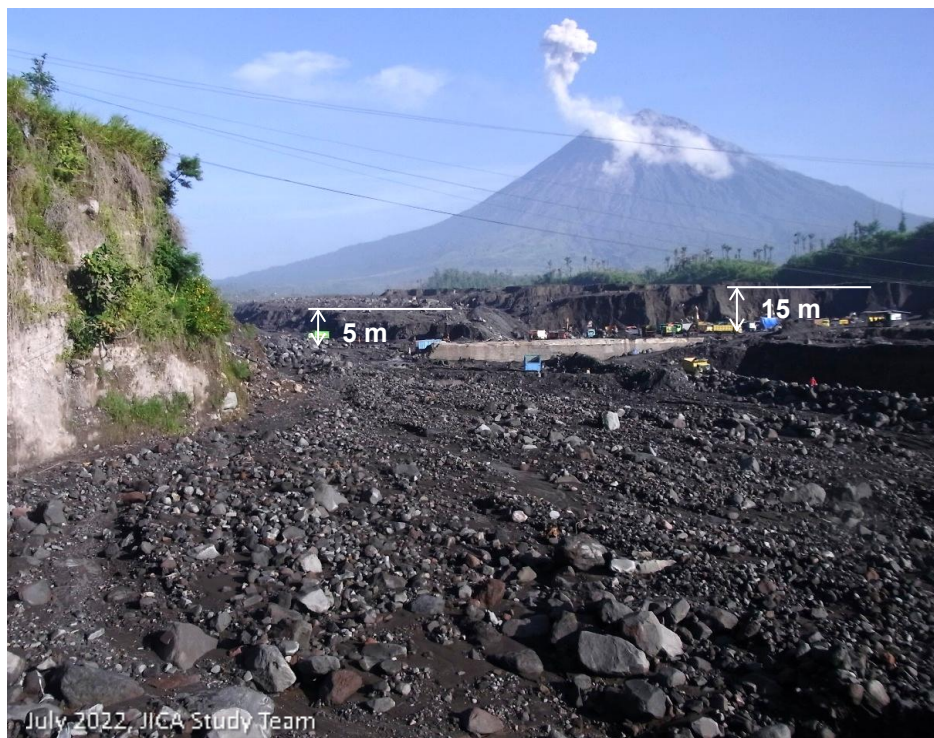
Figure 3-11 Riverbed condition in Curah Lengkong (photographed in July 2022)

The P point in the upper left figure is the position where the upper right figure was taken, and this figure is a photograph showing the P point, which is the shooting position.

- 5) In the section between the narrow part of the river channel and the 17 km point from the summit, sediment flooded the left bank (Figure 3-11). After that, the riverbed fluctuated due to frequent debris flows, and it dropped the riverbed by about 5 m (Figure 3-12).

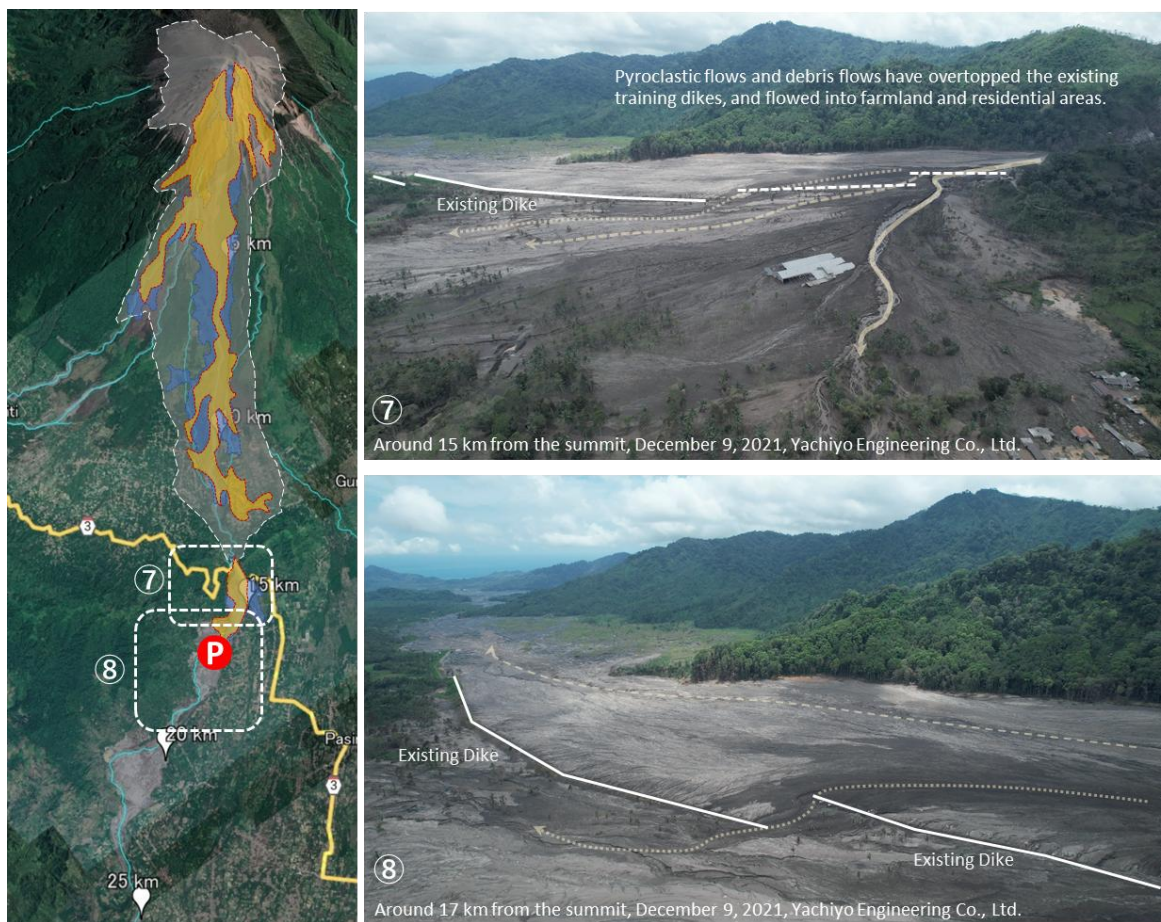
Figure 3-14 Distribution of pyroclastic flow deposits in the upper section of S4 (photographed in December 2021)

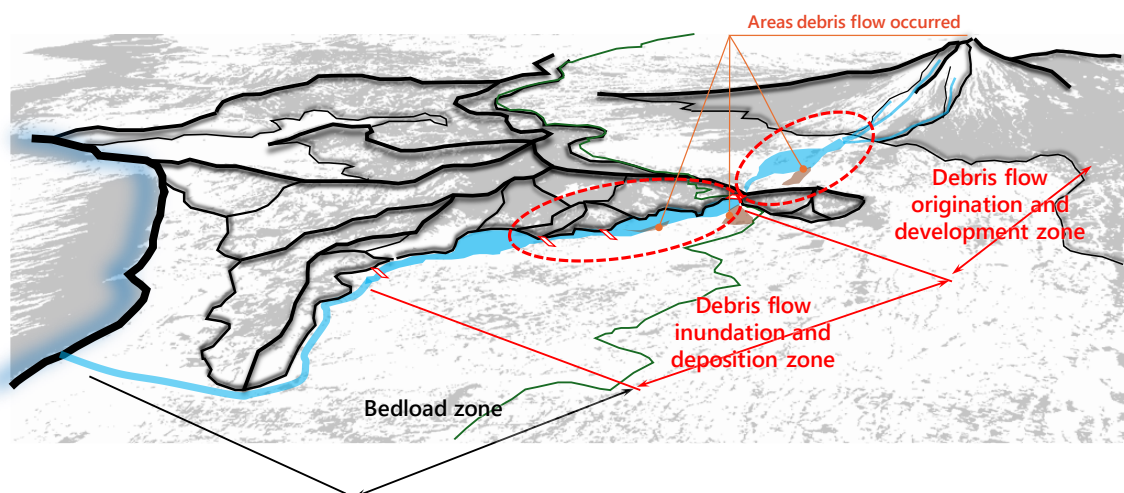
Figure 3-17 Sediment movement and priority development areas in the Rejali river

Due to the history of pyroclastic flows depositing large volumes of sediment in the river channels and the occurrence of debris flow flooding, the most recent issue is to control sediment inundation in the debris flow origination and development zone and in the debris flow inundation and deposition zone. In the immediate aftermath of the 2011 eruption, debris flows flooded these two sections, causing damage to residential areas. For this reason, in this study, it was decided to prioritize the development of measures in these two zones.
