**The Republic of Indonesia
Directorate General of Water Resources
Ministry of Public Works**

**The Project for Capacity Development
of Mt. Semeru Volcanic Disaster
Structural Measure Planning
in The Republic of Indonesia**

**Project Completion Report
Annex (7)
Final Report**

Japan International Cooperation Agency (JICA)

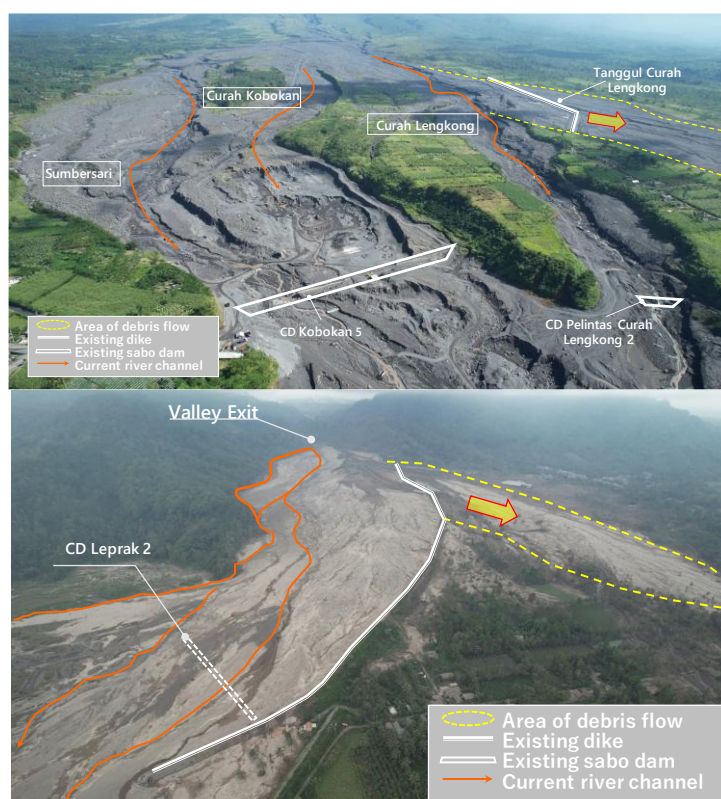
Figure 3-18 Sediment disaster status in S2 and S4 (above: S2 area, bottom: S4 area)

These two priority zones are encompassed by Construction Packages S1 to S4. Among these packages, debris flow flooded the S2 and S4 in 2021 and 2022. Given the high potential for significant pyroclastic flow deposition during future eruptions, S2 and S4 have been selected as priority areas for development.

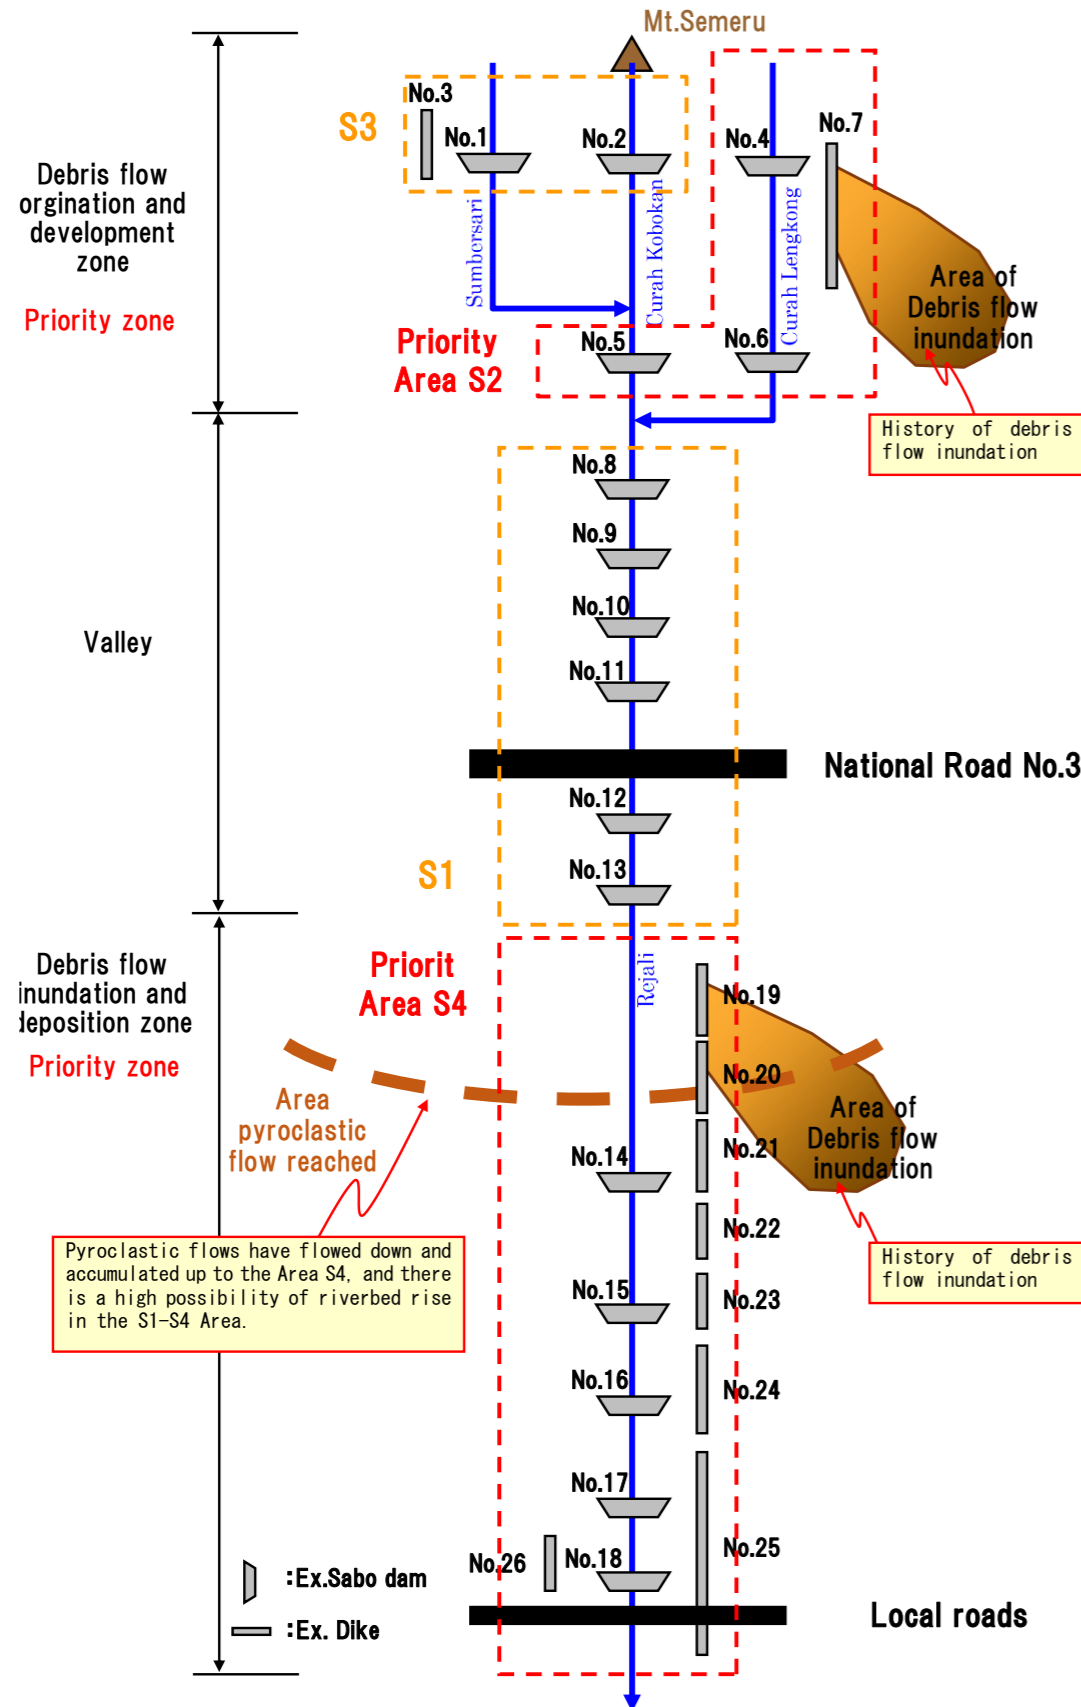
Figure 3-19 Rejali river construction package S1~S4 outline diagram

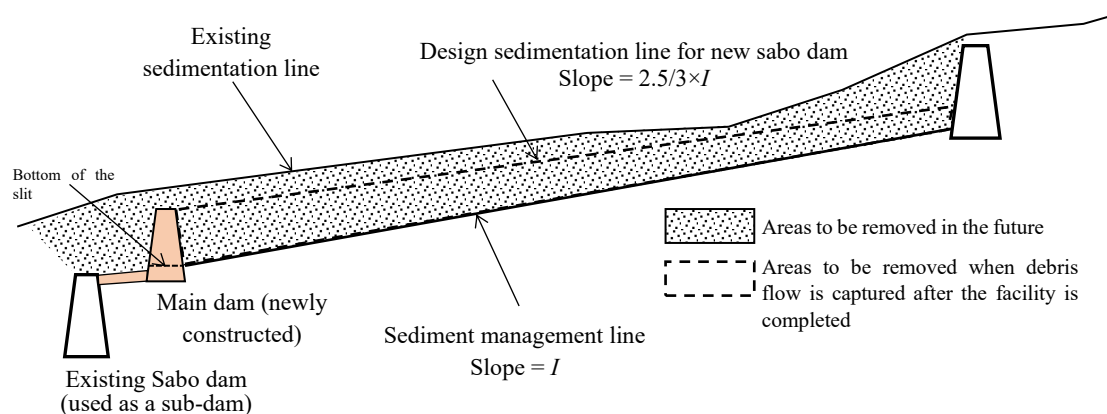
Figure 3-20 Schematic diagram of the sediment management policy

In the river channels in the S2 and S4 areas, unstable sediment has been deposited due to frequent eruptions. The Review Master Plan (2024) stipulates that the interval between major eruptions with pyroclastic flows are five years, and the basic policy for facility development based on the premise of sediment management is being considered. For the S2 and S4 areas, sediment management lines described in (1) Sediment excavation will be carried out up to these lines. Following facility development, sediment captured by the sabo dam will be regularly removed up to the sediment management lines.

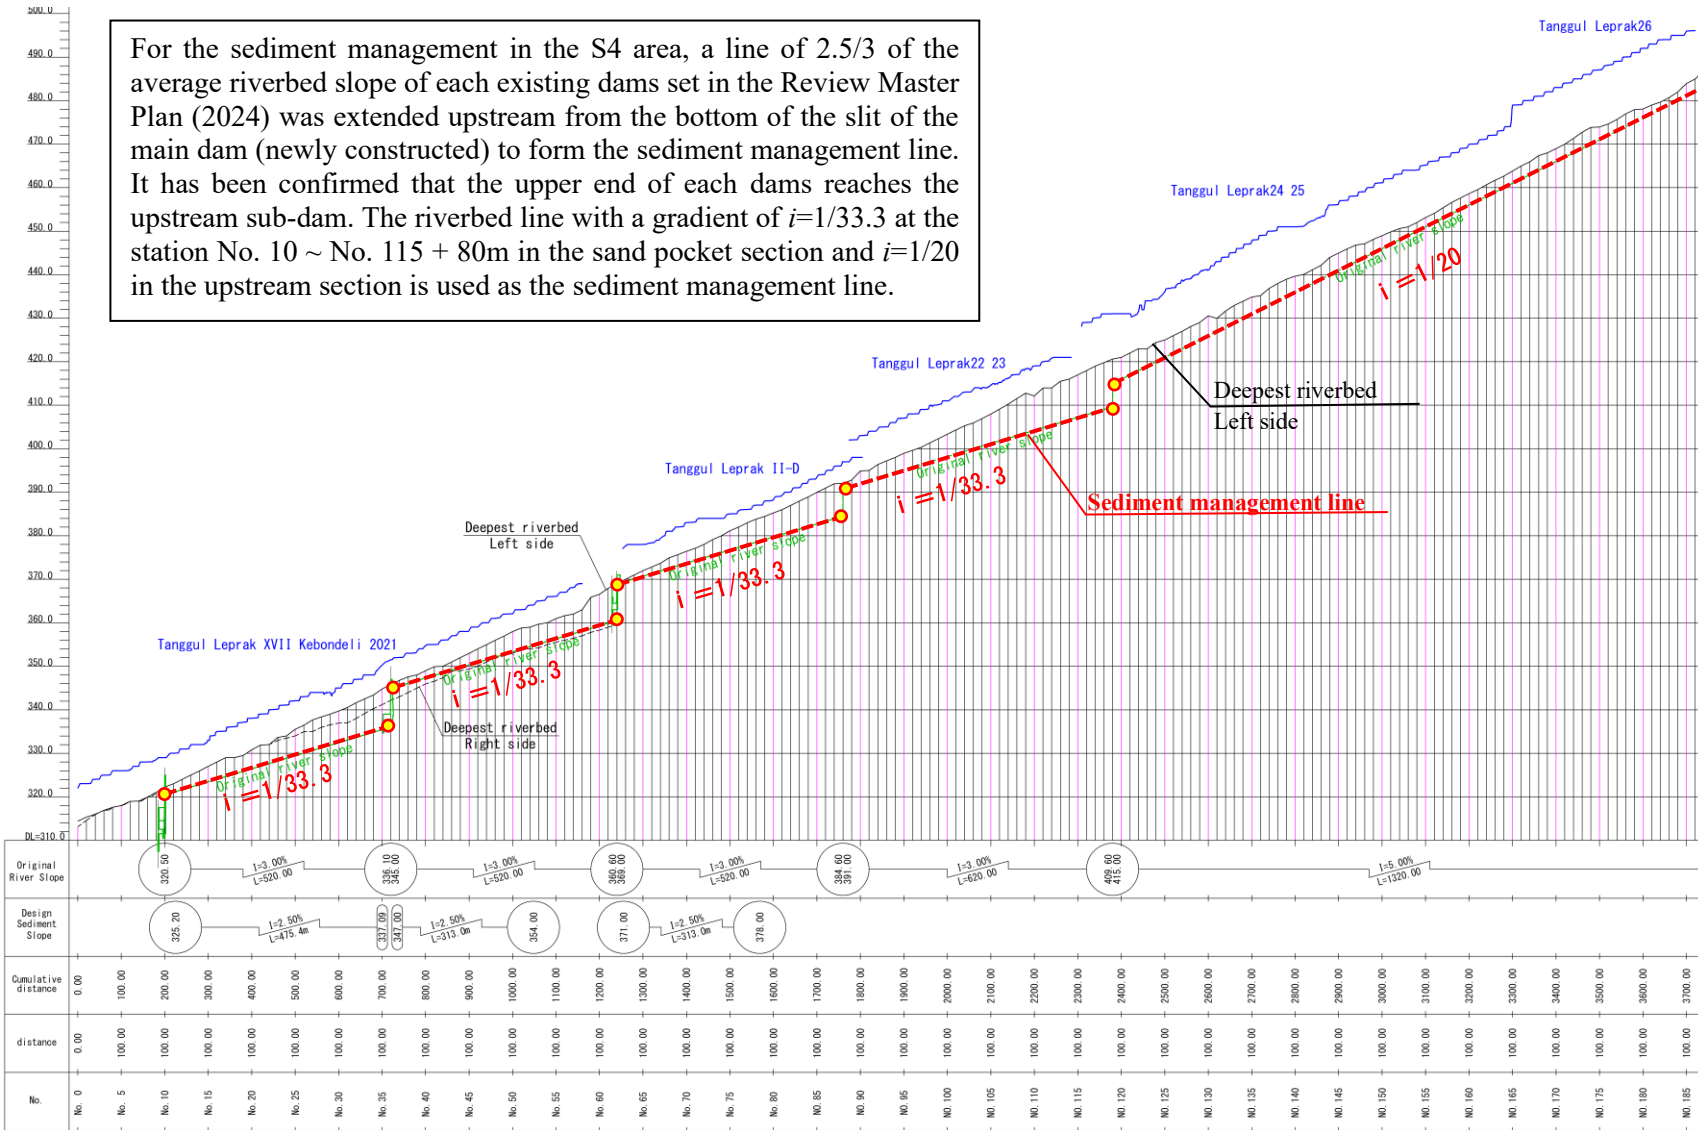
Figure 3-23 Rejali river (S4 area) sediment management line

For the sediment management policy in the S4 area, the riverbed line of $2.5/3$ of the average riverbed gradient of each of the existing dams set in the Review Master Plan (2024) is extended upstream from the bottom of the slit of the main dams (newly constructed) to form a sediment management line. It has been confirmed that the upper end of the line from each main dam reaches the sub-dam upstream. In Figure 3-23, the riverbed line with a gradient of $i=1/33.3$ at station No.10 ~ No.115 + 80m in the sand pocket section and $i=1/20$ in the upstream section is used as the sediment management line.

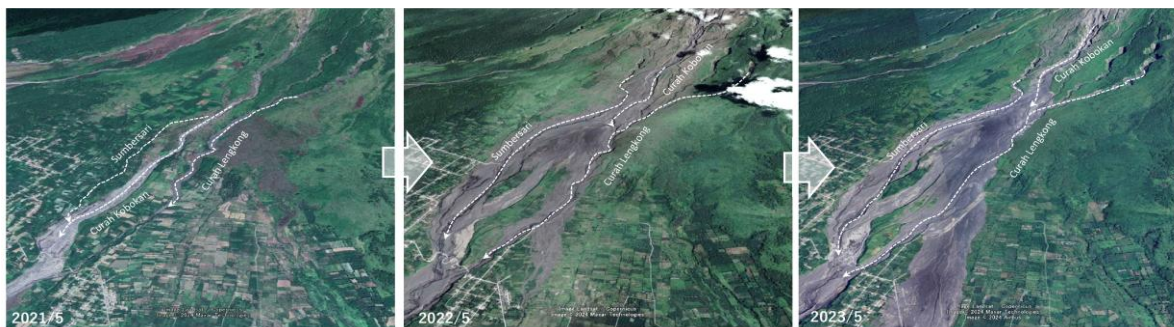
Figure 3-26 Situation in the upstream area

The upstream conditions were evaluated in May 2021 (before the eruption), May 2022 (after the 2021 eruption), and May 2023 (after the 2022 eruption). In Curah Kobokan River, where pyroclastic flows mainly flow, pyroclastic flows and frequent debris flows buried the river channel, causing debris flows to flow into Curah Lengkong River and Summersari River, raising its riverbeds, and resulting in debris flow inundation and damage along Curah Lengkong River.

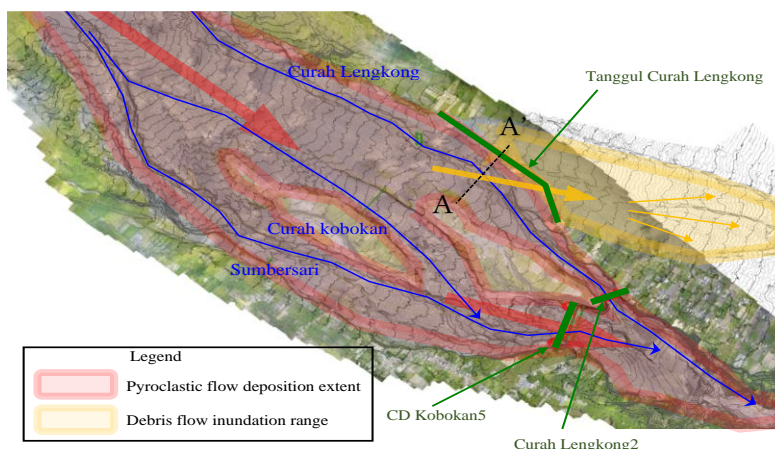
Figure 3-27 Overview of affected areas in S2

The pyroclastic flows moved at high speeds along the valley as ash flows and deposited across the valley floor (red area in Figure 3-27). Subsequent rainfall eroded the pyroclastic deposits upstream, triggering debris flows. Part of the debris flows overtopped the left bank, near Tanggul Curah Lengkong, and caused inundation (marked in yellow in Figure 3-27).

As shown in Figure 3-27, the debris flow flooded on the left bank of Curah Lengkong River (near where the current Tanggul Curah Lengkong dike is located). As stated in Basic Policy 1 and 2, the sediment in the river channel will be excavated, but in case of insufficient excavation due to an inability to carry out emergency sediment excavation after pyroclastic flow deposition, the height of the training dike shall be 3 m higher than the riverbed after pyroclastic flow deposition, to secure the safety against debris flow inundation over the left bank (Figure 3-30).

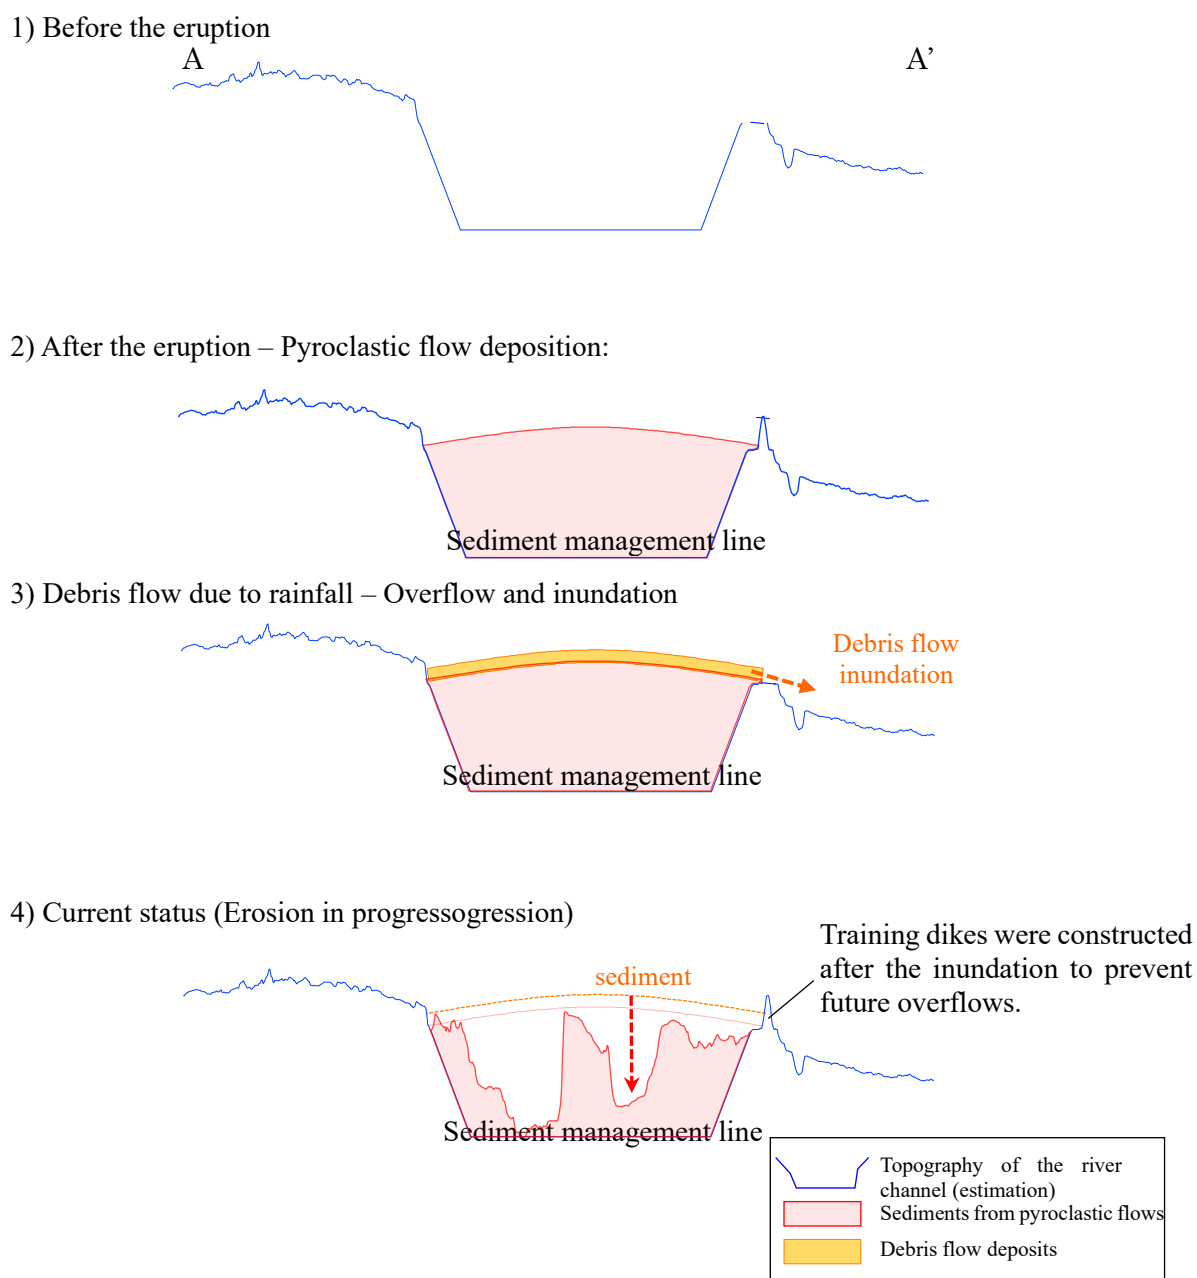
Figure 3-28 Sediment movement timeline along section A-A'

The time series of sediment movement phenomena in the A-A' section shown in Figure 3-27 are organized in Figure 3-28. The S2 area is the section where pyroclastic flows from the 2021 and 2022 eruptions flowed down the river channel. In this section, a large amount of pyroclastic flow was deposited in the river channel after the eruption and the river channel was buried (Figure 3-28 2)). Subsequently, debris flows moved over the pyroclastic deposits, but the blocked river channels caused them to overflow on the left bank which has little elevation difference (Figure 3-28 3)). Over time, sediment within the river channels has been eroded and transported downstream (Figure 3-28 4)).

The S2 channel has a history of being buried with a large amount of sediment during the eruption (Figure 3-28 2) and 3)). Although erosion has progressed, a large amount of sediment is still deposited (Figure 3-28 4)). To maximize the river channel's capacity to retain pyroclastic flow deposits during future eruptions, sediment excavation shall be conducted down to the sediment management line, restoring the channel to its original bed elevation.

As shown in Figure 3-28 2), in past eruptions, pyroclastic flow deposits were later mobilized by rainfall as debris flows, resulting in channel overflow and flooding. In order to reduce the risk of inundation due to debris flows, emergency sediment excavation should be carried out promptly after pyroclastic flow deposition.

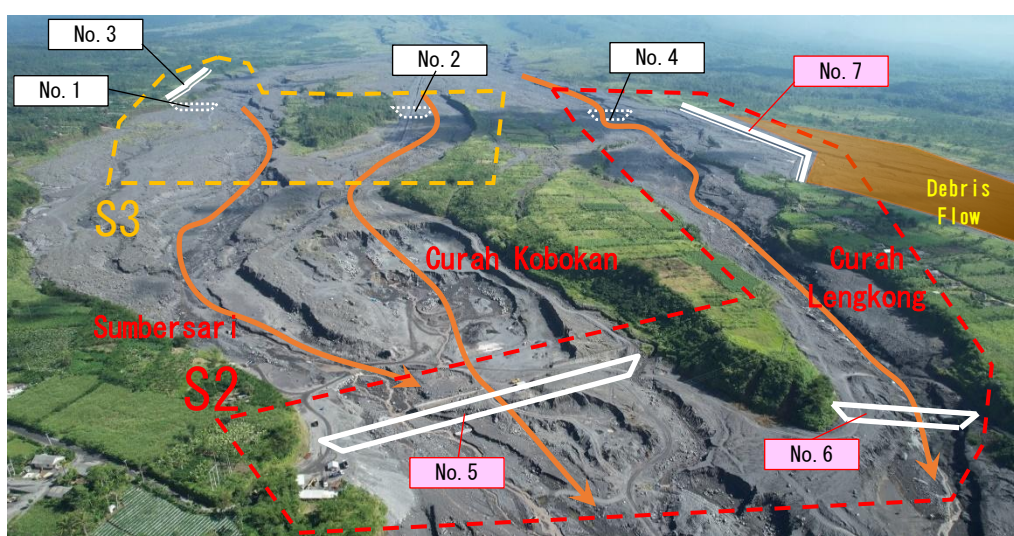
* The number corresponds to the facility number in the figure in Table 3-18, and the pink number corresponds to the target facility.

Figure 3-29 Facility layout situations of S2 area

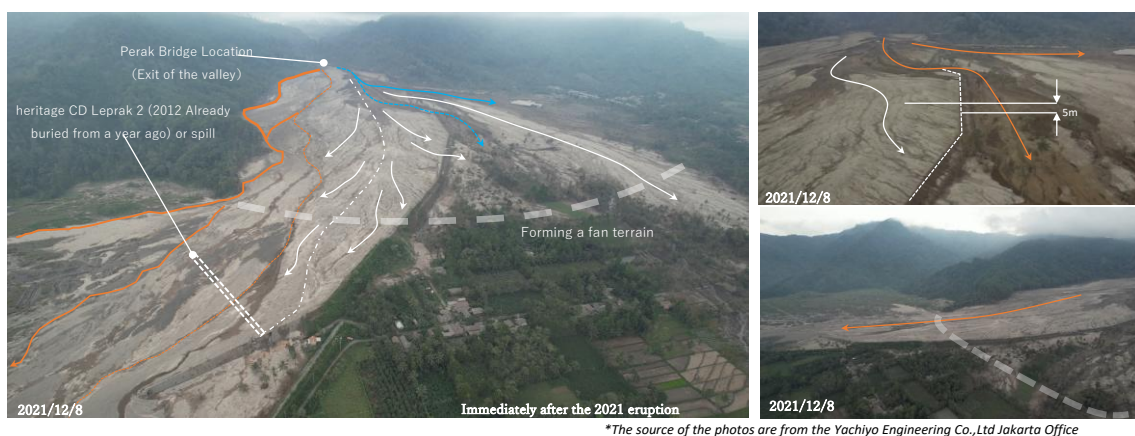
Figure 3-31 Condition of the midstream section (pyroclastic flow reached area)

During the 2021 eruption, pyroclastic flows reached the S4 area multiple times, depositing a massive amount of pyroclastic sediment. As of December 2021, pyroclastic flow deposits were accumulated at a height of more than 5 m above the height of the existing dike.

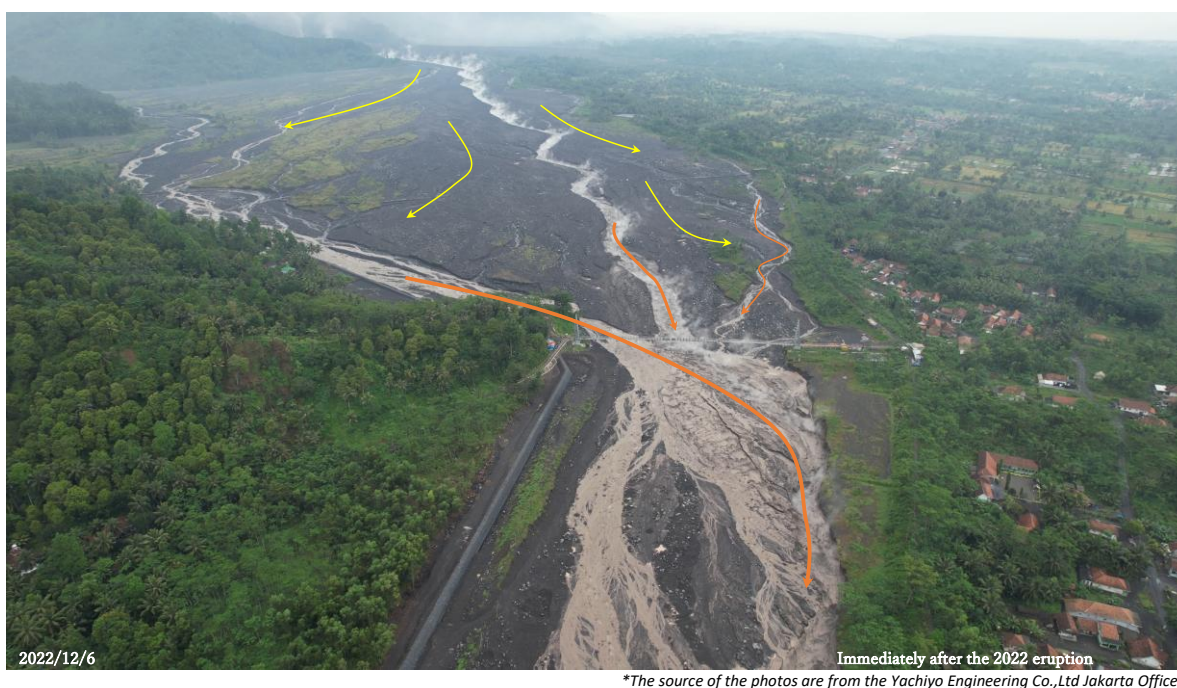
Figure 3-32 Condition of the midstream section (sand pocket section)

Immediately after the 2022 eruption, pyroclastic flows, mudflows, and debris flow deposits flow downstream, and sediment was deposited in the sand pocket. Sediment was mainly deposited in the center of the river channel, and the flow direction of the river channel moved left and right in the sand pocket. Consequently, localized bank erosion and irregular sediment accumulation occurred, changing positions within the sand pocket.

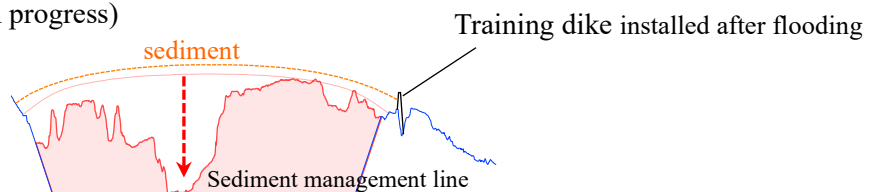
Figure 3-34 Time series of sediment movement phenomena in cross-section B-B'

The sediment movement phenomena along cross-section B-B', as shown in Figure 3-33, are summarized in Figure 3-34. The upstream section of the S4 area is the section where pyroclastic flows flowed down the river channel during the 2021 eruption. A large amount of unstable sediment from pyroclastic flows was deposited in the river channel in this section. It can be assumed that debris flow occurred due to rainfall under the circumstances where this sediment was accumulated, and the debris flow overtopped the raised river channel causing inundation.

The S4 channel has a history of being buried with a large amount of sediment during the eruption (Figure 3-34 2) and 3)). Although erosion has progressed, a large amount of sediment is still deposited ((Figure 3-34 4)). In the event of another eruption in the future, sediment excavation shall be carried out within the river channel (excavation down to the sediment management line) so that pyroclastic flow deposits can be stored in the river channel as much as possible.

As shown in Figure 3-34 3), in past eruptions, debris flows flowed down after pyroclastic flow deposits and some of them flooded over the river channel. To reduce the risk of flooding due to debris flows, emergency sediment excavation should be carried out promptly after pyroclastic flow deposition.

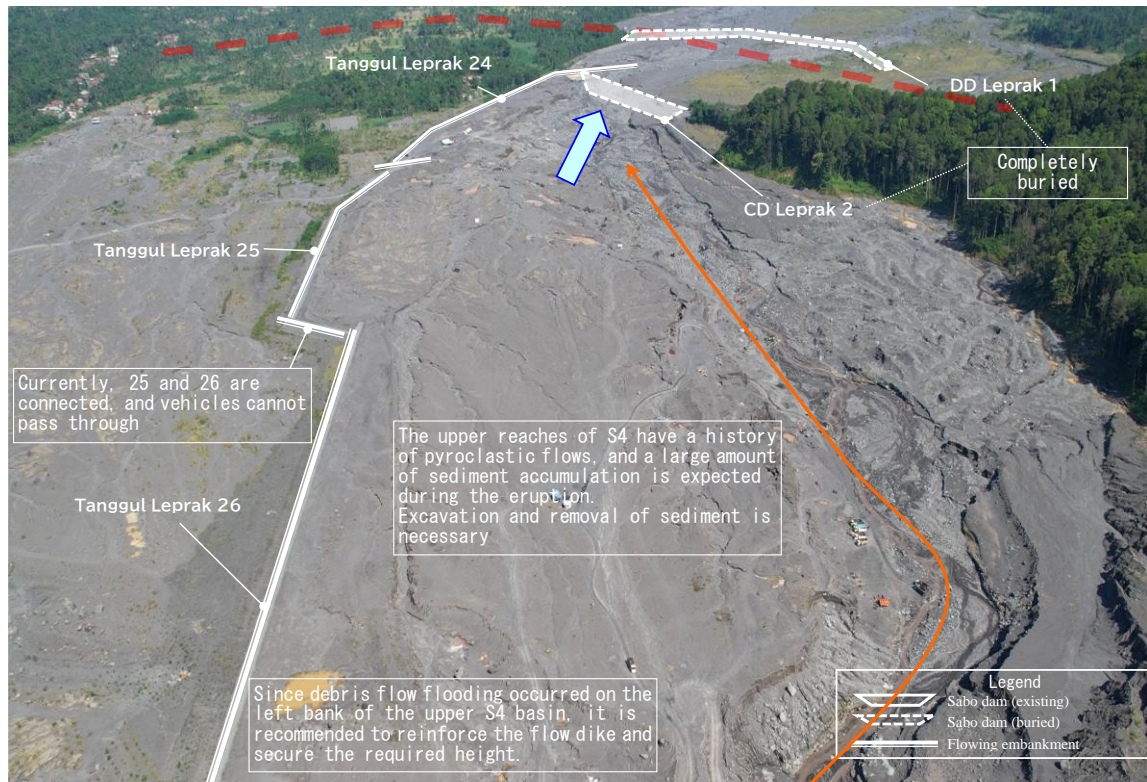
Figure 3-35 Facility layout of S4 area (flow diversion section)

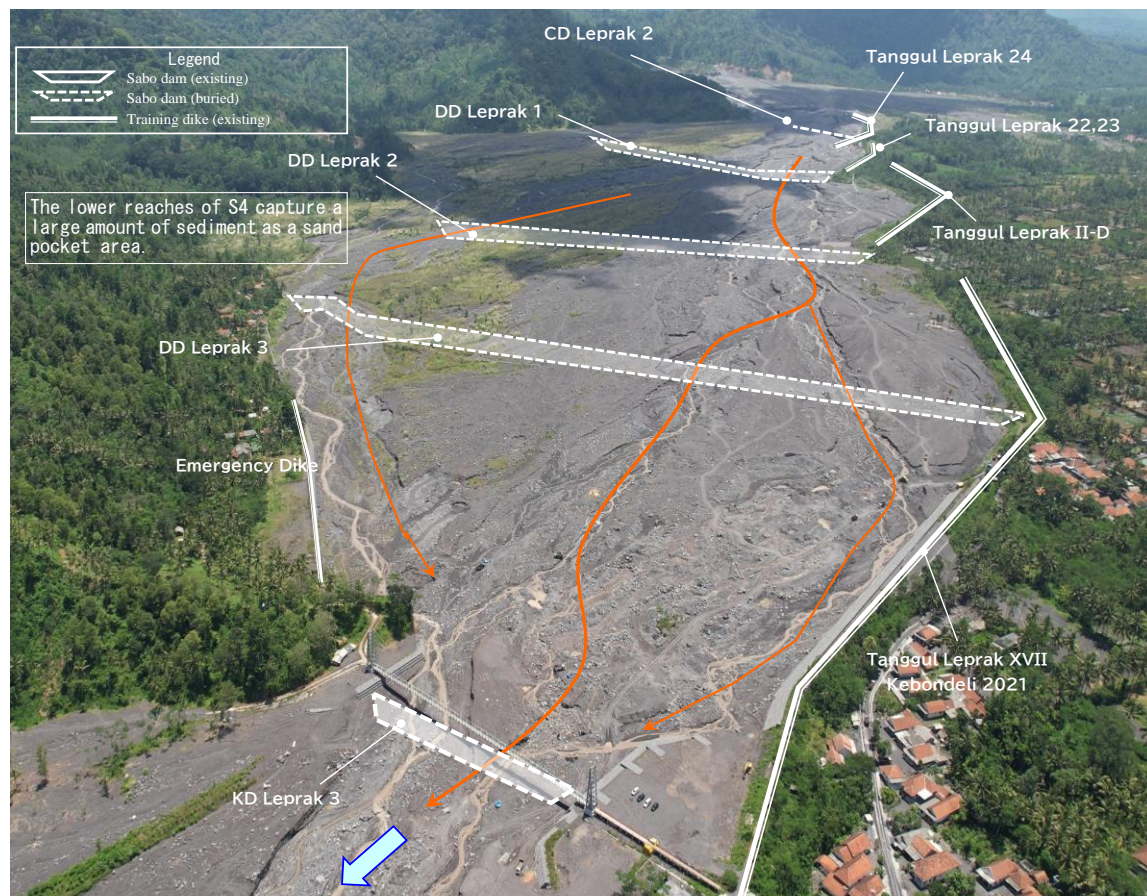
Figure 3-36 Facility layout of S4 area (sand pocket section)

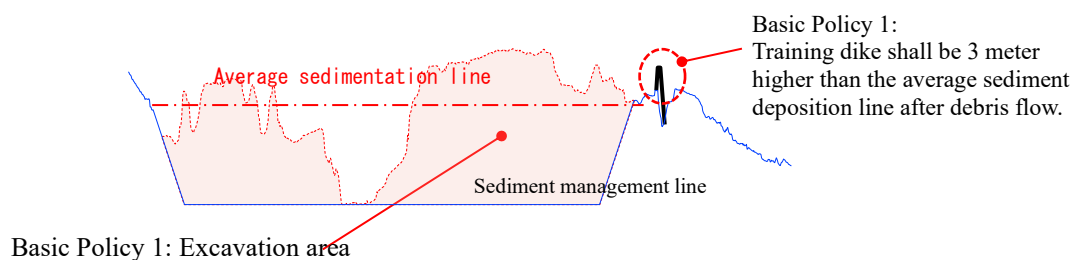
Figure 3-38 Basic policy supplementary diagram

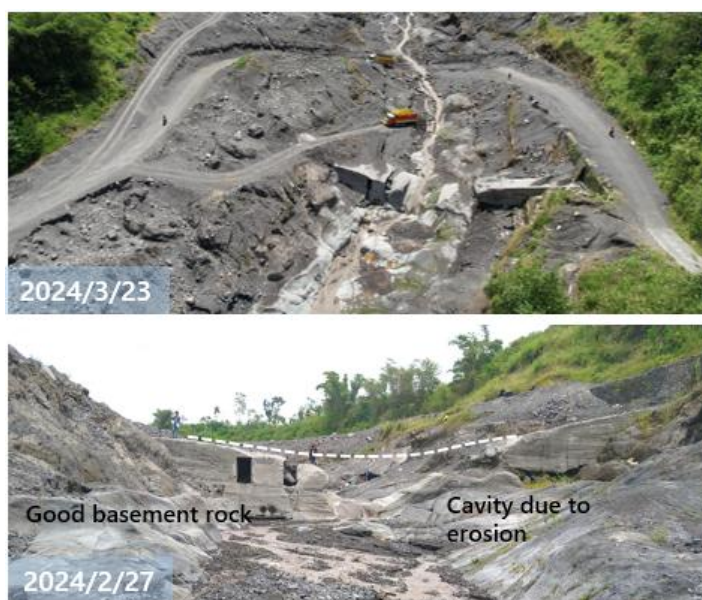
- While it is anchored to the exposed rock bed, the main body of the sabo dam is severely damaged due to significant erosion. The river-crossing function has been lost.
- The concrete material of the dam body remains intact and in good condition.

- The damage is presumed due to abrasion caused by frequent debris flows containing large boulders.

- Abrasion countermeasures are required.
- Treatment of the contacting surfaces between the foundation bedrock and concrete is necessary.
- River-crossing function shall be incorporated into the sabo dam.
- The height of the dam shall be determined by taking into account the elevation difference between the upstream dike and the design sedimentation line.
- The conduit structure should be designed to withstand abrasion and impact loads.

Figure 3-39 Current status of CD Pelintas Curah Lengkong 2

The current state of CD Pelintas Curah Lengkong 2 is shown in Figure 3-39.

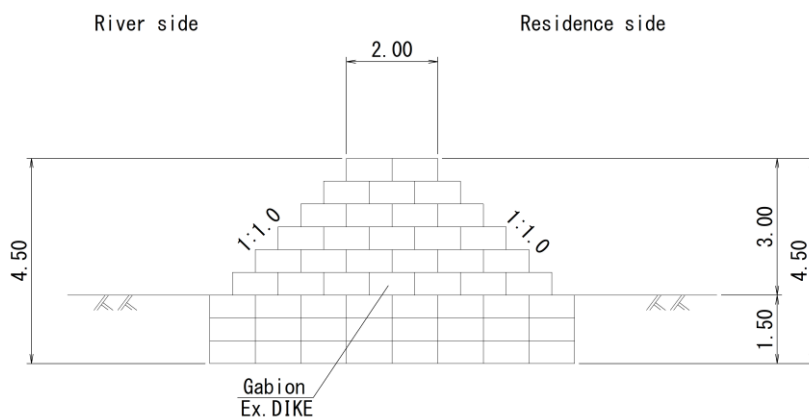
Figure 3-42 Existing structure of Tanggul Curah Lengkong

The basic shape of the existing facility was estimated from past drawings and on-site surveys. The basic shape of Tanggul Curah Lengkong is shown in Figure 3-42.

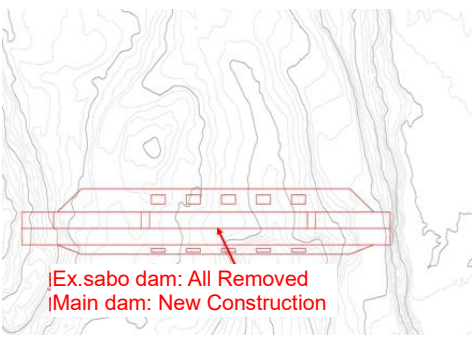
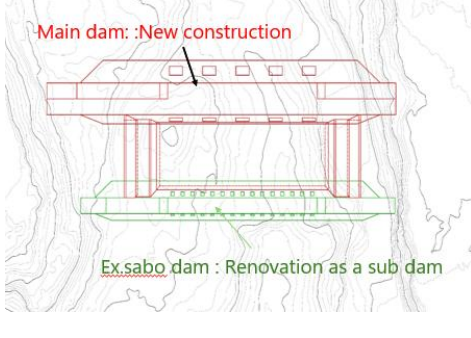
Table 3-21 CD Pelintas Curah Lengkong2 layout comparison study

Option 1 Renew the existing facility	Option 2 Build a new dam upstream of the existing facility
Overview Diagram

Outline of the plan	Construct a new sabo dam at the same position as the existing sabo dam	Utilize the existing sabo dam as a sub-dam and construct the new main dam upstream of the existing sabo dam
Facility effect	Compared to Option 2, there is almost no difference ✓	There is almost no difference compared to Option 1 ✓
Economy	<ul style="list-style-type: none"> Removal of existing dams: all Installation of a new dam: same as Option 2 Excavation Volume: larger compared to Option 2 ¹⁾ 	<ul style="list-style-type: none"> Removal of existing dams: partial Installation of a new main dam: same as Option 1 Reuse existing facilities Excavation volume: less compared to Option 1. <p style="text-align: center;">✓</p>
Ancillary roads	Since the longitudinal slope of the ancillary road is 10% or more, there are risk about the safety of construction vehicles.	Since the longitudinal slope of the ancillary road is 10% or less, construction vehicles can pass safely. ✓

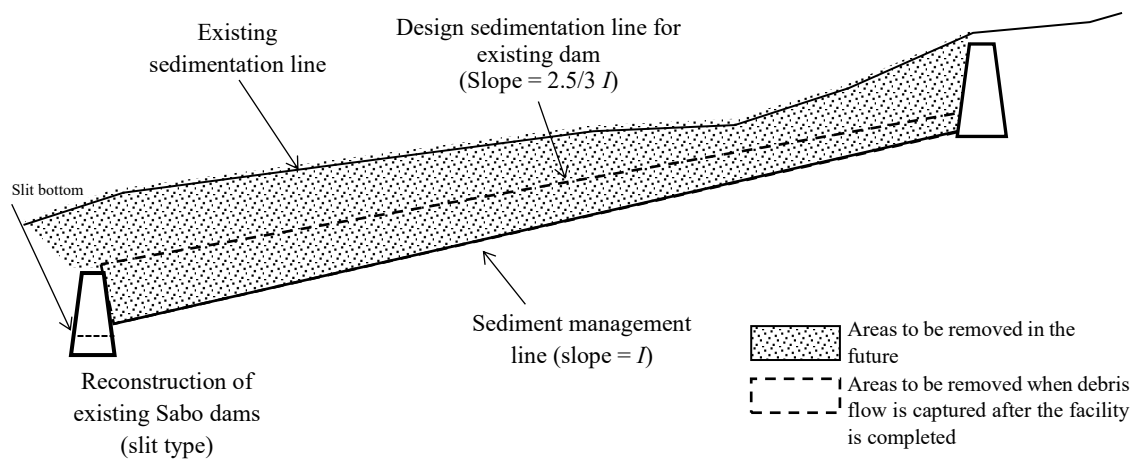
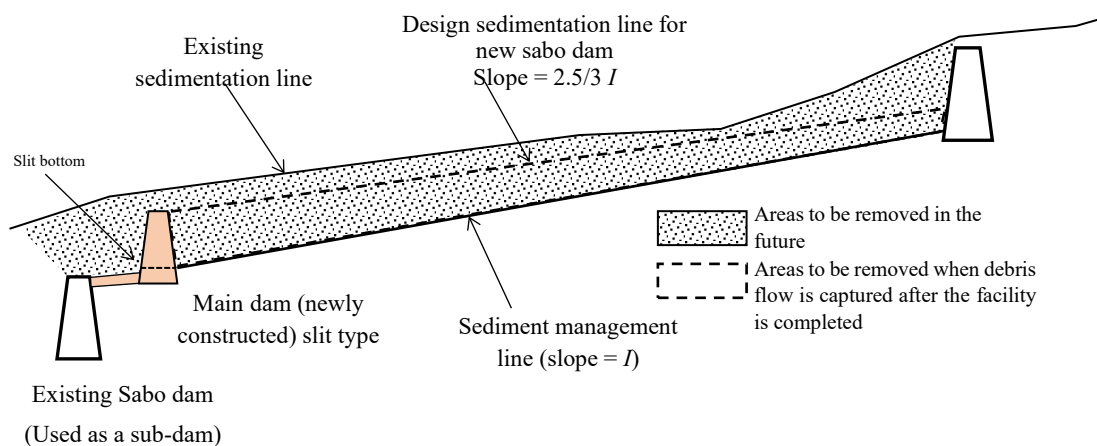
Figure 3-43 Comparison of excavation volumes between converting the existing dam into a slit-type structure and constructing a new slit-type dam

The upper diagram in Figure 3-43 shows the excavation volume when the existing dam is converted into a slit-type structure, while the lower diagram illustrates the excavation volume when a new slit-type dam is constructed. The hatched areas in the longitudinal river profiles represent the excavation volumes for each case. It is evident that the excavation volume for the latter (new construction) is smaller than that for the former (conversion of the existing dam).

(Excavation volume for converting the existing sabo dam into a slit-type structure)

(Excavation volume when a new slit-type dam is constructed)

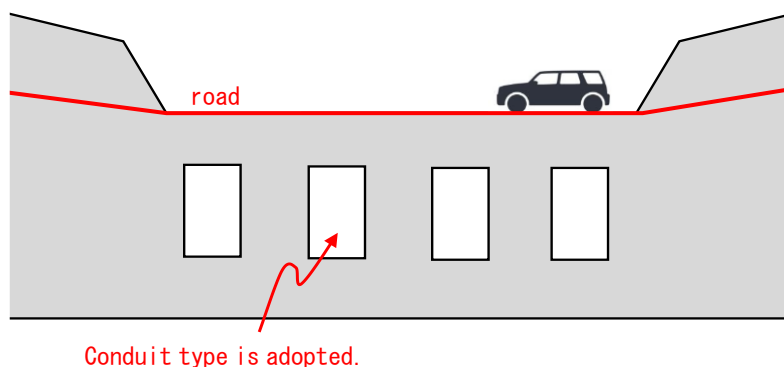
Figure 3-44 Front view of a conduit type sabo dam

The dam types of CD Pelintas Curah Lengkong 2 and CD Kobokan 5 were examined (Figure 3-44). In the Review Master Plan (2024), the existing facilities are planned to be converted from closed-type to open-type to improve the sediment control effect. For this reason, in this study, an open-type sabo dam will be adopted for the newly constructed sabo dam.

Since the dam is planned to have a road function, it was decided to adopt a conduit type dam. The details regarding the incorporation of the road function will be discussed in the next section.

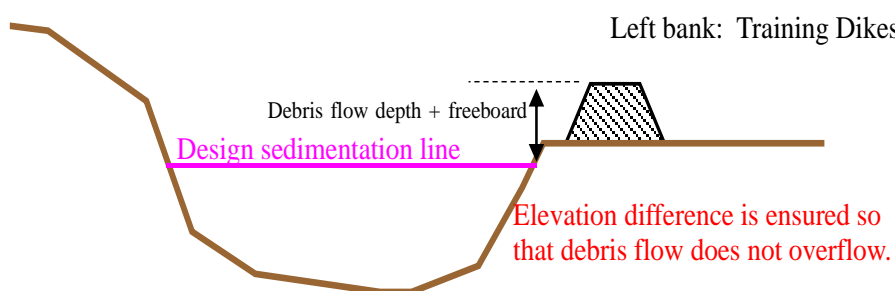
Figure 3-45 Consideration for determining dam height

The size of the dam of CD Pelintas Curah Lengkong 2 was examined. On the upstream left bank of the dam, there is a section where sediment has flooded. Currently, a dike (gabion) has been constructed as an emergency measure. The size of the CD Pelintas Curah Lengkong 2 is determined to ensure the elevation difference between the design sedimentation line and the training dike. It is also designed so that even in the event of pyroclastic flows of a similar scale to those of the 2021 and 2022 eruptions, debris flows will not overtop the training dike (Figure 3-45 and Figure 3-47).

The height of the new sabo dam was set so that the elevation difference between the planned sedimentation level and the top of the dike is greater than depth of the debris flow (1.7 m) + the freeboard (1 m).

The dimensions of KD Leprak 3, DD Leprak 2 and DD Leprak 3 are examined. On the upstream left bank of the dams, training dikes have been constructed. The dimensions of the KD Leprak 3, DD Leprak 2, and DD Leprak 3 dams are determined such that the elevation difference between the design sedimentation line and the dikes is ensured. It is designed so that debris flows will not overflow the dikes even in the events of the pyroclastic flow identical to those of the 2022 and 2022 eruptions, (Figure 3-45).

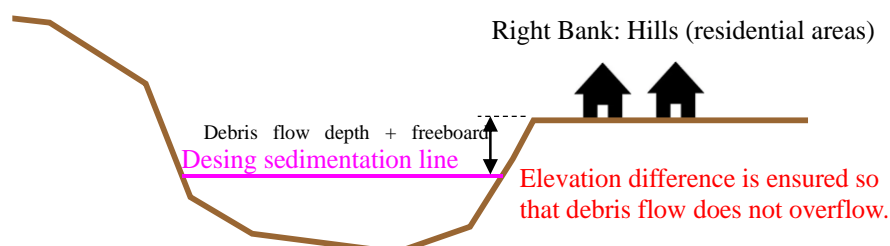
Figure 3-46 Consideration for Determining Dam height

The size of the dam of CD Kobokan 5 was examined. Residential areas exist on the upstream right bank of the dam. The size of the CD Kobokan 5 is planned by ensuring the elevation difference between the design sedimentation line and the right bank. This ensures that even in the event of pyroclastic flows on the same scale as the 2021 and 2022 eruptions, debris flows will not overflow (Figure 3-46 and Figure 3-48).

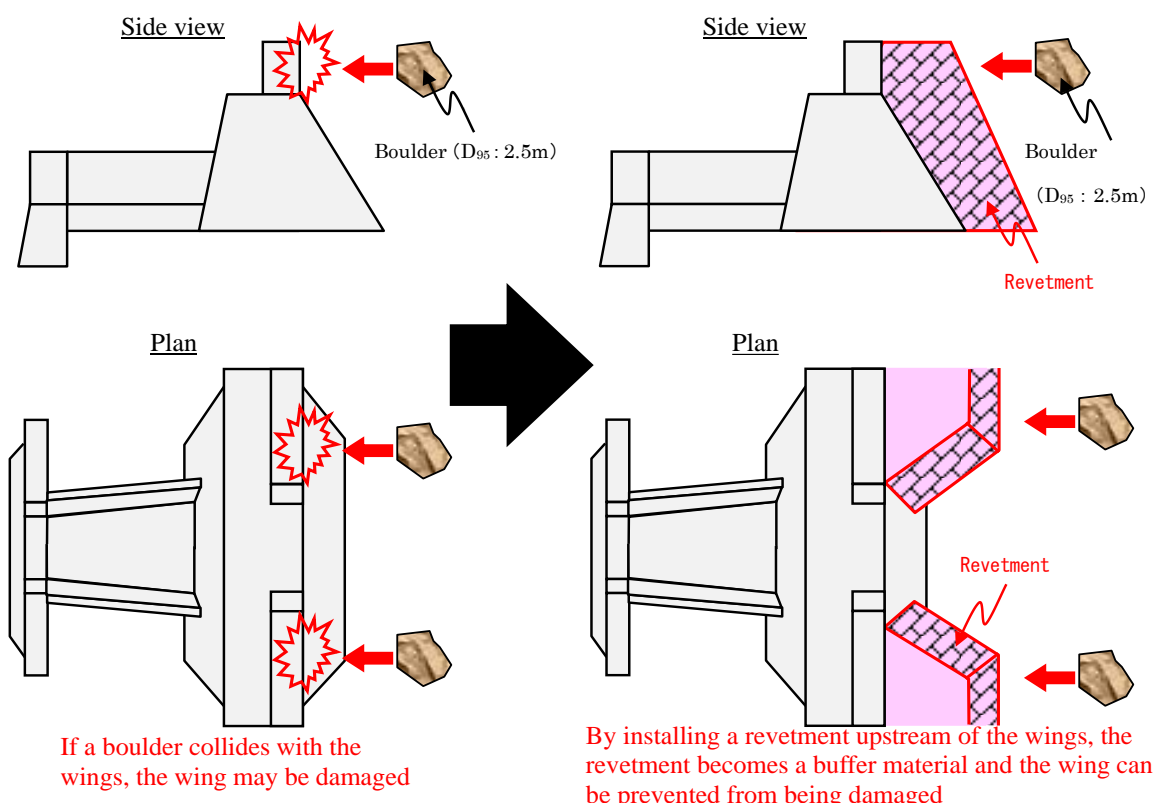
Figure 3-49 Countermeasures against boulder impacts

Large boulders are scattered within the river channel, and debris flows may transport these boulders downstream. If such boulders collide with the dam wings, they could potentially cause damage. To mitigate this risk, revetment shall be installed on the upstream side of the sabo dam to serve as protective barriers. These revetments will act as a buffer, preventing direct impacts on the wing walls, reducing the structural damage. The proposed countermeasure strategy is illustrated in Figure 3-49.

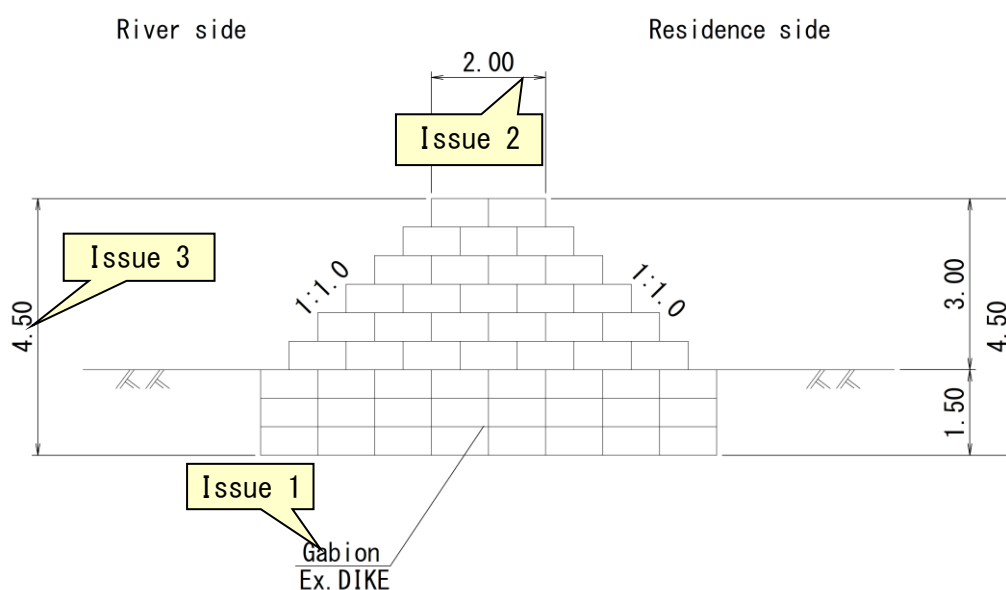
Figure 3-51 Current issues of Tanggul Curah Lengkong

The current issues of Tanggul Curah Lengkong are as follows.

- Issue 1: The existing dike is constructed with gabion, which raises risks about its durability.
- Issue 2: The current dike has a crest width of 2 meters, but according to Indonesia's design technical guidelines "Pd T-16-2004-A_Pencanaan Teknis Tanggul pada Sungai Lahar, P3", a crest width of 4 meters is required.
- Issue 3: In the event of another debris flow, the dike needs to be high enough to prevent the debris flow from overflowing.

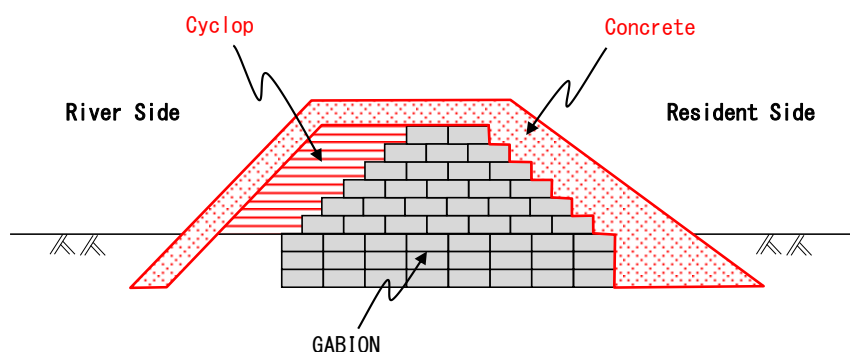
Figure 3-52 Material of Tanggul Curah Lengkong

The plan is to continue to use the gabion, which are the materials for the existing dike. To secure a 4-meter-wide crest for the training dike, the material will be changed to masonry concrete (cyclop). The surface of the dike will be covered with concrete to improve its durability.

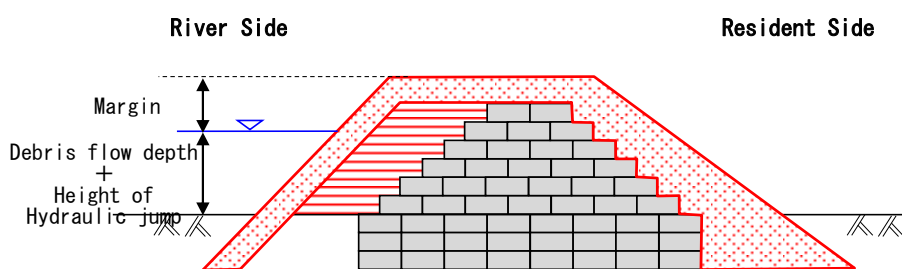
Figure 3-53 Training dike height of Tanggul Curah Lengkong

The height of the training dike will be designed to accommodate the flow depth and the hydraulic jump height of debris flows, with an additional allowance for safety.

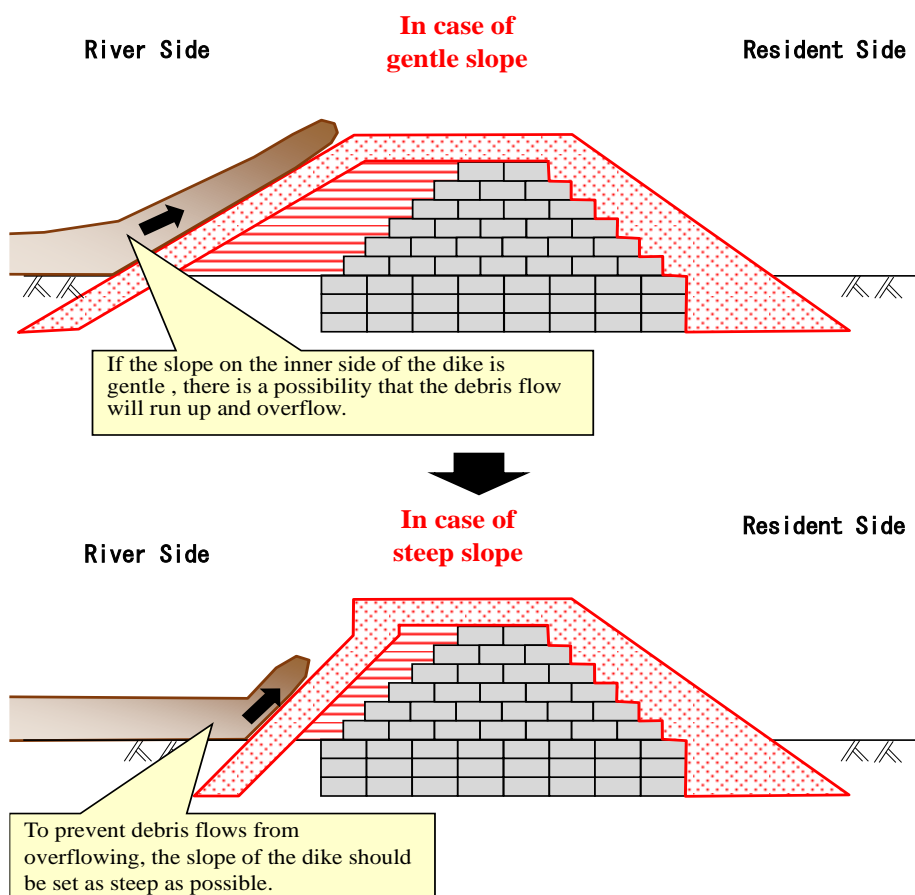
Figure 3-54 Slope of Tanggul Curah Lengkong

Mitigation measures were considered to prevent the debris flow from overtopping. If the slope on the inner side (resident side) of the training dike is too gentle, there is a possibility that the debris flow could run up the dike and overflow. Therefore, the slope on the inner side (resident side) of the dike will be designed to be steep, with the top section set to be vertical (Figure 3-54).

Mitigation measures to prevent debris flows from overflowing are discussed. If the slope of the dike on the inner side (resident side) is gentle, there is a risk that the debris flow will run up and overflow the dike. Thus, the slope of the dike on the river side shall be steep with the top section set vertical (Figure 3-54).

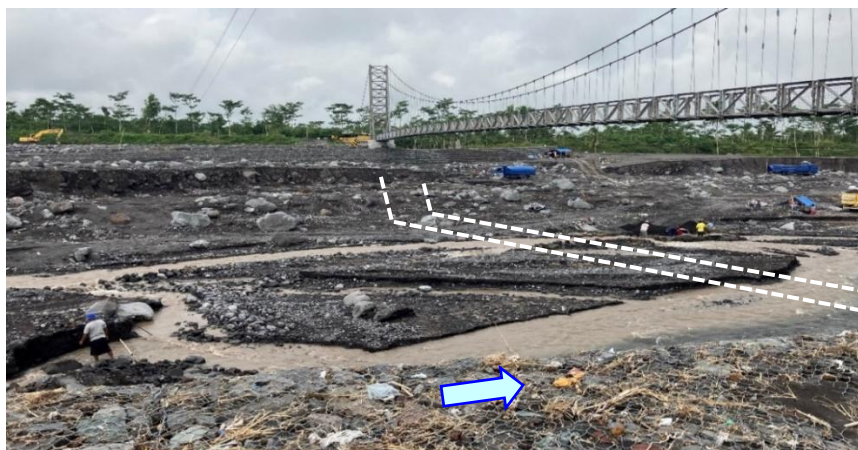
Figure 3-55 Damage to the left bank of KD Leprak 3 (May 2024)

The current state of KD Leprak 3 is shown in Figure 3-55.

- Sediment has accumulated above the groundsill by approximately 1m, where the dam body is buried and cannot be seen.
- Abutments on the left and right banks are only partial damaged.

- The dam body is buried and cannot be seen.
- If a local scouring occurs on the upstream side of the main dam (old dam body), there is a high possibility that major damage will occur in the current structure.
- The absence of a downstream riverbed protection work on the old dam body increases the risk of collapse due to erosion caused by the impact of falling water.
- The old dam body, which is made of soil embankment and gabions, is easily adaptable to changes in topography. However, it is less effective to maintain its functionality for sediment retaining.

- The structure of the old dam body needs to be strengthened.
- It is necessary to take into account the overflow over the sleeves and strengthen the downstream riverbed protection.
- It is necessary to take measures against abrasion over the crest of the dam body (overflow section).
- It is necessary to situate the dam so that it does not interfere with the bridge during construction.
