**The Republic of Indonesia
Directorate General of Water Resources
Ministry of Public Works**

**The Project for Capacity Development
of Mt. Semeru Volcanic Disaster
Structural Measure Planning
in The Republic of Indonesia**

**Project Completion Report
Annex (7)
Final Report**

Japan International Cooperation Agency (JICA)

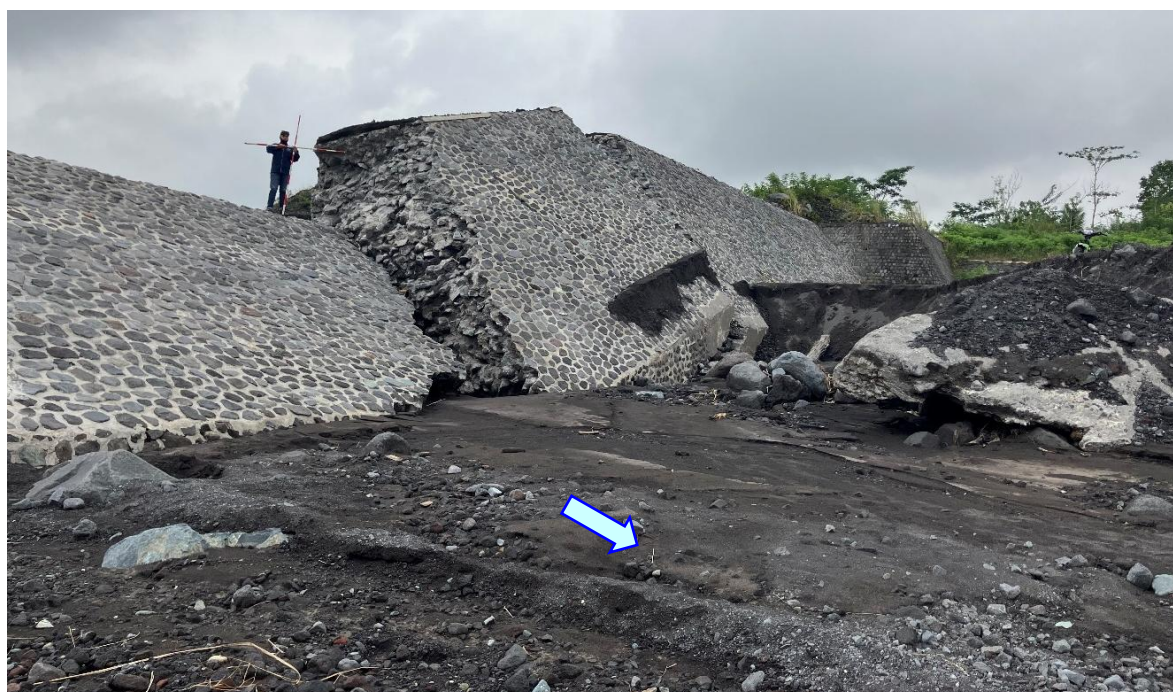
Figure 3-56 Damage to the left wing of DD Leprak 2 (May 2024)

The current state of KD Leprak 2 is shown in Figure 3-56.

- Sediment has accumulated above the dam body by about 1m, where the dam body is buried and cannot be seen.
- Due to the presence of a boulder on the top of the left wing, it is presumed that past debris flows have overflowed the left wing. The left abutment was partially eroded and the internal masonry is exposed. In addition, damage has progressed due to recent debris flows.

- The main body of the sabo dam is severely damaged due to scouring on the riverbed foundation and the impact from frequent debris flows containing boulders.

- It is necessary to use high-strength concrete or other strong materials for the wings and abutments which are exposed to direct debris flow impact.
- Strengthening the downstream riverbed protection work presuming overtopping of the wings is required.
- Erosion protection measures for the dam crest (overflow section) are necessary.

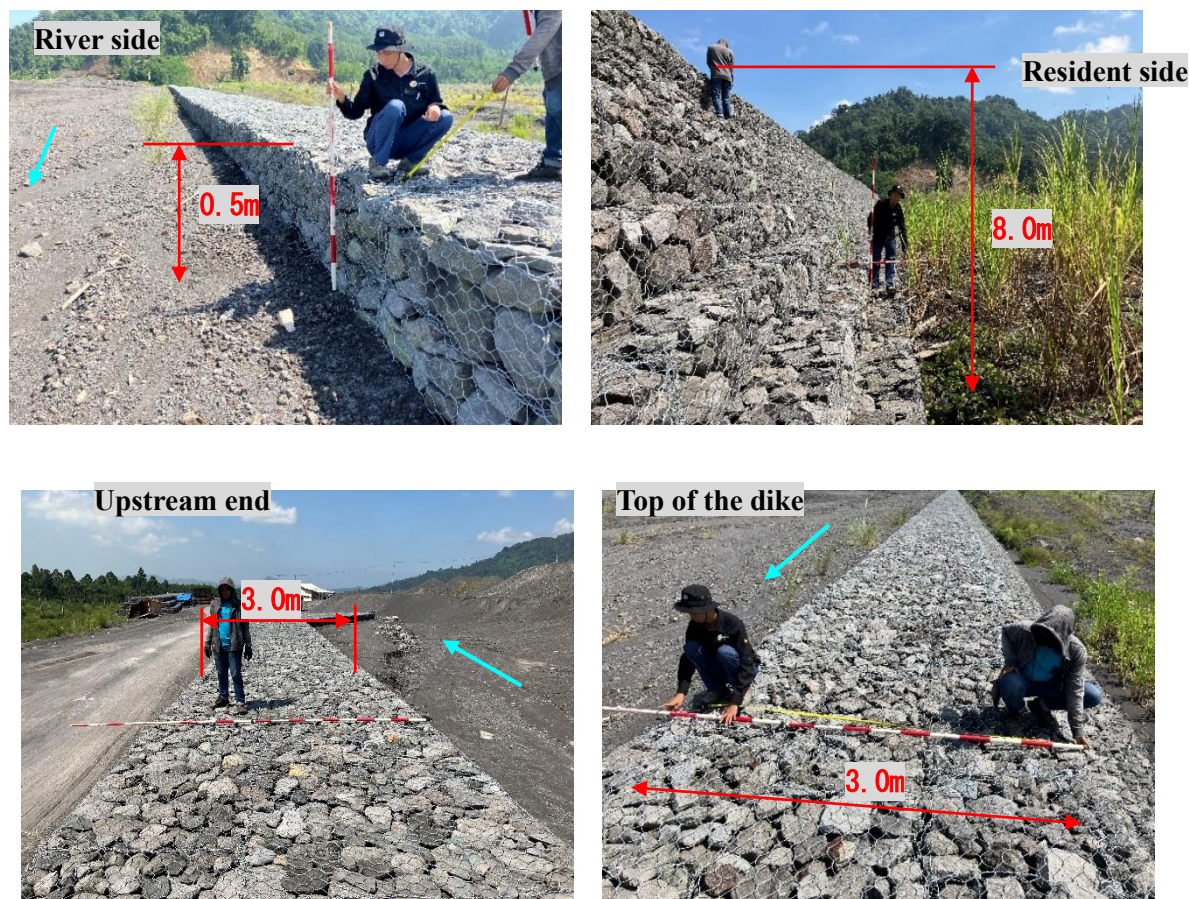
Figure 3-57 Current status of the training dikes (May 2024)

The current status of the existing dikes in the flow diversion section (Figure 3-37) is shown in Figure 3-57. The current status of these dikes (Tanggul Leprak 24, Tanggul Leprak 25, and Tanggul Leprak 26) are summarized below. In the section where the debris flow flooded, emergency dikes were constructed afterwards. These dikes were constructed using gabion as emergency measures to prevent another disaster.

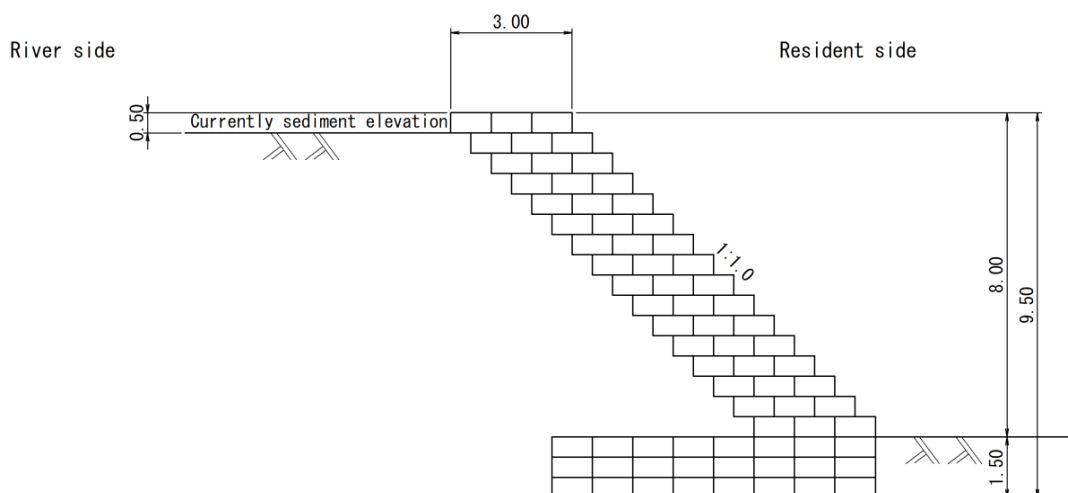
Figure 3-58 Existing dike at Tanggul Leprak 24, 25, and 26

The basic shape of the dikes (Tanggul Leprak 24, Tanggul Leprak 25, and Tanggul Leprak 26) in the flow diversion section is shown in Figure 3-58.

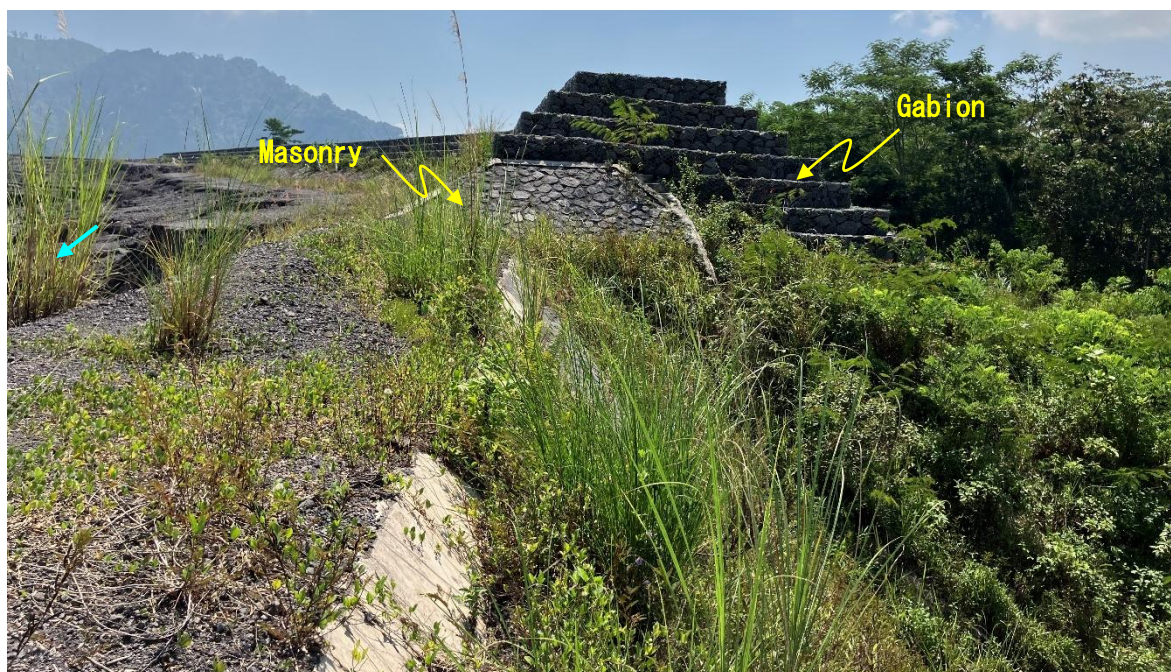
Figure 3-59 Current Status of Tanggul Leprak 22 and Tanggul Leprak 23 (May 2024)

The current status of the existing dikes in the sand pocket section (Figure 3-37) is shown in Figure 3-59 ~ Figure 3-62. Current condition of these dikes (Tanggul Leprak 22, Tanggul Leprak 23, Tanggul Leprak II-D, Tanggul Leprak XVII Kebondeli 2021, Emergency Dike) is summarized below. The materials of these dikes are masonry or gabion.

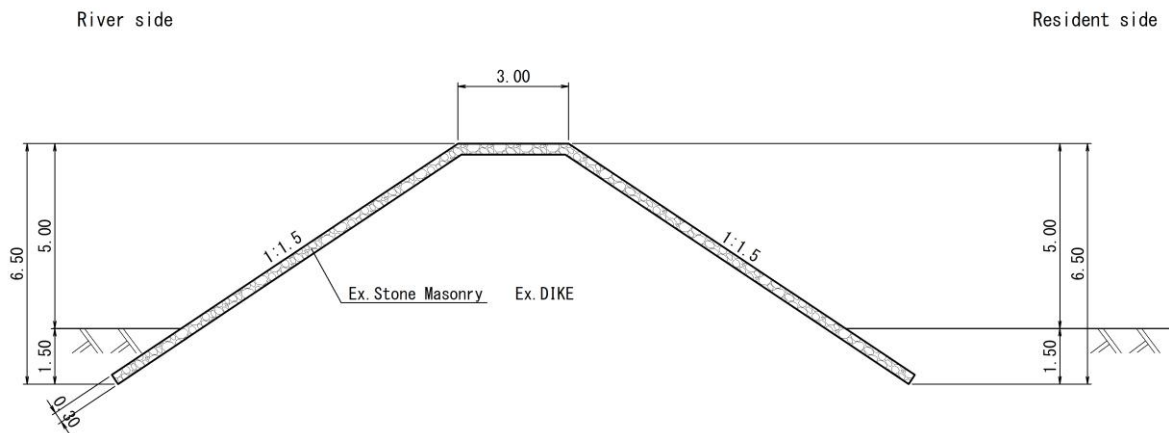
Figure 3-63 Existing dike at Tanggul Leprak 22

The basic shape of the existing dikes in the Sand Pocket Section was estimated from the as built drawings and on-site surveys. The basic shape of the dikes (Tanggul Leprak 22, Tanggul Leprak 23, Tanggul Leprak II.-D, Tanggul Leprak XVII Kebondeli 2021, Emergency Dike) is presented in Figure 3-63 ~ Figure 3-67.

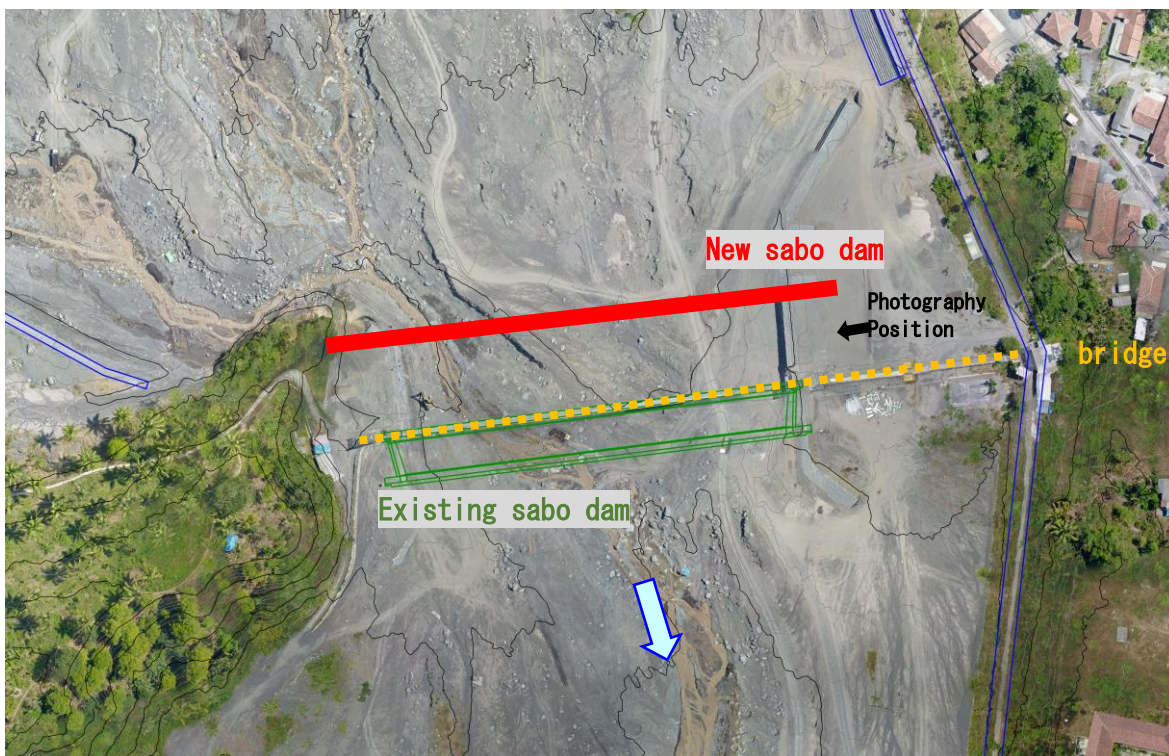
Figure 3-68 Layout plan of KD Leprak 3

A suspension bridge has been constructed at the location of KD Leprak 3. When reconstructing the sabo dam, interference with the bridge is unavoidable and the traffic must be shut down during construction. For this reason, a new dam is constructed upstream of the existing structure which will be used as a sub-dam. The image of layout plan of KD Leprak 3 is shown in Figure 3-68 and Figure 3-69, summarizing the above situation.

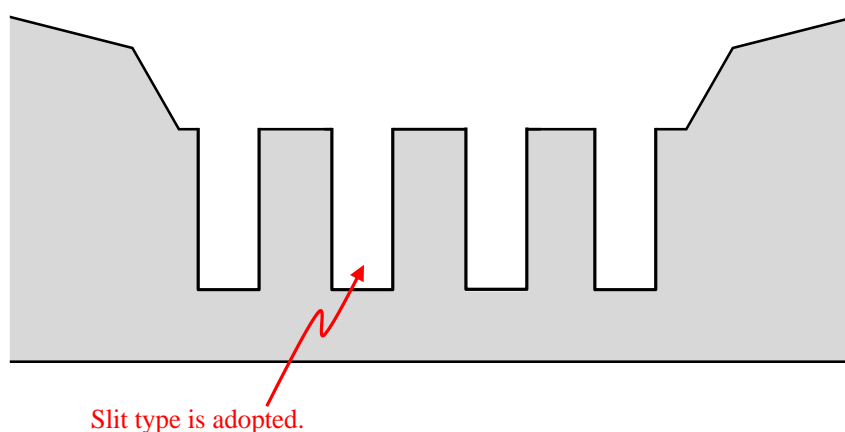
Figure 3-70 Front view of slit type dam

The dam types of KD Leprak 3, DD Leprak 2, and DD Leprak 3 were examined (Figure 3-70). In the Review Master Plan (2024), existing facilities shall be renovated from closed-type to open-type to improve the sediment control effect. Therefore, in this study, the open-type will be adopted for the newly constructed sabo dams. Further, a slit type will be applied, since road functionality is not required.

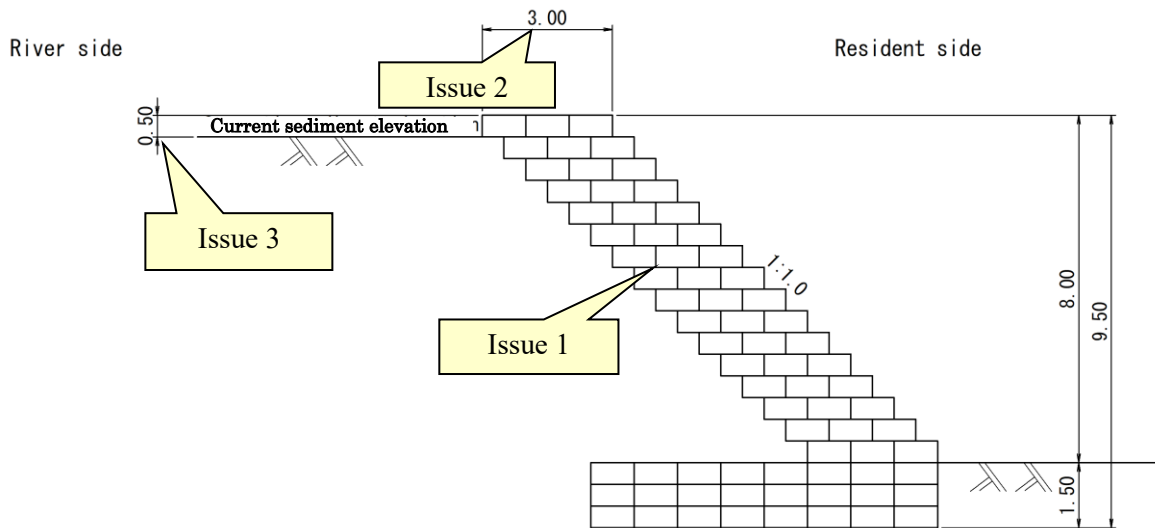
Figure 3-72 Current issues of training dikes in flow diversion section (Tanggul Leprak 24, 25, 26)

The training dikes in the flow diversion section (Tanggul Leprak 24, Tanggul Leprak 25, Tanggul Leprak 26) and training dikes in the sand pocket section (Tanggul Leprak 22, Tanggul Leprak 23, Tanggul Leprak II.-D, Tanggul Leprak XVII Kebondeli 2021, Emergency Dike) are currently facing the following issues (Figure 3-72 and Figure 3-73).

- Issue 1 : The existing dikes are constructed using gabions and masonry. Since the gabion is the materials for emergency structures, there remain issues regarding the durability.
- Issue 2 : The current crest width of the dike is 3 m, while 4 m is required according to the Indonesian design technical guideline “Pd T-16-2004-A_Perencanaan Teknis Tanggul pada Sungai Lahar, P3”.
- Issue 3 : In the event of another disaster in the future, it is to be ensured that debris flows do not overtop the dike.

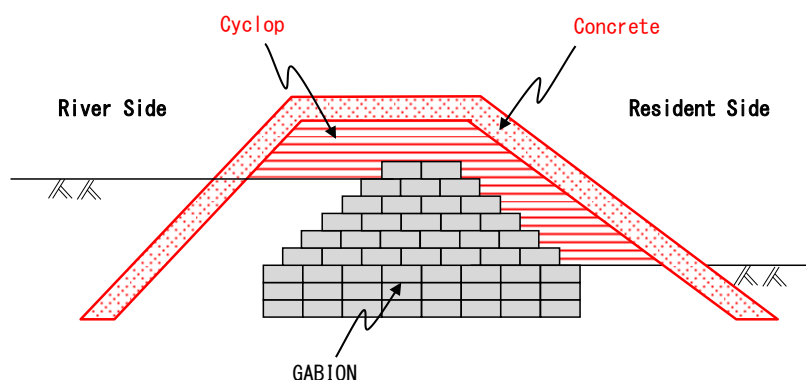
Figure 3-74 Training dike material (Tanggul Leprak 24, 25, 26)

The materials of existing facilities are gabion and it will be utilized as is. To secure a width of 4 m at the crest of the dike, the material inside the dike will be masonry concrete (cyclop). Concrete will be applied to the surface of the training dike to enhance its durability (Figure 3-74).

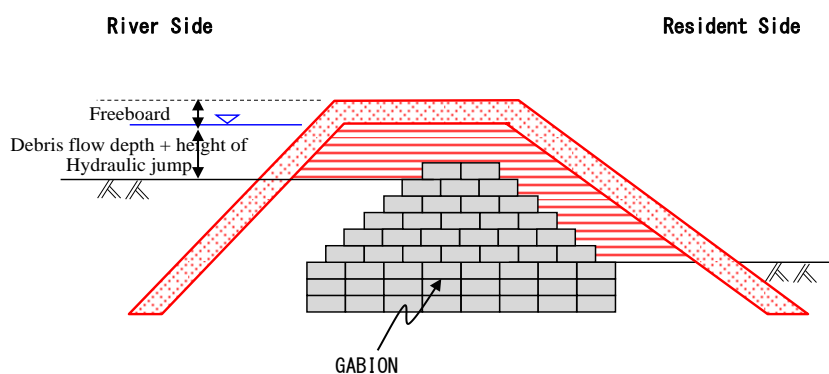
Figure 3-75 Height of the training dike (Tanggul Leprak 24, 25, 26)

The height of the training dike will be determined by adding the debris flow depth, the hydraulic jump height plus the freeboard (Figure 3-75), to ensure the safety against overflow.

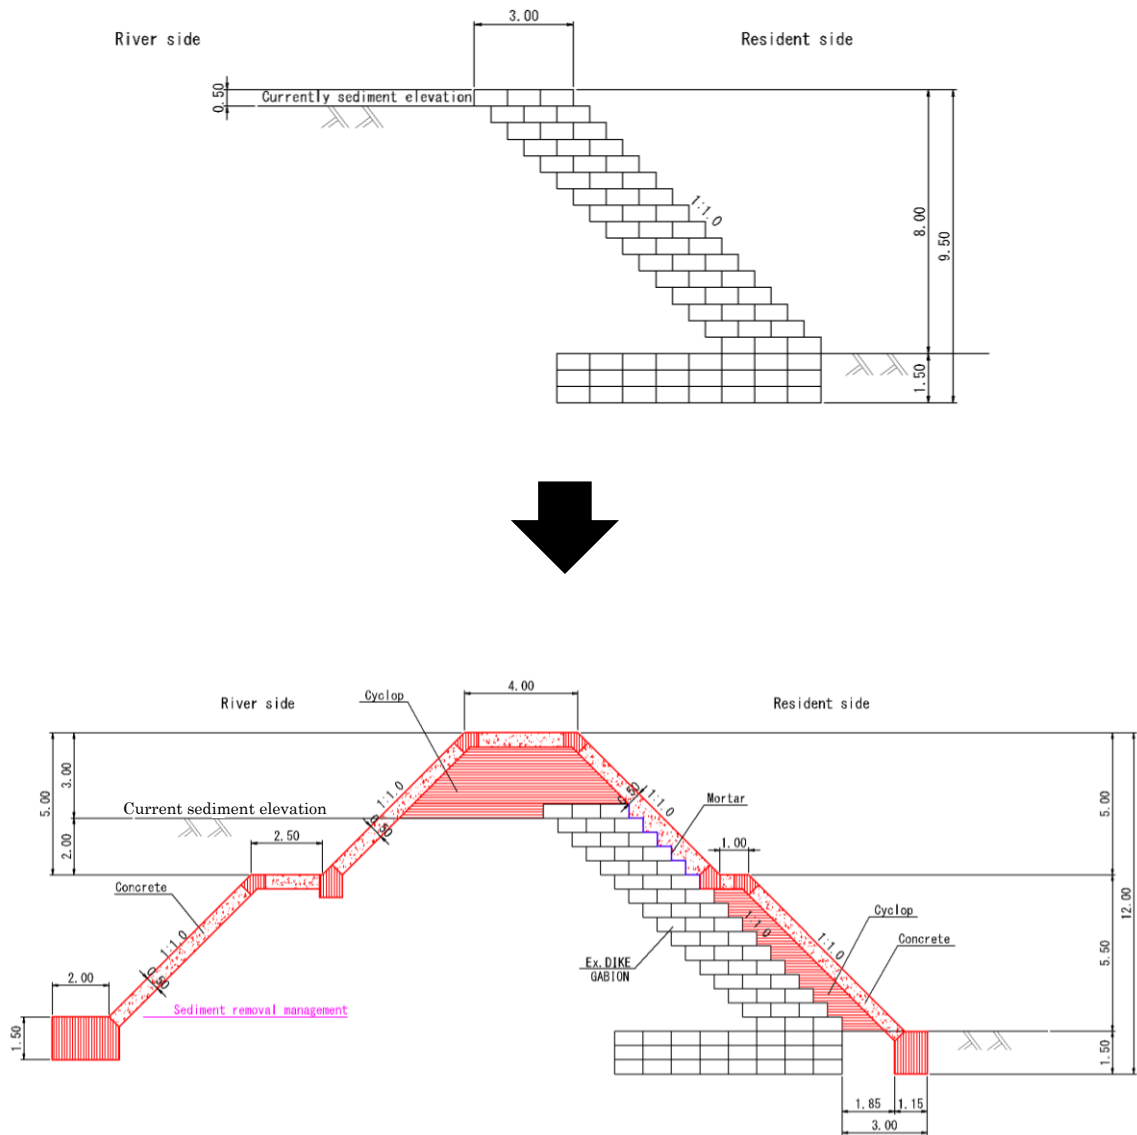
Figure 3-76 Basic shapes of Tanggul Leprak 24, 25, and 26

If the existing material is gabion or masonry, the existing material will be utilized. If the crest width is 4 m, no additional measures will be applied to the surface of the river side of the dike. If the dike is made of gabion, concrete will be applied on its surface to improve the durability. As there is no significant damage to the Tanggul Leprak 22, the crest width will not be changed from the current 3m, and only underpinning work will be carried out.

Tanggul Leprak 24, 25, 26
Shape of existing

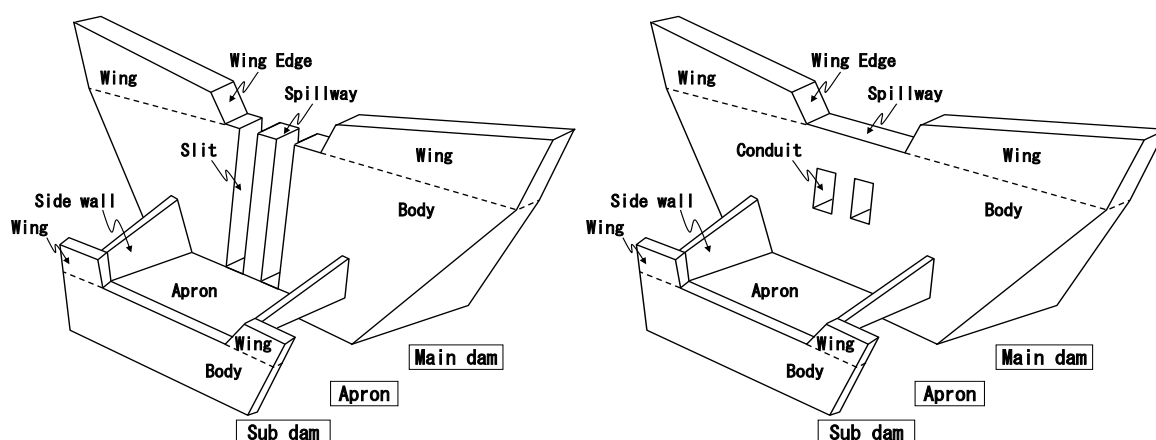
Figure 4-1 Names of components of open type sabo dams (left: slit type, right: conduit type)

The components of sabo facilities are presented in Figure 4-1 as follows. Regarding the type of sabo dam, as mentioned in “3.1.4 Layout Policy and Selection of sabo Facilities”, an open type was adopted.

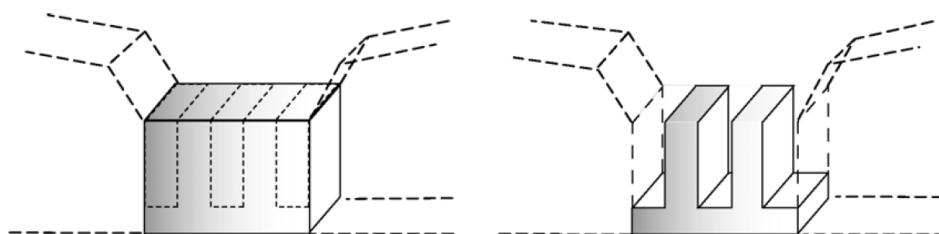
Figure 4-2 Dam body volume of spillway on the slit part

W_{rc} : weight of dam blocks calculated as an open type structure for the open section (kN)

V_c : volume of dam blocks calculated assuming the open section as a closed structure (m³)

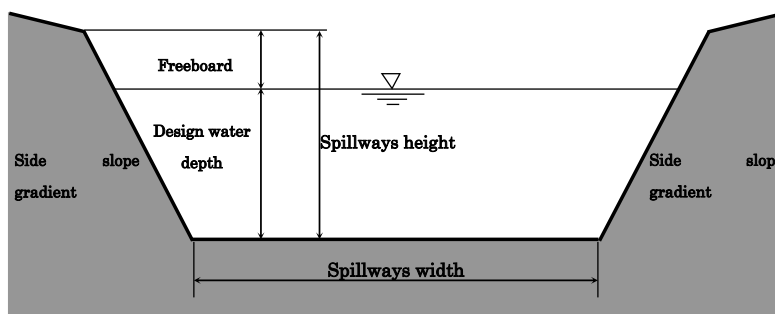
Figure 4-3 Overview of spillway

The components in the design of spillways are as presented in Figure 4-3 as follows.

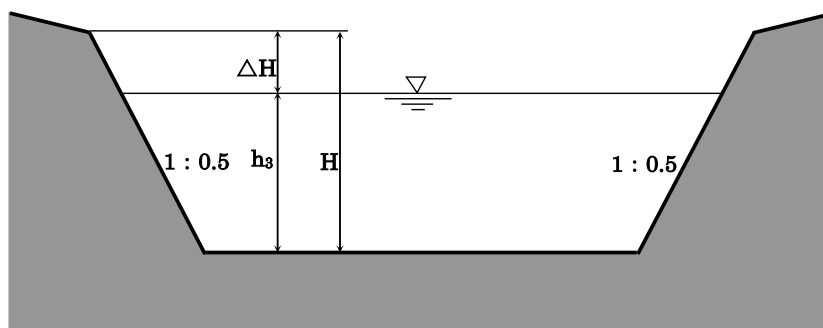
Figure 4-4 Overview diagram of Spillway

Construction Packages	Facility Name	Design Water Depth h_3	Freeboard ΔH	Spillway Height H
S2 Package	CD Kobokan 5	2.5 m	1.0 m	3.5 m
	CD Pelintas Curah Lengkong 2	3.3 m	1.4 m	4.7 m
S4 Package	KD Leprak 3	2.5 m	1.0 m	3.5 m

Construction Packages	Facility Name	Design Water Depth h_3	Freeboard ΔH	Spillway Height H
	DD Leprak 3	2.5 m	1.0 m	3.5 m
	DD Leprak 2	2.5 m	1.0 m	3.5 m

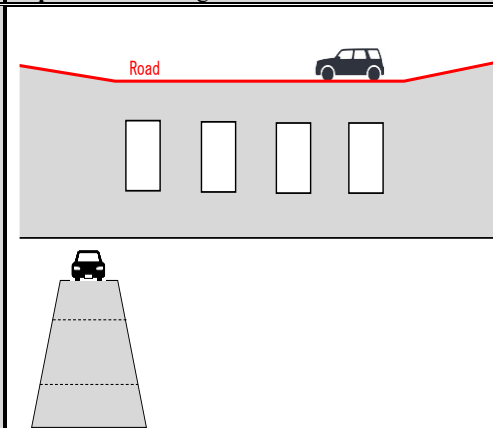
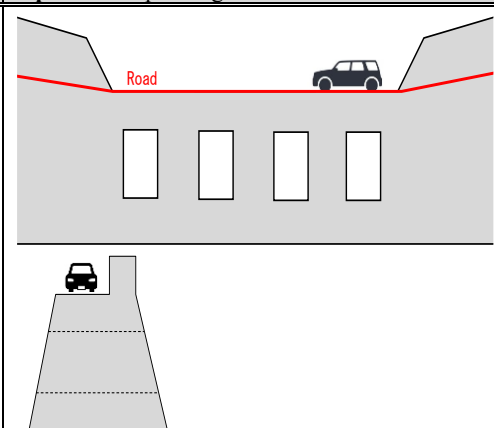
Table 4-18 Crest width for CD Kobokan 5 and CD Pelintas Curah Lengkong 2

Option 1: Utilizing the Crest as a Road	Option 2: Separating the Crest and Road
Overview Diagram

Plan Overview	Utilize the crest as a road without a water flow section.	Separate the crest and road, and include a spillway section.
Safety	Dam Structure: The crest width is smaller compared to Option 2, making it difficult to ensure safety against external forces such as wear and damage. △	Dam Structure: The crest width is larger compared to Option 1, ensuring safety against external forces such as abrasion and damage. ○
	Overflow Area: Without a spillway, the overflow will be wide and the downstream erosion area will be larger. △	Overflow Area: With a spillway, the overflow area is narrow hence minimizing the downstream erosion. ○
Economic Efficiency	Main Dam: Smaller crest width provides economic advantages compared to Option 2. ○	Main Dam: Larger crest width results in lower economic efficiency compared to Option 1. △

Downstream Riverbed Protection: Without a spillway, the downstream riverbed protection will be larger than Option 2, leading to less economic efficiency. △	Downstream Riverbed Protection: With a spillway, the downstream riverbed protection can be minimized, hence providing an economic advantage over Option 1. ○
Evaluation	△ Not Adopted	○ Adopted

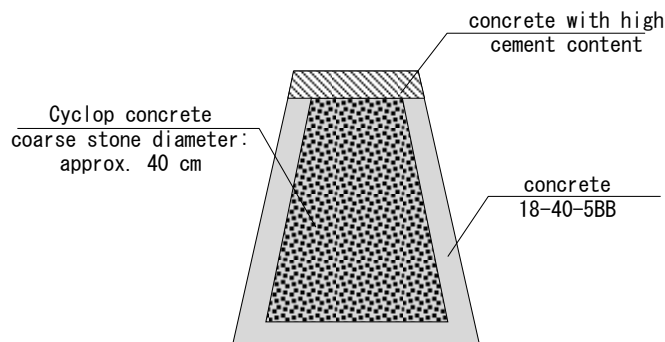
Figure 4-5 Embankment material (side view)

The overflow section of the dam is expected to withstand not only normal flow but also flood flows and debris flows, which could lead to wear and damage from fine sediment and gravel. Therefore, the crest of the dam will be protected to prevent this. The crest of the dam shall be constructed using high-cement-content concrete (300kg/m³).

The dam body will be constructed using concrete (18-5-40BB), and coarse stone concrete (Cyclop) shall be used as the filling material. The coarse stone shall have an approximate diameter of 40 cm.

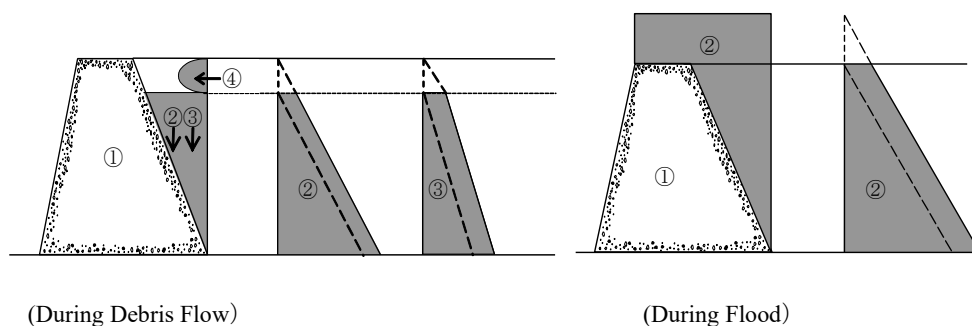
Figure 4-6 Design external forces for stability calculations of sabo dam *1

It is specified the stability conditions and design external forces for the sabo dam shall be shown in Table 4-23 and Figure 4-6.

Sabo Dam Heigh	Normal Conditions	During Debris Flow	During flood
Under 15 m		① Self-Weight ② Hydrostatic Pressure ③ Earth Pressure ④ Drag Force of Debris Flow	② Hydrostatic Pressure

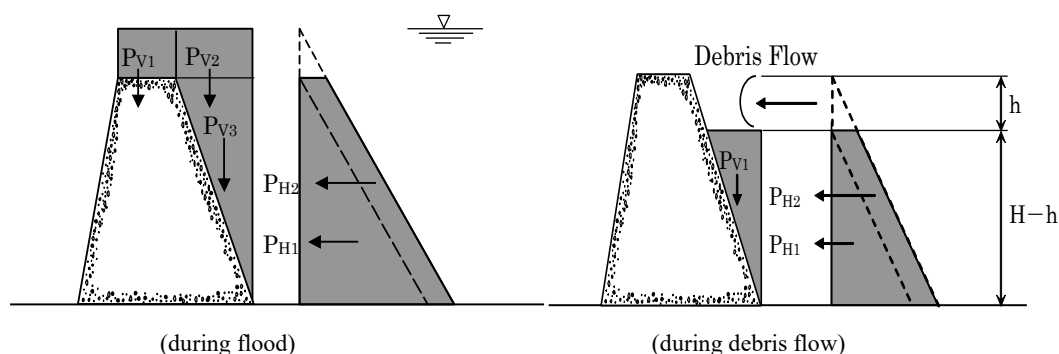
Figure 4-7 Hydrostatic pressure

It is specified that the hydrostatic pressure shall be calculated using the following formula. The water levels during flood events and debris flow events differ, as shown in Figure 4-7. The basis for calculating the hydrostatic pressure is provided in the Appendix 4-3-1.

$$P = W_o \times h_w$$

Where, P : Hydrostatic pressure at depth of h_w (kN/m³)
 W_o : Unit volume weight of muddy water (kN/m³)
 h_w : Depth of water (m)

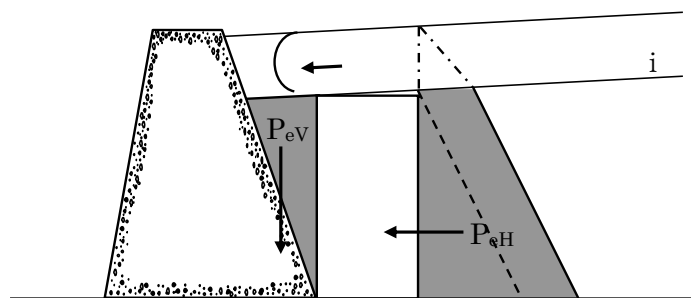
Figure 4-8 Sediment pressure

It is specified that the earth pressure shall be calculated using the following formula. The sediment height is obtained by subtracting the debris flow depth from the dam height, as shown in Figure 4-8. The basis for calculating sediment pressure is provided in the Appendix 4-3-1.

$$P_{eH} = C_e \times W_{si} \times h_e$$

Where, P_{eV} : Horizontal component of earth pressure (kN/m²)
 P_{eH} : Horizontal earth pressure (kN/m²)
 W_{si} : Unit weight of sediment in muddy water (kN/m³)
 h_e : Sediment height (m)
 C_e : Earth pressure coefficient

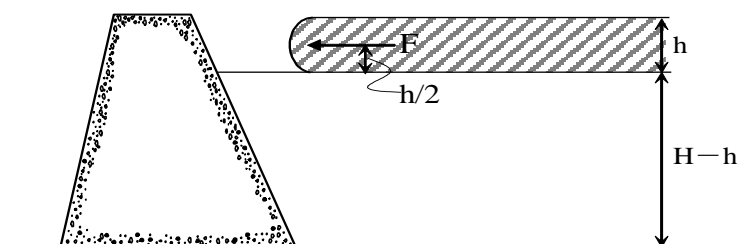
Figure 4-9 Drag force of debris flow^{※2}

The load due to drag force of debris flow is considered most dangerous against overturning and bearing capacity when the sediment accumulation space is nearly full, leaving only the depth of the debris flow as a space for impact. Therefore, the position of the debris flow force load is calculated by assuming that it acts at a height of $h/2$ from the crest elevation, as shown in Figure 4-9.

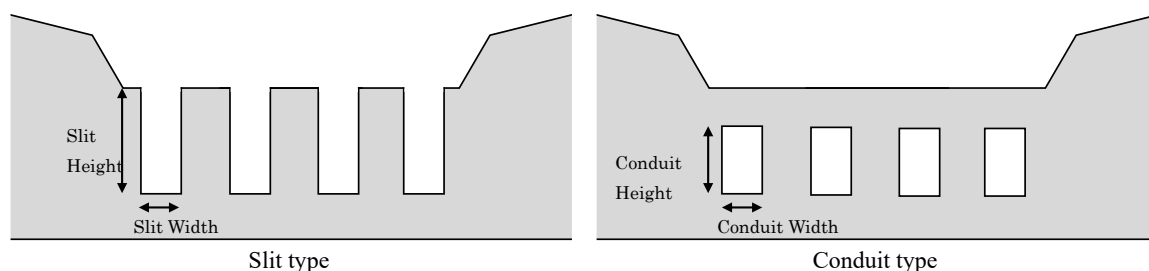
Figure 4-10 Type of the opening section

The proposed dam shall be an open-type sabo dam, designed to allow constant water flow through the openings. The opening type can be selected between slit type and conduit types. The slit type opening is prone to significant damage and wear due to collisions with boulders, as the piers (the concrete section between the slits) are vulnerable to this. Therefore, conduit type is preferred.

However, for the conduit type, a beam-shaped concrete section with an upper slab (at least 3-4 m in width) is required to integrate the left and right concrete sections at the top of the conduit. This will ensure the structural stability. If the dam height is restricted by topographic factors, making it impossible to provide an upper slab equal or greater than the top width, the slit type shall be used to maintain the required open space. As a result, it was determined to use a conduit type for the S2 area and a slit type for the S4 area.

(Refer to Figure 4-10 for the positional relationship)

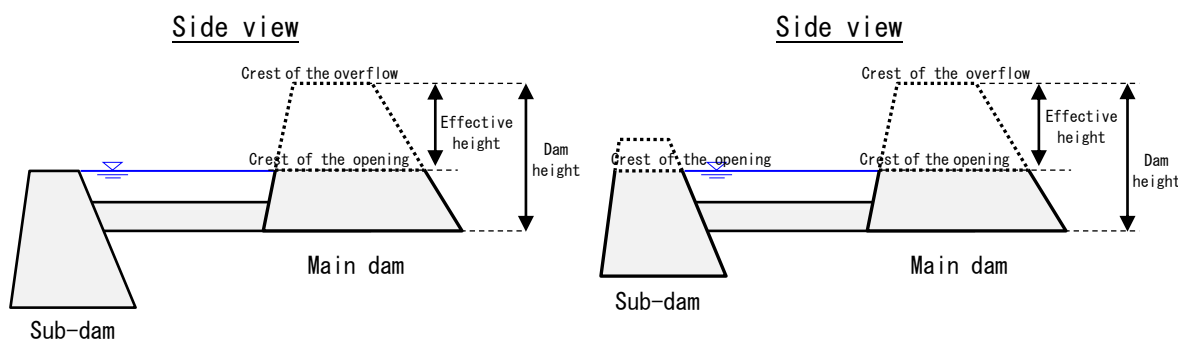
Figure 4-11 Outline of effective height and dam height

The study on the dam height is described in “3.8 Basic Design of S2 Area” and “3.9 Basic Design of S4 Area”. Heights for sabo dams are generally determined in 0.5 m increments. The summary of the effective height from the crest of the opening section to the crest of the overflow section and the total dam height are presented in Table 4-29. As shown in Figure 4-11, the elevation of the crest of the dam opening section is planned to be higher than the elevation of the crest of the sub-dam or the sub-dam’s opening.

Construction Package	Facility name	Effective height	Dam height
S2 Package	CD Kobokan 5	10.0 m	14.5 m
	CD Pelintas Curah Lengkong 2	8.5 m	11.5 m
S4 Package	KD Leprak 3	4.0 m	7.0 m
	DD Leprak 3	2.0 m	5.0 m
	DD Leprak 2	2.0 m	5.0 m

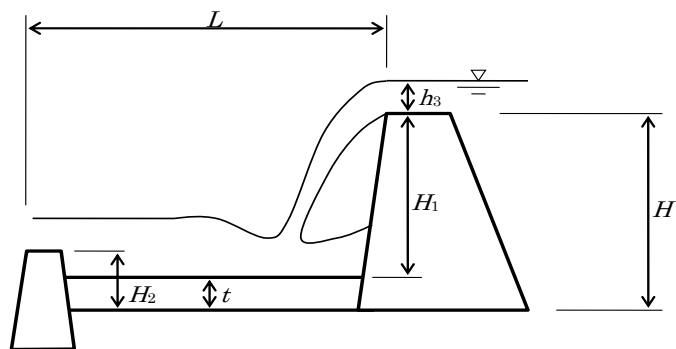
Figure 4-12 Positional relation between main dam and sub-dam

$$L = (1.5 \sim 2.0) \times (H_1 + h_3) \text{ (L is rounded up to the nearest 1.0 m)}$$

Where, L : Length of the apron (including the vertical wall crest) (m)
 H_1 : Effective height of the dam (dam height – apron thickness) (m)
 h_3 : Design water depth of the dam (m)

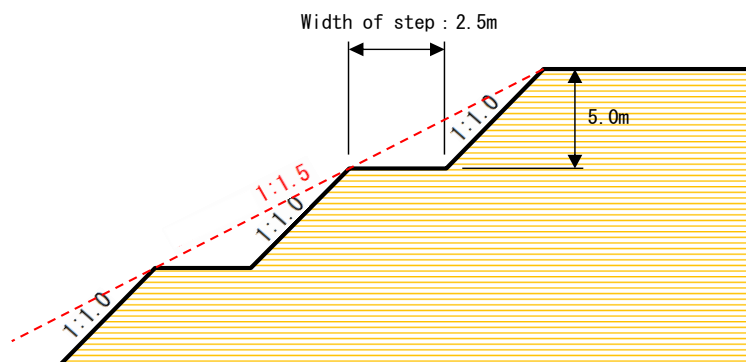
Figure 4-13 Schematic diagram of training dike slope

It is desirable that the slope of the training dike be as steep as possible in order to avoid the risk of overflow due to the debris flow climbing up the slope. Therefore, 1:1.0 is adopted for the dike gradient. However, It is specified that the stable slope of the embankment shall be 1:1.5^{※1}. For this reason, steps with width of 2.5 m are installed every 5m in height of the dike. The mean gradient of the dike slope including the steps is planned to be 1:1.5.

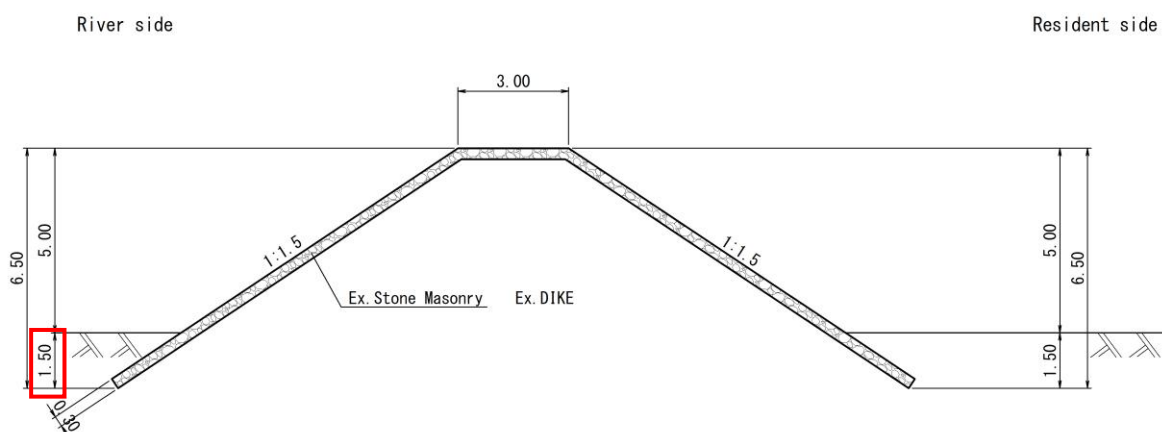
Figure 4-14 Embedment of existing training dike (example: Tanggul Leprak 22)

It is specified the foundation embedment for the training dikes shall be typically required to be at least 1.0 meters, as per standard practices*¹. However, existing dikes in Mt. Semeru area adopt a foundation embedment of 1.5 m (Figure 4-14). Since sand mining is carried out in the target area and considering possibility of excessive excavation due to sand mining, the foundation of dike is also planned to be embedded at 1.5m from the sediment management line.

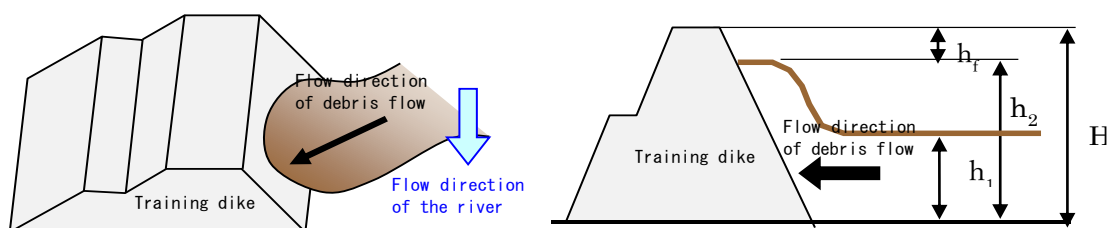
Figure 4-15 Hydraulic jump height (left: overhead view, right: cross-sectional view)

$$Fr = \frac{U}{\sqrt{gh_1}}$$

Where, h_1 : Water depth during debris flow (m)
 h_2 : Water depth during debris flow plus hydraulic jump height (m)
 U : Velocity of debris flow (m/s)
 Fr : Froude number
 g : Gravitational acceleration (m/s²)

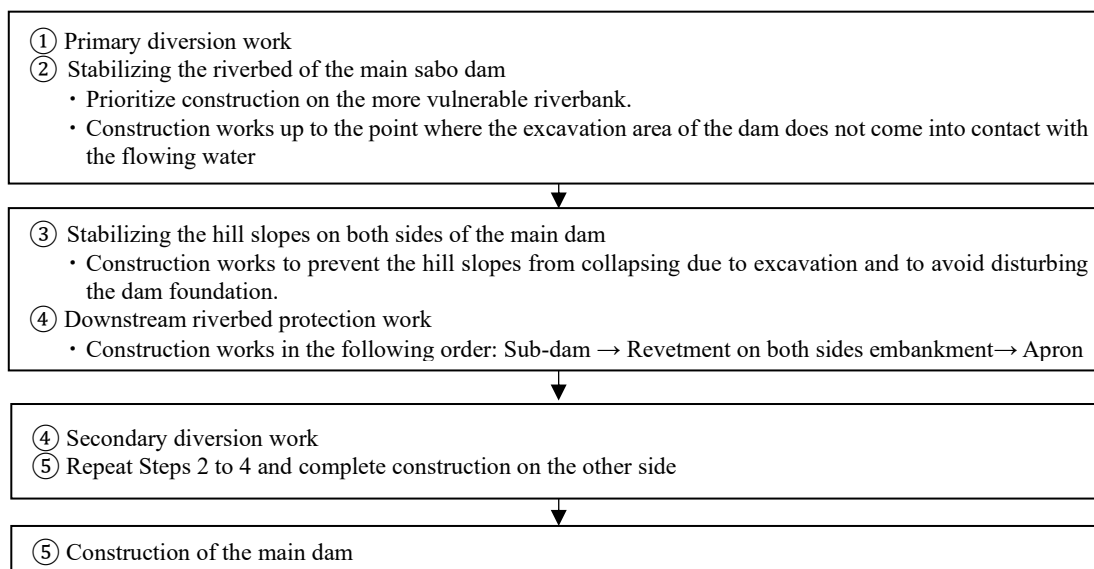
Figure 5-1 Construction procedures of Sabo dam

The construction sequence for sabo dam will follow the order shown in Figure 5-1 as the basic guideline. The starting side of the dam for concrete works is determined after a comprehensive assessment of factors such as access from the existing road, traffic flow from the equipment and material yard, temporary construction plans, and surrounding constraints. In this construction phase (S2 area and S4 area), access is available from the existing road on the left bank, and the equipment and material yard (proposed) are located on the same side. Therefore, to shorten the construction period and reduce costs, concrete works will begin from the left bank. Figure 5-2 illustrates the construction procedure for CD Pelintas Curah Lengkong 2 in the S2 area as an example.

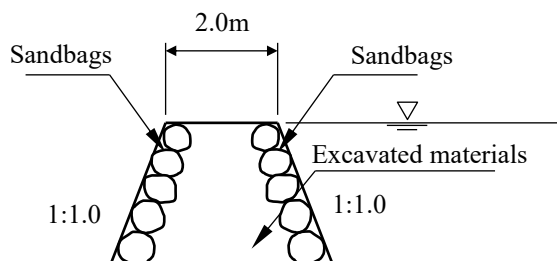
Figure 5-6 Cross-section of temporary cofferdam

In the half-river channel closure method, a temporary cofferdam is installed to guide flooding and to handle normal flow (Figure 5-6). The minimum width of the crest of the cofferdam is 2 m with a structure based on embankment structure using locally available materials. The cofferdam work is an earth embankment, and no freeboard is set up for the cross-sectional height of the diversion channel.

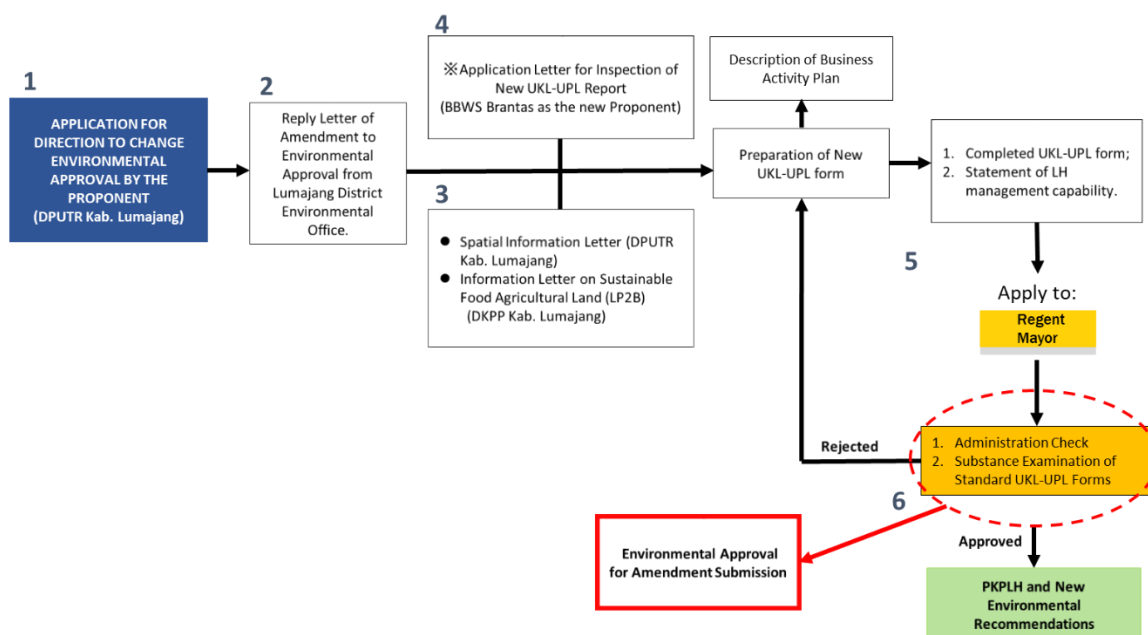
Figure 7-2 Environmental survey report revision workflow

Following discussions with DLH of Lumajang Regency, the regulatory body for environmental approvals, it was agreed to update the existing UKL-UPL as part of the process to secure revised environmental approval. The steps for updating the approval, carried out according to the workflow is presented in Figure 7-2.

1. DPUTR of Lumajang Regency requests modification of the environmental approval.
2. DLH of Lumajang Regency approves the modification request.
3. Notification regarding spatial planning changes is submitted to DLH, and notification regarding sustainable agricultural land is sent to the Food Security and Agriculture Agency (DKPP).
4. A request is submitted to change the implementing agency from DPUTR to BBWS Brantas.
5. The revised UKL-UPL is prepared and submitted to the Governor of Lumajang Regency.
6. The revised UKL-UPL forms the basis for approving the modification of environmental approval.
