Republic of Zambia  
Road Development Agency  
(RDA)

Republic of Zambia  
The Bridge Maintenance Capacity Building  
Project in Zambia, Phase II

**BRIDGE ROUTINE MAINTENANCE  
GUIDELINES**

(Guidelines and Guidebooks for Bridge  
Maintenance/ Management, Vol.1)

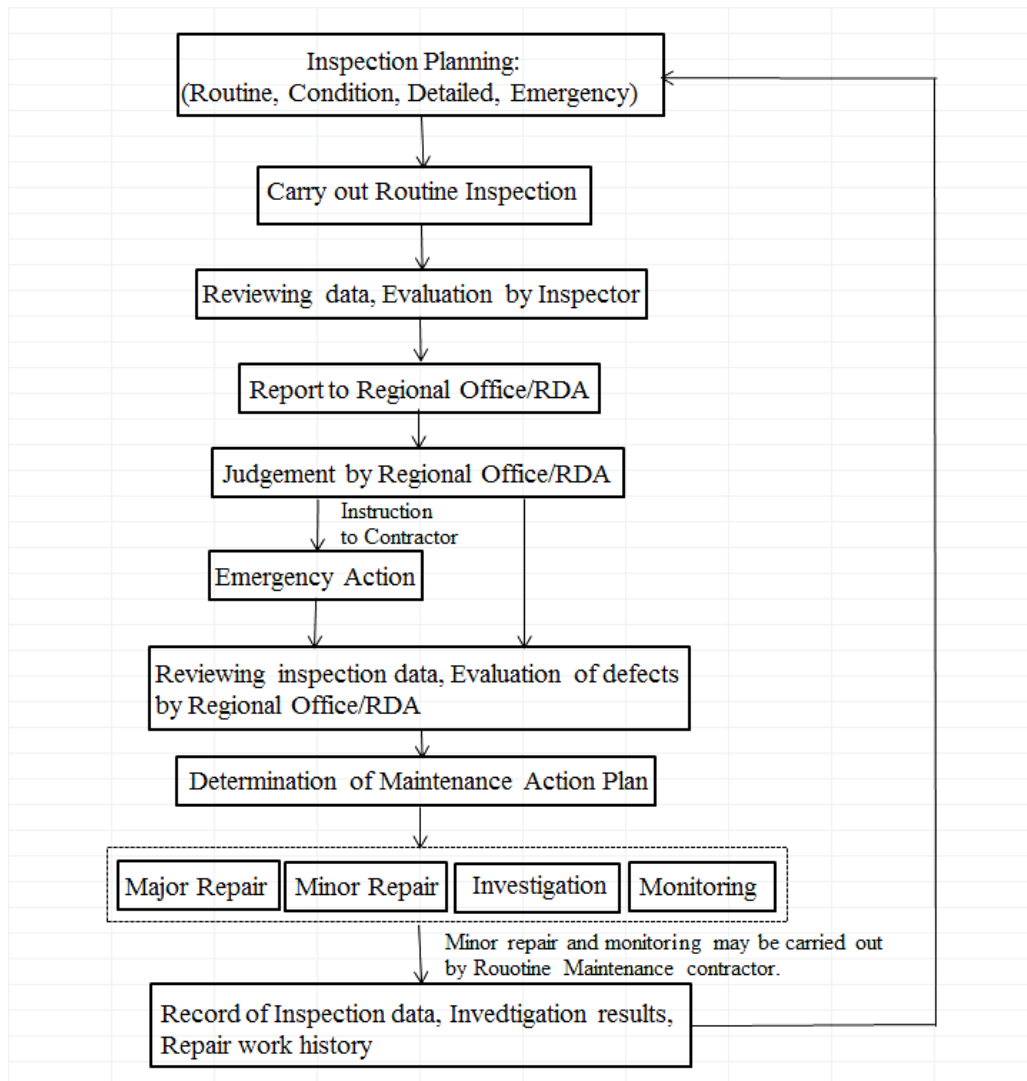
Figure 2-1 Routine Inspection Process

The process for conducting Routine Inspection is shown in Figure 2-1.

The procedure in accomplishing the Routine Inspection Forms and sketches is straightforward and involves visual inspection. The Routine Inspection Forms and is shown in Table 2-4. A copy of the previous Routine Inspection report should be brought to the site as reference. The bridge inspector of contractor, responsible for bridge routine maintenance, should review that the defects, actions and condition ratings for the bridge as listed in the previous inspection reports are accurate and without oversight. The contractor's inspector should check the defects and draw them on sketch drawings sheet, as needed, and photographs should be used to document any major defects or situations concerned. Upon returning to the office, the inspectors determine the Routine Inspection Condition Rating and required maintenance action plan based on the severity of defects. The result of inspection should be compiled as a deliverable and submitted to the regional offices/RDA. If there are any defects that require Emergency Action (AE), it should be reported immediately without waiting for the completion of report. Immediately judged by the regional office/RDA, the contractor will be instructed to carry out emergency repair including temporary work. The condition rating for Routine inspection and Required Maintenance Actions for each defect are shown in Table 2-1 and 2-2. Regarding inspection intervals, this routine inspection shall be in principle performed as frequently as every three months: e.g. 2 times in wet season and 2 times in dry season. In particular, the inspections related to waterways should be carried out after any significant storm events.

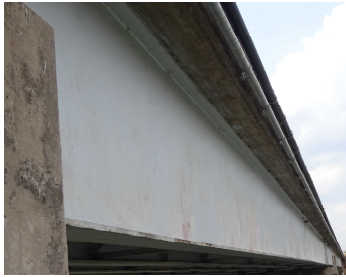
Location	Defects	Photography	Causes/Measure
Steel Superstructure	Paint Peel-off

Pinpoint rusting can occur at pinholes in the paint, which are tiny, deep holes in the paint exposing the steel. It can also be caused by thin paint coverage.  Measure: Touch-up/Re- Painting

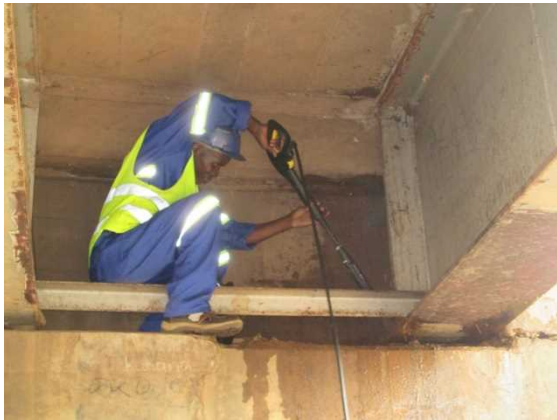
Photo 4-1 Cleaning of Bearing

To prevent deterioration of the bridge structure, cleaning works should be performed including removal of all accumulated foreign materials from the entire bridge such as its deck, sidewalk, curbs, top of pier, trusses and its web members, lower flanges of beams or girders, cleaning of expansion joints, bearing, wind bracing and drains. Areas which have been cleaned shall be ensured free from accumulated sand, gravel, dirt, and other foreign materials.

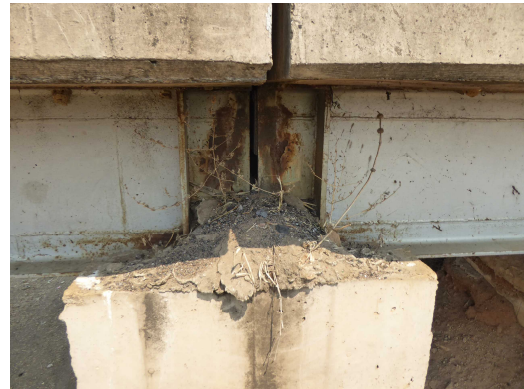
Photo 4-4 Vegetation and Soil on the Girder

All foreign materials such as dirt, dust, sand, rainwater and moss on concrete surfaces and at the gaps between girders shall also be completely removed manually and then washed using a high-pressure water bluster. The following areas on the deck should also be carefully cleaned:

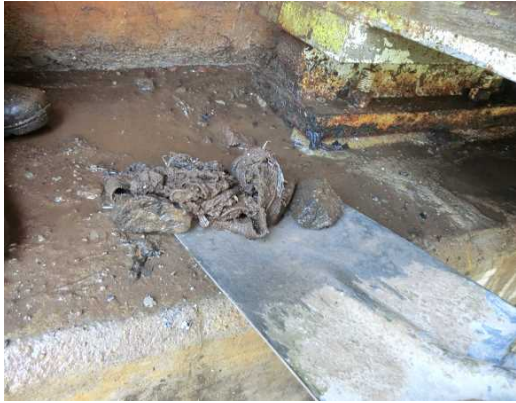
Photo 4-8 Mud, Debris & Sand on Bearing

All foreign materials such as dirt, dust, sand, ponding water, and moss on surfaces of the bearings, the cap of the pier and abutment, and other locations shall be completely removed manually and then washed using a high-pressure water bluster. Mud and sand deposits at the sides of the abutment shall be excavated to maintain its original distance from the river bank.

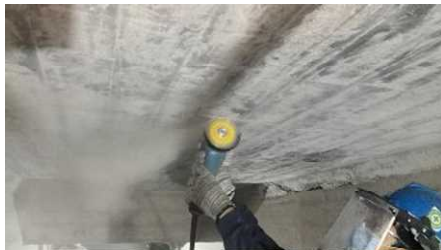
Cutting of spalled area using a grinder.

If the reinforcement is covered with loose corrosion elements and has developed pits, all the rust should be removed by power tools or wire brushing. Protection to the reinforcement can be provided by the use of zinc-rich epoxy primer.

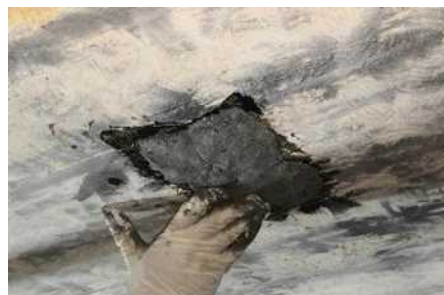
The mortar should be placed in layers of about 20 mm thick. If the thickness exceeds 20 mm, it should be applied in two layers. Compact each layer thoroughly over the entire surface using a wooden trowel or hammer. Generally, there should be no time delays between the placing and compacting of layers.

- Hand-mix the emulsion and water for two (2) minutes.
- Put the mixed emulsion and water into the Pail and then add Polymer Cement Mortar. The mixture should be hand-mixed for two (2) minutes as well.

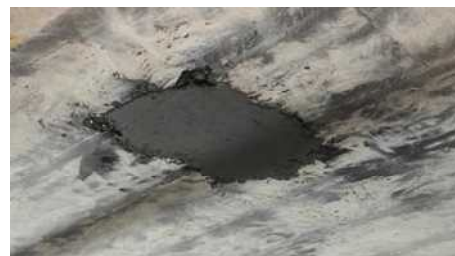
All types of cement repairs need thorough and continuous curing to develop strength and impermeability, and to minimize drying shrinkage while bond strength is developing. For initial curing, the surface should be covered with plastic against direct sun and wind and a waterproof coating can be applied for further protection.

Let the polymer cement mortar cure for 5 hours.

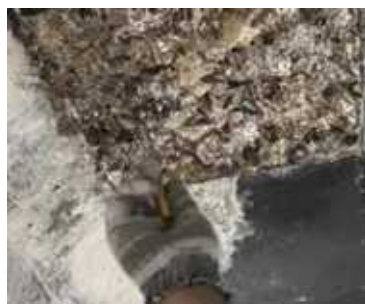
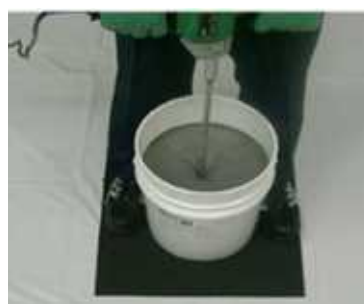
The table below shows the mixing ratios of the Poymer Cement Mortar. However, due to its fast setting property, it is advised to only prepare half a bag of Poymer Cement Mortar at a time to avoid wasting the material.

Poymer Cement Mortar		WATER	TOTAL YIELD		COVERAGE (@10mm Thickness)
POWDER	EMULSION		WEIGHT	VOLUME	
15Kg/Bag	1.65Kg	2.25~2.5Kg	18.9~19.15Kg	12Liter	1.2m <sup>2</sup>

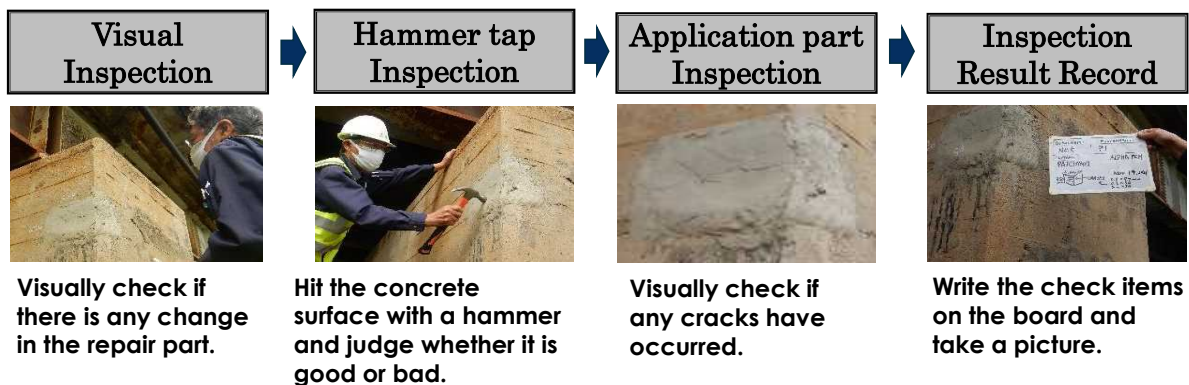
Hammer tap inspection :

When struck with a hammer, the concrete in good condition will produce a ringing sound while the concrete that has voids, cavities etc will produce a flat or hollow sound. A good tapping waveform has a short decay time and a high-frequency distribution.

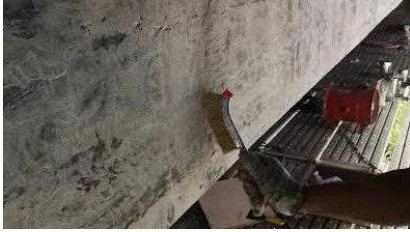
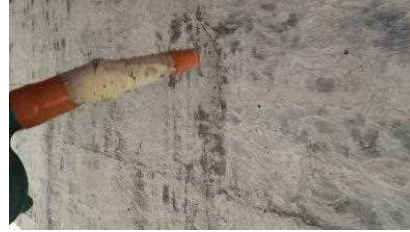
The concrete surface shall be cleared from dust, loose dirt and other foreign materials using a steel brush and vacuum/blower.

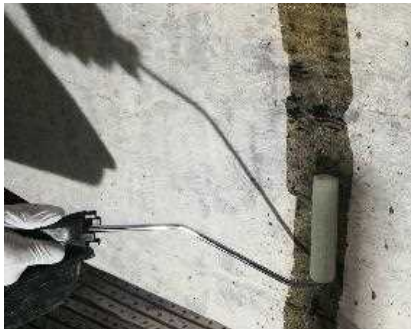
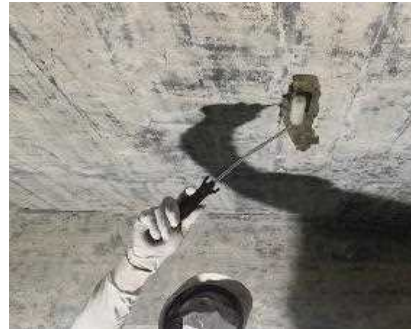
Using a 5 cm (2 inches) wide roller brush, apply the sealant to concrete cracks. If the cracks are straight, a wider roller may be used. The Epoxy Sealant starts to rise from the cracked surface right after application but eventually moves inside the crack. The speed of penetration varies depending on the crack situation.

Repeat this application about 10 times within 30 minutes. The pot life of the sealant is 30 minutes (if the temperature is at 30 °C).

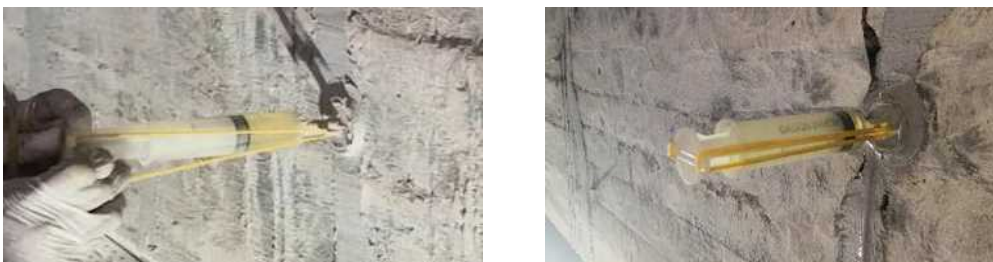
Set all of the cylinders to the entry ports after filling them with the Epoxy Resin, and then fasten rubbers to the cylinders to apply low pressure. If the crack is vertical, commence the setting of cylinders at the lowest entry port fitting to the topmost port. For a horizontal crack, the placing of cylinders onto the ports is done from one end of the crack to another. Continue the injection until there is no more epoxy discharged from the cylinders.

Let the Epoxy Resin cure overnight (about 12 hours), prior to the removal of the cylinders and entry ports. Any damaged areas shall be made good to the satisfaction of the Engineer.

If it leaks 1 to 2 minutes after injection, remove the cylinder and inject again.

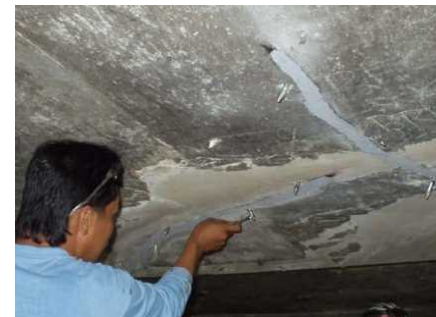
Apply the sealant into the groove using a caulking gun to ensure a smooth continuous flow. The sealant should be tooled to a smooth finish using a spatula.

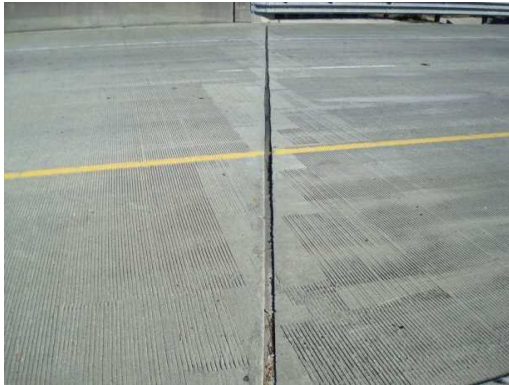
Before Repair

The need for repairs to this joint usually results from the sealant material coming loose and falling out of the joint or the joint becoming tight from filling with incompressible materials which enter through a broken seal at the top.

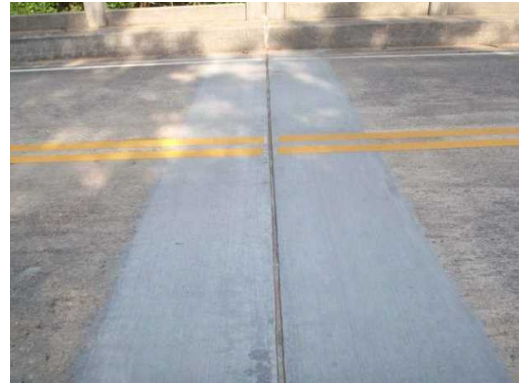
After Repair

To repair a defective joint it should first be cleaned of all dirt, refuse, and existing sealant. Caulk joint gaps with backup material and seal joints using a sealant.

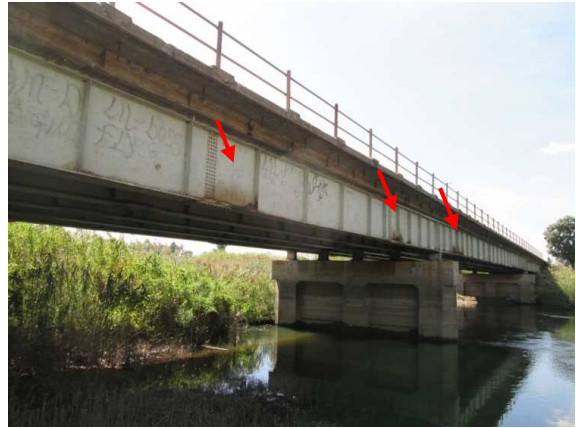
Photo 4-13 Deterioration at drain locations

This operation is performed to carry water discharge of drains away from supporting structure members. Many bridges were built with short deck drains at the gutter line that barely go through the deck. Most of these drains are located close to the girders. Exposure to moisture causes a fast rate of girder deterioration at these locations for both steel and concrete bridges. If clearance to the roadway is not critical, the drain pipe should be extended at least 20cm from the bottom of the girder flange.

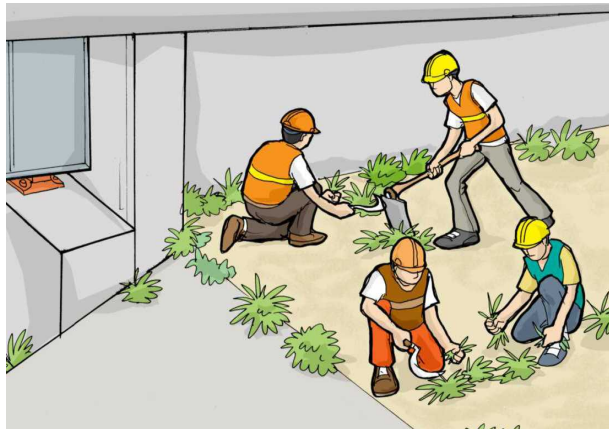
Figure 4-12 Removal of Grass and Shrubs near the Bridge

Grass shall be cut 20 cm or less in height. Shrubs and trees shall be cut to ground level and where there is a need to uproot shrubs, done with the approval of the Engineer. The application of herbicide to kill the tree's root system should be approved by the Engineer.

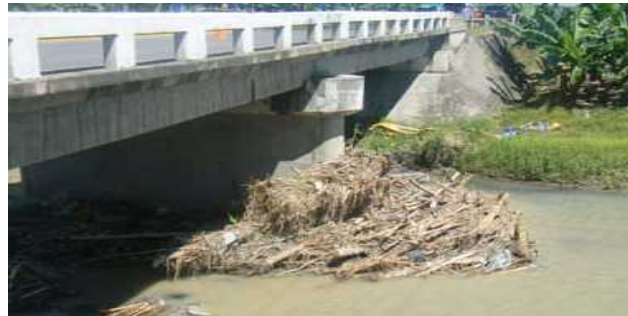
Photo 4-17 Accumulated Drift Wood and Plants around Pier

The works involve the removal of debris and driftwoods from the river channel and overbank area and disposal to a designated area. This operation is performed to prevent scour and erosion of fills under abutments and piers. Excess deposited material reduces the hydraulic efficiency of the waterway and places an excessive lateral load on the whole structure.

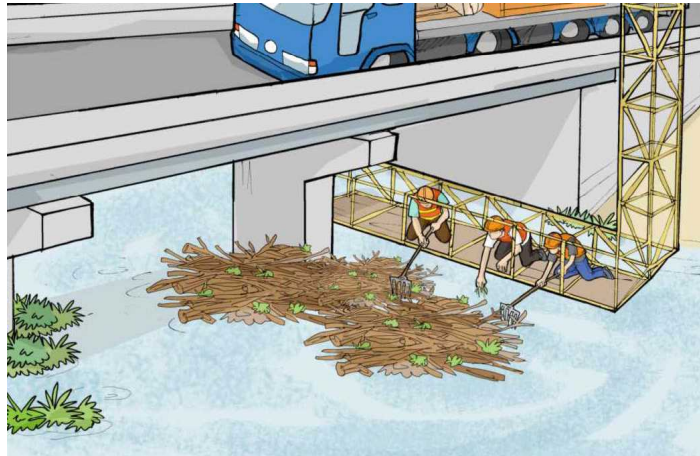
Figure 4-13 Removal of Drift Wood around Piers

If there is difficulty to access the driftwoods piled around piers in the river channel, an access device is necessary for its removal. An inspection vehicle in place of scaffolding can be utilized.

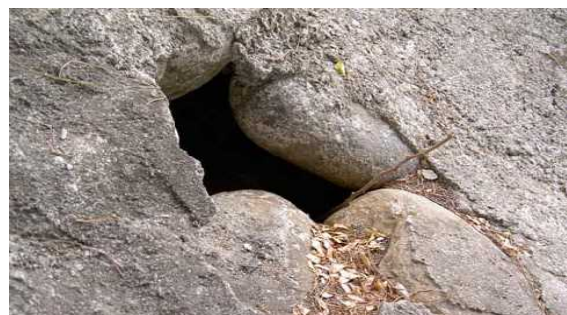
Photo 4-18 Missing Stone on Wet Masonry

The works involve a restoration of the missing stones from masonry.

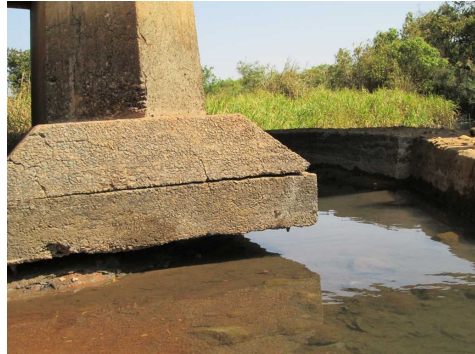
Photo 4-19 Exposed Pier Footing

The Gabion Mattress is used for all areas at and adjacent to bridge substructure units that are subject to scour. When footing/pile-cap of abutment/pier is exposed, this protection prevents further inward erosion.

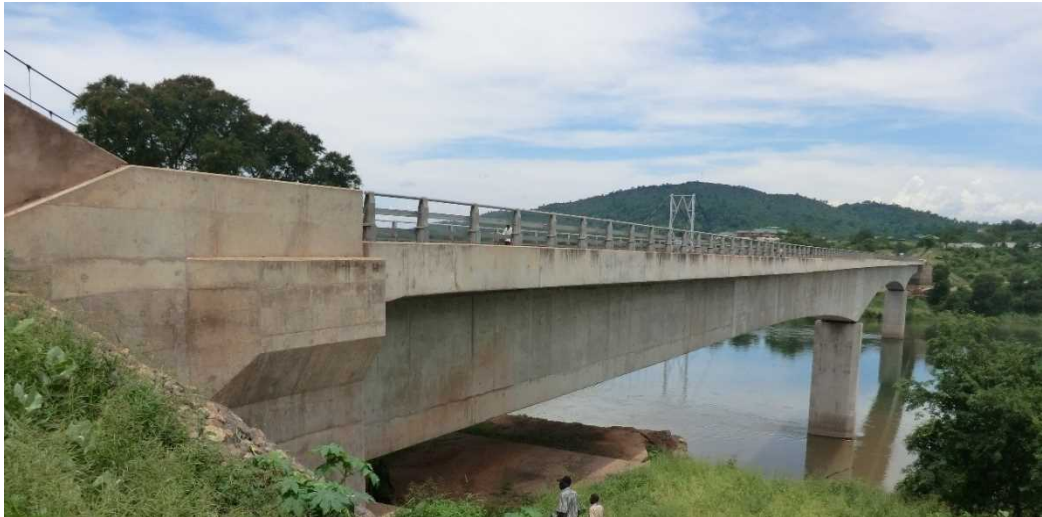
Figure 5-1-1 Structural System of Prestressed Concrete Box Girder Bridge

Prestressed concrete structure (hereinafter referred to as PC structure) is one in which a compressive force is introduced to concrete using the prestressing steel in advance not so as to be generated tensile stress. Even if cracks occur due to excessive load, the cracks will close after removing the load.

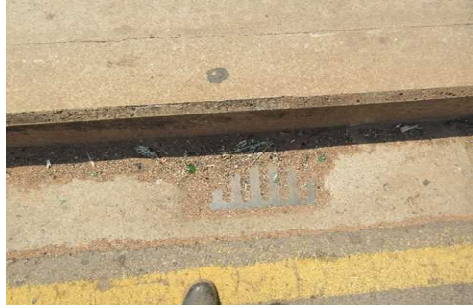
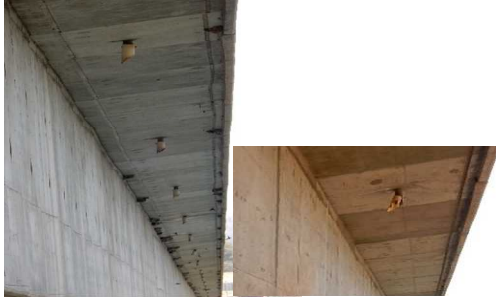
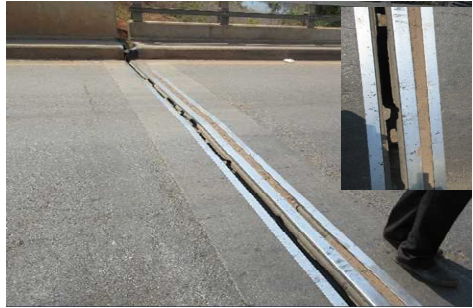
Date:	2019/8/28	Date:	2019/8/28	Date:	2019/8/28
No.:	1	No.:	2	No.:	3
Defect Type:	Accumulation of debris	Defect Type:	Insufficient length	Defect Type:	Brakage of rubber material
Description:	The drain outlets of the carriageway on the downstream side (Otto Beit Bridge side) is buried with earth and sand throughout the bridge.	Description:	The drain pipes under the girder are extremely short.	Description:	Both expansion joints (Hybrid Joint) are damaged.

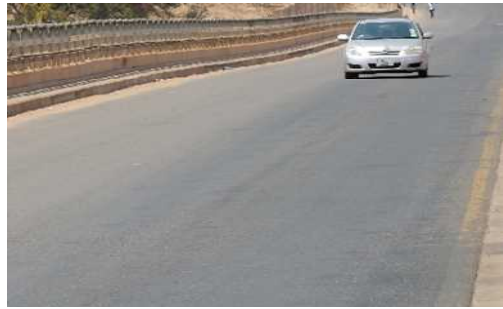
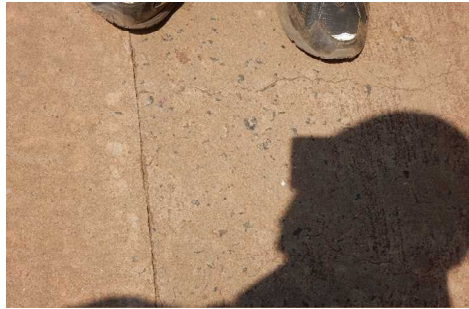
Date:	2019/8/28	Date:	2019/8/28	Date:	2019/8/28
No.:	4	No.:	5	No.:	5
Defect Type:	Abnornal deflection	Defect Type:	Cracks	Defect Type:	Cracks
Description:	The bridge surface in the central span looks like to have sunk.	Description:	Cracks in the transverse direction to the bridge axis, which seems to be due to bending moment, are seen on the kerb and sidewalk surface on the intermediate support points (pier).	Description:	Same as the left

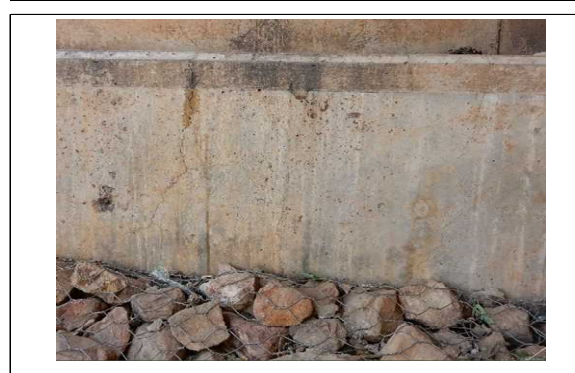
Date:	2019/8/28
No.:	6
Defect Type:	Cracks
Description:	There are many vertical cracks in the front surface of the Zambian side abutment.

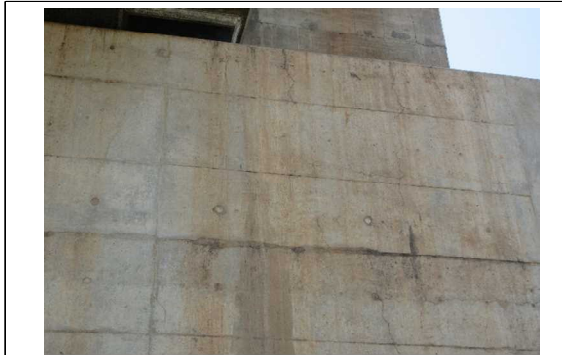
Date:	2019/8/28
No.:	6
Defect Type:	Cracks
Description:	There are many vertical cracks in the front surface of the Zimbabwe side abutment.

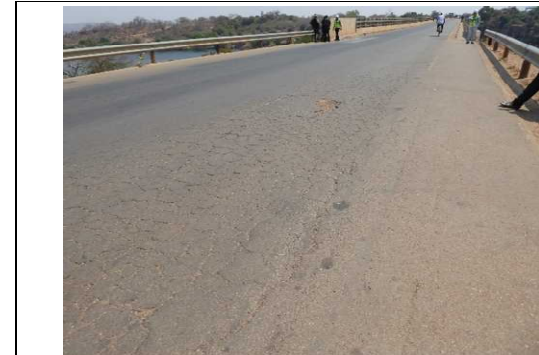
Date:	2019/8/28
No.:	7
Defect Type:	Cracks on pavement
Description:	Many alligator cracks are seen on the pavement of the Zimbabwe approach.

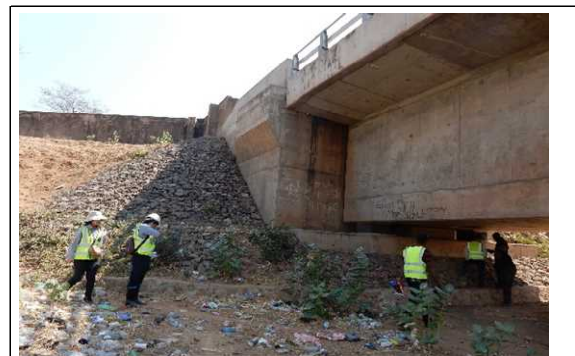
Date:	2019/8/28
No.:	8
Defect Type:	Acumulation of garbage
Description:	A lot of garbage such as plastic bottles is scattered around the Zambian side abutment.

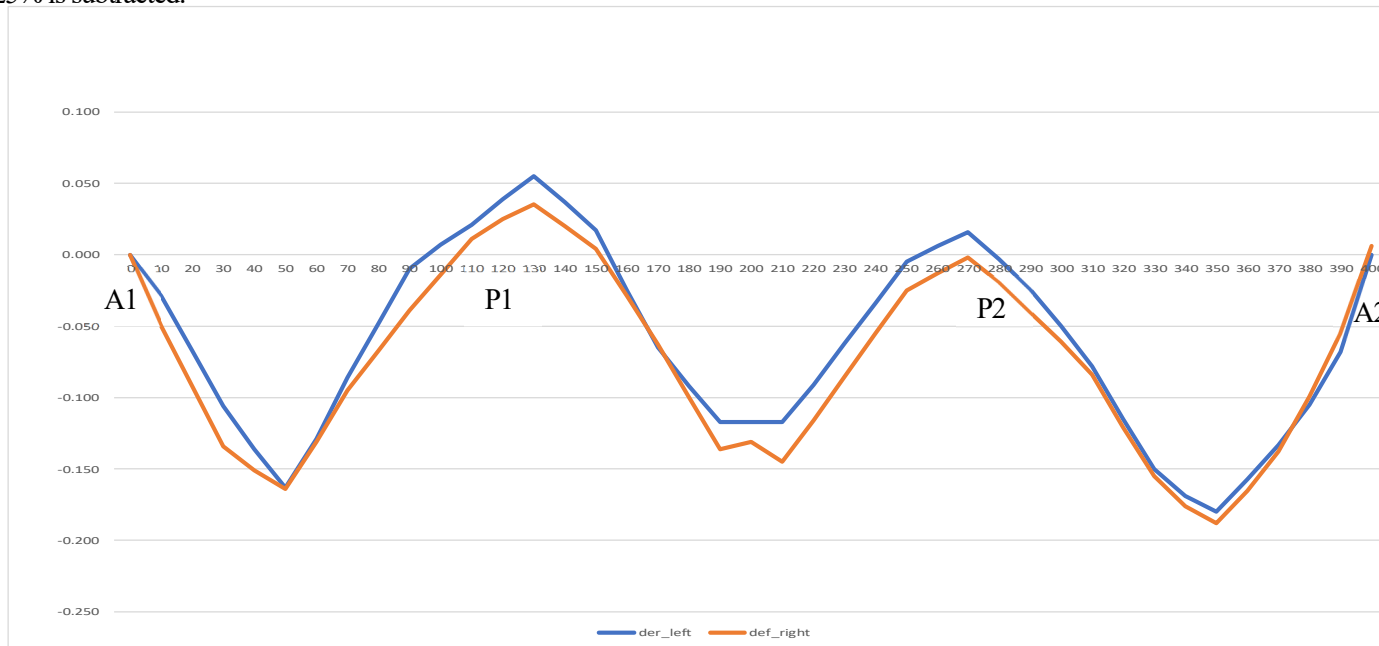
- Many of the defects observed during the 2019 inspection are about the same condition in this inspection.
- These are the damage of the rubber materials of the expansion joints, transverse cracks on the sidewalk and deck surface beside the sidewalk near the intermediate support points, vertical cracks on the front surfaces of the abutments, cracks on the Zimbabwe side approach pavement.
- What is different from the observation result in 2019 is that the previous inspection result in 2019 reported that the bridge surface of the central span seemed to subside, but this time, the RDA survey team measured the vertical profile of the bridge.
- As a result, it is clear that all three spans subsided. From the survey results, the vertical profile of the bridge becomes the vertical curve in the figure below when the vertical gradient -1.25% is subtracted.

- Even when observed with the naked eye in the field, all three spans appear to be lowered. The amount of subsidence is 16 cm in the Zambia side span, 12 to 15 cm in the central span, and 18 to 19 cm in the Zimbabwe side span.

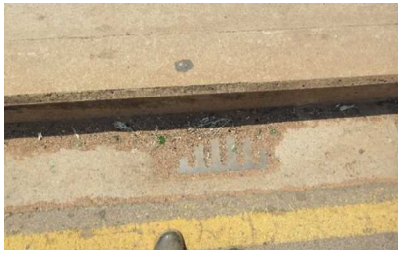
Location+A2:D7	Defects	Photography	Presumed Causes
Drainage (Scupper)	Accumulation of debris

Soil that adhered to the vehicle or was carried by the vehicle fell on the road surface and was carried to the drain scupper by rainwater/wind and accumulated.
Drainage (Drain pipe)	Insufficient length

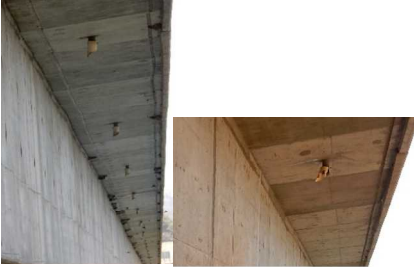
If the drain pipe is short, when it rains with wind, the water flowing down from the pipe is blown by the wind and hits the girder. The water seeps into the girder and may eventually lead to corrosion of the steel. When rainwater contains chloride ions, the progress of corrosion is especially fast.
PC Girder	Abnormal deflection

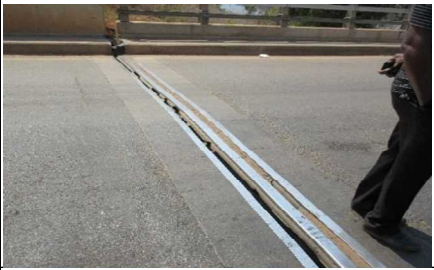
Expansion Joint	Brakage of rubber material

After the bridge was completed, the shrinkage strain due to the drying of the concrete and the creep strain due to the action of the sustained stress due to the dead load progressed more than expected, and as a result, the deflection of the girder increased. Therefore, it is presumed that the rubber bearing was deformed and destroyed diagonally downward toward the river, the expansion joint was pulled in the direction of the bridge axis, and the rubber part could not withstand and was damaged.
Sidewalk, Kerb	Transverse cracks on pier (P1, P2)

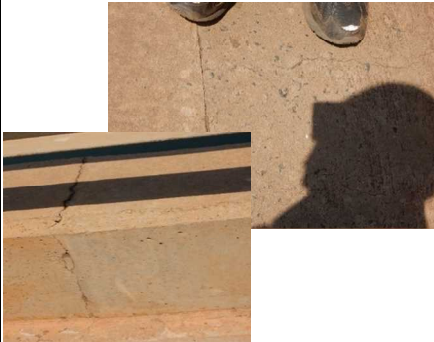
Cracks are seen on the sidewalk surface on the piers due to the negative bending moment. The state of the upper surface of the main girder should be inspected.

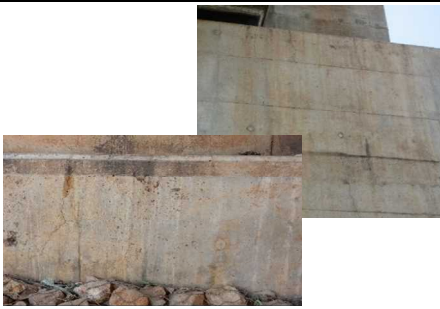
Abutment	Vertical cracks

The following cause is considered: Cracking occurred because the temperature deformation due to the heat of hydration was constrained by the temperature difference between the post-cast and the first cast and/or the temperature difference in the cross section.
Approach Pavement	Cracks

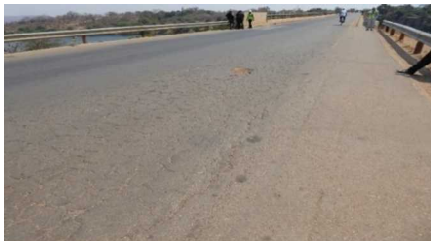
It would be considered a cause of damage that heavy vehicles repeatedly passed the pavement over a long period of time.
Around Zambian side abutment	Accumulation of garbage

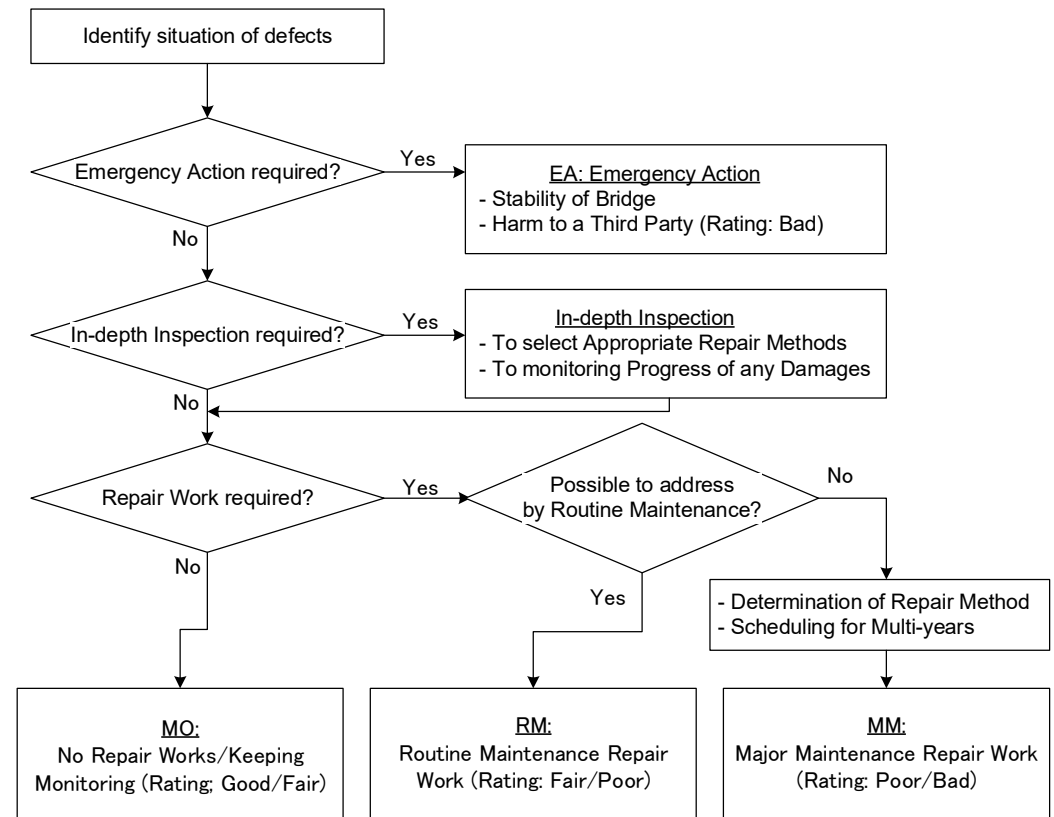
Figure 1 Determination Flow of Maintenance Action

Required Action	Description
MO: Monitoring	No repair work and keeping monitoring (Damage not progressing or very slow)
RM: Routine Maintenance	Should be maintained by Routine Maintenance
MM: Major Maintenance	Should be maintained by Major Maintenance
EA: Emergency Action	Need to take actions immediately to avoid bridge collapse or harm to a third party
In-Depth Inspection	Condition Inspection or Detailed Inspection - Selection of appropriate repair method - Monitoring of progress of any damages

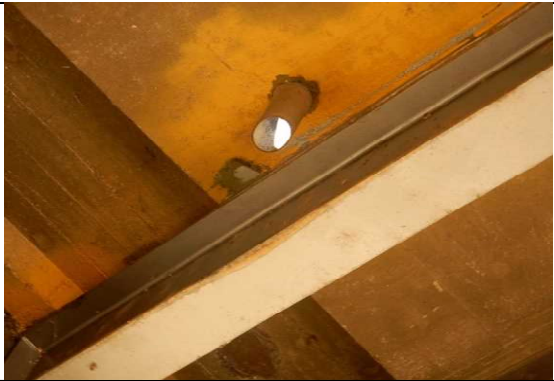
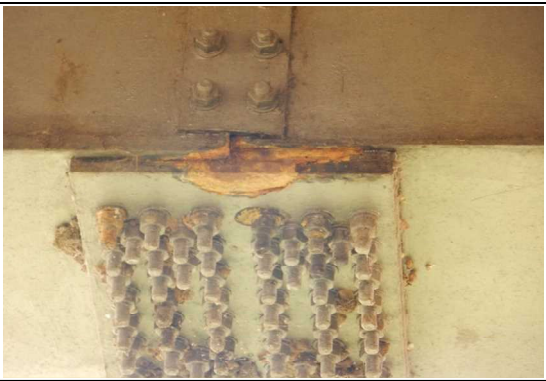
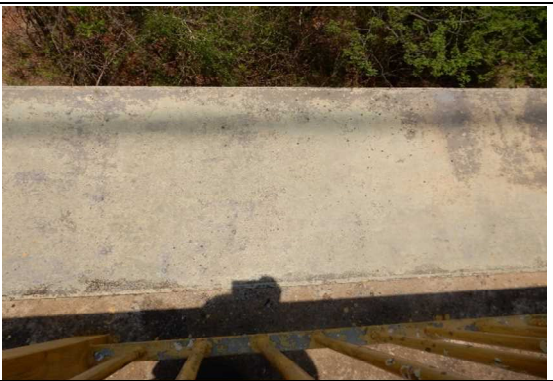
Date:	27/10/2020	Date:	27/10/2020	Date:	27/10/2020
No.:	1.1	No.:	1.2	No.:	1.3
Defect Type:	Short drain pipe & corrosion on cross beam	Defect Type:	Corrosion on girder joint	Defect Type:	Paint deterioration on upper flange of main girder
Description:	Insufficient length of drain pipes (all pipes), cross beam near the drain pipe is corroded.	Description:	Many joint plates and bolts are corroded.	Description:	Paint deterioration is observed on upper flange of main girder.

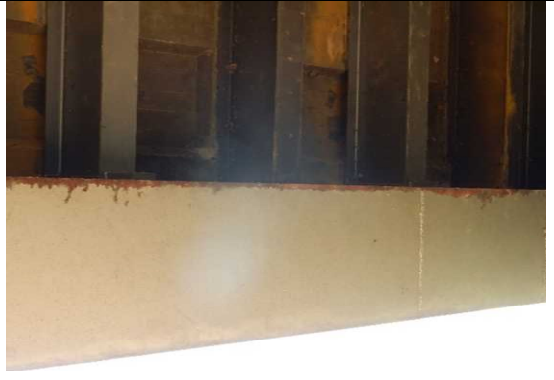
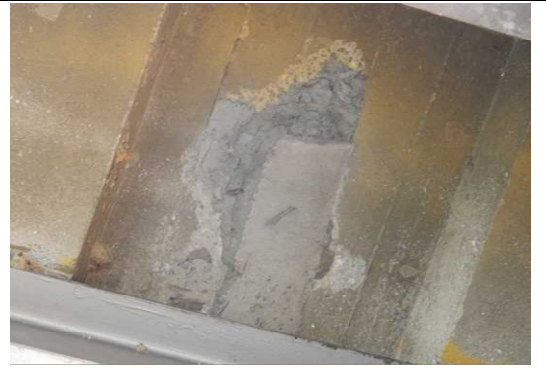
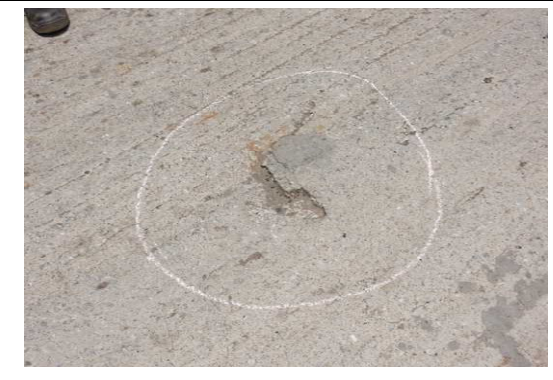
Date:	27/10/2020	Date:	27/10/2020	Date:	27/10/2020
No.:	1.4	No.:	1.5	No.:	1.6
Defect Type:	Corrosion on girder lower flange	Defect Type:	Spalling on bottom surface of deck slab	Defect Type:	Spalling & disintegration on top surface of deck slab
Description:	Corrosion is observed at the edge of lower flange on the main girder.	Description:	A big spalling is observed on bottom surface of deck slab.	Description:	Spalling & disintegration are observed on the top surface of deck slab.

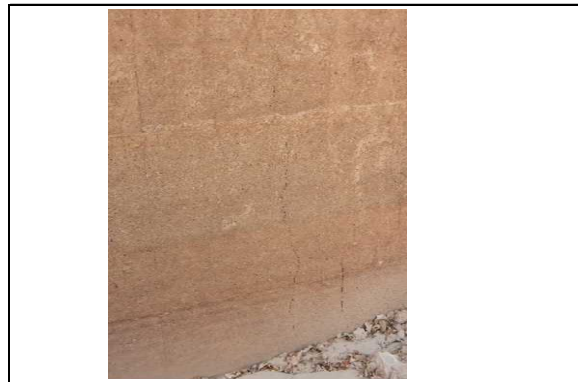
Date:	27/10/2020
No.:	1.14
Defect Type:	Cracks on western side pier (P1)
Description:	Cracks are observed on the eastern side wall of western side pier P1.

Cracking occurred early stage after the construction because the temperature deformation due to the heat of hydration was constrained by the temperature difference between the concrete placed first and the concrete placed later and/or the temperature difference in the cross section.

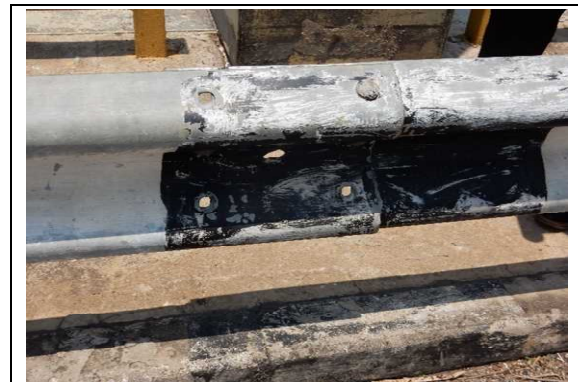
Date:	27/10/2020
No.:	1.15
Defect Type:	Missing bolts on guardrail
Description:

Probably due to a vehicle collision.
Abutment A1, A2	Crack

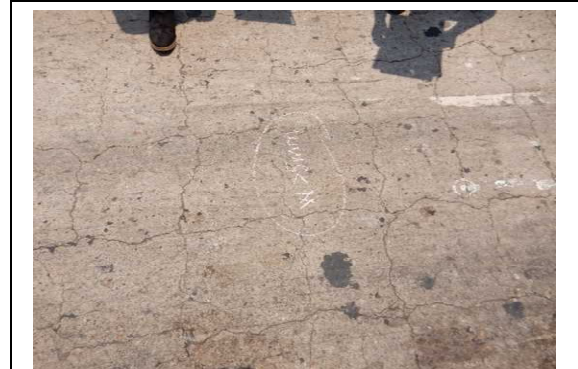
Date:	27/10/2020
No.:	1.18
Defect Type:	Cracks on approach slab
Description:	Many longitudinal & transverse cracks are observed on the approach slab

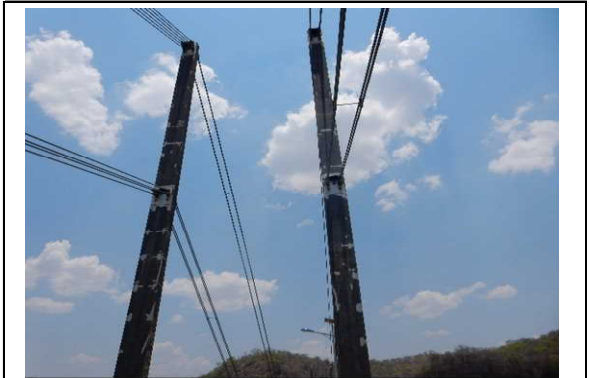
Date:	27/10/2020
No.:	1.2
Defect Type:	Paint deterioration on tower
Description:	Paint deterioration is observed on all tower members.

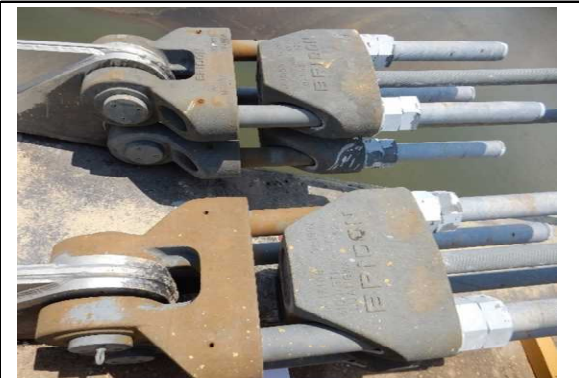
Date:	27/10/2020
No.:	1.21
Defect Type:	Corrosion & paint deterioration on anchorage
Description:	Corrosion & paint deterioration are observed on most anchorages.

It is considered that the paint has deteriorated due to repeated dry and wet for many year. Deterioration of the upper surface of the anchor portion was accelerated by the retention of rainwater.
Cable System (Cable)	Vibration (observed when heavy vehicles loading the bridge)

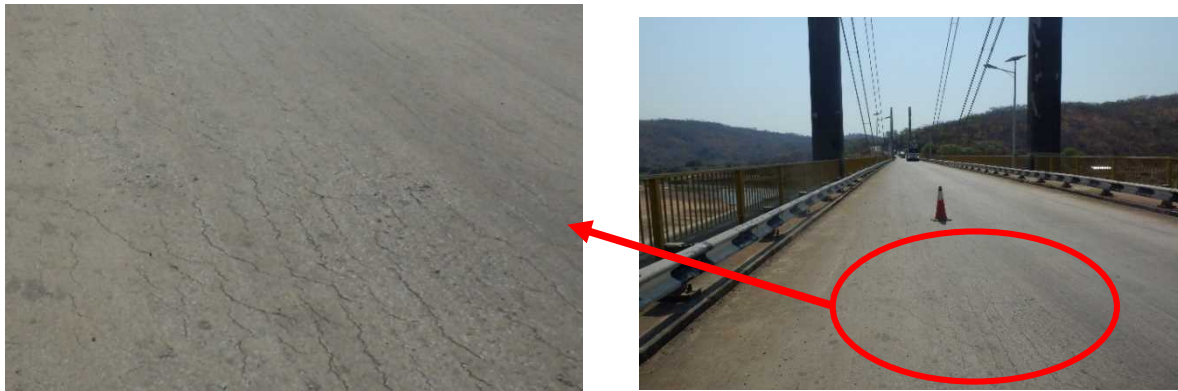
On the top surface of the concrete deck slab, the pavement layer is worn and the concrete surface is exposed. Moreover, many cracks are seen over the entire bridge length. Cracks in the bridge axis direction and in the bridge transverse direction were observed, especially more cracks in the bridge axis direction.

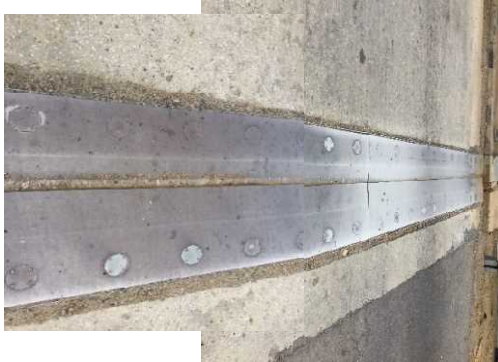
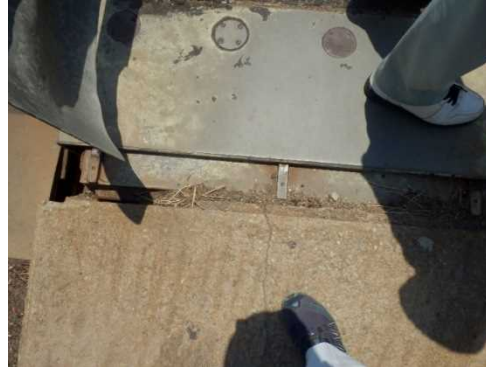
In the Lusaka side expansion joint (steel lap joint), the steel plate on the bridge side moves back and forth when a heavy-loaded vehicle passes by, and a squeak noise is generated. It was observed that there was a large movement when the vehicle was traveling from the center of the bridge to the tower on the Lusaka side, not when the vehicle was passing over the expansion joint.

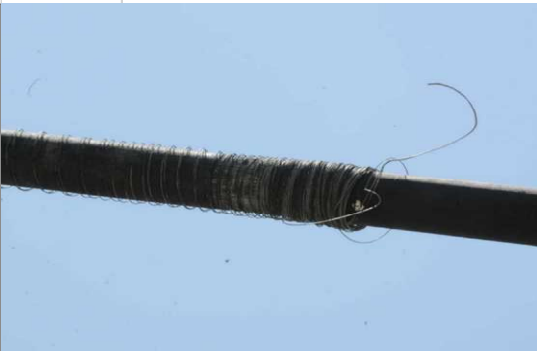
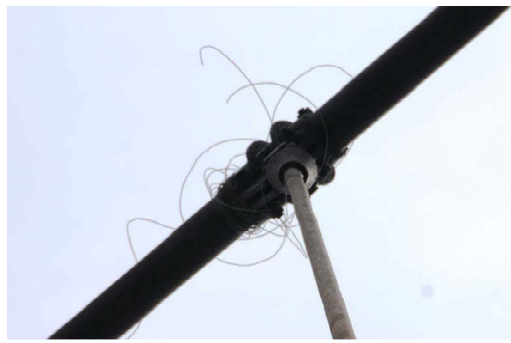
No. :	1	No.:	2	No.:	3
Date:	August 28, 2019	Date:	October 2016	Date:	October 2016
Location:	Zambian side anchorage	Location:	Main cable (West side)	Location:	Main cable (West side)
Defect Type:	Cracks concrete part	Defect Type:	Wrapping wire broken	Defect Type:	Wrapping wire broken
Description:	Cracks are observed near the anchor device of the concrete anchorage	Description:	Broken wrapping wire between Zimbabwe west side tower and anchorage	Description:	Broken wrapping wire between west side hanger 34 and tower

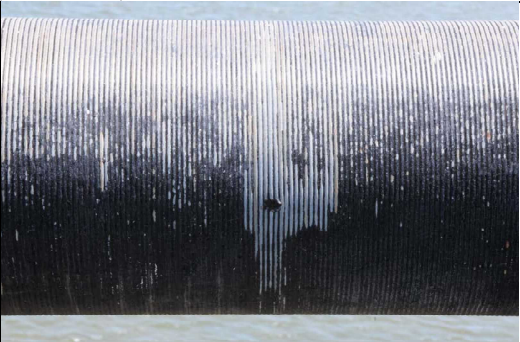
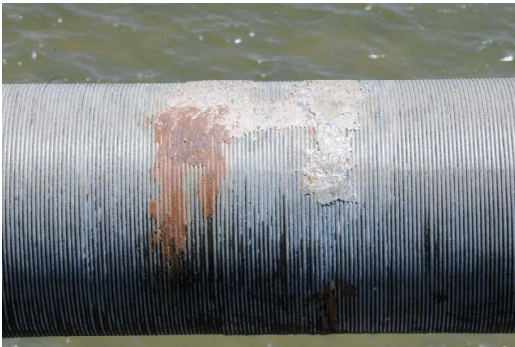
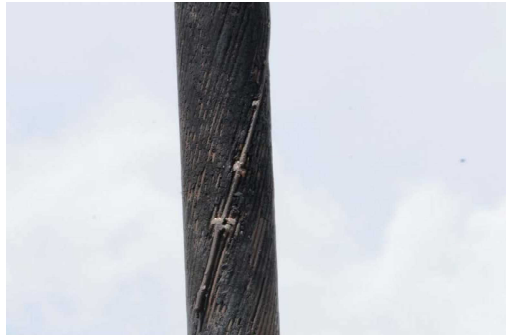
No.:	4	No.:	5	No.:	6
Date:	October 2016	Date:	October 2016	Date:	October 2016
Location:	Main cable (East side)	Location:	Main cable (East side)	Location:	Hanger 2W
Defect Type:	Wrapping wire chipped	Defect Type:	Rust on repaired wire	Defect Type:	Fractured wire
Description:	Chipped wrapping wire between hangers 21E and 22E	Description:	Rusted repaired area between hangers 20E and 21E	Description:	Fractured wire on hanger 2W

5	Cable System	Hanger Rope	Fractured wire	Bad	Partial repair (Wrapping wire+Bituminous paint) (L=10m)	EA	Existing	Oct. 2016	Fractured wire on hanger 2W. See sketch and photo 6.
6	Cable System	Hanger Rope	Rusted	Bad			Existing	Oct. 2016	Rust caused by local loss of bituminous paint. See sketch and photos 7 & 8.
7	Cable System	Shackle & Clamp of Hanger Rope	Rusted	Fair	Repainting (All members)	MM Repair	Existing	Aug. 2019	Many shackles and some clamps of hanger ropes are rusted. See sketch and photos 9 & 10.
8	Superstructure	Stiffening Girder	Corrosion	Fair	Repainting (All members)	MM Repair	Existing	Oct. 2016	Corrosion, mostly lower cords and their surrounding members. See sketch and photos 11 to 14.
9	Sidewalk	Grating panel	Rusted and/or Buckled	Bad	Replacement (All)	EA	Existing	Oct. 2016	Most of sidewalk panels are rusted and/or buckled. See sketch and photos 15 & 16.

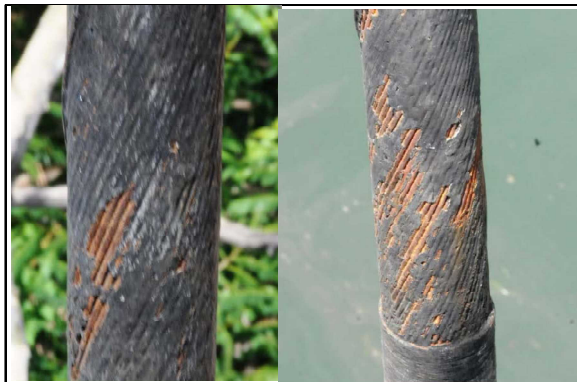
No.:	7
Date:	October 2016
Location:	Hanger 2W & 4W
Defect Type	Rusted
Description:	Rust caused by local loss of bituminous paint

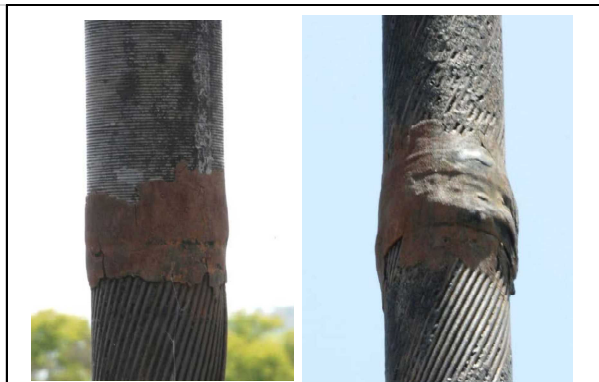
No.:	8
Date:	October 2016
Location:	Hanger 23E & 26E
Defect Type	Rust on some repaired area
Description:	Rust on some repaired area (Recent repairing)

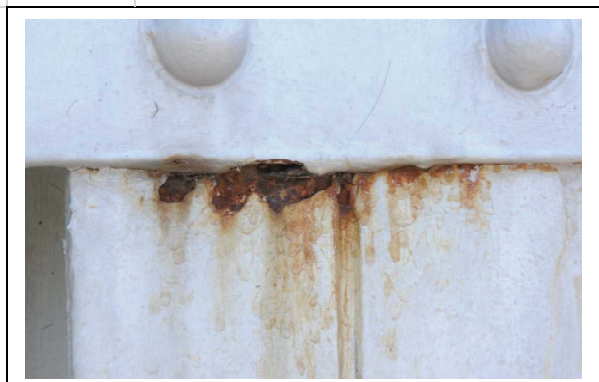
No.:	11
Date:	October 2016
Location:	Stiffening girder (9E)
Defect Type	Corrosion
Description:	Corrosion spot

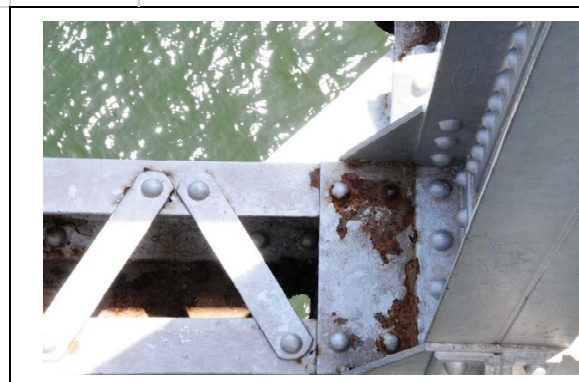
No.:	12
Date:	October 2016
Location:	Stiffening girder (14E)
Defect Type	Corrosion
Description:	Corrosion spot (Lower cords and their surrounding members)

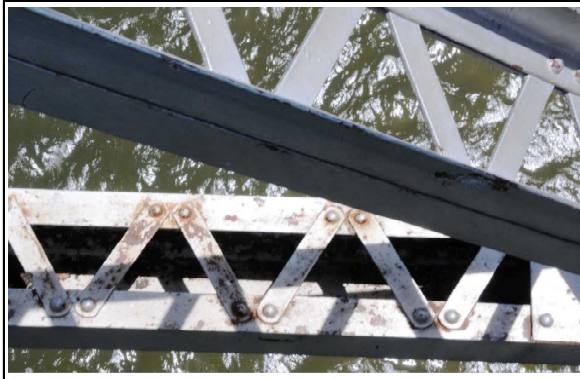
No.:	13
Date:	October 2016
Location:	Stiffening girder (18E-19E)
Defect Type	Corrosion
Description:	Corrosion spot (Lower cords and their surrounding members)

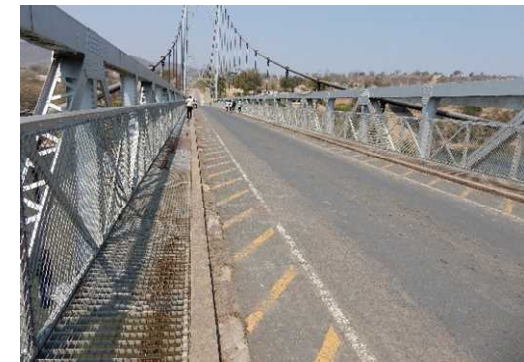
No.:	15
Date:	August 28, 2019
Location:	Sidewalk
Defect Type	Corrosion
Description:	Most of sidewalk are rusty

Rust and corrosion appear to be the effects of long-standing rainwater. The buckling may be caused by the event that the vehicle's tires rode on the sidewalk.
Superstructure - Access Bridge -	Steel girder is corroded (span 4)

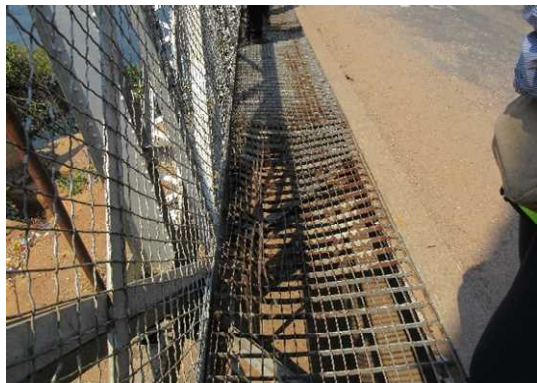
No.:	16
Date:	August 28, 2019
Location:	Sidewalk
Defect Type	Buckling
Description:	Some parts of sidewalk are buckled.

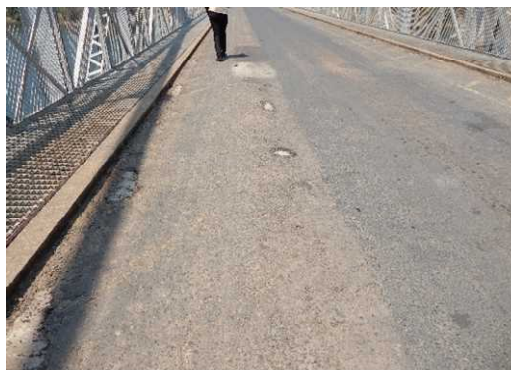
No.:	17
Date:	August 28, 2019
Location:	Pavement on deck slab (Main span)
Defect Type	Pothole
Description:	Many potholes in the asphalt pavement on the deck slab

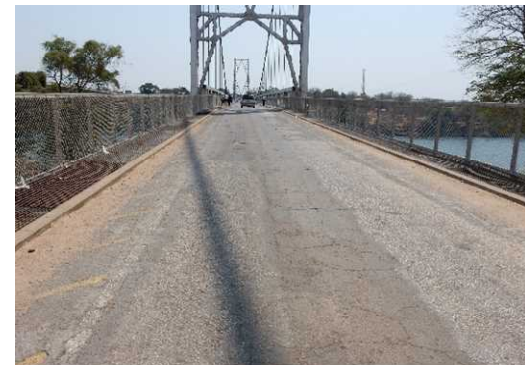
No.:	18
Date:	August 28, 2019
Location:	Pavement on deck slab (Side span)
Defect Type	Potholes and Cracks
Description:	Potholes and cracks in the asphalt pavement on the deck slab

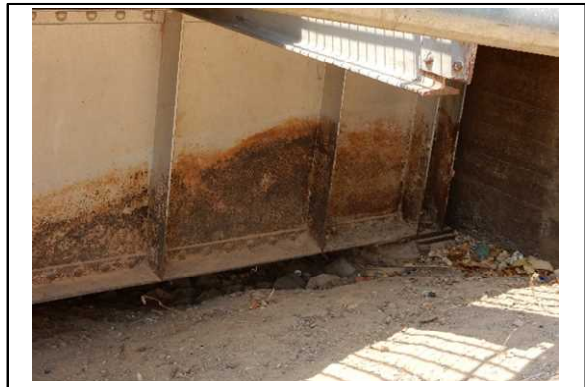
No.:	19
Date:	August 28, 2019
Location:	Span 4 (abutment side)
Defect Type	Corrosion
Description:	Steel girder of span 4 is corroded near the abutment

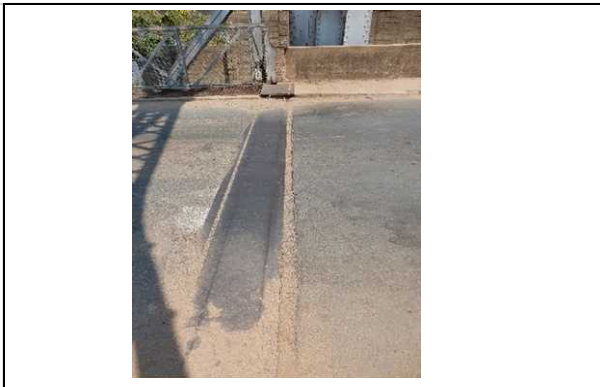
No.:	20
Date:	August 28, 2019
Location:	Zambian side expansion joint
Defect Type	Covered with sandy materials
Description:	Expansion device is covered with accumulated sandy materials

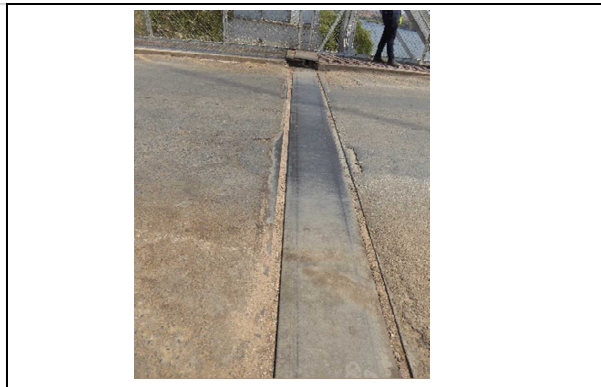
No.:	21
Date:	August 28, 2019
Location:	Zimbabwe side expansion joint
Defect Type	Damage to adjacent pavement
Description:	Adjacent pavement is damaged
