Republic of Zambia  
Road Development Agency  
(RDA)

Republic of Zambia  
The Bridge Maintenance Capacity Building  
Project in Zambia, Phase II

**BRIDGE ROUTINE MAINTENANCE  
GUIDELINES**

(Guidelines and Guidebooks for Bridge  
Maintenance/ Management, Vol.1)

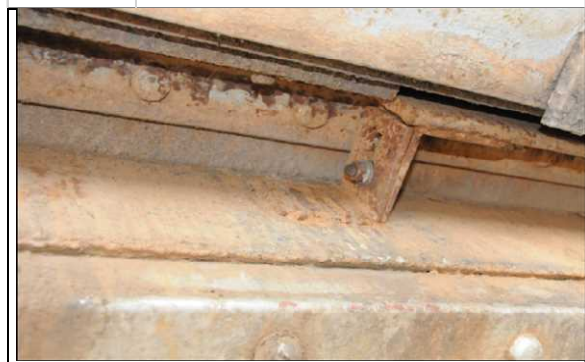
No.:	22
Date:	October 2016
Location:	Zimbabwe side expansion joint
Defect Type	Corrosion
Description:	The lower part of the expansion joint is corroded.

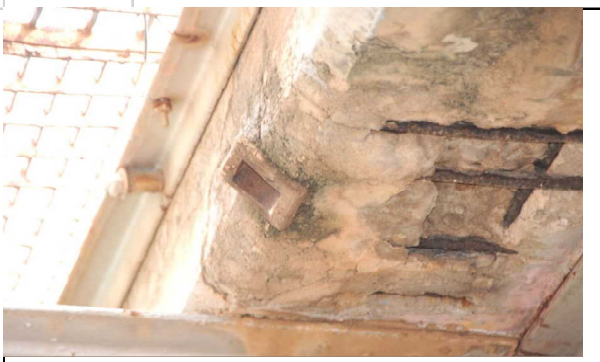
No.:	23
Date:	October 2016
Location:	Deck slab (Near Zambian tower)
Defect Type	Spalling, Rebar exposure
Description:	Spalling, rebar exposure and corrosion

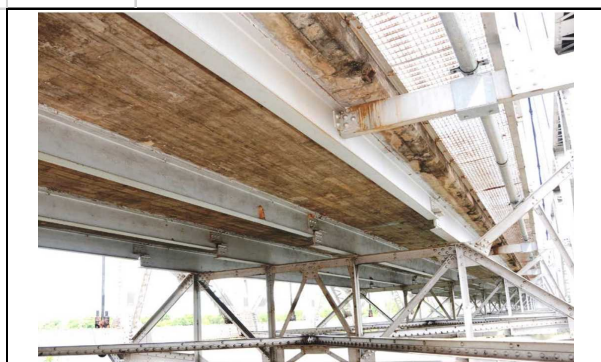
No.:	24
Date:	October 2016
Location:	Deck slab (Near Zambian tower)
Defect Type	Spalling, Rebar exposure
Description:	Spalling, rebar exposure and corrosion (distant view)

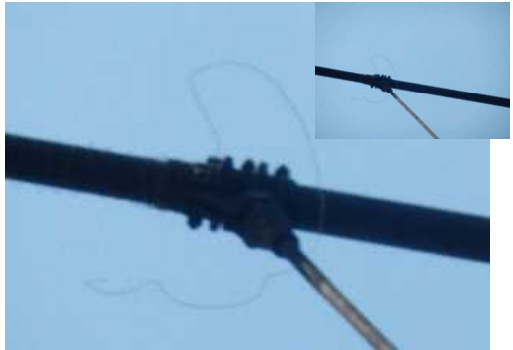
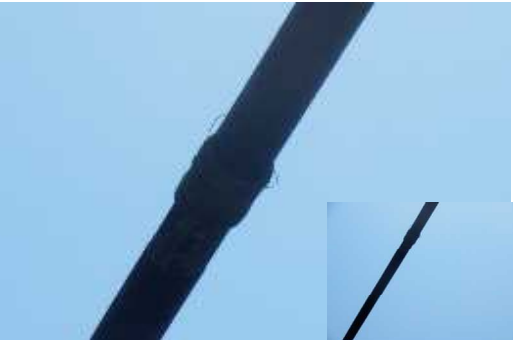
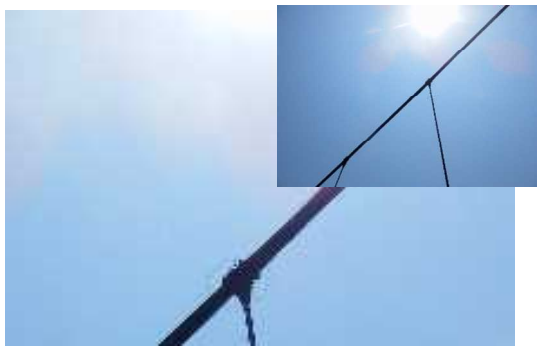
No. :	1-1	No.:	1-2	No.:	1-3
Date:	October 22, 2021	Date:	October 22, 2021	Date:	October 22, 2021
Location:	Main Cable (East side)	Location:	Main Cable (East side)	Location:	Main Cable (East side)
Defect Type:		Defect Type:		Defect Type:	
Description:	Wrapping wire is broken (near 1E)	Description:	Wrapping wire is broken (between 7E & 8E))	Description:	Wrapping wire is coming out. (near 28E)

It seems that the main cable has never been repaired or otherwise maintained after the bridge was completed in 1939. It is presumed that the wrapping wire has deteriorated and damaged due to the effects of long-term wind and rain and vibration when the vehicle passes through.
Cable System - Anchorage -	Cracks

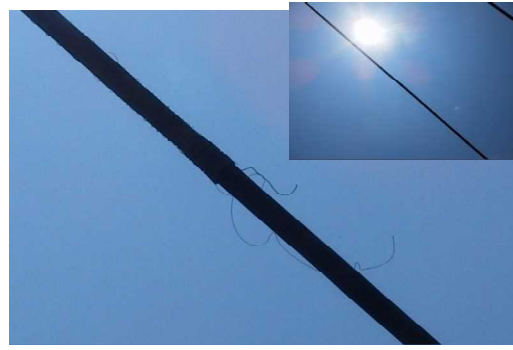
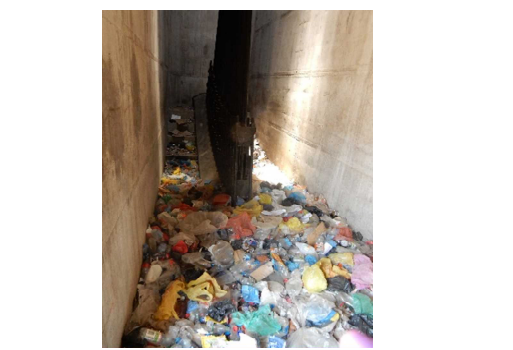
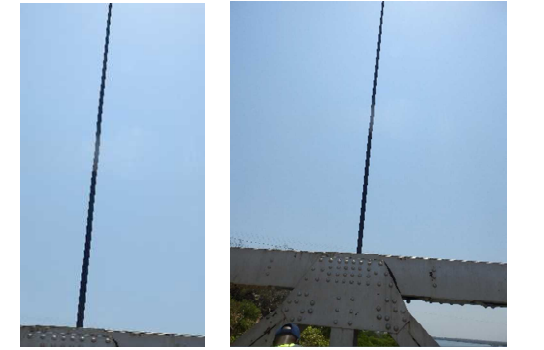
No.:	1-4	No.:	2	No.:	3-1
Date:	October 22, 2021	Date:	October 22, 2021	Date:	October 22, 2021
Location:	Main Cable (East side)	Location:	Anchorage (Zimbabwe side)	Location:	Hanger Rope (East side)
Defect Type:		Defect Type:		Defect Type:	
Description:	Wrapping wire is broken (between Zimbabwe east side tower & anchorage)	Description:	Zimbabwe side anchorage houses are full of garbages	Description:	Hanger Rope is not straight (2E)

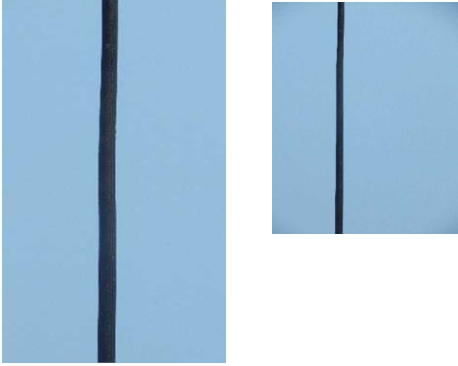
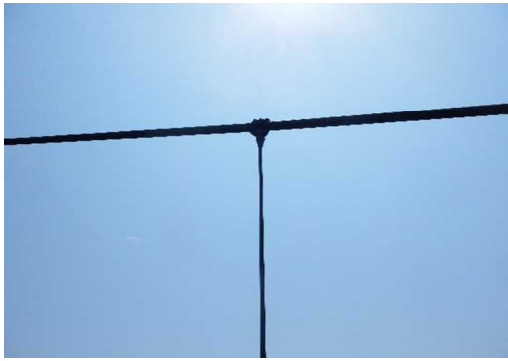
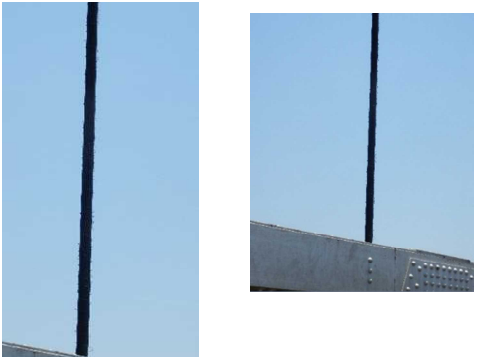
No.:	3-2	No.:	4	No.:	5
Date:	October 22, 2021	Date:	October 22, 2021	Date:	October 22, 2021
Location:	Hanger Rope (West side)	Location:	Hanger Rope (East side)	Location:	Hanger Rope (West side)
Defect Type:		Defect Type:		Defect Type:	
Description:	Hanger Rope is not straight (6W)	Description:	Hanger wrapping (Bituminous paint) is removed (1E, 2E & 9E)	Description:	Wrapping wire is removed (8W)

5	Cable System	Hanger Rope	Wrapping wire removed				New	Oct. 2021	Wrapping wire is removed. (8W), (Photo: 5)	
6	Cable System	Hanger Rope	Fractured wire				New	Oct. 2021	Hanger wire is fractured. (9W), (Photo: 6)	
7	Cable System	Hanger Rope	Rusted hanger				New	Oct. 2021	Hanger Rope is rusted. (14E), (Photo: 7)

The hanger ropes are covered with Bituminous Paint, but those paints have deteriorated over time, and at some portions, those coatings have peeled off and wires have been damaged. Those damaged portions have been partially repaired with wrapping wire, but the repaired portions are also deteriorating.

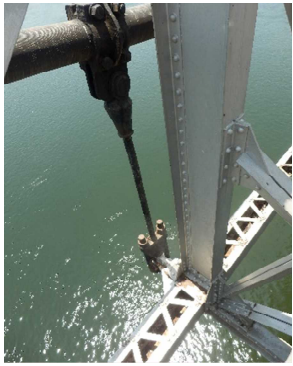
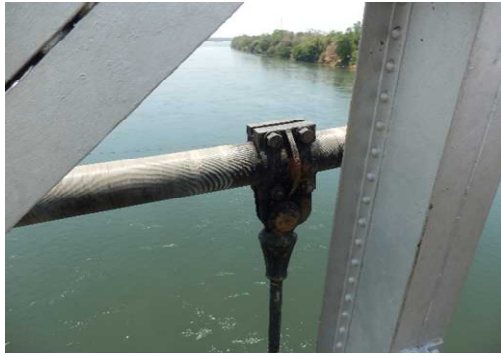
No.:	6	No.:	7	No.:	8
Date:	October 22, 2021	Date:	October 22, 2021	Date:	October 22, 2021
Location:	Hanger Rope(West side)	Location:	Hanger Rope (East side)	Location:	Hanger Rope (East side)
Defect Type:		Defect Type:		Defect Type:	
Description:	Hanger wire is fractured (9W)	Description:	Hanger Rope is rusted (14E)	Description:	Hanger clamp is rusted (21E)

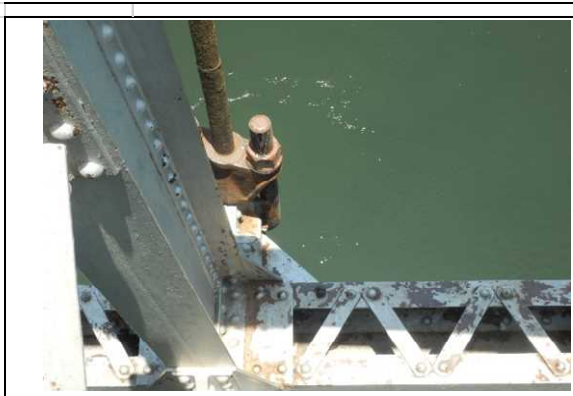
No.:	9-2
Date:	October 22, 2021
Location:	Hanger Rope (West side)
Defect Type:	
Description:	Hanger shackle has been rotated (26W, 27W and 31W)

If it is not straight, it is possible that the tension is reduced. It seems that the shackles are rotating because of vibrations by passing vehicles/strong winds which have affected the bridge for many years.
Superstructure - Stiffening Girder -	Many lower cord members are rusted

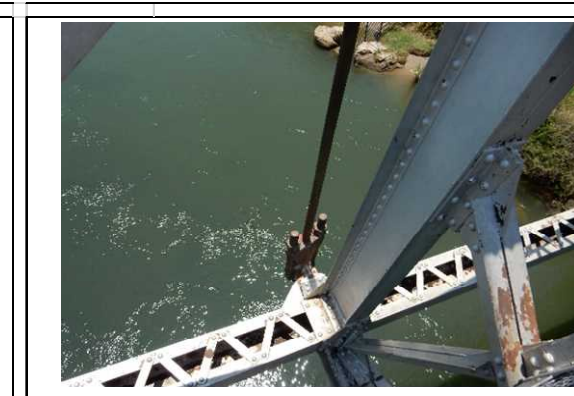
No.:	10
Date:	
Location:	Stiffening Girder (Whole girder)
Defect Type:	
Description:	Many lower cord members are rusted

When it rains, water from the upper structures such as the road surface and the upper chord members falls on the lower chord members, so it is presumed that the rust has progressed due to the repetition of those phenomenon.
Sidewalk - Grating Panels -	Most panels are rusted and some parts of sidewalk are buckled

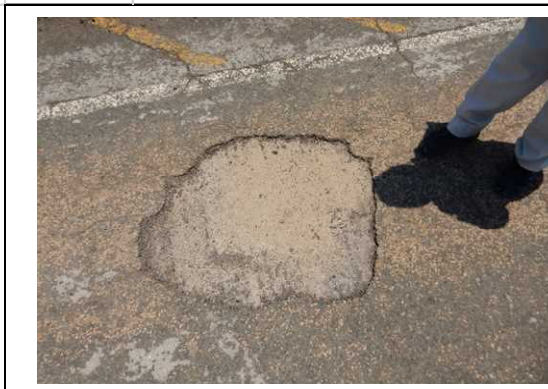
No.:	12
Date:	October 22, 2021
Location:	Access Bridge surface
Defect Type:	
Description:	Damages (Potholes & Cracks) are worse than at the last inspection

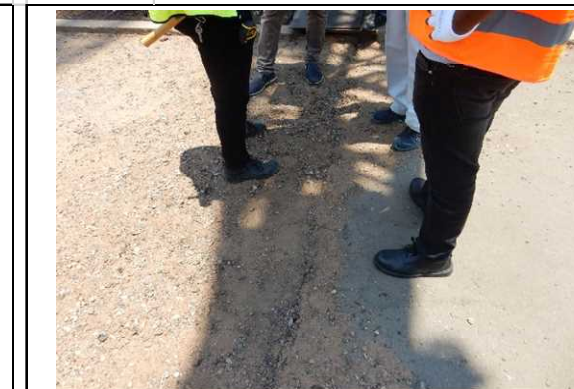
No.:	13
Date:	October 22, 2021
Location:	Expansion Joint (Zambia side)
Defect Type:	
Description:	Expansion joint is covered with more sandy materials than at the last inspection

8	Cable System	Hanger Rope	Clamp rusted	Poor	Repainting (Clamps and Shackles of All Hangers)	MM Repair	Existing	Oct. 2021	Hanger clamp is rusted. (21E), (Photo: 8)
9	Cable System	Hanger Rope	Rotated shackle	Poor	Correcting position	MM Repair	New	Oct. 2021	Shackles have been rotated. (32E, 26W, 27W 31W), (Photo: 9-1, 9-2)
10	Superstructure	Stiffening girder	Rusted	Fair	Repainting (All members)	MM Repair	Existing	Oct. 2021	Many lower cord members are rusted. (Photo: 10)
11	Deck slab	Main bridge	Pothole, crack	Bad	Replace with precast slab	MM Repair	Existing	Oct. 2021	Deck slab and pavement are in even worse condition than the last inspection (potholes, cracks, etc.) (Photo: 11)
12	Deck slab	Access bridge	Pothole, crack	Bad	Reconstruction	MM Repair	Existing	Oct. 2021	Damages (potholes & cracks) are worse than at the last inspection. (Photo: 12)
13	Expansion joint	Zambia side	Buried with sandy materials	Poor	Cleaning	RM Repair	Existing	Oct. 2021	Expansion joint is covered with more sandy materials than at the last inspection. (Photo: 13)

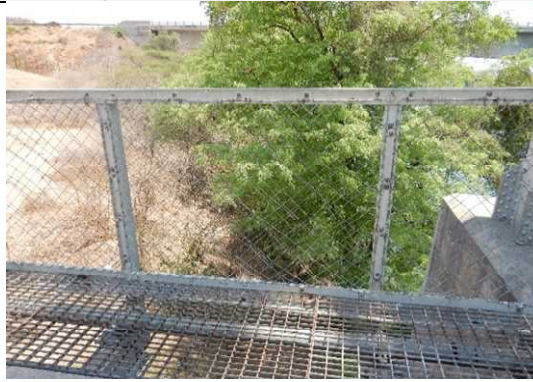
No.:	15
Date:	October 22, 2021
Location:	Guard fence (Access Bridge)
Defect Type:	
Description:	Wire mesh of the guard fence is deformed in several places

14	Expansion joint	Zimbabwe side	Damage of adjacent pavement	Poor	Replacement	MM Repair	Existing	Oct. 2021	Damage of adjacent pavement to expansion joint become worse than at the last inspection. (Photo 14)
15	Guard fence	Access bridge	Wire mesh deformed	Poor	Partial replacement	RM Repair	New	Oct. 2021	Wire mesh of the guard fence is deformed in several places. (Photo: 15)

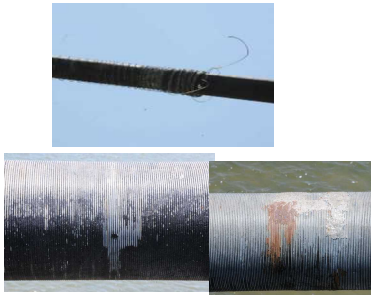
Location	Defects	Photography	Presumed Causes
Cable System - Main Cable -	Wrapping wire broken, Chipped & rusted

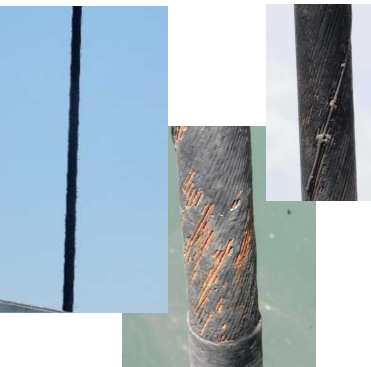
It seems that it was used as a garbage dump for some reason.
Cable System - Hanger Rope -	Bituminous paint deteriorated, Hanger rope rusted, Repaired wrapping wire broken

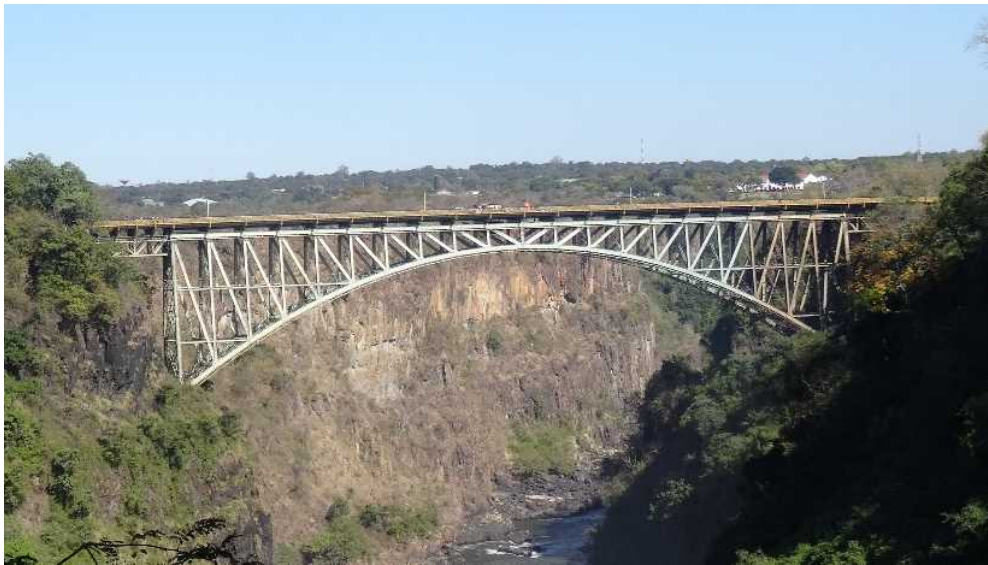
Arch bridge is a structure that transmits loads using a bow-shaped arch members (arch rib). As shown in the figure below, when an external load is applied, a compressive force (axial force) acts on the arch rib, and ground reaction forces (horizontal and vertical reaction forces) corresponding to the compressive force are generated on the support points at the both ends of the arch rib. The basis of arch design is to determine the axial shape so as to be resisted dead load by only axial force. Axial force increases in accordance with going to the springing from the crown portion, the dead load also increases in accordance with the going to the end. Therefore, the arch axis shape is a curve having a steep slope toward the end.

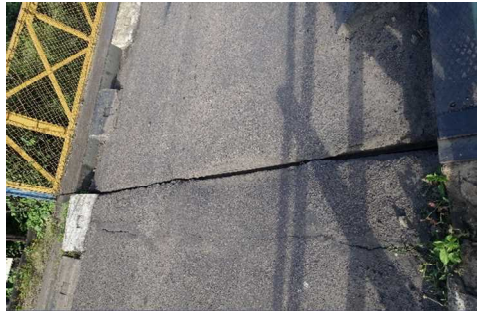
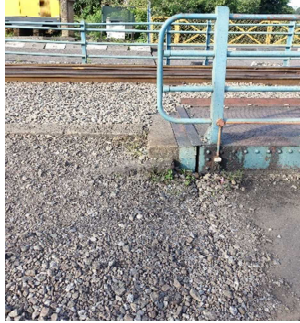
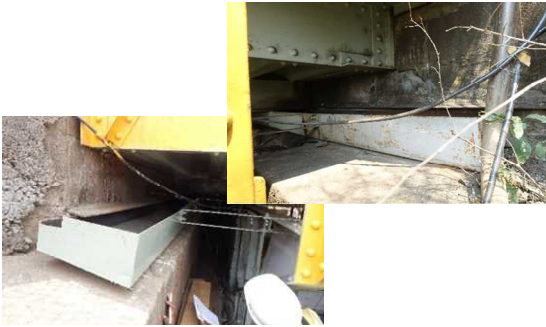
No. :	1-1	No.:	1-2	No.:	1-3
Date:	2022/04/21	Date:	2022/04/21	Date:	2019/09/25
Location:	Expansion joint (Zimbabwe side)	Location:	Expansion joint (Zimbabwe side)	Location:	Expansion joint (Zimbabwe side)
Defect Type:		Defect Type:	Buried with soil and gravel	Defect Type:	Drainage tray has no drainage pipe
Description:	It is considered a simple butt joint. A steel tray is installed under the expansion joint for the full width of the bridge, but the tray does not have a drainage pipe.	Description:	Same as the left column. The tops of the joints need to be cleaned.	Description:	The drainage tray below the joint has no drainage pipe connected to it. It may be need to monitor if tray overflows during rainy season.

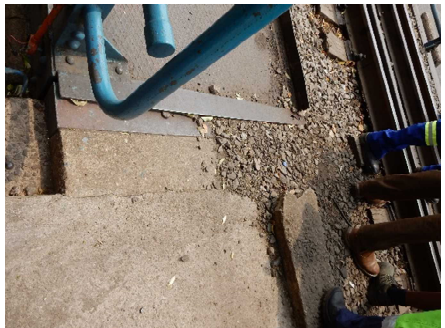
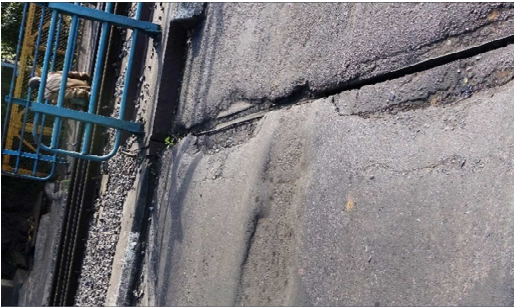
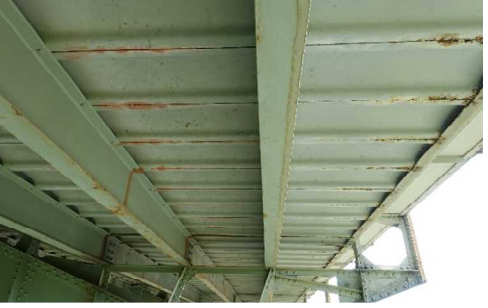
No.:	2-1	No.:	2-2	No.:	3
Date:	2022/04/21	Date:	2022/04/21	Date:	2022/04/21
Location:	Expansion joint (Zambia side, Footway)	Location:	Expansion joint (Zambia side, Roadway)	Location:	Deck/Steel troughing (Roadway)

Defect Type:	Buried with soil and gravel	Defect Type:	Damage to the adjacent pavement	Defect Type:	Corrosion
Description:	The tops of the joints need to be cleaned.	Description:	Need to repair the joint and the adjacent pavement.	Description:	The troughs on the underside of the roadway are corroding due to leakage from gaps (1 cm) between the troughs along the entire length.

Date:		Contractor Name:			Contract Ref. No. :		Province:		
Bridge No.:		Bridge Name:			Road No.:		Road Name:		Location:
		Victoria Falls Bridge							
No.	(1) Bridge Component	(2) Sub-Component	(3) Defect Type	(4) Condition Rating	(5) Quantity (Unit)	(6) Proposed Action	(7) New/ Existing	(8) Date of Detection	(9) Remarks
1	Expansion joint/ Zimbabwe side	Roadway	No sealant	Fair	L=5 m	Monitoring	Existing	Apr-22	A steel tray is installed under the expansion joint for the full width of the bridge, but the tray does not have a drainage pipe. Photo: 1-1, 1-3
2	Expansion joint/ Zimbabwe side	Footway	Covered with soil & gravel	Fair	Cleaning	RM Repair	Existing	April 2022	Photo: 1-2
3	Expansion joint/ Zambia side	Footway	Covered with soil & gravel	Fair	Cleaning	RM Repair	Existing	April 2022	Photo: 2-1
4	Expansion joint/ Zambia side	Roadway	Damage to the adjacent pavement	Poor	L=6.0m	MM Repair	Existing	April 2022	Need to repair the joint and the adjacent pavement. Photo: 2-2

5	Deck/ Steel troughing	Roadway	Corrosion	Poor	Entire roadway	MM Repair	Existing	April 2022	Repainting (with Pavement repair) Photo: 3
6	Deck/ Steel troughing	Railway	Corrosion	Bad	Entire railway	MM Repair	Existing	April 2022	Partially replace the troughs and track materials sequentially. Photo: 4
7	Deck/ Steel troughing	Footway	Corrosion	Fair	Entire footway	MM Repair	Existing	April 2022	Repainting (with Pavement repair) Photo: 5
8	Pavement	Roadway	Cracks (or Construction joints)	Fair	Entire roadway	MM Repair	Existing	April 2022	Replacement of pavement and installation of waterproof layer Photo: 6-1, 6-2
9	Pavement	Footway	Cracks (or Construction joints)	Fair	Entire footway	MM Repair	Existing	April 2022	Replacement of pavement and installation of waterproof layer Photo: 7

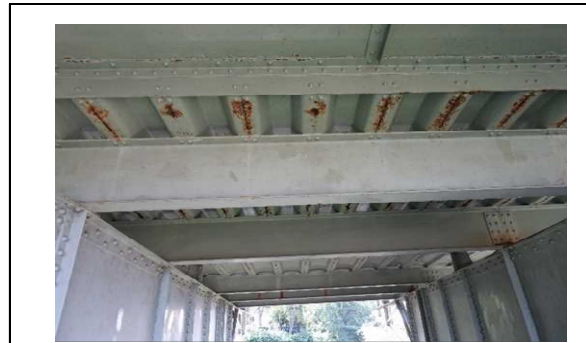
No.:	4
Date:	2022/04/21
Location:	Deck/Steel troughing (Railway)
Defect Type	Corrosion
Description:	The troughs on the underside of the railway are corroding due to leakage from gaps (1 cm) between the troughs along the entire length.

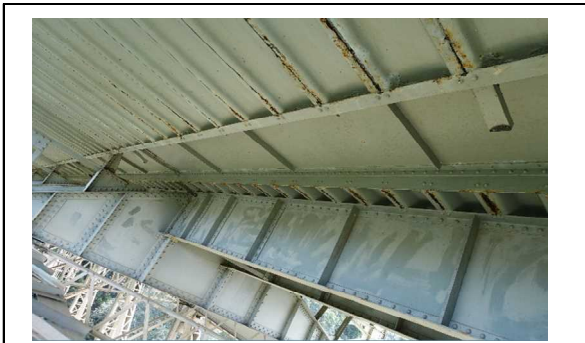
No.:	5
Date:	2022/04/21
Location:	Deck/Steel troughing (Footway)
Defect Type	Corrosion
Description:	The troughs on the underside of the footway are corroding due to leakage from gaps (1 cm) between the troughs along the entire length.

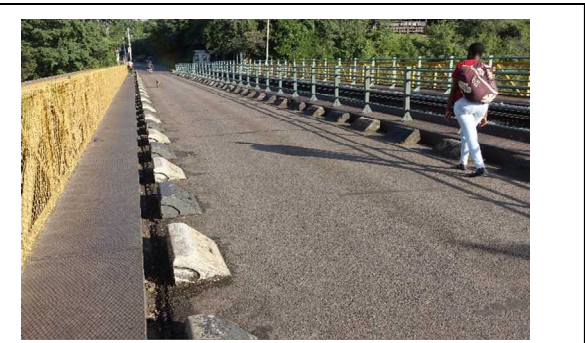
No.:	6-1
Date:	2022/04/21
Location:	Pavement (Roadway)
Defect Type	Cracks (or Construction joints)
Description:	Transverse cracks (or construction joints) in the roadway pavement at 7 to 8 m intervals are suspected to be leaking from these cracks.

Roadway pavement  
(Cracks (or construction joints) are seen at intervals of 6 to 7 meters.)  
Photo: 6-1, 6-2

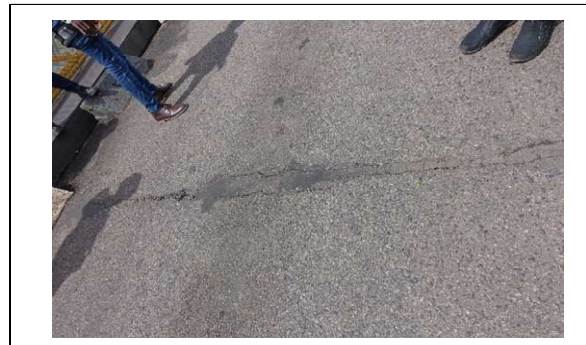
No.:	6-2
Date:	2022/04/21
Location:	Pavement (Roadway)
Defect Type	Cracks (or Construction joints)
Description:	Transverse cracks (or construction joints) in the roadway pavement at 7 to 8 m intervals are suspected to be leaking from these cracks.

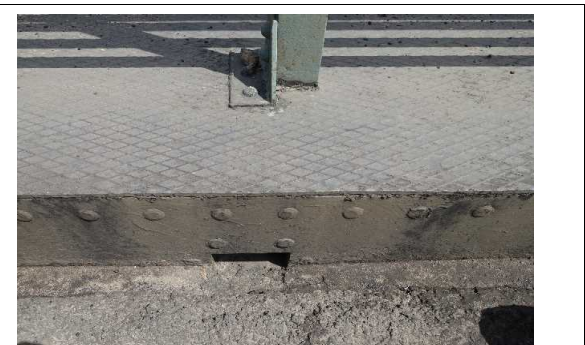
No.:	8-1
Date:	2022/04/21
Location:	Drainage (Roadway)
Defect Type:	
Description:	Scupper in the roadway.

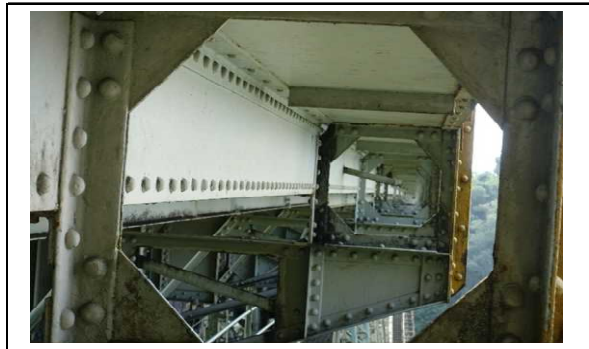
No.:	8-3
Date:	2022/04/21
Location:	Drainage (Roadway)
Defect Type:	Same as left column.
Description:	Same as left column.

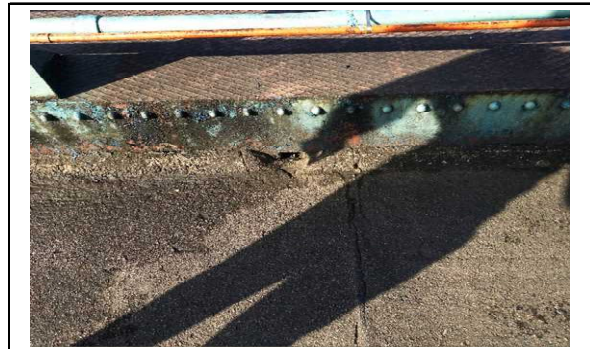
No.:	9-1
Date:	2022/04/21
Location:	Drainage (Footway)
Defect Type:	
Description:	Scupper in the footway.

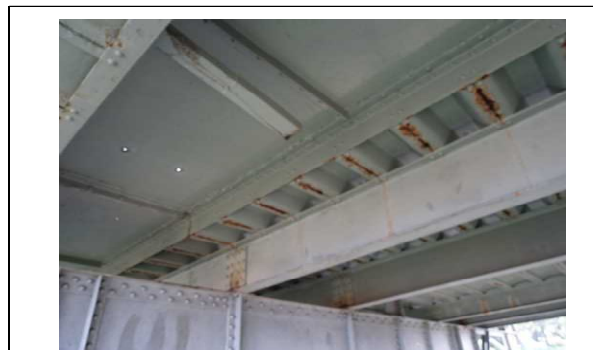
No.:	9-2
Date:	2022/04/21
Location:	Drainage (Footway)
Defect Type:	The outlets of pipes are in the extent of the bridge.
Description:	The pipes are short and those outlets are extent of the bridge. The drainage pipes should be lead to the outside of the bridge.

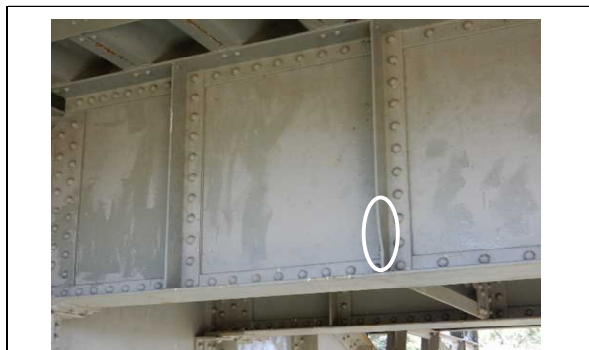
No.:	10-1
Date:	2021/11/07
Location:	Superstructure (Longitudinal girder)
Defect Type:	Deformation (Buckling)
Description:	Vertical stiffener of the girder is deformed. (bay 10)

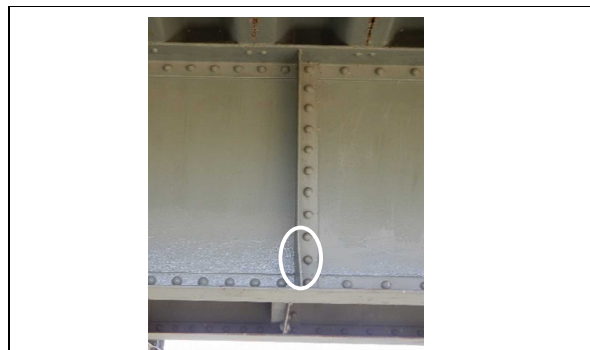
No.:	10-2
Date:	2021/11/07
Location:	Superstructure (Longitudinal girder)
Defect Type:	Deformation (Buckling)
Description:	Vertical stiffener of the girder is deformed. (bay 11)

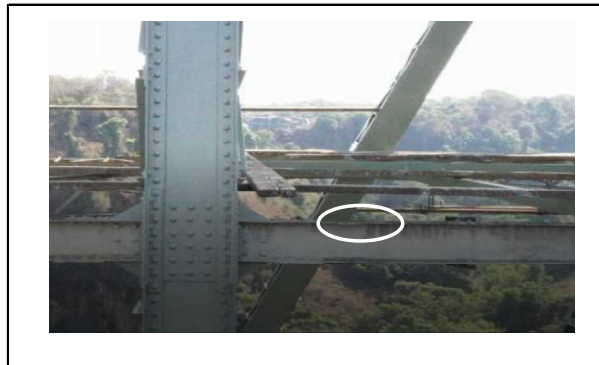
No.:	11-1
Date:	2021/11/08
Location:	Arch (Horizontal member, bay 25)
Defect Type:	Deformation (Buckling)
Description:	The flange of the horizontal member is deformed.

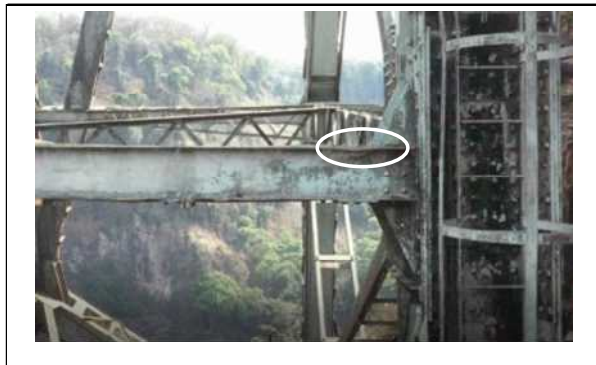
No.:	11-2
Date:	2021/11/08
Location:	Arch (Horizontal member, bay 27)
Defect Type:	Deformation (Buckling)
Description:	The flange of the horizontal member is deformed.

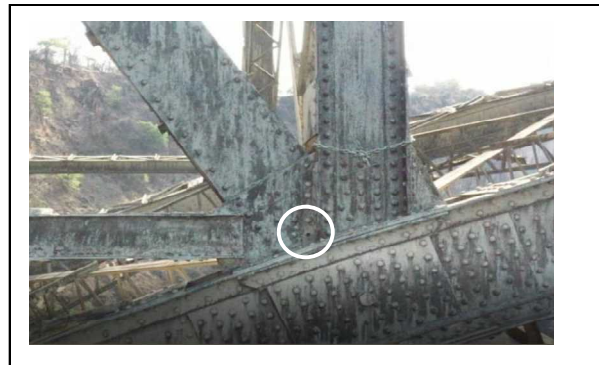
No.:	12
Date:	2021/11/08
Location:	Arch (Grid point, bay 21, 22)
Defect Type:	Missing ribet
Description:	1 ribet is missing on the splice plate.

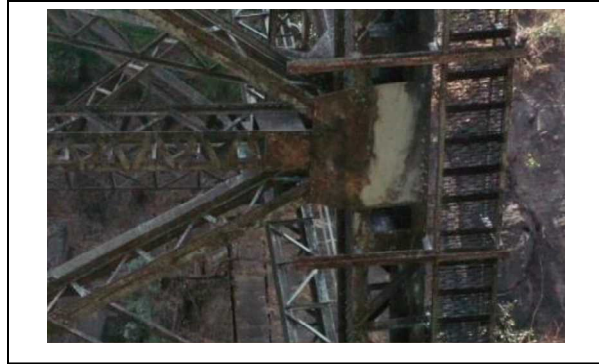
No.:	13-1
Date:	2021/11/08
Location:	Arch member (Grid points)
Defect Type:	Corrosion
Description:	Rusting has occurred on many of the members inside the arch main structure. By the drone survey, the underside of the Arch Liv has areas of rusting.

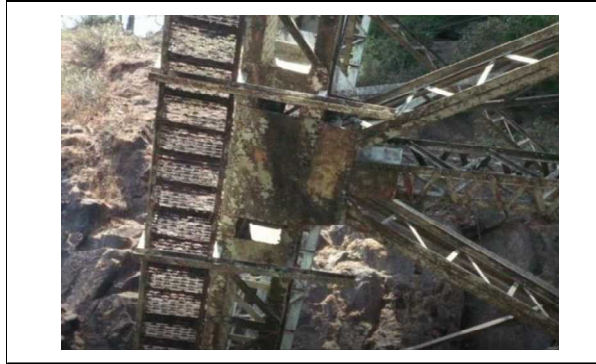
No.:	13-2
Date:	2021/11/08
Location:	Arch member (Grid points)
Defect Type:	Corrosion
Description:	Same as left column.

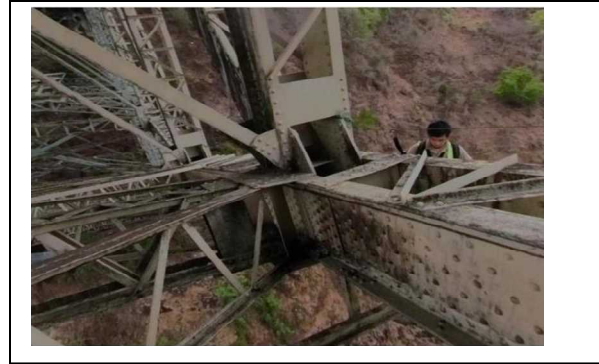
No.:	13-3
Date:	2021/11/08
Location:	Arch member (Grid points)
Defect Type:	Corrosion
Description:	Same as left column.

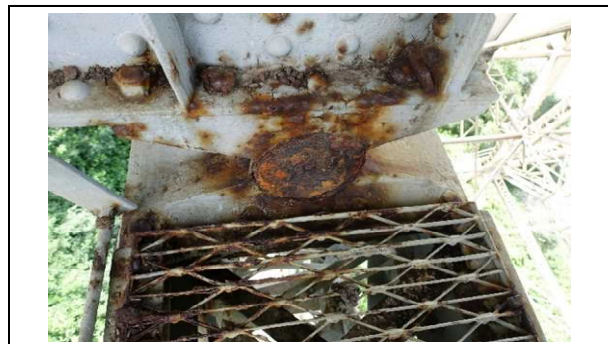
No.:	14-1
Date:	2022/04/21
Location:	Fixed Bearing (Zimbabwe side truss)
Defect Type	Corrosion
Description:	Fixed bearings of truss span at the arch side are corroded.

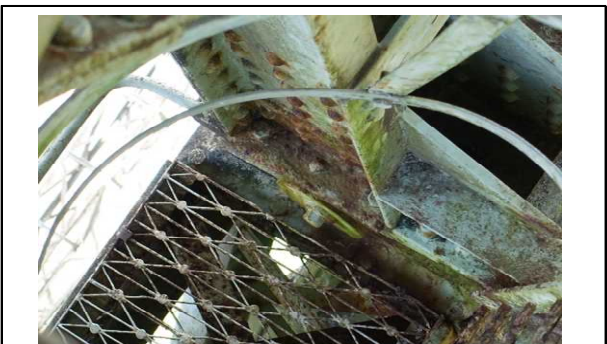
No.:	14-2
Date:	2022/04/21
Location:	Fixed Bearing (Zambia side truss)
Defect Type	Corrosion
Description:	Same as left column.

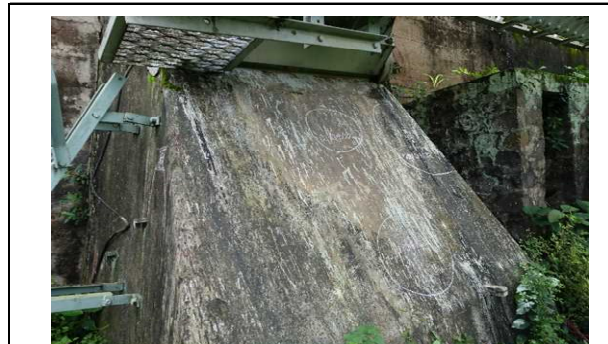
No.:	15-1
Date:	2022/04/21
Location:	Arch Bearing (Zim, Downstream side)
Defect Type	Lower shoe is buried
Description:	The bearing of the springing of the main arch has the lower shoe buried in the concrete base unlike the drawing.

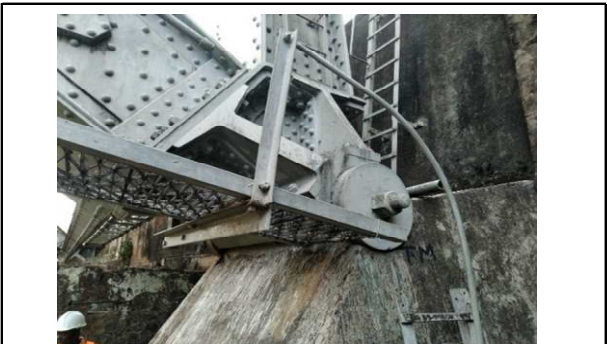
No.:	15-2
Date:	2022/04/21
Location:	Arch Bearing (Zim, Downstream side)
Defect Type	Lower shoe is buried
Description:	Same as left column.

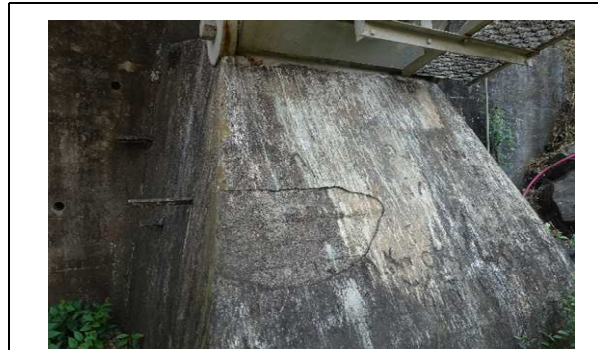
No.:	15-4
Date:	2019/09/25
Location:	Arch Bearing (Zim, Upstream side)
Defect Type:	Mortar cover detached
Description:	The mortar cover on the concrete foundation is detached and partially peeling.

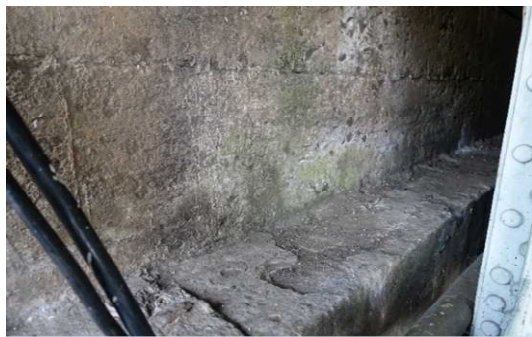
No.:	17-2
Date:	2022/04/21
Location:	Abutment (Zimbabwe side)
Defect Type:	Cracks, Loose Concrete, Surface weathering
Description:	Same as the above

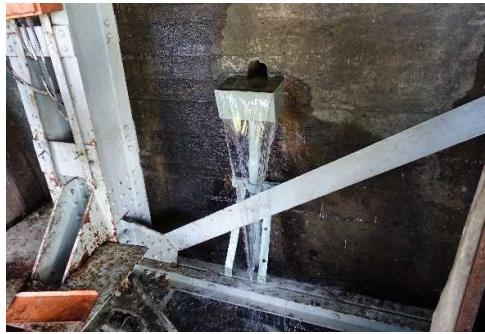
No.:	16
Date:	2022/04/21
Location:	Abutment (Zimbabwe side)
Defect Type:	Overflow of drainage system
Description:	The drainage system installed in the abutment wall is overflowing.

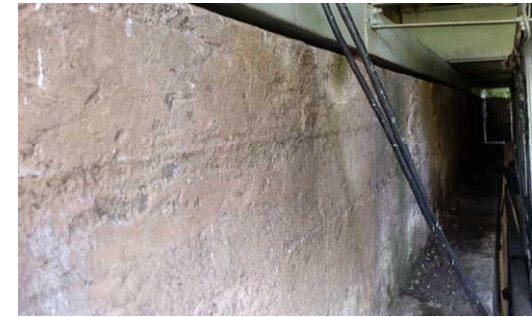
No.:	17-1
Date:	2022/04/21
Location:	Abutment (Zimbabwe side)
Defect Type:	Cracks, Loose Concrete, Surface weathering
Description:	Cracks, loose concrete, and other damage have occurred on the front and top surfaces of the abutment.

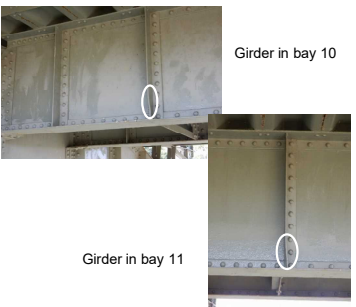
Location	Defects	Photography	Probable Causes
Superstructure/ Longitudinal Girder	Deformation of vertical stiffness

<p>Girder in bay 10</p> <p>Girder in bay 11</p>	<p>Temporarily large forces (bending moment and shear force) acted on the steel girder web, causing some of the vertical stiffeners to buckle.</p> <p>Or, external forces acted on the vertical stiffeners.</p> <p>The steel girder seems to maintain its load-bearing capacity thereafter.</p>
Arch/ Horizontal member	Deformation (Buckling)

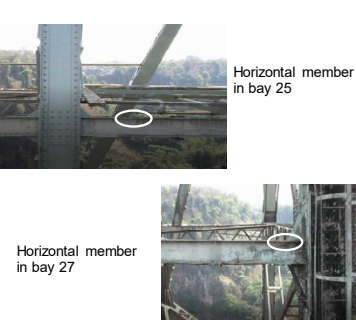
<p>Horizontal member in bay 25</p> <p>Horizontal member in bay 27</p>	<p>Some force acted on the horizontal member and buckled the flange in that area.</p>
Arch/ Grid points	Missing Ribets & Corrosion

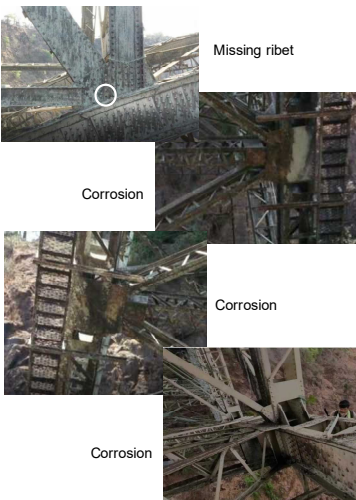
<p>Missing ribet</p> <p>Corrosion</p> <p>Corrosion</p> <p>Corrosion</p>	<ul style="list-style-type: none"> <li>•Missing bolts --- Ribet broken or loosened</li> <li>•Corrosion --- This may be due to rainwater and water from Victoria Falls spraying on the bridge and stagnating along the arch ribs.</li> <li>•For arch structures, the Arch Main Structure (Arch Riv, Upper Cord Members, Vertical Members, Diagonal Members and Horizontal Members) has been repaired with timely painting. But the underside of the Arch Riv has areas of rusting (Drone survey results).</li> </ul> <p>And, rusting has occurred on many of the members inside the Arch Main Structure (Horizontal Members perpendicular to the bridge axis, Sway Bracings, Transverse members and other supporting members).</p>

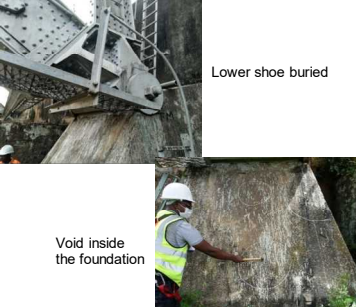
Bearing of Arch (Springing)	Zimbabwe side downstream bearing --- Internal void noise (percussion inspection) All Bearings --- the lower shoes are buried in the concrete bases. (different from the original drawings)

<p>Lower shoe buried</p> <p>Void inside the foundation</p>	<ul style="list-style-type: none"> <li>•Inside void --- The mortar cover on the concrete foundation is detached and partially peeling.</li> <li>•Lower shoes buried in concrete foundation --- May have been changed during construction.</li> </ul>
Bearing of Truss/ Arch side	Corrosion

However, corrosion is ongoing in the Deck steel troughs, Steel members and those grid points of the Arch structure, and Bearings of trusses which are on the arch ends. The concrete foundations of the arch bearings have different shapes from the original design drawing, and the lower portions of the shoes are buried in the foundations.

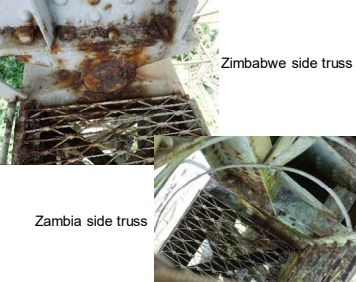
<p>Zimbabwe side truss</p> <p>Zambia side truss</p>	<p>This may be due to rainwater and water from Victoria Falls spraying on the bridge and stagnating at the bearings.</p>

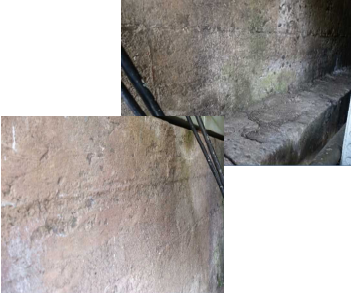
Over the long years (117 years), the concrete surface has weathered and cracks and other damage have occurred.

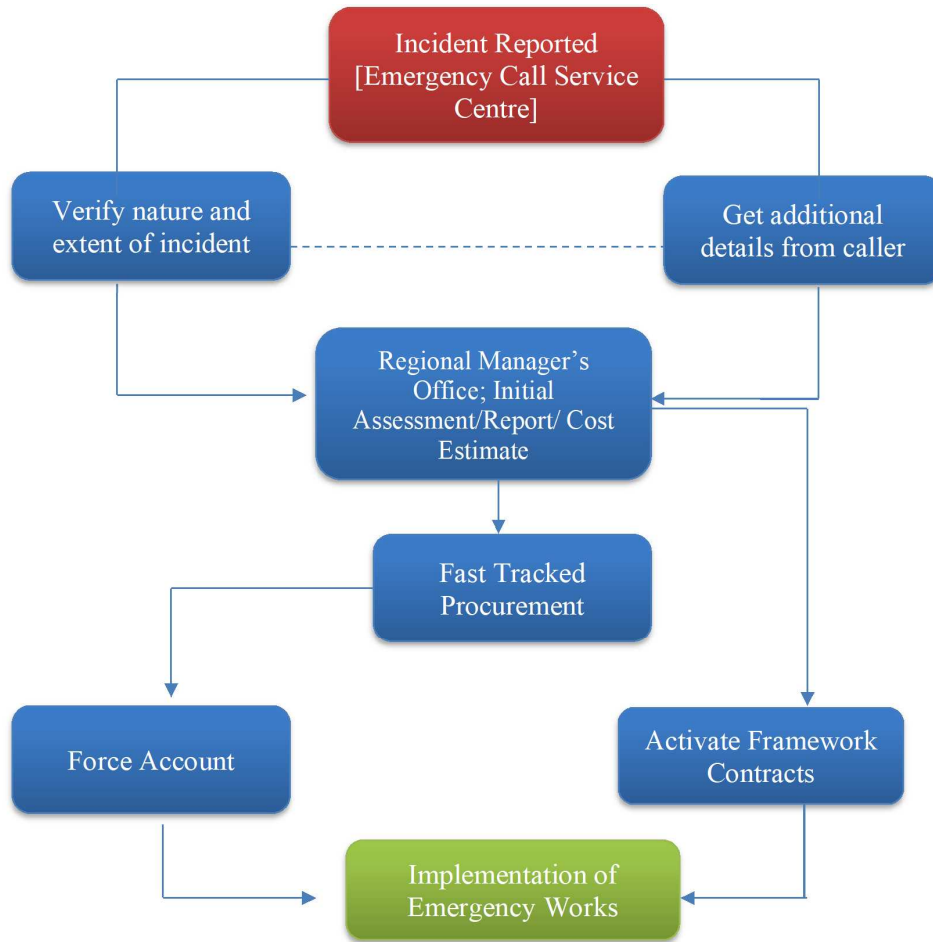
Figure 6-1 Emergency Response Flow Chart

Figure 6-1 shows the emergency response flow chart through either Force Account or Framework Contract approach. The RDA will maintain to a limited extent Force Account works for emergencies while at the same time use Framework and Supply Contracts to deal with all major emergency works in the regions.

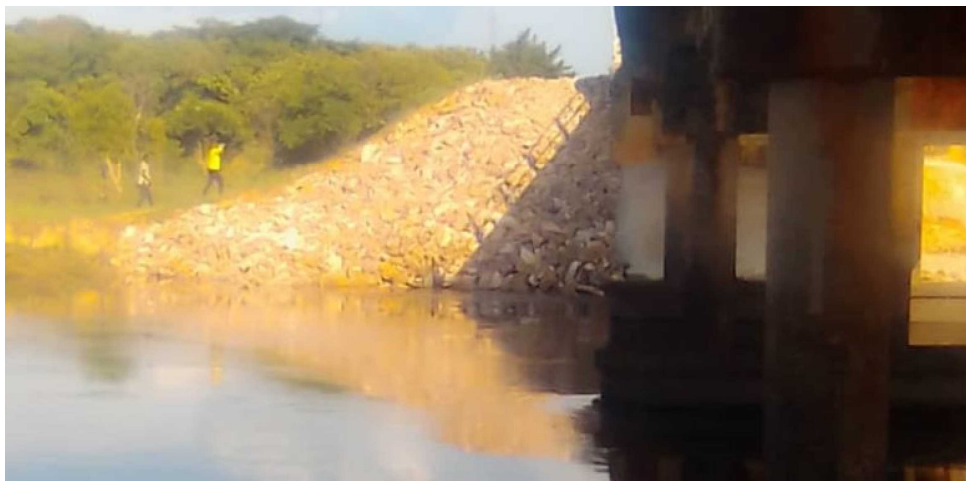
Photo 6-3 Repair around abutments

- Immediate repair of damaged portion of bridge to ensure safety and stability of structure.
