**Project for Control and Mitigation of
Slope Disasters
in the Central District in Republic of
Honduras
Project Completion Report**

February 2026

Japan International Cooperation Agency (JICA)

Kokusai Kogyo Co., Ltd.

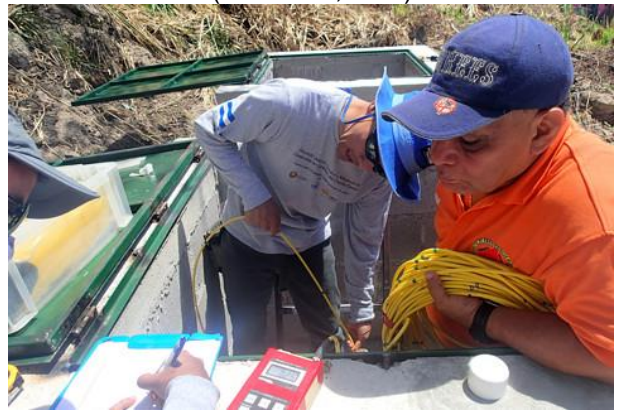
Photo 4 Electrical resistivity logging
(Campo Cielo: September 6th, 2019)

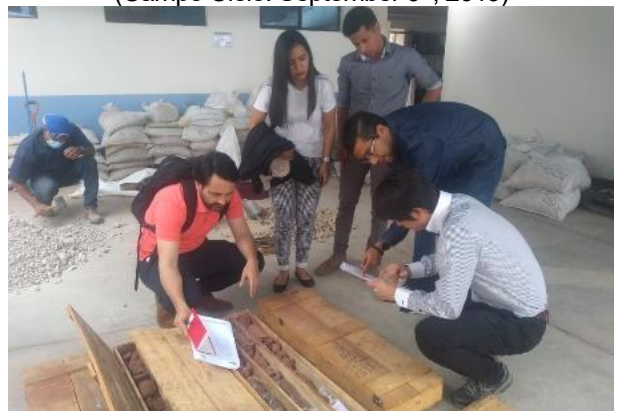
Photo 6 Observation of core sample
(ASP: January 20th, 2020)

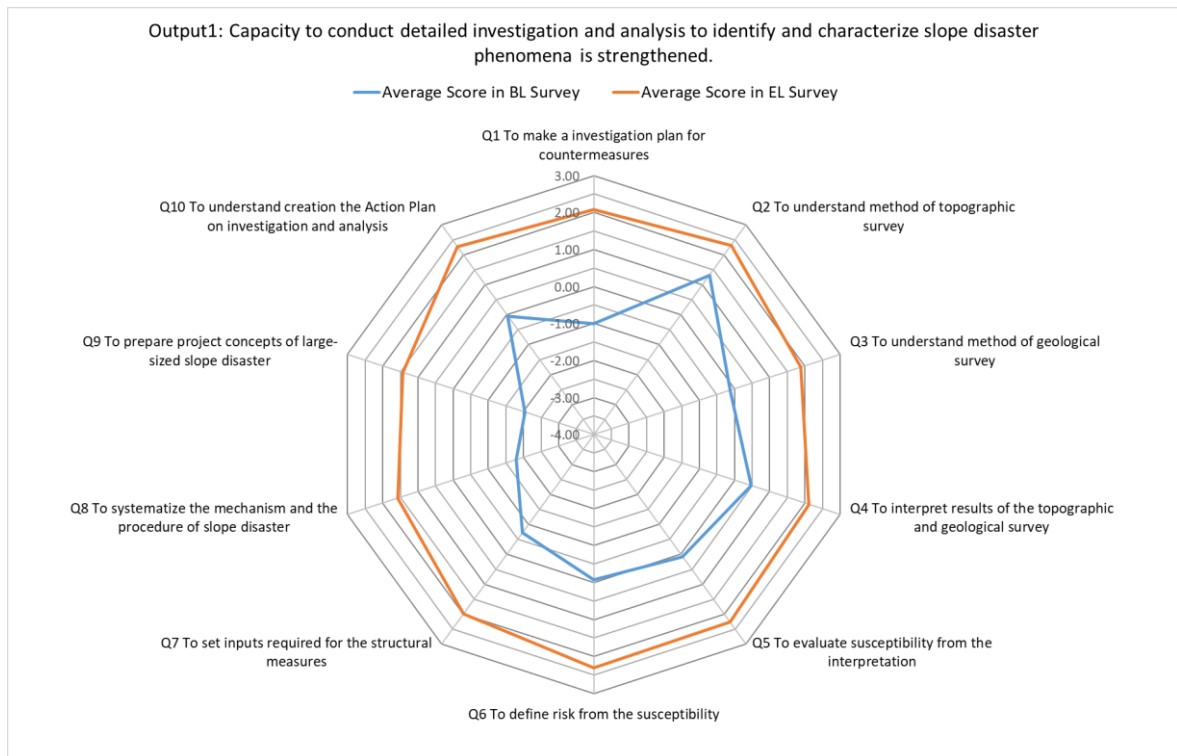
Figure 1 Comparison of BL Survey and EL Survey (Output 1)

For Output 1, in the BL survey, relatively high scores were observed in the basic survey-related questions such as “Q2: Topographic Survey,” “Q3: Geological investigation,” “Q4: Interpretation of survey results,” “Q5: Evaluation of influence,” and “Q6: Risk definition.” This indicates that the C/P personnel had already been conducting basic investigations related to slope disasters prior to the Project. However, in the EL survey, these items showed further improvement, suggesting that the Project helped strengthen their technical capacity and clarify previously ambiguous knowledge in survey and analysis. On the other hand, low scores were recorded in the BL survey for “Q7: Inputs required for structural measures,” “Q8: Systematization of disaster mechanisms and countermeasures,” and “Q9: Project formulation for large-scale disasters.” This is presumed to be due to the limited experience in linking geological investigation and analysis results to

subsequent countermeasures before the Project. In the EL survey, these items showed larger increases in average scores compared to other questions, indicating that the Project significantly enhanced their capability in planning and formulation for future countermeasure projects.

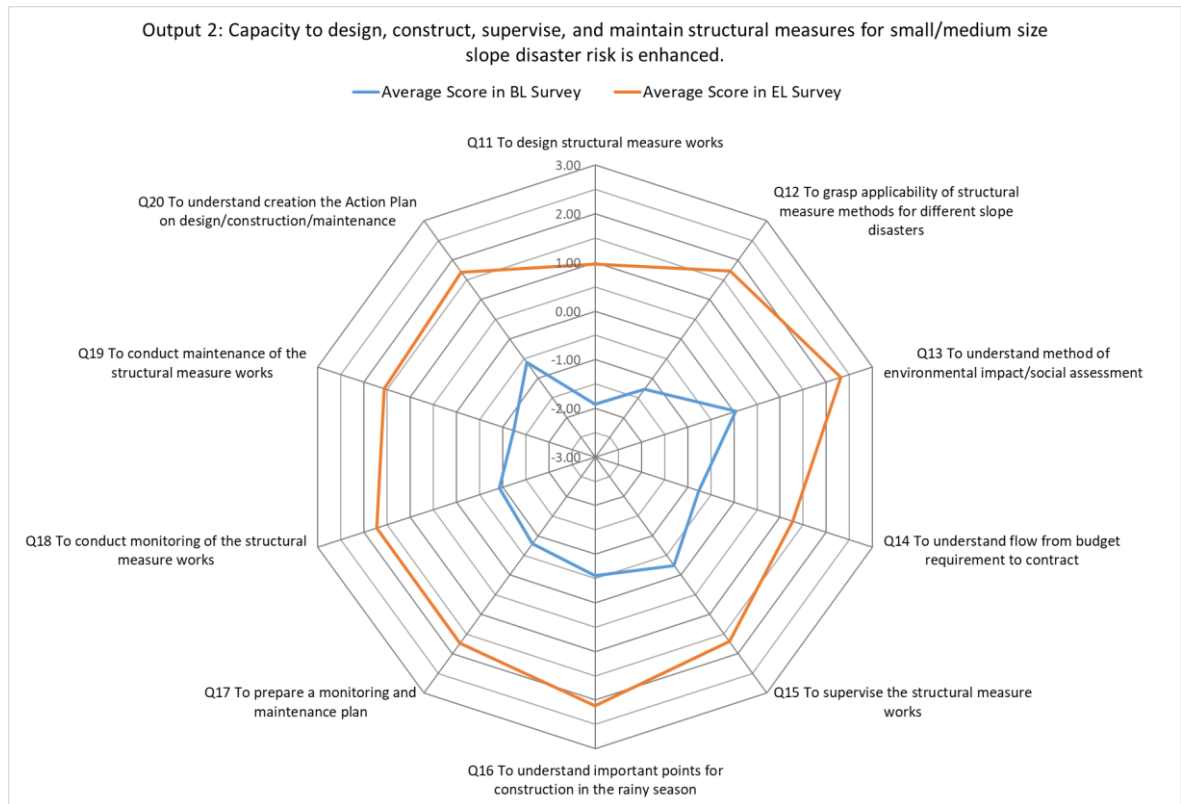
Figure 2 Comparison of BL Survey and EL Survey (Output 2)

For Output 2, significant improvements were observed in the questions related to the design, application, and maintenance of structural countermeasures, particularly in “Q11: Design of structural countermeasures,” “Q12: Applicability of countermeasure methods,” and “Q19: Maintenance of structural countermeasures.” Before the Project, the C/P personnel had little experience in implementing actual structural countermeasure works. However, through the Project activities, their comprehensive management capacity—from planning and designing appropriate structures for slope disasters to maintenance—was significantly enhanced. Furthermore, the results of other questions also show an overall improvement in understanding in the EL survey, confirming that the technical capacity related to structural countermeasure works under Output 2 has been steadily established among the C/P personnel.

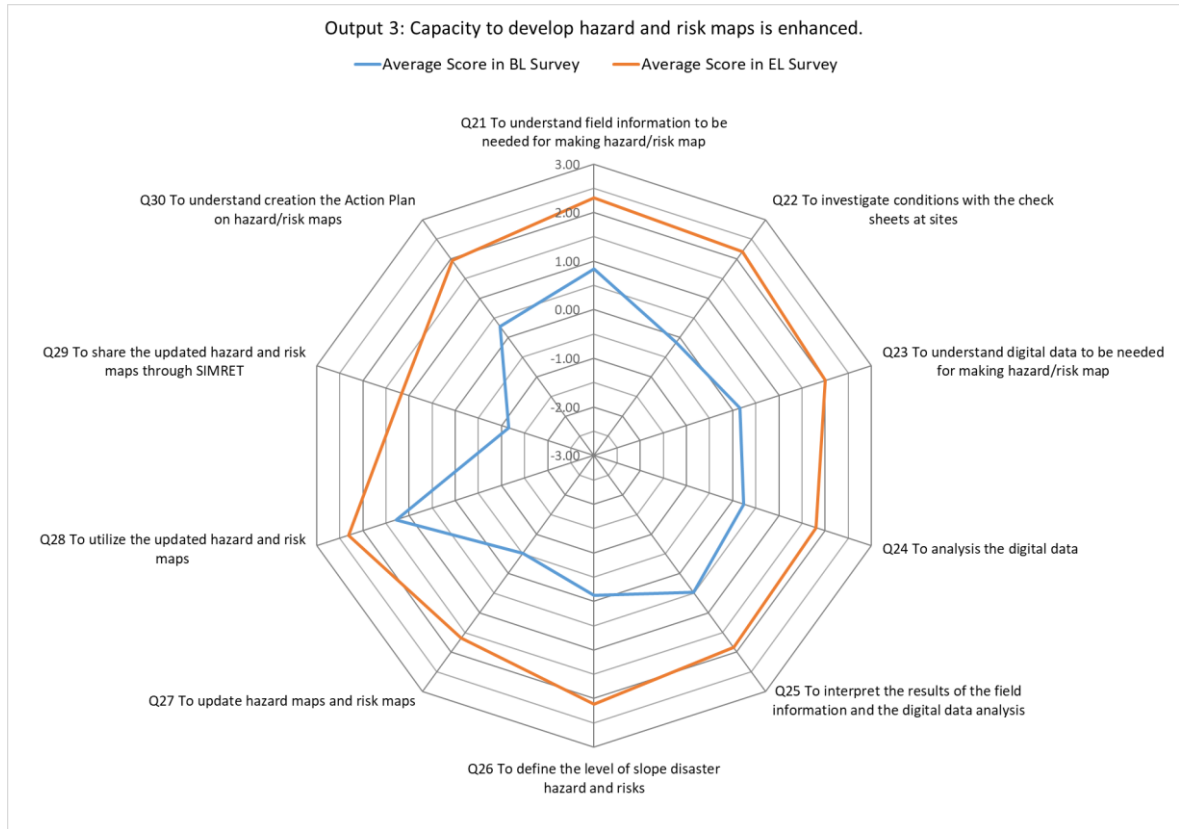
Figure 3 Comparison of BL Survey and EL Survey (Output 3)

For Output 3, remarkable improvement was observed particularly in the capacities related to the preparation and application of hazard and risk maps. Specifically, “Q22: On-site survey,” “Q26: Definition of hazard and risk,” and “Q29: Public dissemination of hazard and risk maps” showed notable progress. This indicates that the C/P personnel significantly improved their ability to carry out the entire process—from defining hazards and risks based on quantitative data collection and organization in the field, to disseminating the results of hazard and risk evaluations. In addition, other questions also showed improvement in understanding, confirming that the capacity-building activities related to hazard and risk mapping were highly effective and meaningful.

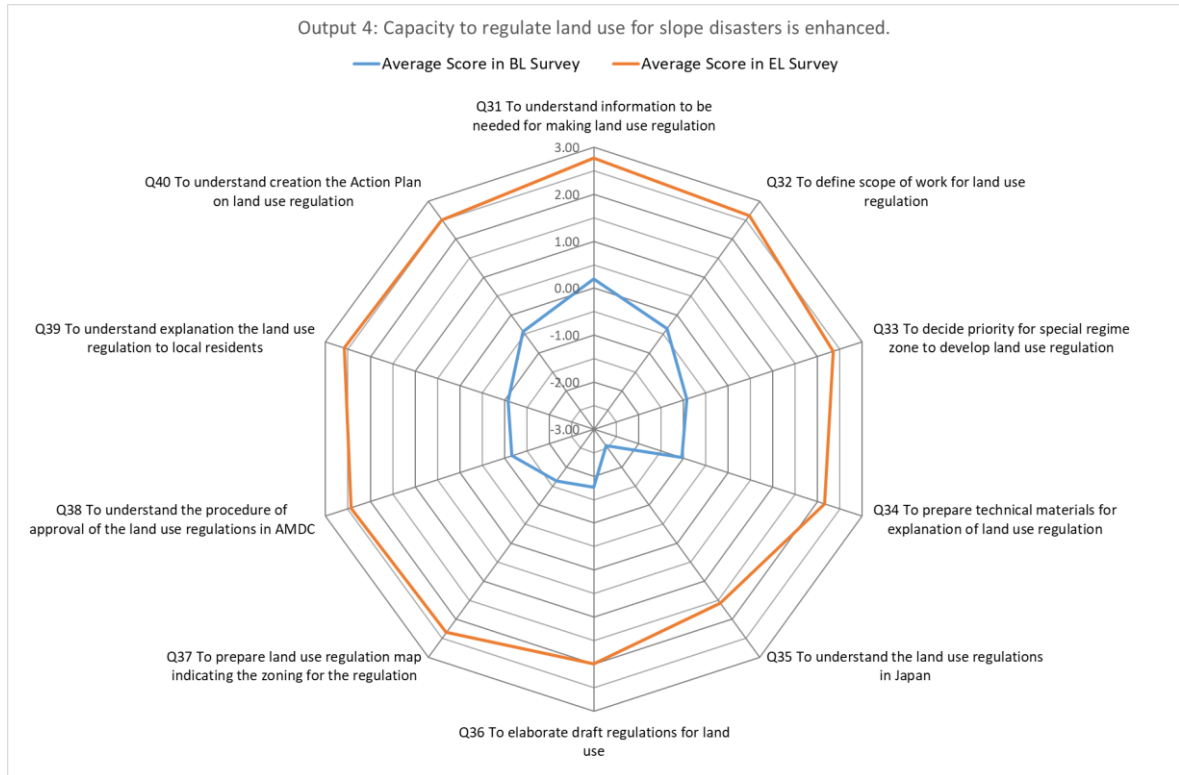
Figure 4 Comparison of BL Survey and EL Survey (Output 4)

For Output 4, the concept of land-use regulation related to slope disasters had not existed in Honduras prior to the Project, resulting in a very limited understanding among C/P personnel at the time of the BL survey. However, through the implementation of the Project, significant improvement was observed, particularly in the fields related to regulation formulation and consensus building with local residents—such as “Q35: Understanding of land-use regulation,” “Q36: Land-use regulation,” “Q37: Regulation map,” “Q38: Process to approve the regulation,” and “Q39: Explanation to residents.” In the EL survey, comprehension levels for Output 4 were consistently high compared to other Outputs, and the degree of improvement from the BL survey was also remarkable. These results indicate that the Project effectively promoted the establishment and institutionalization of technical capacity related to land-use regulation for slope disasters.

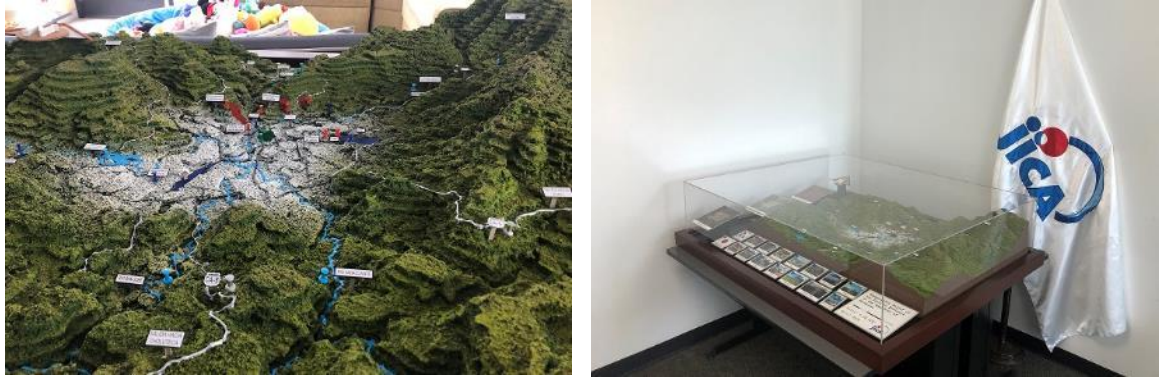
A 3D terrain model was created in order to help understand the accurate topography of the Tegucigalpa Central District and the model was submitted to the JICA Honduras office. The main roads and rivers in Tegucigalpa, the offices of the C/P institutions, the JICA Honduras office, the Japanese Embassy and other major buildings are shown on the 3D terrain model whose size is approximately 1.5m x 1.2m. The cost of the model was USD 4,900.

Figure 5 3D terrain model (left), model submitted to JICA Honduras office (right)

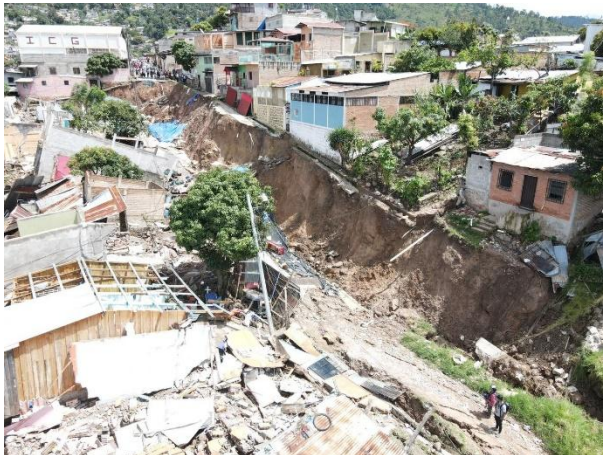
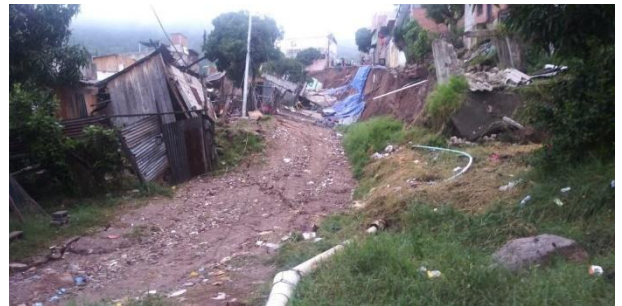
Figure 7 Landslide in La Guillen

- On October 10, after rainfall from Hurricane Julia (10/9: 26.8mm/day, 10/10: 8.0mm/day), a small landslide occurred in Nueva Santa Rosa, adjacent to La Guillén. Six houses were damaged by this landslide. The landslide movement is related to the La Guillén landslide. No dead/injured.

- On October 17, the main part of landslide body in La Gullén is stable, but the head is in a state of domestic wastewater accumulation. Cracks have expanded in the southeastern part (scarp) and southwestern part (Nueva Santa Rosa).

- On October 31, deformation is progressing in a landslide-affected house in Nueva Santa Rosa (a simple tilt measuring device was installed on October 24).

- Since late August, relatively heavy rain (around 40 to 80 mm/day) has continued in the Tegucigalpa.
- Since around September 1, cracks in houses and subsidence of roads have been reported in La Guillen.
- On September 6, major cracks and wall damage were reported at least three homes.
- On September 7, a field survey was conducted with AMDC staff, and AMDC investigated the damage situation at the site (the mayor also visited the site). JET made proposals to AMDC regarding covering road cracks with vinyl sheets (prevention of rainwater permeation), continuous inspection, future emergency countermeasures and monitoring policies.
- On September 10 to 11, after receiving reports that cracks in houses and road subsidence had increased significantly (20cm/day) due to continuous rainfall, on the morning of the 11th, JET recommended that

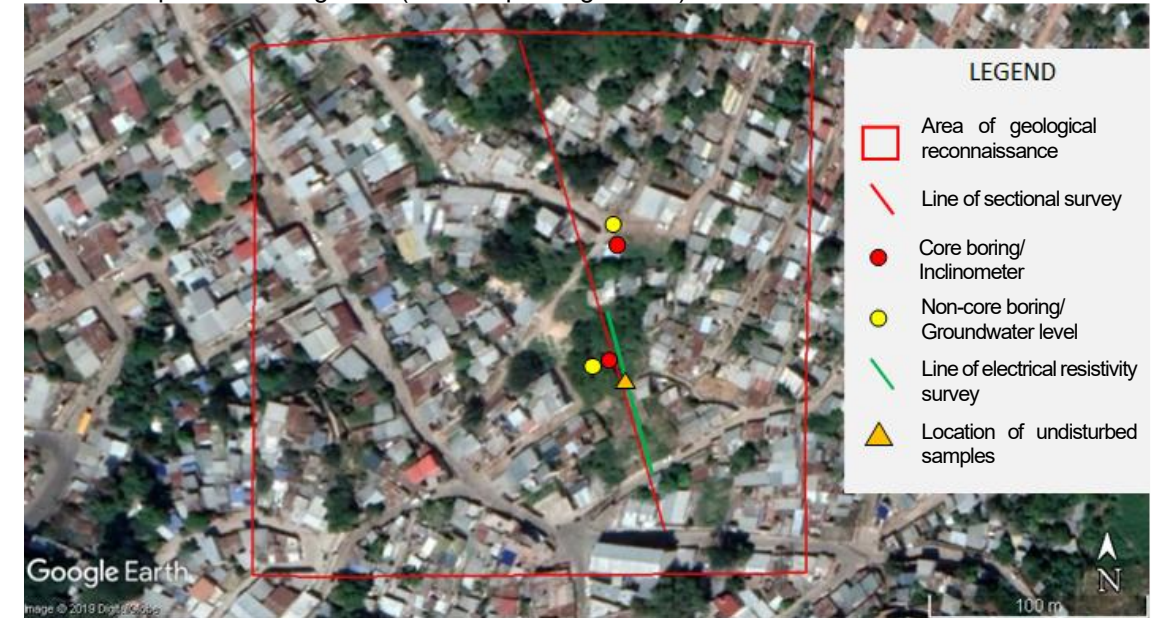
Location map of the investigations (Base map: Google Earth)

At this site, investigations were conducted to comprehend the geophysical and mechanical properties of landslide and geological distribution. Since the slip surface of the landslide was found at the outcrop on the site, soil block samples were collected near the slip surface and used as a specimen for the laboratory soil test.

Investigation item		Quantity	Remarks
Geological reconnaissance		44,100 m ²	The reconnaissance was conducted based on the contour map and sectional diagrams.
Drilling survey	Core boring	26 m	Drilling core samples were taken to comprehend the geological condition.
	Non-core boring	25 m	Borehole was made to conduct S.P.T. and for installation of monitoring equipment.
In-situ test	Standard penetration test	23 tests	The test was conducted to estimate physical and mechanical property of the ground.
	Electrical resistivity logging	2 boreholes	The test was conducted to find a depth of groundwater flow in the borehole for groundwater level monitoring.
Monitoring on landslide	Ground water level	26 m	Groundwater level is being monitored regularly in perforated pipe installed in the borehole.
	Borehole Inclinator	27 m	Inclination of the pipe installed in the borehole is being monitored regularly by the instrument.

Geophysical exploration	Electrical resistivity survey	90 m	The survey was conducted to estimate distribution of geological strata, groundwater and landslides.
Laboratory test	Direct shear test	3 samples	The test was conducted to obtain mechanical parameter of the ground by using undisturbed samples.

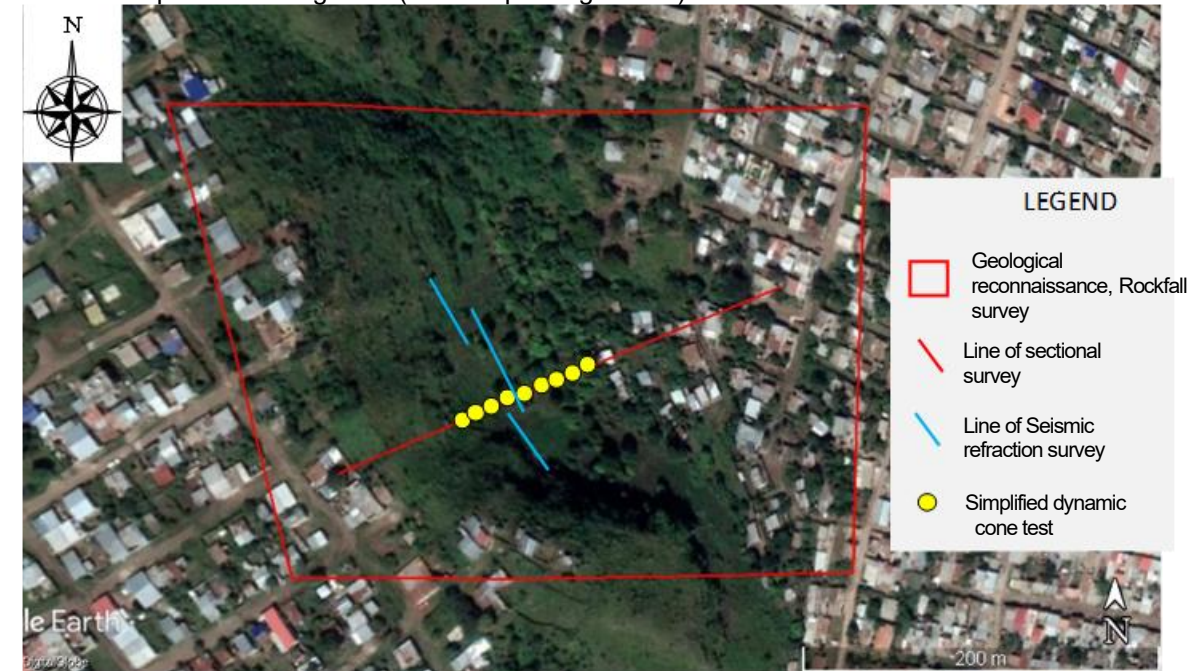
Location map of the investigations (Base map: Google Earth)

The survey was conducted to determine the status of unstable rock, past rockfall damage, to investigate the geophysical and mechanical characteristics.

Contents of investigation		Quantity	Remarks
Ground geological survey		57,500 m ²	Geological survey was conducted based on the topographic map and profiles created by topographic survey.
Rockfall survey		57,500 m ²	The distribution and size of rockfall on talus were investigated
On situ test	Standard penetration test	9 sites	The thickness of the surface colluvial deposit was surveyed.
Geophysical investigation	Elastic wave exploration	200 m	The thickness of the surface colluvial deposit and the depth of the base rock were confirmed.

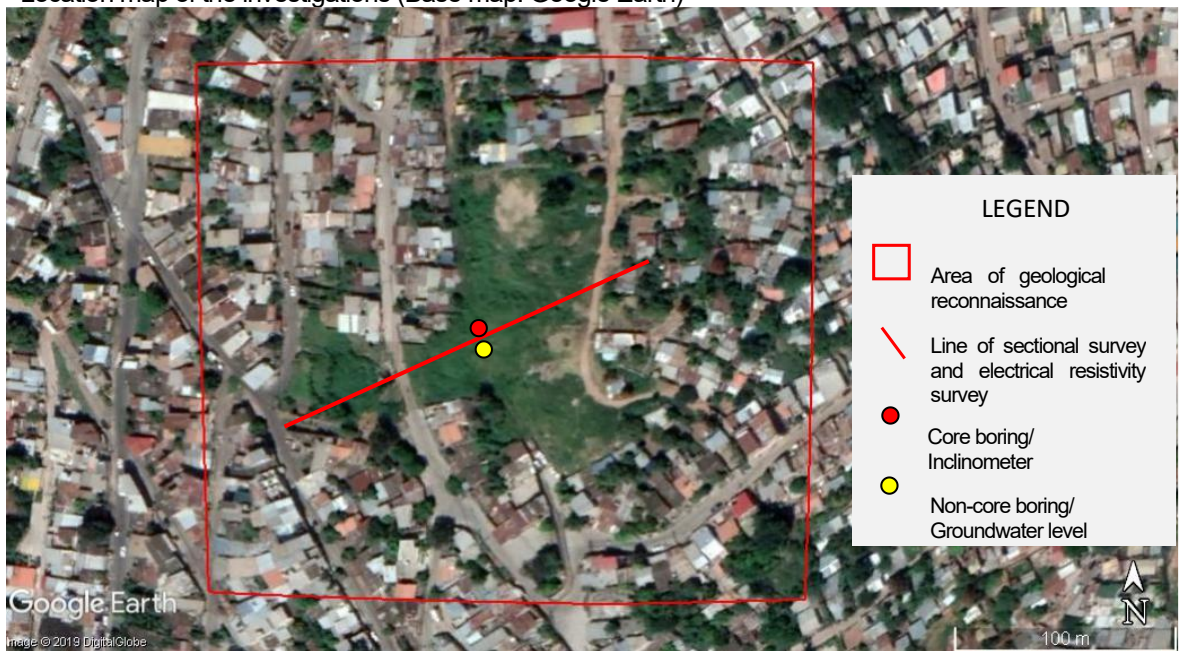
Location map of the investigations (Base map: Google Earth)

At the site, investigations were conducted to comprehend the geophysical and mechanical properties of landslide and geological distribution. AMDC has conducted some investigations on this site in the past. Therefore, the investigations at this time were planned and conducted based on a premise that existing investigation results will be used.

Investigation item		Quantity	Remarks
Geological reconnaissance		57,200 m ²	The reconnaissance was conducted based on the contour map and sectional diagrams.
Drilling survey	Core boring	25 m	Drilling core samples were taken to comprehend the geological condition.
	Non-core boring	25 m	Borehole was made to conduct S.P.T. and for installation of monitoring equipment.
In-situ test	Standard penetration test	23 tests	The test was conducted to estimate physical and mechanical property of the ground.
	Electrical resistivity logging	0 borehole	The test has not been conducted due to low level of groundwater in the borehole.
Monitoring on landslide	Ground water level	25 m	Groundwater level is being monitored regularly in perforated pipe installed in the borehole.
	Borehole Incliner	25 m	Inclination of the pipe installed in the borehole is being monitored regularly by the instrument.
Geophysical exploration	Electrical resistivity survey	200 m	The survey was conducted to estimate distribution of geological strata, groundwater and landslides.

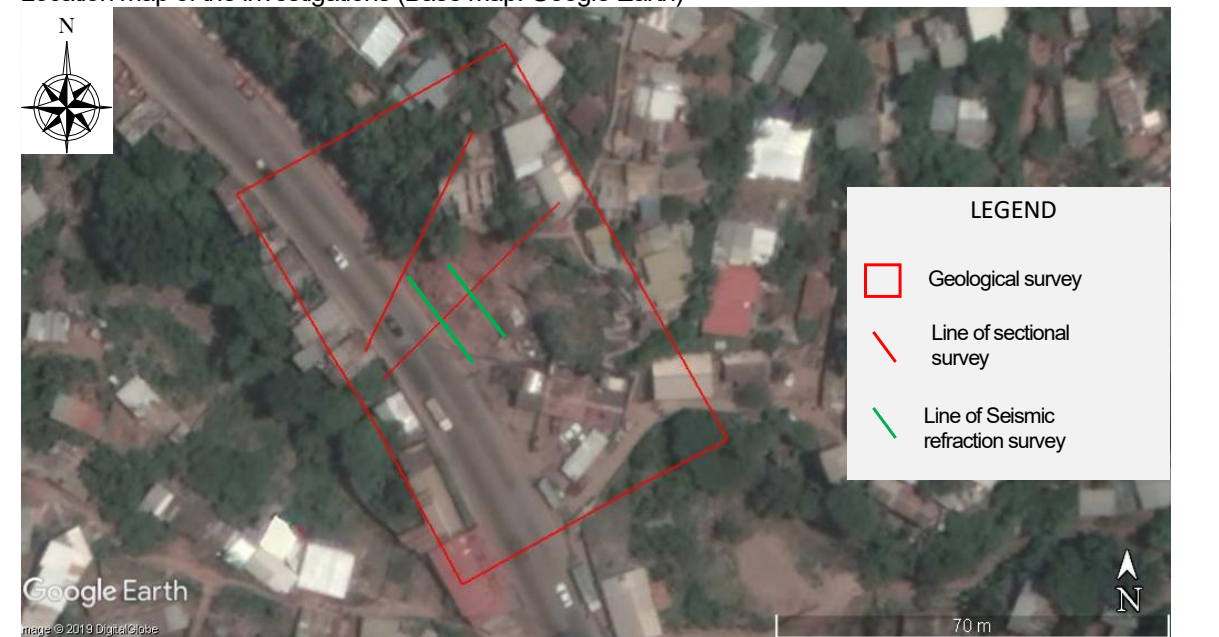
Location map of the investigations (Base map: Google Earth)

The investigation was conducted to determine the geology, distribution of cracks and unstable rocks, and geophysical characteristics. COPECO has conducted investigations in this area before, so the investigation contents are being planned and implemented taking that into account in this area.

Investigation item		Quantity	Remarks
Ground geological survey		5,100 m ²	Geological survey was conducted based on the topographic map and profiles created by topographic survey.
Crack survey		5,100 m ²	Joints and crack distribution and crack direction were surveyed.
Geophysical investigation	Elastic wave exploration	40m	This was conducted by UNAH to check the thickness of the colluvial deposit (the depth of the basement rock).

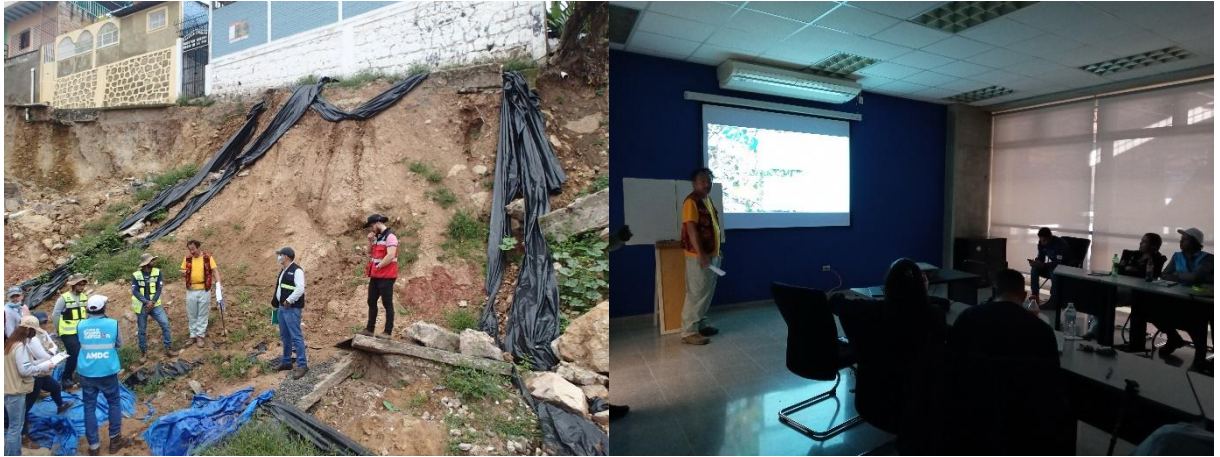
Figure 9 Site Reconnaissance and Workshop on Landslide in Nueva Santa Rosa and la Guillen

Through the joint site reconnaissance, WG members and JET determined the extent and direction of movement of landslide blocks in La Guillen and Nueva Santa Rosa, as well as the characteristics of each landslide. In both landslide sites, the slip surface is shallowly distributed due to the fact that the landslide blocks were formed into small blocks by sliding. In addition, water inflow from behind the landslide blocks was observed, and many open fractures were developed on the ground surface, indicating that surface water tends to percolate into the ground. Based on the information obtained on the site, an investigation plan was

developed to determine the exact distribution of slip surfaces and groundwater level variations required for the design of the countermeasure work. In addition to developing an overall project schedule, the WG members were instructed to review the investigation and monitoring plan and the departments responsible for each task

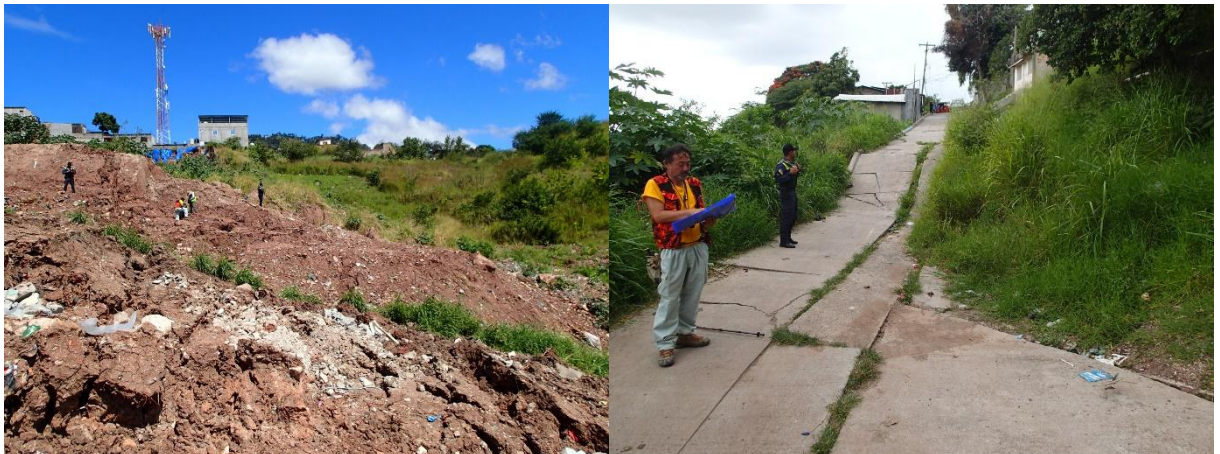
Figure 10 Site Reconnaissance (Left : Villa Delmi, Right : Suazo Cordova)

Landslides occurred in the Suazo Cordova and Villa Delmi site at the same time as the landslide in the La Guillen site. Although these two sites are not the target of this project, AMDC requested JET to support their future response, and JET and members of WG1 and 2 conducted a site reconnaissance and assessment of the current situation.

Based on the findings by the site reconnaissance, AMDC was advised on the survey plan for Suazo Cordova, and proposed the evacuation of the residents since the deformation progressed in about 10 days. As a result of discussions within AMDC on this proposal, it was decided to implement emergency measures as soon as possible instead of evacuating the residents.

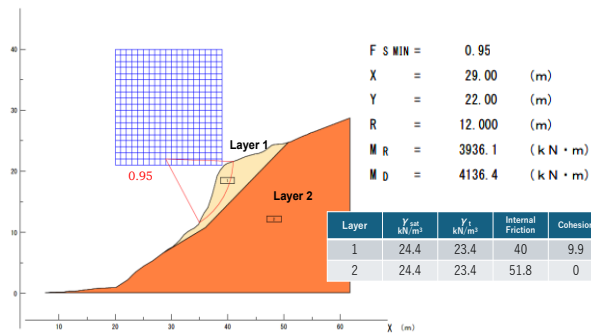
Figure 34 Stability Calculation

Based on the results of the site reconnaissance, the stability analysis model was developed with two geological layers: a weathered layer and a highly weathered layer of the bedrock conglomerate. These layers were distributed above and below the boundary of the 40-degree dip plane joint. Two slope models were developed: one for the pre-collapse condition and one for the post-collapse condition. For soil properties, undisturbed samples were collected from both layers with UNAH's counterparts. Direct shear tests were conducted at soil testing laboratory of Engineering faculty, UNAH. AMDC performed simplify dynamic cone penetration tests (DCP) on each soil layer to measure N_c values. Soil parameters were established for each stratum based on the laboratory test results and the DCP test results. Stability calculations were performed using these parameters in the pre-collapse model to verify their validity. The results showed a safety factor of $F_s=1.05$ in the pre-collapse model, differing from the actual collapse outcome. Therefore, parameters yielding a safety factor of $F_s=0.98$ were calculated using a back analysis method and adopted as the soil parameters for verifying the stability of the current slope. Using these parameters, stability calculations were performed on the post-collapse slope model. The results showed that the post-collapse slope model developed for all

three survey lines yielded Fs values of 1.0 or higher. Based on the results, it was determined that the likelihood of a large-scale collapse, such as the one that occurred in June 2024, recurring on the current slope is low.

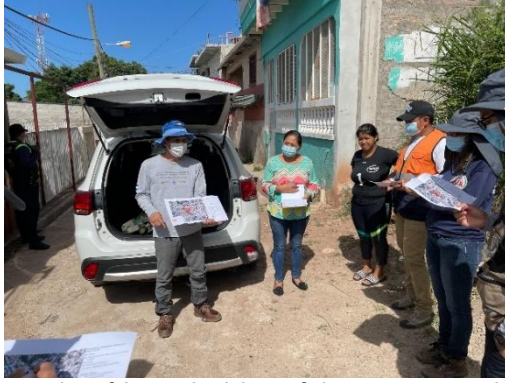
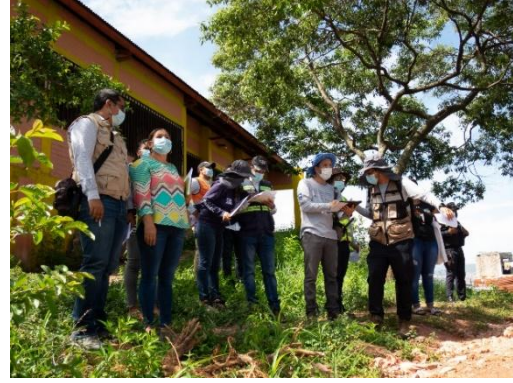
Figure 35 Site survey for vulnerability evaluation

Instruction of the methodology of site survey to member of the WG 1 and CODEL

Site survey

In order to evaluate the vulnerability in the risk zones classified in Activity 1-7, the WG members are conducting the survey on the above items with the cooperation of IDEM (Institute of Development in Metropolitan) in AMDC.

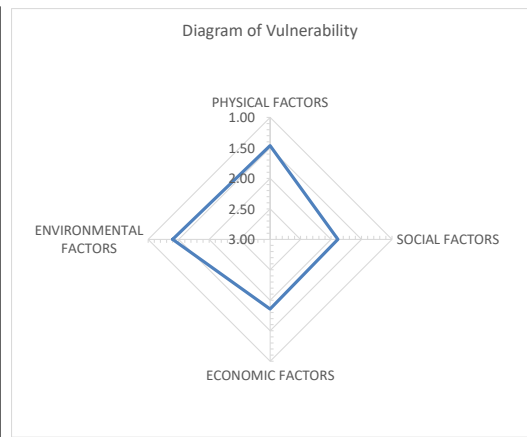
Figure 36 Evaluation result of vulnerability for slope disaster hazard in site in Campo Cielo

PHYSICAL FACTORS											
E	Strength of house	Countermeasure	Shelter, Evacuation route	Electricity, Water	Sanitary sewage	Waste collection Service		P	F	EXPXF	PxF
1	X	X			X			3	3	9	9
2						X		2	1	4	2
3			X	X				1	2	6	2
TOTAL VALUE = ((Σ(1-3) (E x P x F)) / (Σ(1-3)(P x F)))							19/13=	1.46		19	13
SOCIAL FACTORS											
E	Residential network	Reciprocal relations	Trained, skilled person	Vulnerable person	Security			P	F	EXPXF	PxF
1					X			3	1	3	3
2			X	X				2	2	8	4
3	X	X						1	2	6	2
TOTAL VALUE = ((Σ(1-3) (E x P x F)) / (Σ(1-3)(P x F)))							17/9=	1.89		17	9
ECONOMIC FACTORS											
E	Asset	Public deed	Income	Financial support (NGO)				P	F	EXPXF	PxF
1				X				3	1	3	3
2		X						2	1	4	2
3	X		X					1	2	6	2
TOTAL VALUE = ((Σ(1-3) (E x P x F)) / (Σ(1-3)(P x F)))							13/7=	1.86		13	7
ENVIRONMENTAL FACTORS											
E	Medical care	Disaster condition						P	F	EXPXF	PxF
1		X						3	1	3	3
2	X							2	1	4	2
3								1	0	0	0

TOTAL VALUE = ((Σ(1-3) (E x P x F)) / (Σ(1-3)(P x F)))							7/5=	1.40		7	5
SUMMARY OF THE ASSESSMENT											
COMPONENTS							SCORES				
PHYSICAL FACTORS							1.46				
SOCIAL FACTORS							1.89				
ECONOMIC FACTORS							1.86				
ENVIRONMENTAL FACTORS							1.40				
VULNERABILITY INDEX							1.60

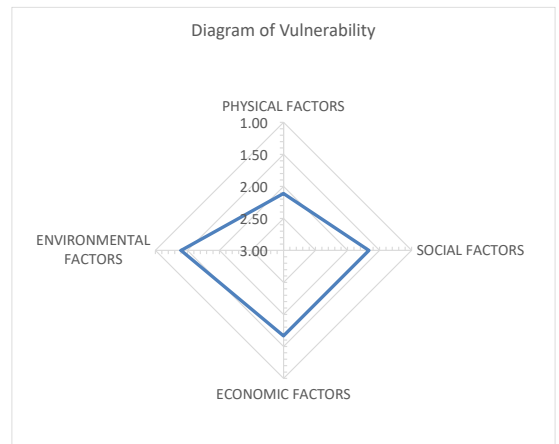
Figure 38 Result of vulnerability assessment to slope disaster in Nueva Santa Rosa

The result of the vulnerability assessment in this site is shown below. The table on the left side of the figure below shows the results of the scoring for each factor of vulnerability. Based on this score, the overall vulnerability score for the site is 1.8. A higher vulnerability score would be closer to 1.0. This indicates that the site is somewhat vulnerable to slope hazards, and its overall vulnerability is not as high as that of Campo Cielo (1.6) or Fuerzas Unidas (1.5). According to the vulnerability of each factor in the upper right of the figure below, economic and environmental factors are rated as relatively more vulnerable, while physical factors are rated as less vulnerable to disasters. The detailed contents of the vulnerability evaluation are shown in Appendix 9.

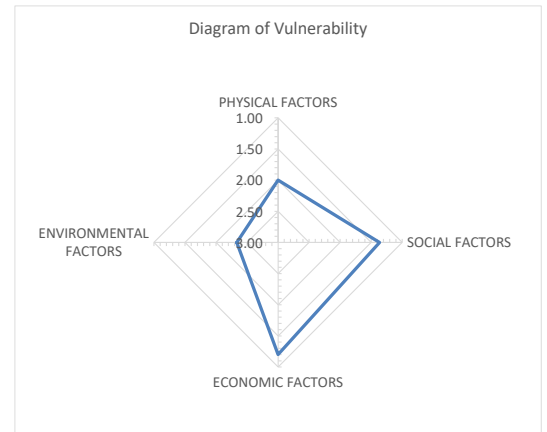
Figure 39 Result of vulnerability assessment to slope disaster in Villa Nueva

The result of the vulnerability assessment is shown below. The table on the left side of the figure below shows the results of the scoring for each factor of vulnerability. Based on this score, the overall vulnerability score for the site is 1.7. A higher vulnerability score would be closer to 1.0. This indicates that the district is somewhat vulnerable to slope hazards and is not as high as the Campo Cielo (1.6) and Fuerzas Unidas (1.5). According to the vulnerability of each factor in the upper right part of the figure below, the social and economic factors is relatively high vulnerability, while environmental factors are not particularly vulnerable to disasters, given the easy access to medical services and the fact that disasters do not occur frequently. The detailed contents of the vulnerability evaluation are shown in Appendix 9.

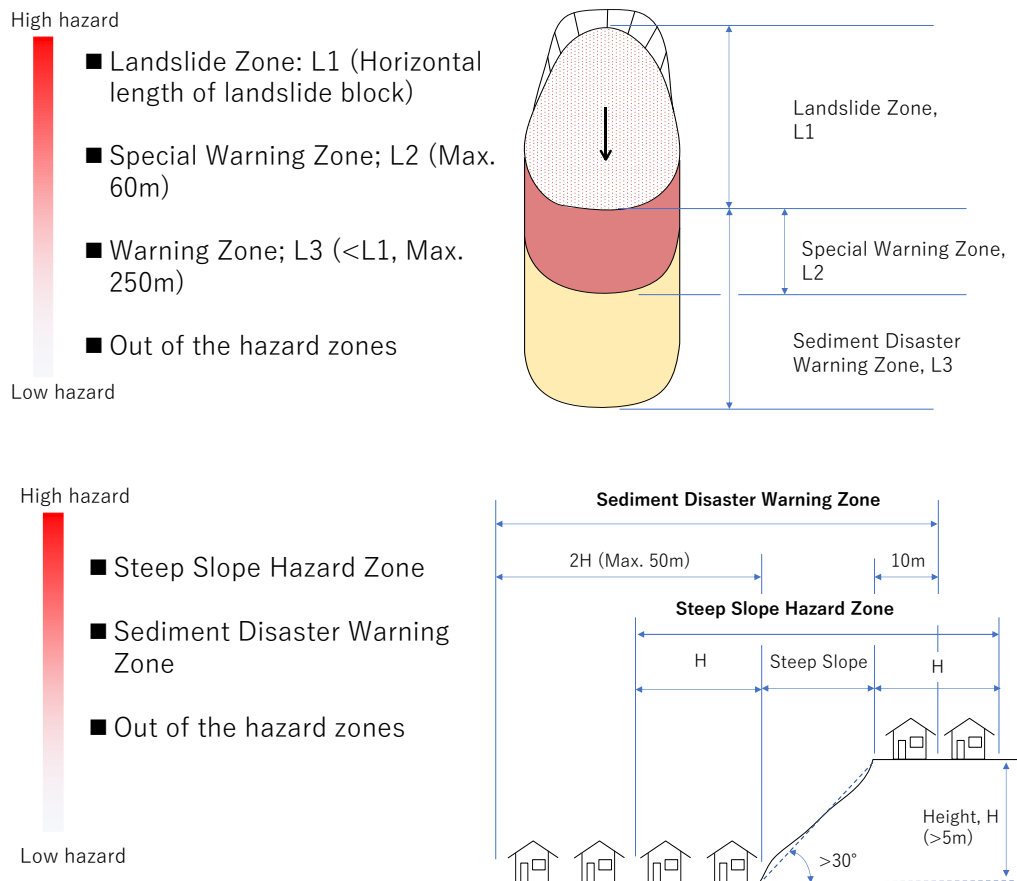
Figure 40 Risk zoning classification standard (for Landslide (upper), for slope failure/rockfall (lower))

The slope risk zoning and definition survey was conducted for the slope disaster risk sites, Campo Cielo and Fuerzas Unidas of the four pilot sites. The risk zoning was carried out with reference to the disaster warning zone classification standard in the Law of Japan on Sediment-related Disaster Prevention (refer to the figure below). The risk zone for landslide site is divided into four zones: "Landslide zone", "Special warning zone", "Sediment disaster warning zone" and "other than the warning zone", and the zone for slope failure/rockfall site is divided into three zones: "Steep slope hazard zone", "Sediment disaster warning zone" and "other than the warning zone".

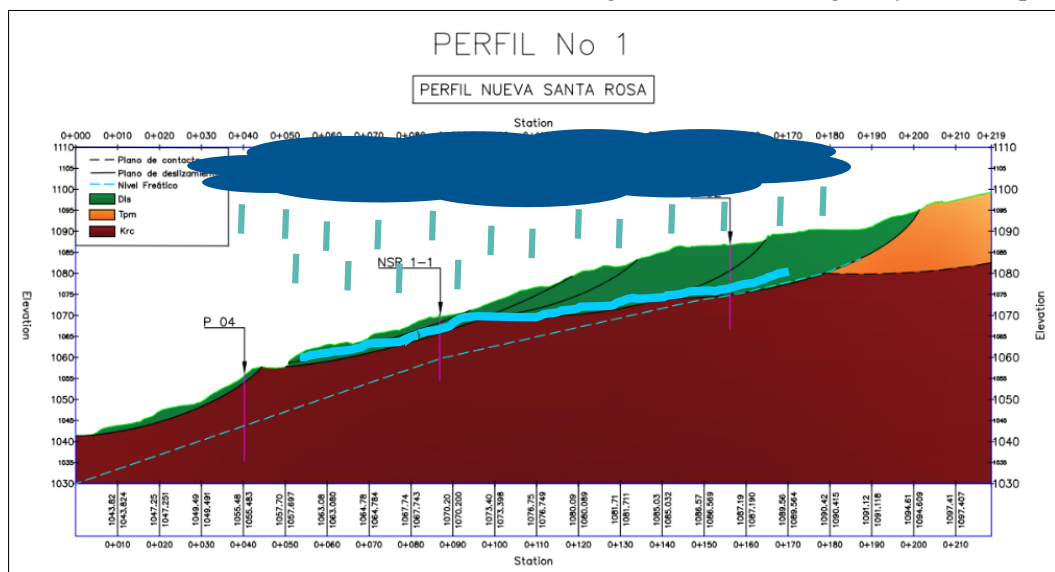
Figure 49 Image of landslide mechanism in Nueva Santa Rosa

- Predisposition: The conditions of the landslide blocks have become unstable / softened due to past landslide activities. In addition, tuff, which is the origin rock of the landslide body, is susceptible to weathering and softening. The material with such geological conditions is prone to landslide.

- Trigger: The landslides were activated due to the shallow groundwater table due to the infiltration of continuous rainfall due to the rainy season and hurricanes and the infiltration of domestic wastewater into the ground, and the decrease in ground strength.
- Landslide occurrence process:
 1. The upper landslide block was activated by infiltration of rainfall and leaking water
 2. The lower part of the upper landslide block became unstable, and a small landslide block was activated in a place where the toe of the upper landslide could not be retained because there were no houses or structures.
 3. There is a possibility that landslide activities will become more active in the surrounding small-scale landslide blocks, and if no measures are taken, the range of landslide damage may further expand.

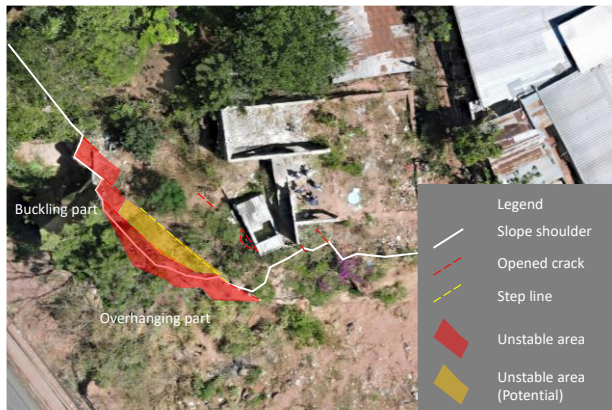
Figure 50 Range of unstable rocks (Plan view)

- Predisposition: High-angle joints develop on relatively hard rock slopes. The opening of this joint destabilizes the surface of the rock slope. The debris slope contains boulders, and the sediment in the matrix portion is in a loose condition.
- Trigger: Surface water such as domestic wastewater and rainwater from the back slope infiltrates through the cracks in the bedrock and the cracks open further by erosion, or the open cracks develop further due to the load of the unstable rock mass and the rock slope become unstable. On the debris slope, it is

1. Strength of open high-angle joints decrease by load of unstable rocks and surface water flow.
2. Unstable rock on the surface of the rock slope fall and/or topple.
3. Rocks and debris fall from the slope reach the road and obstruct a traffic.

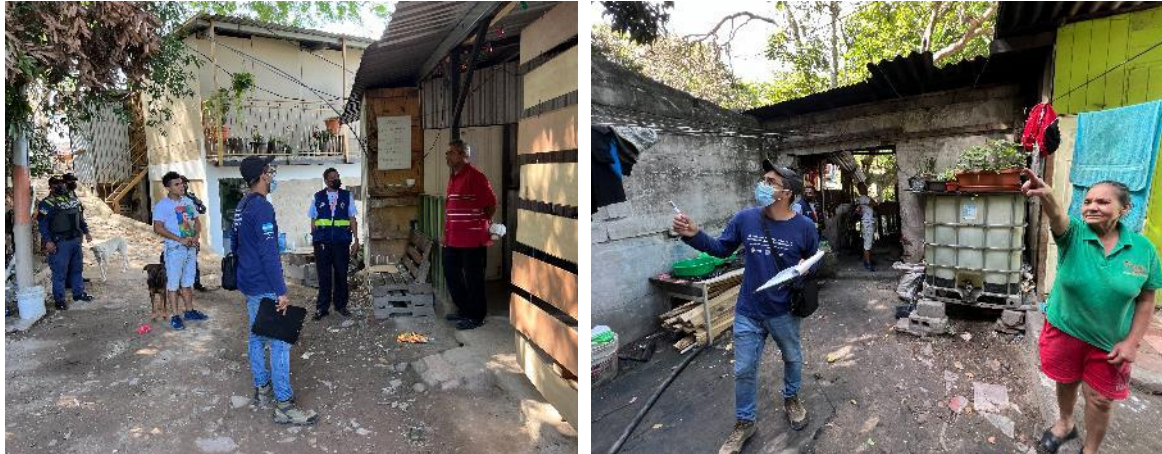
Figure 52 Interview Survey (El Eden)

Interviews with the residents around the landslide were conducted on 28, 29 July, in order to confirm the limit of the landslide and the condition of the surrounding of the landslide in El Eden. Fourteen (14) homes were visited and interviewed. The information from the residents were useful for confirmation of the range of the landslide and the condition of the surroundings. The shape of the landslide of El Eden and the cause of the landslide were studying based on the results of this interview survey.

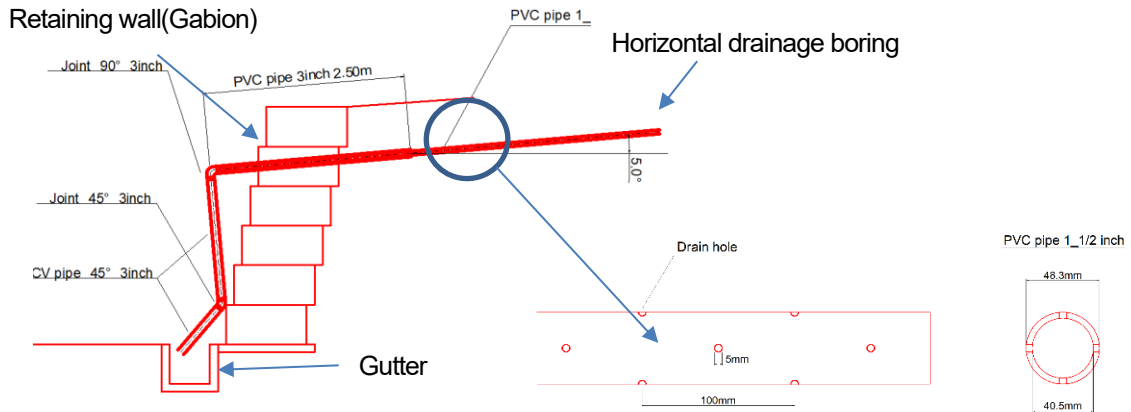
Figure 56 Structure of horizontal drainage boring

The following figure shows structure of horizontal drainage boring which is the main method in this site. This is the first time that a local contractor in Honduras implement this method.

Regarding the horizontal drainage boring constructed at the toe of the landslide, drainage pipe is installed by drilling the landslide mass through the retaining wall. The PVC pipe (1 1/2 inch) with drain holes is inserted into a hole excavated by a boring machine. The hole excavated by a boring machine has a predetermined length at an elevation angle of 5 °. The collected groundwater is drained by gutters. Other works such as channels, retaining walls, gutters constructed at the site have been conventionally implemented in Honduras.

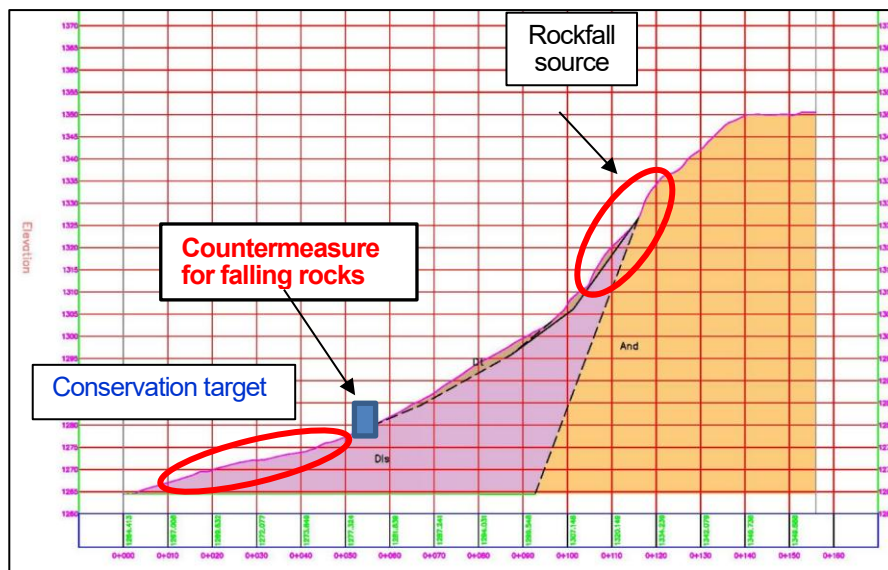
Figure 66 L-section of countermeasure located

In order to consider type of rockfall protection works, the rockfall energy was calculated. The rockfall energy is estimated to be 350 kJ, and the rockfall protection wall or a high energy absorbing rockfall protection fence is required to catch a rockfall of this size. The following figure shows the location between the rockfall source and the rockfall protection structure.

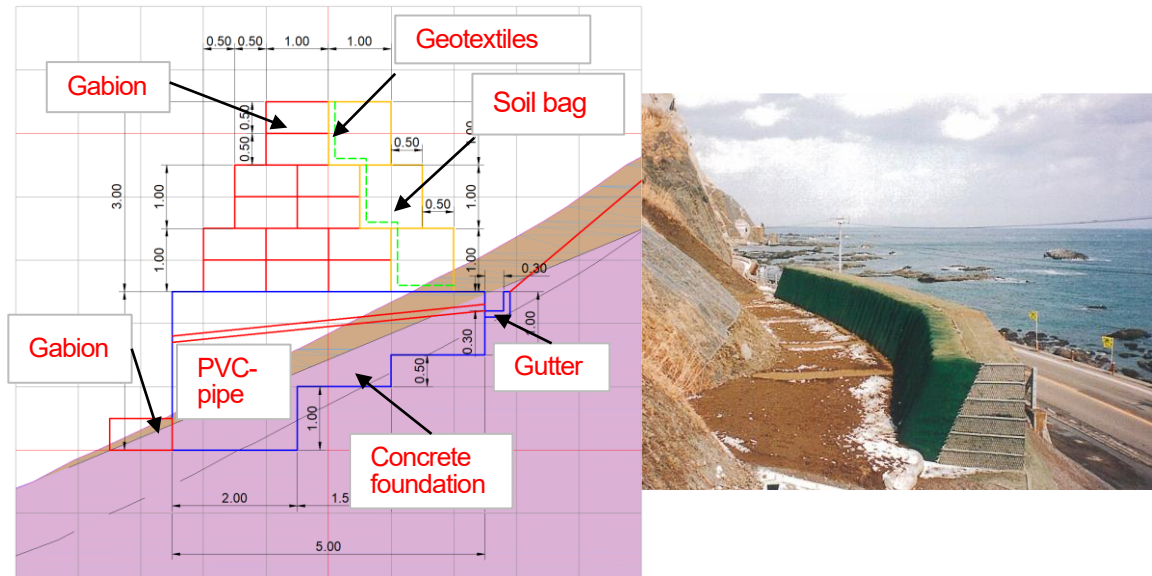
Figure 67 Rockfall protection wall

The rockfall protection wall consists of Gabions, sandbags, geotextile, and foundation concrete. This method has been used by many local contractors in Honduras. It is a simple method and quality control is easy. It is also easy to maintain, and maintenance costs are low. The construction cost is \$225,000/100m, which is lower than that of high-energy absorption rockfall protection fence.

Item	Quantity	Purpose
Sand bag	262.1m ³	Receives rockfall and absorbs their energy.
Gabion	524.2m ³	Catching rockfall with sandbags.
Geotextile	436.9m ²	Distribute the energy absorbed by the sandbag.
Foundation concrete	V=916m ³	Foundation of structures (Gabion, sandbag, Geotextile) to catch rockfall.

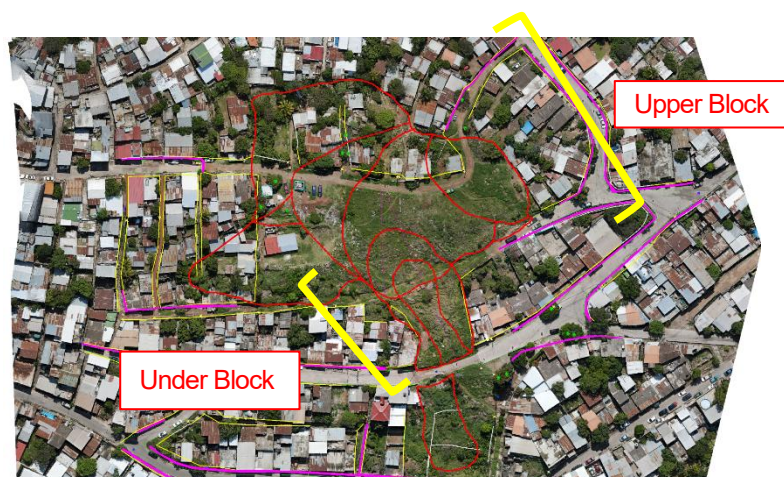
Figure 69 Landslide block

The target slope is divided into two blocks: the upper block, the main part of the landslide mass, and the lower block, the moving part of the landslide mass.

Observations of the target slope show that the landslide moves during rainfall. Excessive groundwater is supplied during heavy rainfall, which causes an increase in pore water pressure acting on the slip surface, and which destabilizes the landslide. The predisposition and trigger of the landslide are summarized as follows.

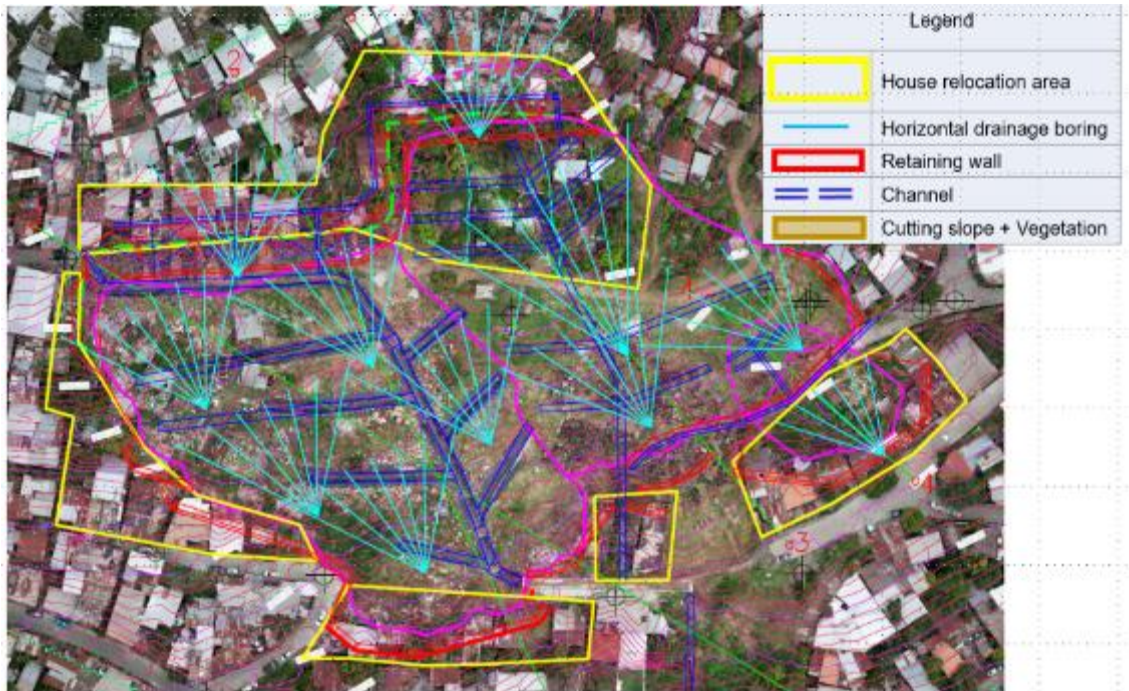
Figure 79 Plan view of the countermeasure work (preliminary design) and the range of required houses relocation of residences

In order to expedite the procedure, a preliminary design of the countermeasure works was implemented in November 2023 at this stage when before investigation, based on the preliminary design, required house relocation scope was decided.
