**Project for Control and Mitigation of
Slope Disasters
in the Central District in Republic of
Honduras
Project Completion Report**

February 2026

Japan International Cooperation Agency (JICA)

Kokusai Kogyo Co., Ltd.

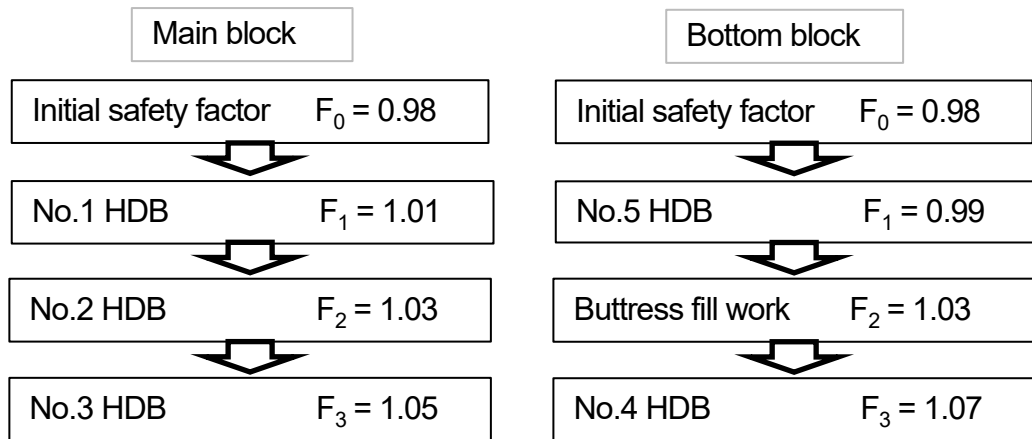
Figure 86 Flow of the safety factor (Nueva Santa Rosa)

The flow of the safety factor in the countermeasure plan is as follows.

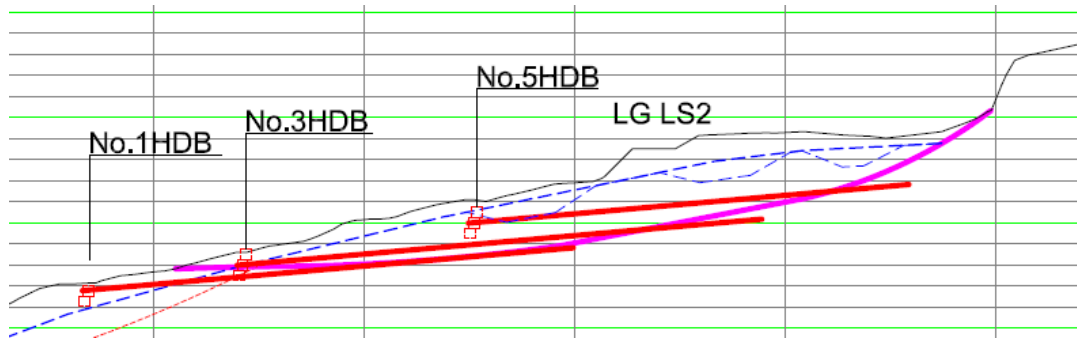
Figure 89 L-section shown the Countermeasure A-A (La Guillen LS-1 block)

- Groundwater control: Groundwater control will be carried out as much as possible by horizontal drainage boring.
- Surface water control: Control to surface water by channel and drain at landslide area.

- Fix at landslide bottom: Install Gabion retaining walls with excellent permeability and with follow-through against deformation at the bottom of the landslide block to fix the bottom of the landslide block.

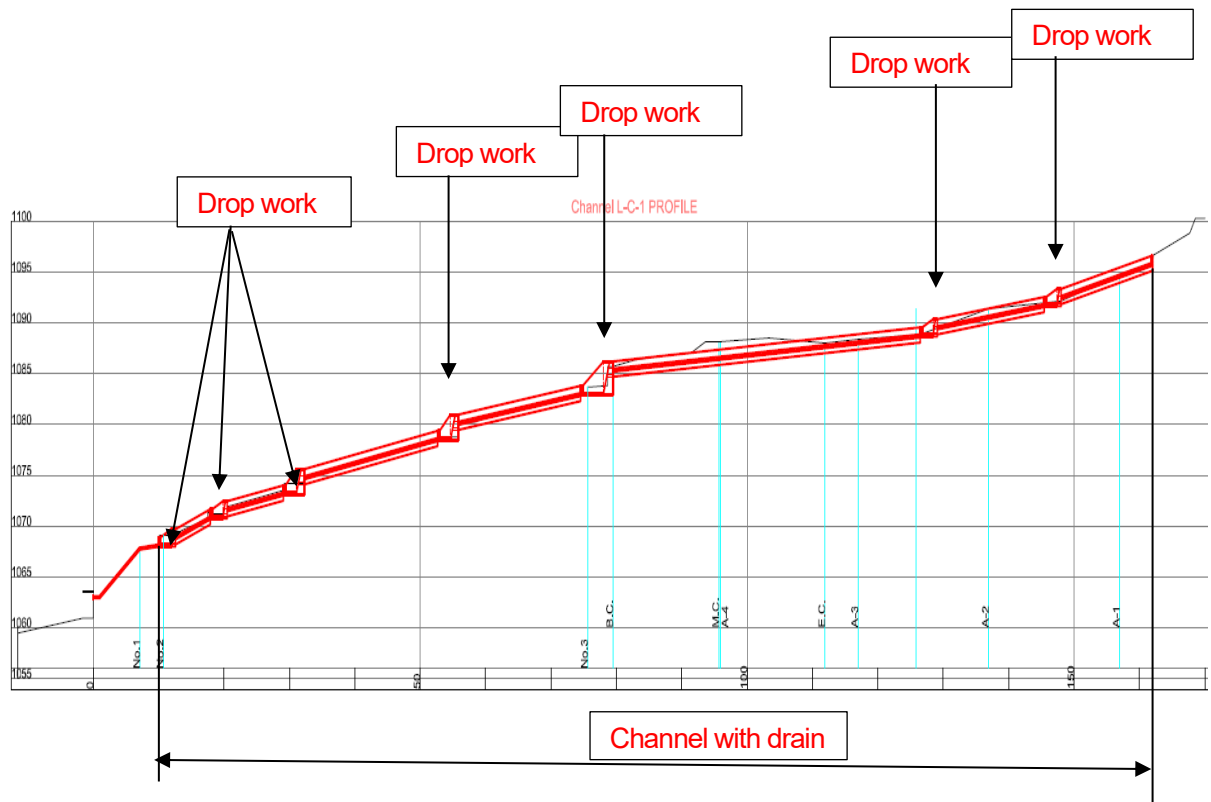
Figure 93 Profile of Channel (La Guillen)

The structural drawings of the countermeasure works are shown below.

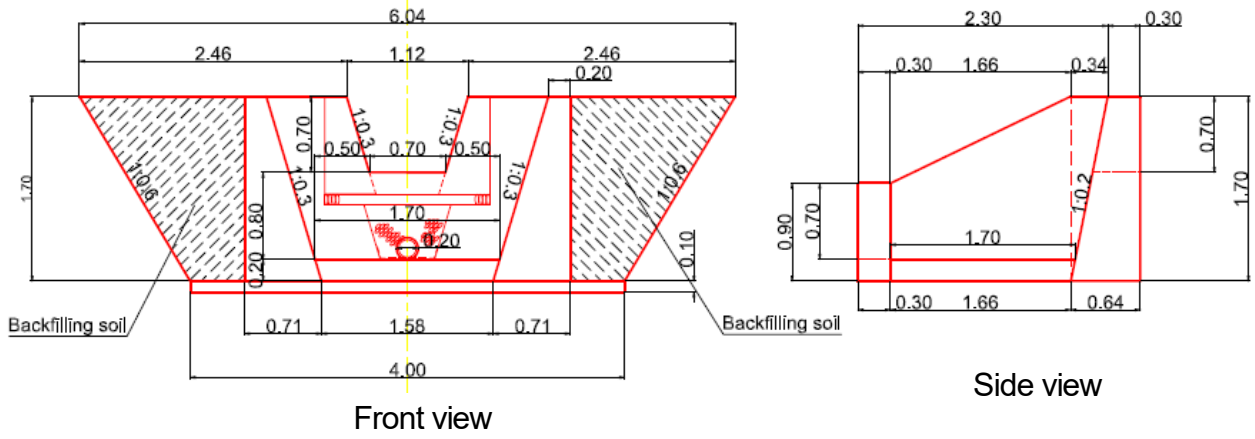
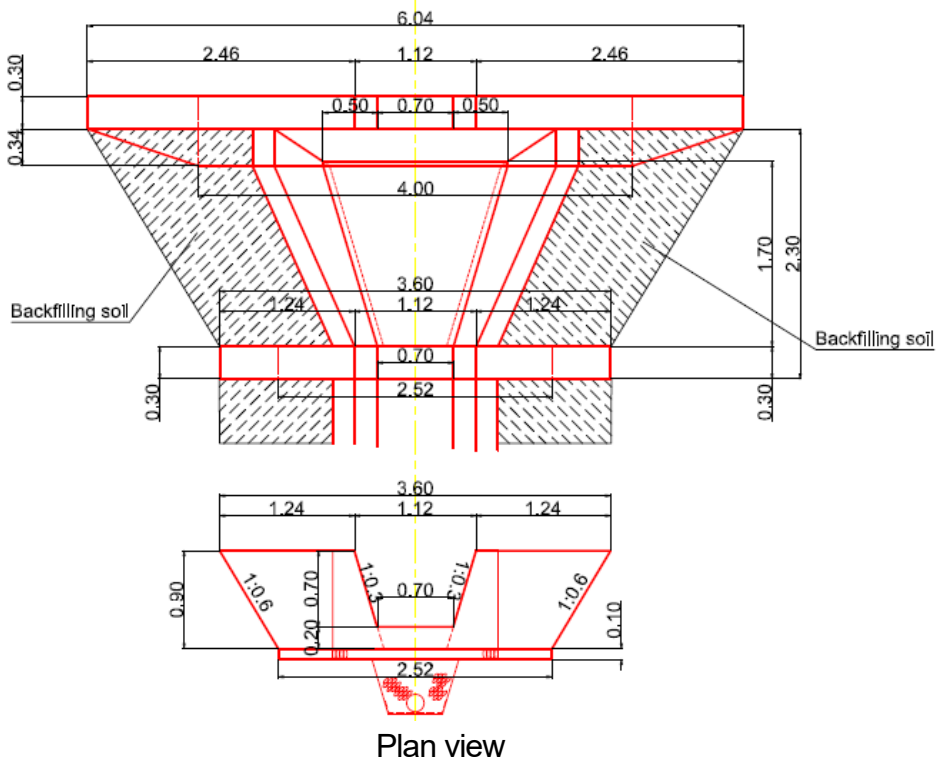
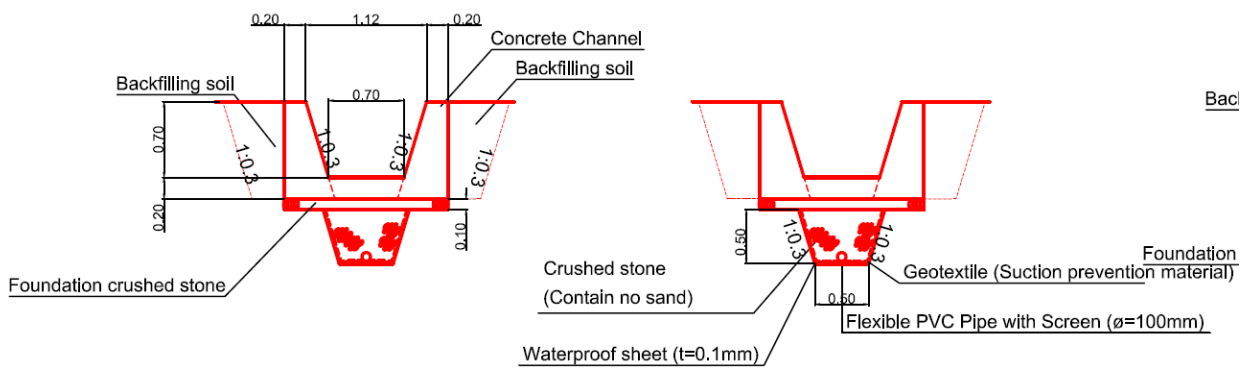
Figure 94 Structural drawing of Channel (La Guillen)

Dropwork Type1

Channel with drain Type 1

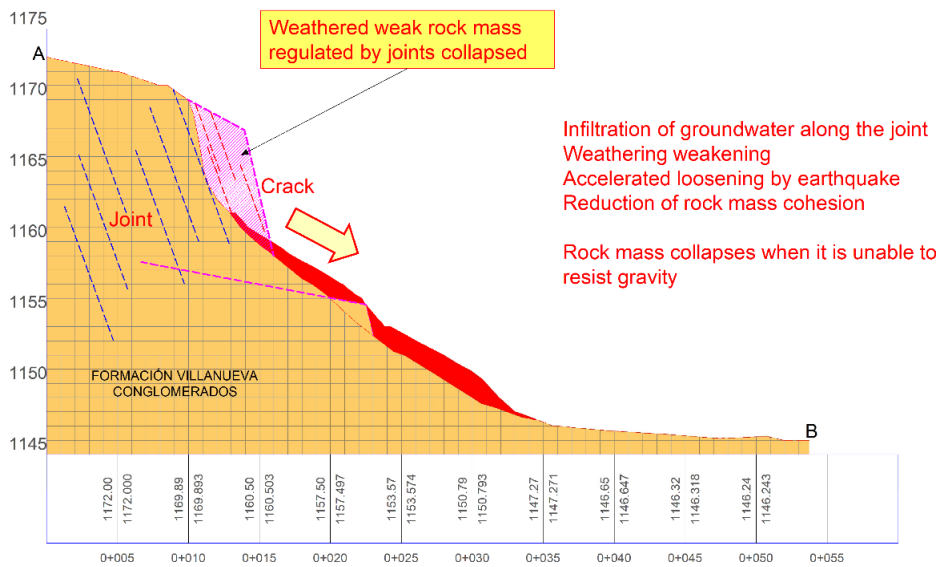
Figure 101 Collapse mechanism of No. 2 area

Comparing the present conditions with the photographs taken in 2017 when the collapse occurred, a significantly weathered and weakened bedrock distributed in a regulated state in the joint was collapsed. It is

thought that surface water penetrated into the joint and weathering and loosening progressed. Additionally, the strength of the rock mass gradually decreased and deformation occurred. The collapse is considered to have occurred when the strength of the rock mass could no longer withstand the deformation in the gravity.

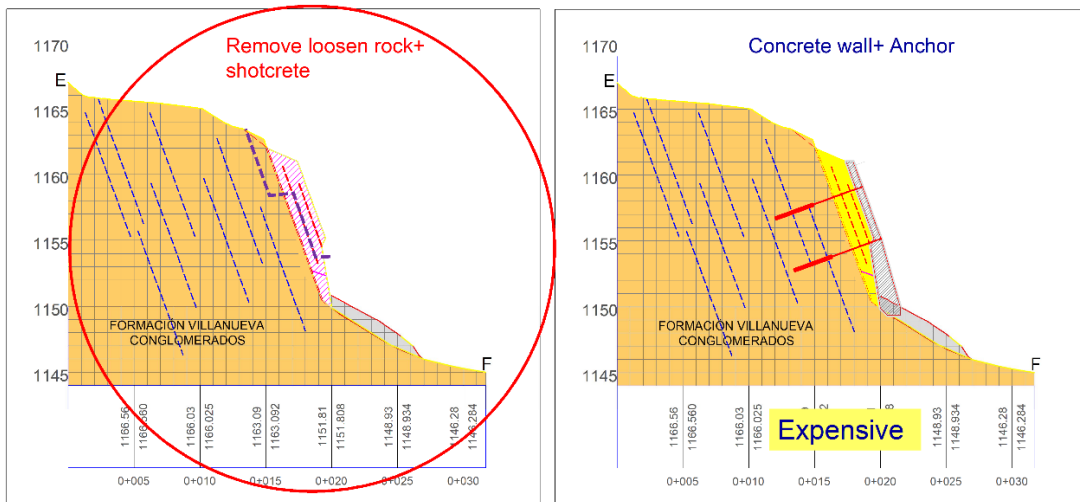
Figure 103 Countermeasure policy of No.1 area (L-section)

The rock in this area collapses due to the gradual downward deformation of the rock regulated by the joint due to gravity. Seepage and erosion caused by rainfall also contribute to the deformation. To prevent the collapse of unstable rock masses, the rock must be removed or fixed. At the same time, it is necessary to control rainwater infiltration and erosion. The size of rock mass at this area is able to be removed and economically advantageous compared to fix (anchoring).

Therefore, the policy here is to remove the rock mass. In addition, the slope after removal will be sprayed with mortar to prevent rainwater infiltration and erosion.

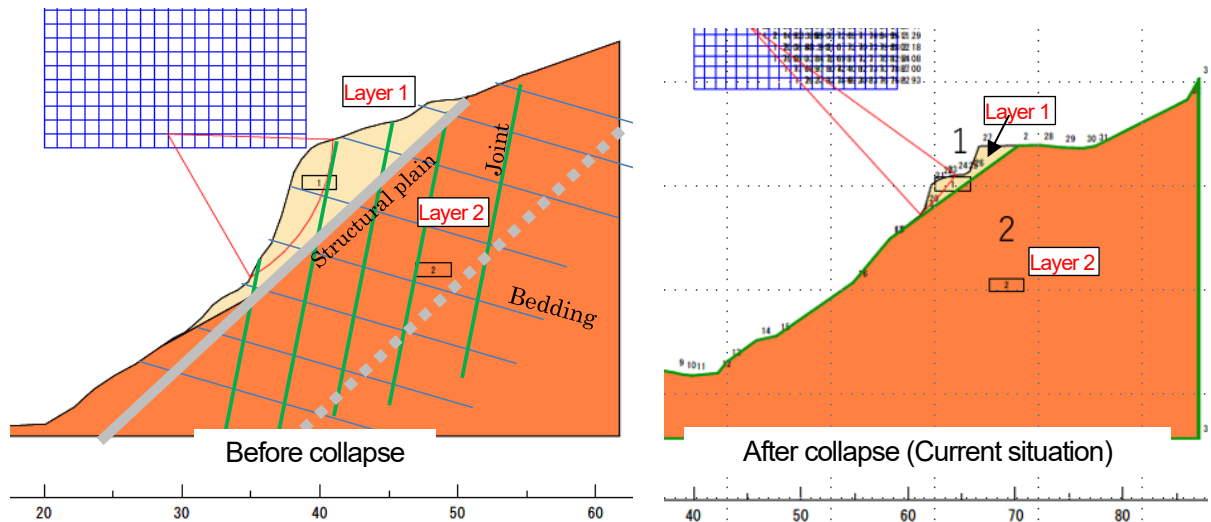
Figure 109 Countermeasure design drawing

- The stability of the back slope was assessed using a circular slip surface model, resulting in a minimum safety factor of $F > 1.50$.
- Based on this result, the risk of a large-scale collapse on the back slope was considered low.
- Although the height of the cliff at the top of the collapse is relatively low (2.0 to 3.0 m), it has become unstable with visible cracks. Therefore, it is recommended to regrade the slope to a gentler angle and stabilize it.

- Debris with a depth of approximately 0.4 to 1.5 m remains on the collapsed slope and should be removed.
- The stability of a slope cut at a 45° angle was also evaluated using a circular sliding model.
- The analysis showed a minimum safety factor of $F > 1.50$, confirming that the slope cut at 45° would be stable.

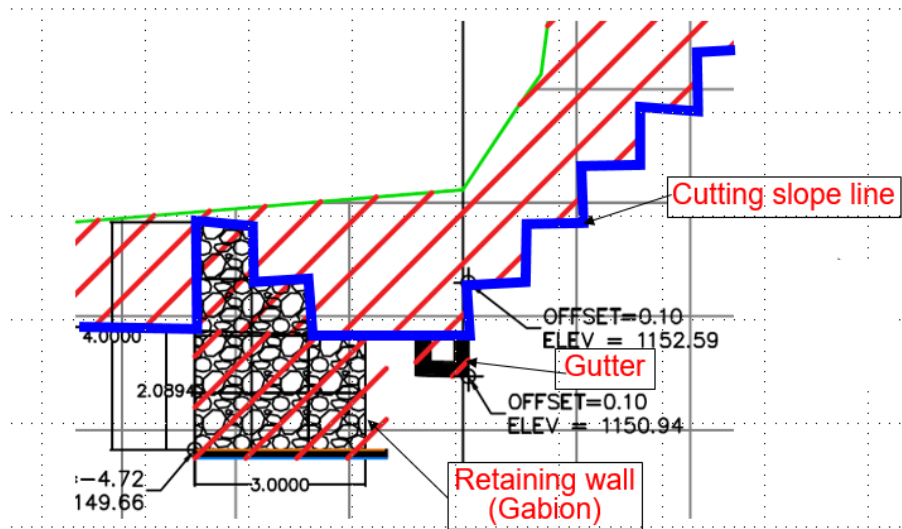
- ⑤ The design shape of the retaining wall is not intended to serve as a soil retaining structure, as shown in the figure below (The shape has pockets on the backside of the retaining wall.) . Since it is installed on the foot of the slope stabilized by cutting slope and shotcrete, it is unlikely to be intended to capture falling rocks. As the purpose of the retaining wall is unclear, we propose that the shape and layout be determined based on the purpose, and that the shape be determined based on stability calculations.

Figure 112 Retaining wall shape in current design

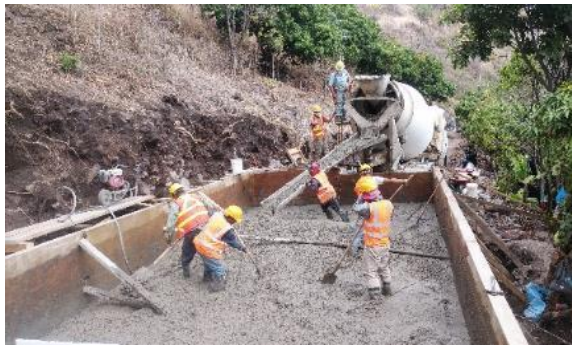
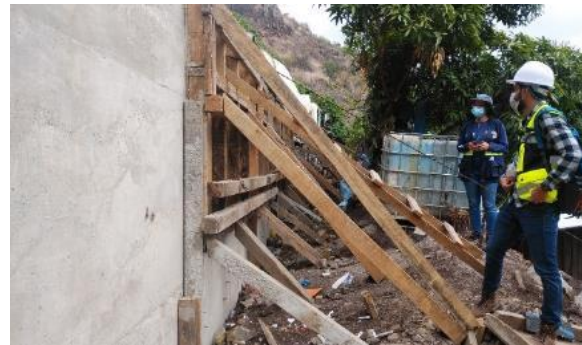
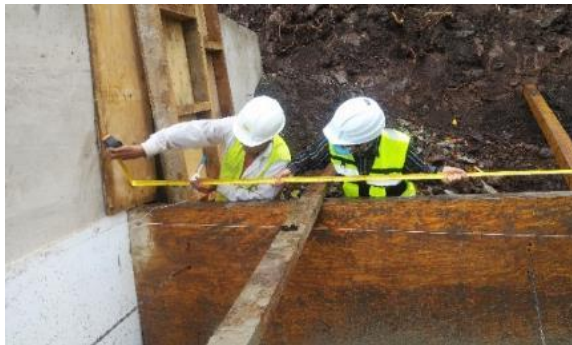
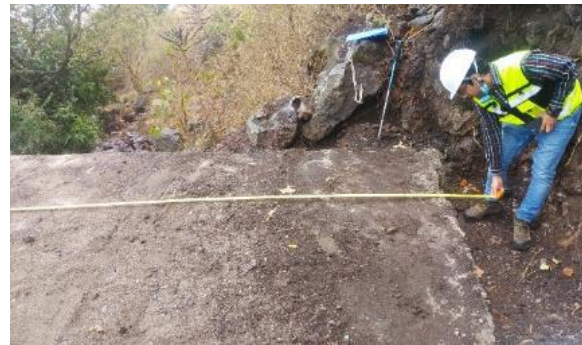
Figure 119 Concrete foundation construction

Foundation work for the rock fall protection wall began in March, but as of March 19, it had taken about three weeks to construct a 5-meter span of foundation concrete work. At this pace, we judged that it would be extremely difficult to construct the wall within the construction period, so we held a meeting with the contractor to discuss the process. We proposed a change in the installation procedure for formwork installation, which was the most time-consuming part of the project, and both parties agreed to change the installation procedure, which was then implemented.

Placing concrete situation

Setting form work situation

Measuring form work situation

Measuring concrete foundation sizesituation

Due to changes in construction procedures, progress was made by 20m in the month of April (four times faster than the original speed). At the same time, construction of Gabion began on the completed foundation.

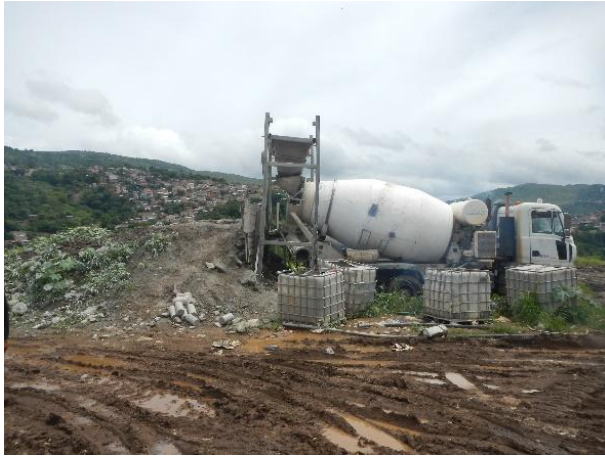
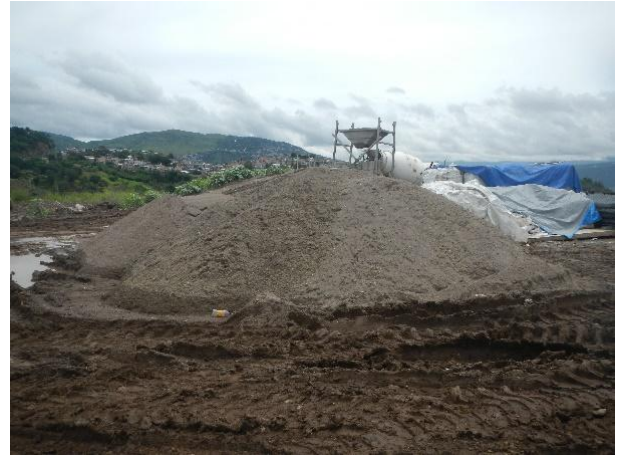
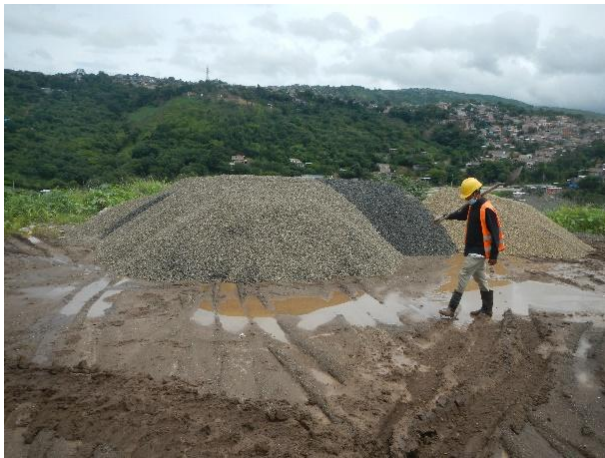
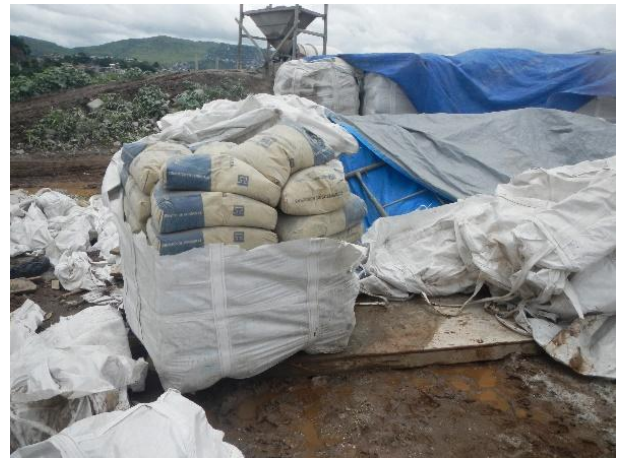
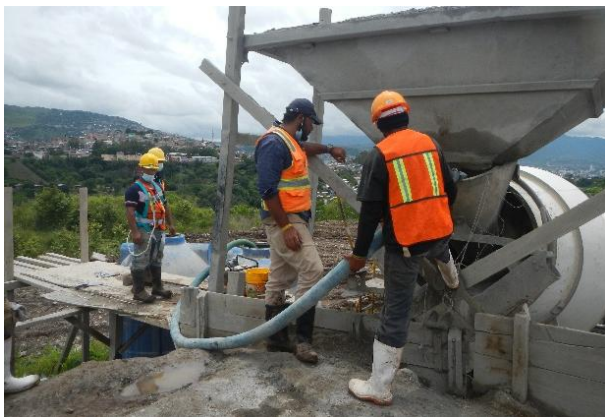
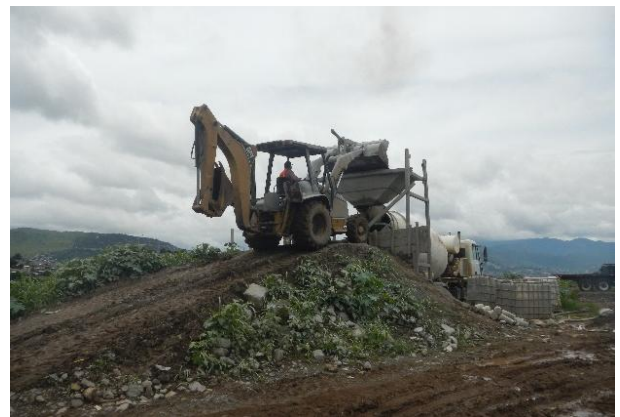
Figure 120 Concrete preparation situation

- Materials (fine aggregate and coarse aggregate) are exposed to rain and the moisture content of the materials is not controlled.
- When making concrete during the rainy season, the amount of moisture was reduced and the mixing condition was determined by skilled engineers.
- This causes slump values to vary. (Compressive strength tests show that the specified strength is maintained.)

- Improvement of aggregate management (establishment of an aggregate storage area with a roof and curing with sheets)
- Quantification of water content according to moisture content
- Quantitative control should be carried out by this method, not only by the sense of skilled workers.

Mixing plant

Storage of fine aggregate condition

Coarse aggregate storage condition

Cement storage condition

Water supply situation

Aggregate supply situation

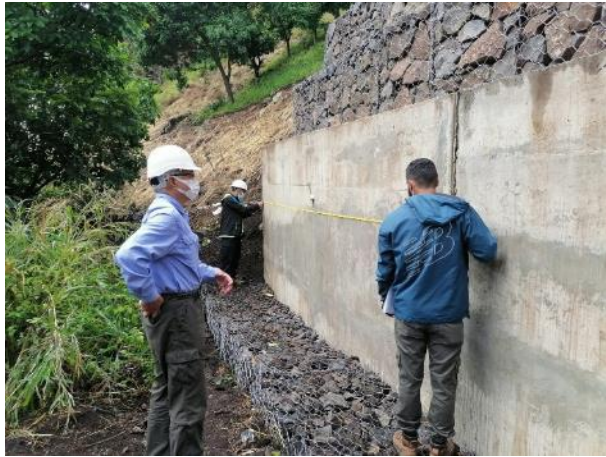
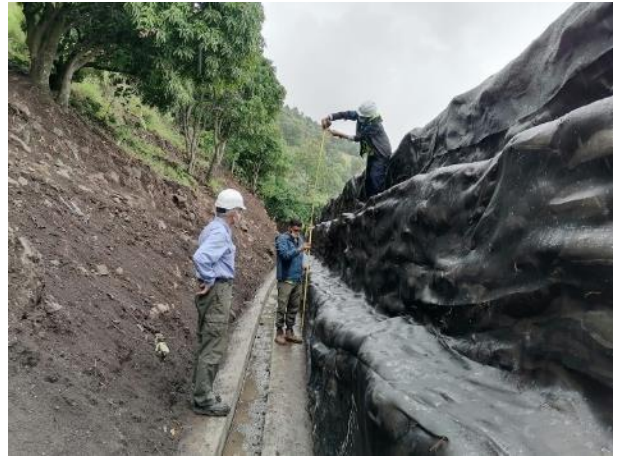
Figure 121 Photographs of completion inspections

Construction was completed in early August, and a completion inspection was conducted on August 19. During the completion inspection, the dimensions of each structure and the quantity of work were confirmed, and it was confirmed that the construction had been carried out as contracted.

Foundation concrete dimensions measuring situation

Dimension of sandbag stacking measuring situation

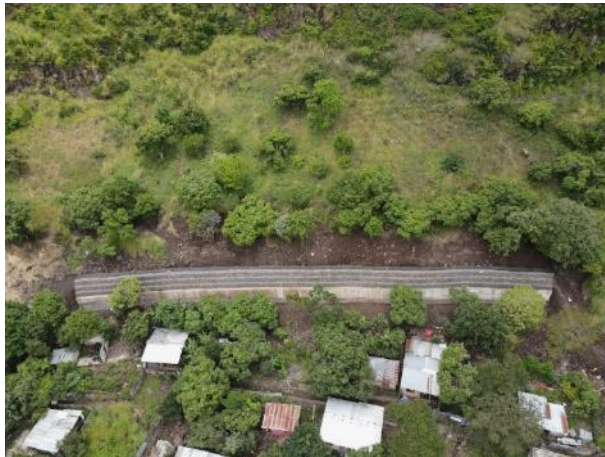
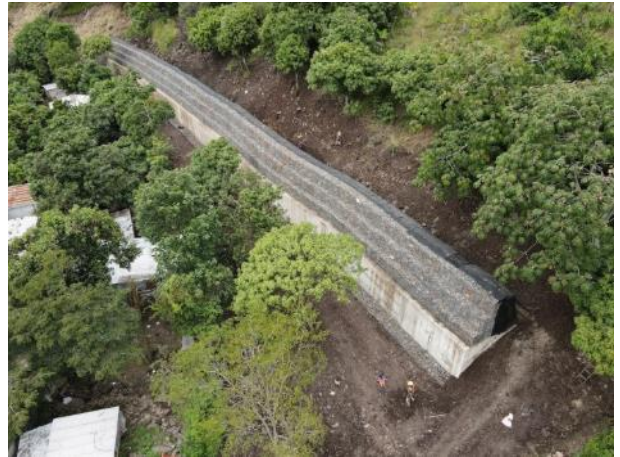
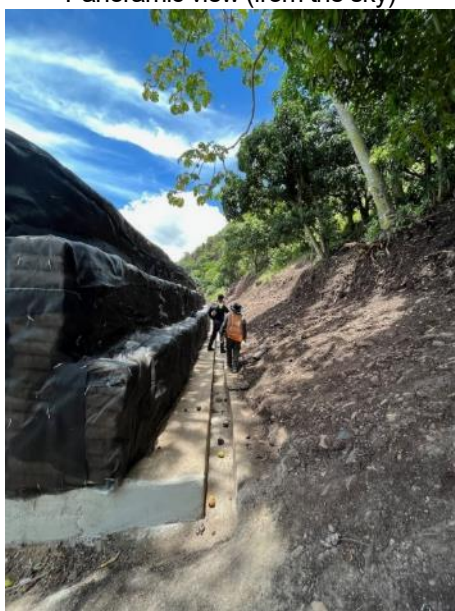
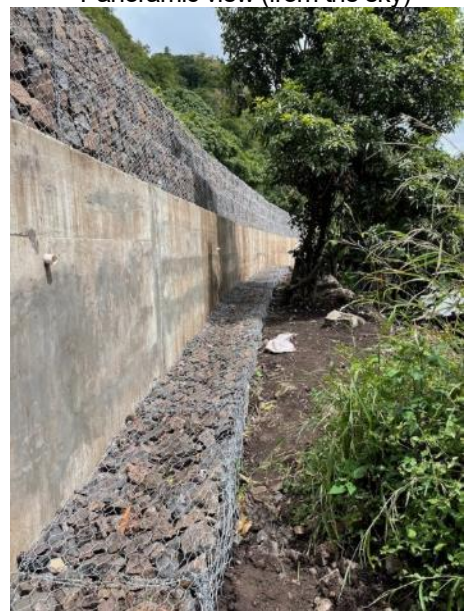
Figure 122 Photo of completion of construction

Sandbag stack, Gutter

Gabion, foundation concrete

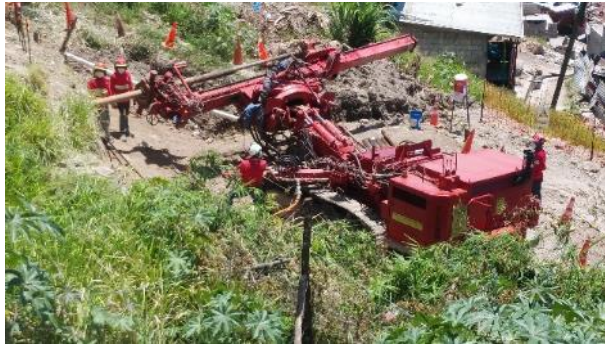
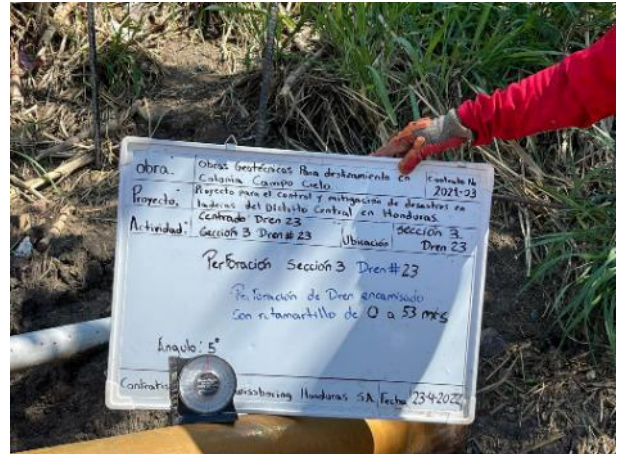
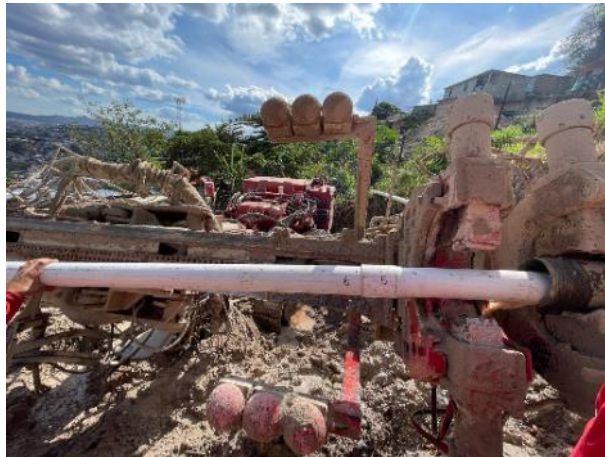
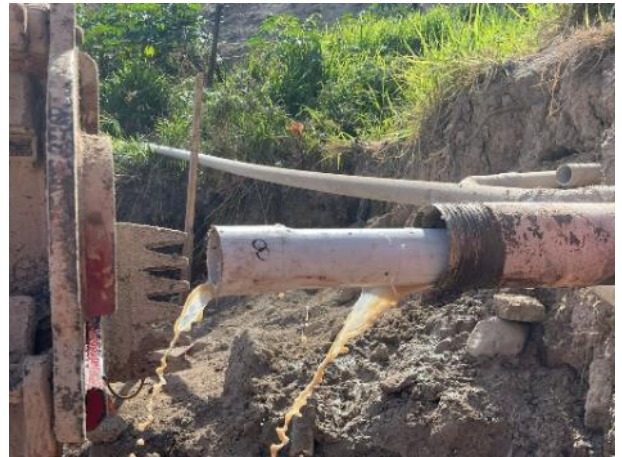
Figure 125 Construction situation (Horizontal drainage boring)

Construction of the horizontal drainage boring work began in April with Section 3 (No.13 to 23), and by the end of April, construction of Section 3 (No.13 to 23) and Section 2 (No.10 to 12) was completed.

Drilling situation

Drilling angle checking situation

Install drainage pipe

Drainage situation

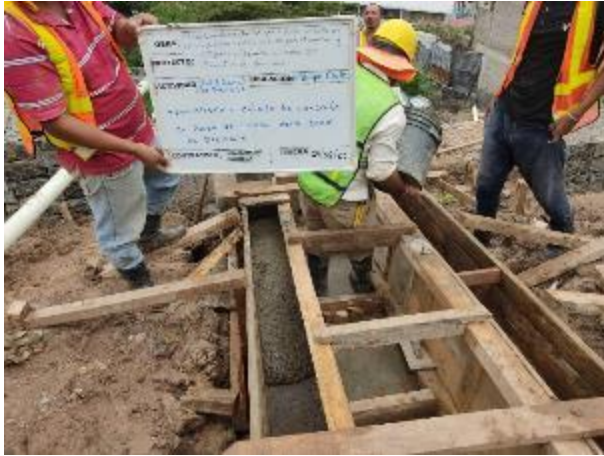
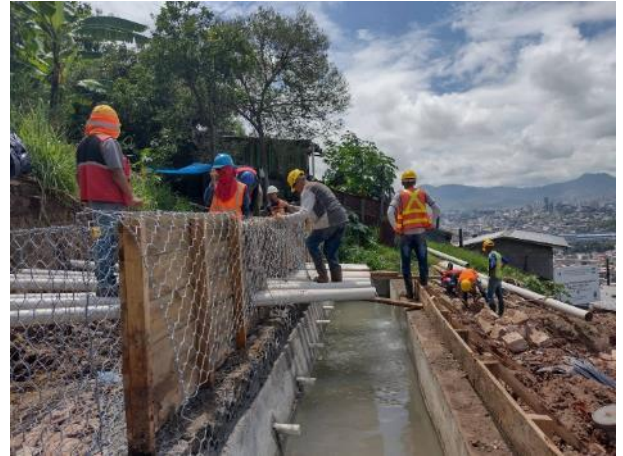
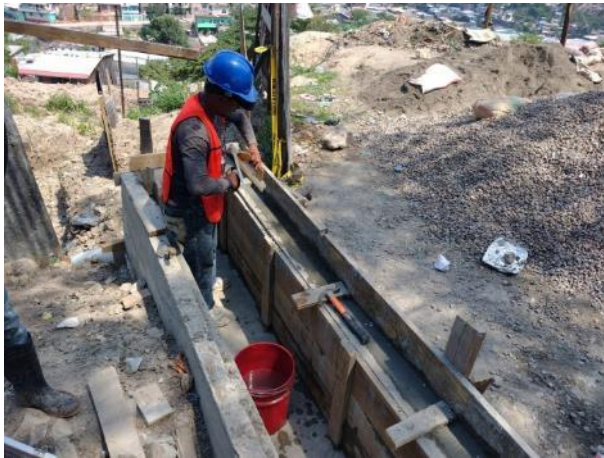
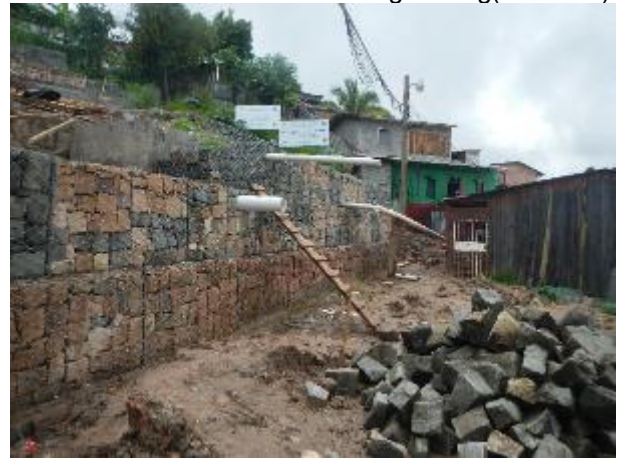
Figure 126 Construction situation (Other general work)

In May, we completed the catch basin, water stop concrete, and ditch No. 2 in Section 3, in June, we completed the catch basin, waterway, watertight concrete, and drainage pipe installation in Section 2, and in mid-July, we completed the retaining wall and ditches, completing all construction.

Channel construction situation

Catiment basin of horizontal drainage boring(Section 3)

No.2Gutter construction situation

Retaining wall construction situation

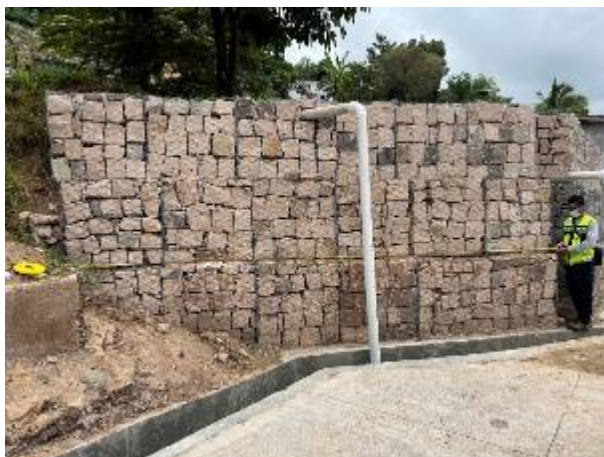
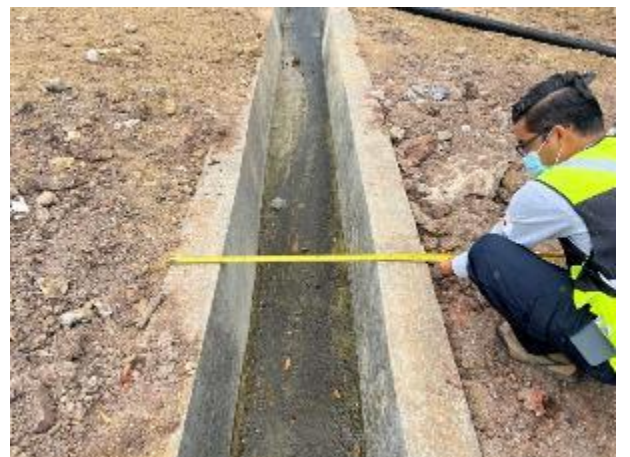
Figure 127 Photographs of completion inspections (Other general work)

All work was completed, and completion inspections were conducted on July 28 for the other general work and August 3 for the horizontal drainage boring work. During the completion inspections, the dimensions and quantities of each structure were confirmed, and it was confirmed that the construction had been carried out as contracted.

Retaining wall length measuring situation

Channel size measuring situation

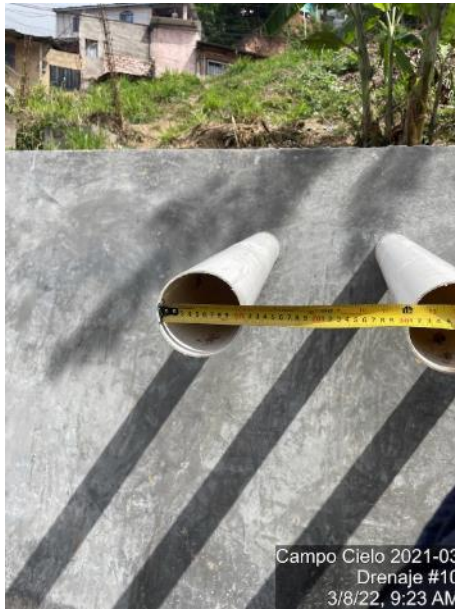
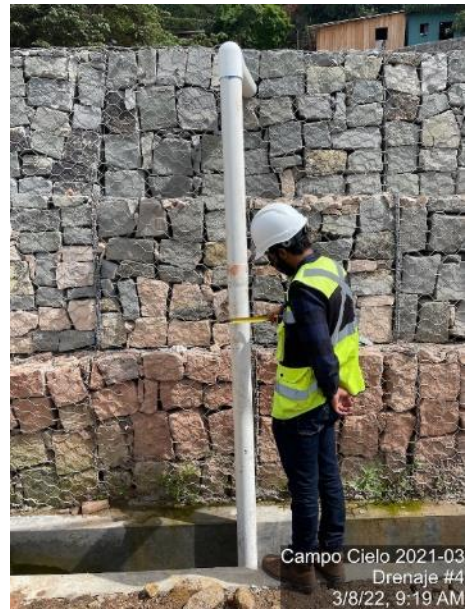
Figure 128 Photographs of completion inspections (Horizontal drainage boring)

Horizontal drainage boring dimension measurement situation

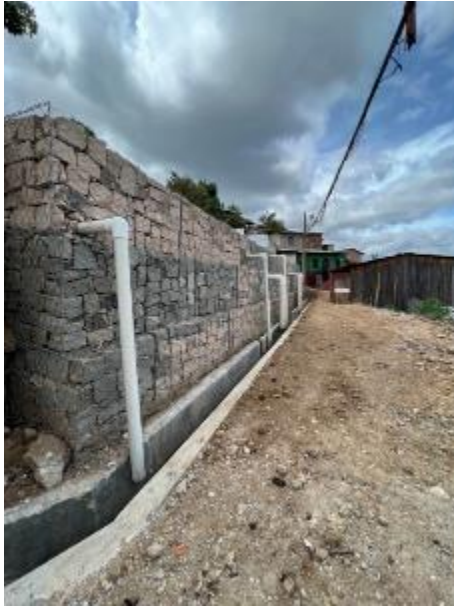
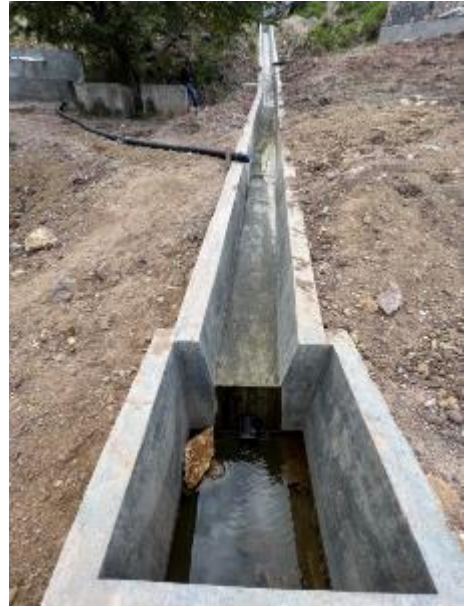
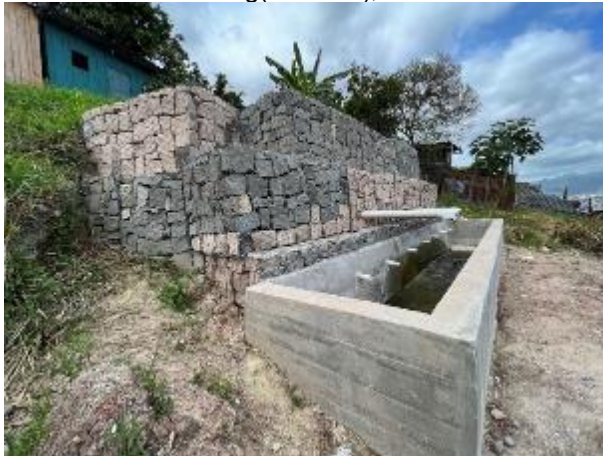
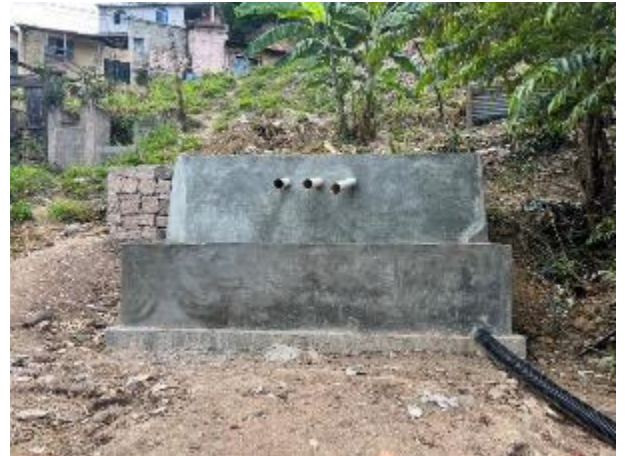
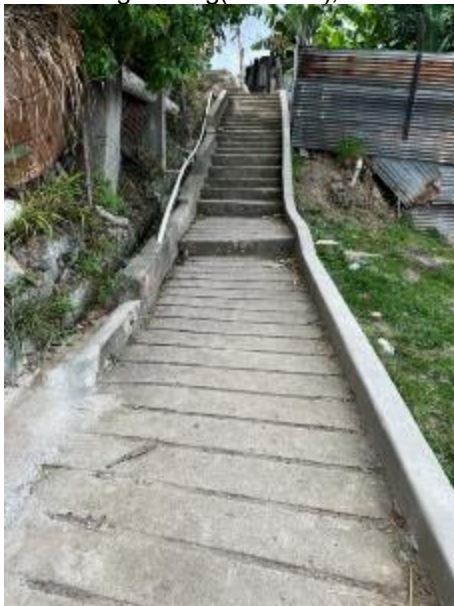
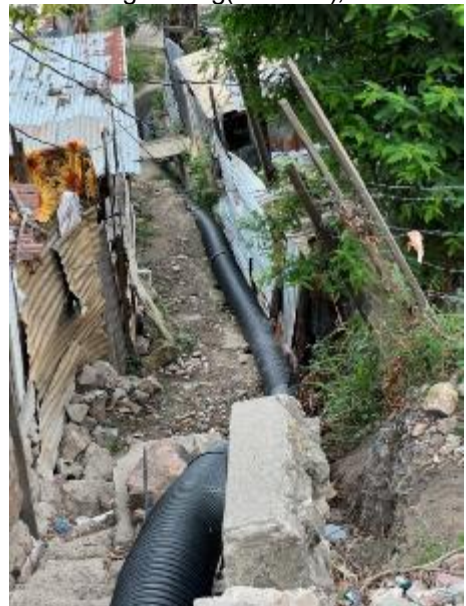
Figure 129 Photo of completion of construction

Retaining wall, Horizontal drainage boring(Section1), Gutter

Channel, Catchment basin

Horizontal drainage boring(Section3), Catchment basin

Horizontal drainage boring(Section2), Catchment basin

Water stop concrete

Drainage pipe

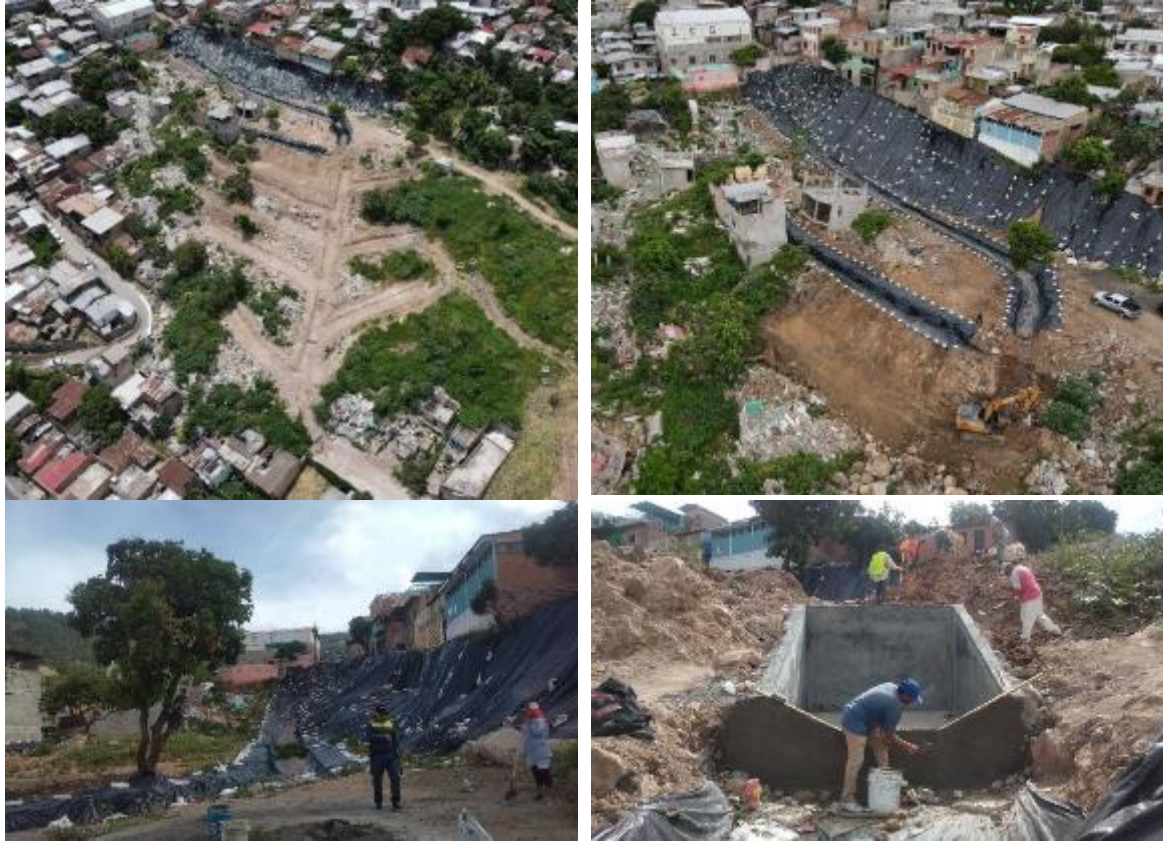
In April 2023, AMDC's direct control construction team (CODEM) and the contractor CODELCO started emergency countermeasure works. The work included plastic sheet lining to prevent erosion of the landslide top cliff, excavation of a channel, and outlet facility of channel.

Figure 130 Construction situation of emergency countermeasure

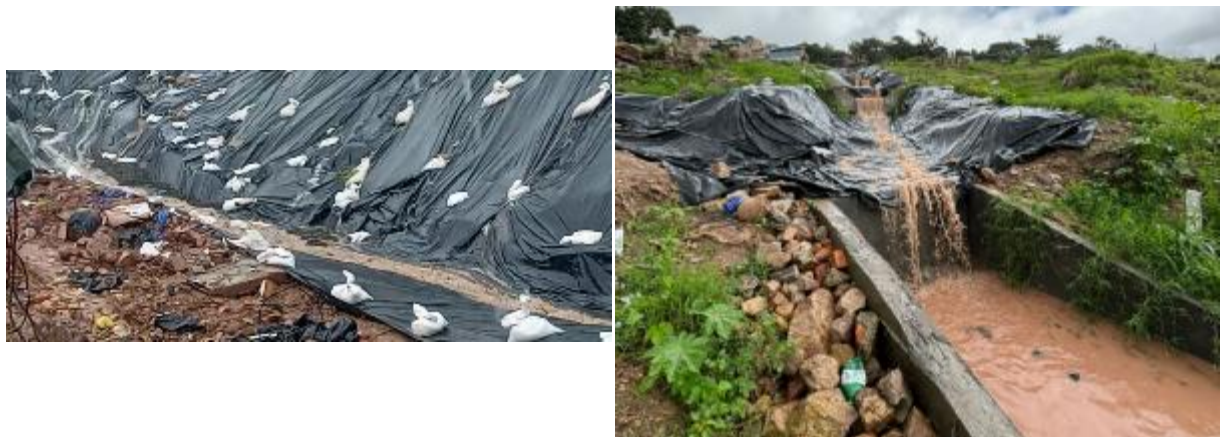
The implementation of surface water control measures has prevented the landslide from re-activity during rainfall, and no new damage has occurred.

Figure 131 Surface water control situation (Drainage situation)

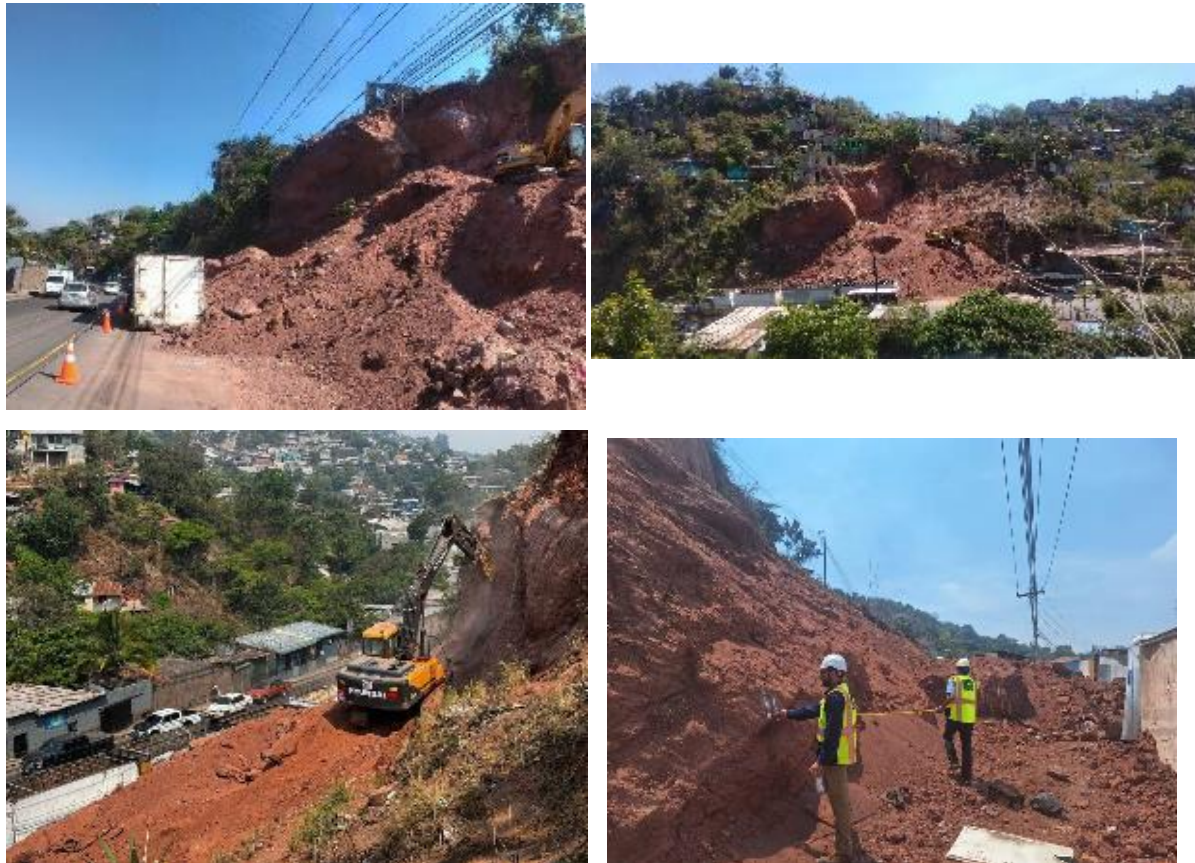
Figure 135 Construction situation (Villa Nueva)

In May 2024, contractor (Cosmo) removed the unstable rock mass and the work was almost complete. After that, construction work was suspended, geological investigation for design verification, design verification and revised design by Supervisor (GEOCONSULTANT) were being carried out.

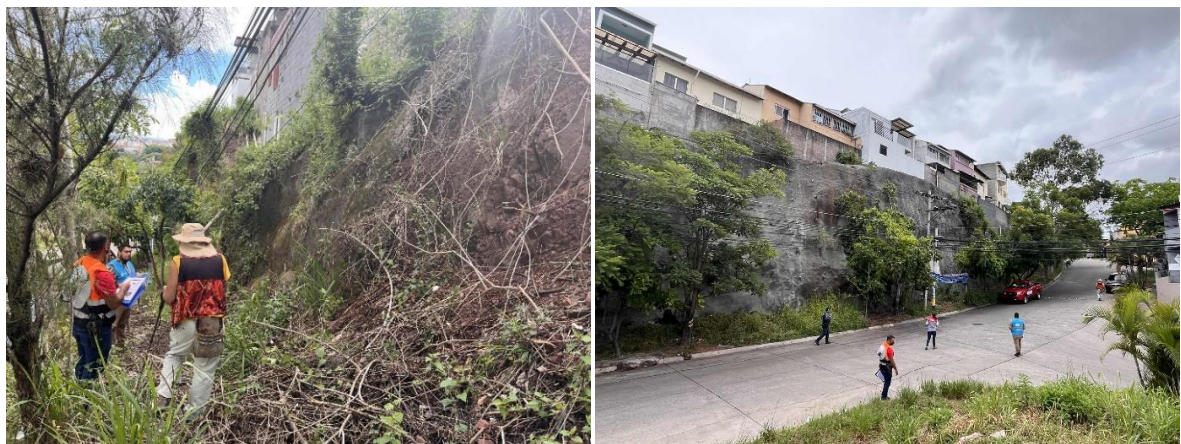
In July 2025, the monitoring and maintenance plans for Campo Cielo and Fuerzas Unidas, where countermeasures had already been completed, were finalized. In September 2025, the monitoring and maintenance plans for Nueva Santa Rosa & La Guillen and Villa Nueva were finalized. Additionally, training on facility monitoring methods was conducted for CODEM and UMGIR staff, using deteriorated shotcrete as a case study.

Figure 136 Monitoring status

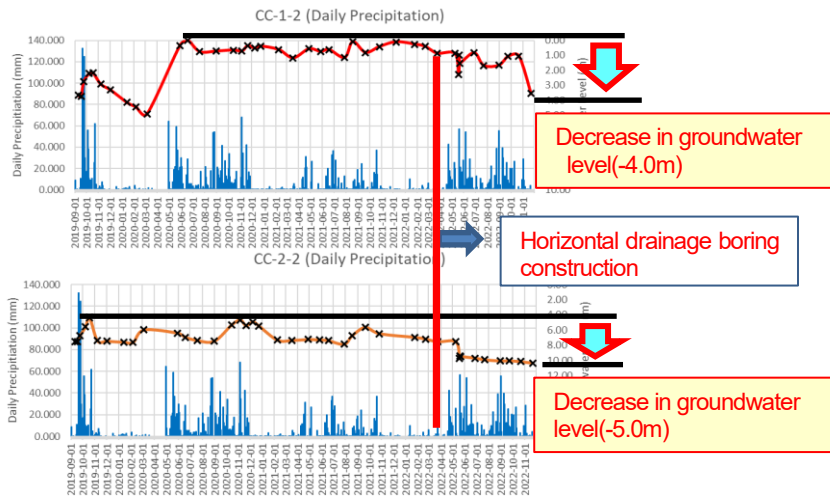
JET has been continuously monitoring the movement of the landslide since before the construction of the landslide countermeasures, and confirmed the movement of the landslide before and after the construction of the countermeasures. As a result of the monitoring, a clear decrease in the groundwater level and a lull in the landslide slide were confirmed by in-borehole inclinometer measurements. In addition, interviews with

Figure 138 Groundwater level observation results (Campo Cielo)

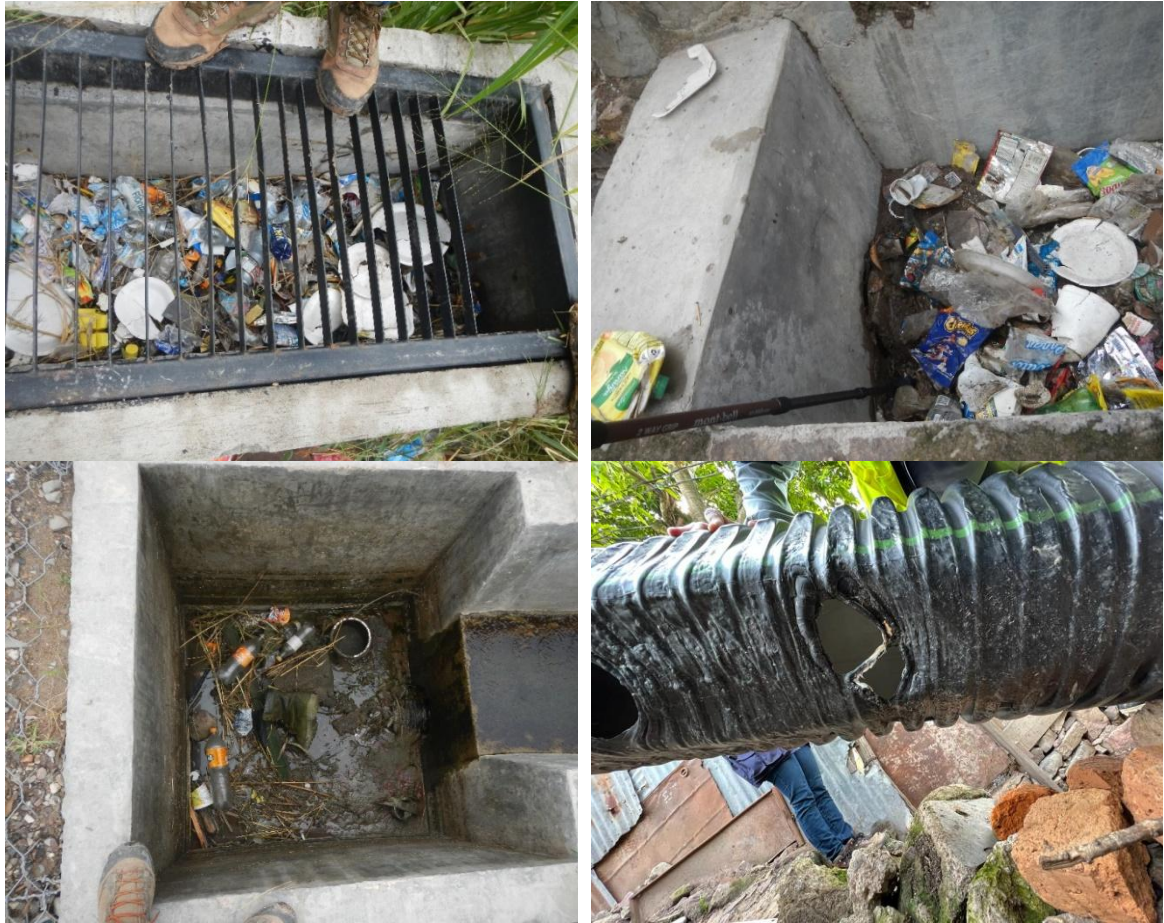
On the other hand, the facility introduced in this area has been found to be clogged by garbage dumped in the surrounding area and damaged due to the actions of local residents. In terms of maintenance and management, we explained and proposed that while facility maintenance and repair are important, it is also important to raise the awareness of local residents and to synchronize the maintenance of the surrounding social infrastructure (roads and their ancillary facilities, water supply and sewerage, etc.).

Figure 139 Current facility situation

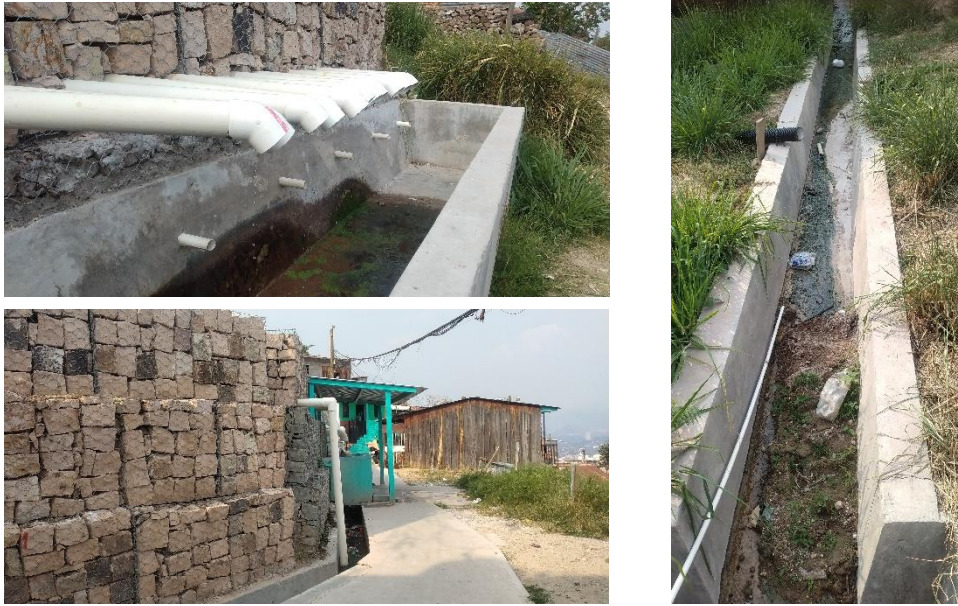
AMDC and JET checked the situation on site in 2024, two years after the countermeasures were completed. The amount of trash in the channel has decreased considerably compared to the past, due in part to regular trash cleaning by CODEM and trash collection by local residents. Groundwater has been continuously drained from the horizontal drainage boring even when there is no rainfall. Effectiveness of countermeasures is maintained sufficiently by cooperation and maintenance of CODEM and local residents, and no new landslide deformations have been observed and the site is considered to be stabilized. In addition, local residents were interviewed, and they stated that the deformation of their houses and inflow of surface water during rainfall, which had previously occurred, had been prevented, and that they felt the effectiveness of the countermeasure works.

Figure 140 Current facility situation (May 2024)
