**Project for Control and Mitigation of
Slope Disasters
in the Central District in Republic of
Honduras
Project Completion Report**

February 2026

Japan International Cooperation Agency (JICA)

Kokusai Kogyo Co., Ltd.

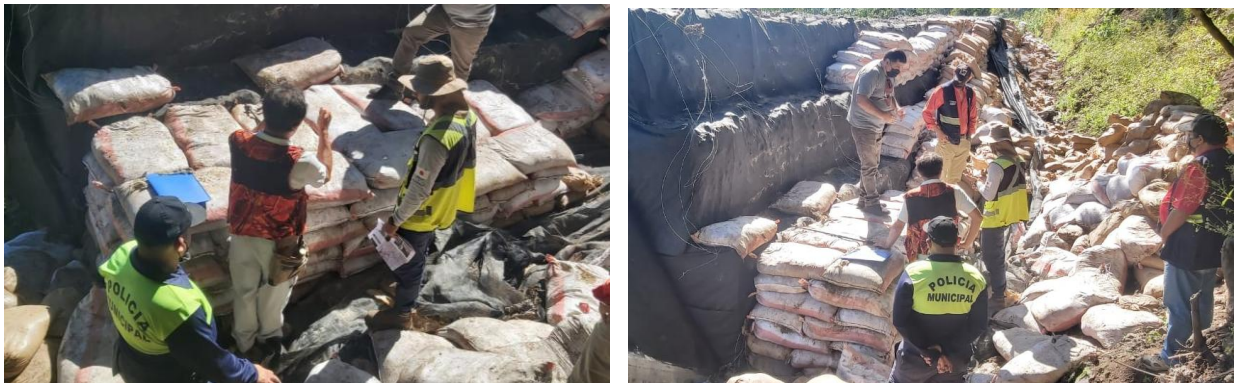
Prior to the November repair of the sandbags, the method of creating a less-breakable sandbag pile was instructed in the field, and precautions for construction were checked together with WG2 and the workers.

Figure 141 Sandbag repair work guidance and consultation situation

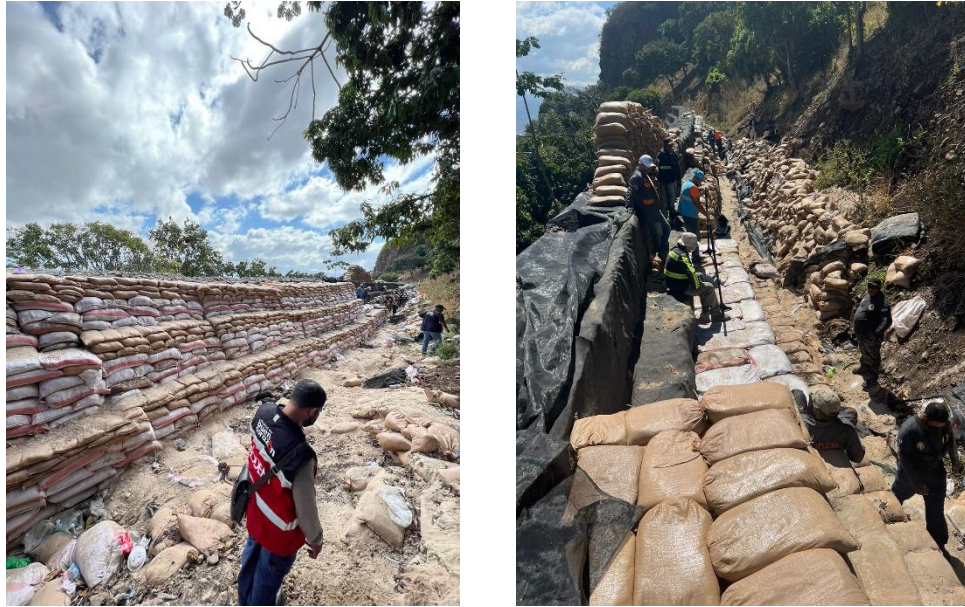
Repair work began on January 17, 2023, with a 25-person team to complete the process in two months.

Figure 142 Sandbag repairing situation

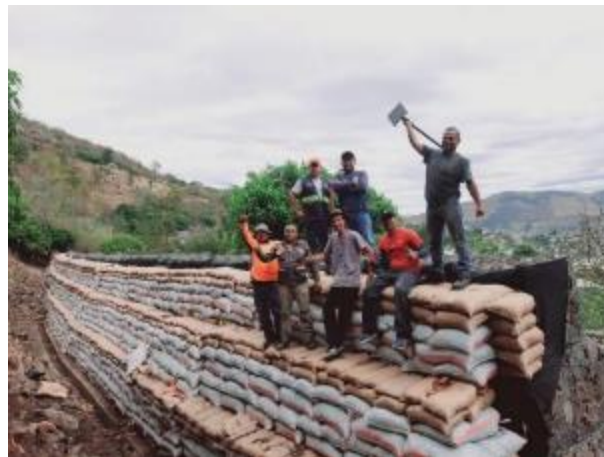
Repair work to re-stack sandbags was completed in March 2023.

Figure 143 Sandbag repairing completion situation

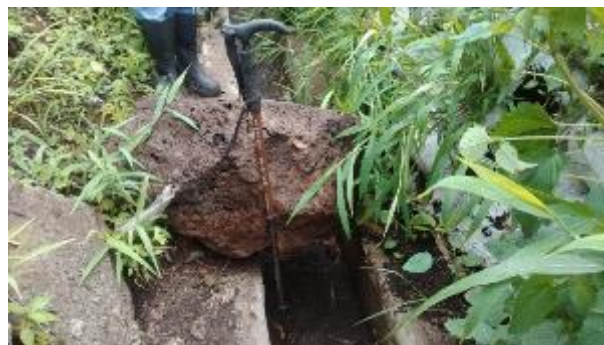
It has not confirmed any deformation of the sandbags by result of monitoring after repairing. Catching falling rocks has been confirmed and the effectiveness of the countermeasure works has been demonstrated.

Figure 144 Falling rock captured situation

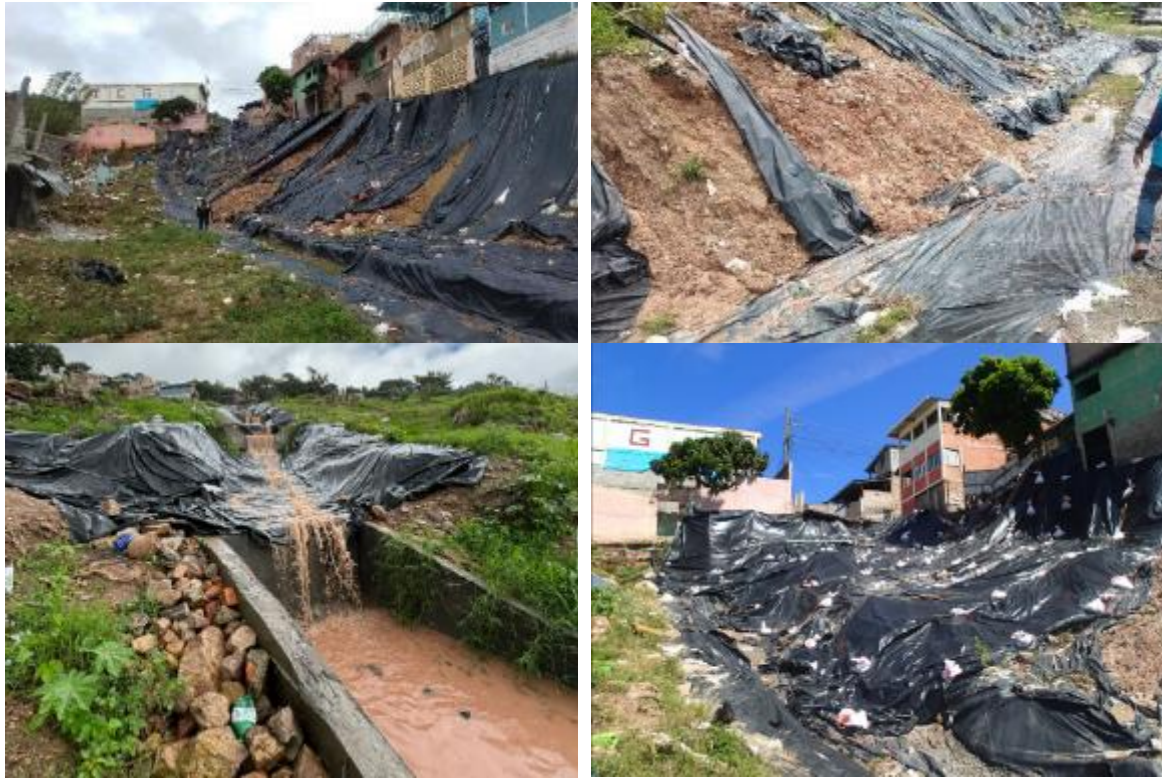
Emergency measures have been undertaken in the La Guillen area to manage surface water during rainfall. However, basic plastic sheets covering the excavated area result in damage and deformation due to minor collapses and other issues. JET conducted monitoring alongside CODEM and provided guidance regarding the repair approach. Presently, CODEM is actively engaged in the repair work

Figure 145 Monitoring and maintenance situation

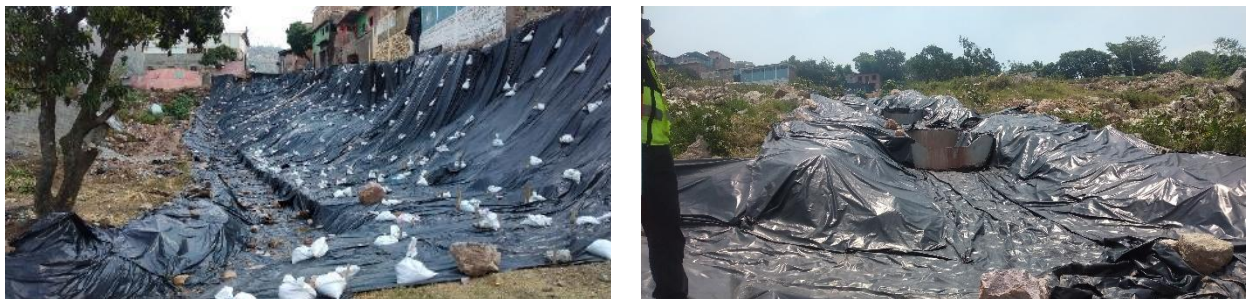
Since it is essential to remove surface water using emergency temporary measure works until the permanent countermeasures are completed, maintenance continue in 2024. By the maintenance, the function of emergency temporary measure work has been maintained.

Figure 146 Monitoring and maintenance situation (May 2024)

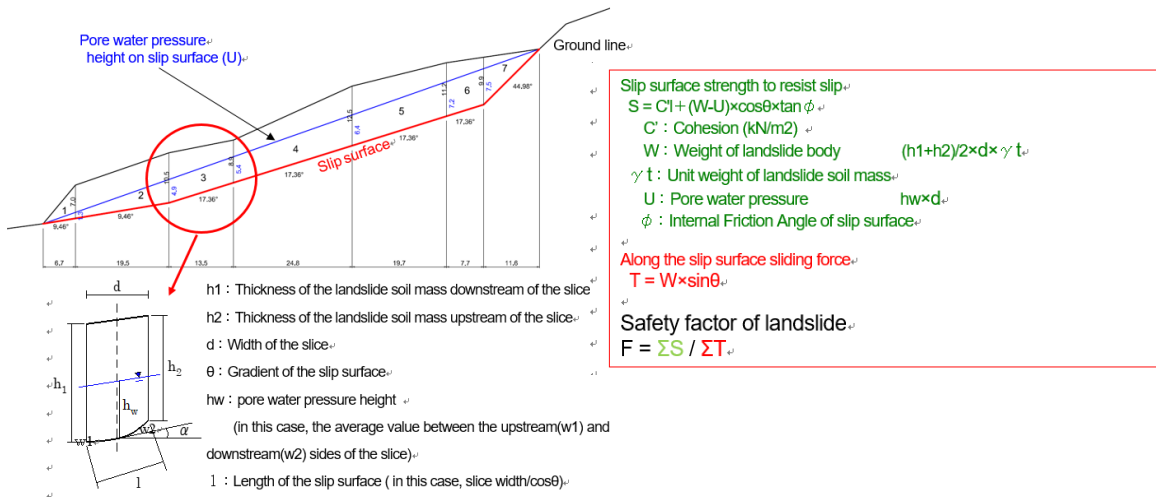
For landslide countermeasure works, the manual details the procedures for stability analysis and the design procedures for lateral boreholes, which are expected to be applied in Honduras in the future.

Figure 147 Stability Analysis Procedures (excerpt)

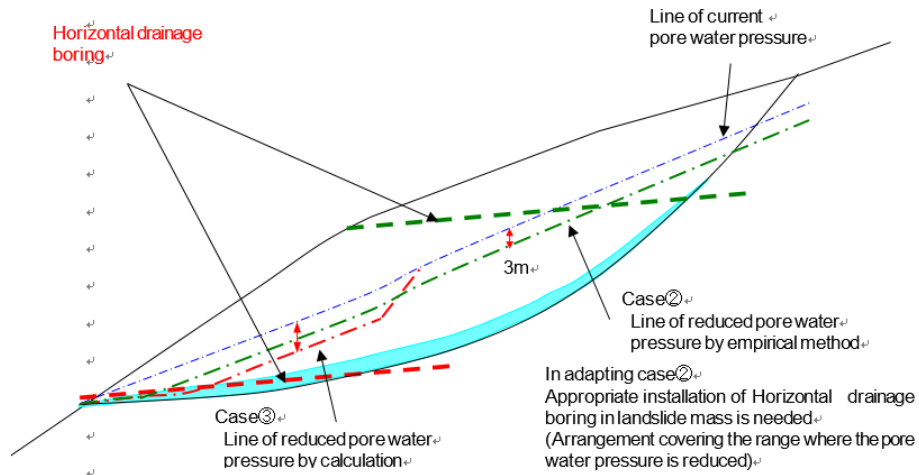
Figure 148 Procedures for the design of horizontal drainage boring (excerpt)

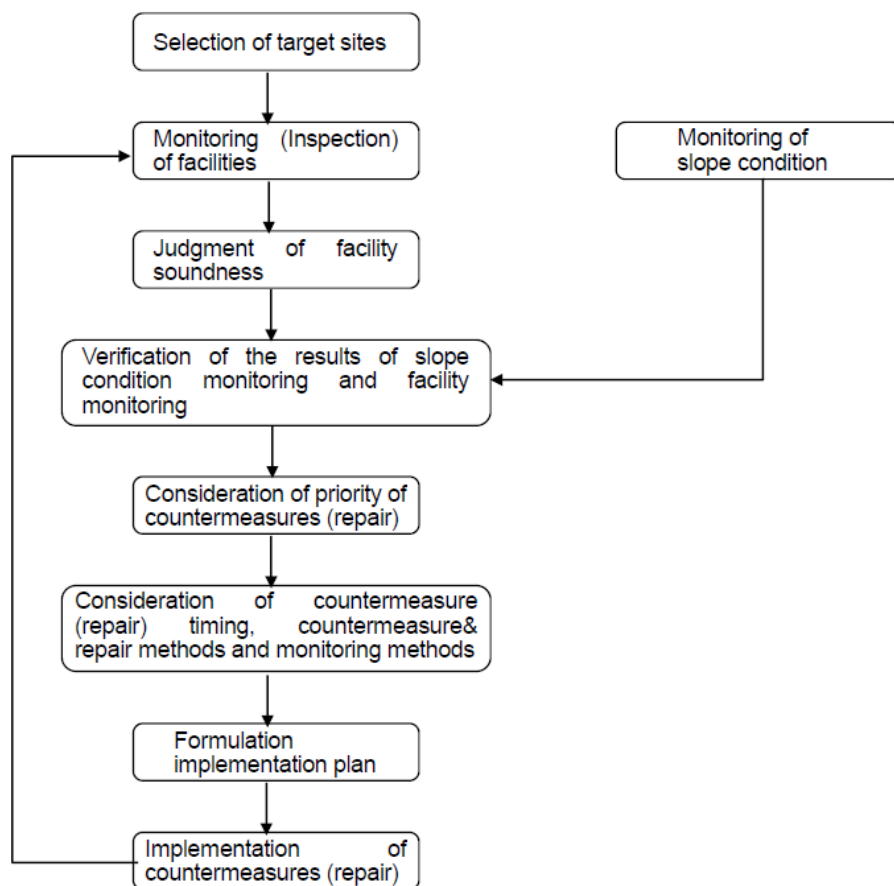
Figure 150 Workflow of monitoring and maintenance

The manual is prepared with a focus on the types of work carried out in this project. It is explained the cases of aging facilities, cases of facility deformation caused by slope movement, monitoring methods, the relationship between landslide monitoring and facility monitoring, and repair methods, based on monitoring and maintenance cases carried out in Japan. The following is an excerpt from the content of the manual.

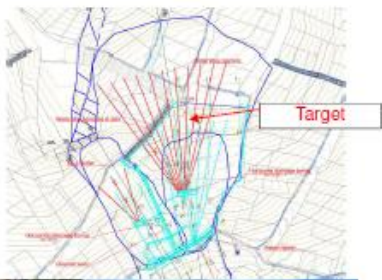
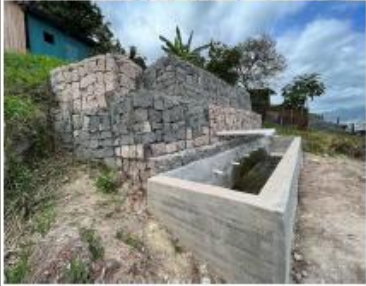
Figure 151 Monitoring sheet (Horizontal drainage boring)

Site		Campo Ciero	Landslide Block	L-1
Construction year		2002	Structure No.	No.1
Structure specifications	Drainage pipe	PVC pipe	Report No.	1
	Retaining wall	Gabion	Monitoring date	2024/11/11
	Catchment basin	Concrete	Organization conducting monitoring	JET
	Outlet Channel	Flexible pipe	Name of person conducting monitoring	Hotaka Aoki

Item	Deformation	Comment		
Drainage pipe	Blockage	c	6pc pipe are blockaged at outlet(over 50% area of pipe outlet)	
	Breakage	a	No damage	
Retaining wall	Breakage	a	No damage	
Catchment basin	Breakage	a	No damage	
	Blockage	b	Some sedimentation, no overflow	
Channel(Pipe)	Breakage	a	No damage	
	Blockage	a	No sedimentation	
Surround slope	Breakage	a	No deformation

Comment		
Judgement	A : No action required	Due to the significant blockage of the drainage pipe outlet, detailed monitoring will be carried out in order to determine the need for cleaning work or other repairment.		
	B : Observation	No deformation was observed in other parts, and daily monitoring will continue to be carried out.		
	C : Reruire measures

<p>Outlet blockage</p>

Evaluation Points		<ul style="list-style-type: none"> Decrease of drainage capacity, leakage of drainage water, and overflowing water cause to increase the groundwater level and to be unstable of landslides. Data of groundwater observation and groundwater drainage volume observation is useful information for evaluating the soundness of facility. 	<ul style="list-style-type: none"> There is a risk that the drainage water from the horizontal drainage system may not be collected or that the collected water may leak. 	<ul style="list-style-type: none"> There is risk of re-infiltration into landslide body of overflowing water. 	<ul style="list-style-type: none"> There is risk that it is impossible to collect drainage water into the catchment basin. 	<ul style="list-style-type: none"> Blockage of the drainage pipe causes a decrease in drainage capacity and re-infiltrate drained groundwater.
Points to note for monitoring		<ul style="list-style-type: none"> Check for any changes by visual inspection. It is desirable to record the drainage volume. Check the condition of corrosion of steel materials and deterioration of concrete and other materials due to aging. Check the condition of damage and deformation of retaining walls and catchment basins due to landslide activity. 	<ul style="list-style-type: none"> Check the condition of sedimentation of soil, plant remains, trash, etc. in the catchment basin. 	<ul style="list-style-type: none"> Check the condition of corrosion of steel materials and deterioration of concrete and other materials due to aging. Check the condition of damage and deformation of retaining walls and catchment basins due to landslide activity. 	<ul style="list-style-type: none"> Check for blockages situation in the water outlet.

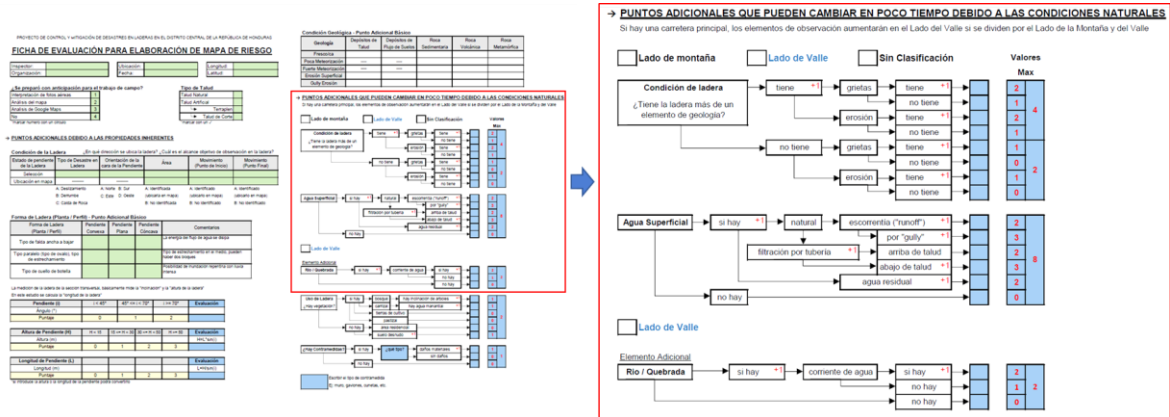
Figure 165 Simple check sheet for hazard/risk assessment Ver0

A simple check sheet for hazard/risk assessment Ver. 0 were created. This check sheet was designed so that surveys related to “landslide”, “slope failure”, and “rockfall” could be performed on a single sheet.

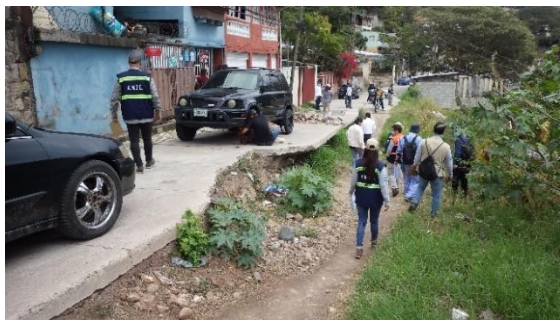
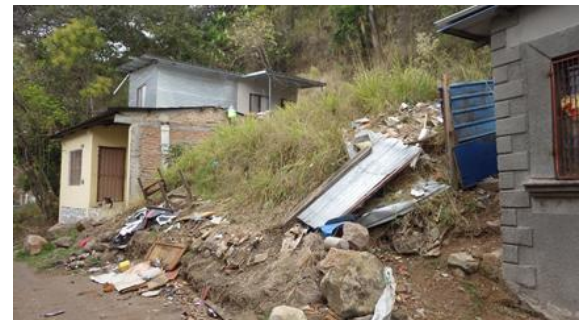
Figure 176 Field survey after the disaster in the Hurricanes

JET and WG3 conducted a field survey in the sites damaged by Hurricane IOTA and ETA in November 2021. The figure below shows 2 photos and total score of the field survey. There are 5 survey points, Nueva Santa Rosa (polygon: LS_NSR16, score 55), Reparto Arriba (polygon: LS_NSR58, score 80), Villa Delmi (polygon: LS_NSR58, score 58), El Hatillo (polygon: LS_NSR59, score 70), Barrio El Bosque (Polygon: SF_EDN24, score 75).

Reparto Arriba (LS_NSR41: score 80)

Barrio El Bosque (SF_EDN24: score 75)

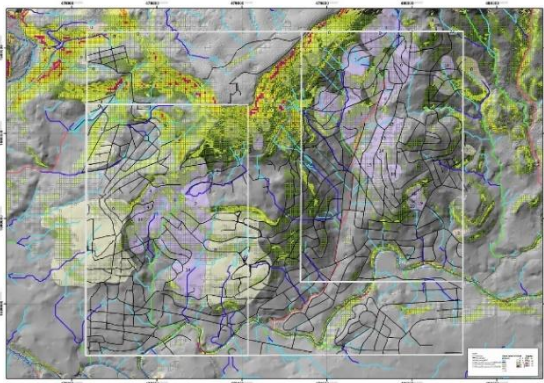
Figure 177 composed map with relief energy and slope inclination on shading background

In the field survey in Activity 3.4, digital elevation data (1m grid DTM, purchased in this Project) was analyzed using ArcGIS Spatial Analyst. The results were displayed on a map for the purpose of screening the rockfall and slope failure locations for field surveys. The topographic indicators adopted this time are slope classification and relief energy. For the amount of relief energy, the difference between the highest point and the lowest point is calculated in 10m grid cells.

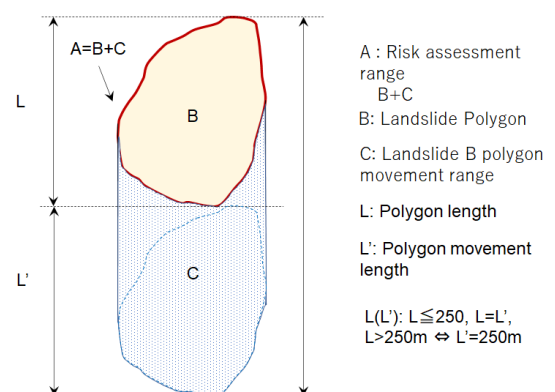
Figure 183 Risk impact range for landslide

The risk impact range A includes the polygon B (target of hazard evaluation) and polygon C (polygon B’ movement range). The distance to extend of polygon C is taken in the sliding direction, and the length of the same distance as the landslide polygon length (L) is added. However, L (L’) is defined as ≤ 250 m, and if L exceeds 250 m, L’ is 250 m.

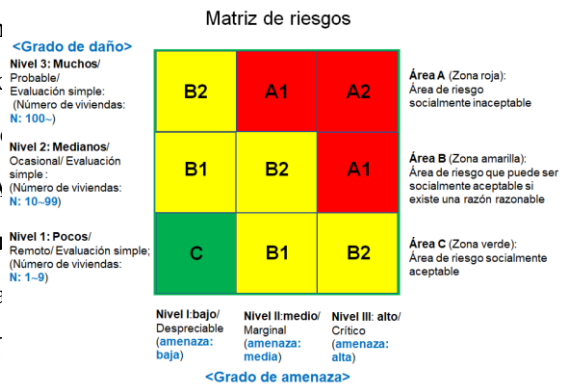
Figure 185 Risk matrix diagram

For the risk assessment of landslide and, a risk assessment classification on the horizontal axis and the degree of damage on the vertical axes were classified into three categories. Risks were classified into three categories: A, B, and C, according to their combination. The magnitude of risk is A, B2 and B1 for Risk B were considered for use in Outcome 4, such as the degree of damage on the vertical axis was set to Level 3. The table below.

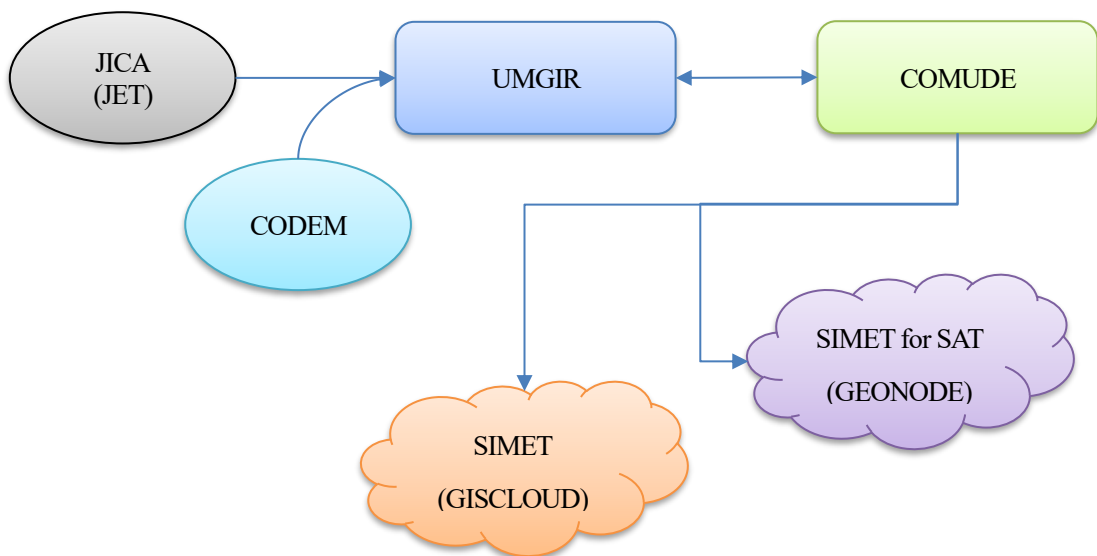
Figure 192 Flowchart for SIMET data update

In consultation with UNGIR, which manages SIMET, it was agreed that UNGIR would upload the data to the SIMET website as needed. The flowchart for data upload is shown in the figure below: GIS data to be registered in SIMET are GIS data with hazard assessment results and risk assessment results as attribute information for landslide and impact area polygons. In addition, the release of data related to individuals, such as land use regulation maps, was at the discretion of AMDC after uploading.

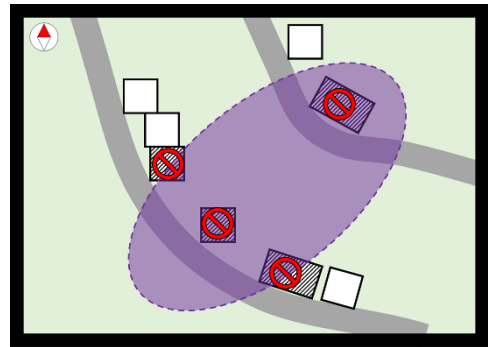
Figure 194 Land use to which the regulation is applied

All type of construction work for Service use, Production use and Commercial use are prohibited in every zone as it is difficult to conduct the construction work according to AMDC’s structural regulations. The following table shows the land use permitted in each regulated zone. The detailed list is in Appendix 20.

In case that a land on which the above land use takes place is even slightly included in the regulated zones of Zone A to E, the regulation is applied.

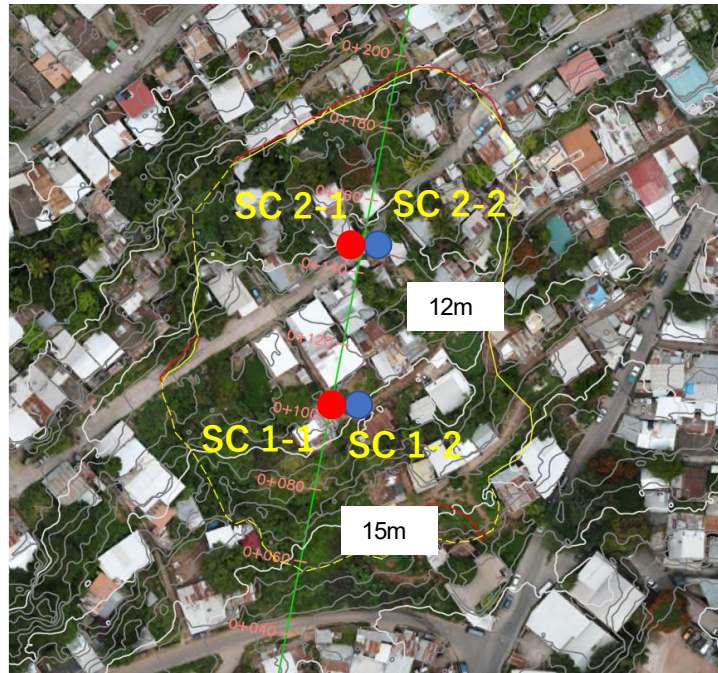
Figure 202 Monitoring plan in the Suazo Cordova landslide site

As of October 2025, all inclinometer wells have become unmeasurable due to landslide activity. AMDC has therefore established simple surface observation points to continue measuring surface movements. Additionally, groundwater drainage works are planned at the toe of the landslide block. UMGIR has prepared the plan, and the Civil Engineering Department has been requested to prepare the drawings in AMDC.

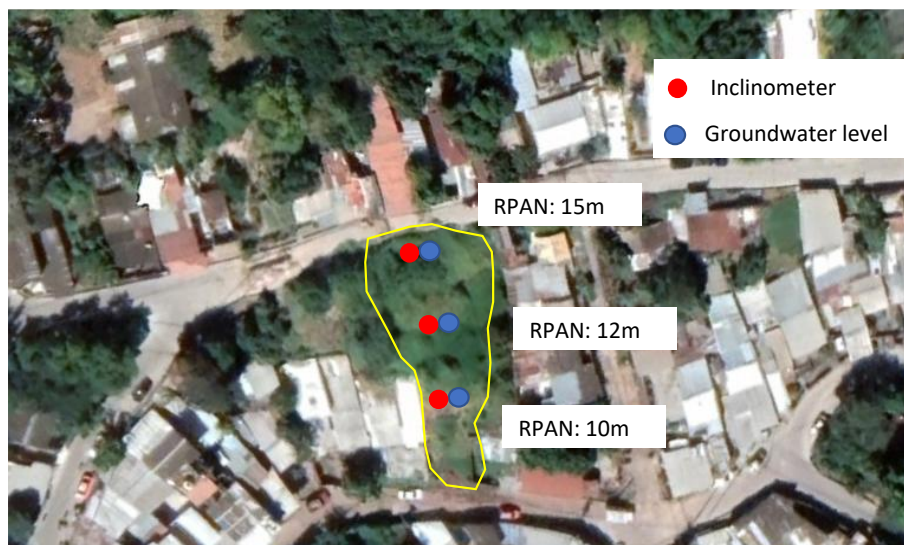
Figure 203 Monitoring plan in the Reparto Arriba landslide site

This landslide, located within a residential area, has shown activity since 2019, causing deformation of houses and roads. AMDC prepared an investigation plan, conducted a geological survey in August 2025, and began monitoring in September 2025.

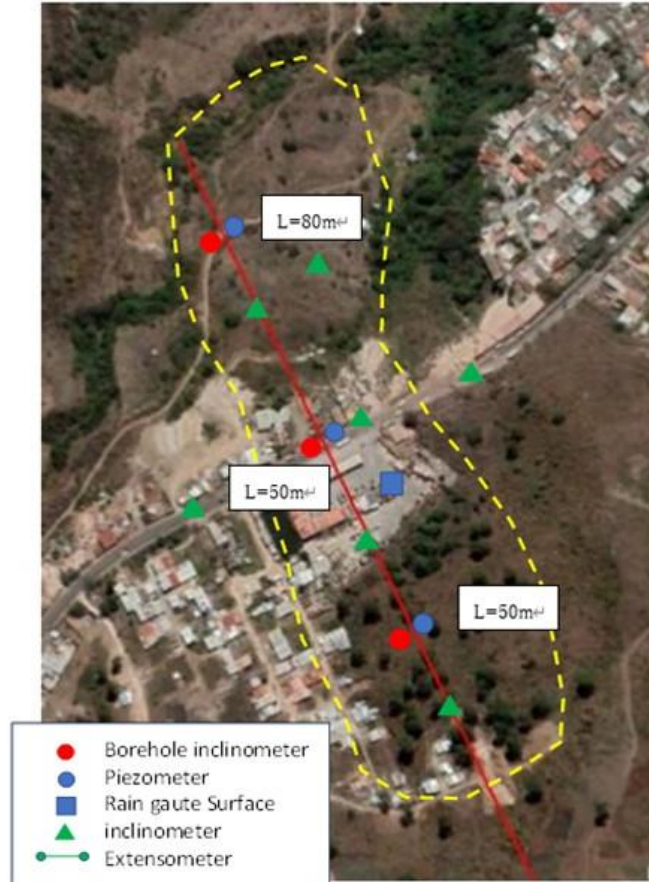
Figure 204 Monitoring plan in the Cerro Grande landslide site

This landslide block is located across National Route 5. Deformation has been observed not only on the road but also at an upstream gas station and nearby houses. AMDC is currently planning geological surveys and monitoring.
