7.4 Bridge Condition

7.4.1 Bridge Inventory

7.4.2 Result of Bridge Visual Investigation

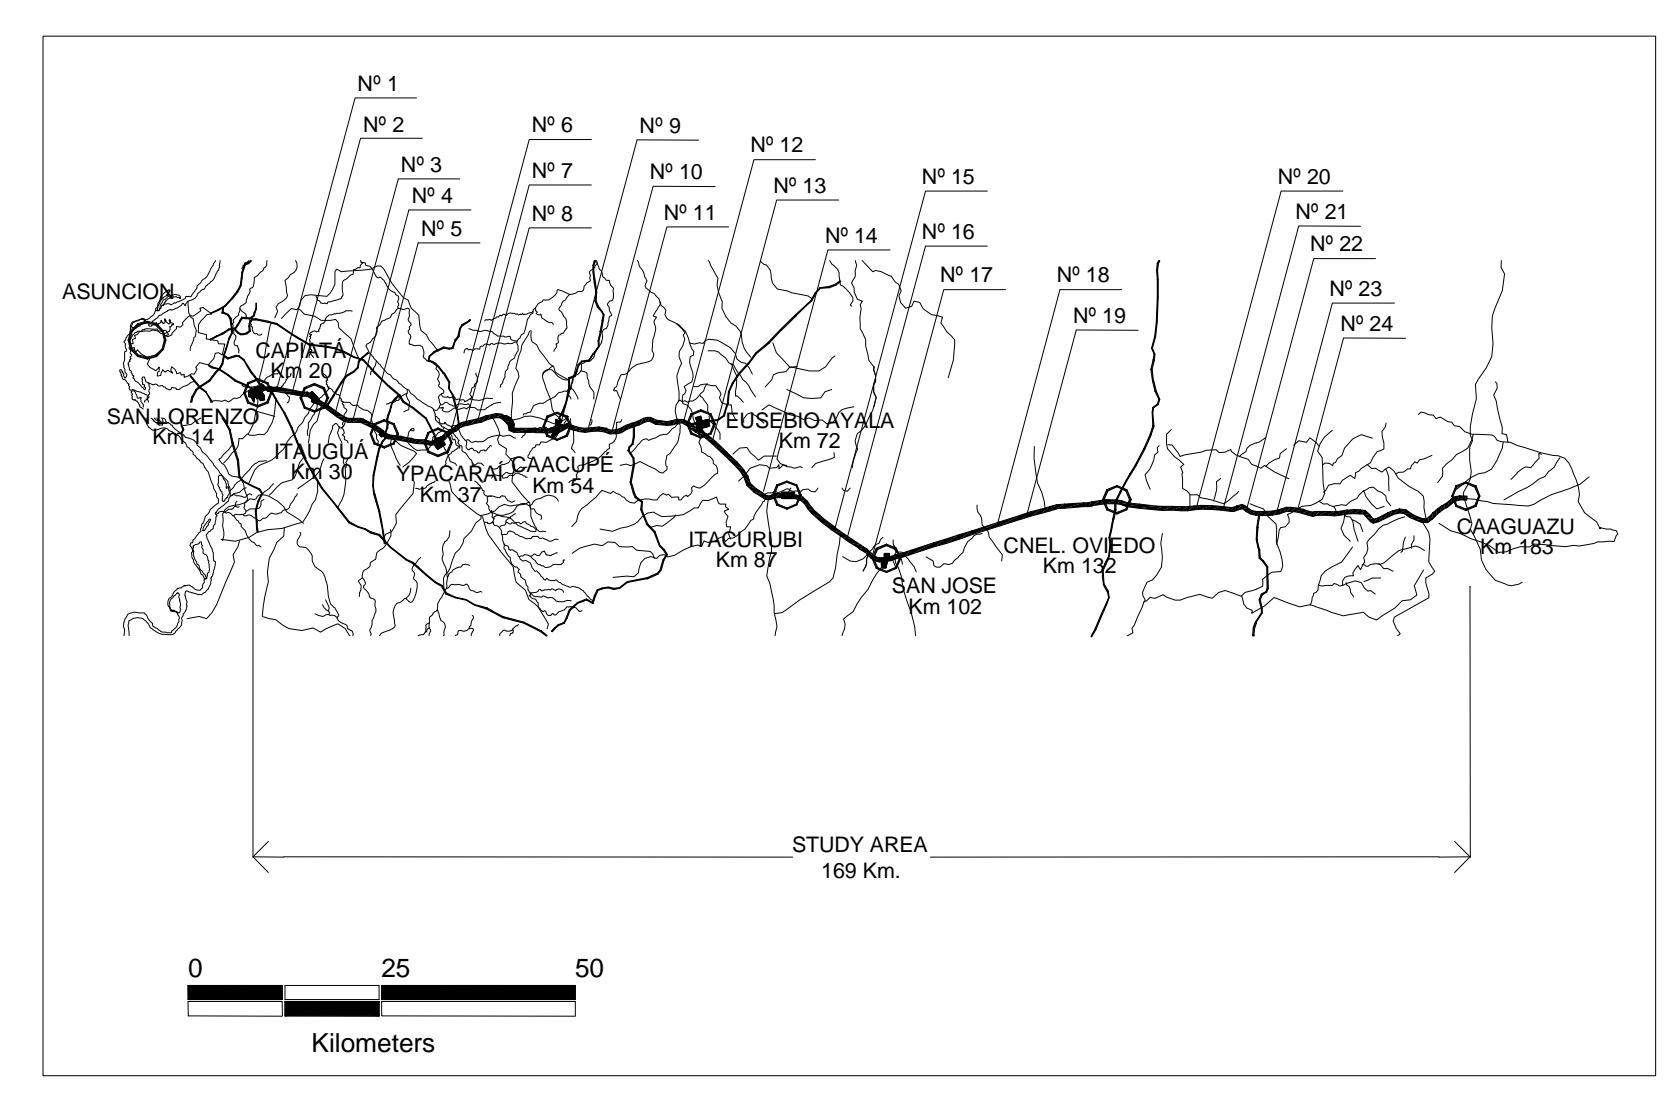
Figure 7.4.1 Location Map of Existing Bridges

The MOPC has no bridge inventory for all national roads in Paraguay. Therefore in this study a bridge inventory along the study area on National Roads 2 and 7 between San Lorenzo and Caaguazú has been prepared. A location map and an inventory have been prepared for the twenty four bridges in this section, as shown in Figure 7.4.1.
