. MASTER PLAN

CHAPTER 1 CONCEPT FOR ESTABLISHMENT OF MASTER PLAN

1.1 Introduction

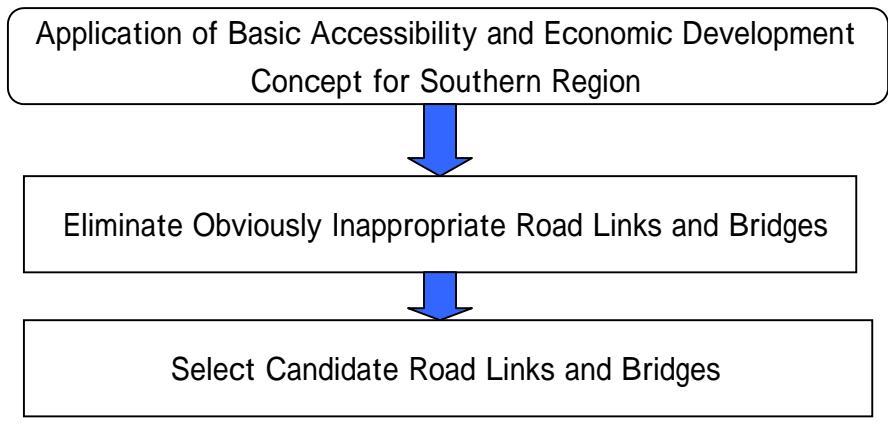
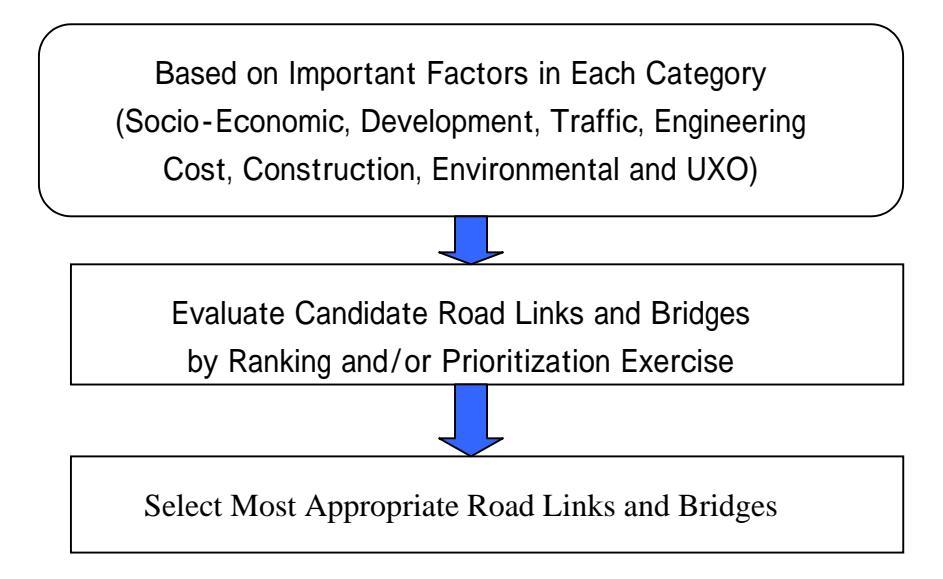
Figure 1.2.1 Selection Process and Priority Setting Method

The above concept to be applied for the Study is illustrated in the following chart.

Step 1 (Screening)

Step 2 (Ranking)
