# RESEARCH STUDY ON REVIEW AND APPLICATION OF THE BRIDGE ENGINEERING TRAINING CENTRE PROJECT IN MYANMAR

# **FINAL REPORT**

SEPTEMBER 2012

JAPAN INTERNATIONAL COOPERATION AGENCY

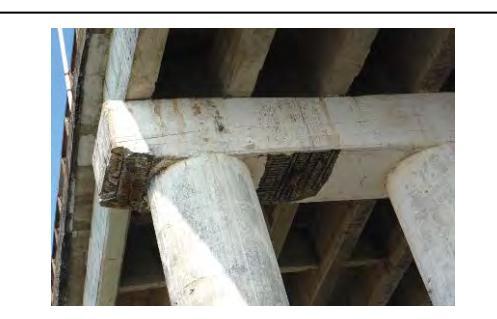
Photo 2.6 Salt Damage at pier

3) Technical problems: Quality of concrete (salt damage, rock pocket of concrete, and tilting of bridge abutments)

Quality control of control was one of the technical transfer items of the BETC Project. Quality control techniques had been successfully transferred to local people upon completing the Project. But bridge inspections indicated that there were problems, including salt damage to concrete. Furthermore, according to the result of bridge site survey (expressway bridge), technical challenges such as rock pocket of concrete and insufficient compaction aspect were observed. The details concerning this damage are explained in Paragraph 3.3 Bridge inspection. The damage was caused primarily because quality control was left to individual discretion and no national criteria for quality control had been established. The BETC Project did not include establishing such a standard within the scope of the Project, but considering the importance of technical sustainability, it will be given priority in the future.

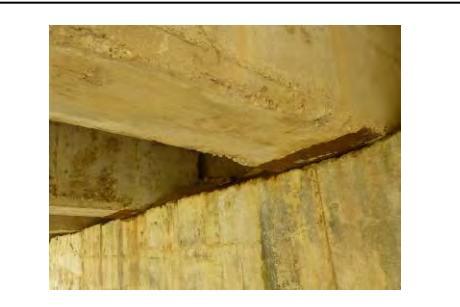
Photo 2.7 Rock pocket of concrete at bridge girder

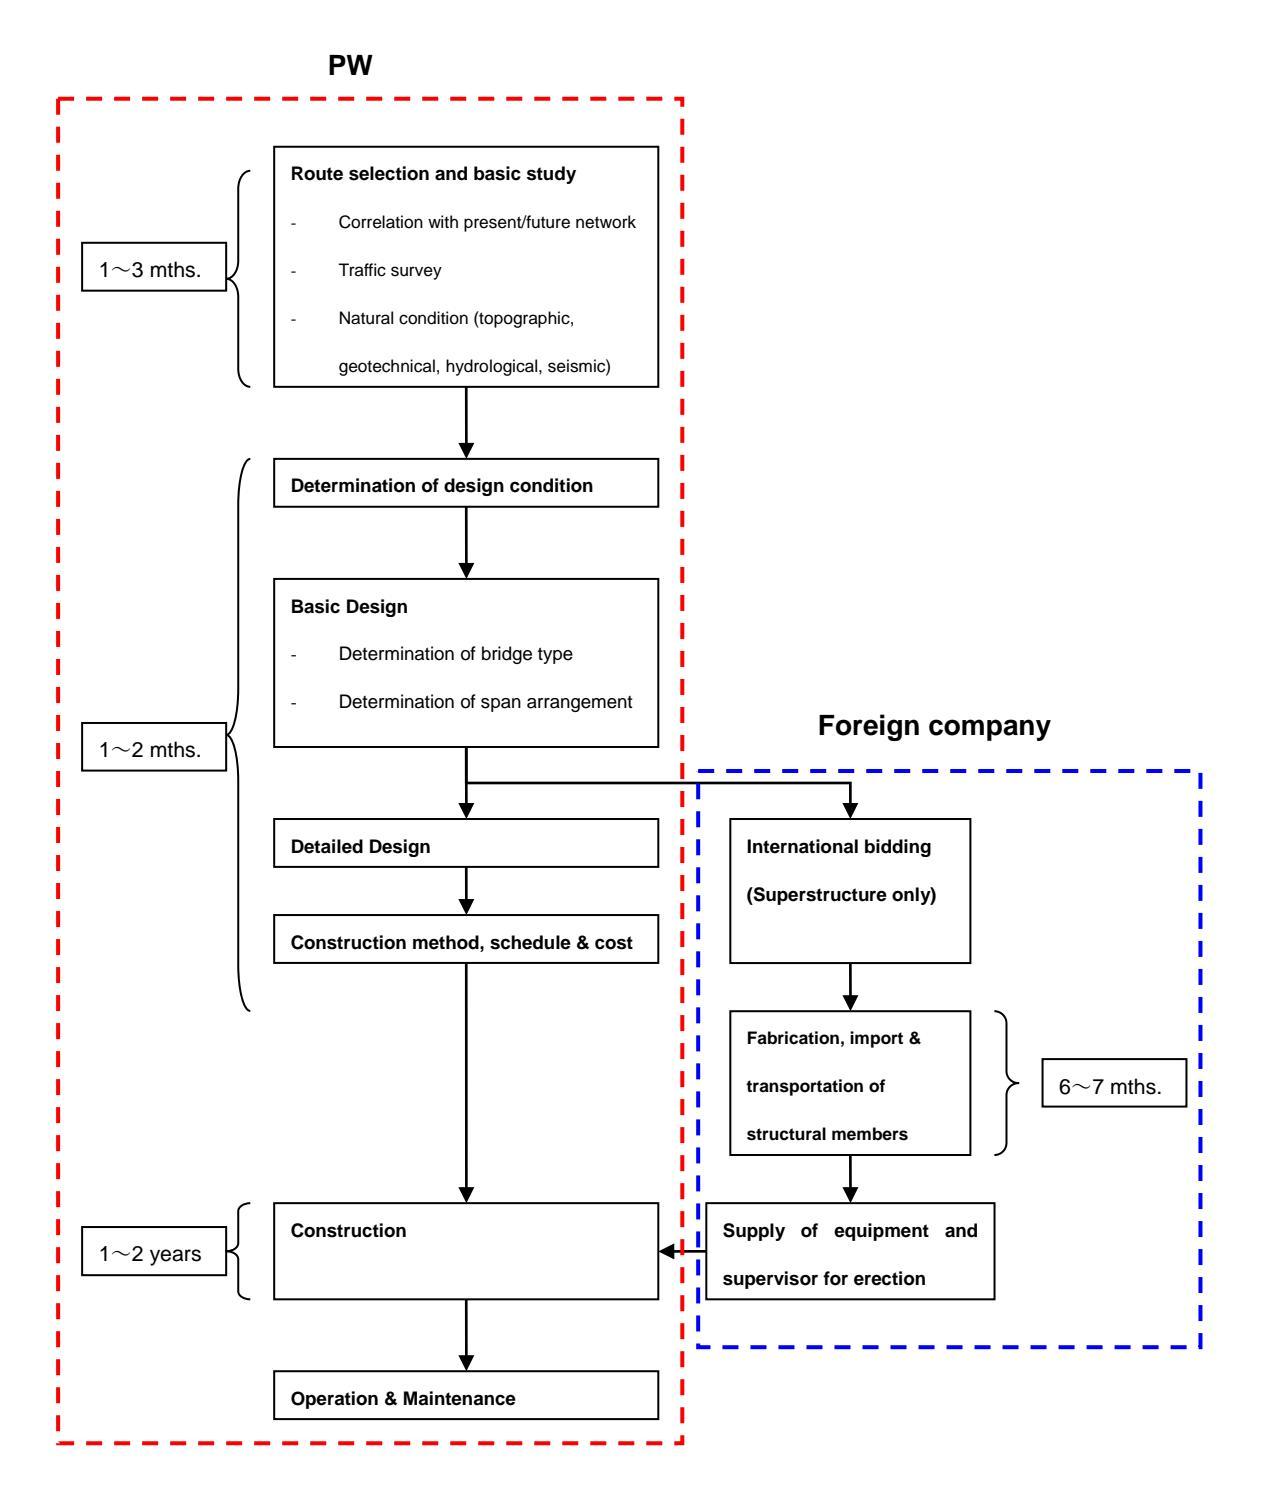
Figure 3.4 Flow chart of implementation of steel truss bridge project

The following flow chart shows the typical procedure from planning to construction stage in steel truss bridge projects which have been widely adopted in Myanmar.

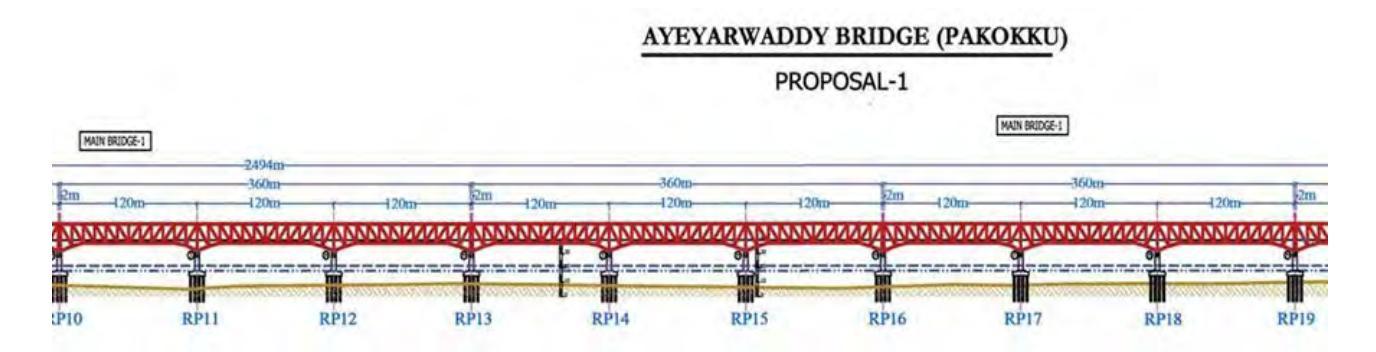
Figure 3.8 Common span length of a steel truss bridge (Pakokku Bridge)

According to a contract document between China and PW on design/construction of a steel truss bridge designed/manufactured in China, manufactured steel members are supposed to be transported into Myanmar within six months. Even though steel truss bridges are straight bridges and are similar to one another in terms of structures to be manufactured, the time needed for bridge design seems to be very short given the time needed for material arrangement/processing. As for design verification, the contract stipulates that two PW employees take responsibility for checking the design and drawings as the contractor. Considering the process, however, such verification seems to be practically impossible. The Study Team also confirmed that the contents of design drawings of a steel truss bridge were the same as those of another steel truss bridge, which may be an indication that the design calculation document of an older bridge was used for a new bridge. Therefore, it is necessary to strictly ensure that contractors submit the design calculation documents as clearly specified in the contracts. In a standard construction of a steel truss bridge, span length is 120m with some adjustments made according to river width as shown in Figure 3.8. In Myanmar, however, river transportation is still predominant and therefore there will be a need for plans of steel truss bridges with longer span lengths. To meet such a need, the PW employees will also need to enhance their technical abilities to design steel structures themselves.

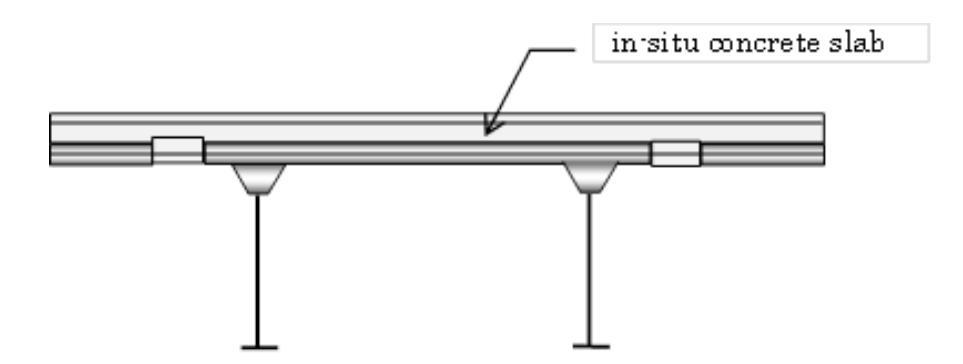
Figure 3.9 Cross section of deck slab (two-part construction)

The Study Team learned, especially from the workability point of view, that some of the bridges had deck slabs separated into two parts in the cross-sectional direction as shown in Figures 3.9 and 3.10, and the bottom part was made of precast slabs which were also used as formwork. This type of deck slab is constructed by pouring concrete on site on the precast slabs placed on the stringers of the truss floor system, where deck slab tension bar is placed inside the precast slabs. This type of structure was initially adopted for bridges designed in Switzerland in the 1980s and is still used today for Maubin Bridge and other bridges even after more than 20 years.

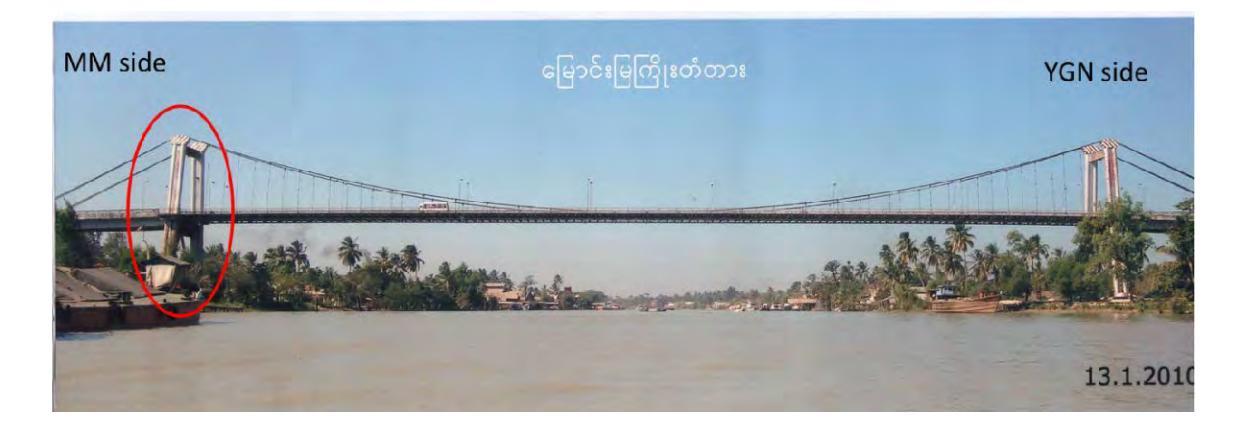
Photo 3.2 Substructure movement (Myaungmya Bridge)

Surveys of Bayinaung Bridge, Maubin Bridge and others revealed that the abutments of these bridges were pushed forward by earth pressure on the structure wall as shown in Photo 3.1. There is lateral flow in general, and when calculating the lateral flow of Maubin Bridge with a formula provided in the Japanese Specification for Highway Bridges IV, the lateral flow value (I value) determining the chance of lateral flow of the abutment was 1.96, indicating that "there is a chance of lateral flow." When the I value is 1.2 or above, it is determined that "there is a chance of lateral flow."

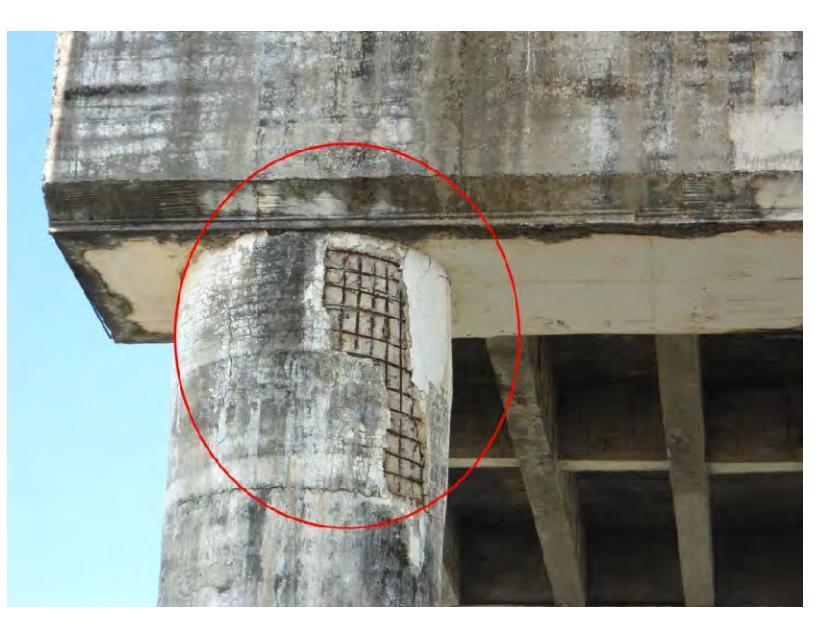
Photo 3.3 Salt damage (Min Chaung Bridge)

The coastal area along the Bay of Bengal is a vast delta where there are many swamps containing sea water. Sand and fresh water are not easily accessible due to high cost of collection/transportation of salt free sand and fresh water from remote locations, and therefore water containing sea sand and salt was used when constructing the concrete bridges. This has resulted in concrete spalling and corrosion of reinforced

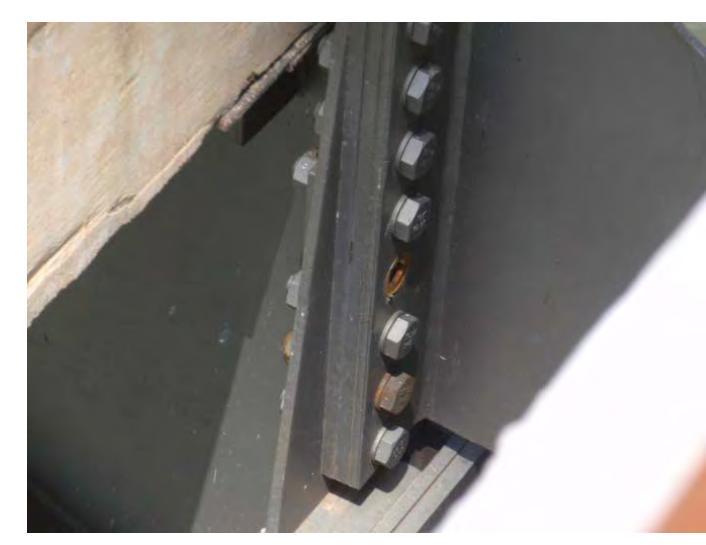
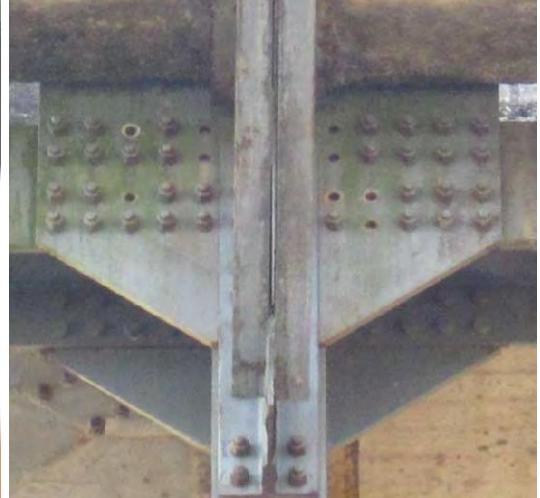
Photo 3.4. Missing high tension bolt (Yadanarpon Bridge)

High tension bolts were found to be missing and damaged on Yadanarpon Bridge, Pathein Bridge and other bridges. As these bridges were designed in China, one commonality among them is that the high tension bolts used on them were made in China. This time, the Study Team conducted a site inspection of Yadanarpon Bridge, where 50-80 bolts are found to be missing every month. Given that the bridge was completed in 2008, the number of damage events is just extraordinary. The problem seems to be caused by the material of bolts rather than construction work. It is advisable that appropriate material specifications and quality control values are established to ensure adequate quality. (See Photo 3.4 and 3.5.)

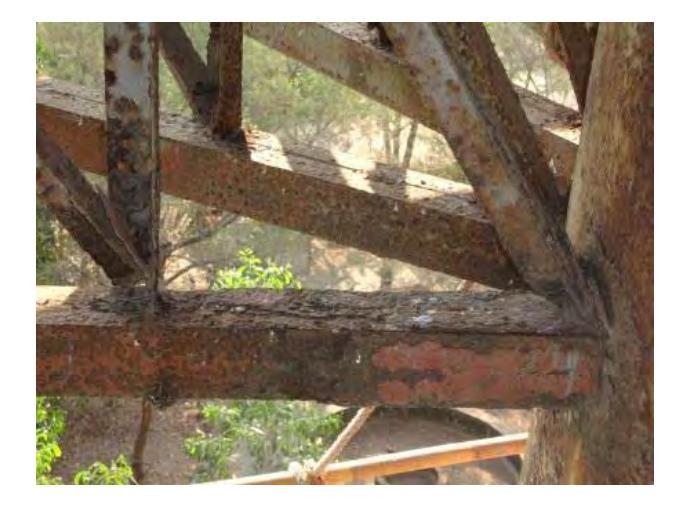
Photo 3.6 Myaungmya Bridge corrosion (before repainting)

Repainting of the girders of Myaungmya Bridge is shown in Photo 3.6 to 3.9.

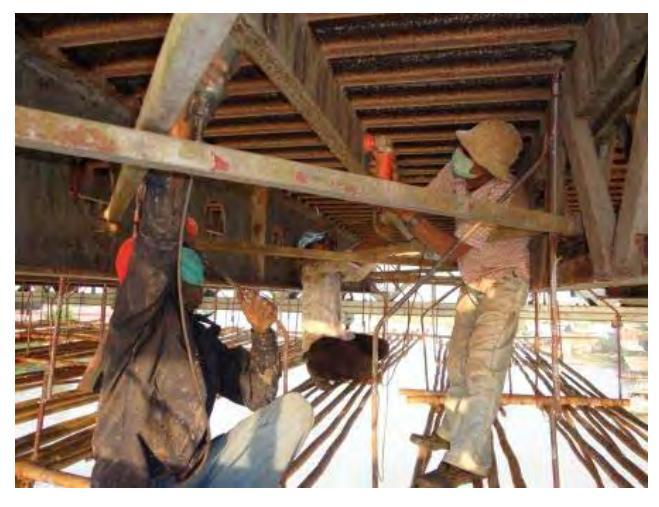
Photo 3.7 Myaungmya Bridge repainting (surface preparation)

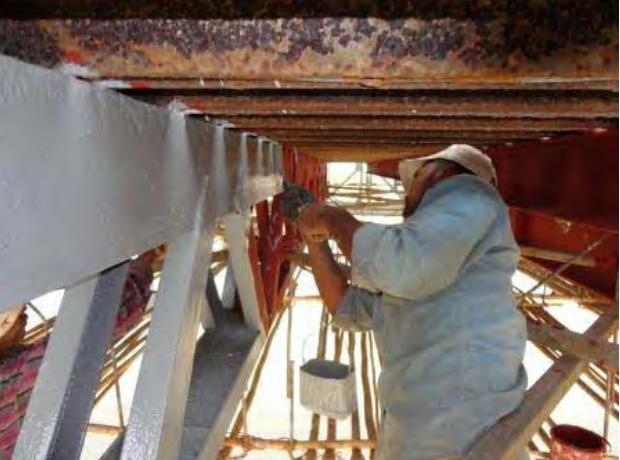
Photo 3.9 Myaungmya Bridge repainting (second coat)

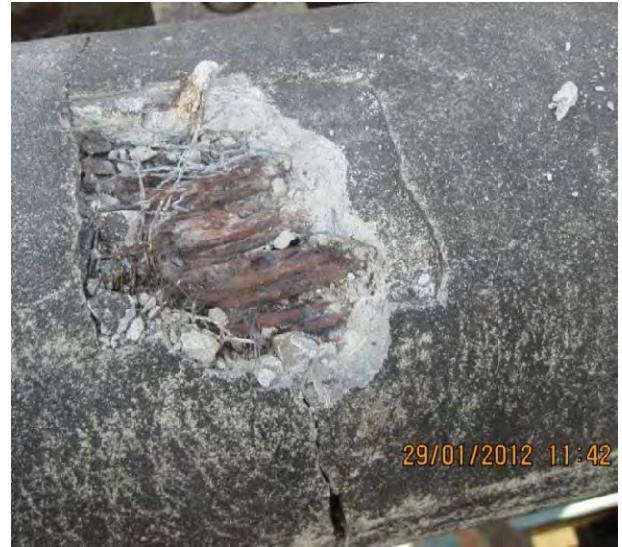
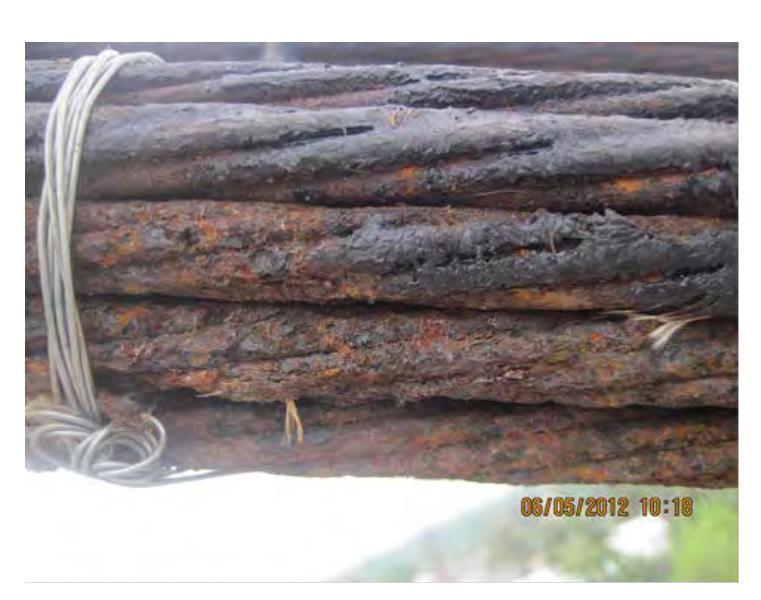
Photo 3.10 Myaungmya Bridge main cable corrosion

On Myaungmya Bridge (suspension bridge) completed in 1996, strands of the main cable were partially broken/corroded. The cable was repaired through a six-step process: 1) primer, 2) primer, 3) inner wrap, 4) primer, 5) outer wrap and 6) color. If breakage of the main cable progresses, there is high risk of collapse of the bridge. Therefore, it is advisable to establish proper painting specifications and quality control values to ensure adequate quality. (See Photo 3.10 and 3.11.)

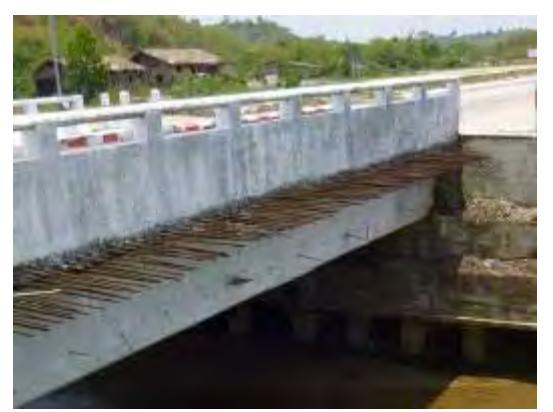
Photo 3.12 Steel beams of deck slabs for widening are rusting

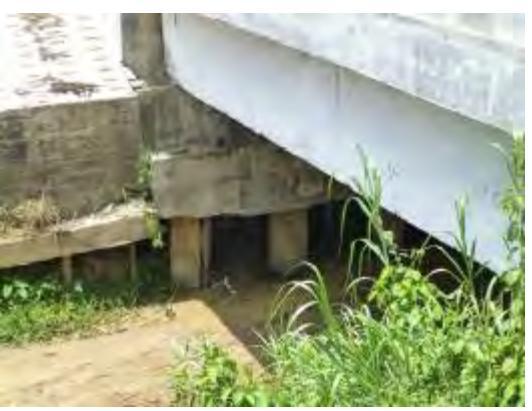
Photo 3.13 Scouring of pier foundations

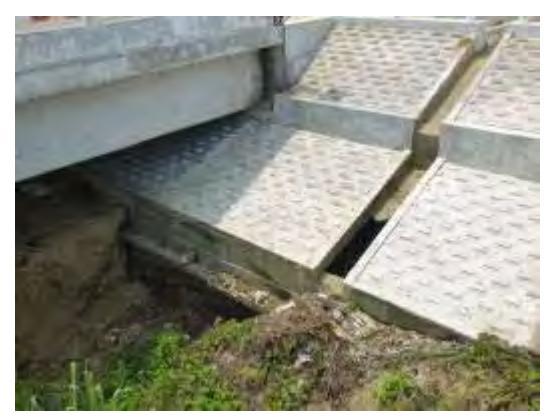
Photo 3.14 The bottom of the block is greatly scooped out.

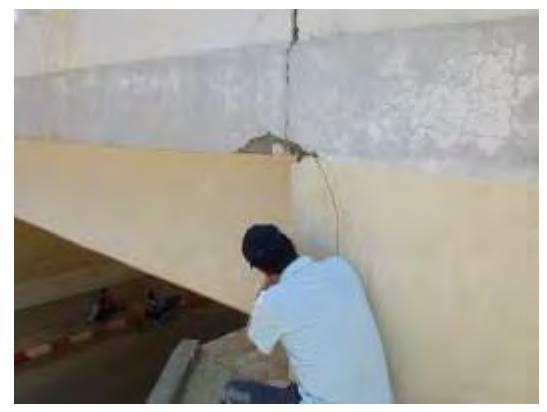
Photo 3.15 Both the abutment parapet and girders are cracked

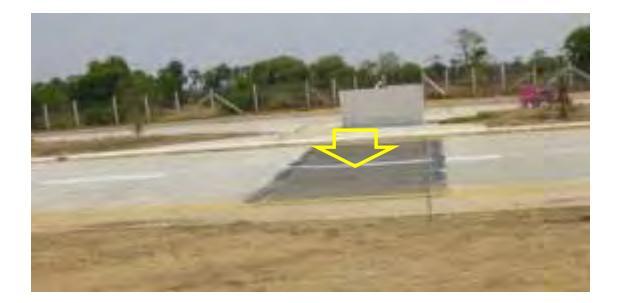
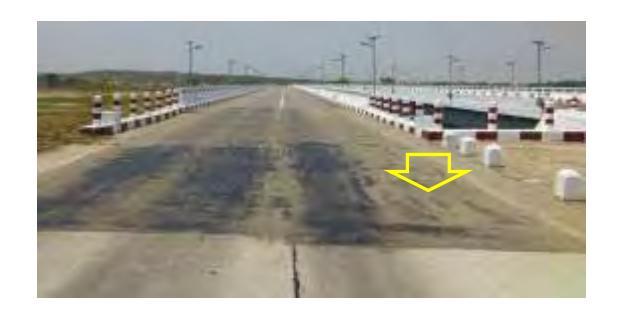
- 2) Construction supervision
- At many points, concrete pavement which has approximately 45cm thickness is caused a uneven settlement. Particularly, the road surface is uneven at either end of bridges and in areas where structures are added on to crossings. It was caused by insufficient supervision for earthwork in the construction stage.

Photo 3.20 Settlement at a box culvert

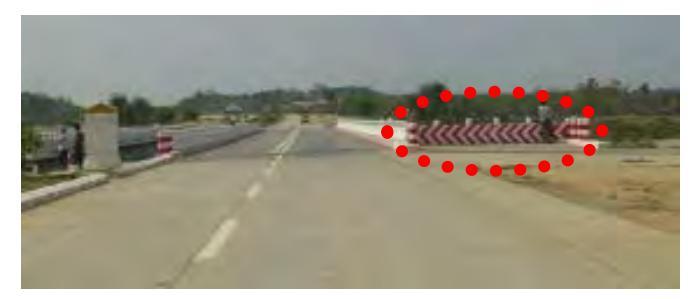
• At the ends of bridges, there are walls or concrete poles to prevent vehicles from falling in a river. As the expressway has no guardrails, there is a risk that cars can go out of the lane and collide with these walls, resulting in major, fatal accidents. Particularly at small bridges such as the one shown in Photo 3.22, this risk becomes greater diuring nighttime. There is an urgent need to take measures such as installation of reflectors and cushion drums, etc.

Photo 3.22 Bridge area with high risk of collision

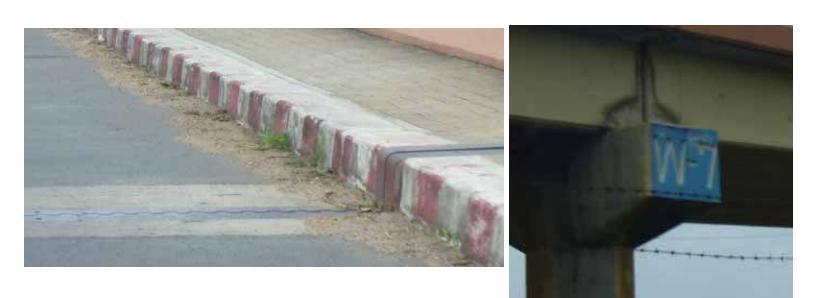
Leakage from the joints have already soiled the girders and bridge piers.
 Above the RC, there is a bearing consisting only of an iron plate, so its functions might be lost because of corrosion deterioration caused by water.

No shear connectors were installed on the girders at right angles in the bridge axis.

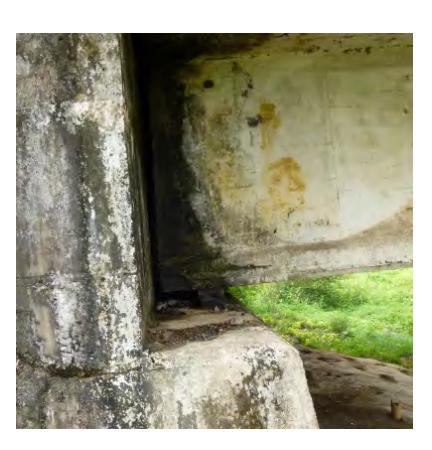
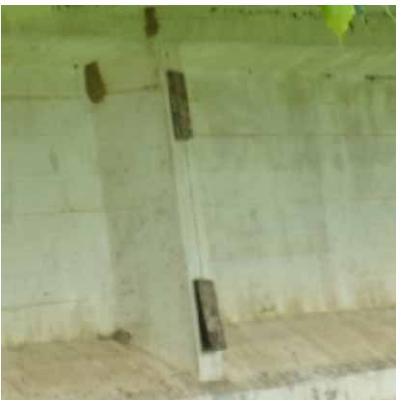
• On the pier, the ends of the girders are severely deteriorated by leaking water. On the road surface, there is a pavement overlay from above the existing joint (angle material), but there are gaps at the girder ends, and water blocking measures are not taken.

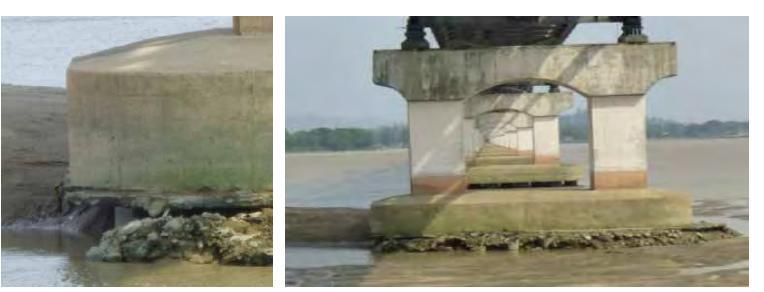
• The foundation was badly scoured. The piles were under the footing, and appeared to be cut. It is possible they were cut, because the scouring around the piles caused by the flowing water had reduced the horizontal resistance of the piles.

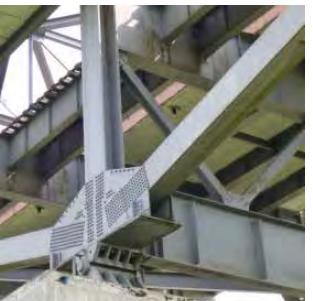
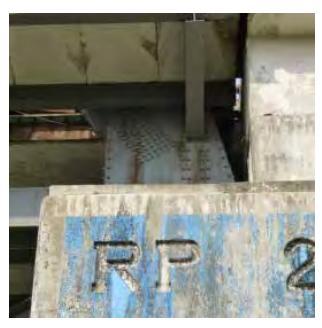
Places where the bolts had fallen out were seen. It is concerned that the bridge is not adequately inspected and maintained.

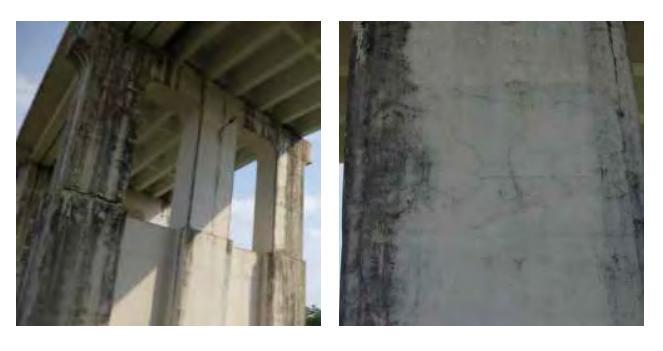
- Water leaking from the expansion device on the bridge surface was severely soiling the bridge piers.
- The bridge piers were cracked. Because it is close to the ocean, a detailed inspection must be done.

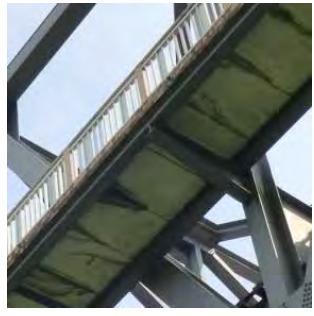
• The concrete panels on the sidewalk are deteriorated. There is danger that they will fall out.

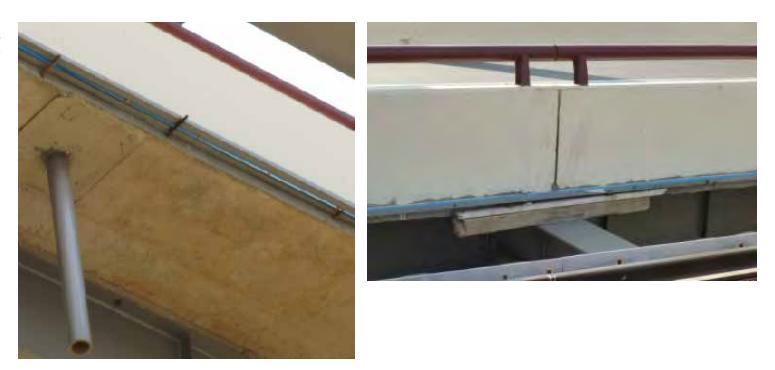
A cable is passed under the railing, but one part only hung on a steel iron bar and a part with its height adjusted by a wooden panel remained, so it is still in temporarily installed state.

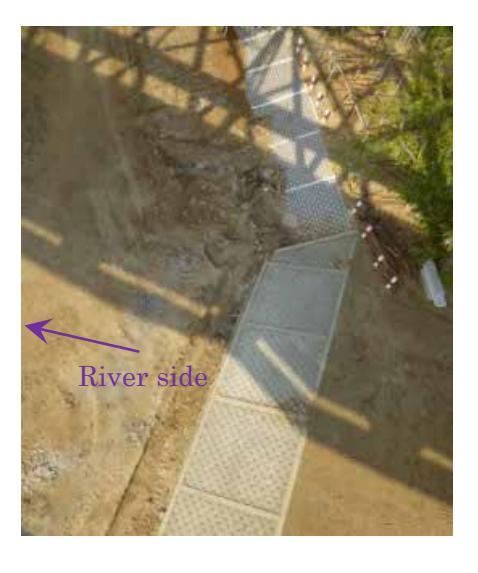
• Slope protection work executed by block pitching has been done. But the block pitching work is not sufficiently embedded so there is fear of damage to the block pitched foundations.
